Slope Instability at Country Lane and Jericho Road, Hartford, Vermont

May 15, 2008

Photos from site visit of May 13, 2008 by
Laurence Becker, Vermont State Geologist,
Vermont Department of Environmental
Conservation, and George Springston,
Research Associate, Norwich University
Department of Geology and Environmental
Science.

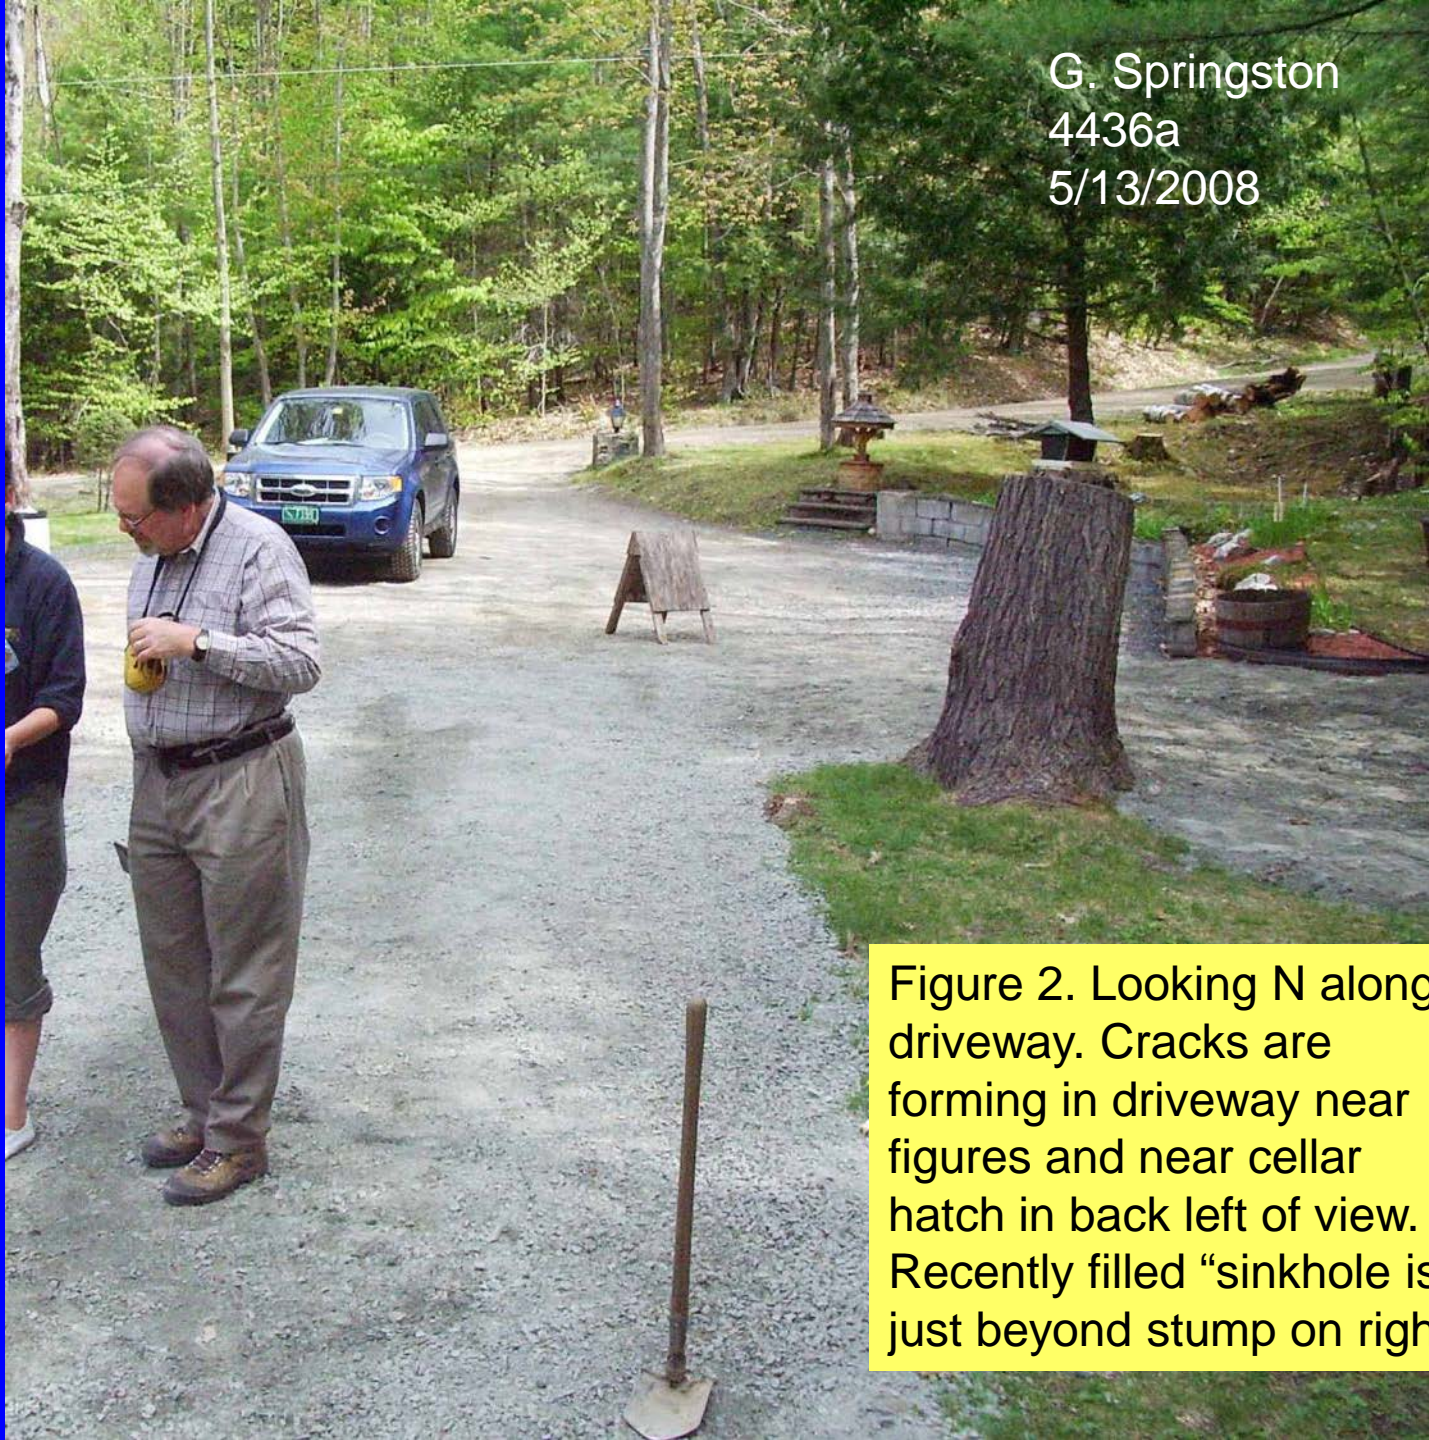
Figure 2. Looking N along driveway. Cracks are forming in driveway near figures and near cellar hatch in back left of view. Recently filled "sinkhole is just beyond stump on right.

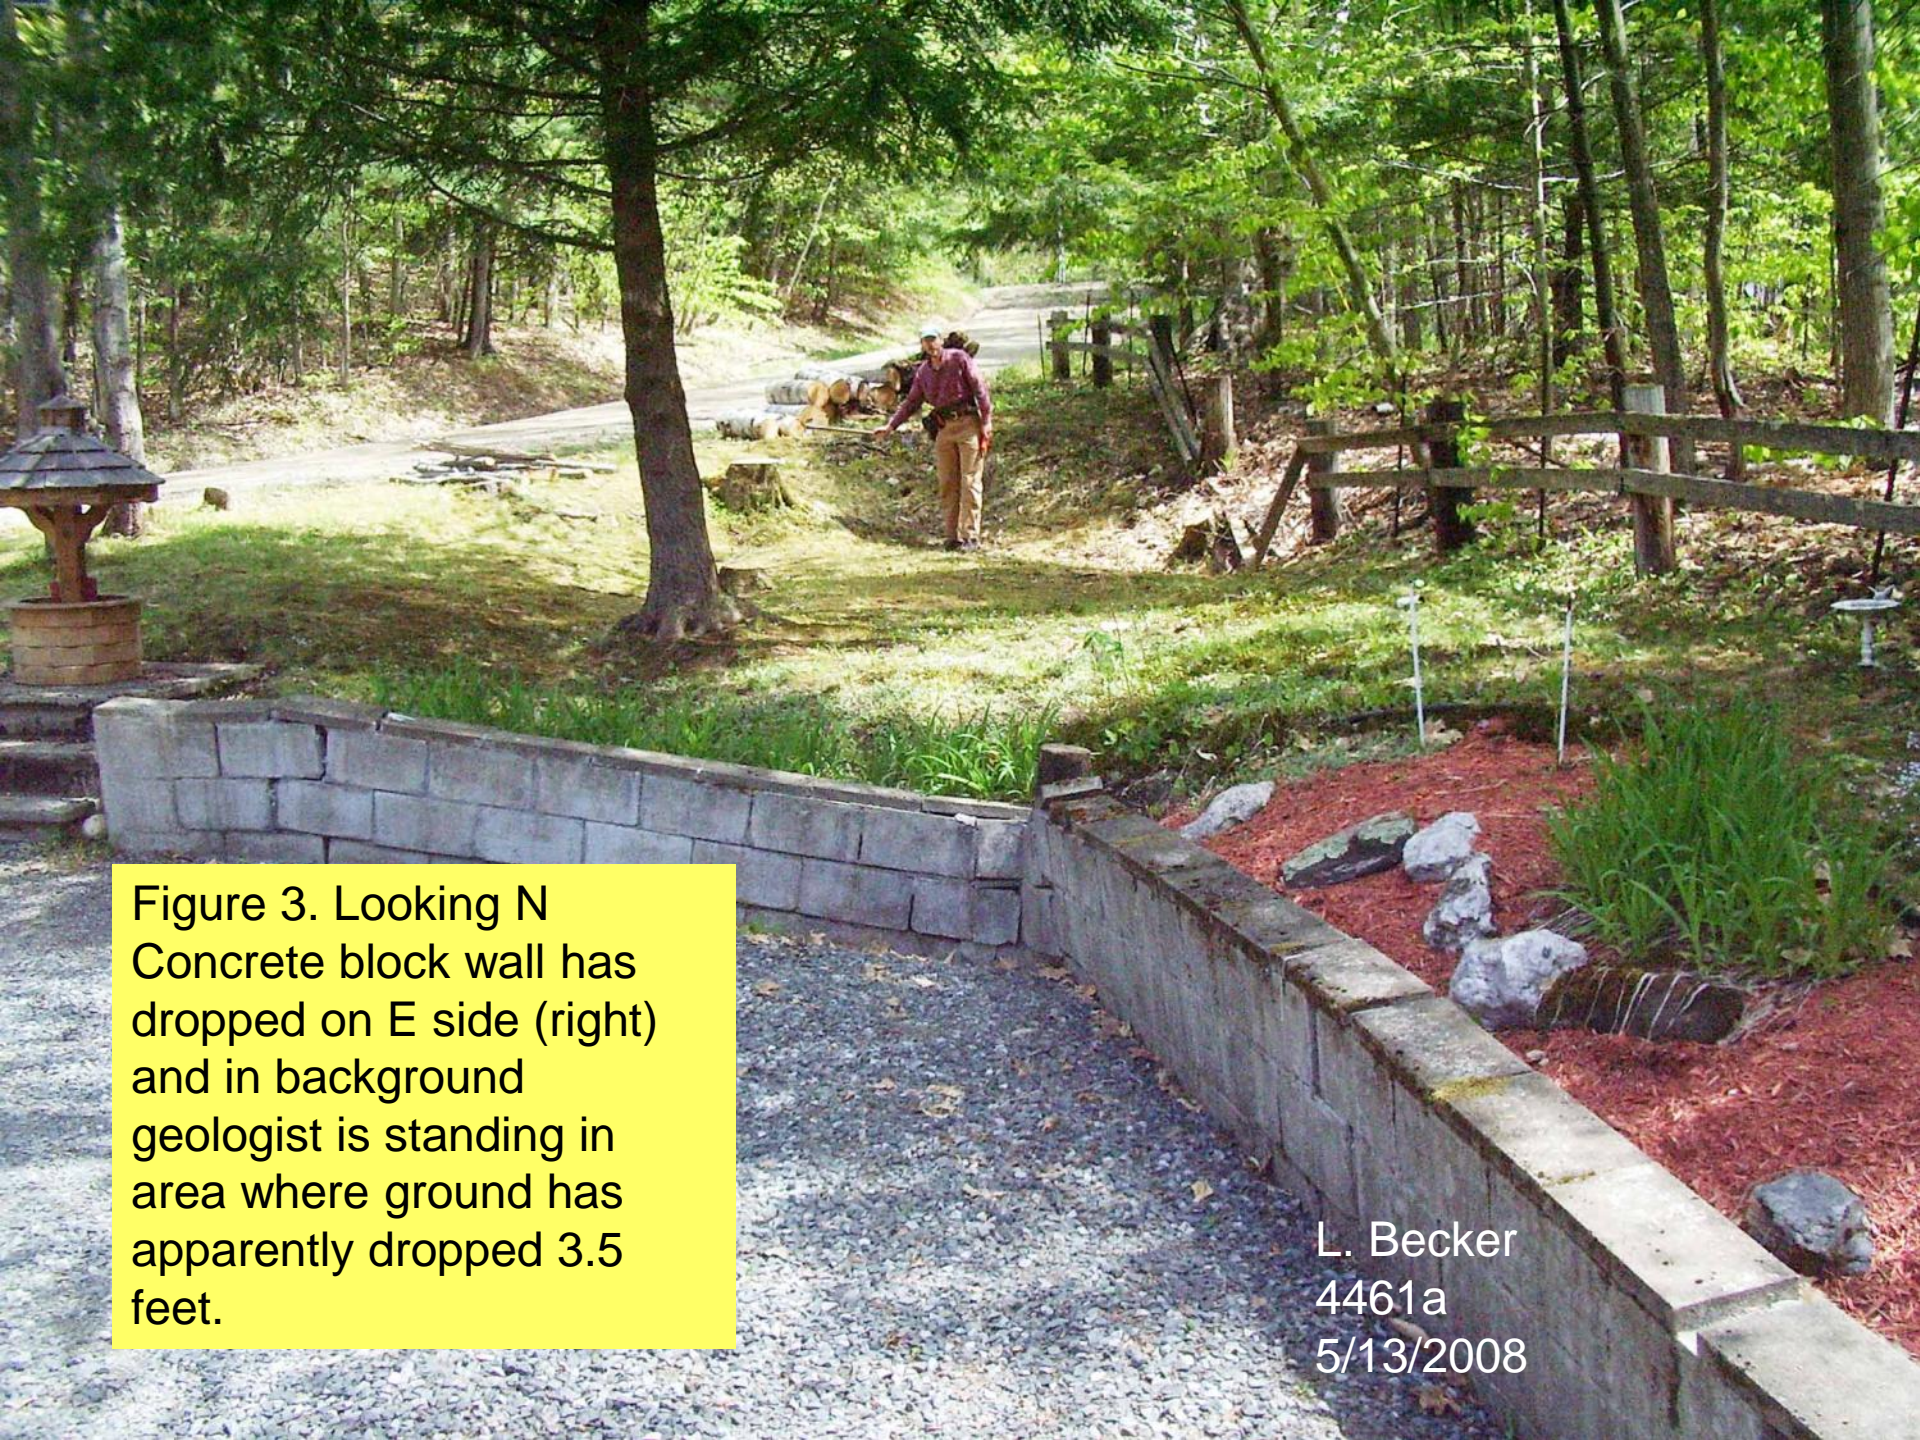
Figure 3. Looking N
Concrete block wall has
dropped on E side (right)
and in background
geologist is standing in
area where ground has
apparently dropped 3.5
feet.

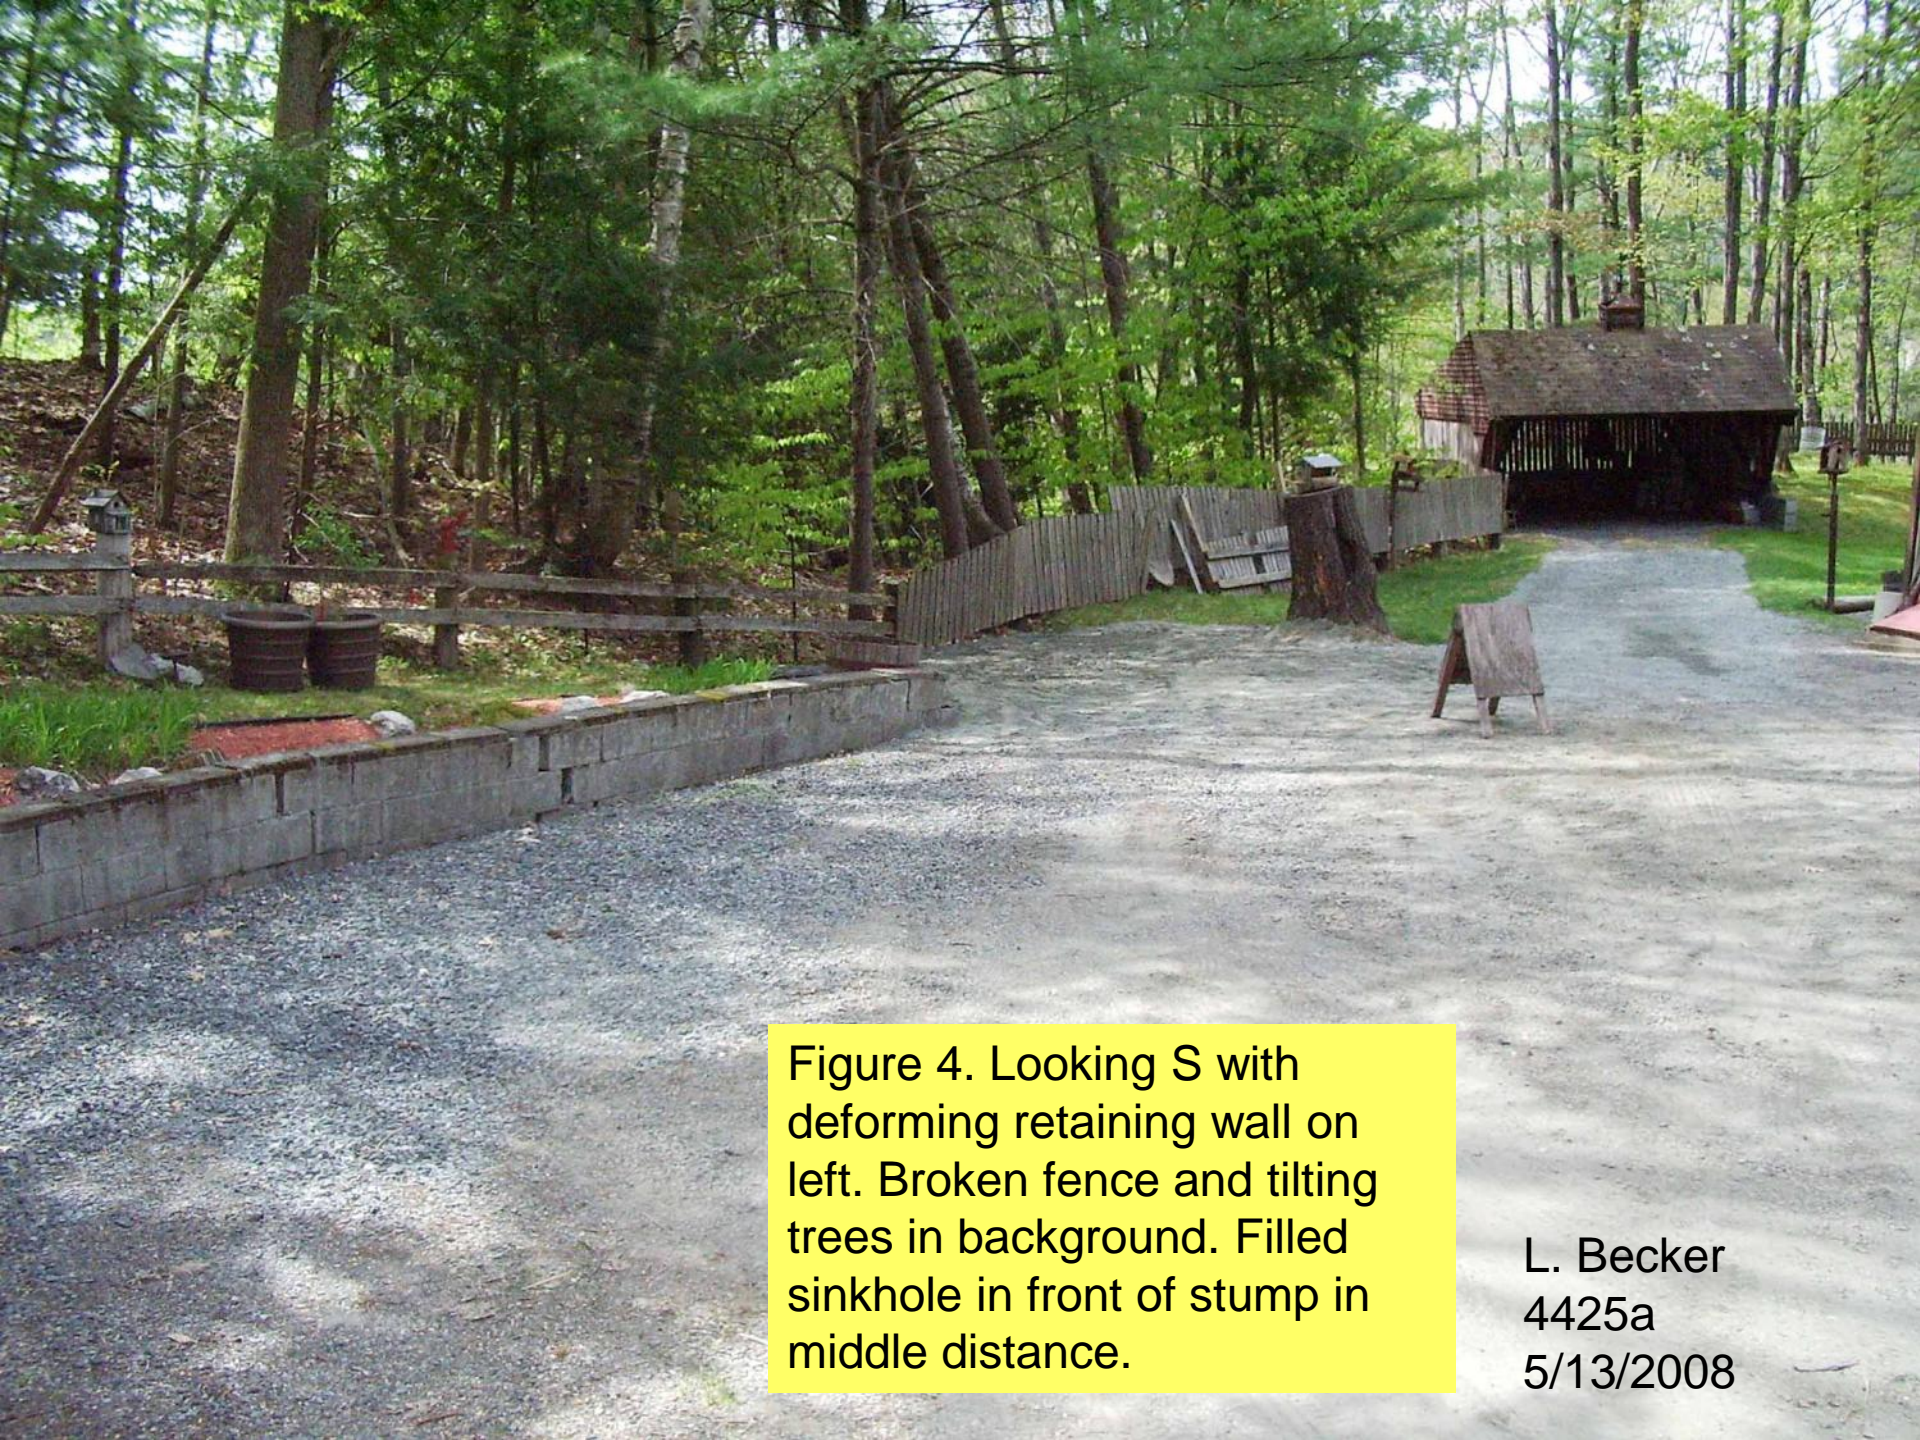
Figure 4. Looking S with deforming retaining wall on left. Broken fence and tilting trees in background. Filled sinkhole in front of stump in middle distance.

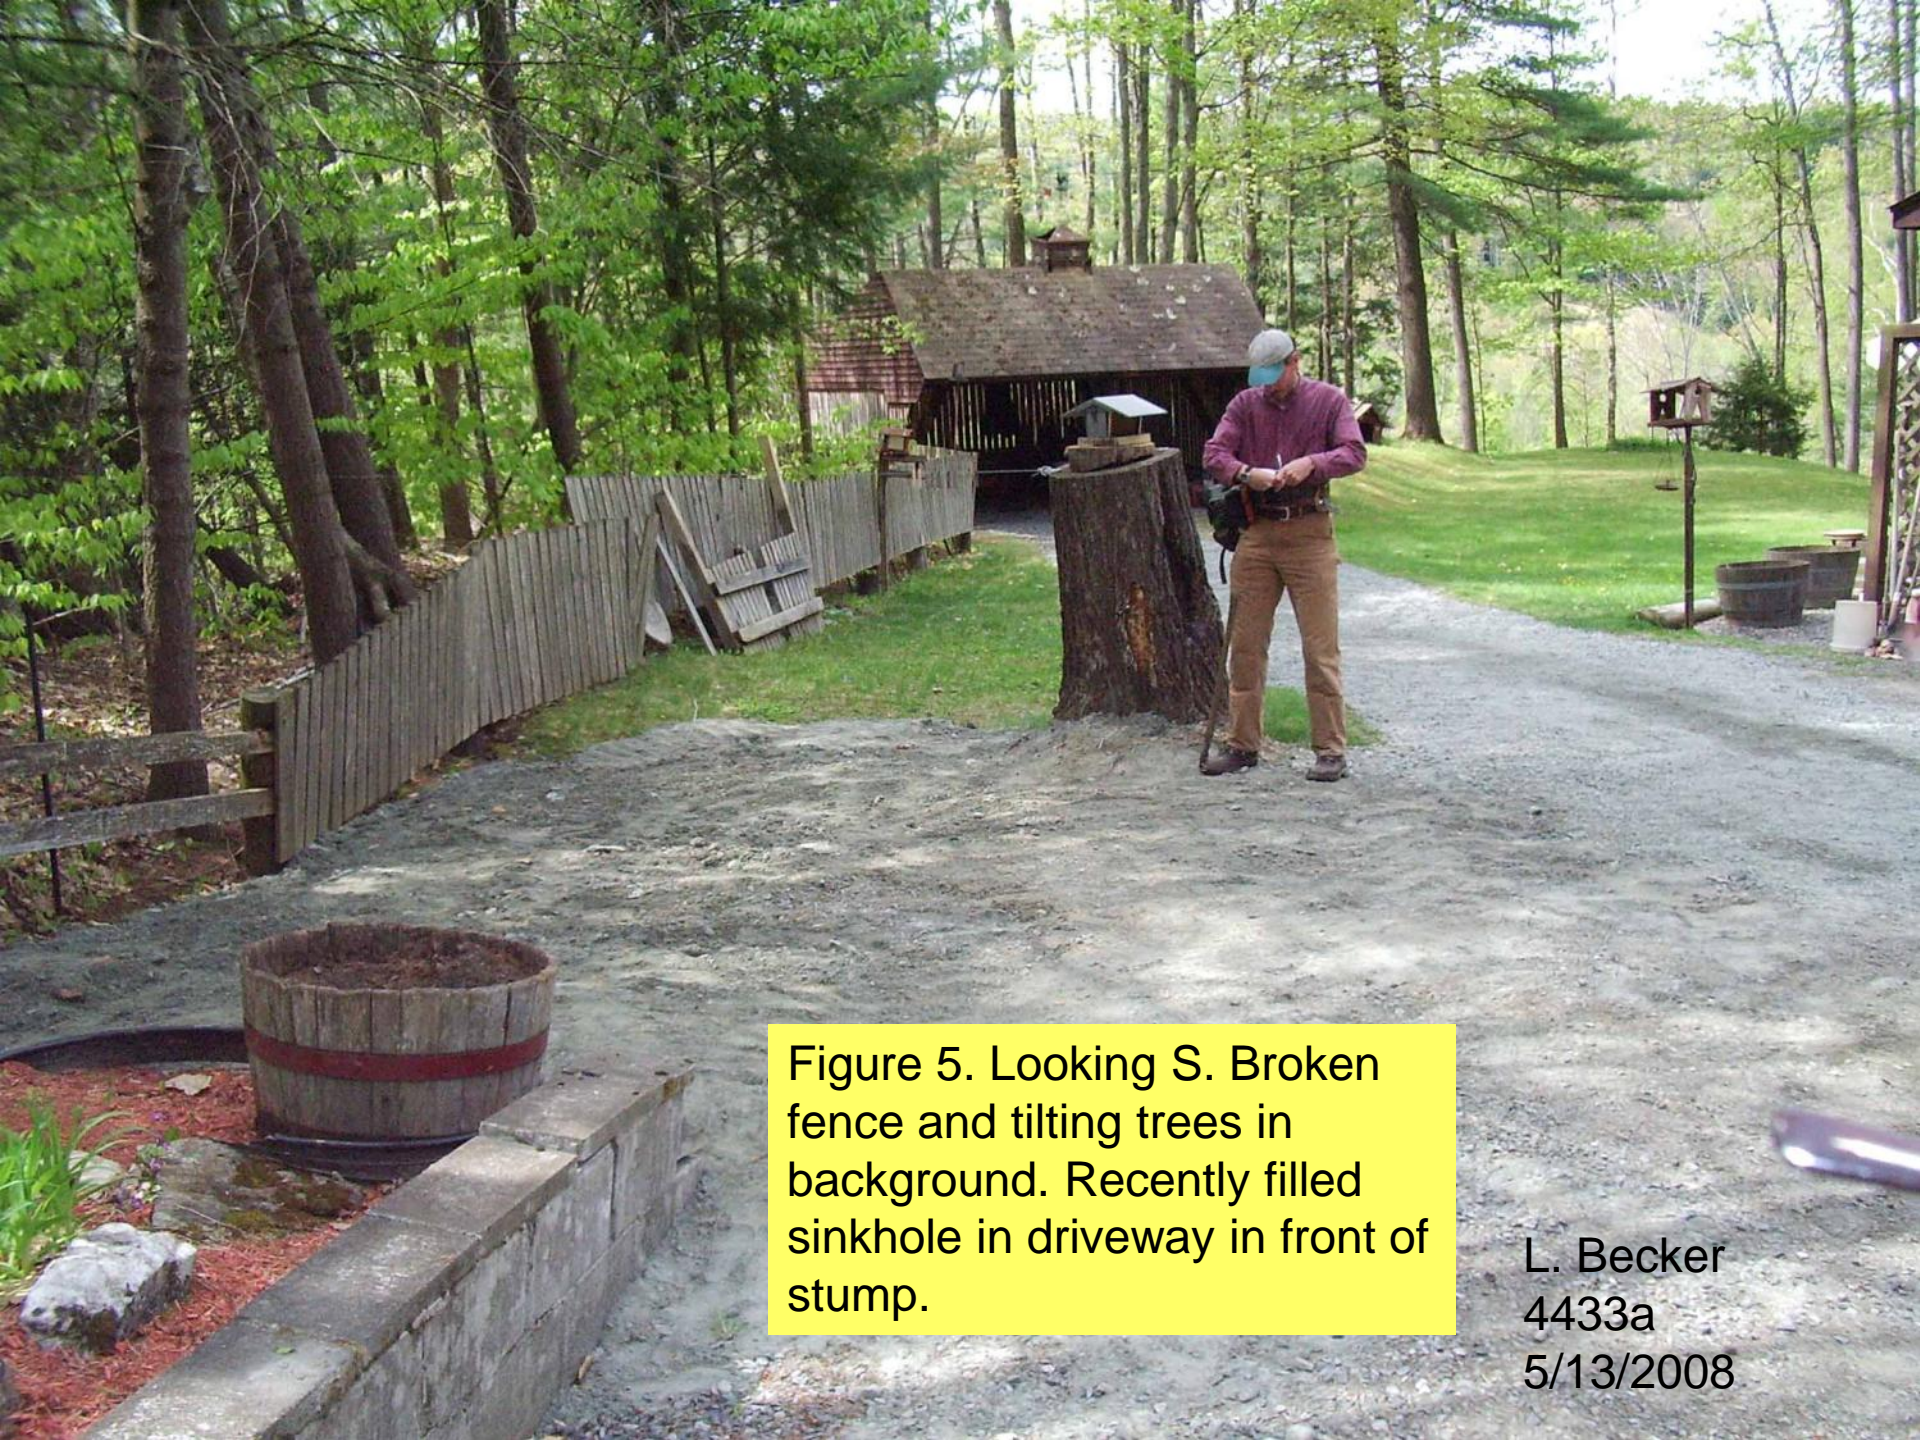
Figure 5. Looking S. Broken fence and tilting trees in background. Recently filled sinkhole in driveway in front of stump.

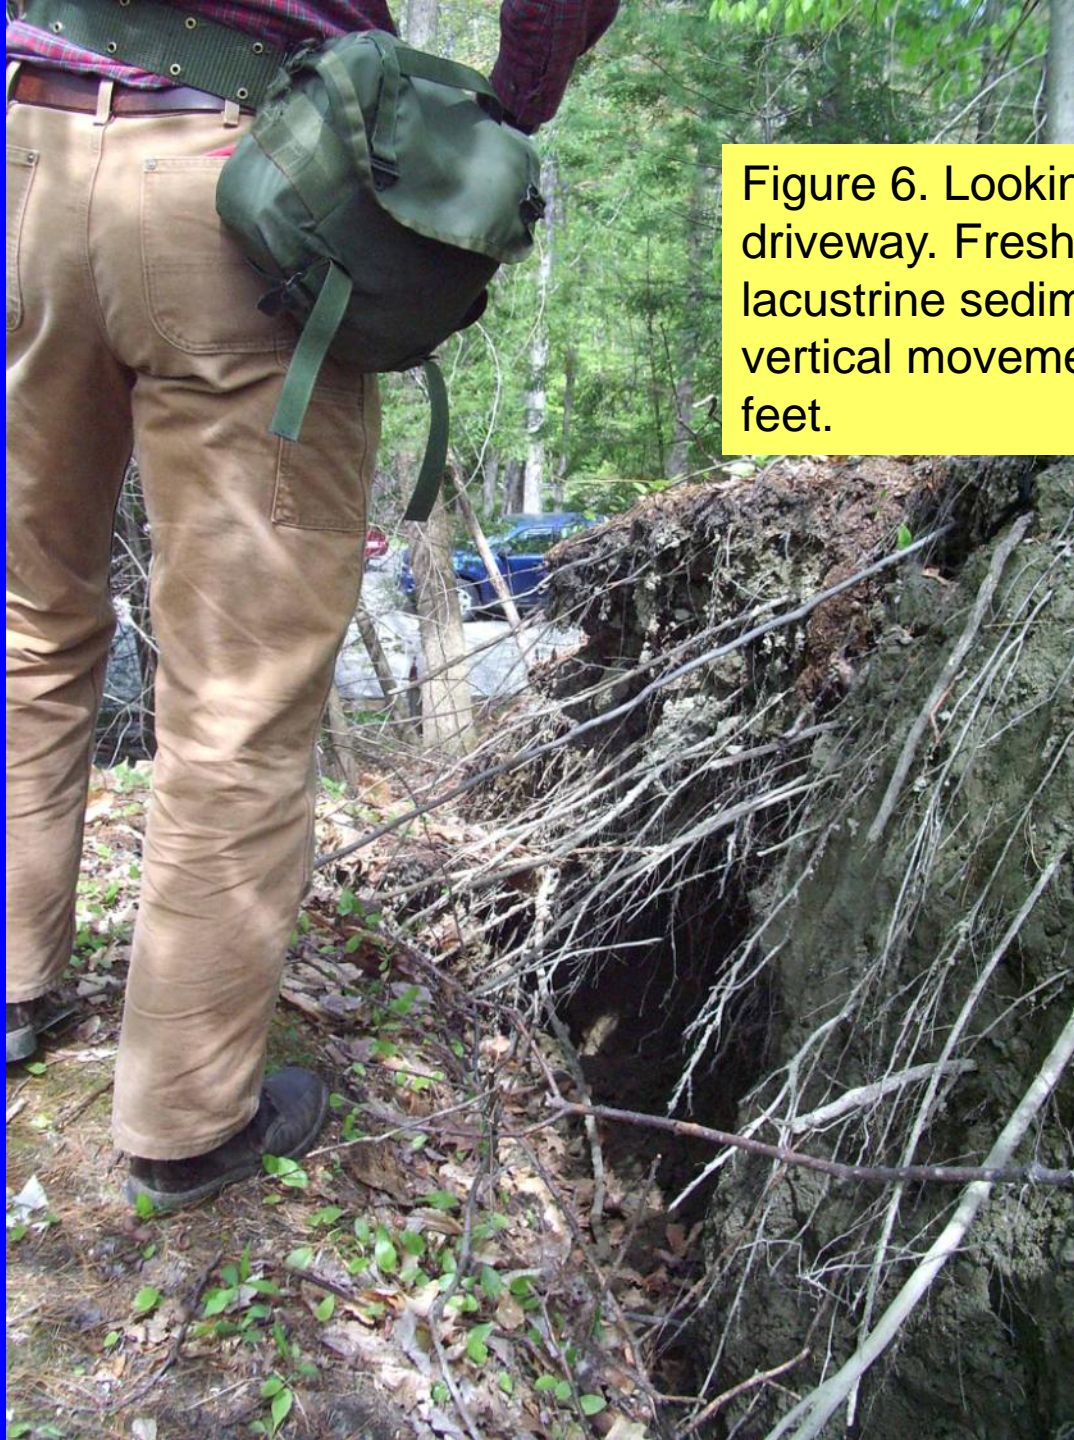
Figure 6. Looking W towards driveway. Fresh fault scarp in lacustrine sediments with vertical movement of about 2 feet.

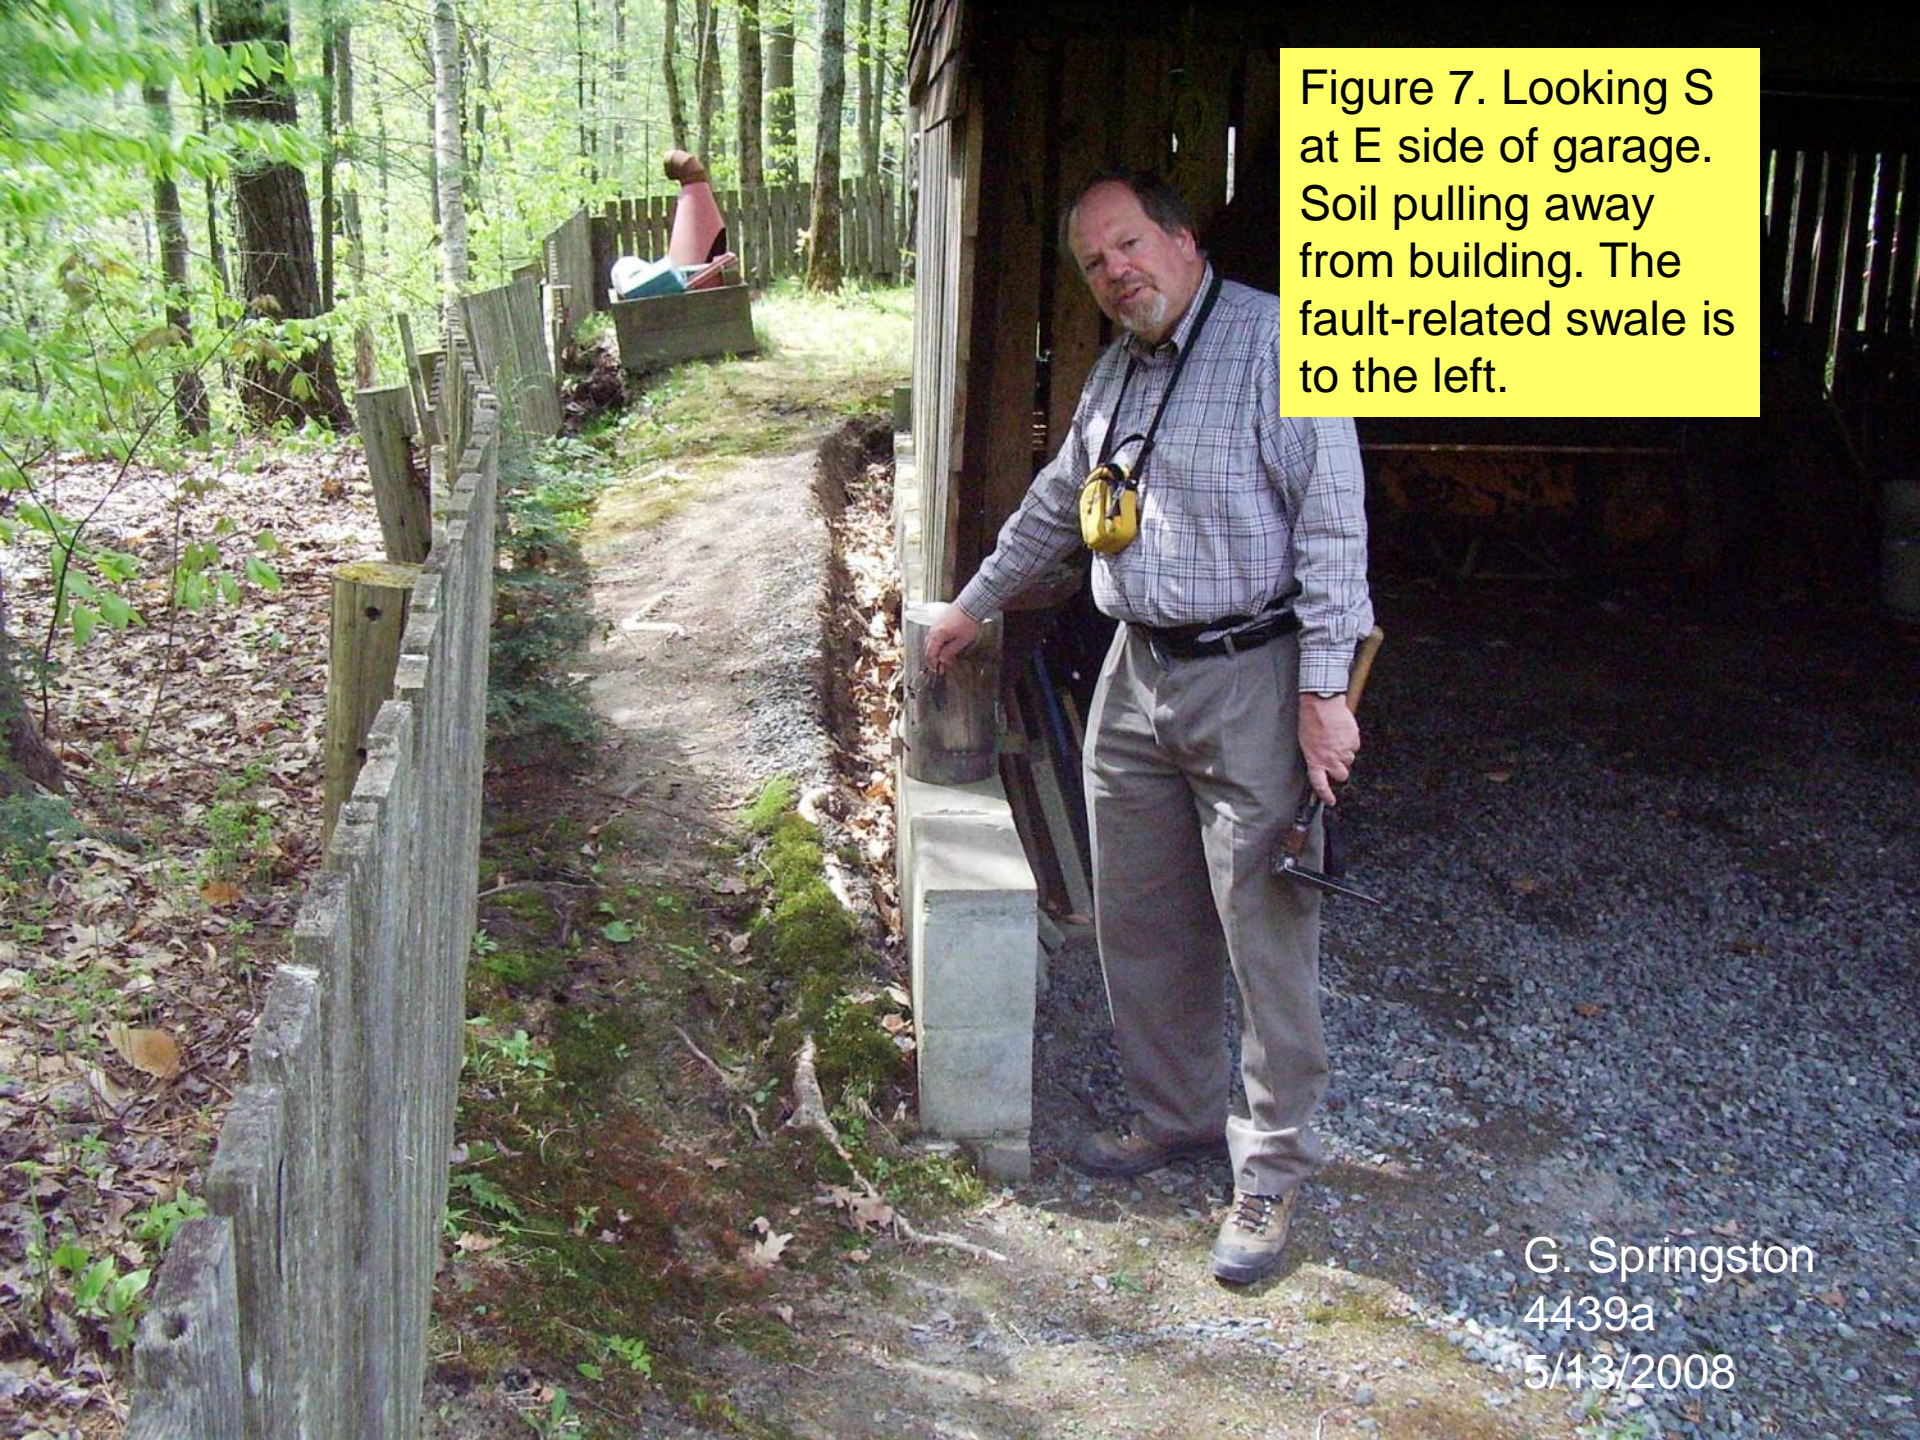
Figure 7. Looking S at E side of garage. Soil pulling away from building. The fault-related swale is to the left.

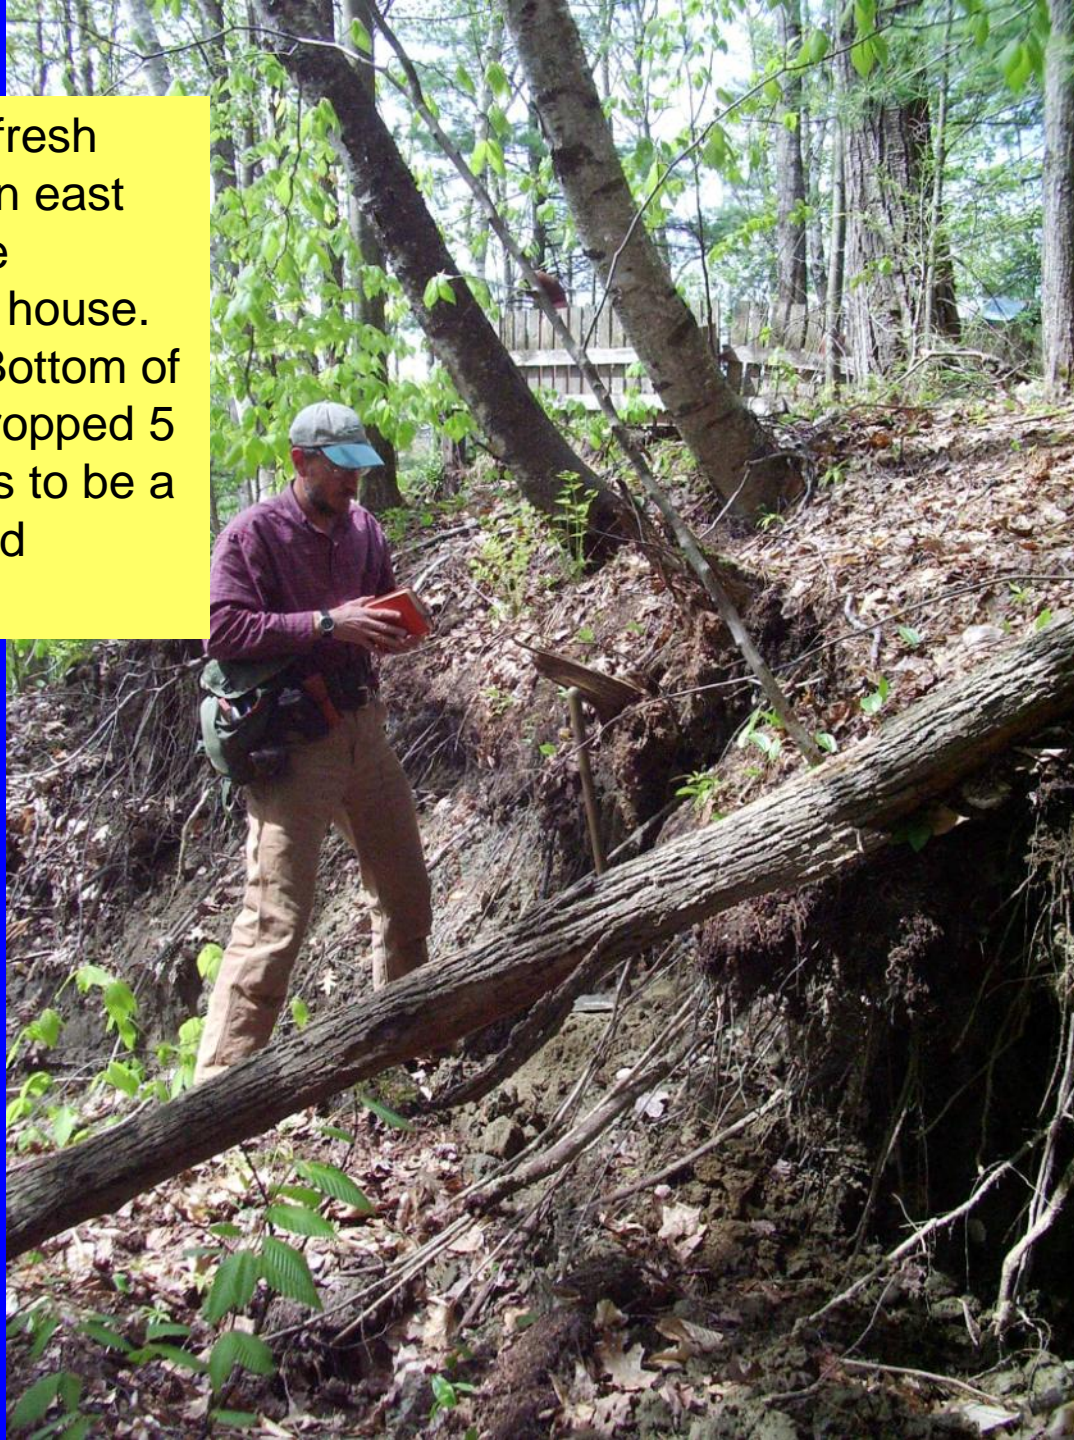
Figure 8. At fresh fault scarp on east side of swale southeast of house. Looking N. Bottom of swale has dropped 5 feet. Appears to be a fault-bounded graben.

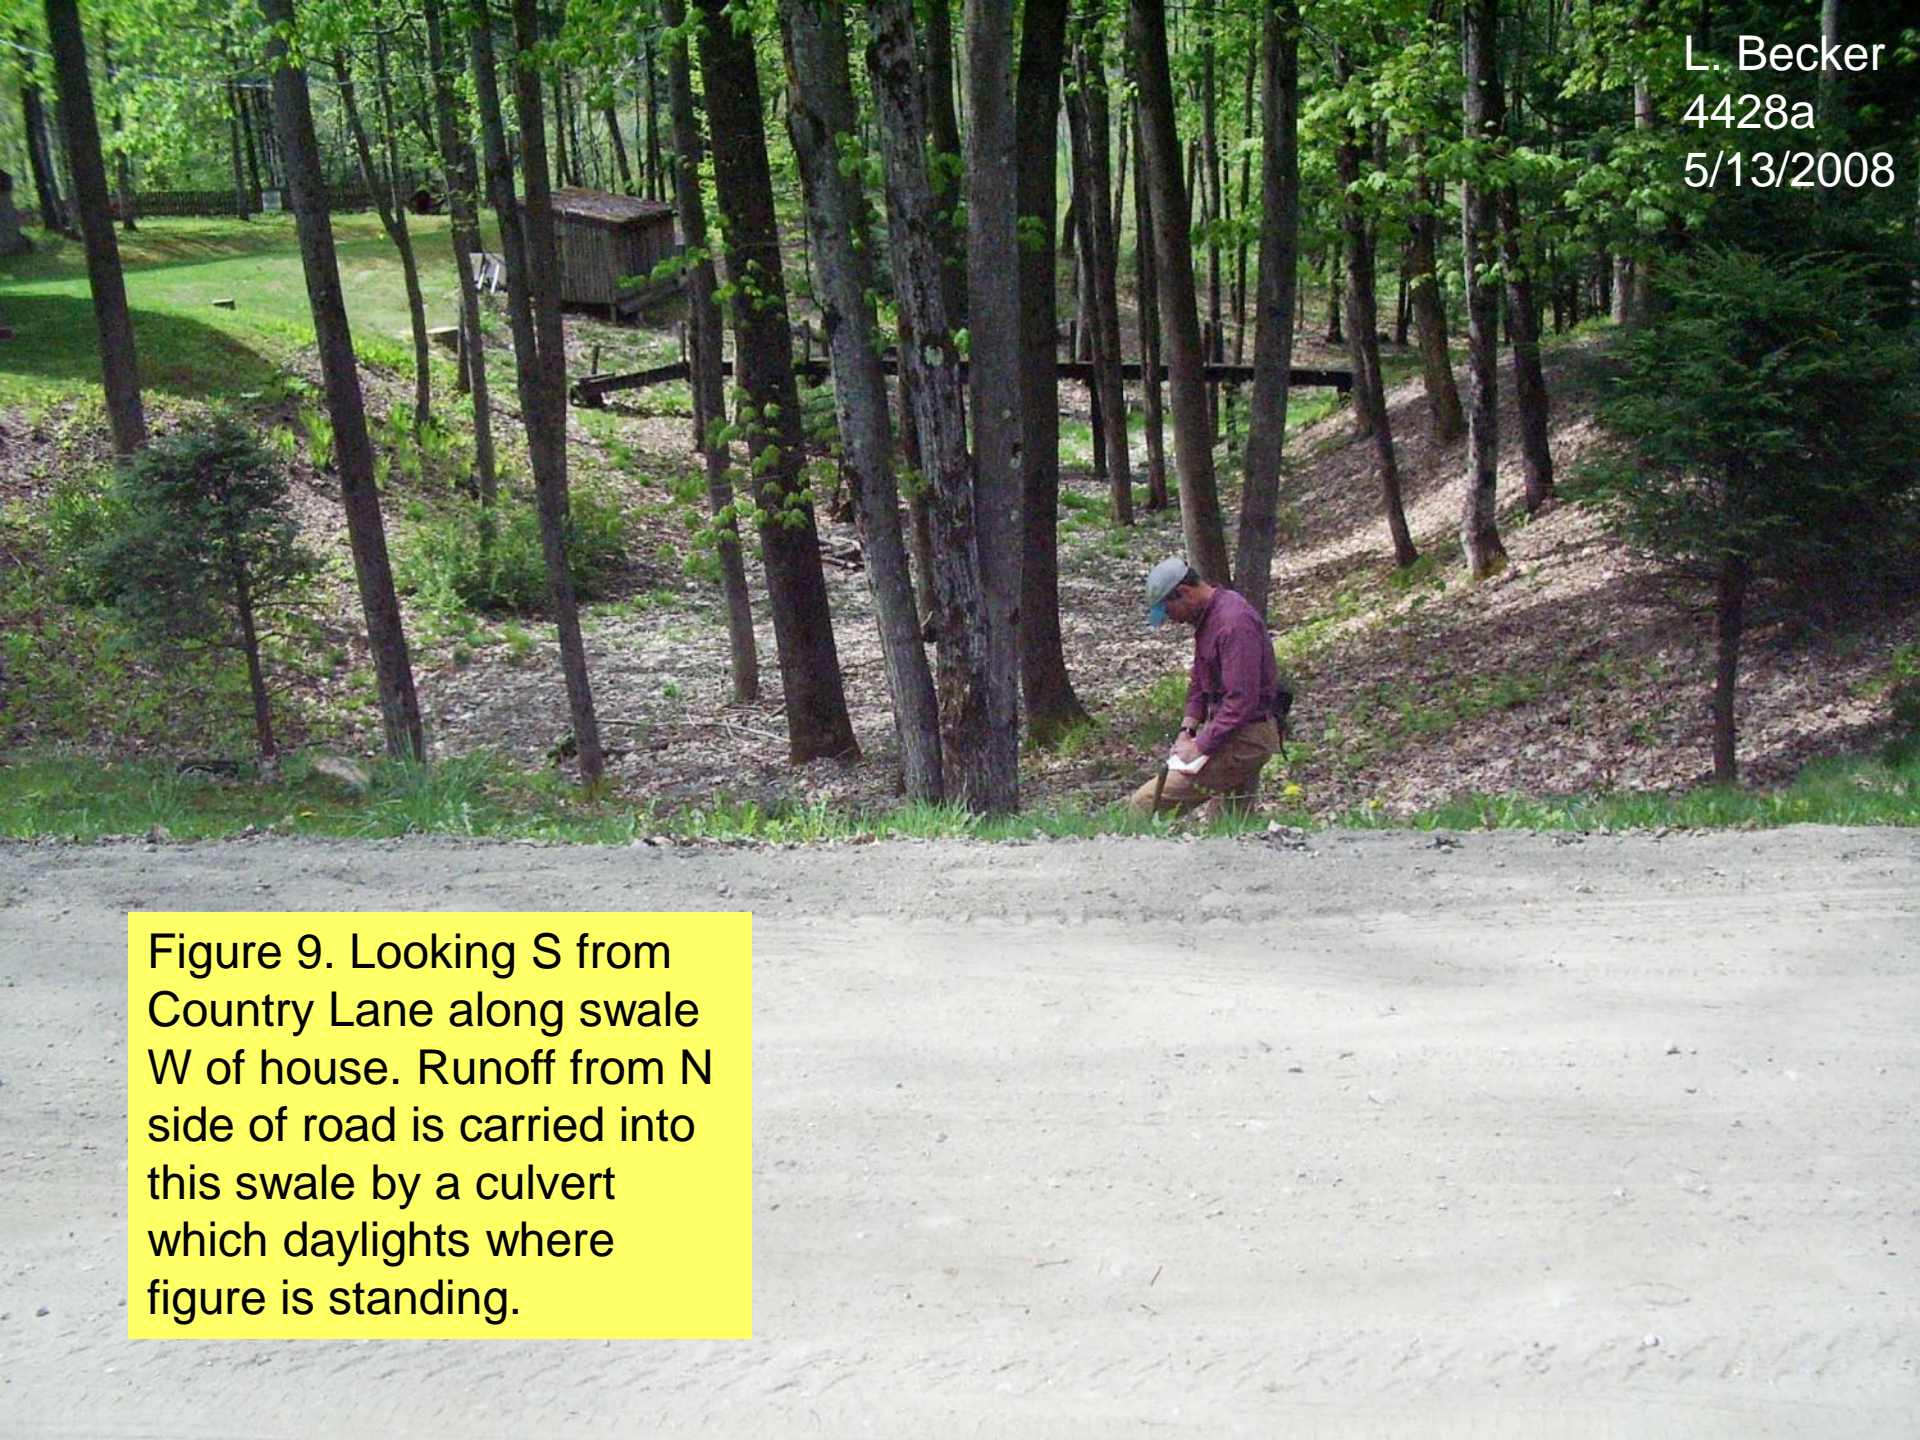
Figure 9. Looking S from Country Lane along swale W of house. Runoff from N side of road is carried into this swale by a culvert which daylights where figure is standing.

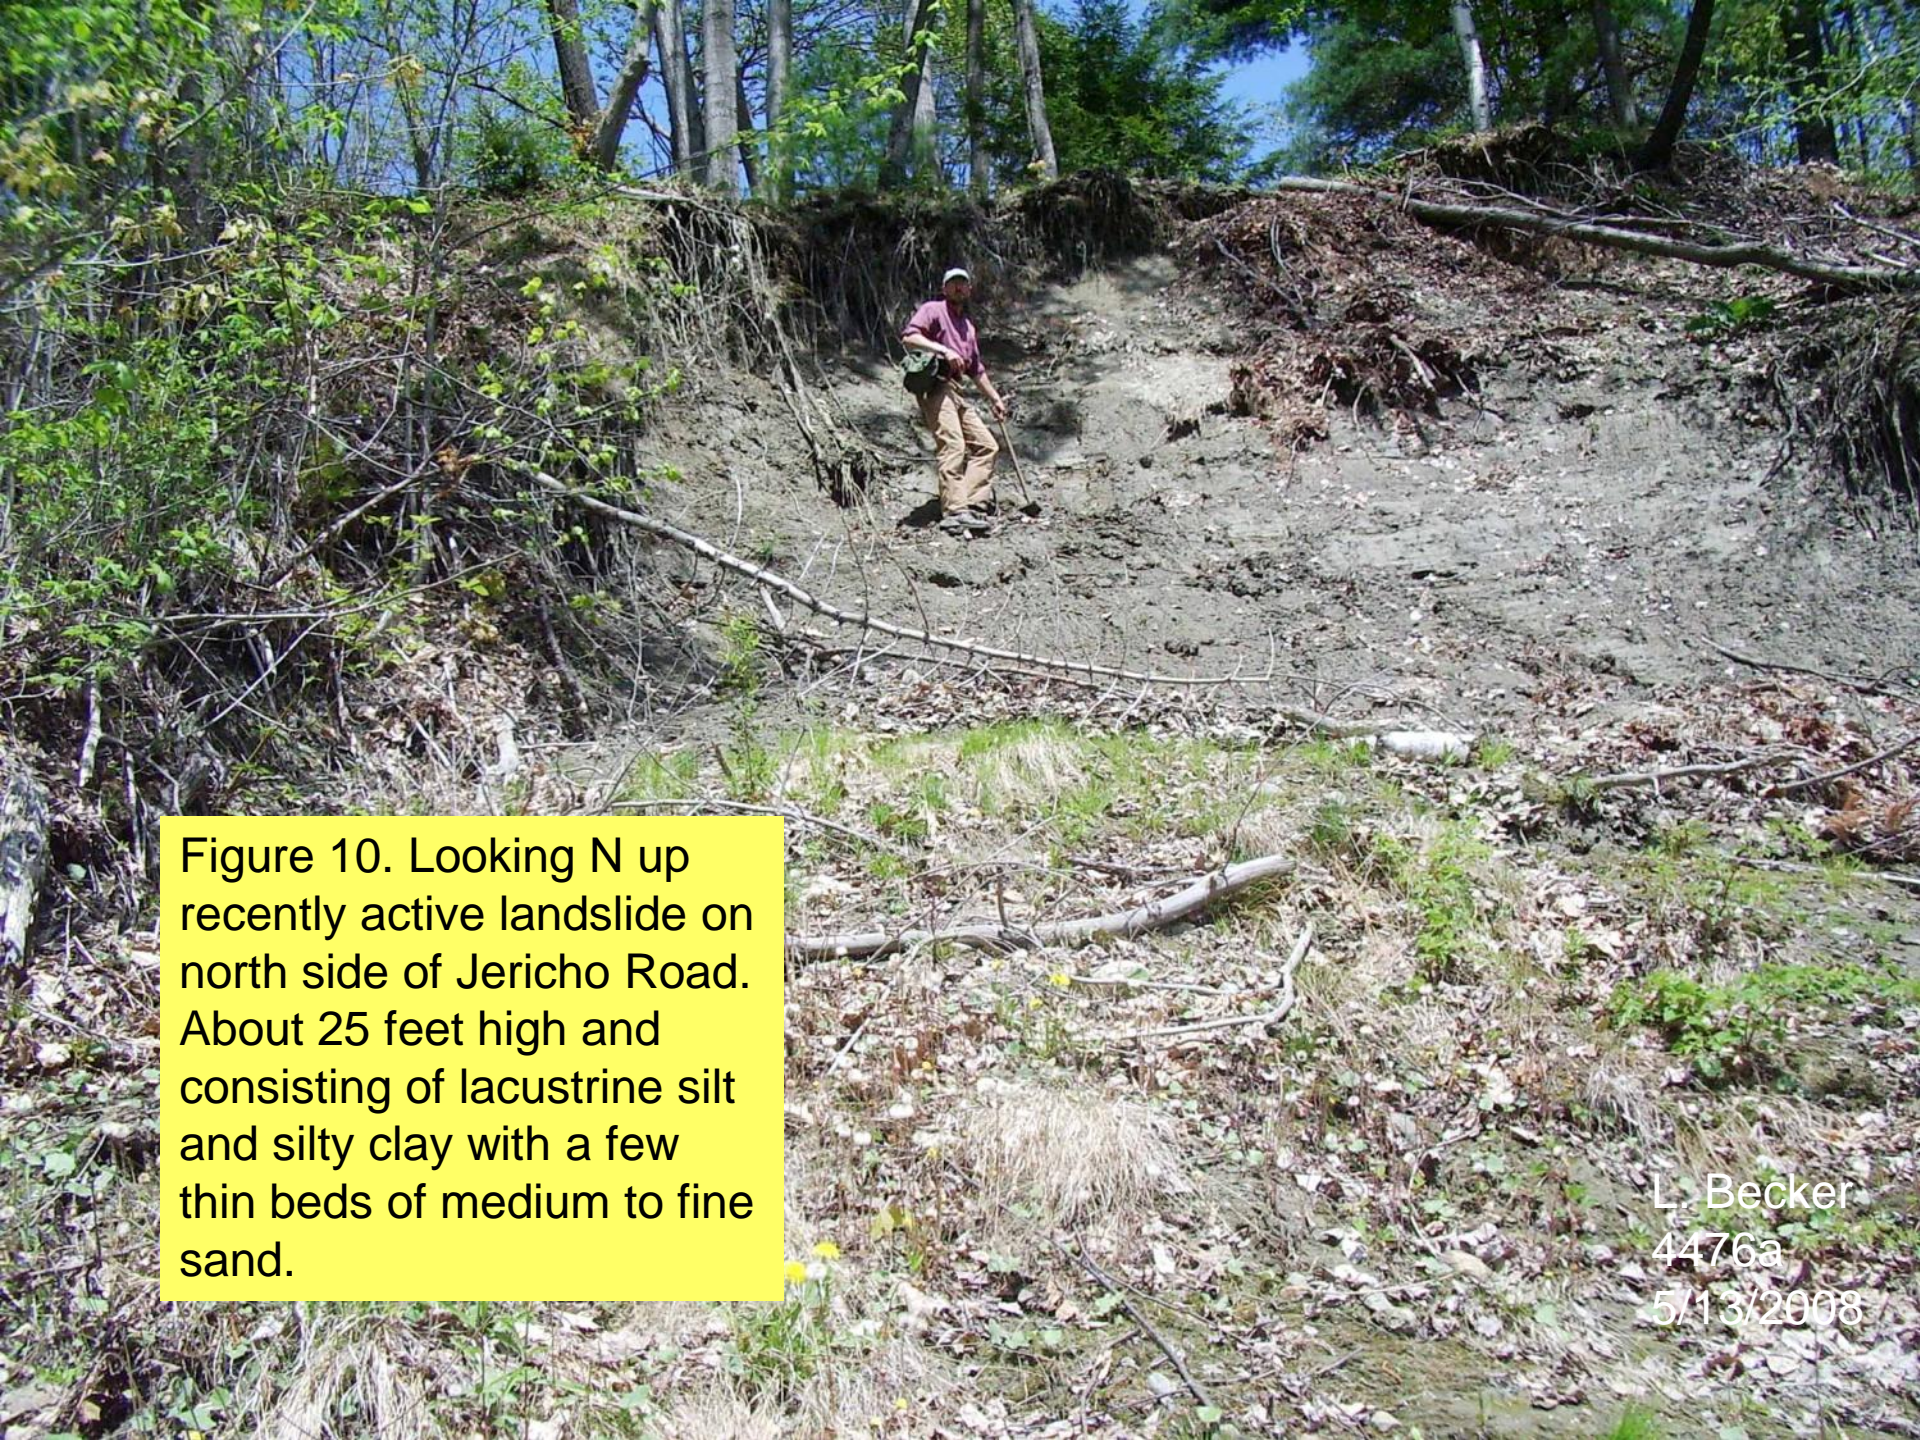
Figure 10. Looking N up recently active landslide on north side of Jericho Road. About 25 feet high and consisting of lacustrine silt and silty clay with a few thin beds of medium to fine sand.
