Slope Instability at Country Lane and Jericho Road, Hartford, Vermont

May 15, 2008

Photos from site visit of May 13, 2008 by
Laurence Becker, Vermont State Geologist,
Vermont Department of Environmental
Conservation, and George Springston,
Research Associate, Norwich University
Department of Geology and Environmental
Science.

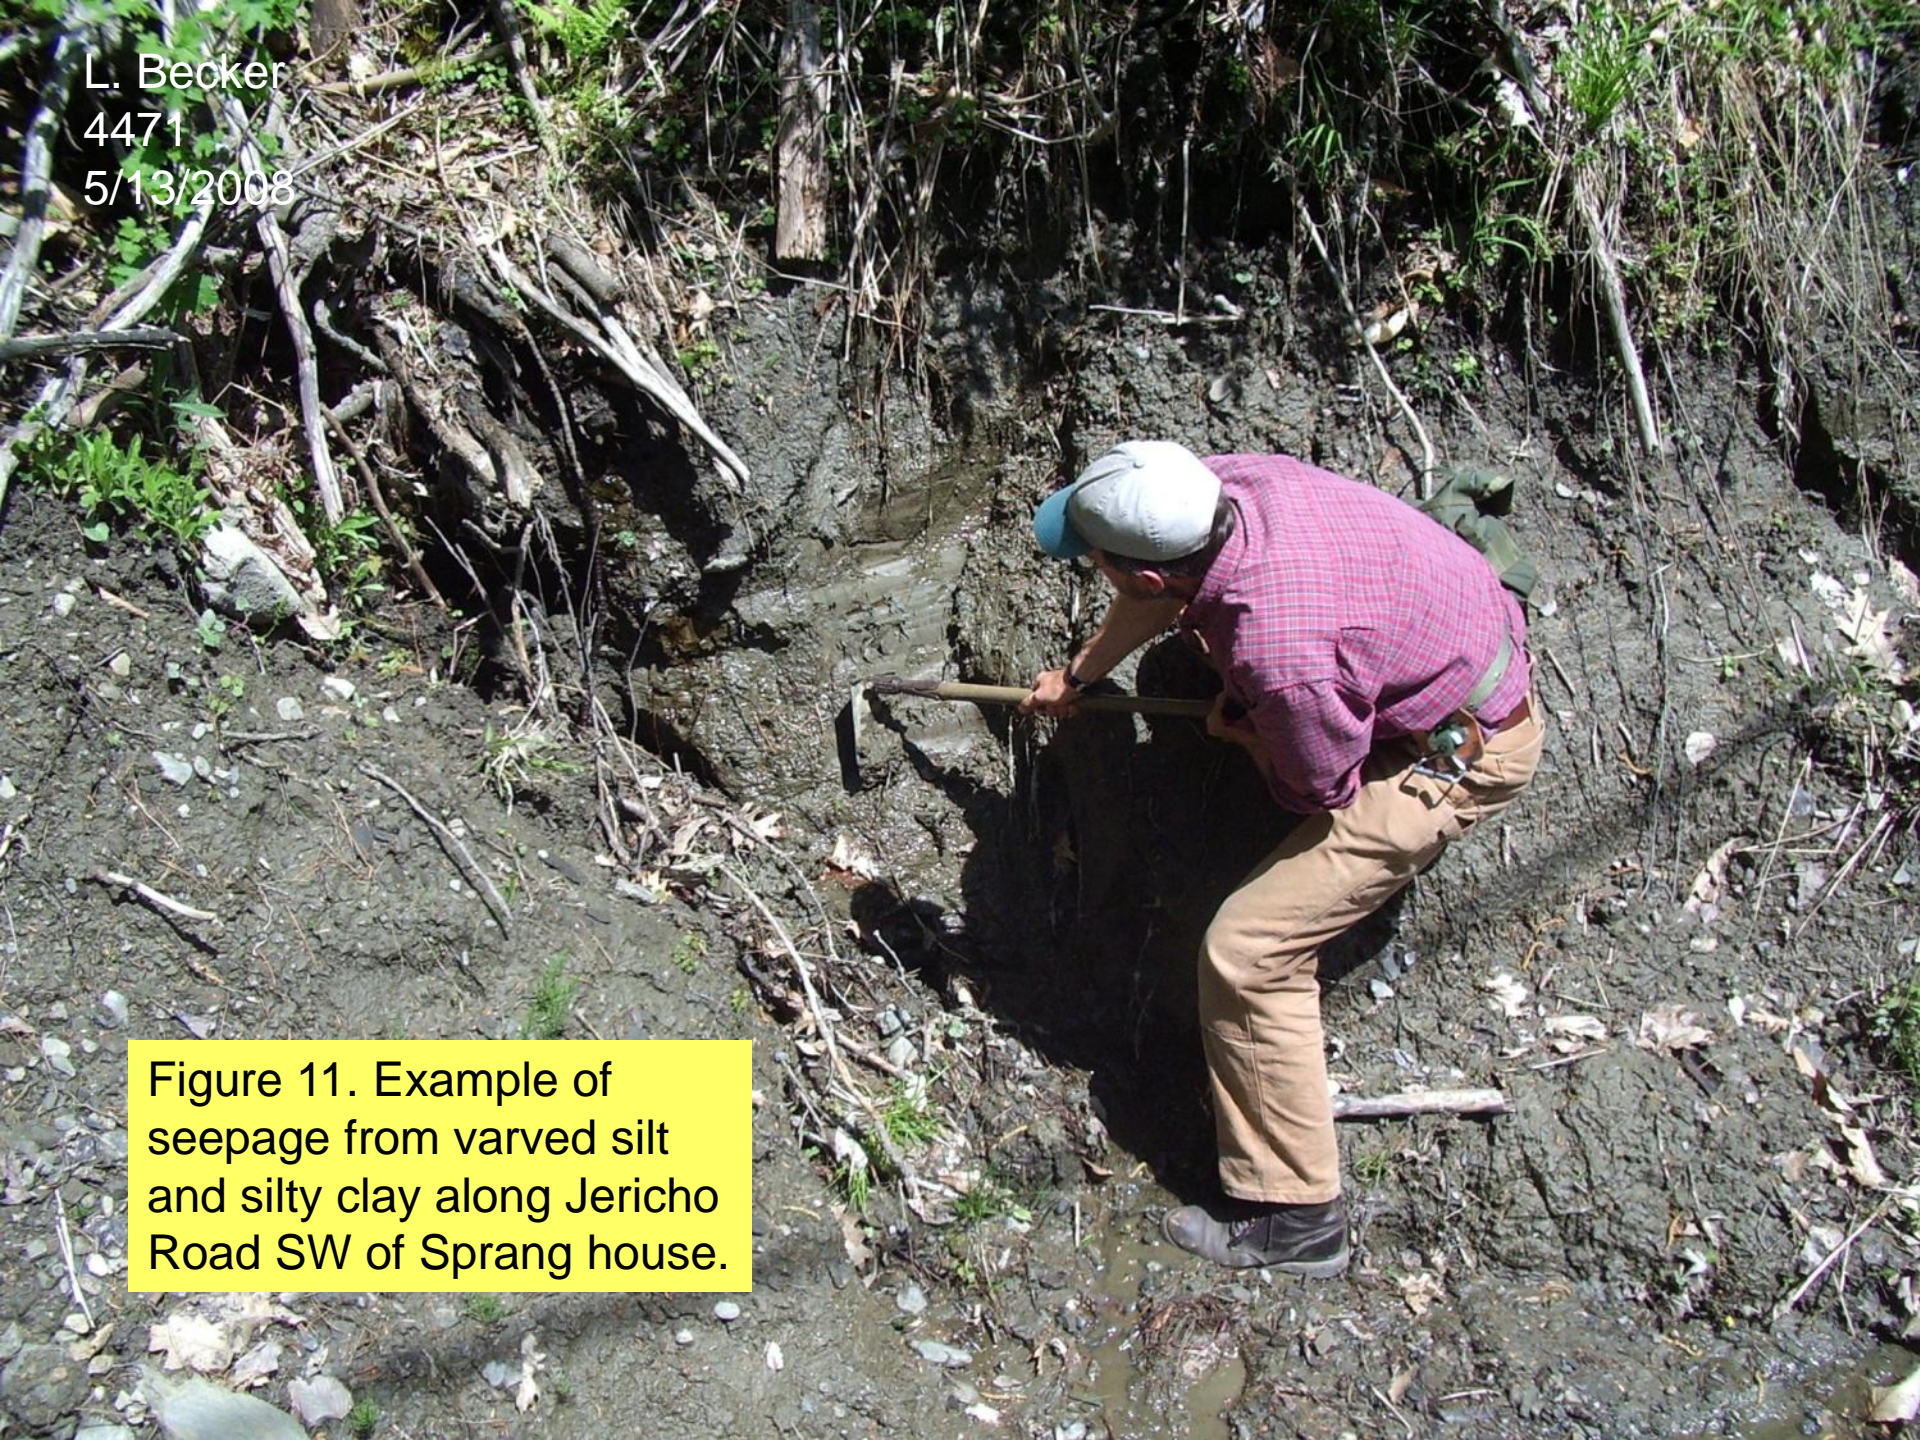
Figure 11. Example of seepage from varved silt and silty clay along Jericho Road SW of Sprang house.

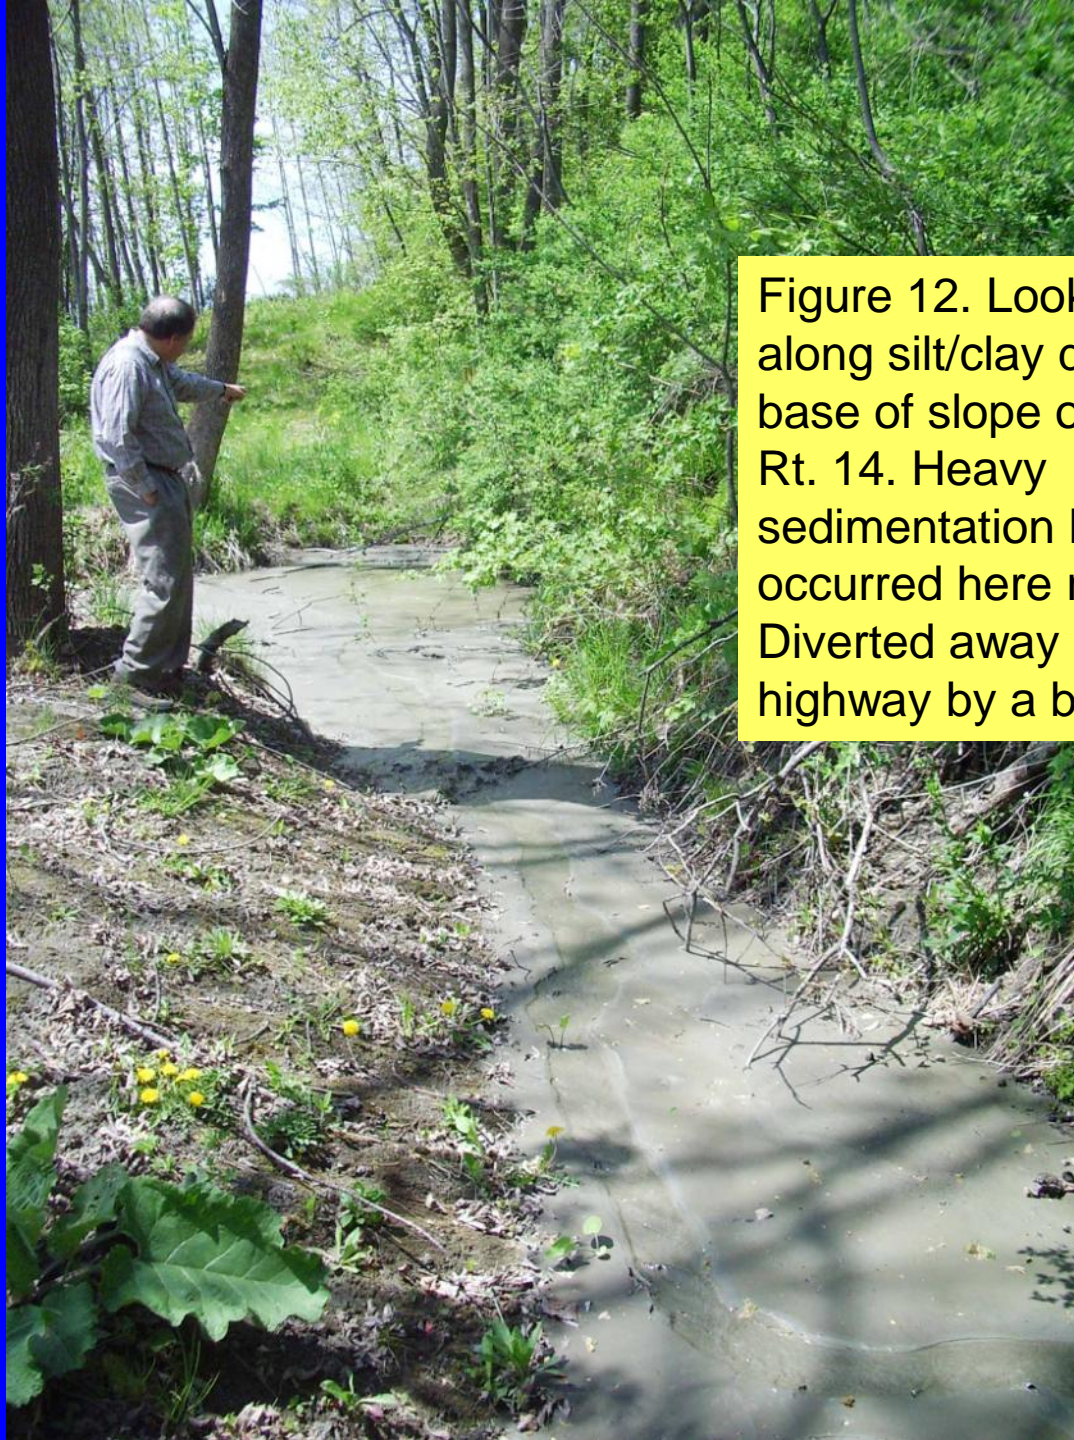
Figure 12. Looking W along silt/clay deposit at base of slope on N side Vt. Rt. 14. Heavy sedimentation has clearly occurred here recently. Diverted away from highway by a berm.
