Rock Fall and Debris Flow Hazards in Smugglers Notch

**Vermont Geological Survey,
Laurence Becker, State Geologist**

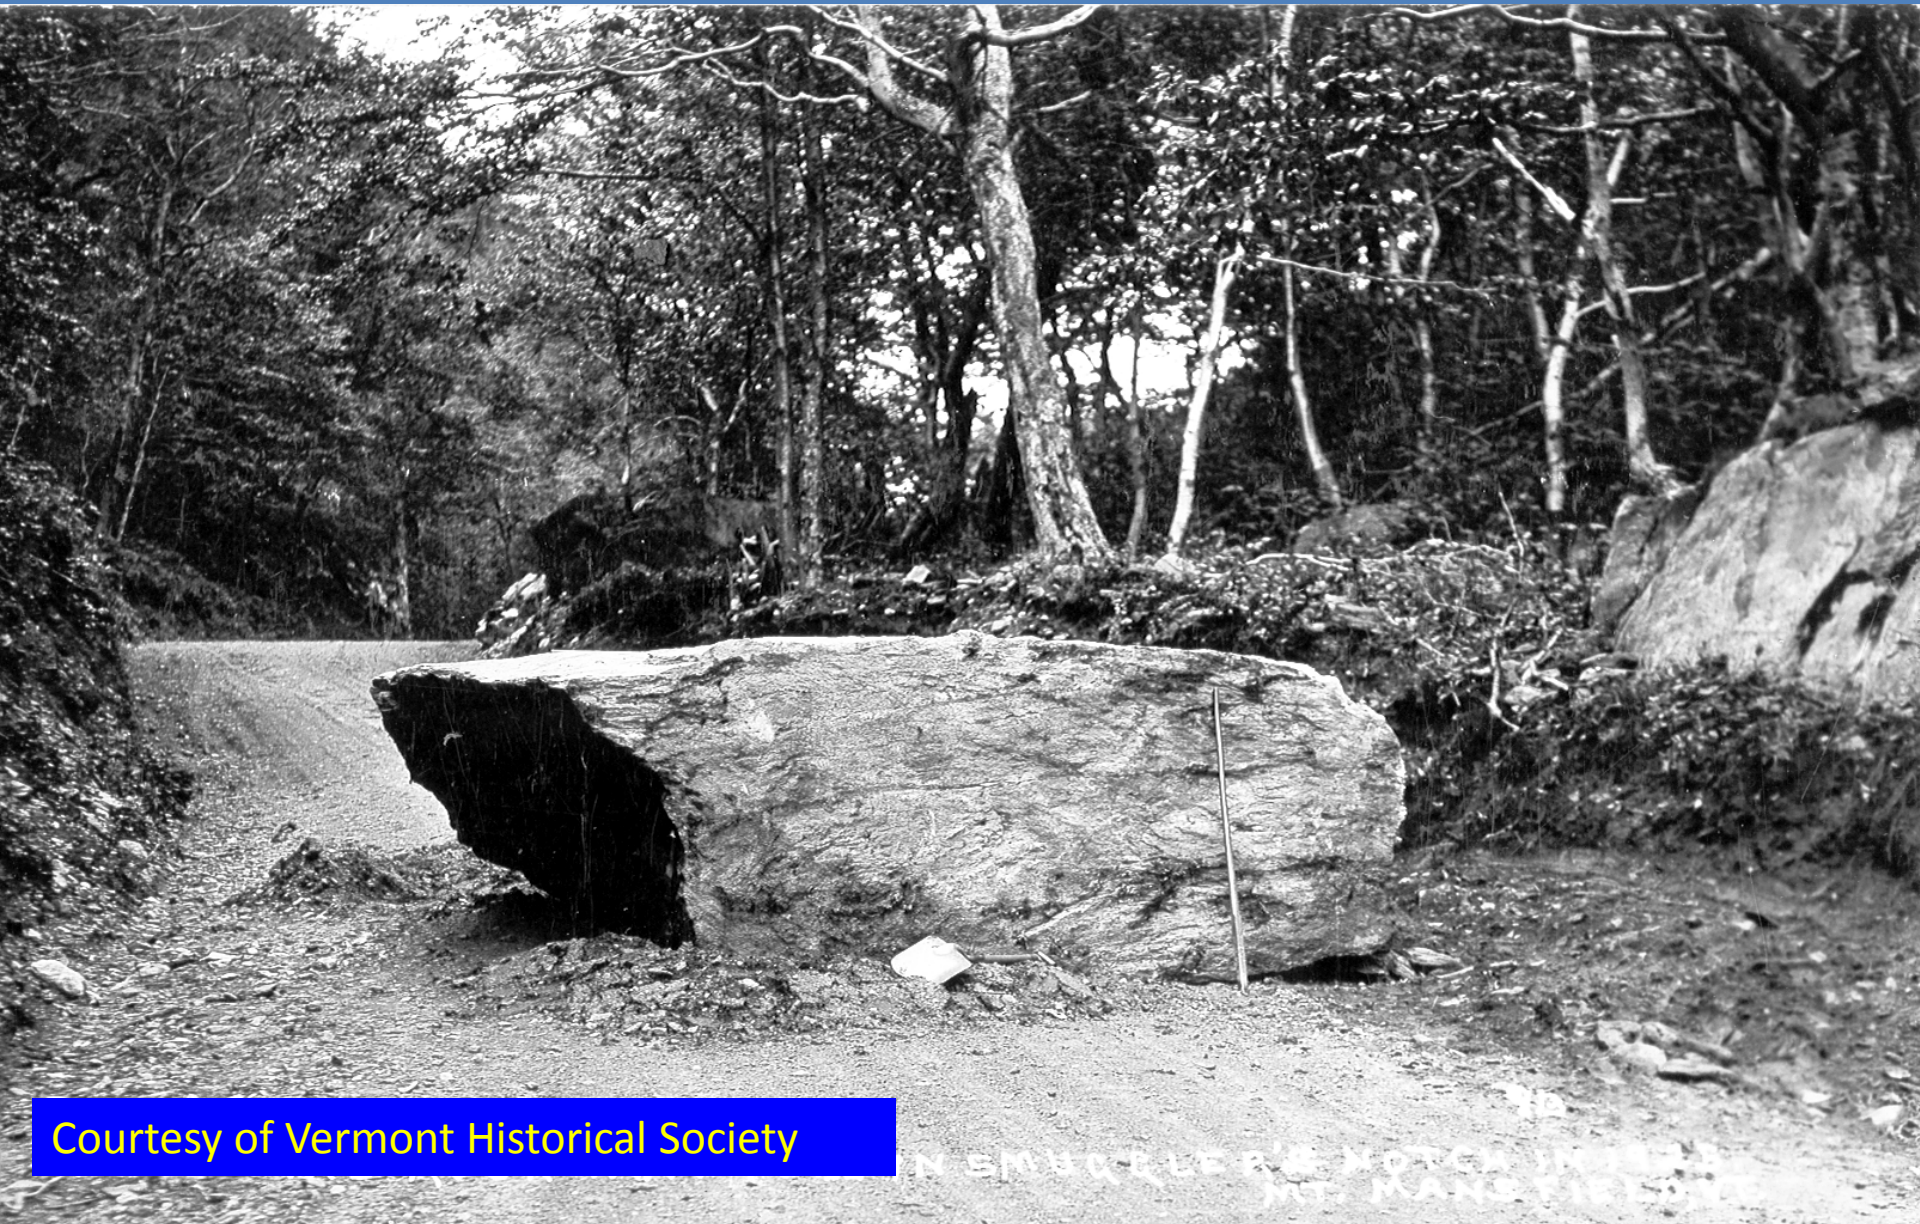
Fallen Boulder in Middle of Smugglers Notch Road, about 1925

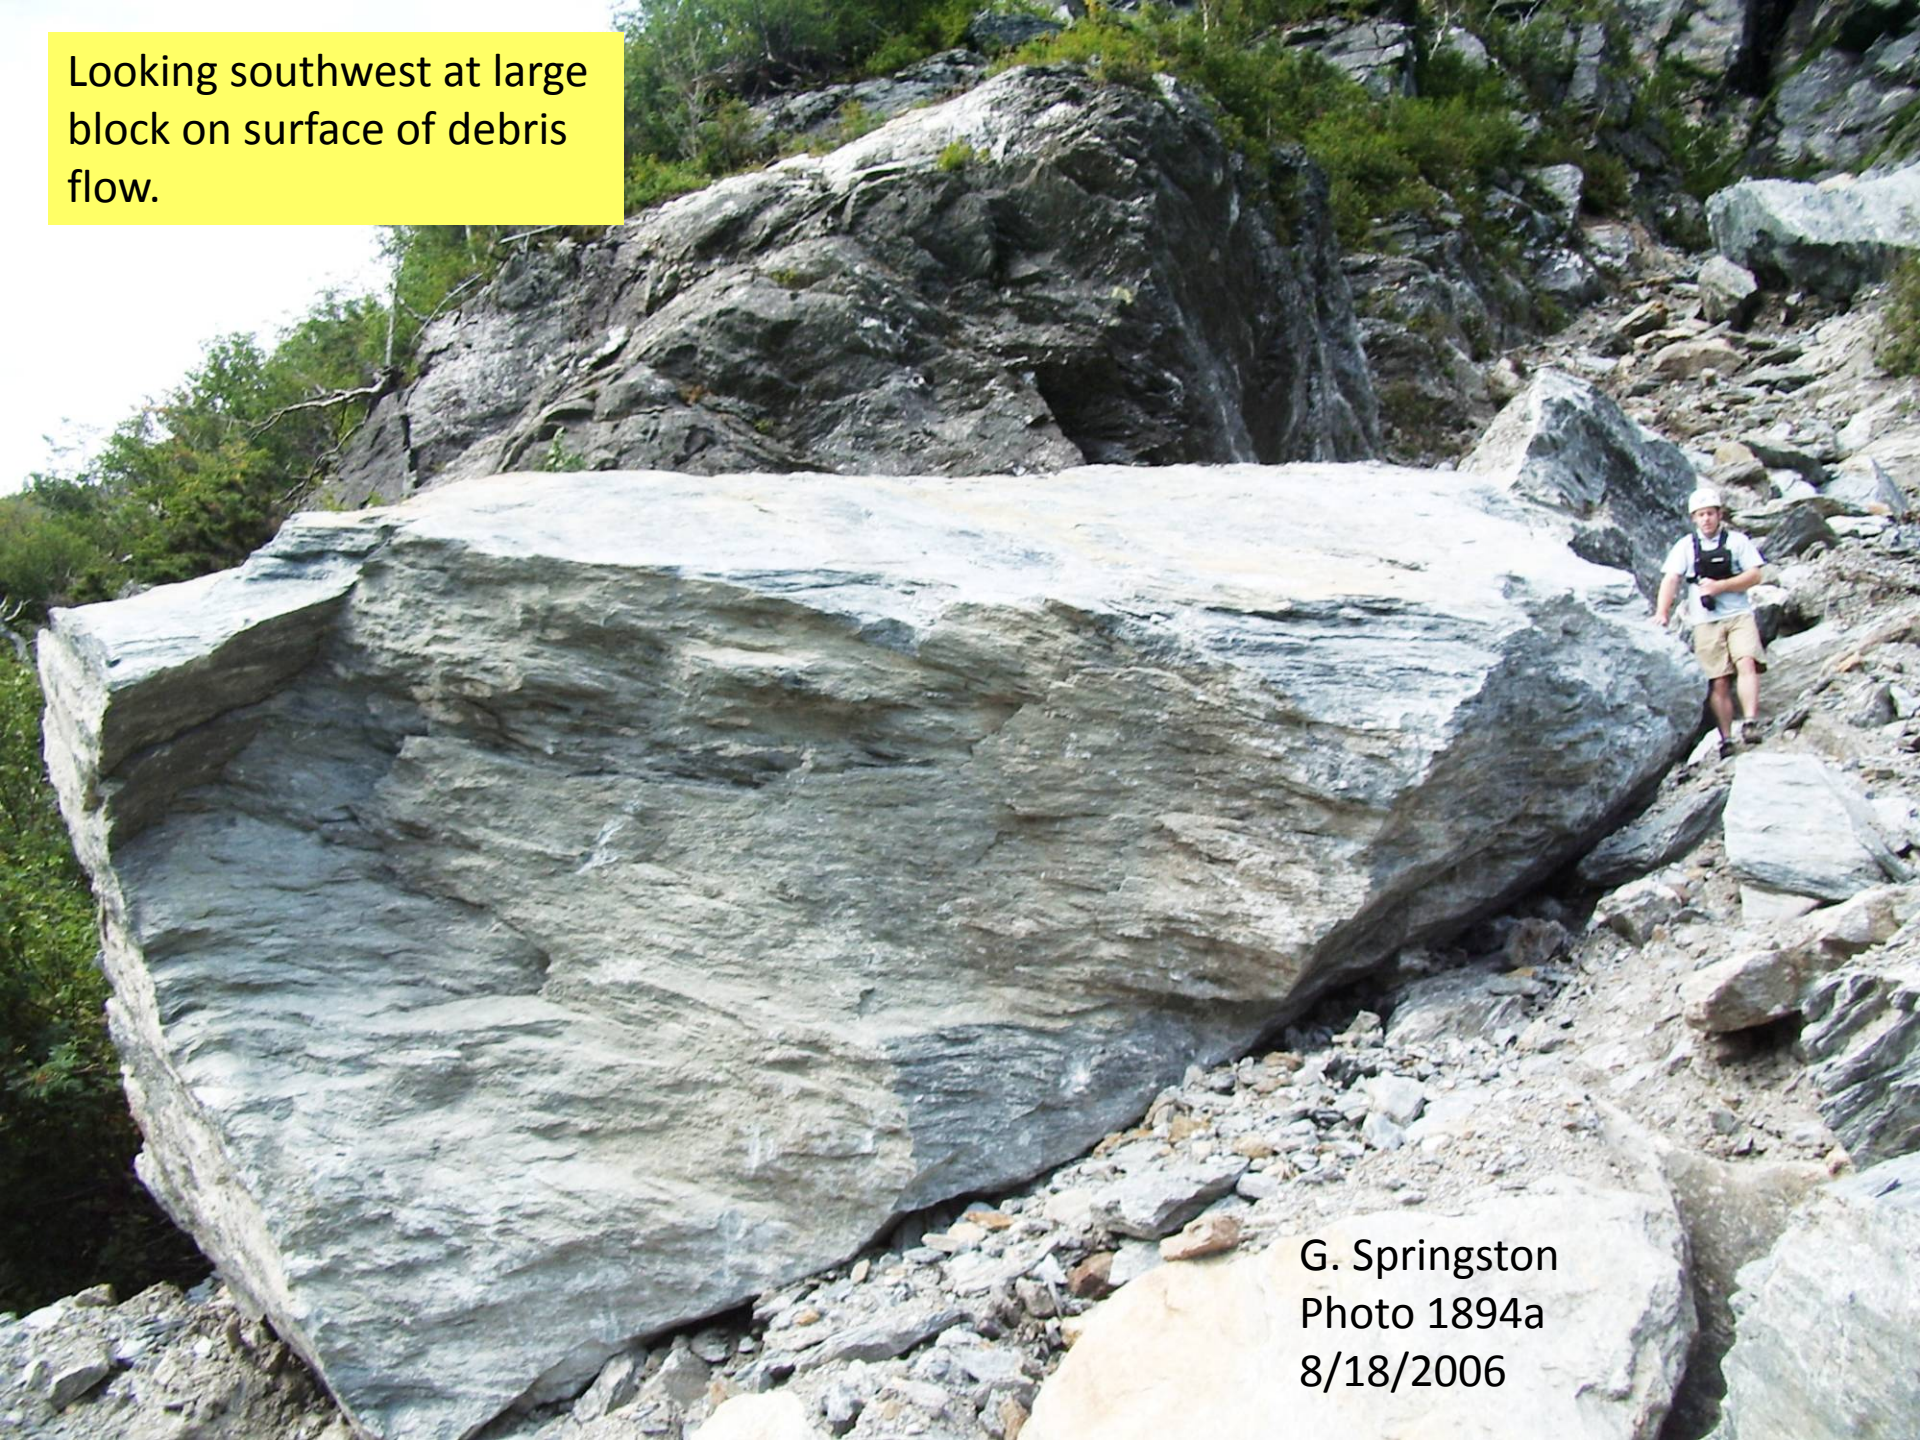
G. Springston
Photo 1894a
8/18/2006

Looking southwest at large
block on surface of debris
flow.

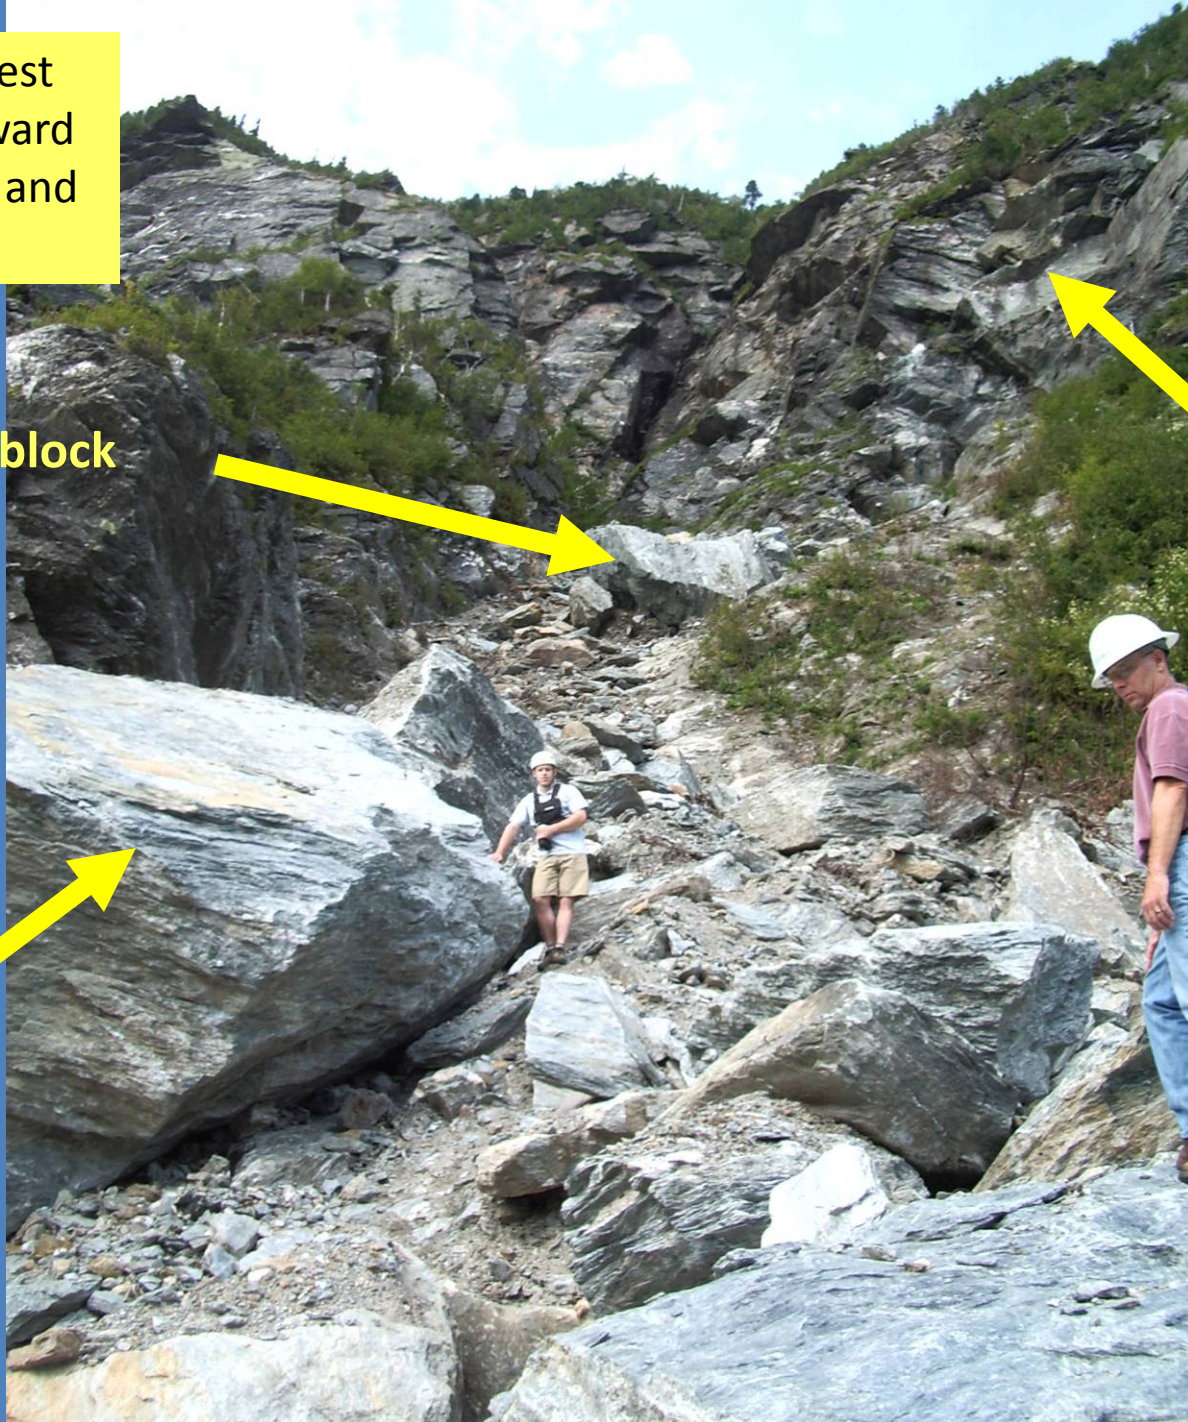
G. Springston
Photo 1895a
8/18/2006

Looking northwest
up the track toward
the source area and
Easy Gully.

Upper block

Source area

Largest block

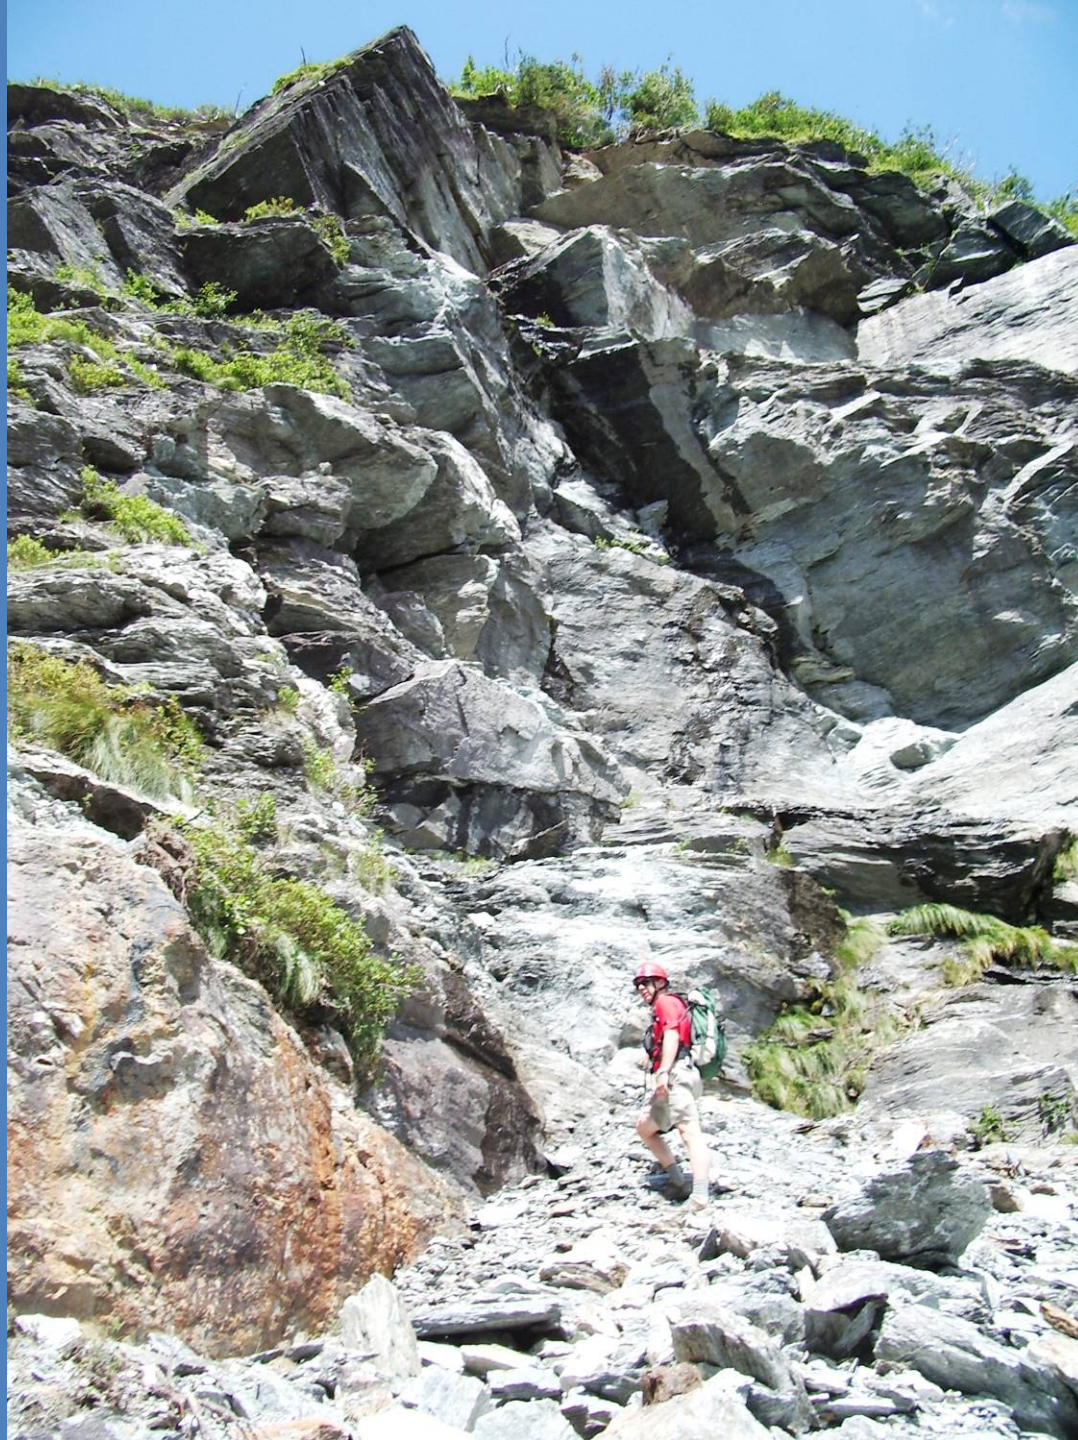
G. Springston
Photo 1900a
8/18/2006

Looking
northwest at
overhanging
ledges in source
area for rock fall.

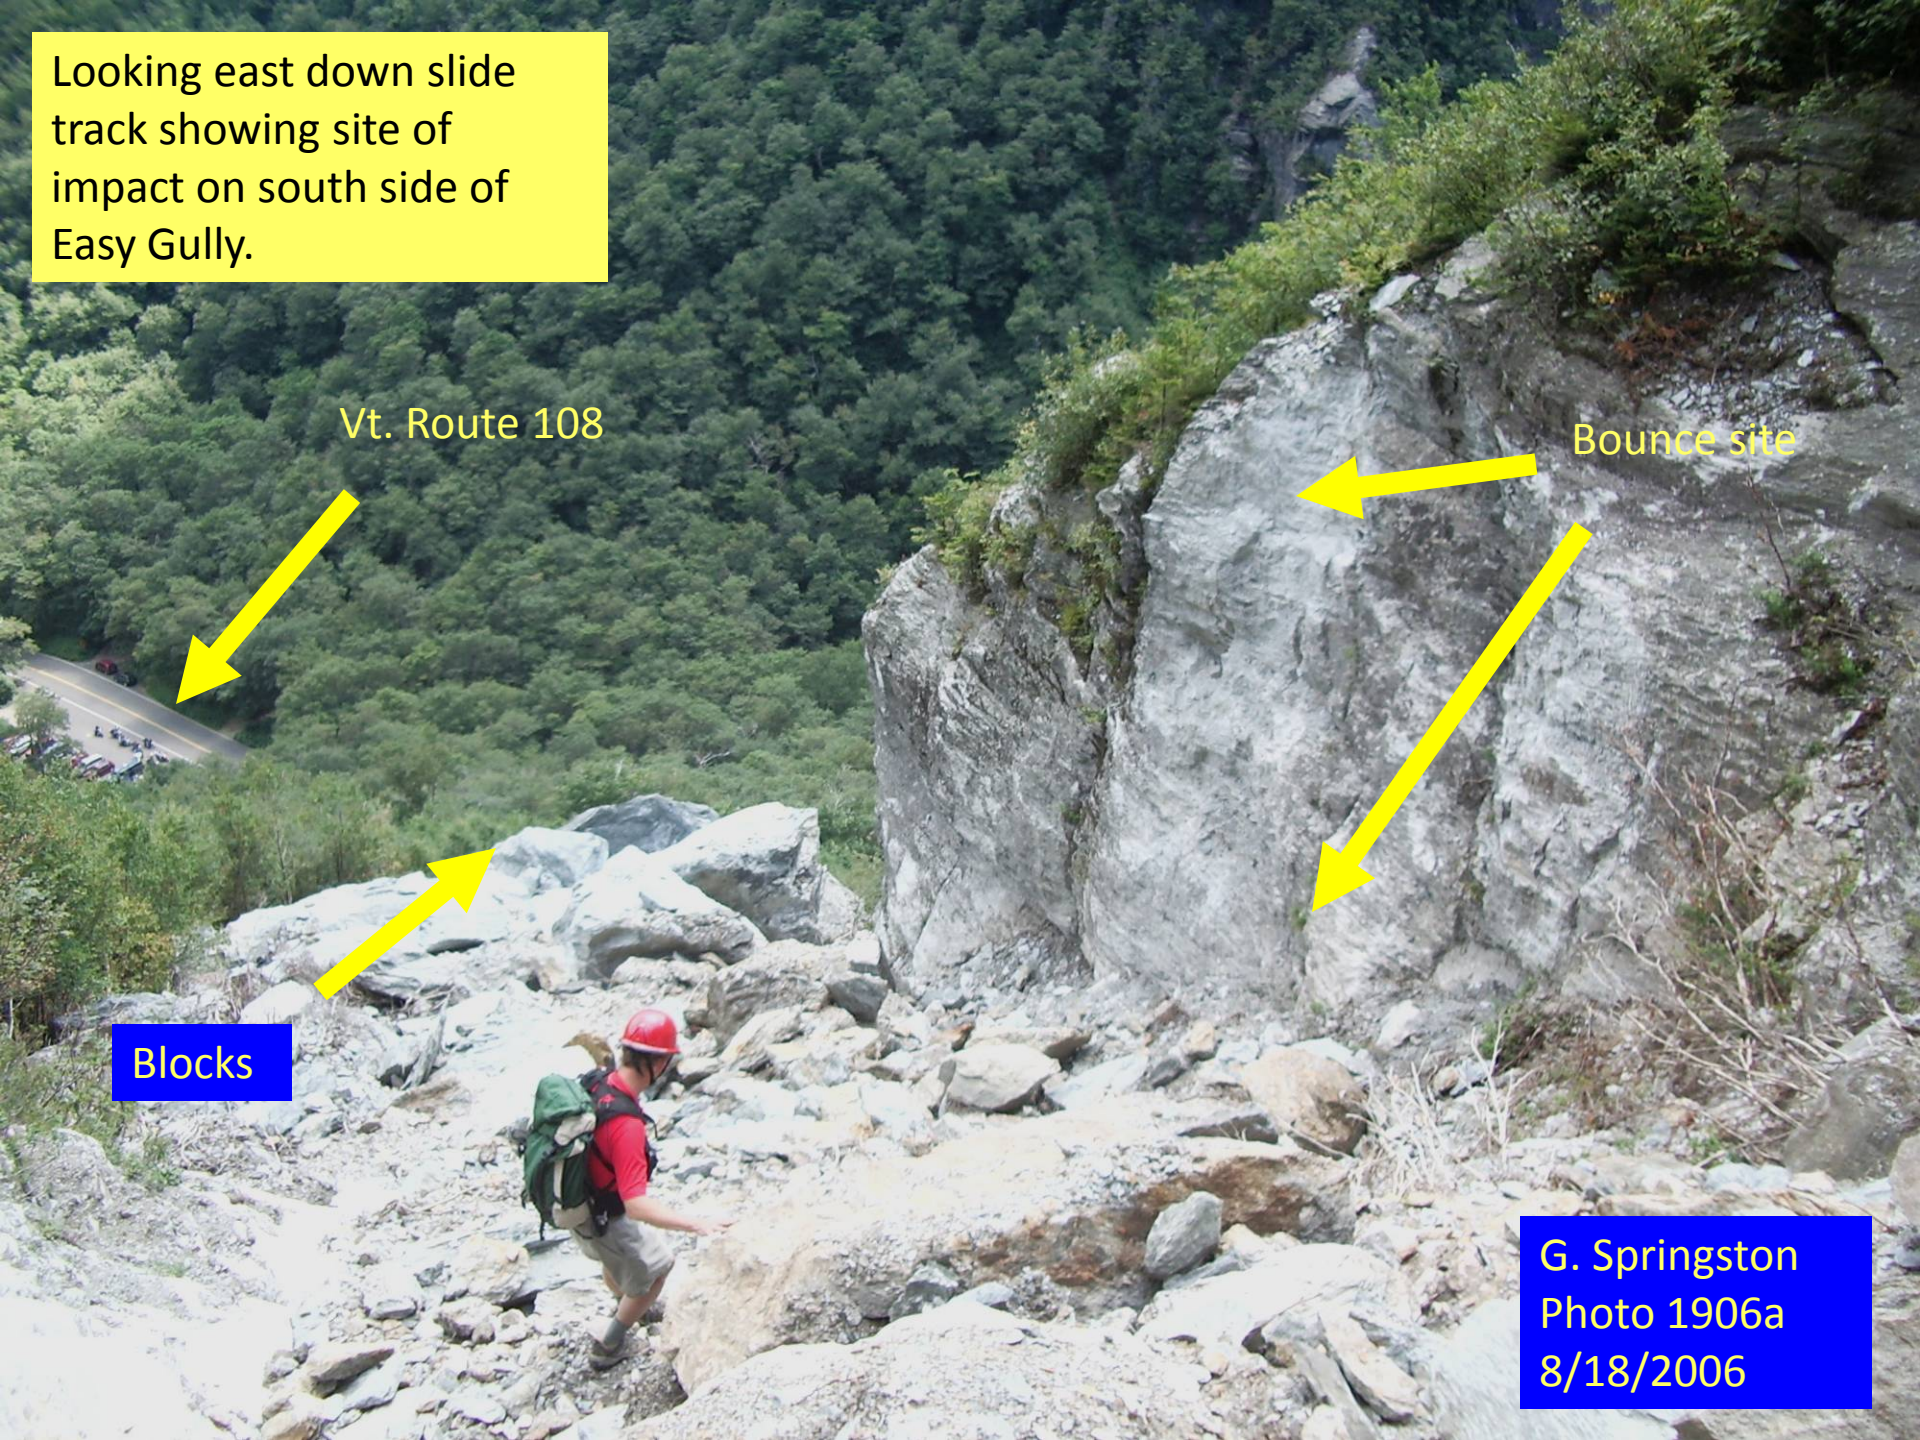
G. Springston
Photo 1906a
8/18/2006

Looking east down slide track showing site of impact on south side of Easy Gully.

Vt. Route 108

Bounce site

Blocks

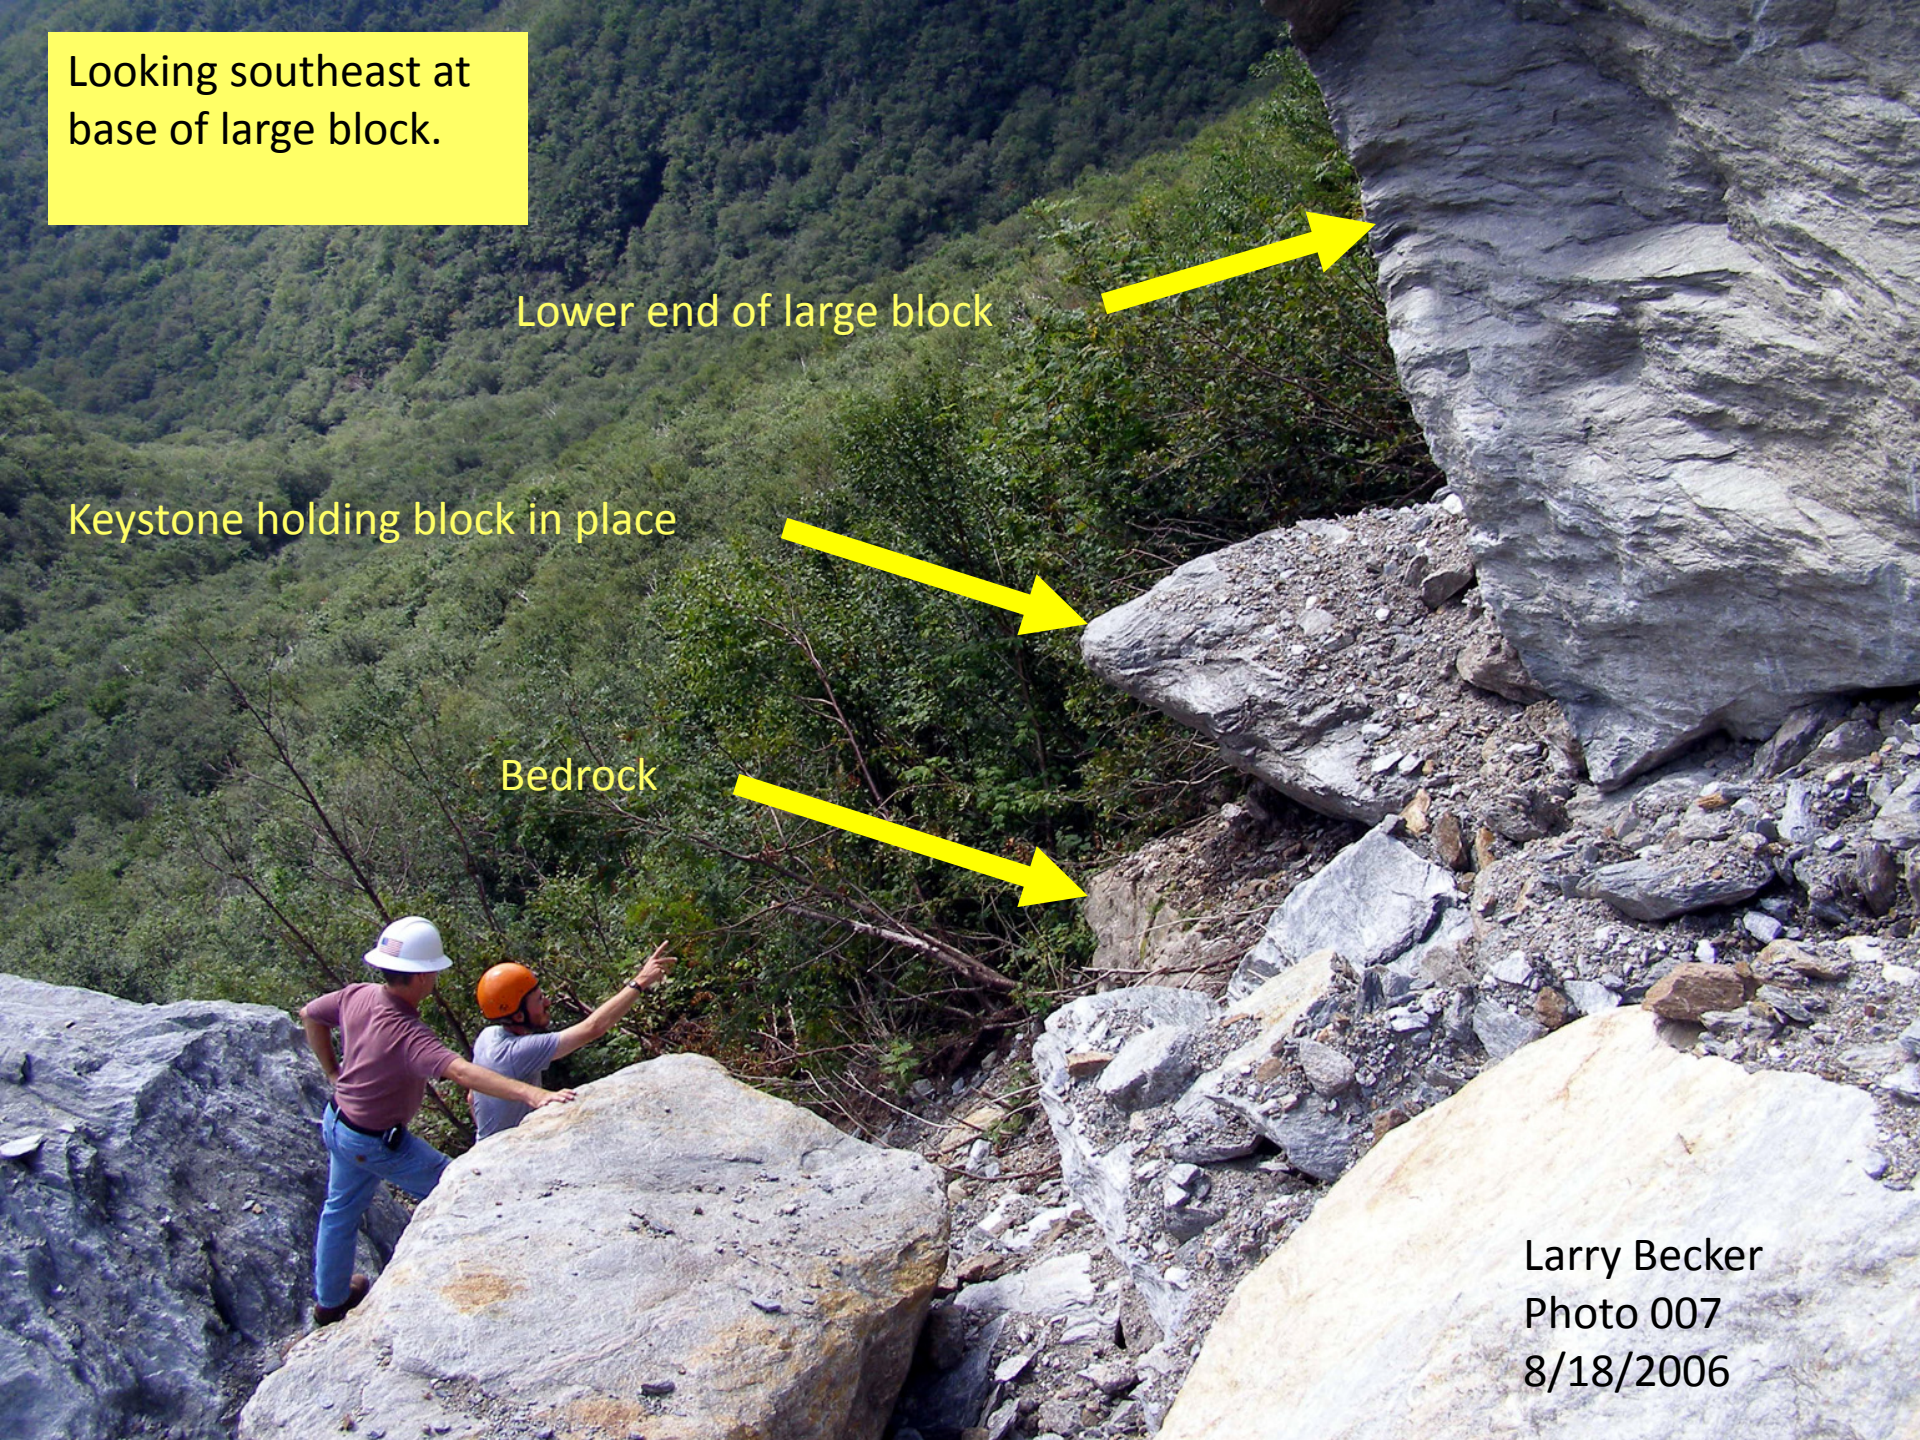
Larry Becker
Photo 007
8/18/2006

Looking southeast at
base of large block.

Lower end of large block

Keystone holding block in place

Bedrock

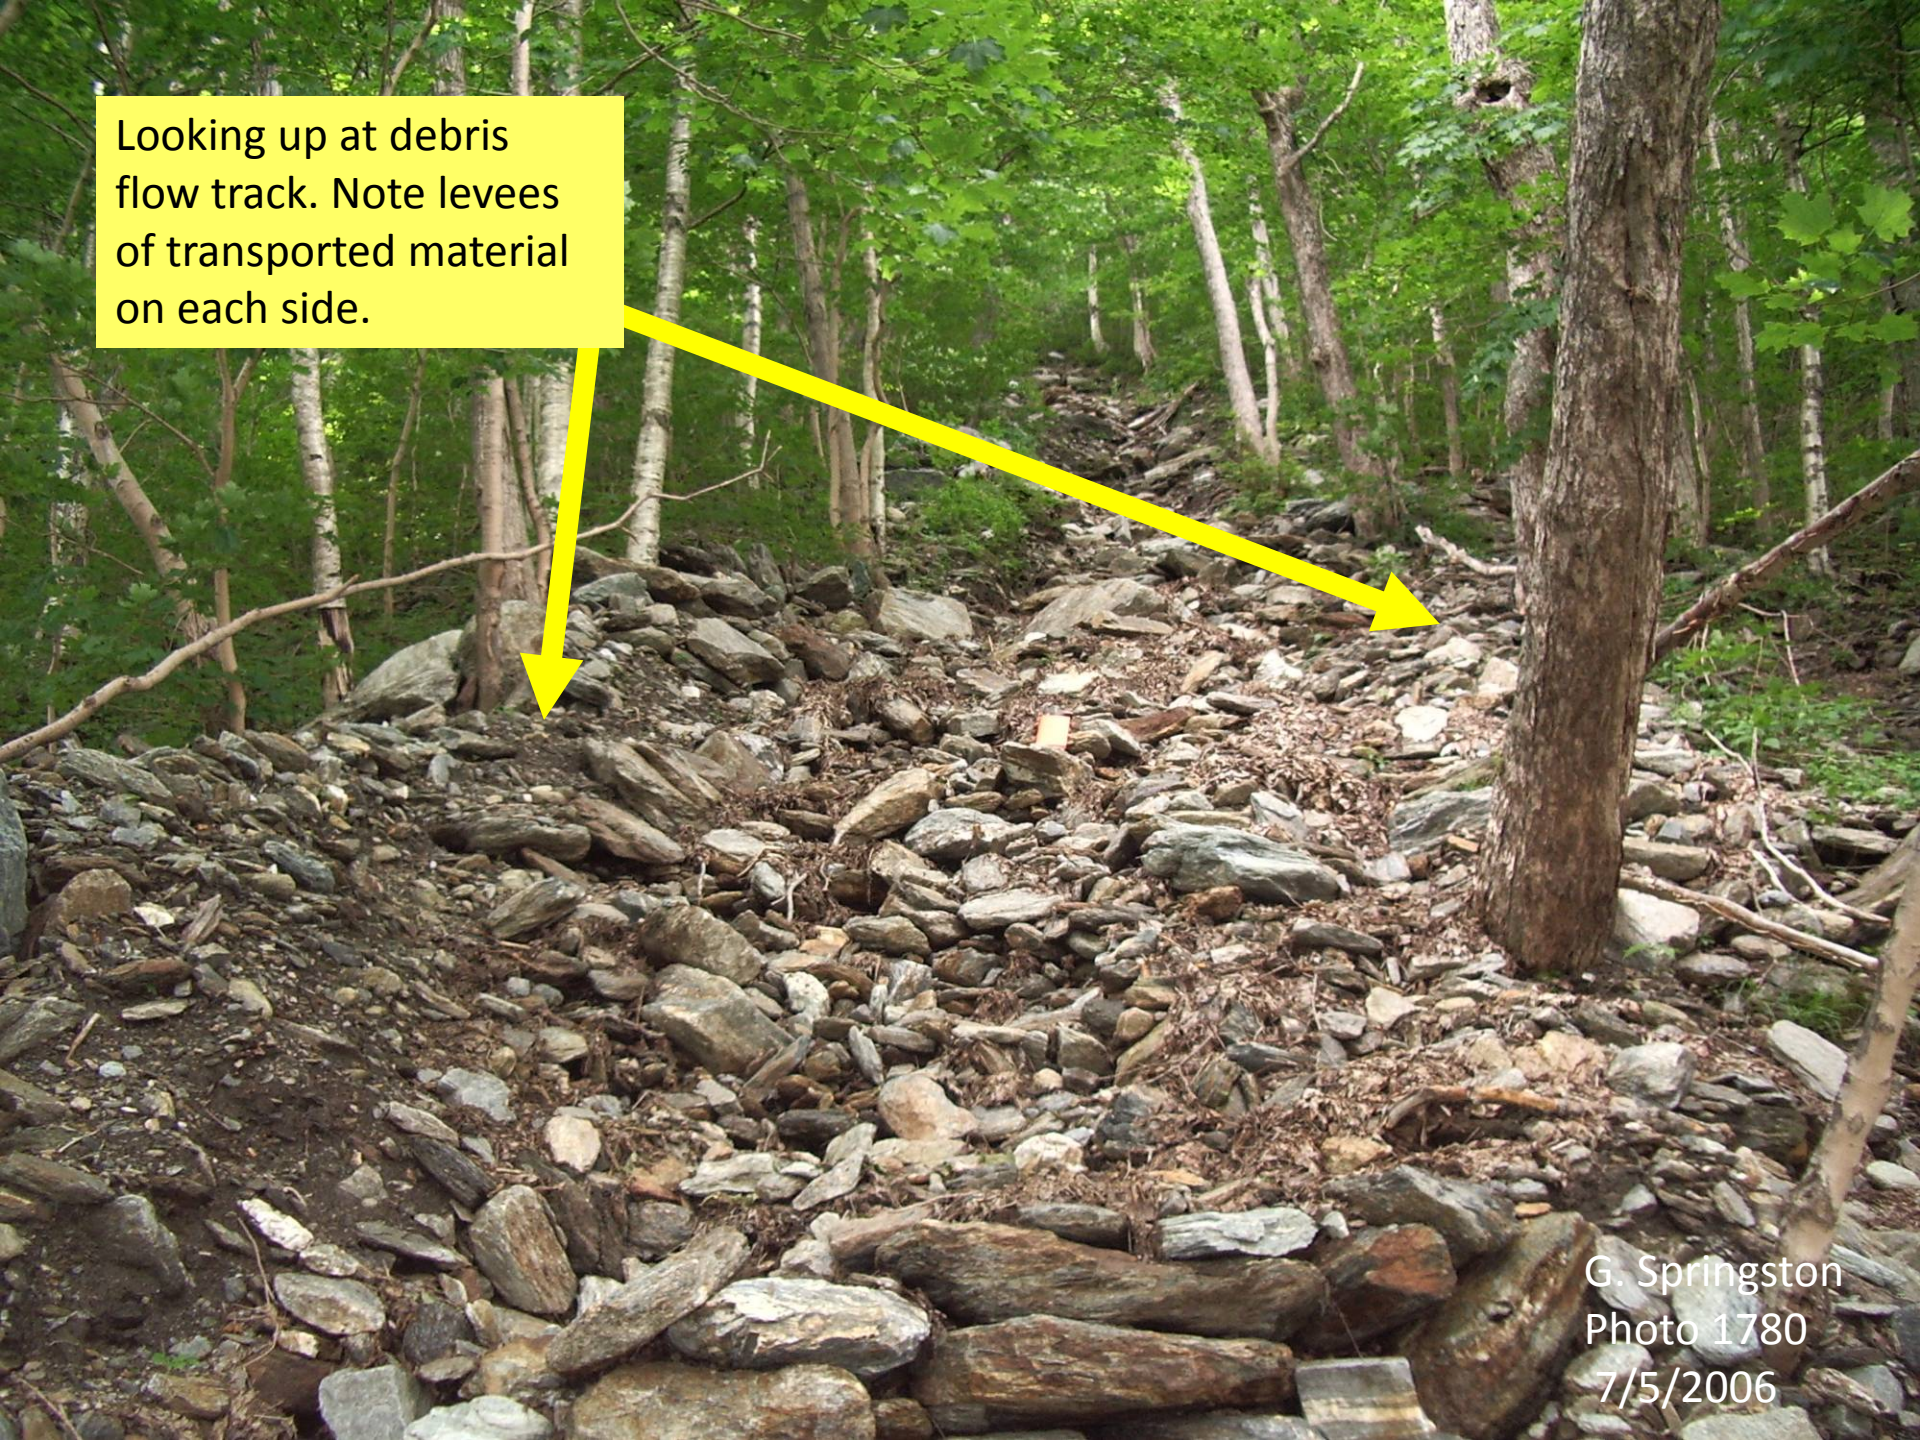
G. Springston
Photo 1780
7/5/2006

Looking up at debris
flow track. Note levees
of transported material
on each side.

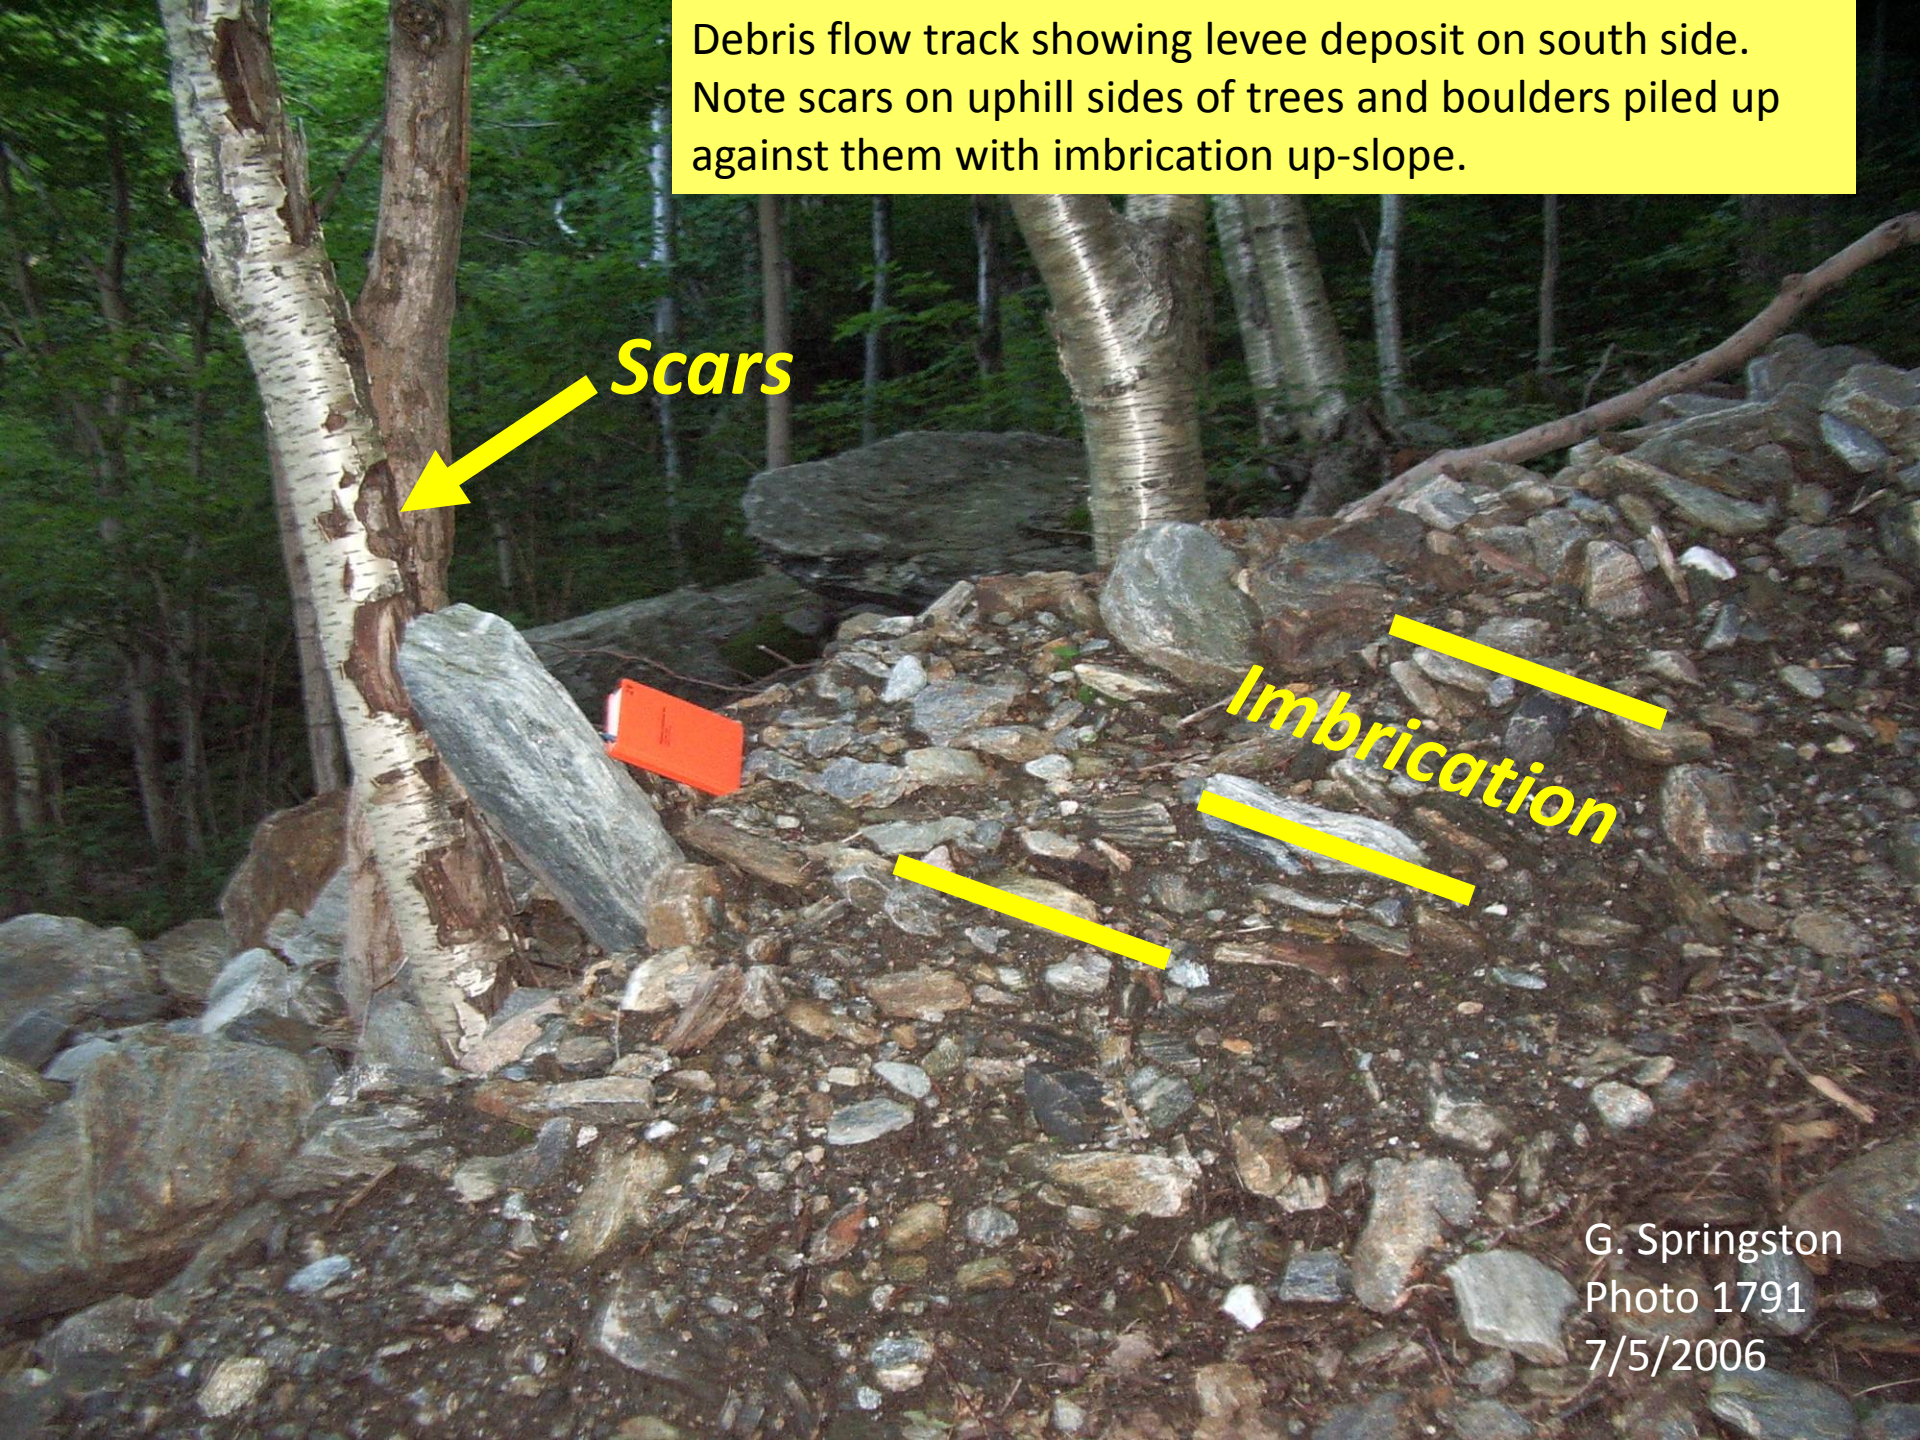
G. Springston
Photo 1791
7/5/2006

Debris flow track showing levee deposit on south side.
Note scars on uphill sides of trees and boulders piled up
against them with imbrication up-slope.

Scars

Imbrication

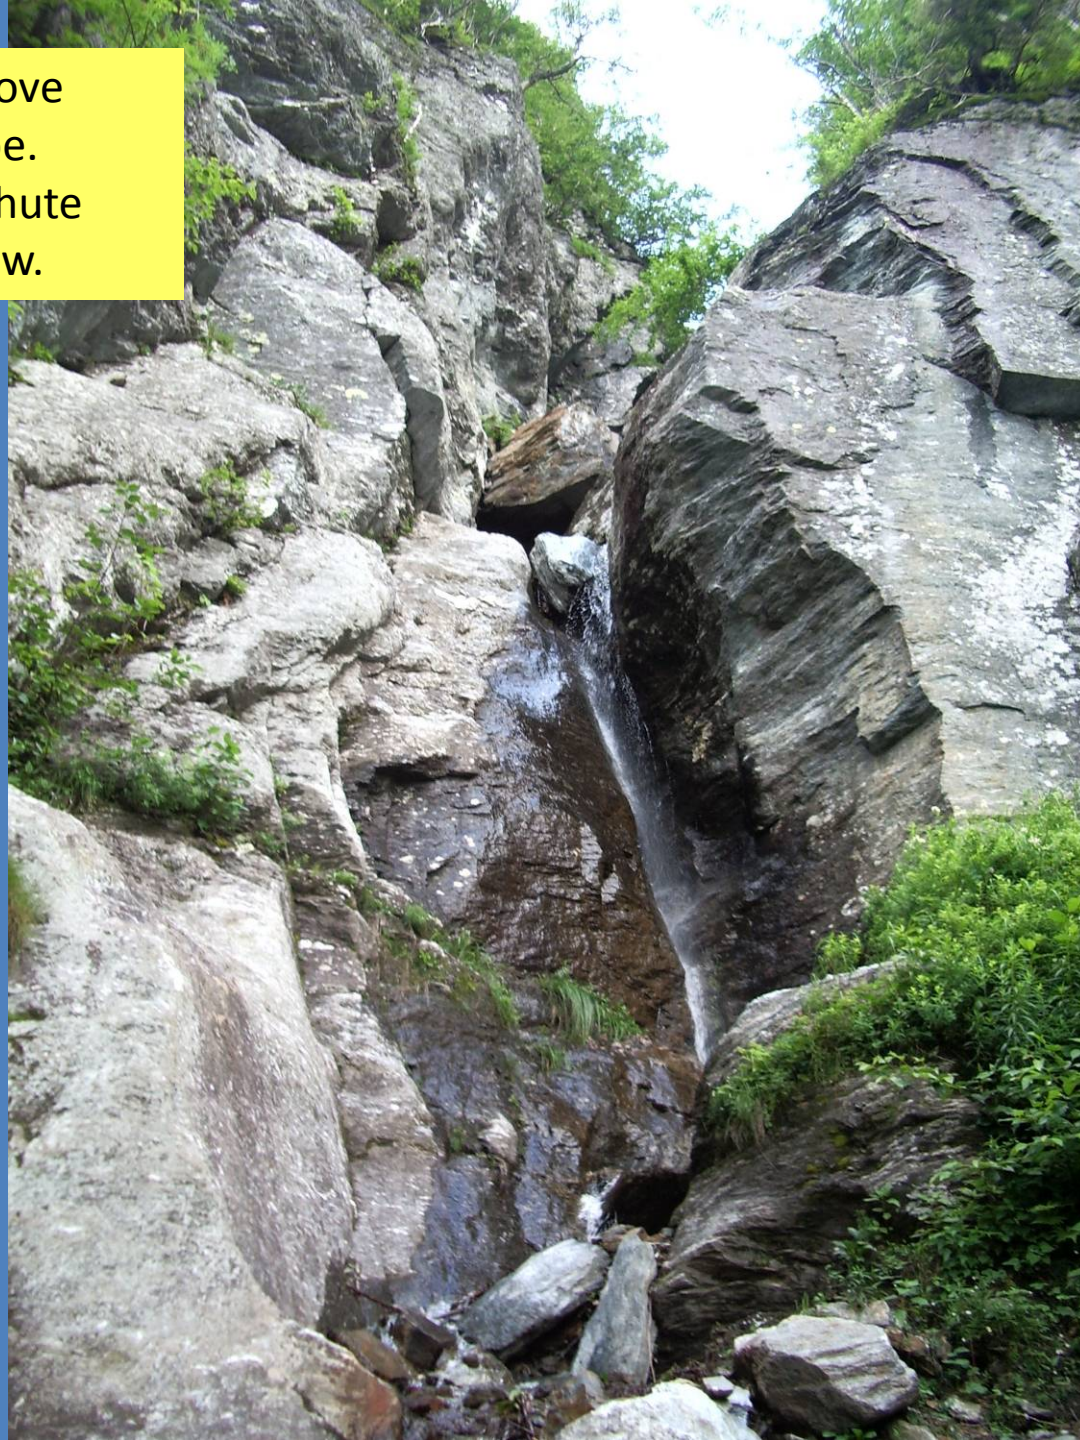
G. Springston
Photo 1788a
7/5/2006

Bedrock cascade above
talus/colluvium slope.
Lower end of rock chute
that feeds debris flow.
