Rock Fall and Debris Flow Hazards in Smugglers Notch

**Vermont Geological Survey,
Laurence Becker, State Geologist**

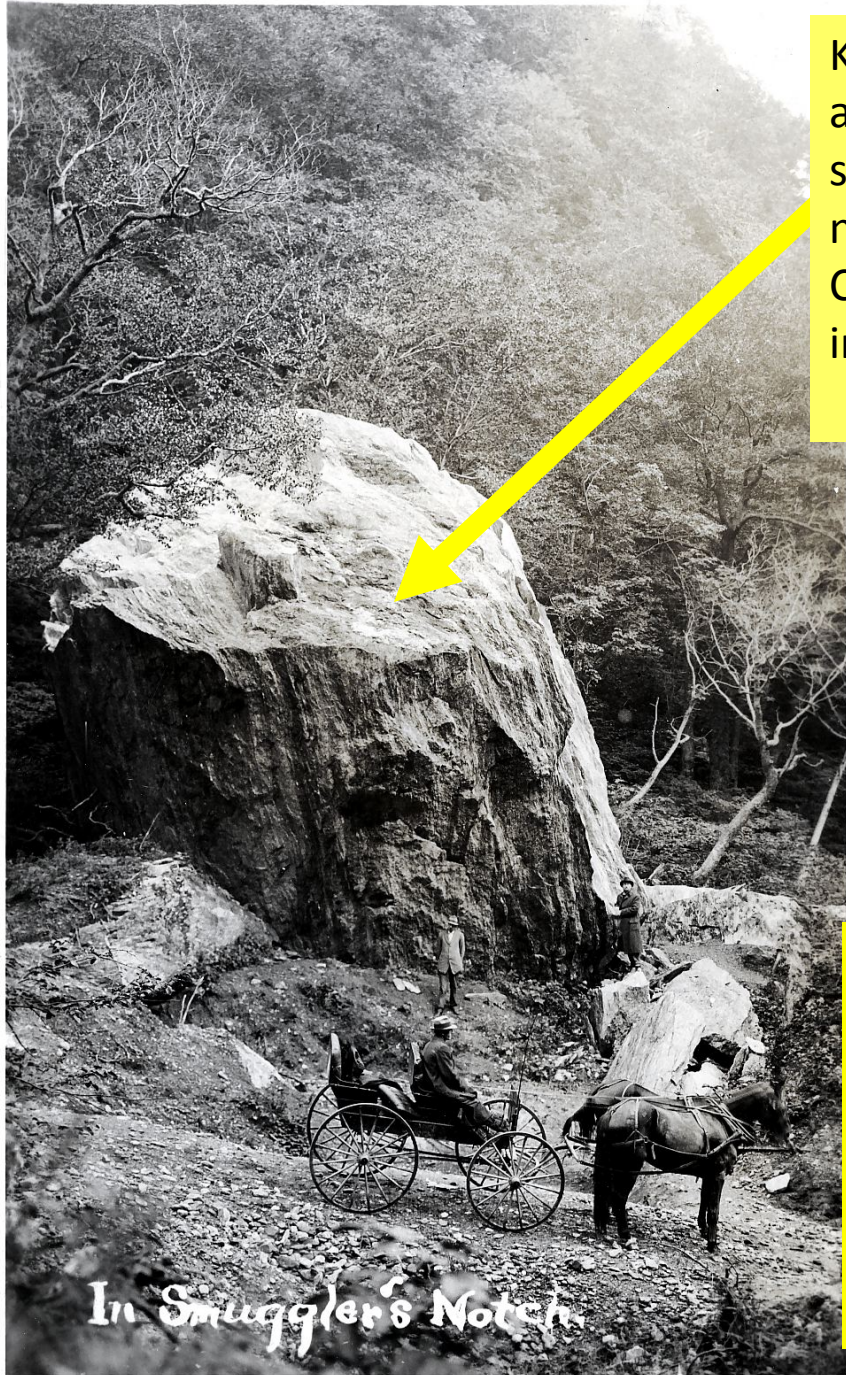
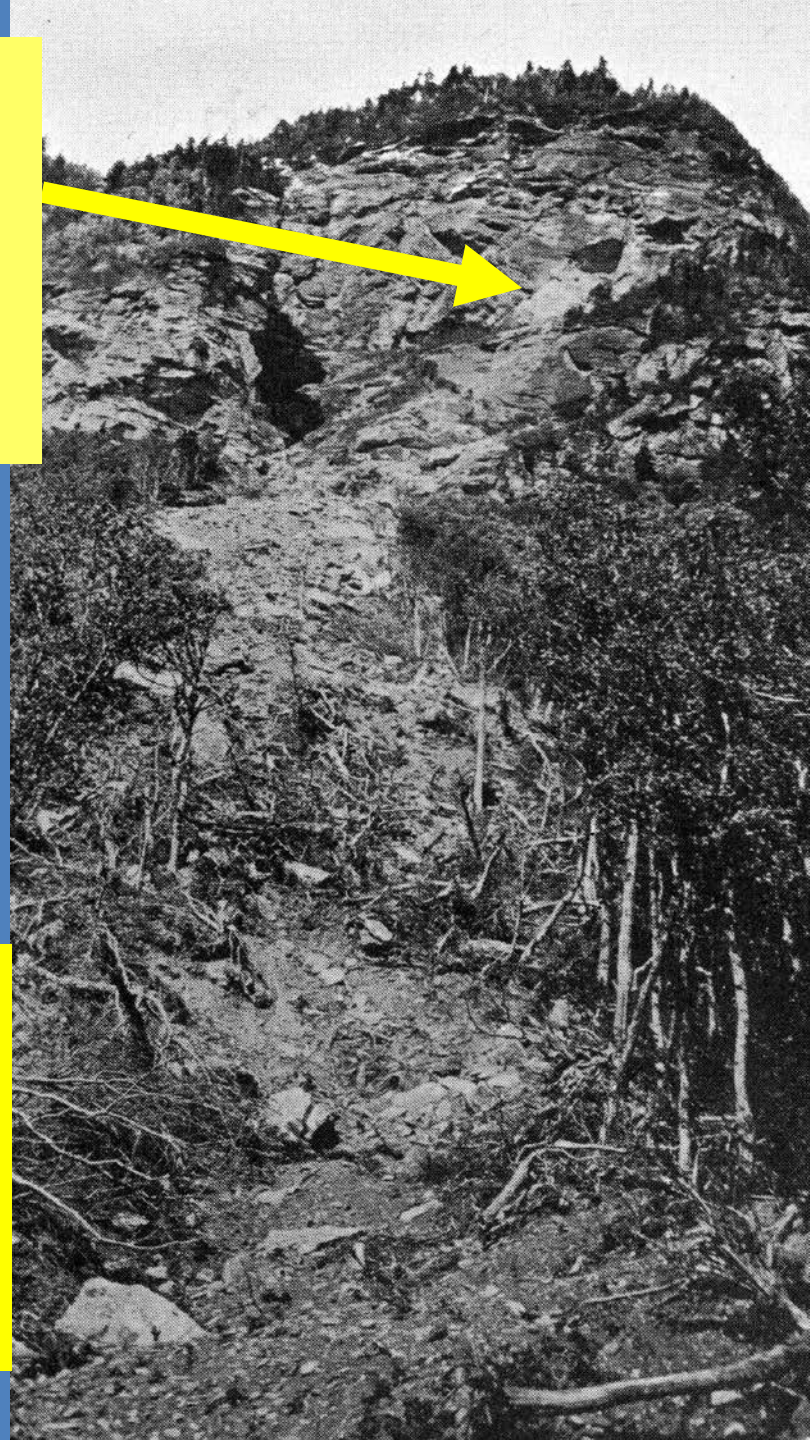
King Rock
and the
slide scar
north of
Cass's Gully
in 1911.

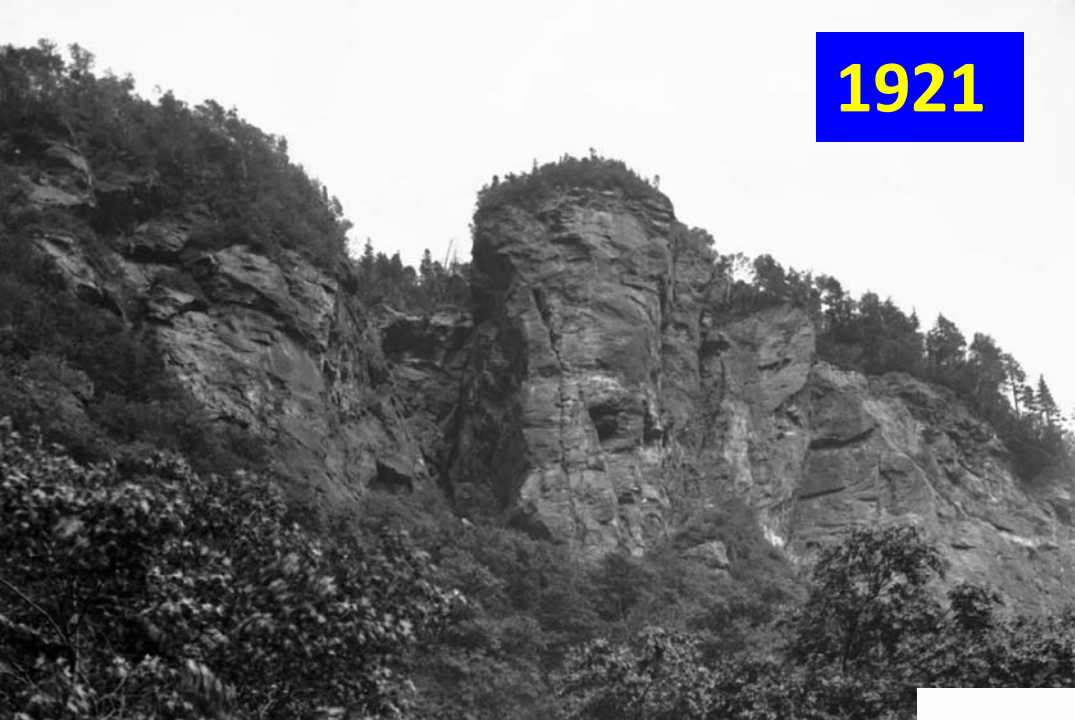
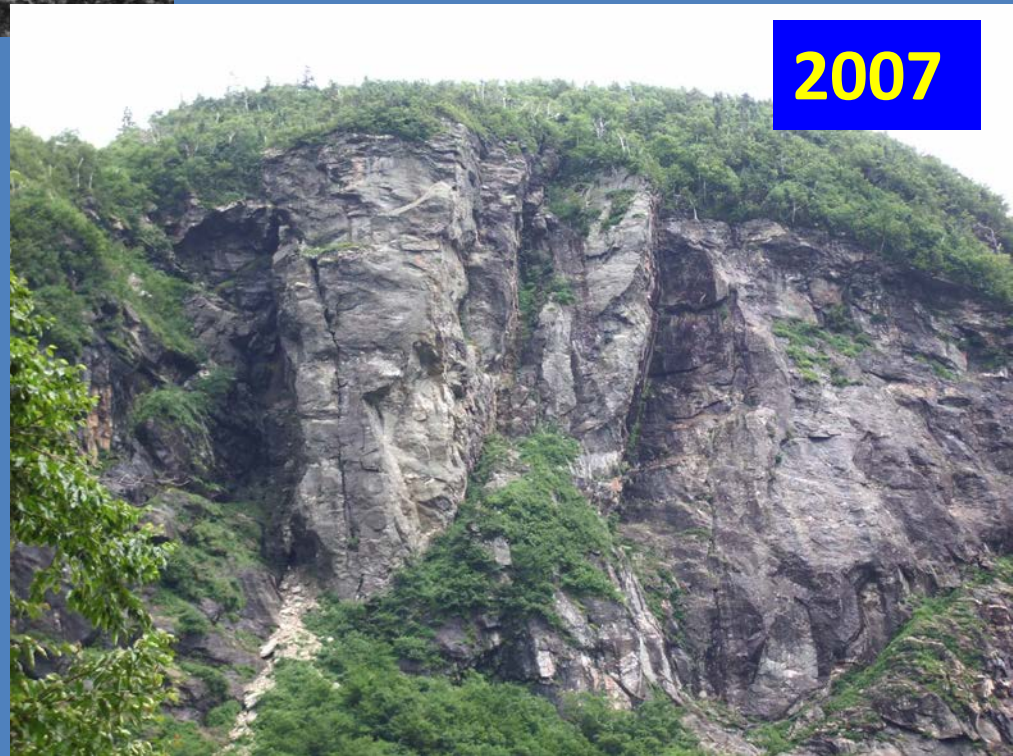
Elephant's Head in 1921 and in 2007.

**Above: 1921. Landscape Change Program
Image LS06988. Courtesy of the Vermont
State Archives.**

Below: July, 2007.

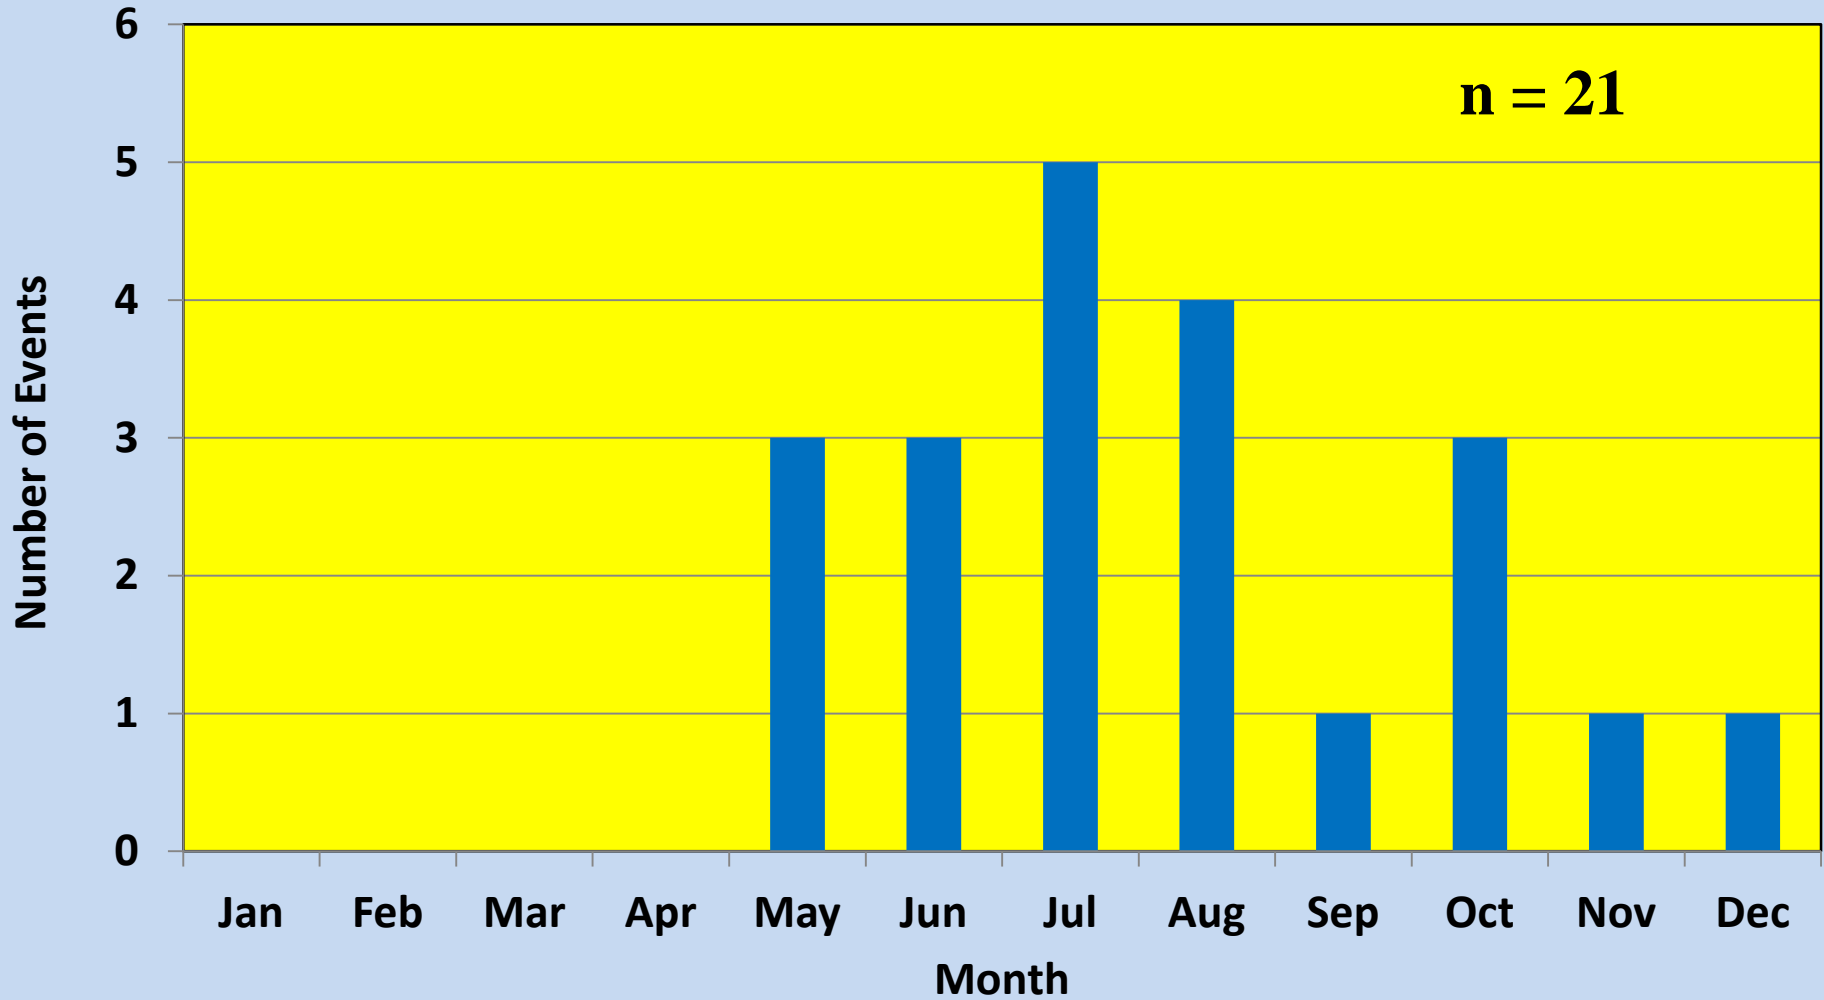
Landslide Activity Near Smugglers Notch by Month

- **Rock falls and debris flows will occur in the future and they will usually reach the road.**
- **Individual blocks can exceed 500 or 1000 tons and individual debris flows can run to thousands of cubic meters.**
- **19 of 21 events occurred between May and October with peak in July.**
- **Strong connection between extreme precipitation events and landslides (especially the debris flows).**

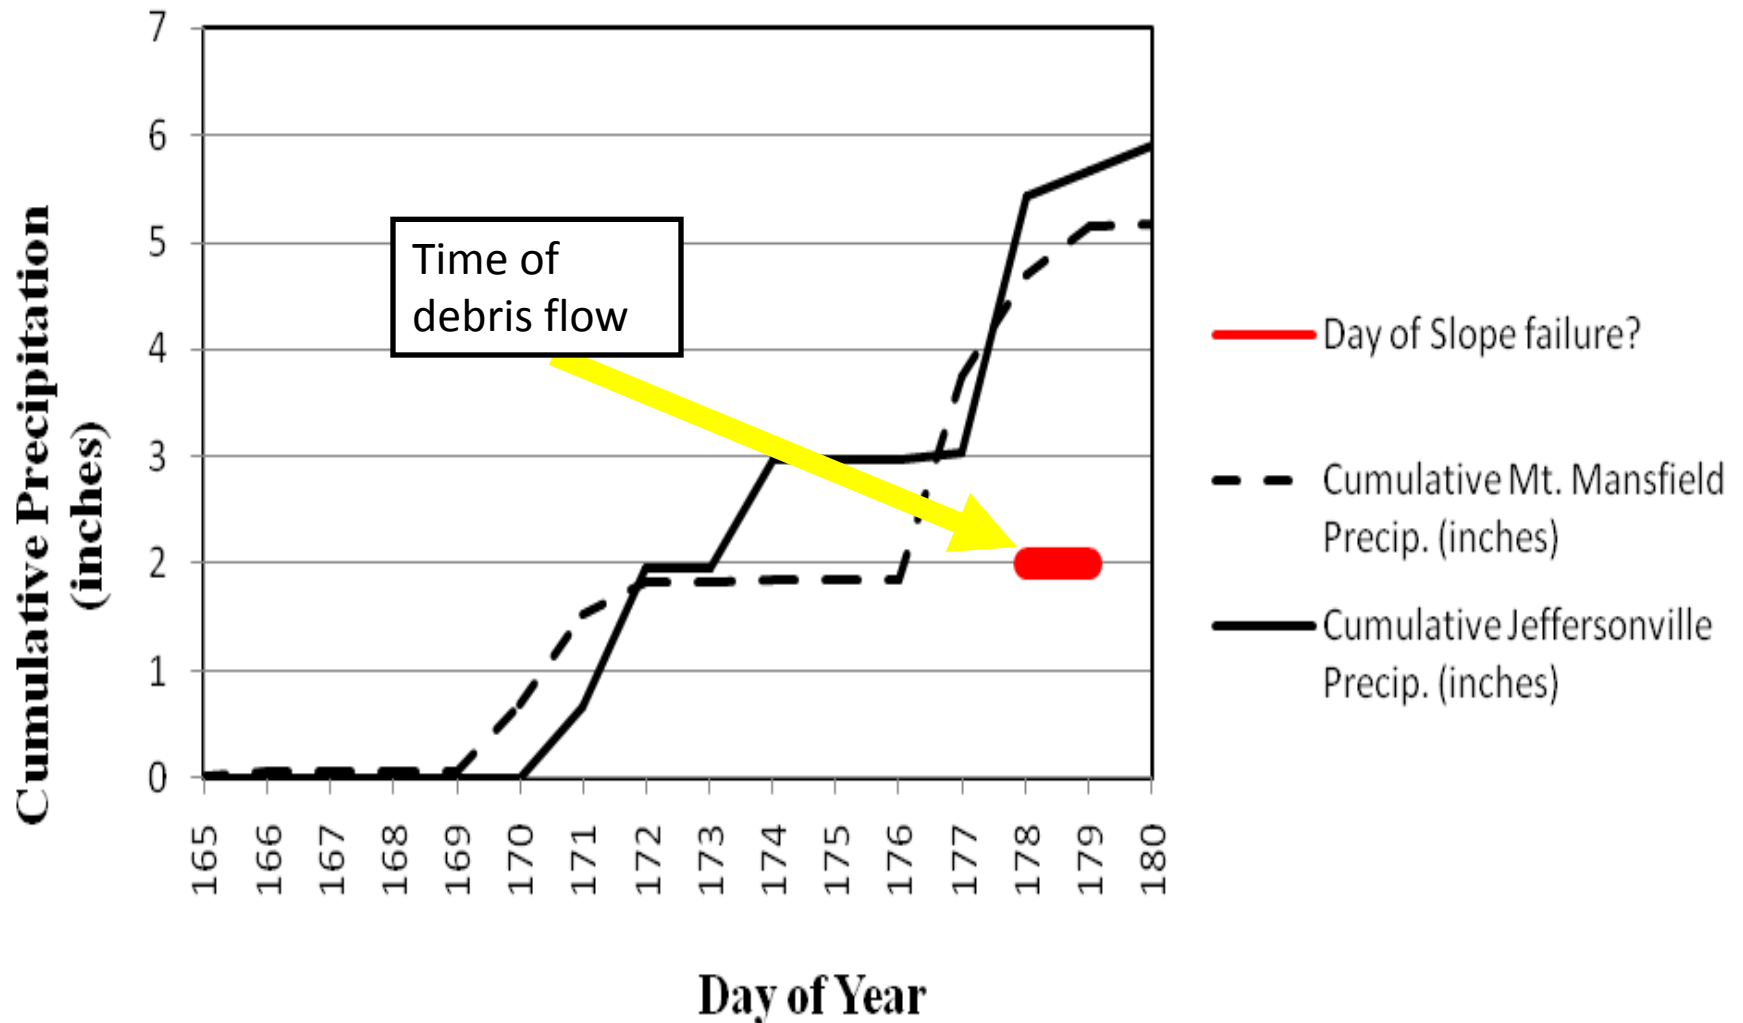
Cumulative precipitation prior to the debris flow event below Hidden Gully, June 27 or 28, 2006 (Day of year = 178 to 179).

- At present, the most effective means of anticipating slope instability events in the Notch is to use a precipitation threshold.
- Milender (2004) proposes:
 - 1. Storm delivering 2 inches in 24 hours with peak intensity of 0.7 inches/hour or greater or...
 - 2. Storm delivering 2.5 inches or more over 30 hours.

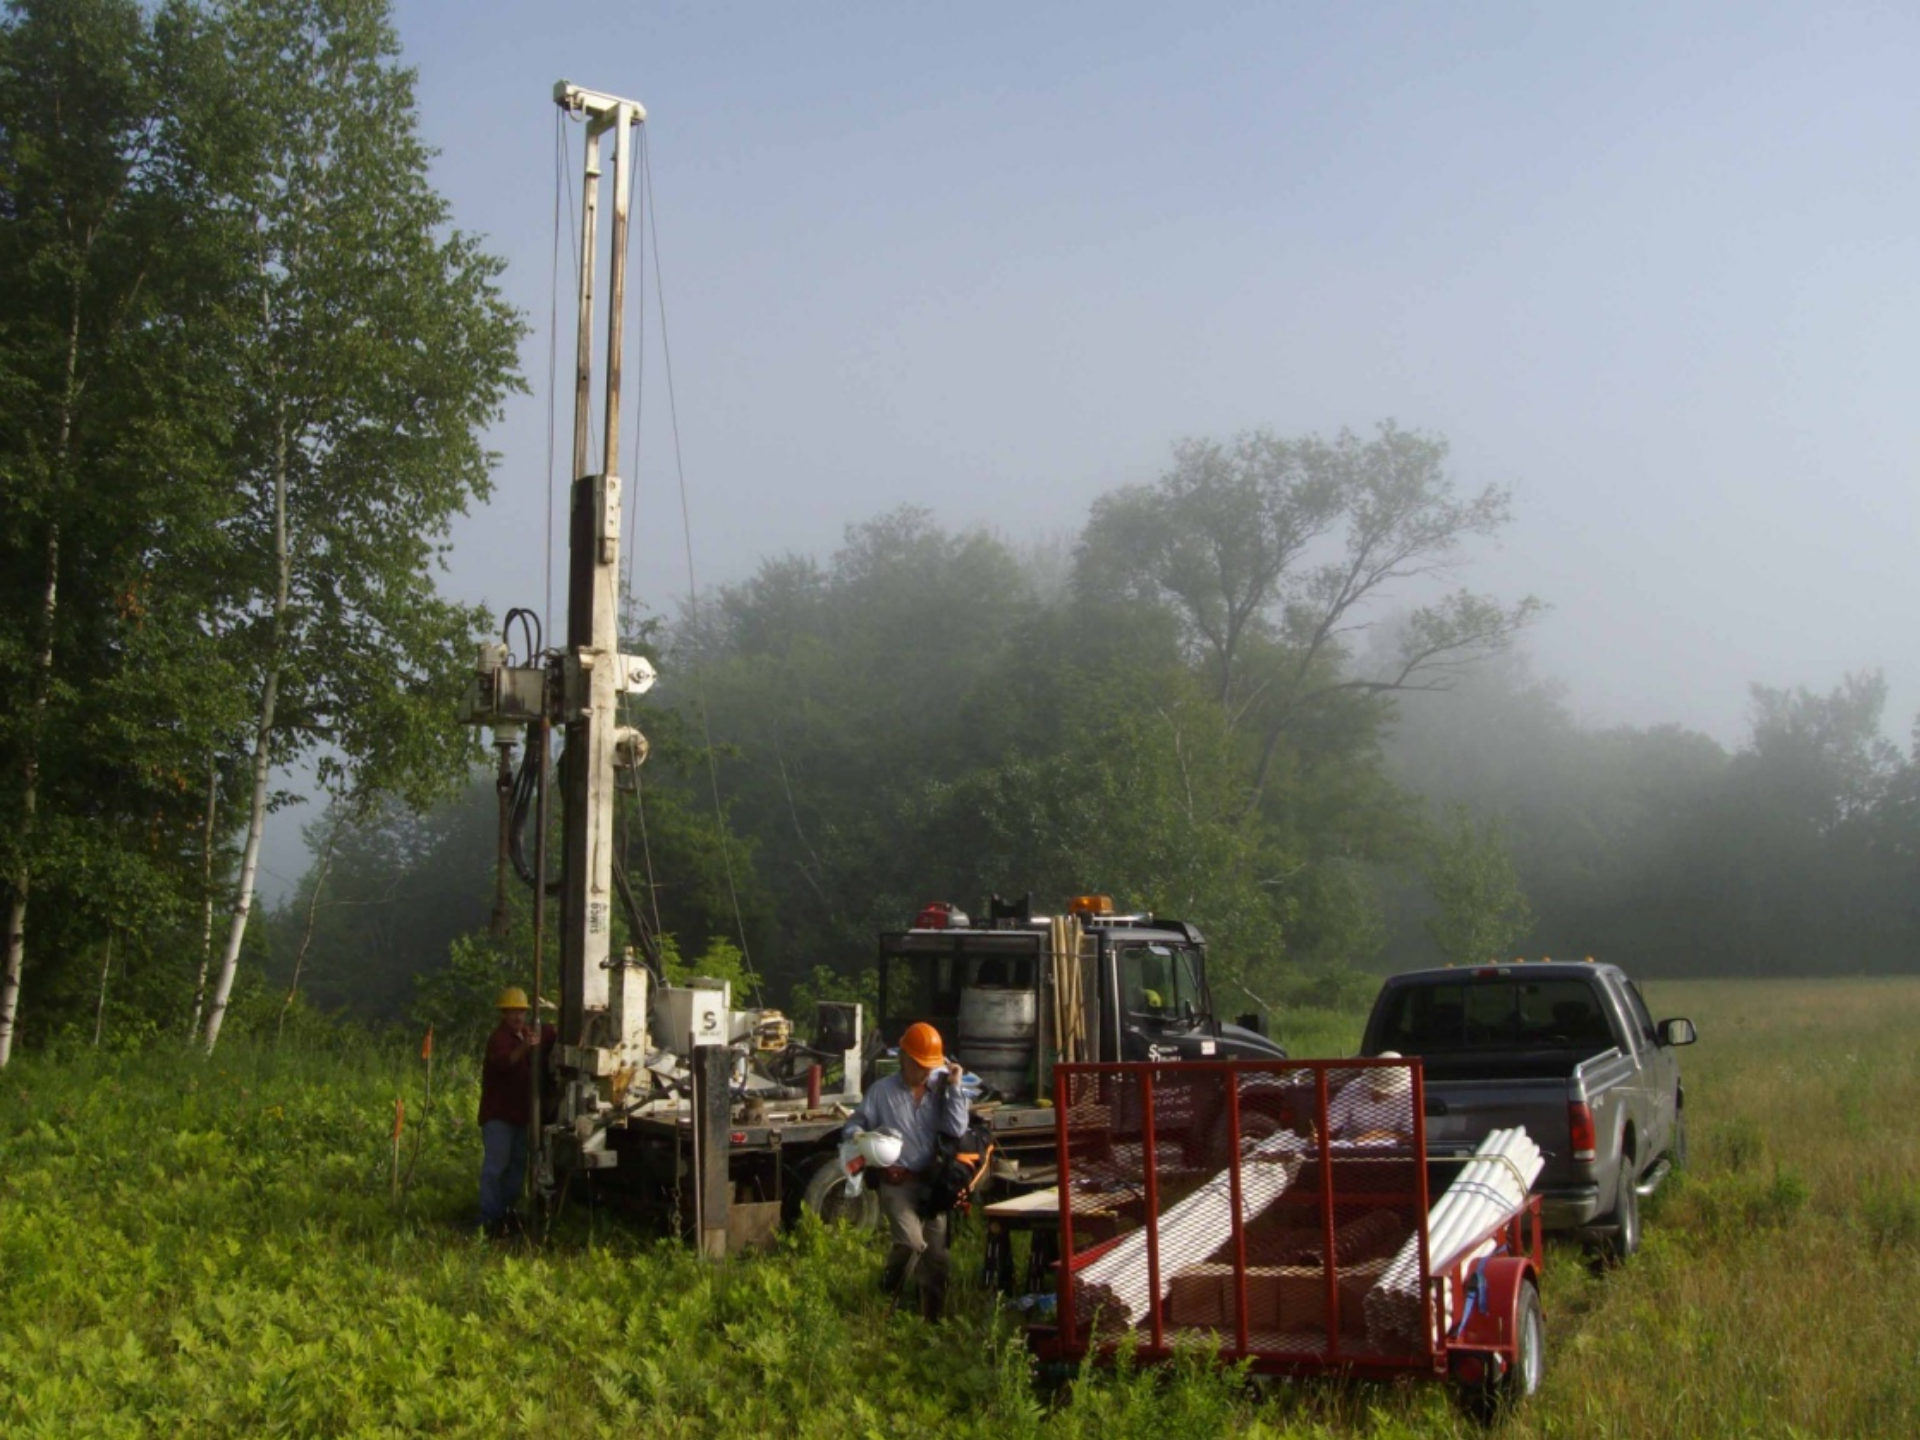
Figure 3. Looking east
across Brewster River at
1999 slide on right and
Farara slide in wooded
section.
