**1962 Aerial Photo of Smugglers Notch
Cambridge, Vermont
George Springston**

**Landform Map of Smugglers Notch
Cambridge, Vermont**
George Springston

**Slope Instability Hazard Map of Smugglers Notch
Cambridge, Vermont**
George Springston

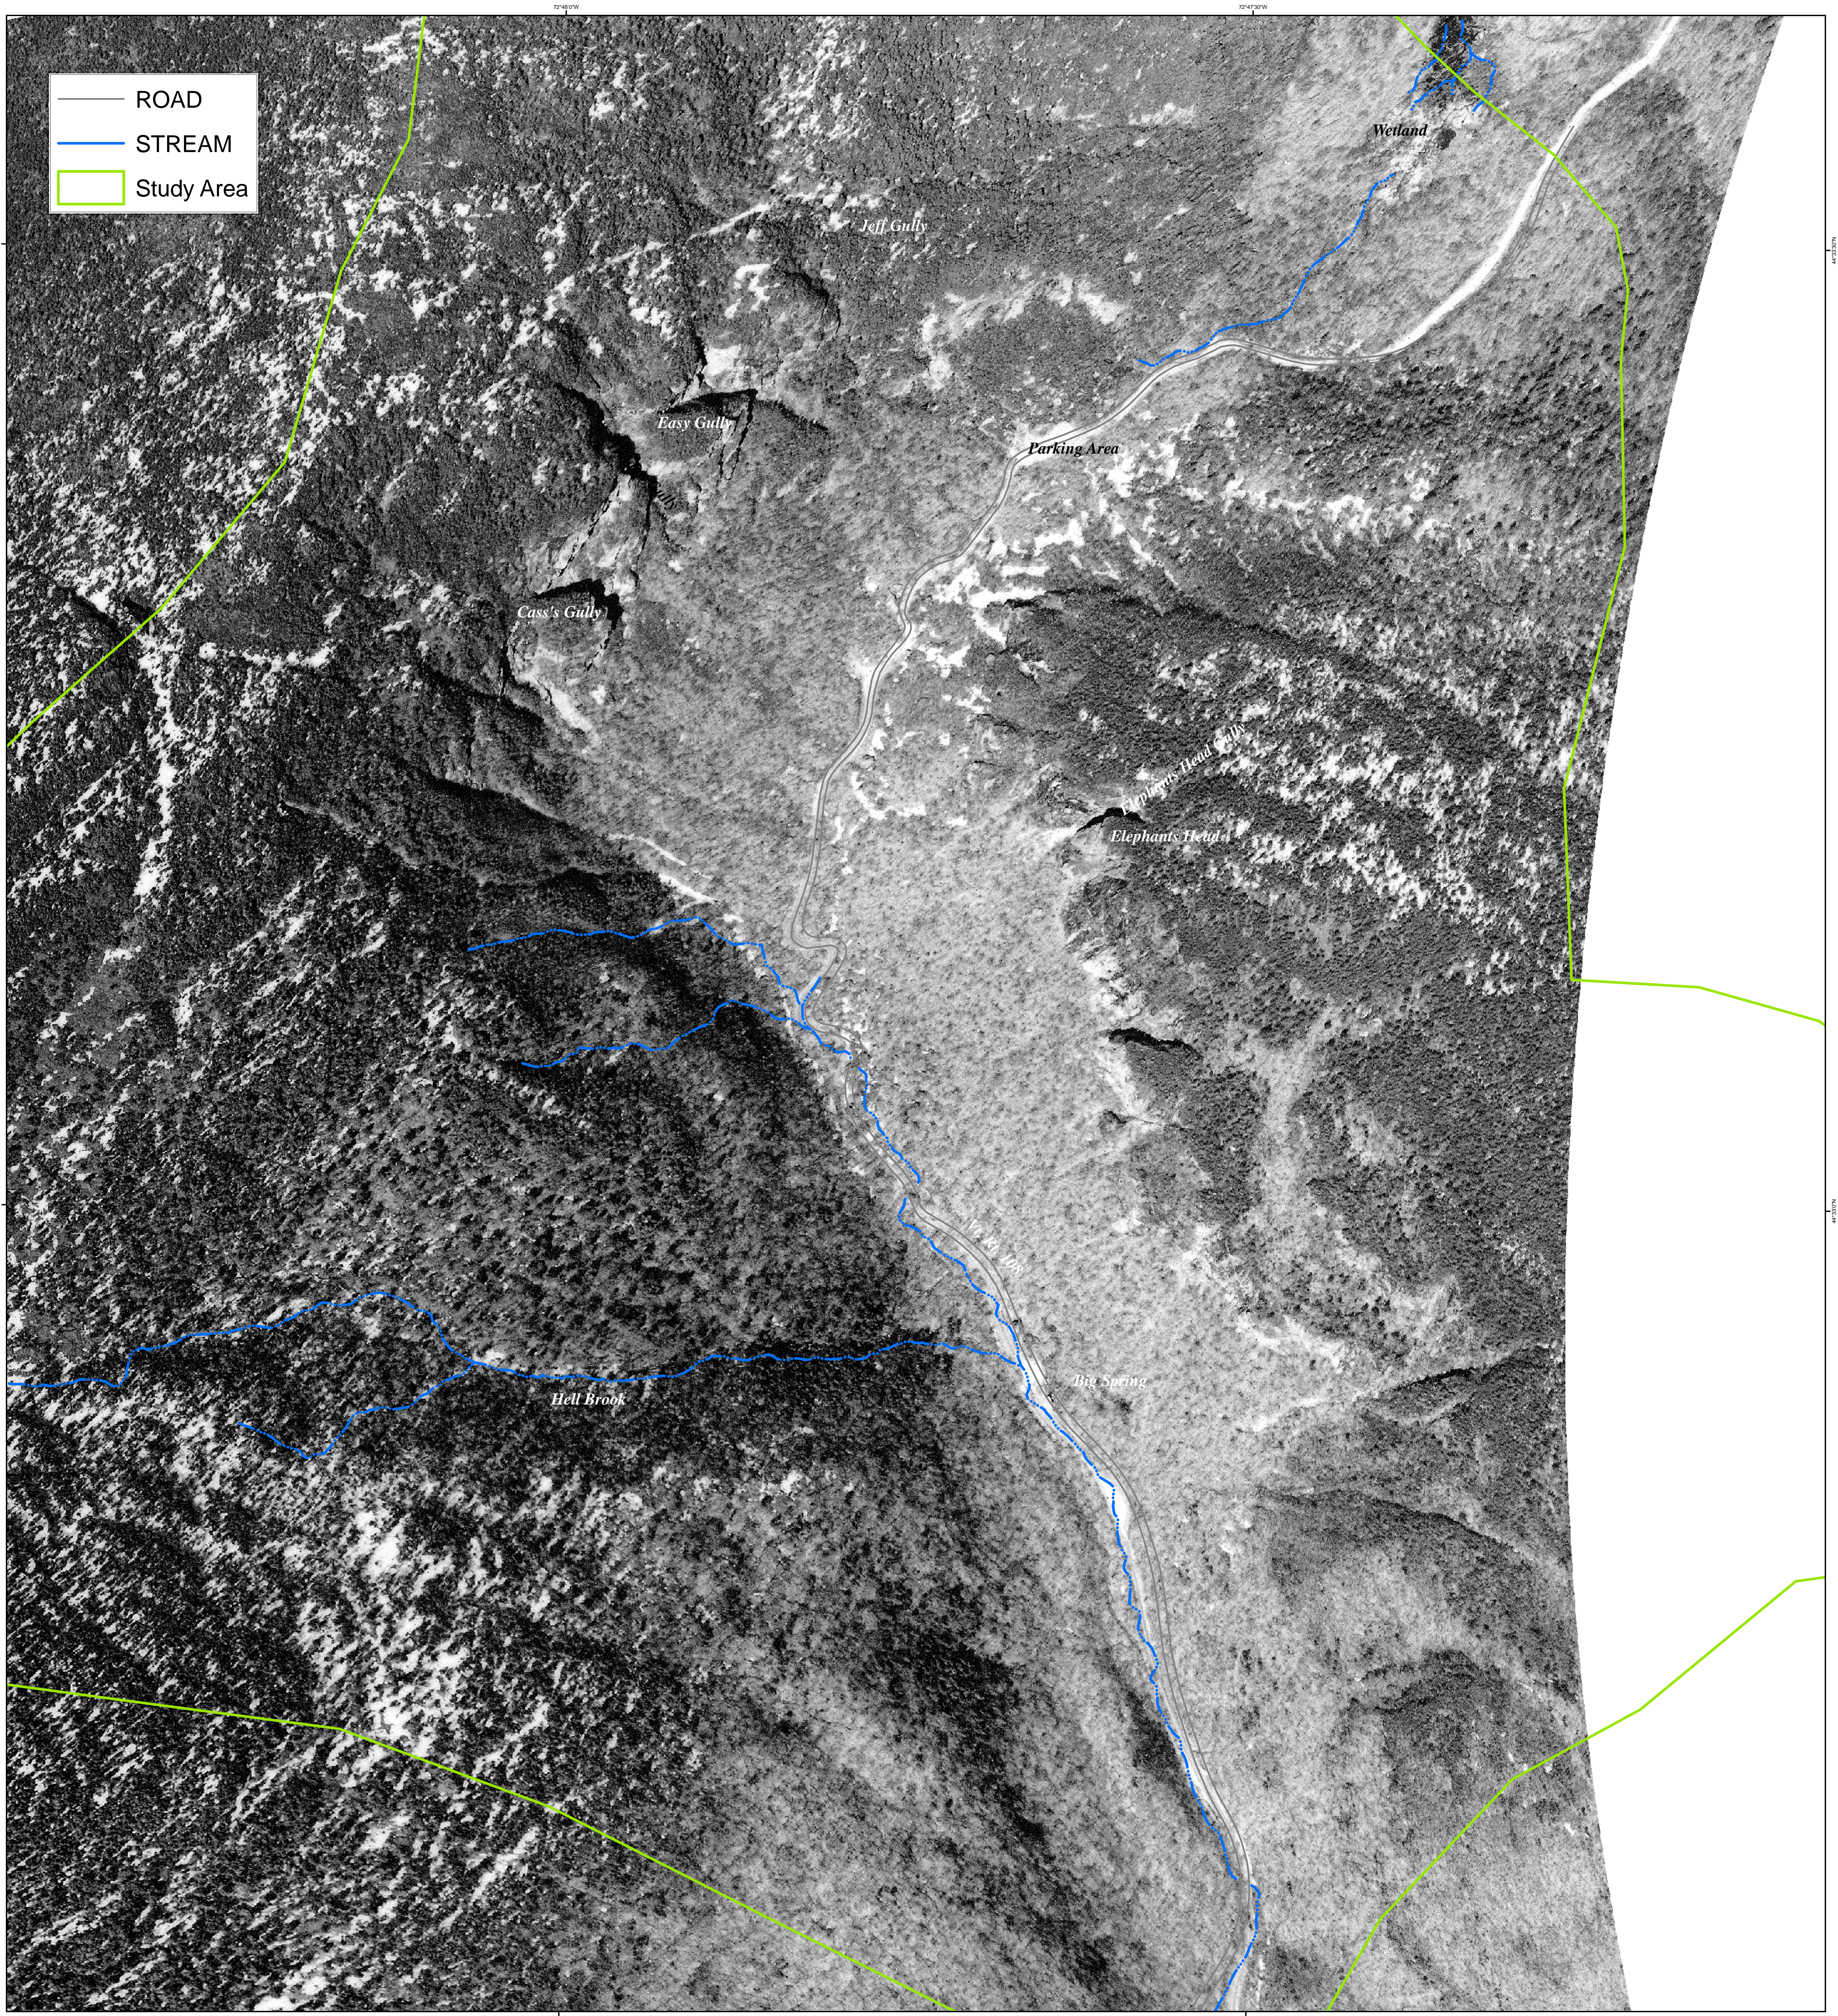
Aerial photograph taken in 1962 and approximately georeferenced. Road and streams are from photogrammetry by James W. Sewall Co. in 2007. Map produced for Vermont Geological Survey by Norwich University Geology and Environmental Science Department. Cartography by George Springston, March 25, 2008.
