**SURVEY OF HIGHWAY CONSTRUCTION MATERIALS
IN THE TOWN OF WESTMINSTER, WINDHAM COUNTY, VERMONT**

**Geologic Survey Section, Construction Division
Vermont Department of Highways**

March, 1960

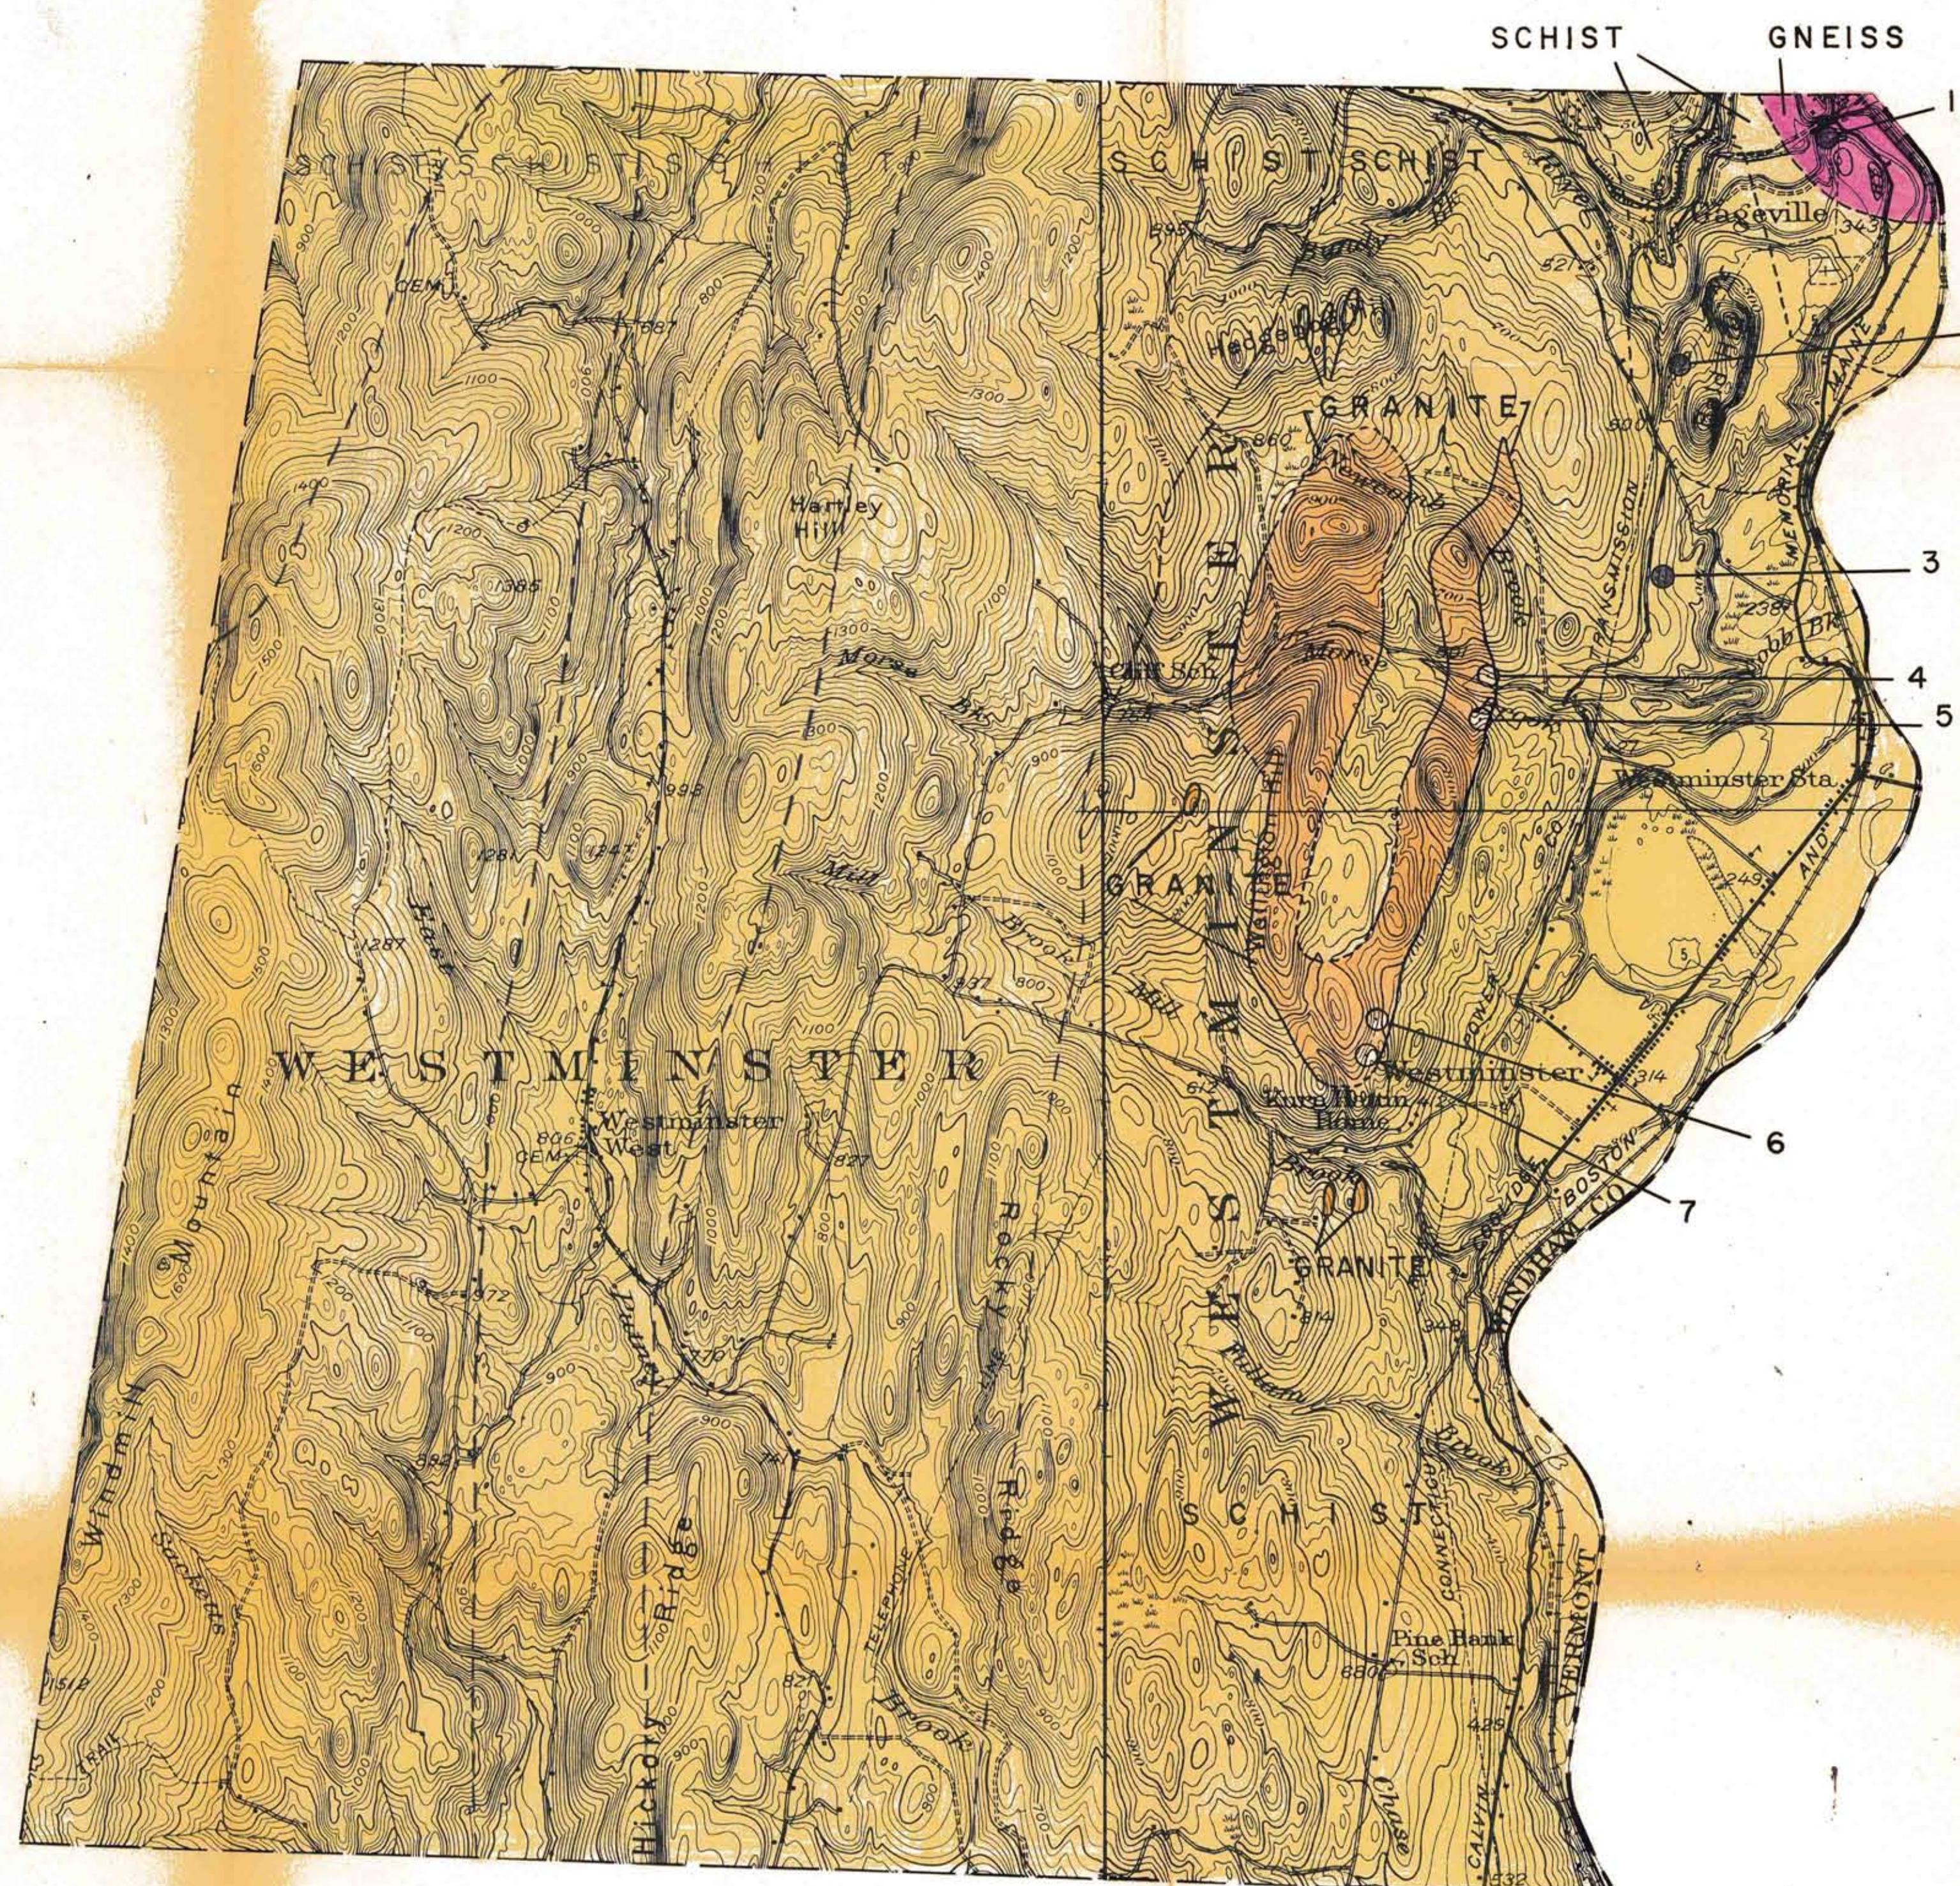
ROCK
MATERIALS MAP

Included in this folder are two surface-geology maps; one defining the location of tests conducted on bed-rock sources, the other defining the location of tests conducted on granular materials. These maps are derived from 15 minute quadrangles of the United States Geologic Survey enlarged to 1:31250 or 1" = 2604'. Delineated on the Bedrock Map are the various rock types of the area. This information was obtained from numerous sources; i.e. Vermont Geological Society Bulletins, Vermont State Geologist Reports, United States Geological Survey Bedrock Maps, as well as other references. The Surficial Map depicts areas covered by types of glacial deposits (outwash, moraines, kames, kame terraces, etc.) by which potential sources of gravel and sand may be recognized. This information was obtained primarily from a survey being conducted by Prof. D. P. Stewart of Miami University, Oxford, Ohio who, since 1956, has been mapping the glacial features of the State of Vermont during the summer months. Further information was obtained from the Soil Survey (Reconnaissance) of Vermont, conducted by the Bureau

On both maps the areas tested are represented by Identification Numbers. Several tests were usually conducted in each area represented by an Identification Number, the number of such tests being more or less arbitrarily determined either by the character of the material tested or by topography.

face on the east edge having an average height of approximately 40 feet above the valley floor. The sampling of this formation is represented on the map by Identification Numbers 4, 5, 6, and 7. The wear of this material as indicated by the samples taken in the four locations ranged from 3.7% to 7.6% representing a material suitable for Item 204 (sub-base of crushed rock) as denoted in the Vermont Department of Highways specifications. The samples in each of the Identification Numbers were taken by drilling to a depth of about three feet and blasting at intervals of approximately 25 feet across the trend or long axis of the formation. The material in Identification Number 4, the northernmost of the four areas, was apparently more gneissic in character and represented a smaller volume due to a lower relief and apparent narrowing of the structure. Identification Number 4 was sampled for a distance of 119 feet across the trend of the formation, while Identification Numbers 5, 6, and 7 were sampled for 253 feet, 185 feet, and 210 feet respectively. The west limb of the U-shaped body was not investigated or sampled due to the large and sufficient quantity of satisfactory material represented in the east limb and to the more advantageous location of the latter for most future highway construction.

A small exposure of gneiss in the northeast corner of the town as represented by Identification Number 1 was sampled. The strike of schistosity of this material was in a general north-south direction. A steep exposure approximately 60 feet high faces northwest towards the Saxtons River Valley. Six blast samples at a depth of about 3 feet were taken at average intervals of 25 feet for a total distance of 155 feet across the strike. The wear of the samples ranged from 7.2% to 13.4% with only two samples indicating satisfactory material. The predominance of samples failing to meet the maximum percent wear allowed by the specifications for Item 204 ruled out the gneiss exposure as a suitable source for this item.
