The Cotton Brook Landslide in the Mount Mansfield State Forest, Waterbury, Vermont

George Springston (Norwich University), Stephen Wright (University of Vermont), Julia Boyles and Jonathan Kim (Vermont Geological Survey)

Summary

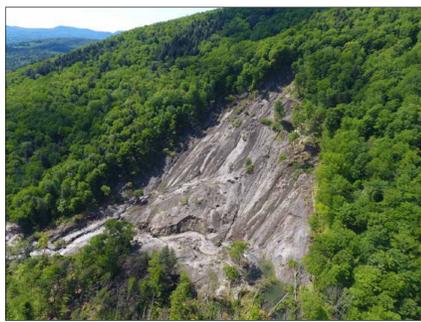
Figure 3. Cotton Brook landslide, looking south. The landslide deposit is at the bottom, center and the ponded area is at lower right. Height = 358 feet (109 meters), width across base ~570 feet (175 meters). Photo by E. Robinson, VTrans U.A.S. Team, 6/12/2019.

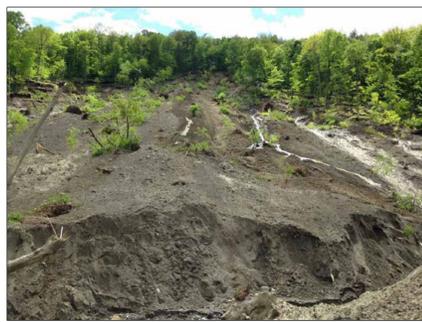
Figure 4. Looking up from toe deposit on north side of brook, 6/4/2019.

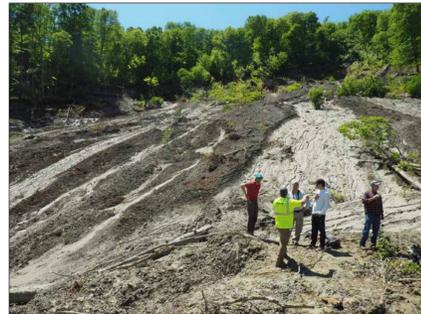
Figure 5. On Cotton Brook landslide surface. Note active mudflows and slide scars, 6/12/2019.

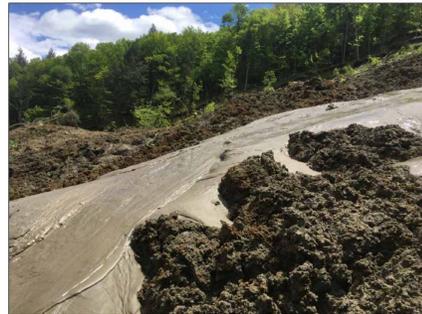
Figure 6. Mudflows, saturated sand, and newly deposited boulders and trees indicated the site was still active. Water feeding the mudflows was from seeps partway down the slope, likely at a sand-silt interface or due to elevated water table. Photo on 6/4/2019.

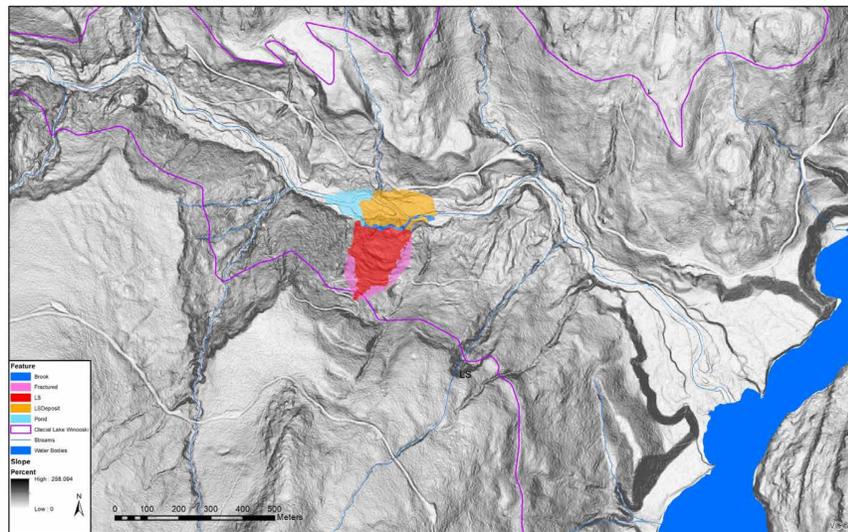
Figure 7. LIDAR slope map of Cotton Brook area showing the extent of the landslide (red), the toe deposit (orange), the ponded area (pale blue), and the fractured area around the margin (lavender). These are as of June, 2019. See the map below for an update.

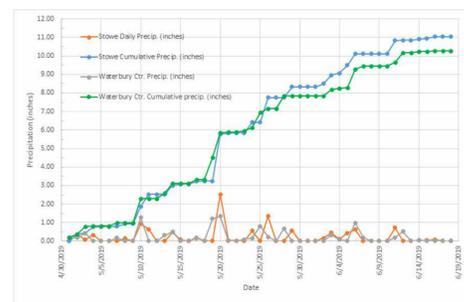
Figure 2. Rainfall recorded at two nearby weather stations. Landslide was reported on May 31, 2019. Rain in excess of 6 inches of rain fell in the preceding three weeks.

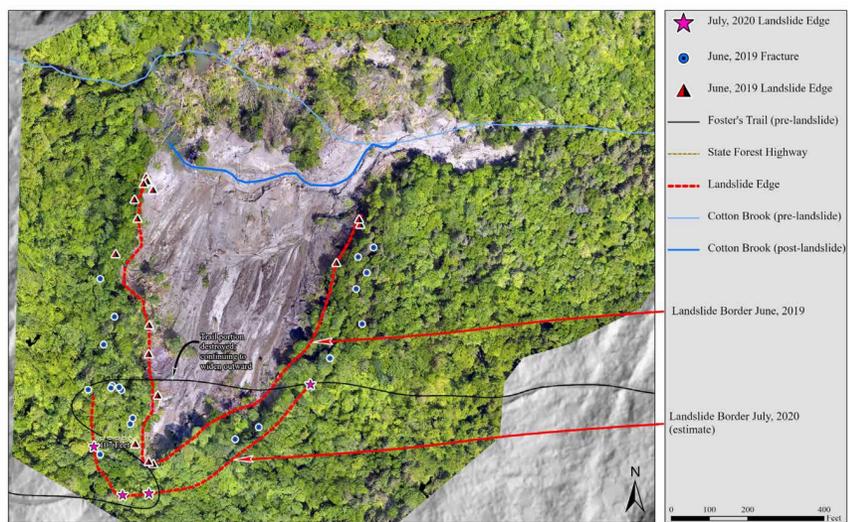
Figure 8. Orthophoto showing the updated extent of the landslide as of July, 2020. Orthophoto courtesy of E. Robinson, VTrans U.A.S. Team.

GPS measurements and satellite image analysis in July of this year show that the landslide has continued to expand as blocks of soil and trees collapse in from the margins.

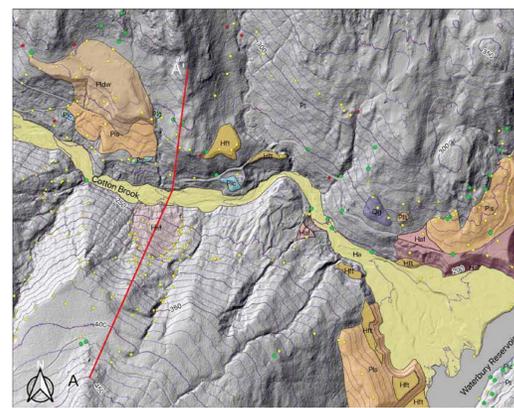
Figure 9. Surficial geologic map, modified from Wright, S.F., 2018, Surficial geology and hydrogeology of the Bolton Mountain quadrangle, Vermont: VGS Open-File Report VG2018-4

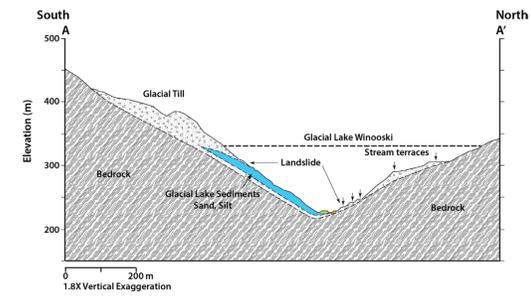
Figure 10. South-North cross-section across the Cotton Brook valley. Bedrock outcrops high along slopes and rarely along Cotton Brook up- and down-stream of the landslide. Glacial till is widely distributed across deeply incised tributaries along the south slope of Cotton Brook. The recent landslide reveals that this till overlies glacial lacustrine sediments at least below the elevation of Glacial Lake Winooski. Numerous high-elevation stream terraces indicate that the valley was largely filled with sediments deposited in Glacial Lake Winooski before the lake drained

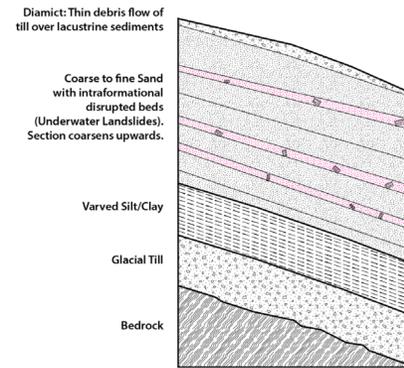
Figure 11. Schematic stratigraphy at Cotton Brook landslide. Not to scale.

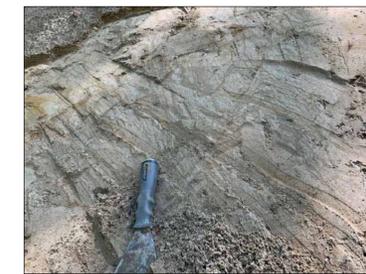
Figure 12. Traces of steeply inclined and faulted medium to fine sand and silt beds exposed along the headwall of the Cotton Brook landslide. Bedding disruption occurred in an underwater landslide that occurred shortly after beds were deposited on the steeply-sloping sides of the Cotton Brook valley when the valley was inundated by Glacial Lake Winooski.

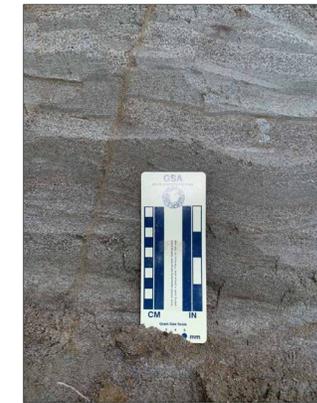
Figure 13. Graded beds of coarse to fine sand and silt near top of the exposed section. These are interpreted to be the bottom-set beds of a delta deposited in Glacial Lake Winooski by Cotton Brook.

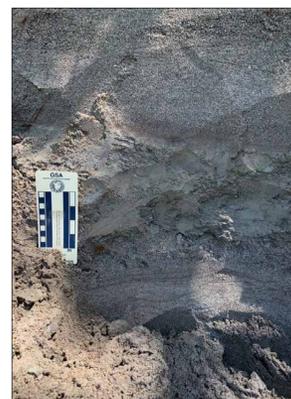
Figure 14. Beds of coarse sand and pebble gravel at the top of the exposed section incorporate clumps of till that may have been ice-rafted or eroded from farther up-valley and later transported and deposited near the Glacial Lake Winooski delta.

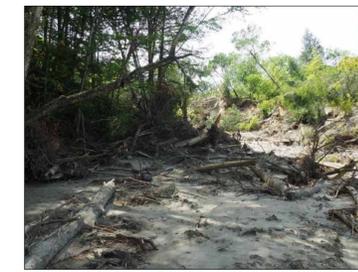
Figure 15. Woody debris field downstream of Cotton Brook landslide, 6/24/2019.

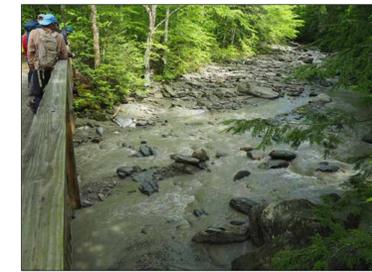
Figure 16. View looking upstream from bridge over Cotton Brook, downstream of the landslide. Note heavy sedimentation on bars and extremely turbid water. Photo taken 6/4/2019.

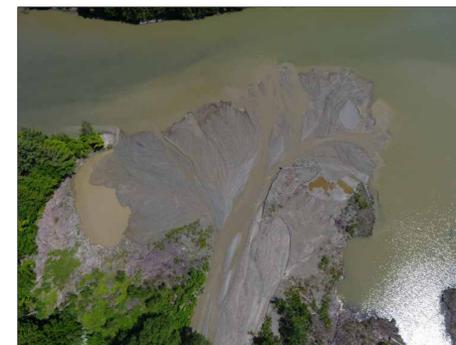
Figure 17. The enlarged delta in Waterbury Reservoir, 6/12/2019. Photo courtesy of E. Robinson, VTrans U.A.S. Team.

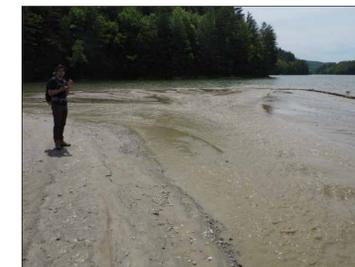
Figure 18. Delta of Cotton Brook building out into Waterbury Reservoir, 6/10/2019.

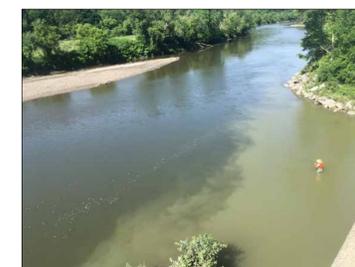
Figure 19. Sediment plume from the Little River coming in from right and mixing with the waters of the Winooski River, Waterbury, 6/24/2019.

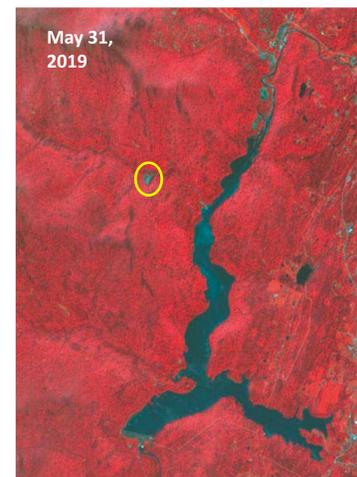
Figure 20. Color infrared Sentinel 2 Satellite from 5/31/2019, immediately after first recognition of landslide. Note the pale blue color of the reservoir waters, interpreted as high sediment load.
