Monitoring of Landslides in Vermont Using Drone and Geologic Surveys

Kim, Jonathan¹ ; Springston, George² ; Klepeis, Keith³ ; Boyles, Julia¹ ; and Robinson, Evan⁴
¹Vermont Geological Survey, ²Norwich University, ³University of Vermont, ⁴Vermont Agency of Transportation

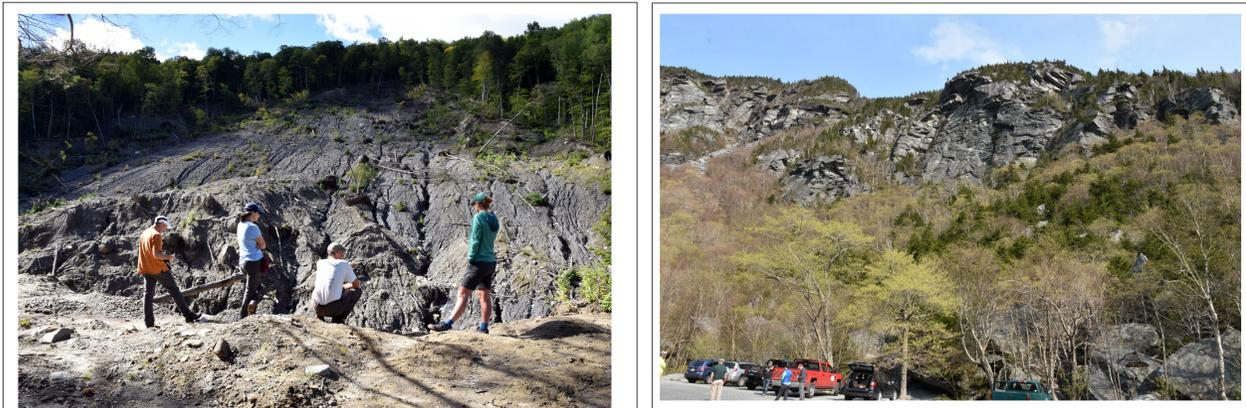
Figure 1. We are conducting annual monitoring surveys of the Cotton Brook landslide (Waterbury- left) and rockslides in Smugglers Notch (Cambridge-right).

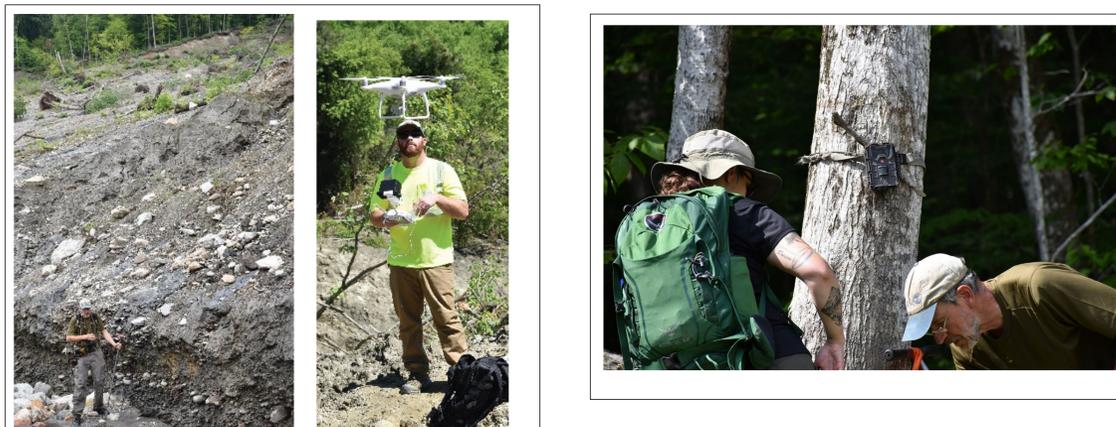
Figure 2. Field survey (left), drone takeoff (center), and game camera (right).

Intensive field surveys are necessary to understand the underlying geologic framework for a landslide and drone surveys give a critical aerial perspective. Game cameras can be used to view parts of a landslide area on an hourly basis. Each of these field methods is completed annually. All data sets are integrated using photogrammetry software to produce 3-D geologic maps (next section).

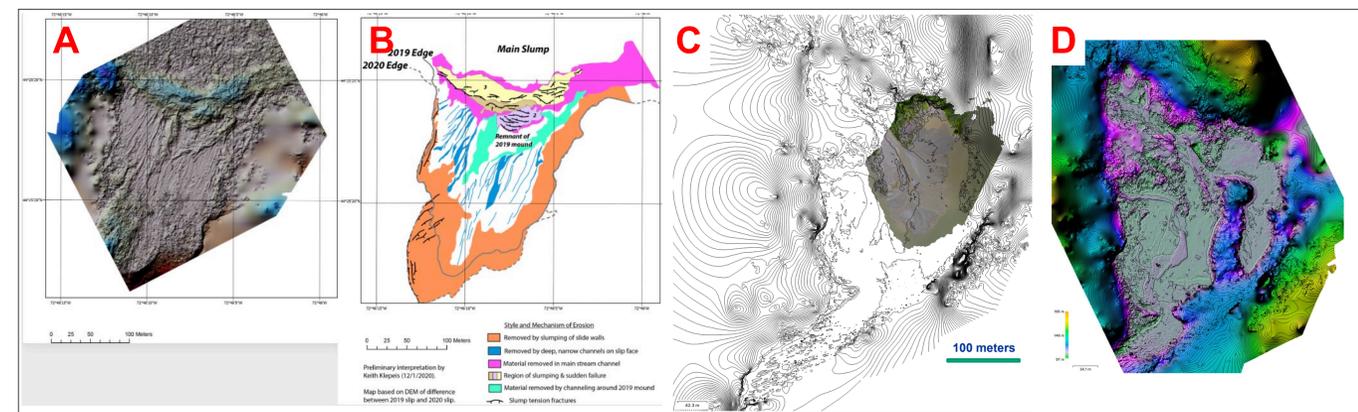
Quantitative changes to the landslide and different mechanisms of failure and erosion between 2019-2020 are shown below: (A) DEM of Difference (DOD) of the landslide surface was created by subtracting the 2020 photogrammetrically-derived model from the 2019 model. The raised areas (bumps) are shaded with cool colors and show material that was eroded between the 2019 and 2020 events. This map allows us to distinguish different mechanisms of mass wasting. (B) Interpretive geologic map showing the landslide's internal structures and the different mechanisms of erosion that created it. (C) Cotton Brook delta located downstream from the landslide in 2019 (post slide), with contours (black lines, 1 m interval) of the delta in 2020, representing the peak of sediment deposition. This image is used to quantify how much the delta grew after the 2019 failure. (D) DOD created by subtracting the 2020 model (peak state) of the delta from a 2021 model (erosive state). Topographic highs (blues and purples) show material that was eroded between 2020 and 2021. Contour lines (1 m interval) highlight domains and patterns of erosion.

Figure 3. Quantifying land surface change from source to sinks (landslide to delta).
