Sliding Down the Cotton Brook and Other Tales of Slope Instability

George Springston, Norwich University

Marjorie Gale, State Geologist, DEC

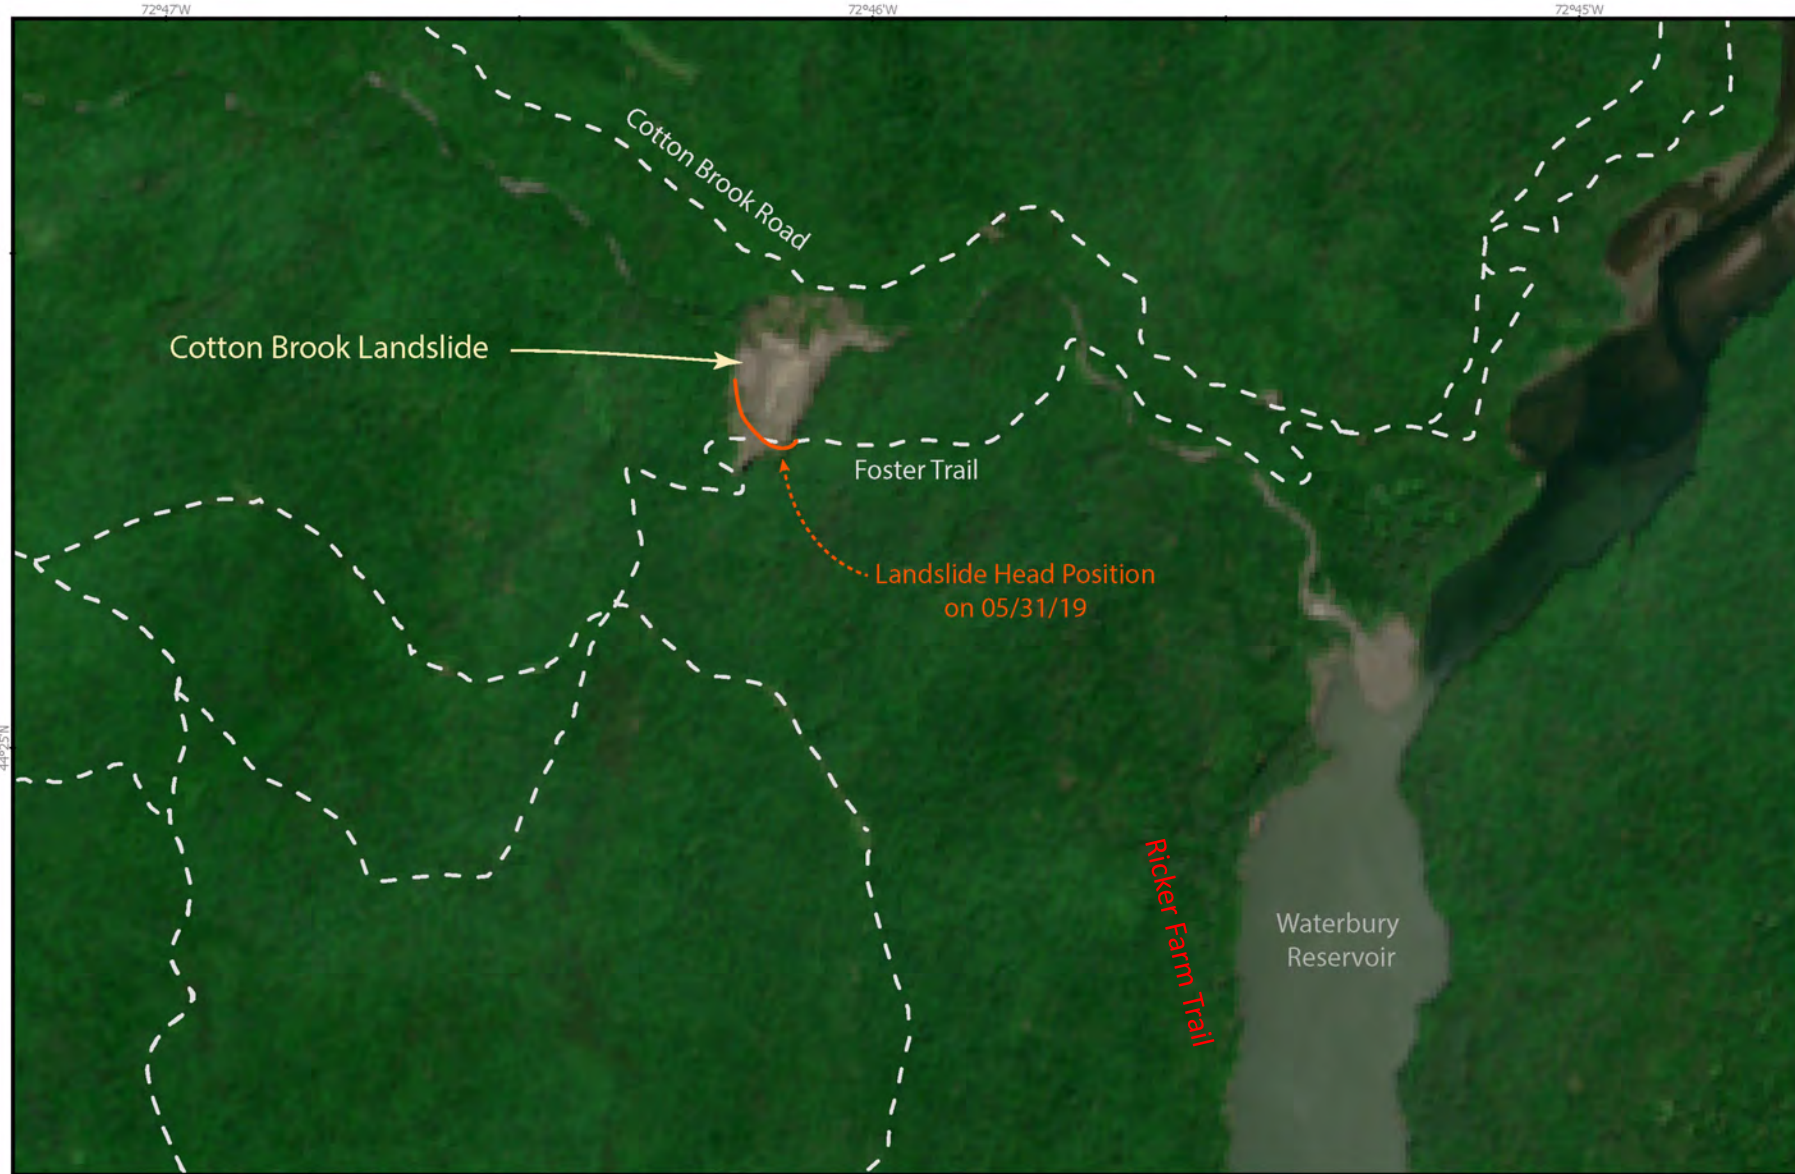
Landslide reported: May 31
Image: 6/17/2019

12 acres active

2.2 acres detached

~1.8 acres impounded water

~2.8 acres delta

~250,000 cubic meters excavated

~100,000 cubic meters in brook

Flag (at arrow) is gone by 7/8

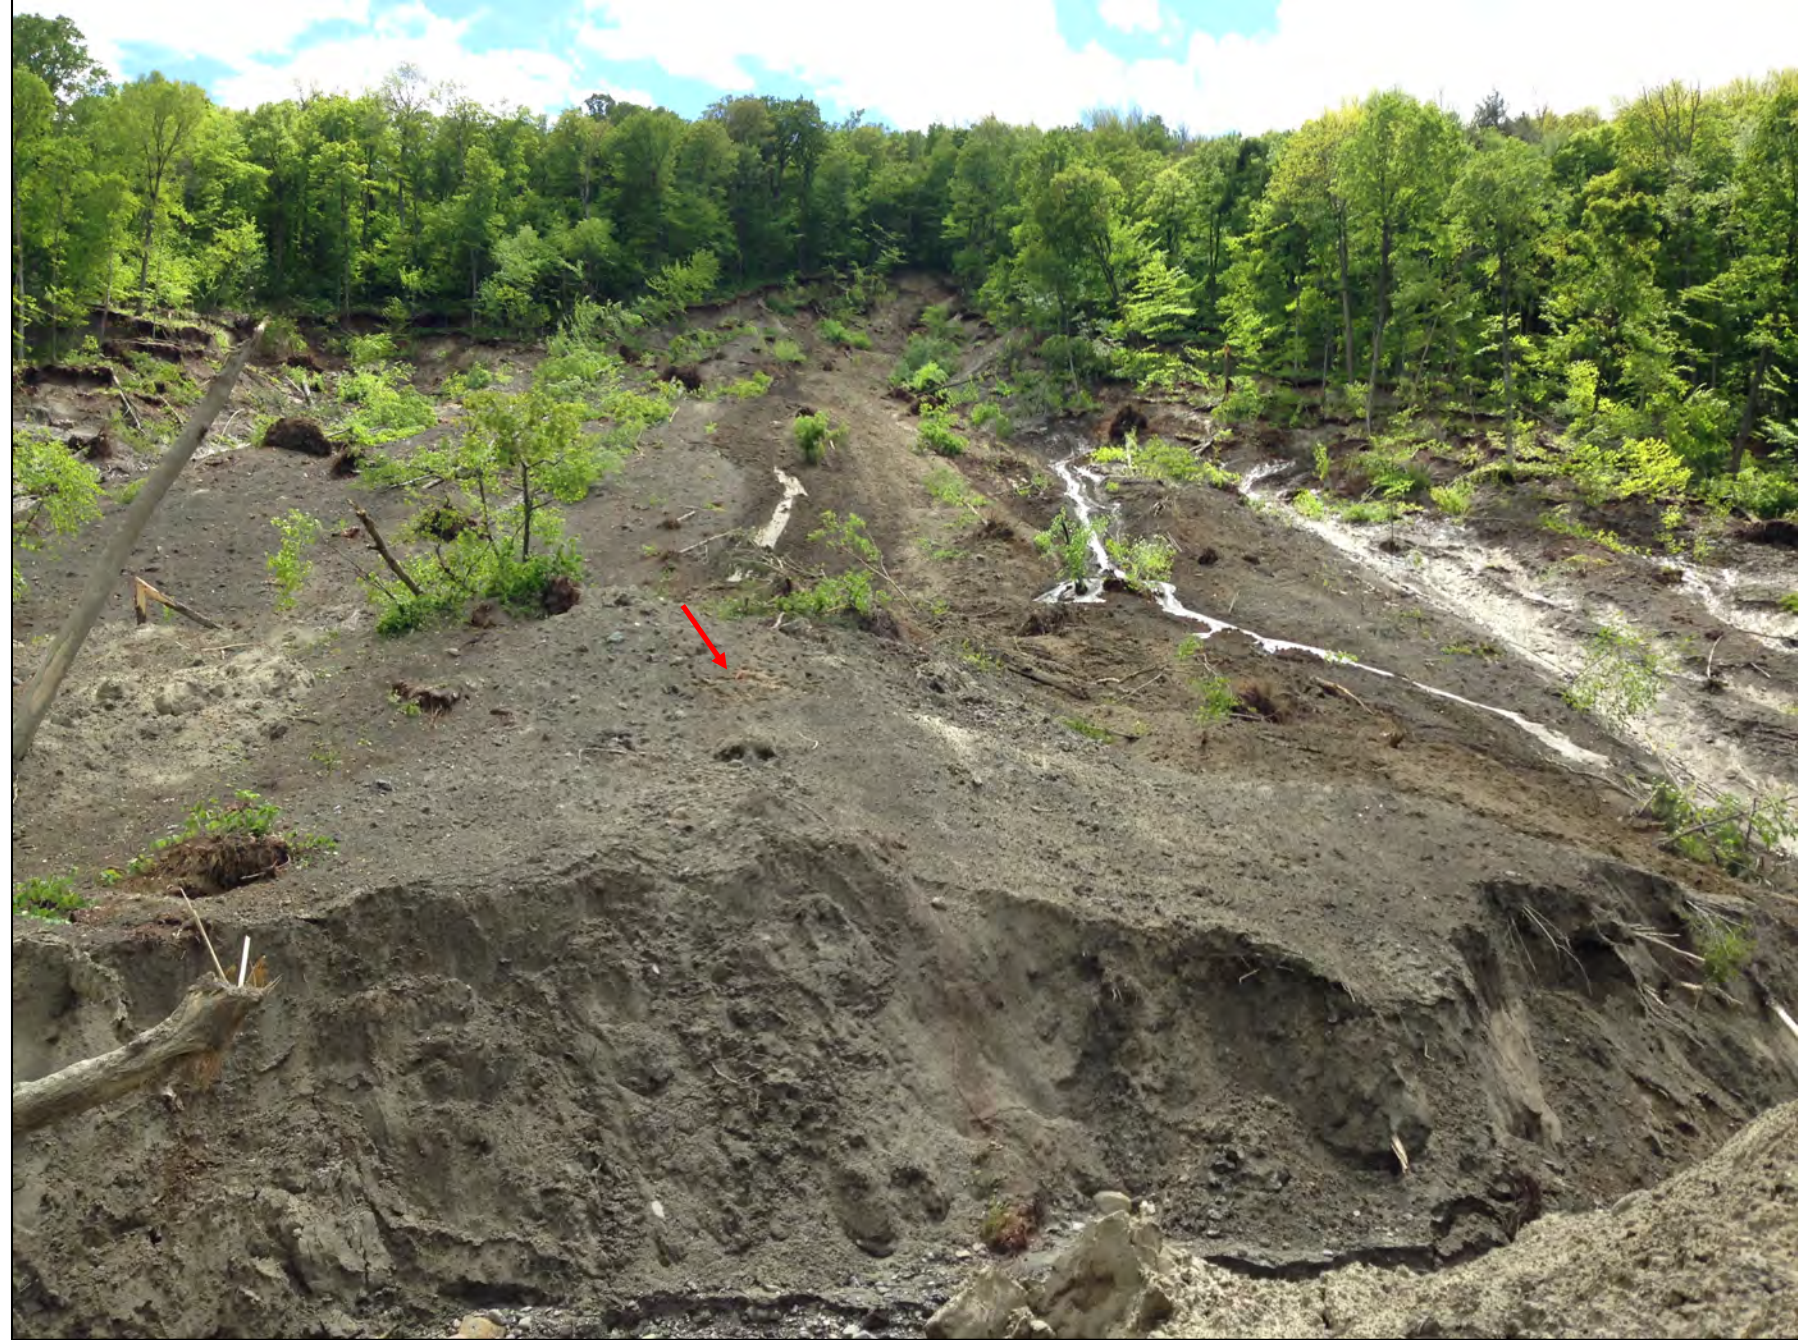
6/4/2019

Ground cracks and offset
Detached blocks will
continue to fail
6/4

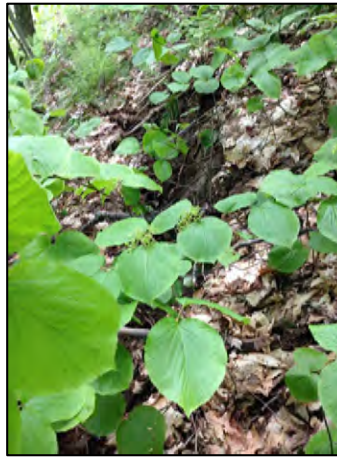
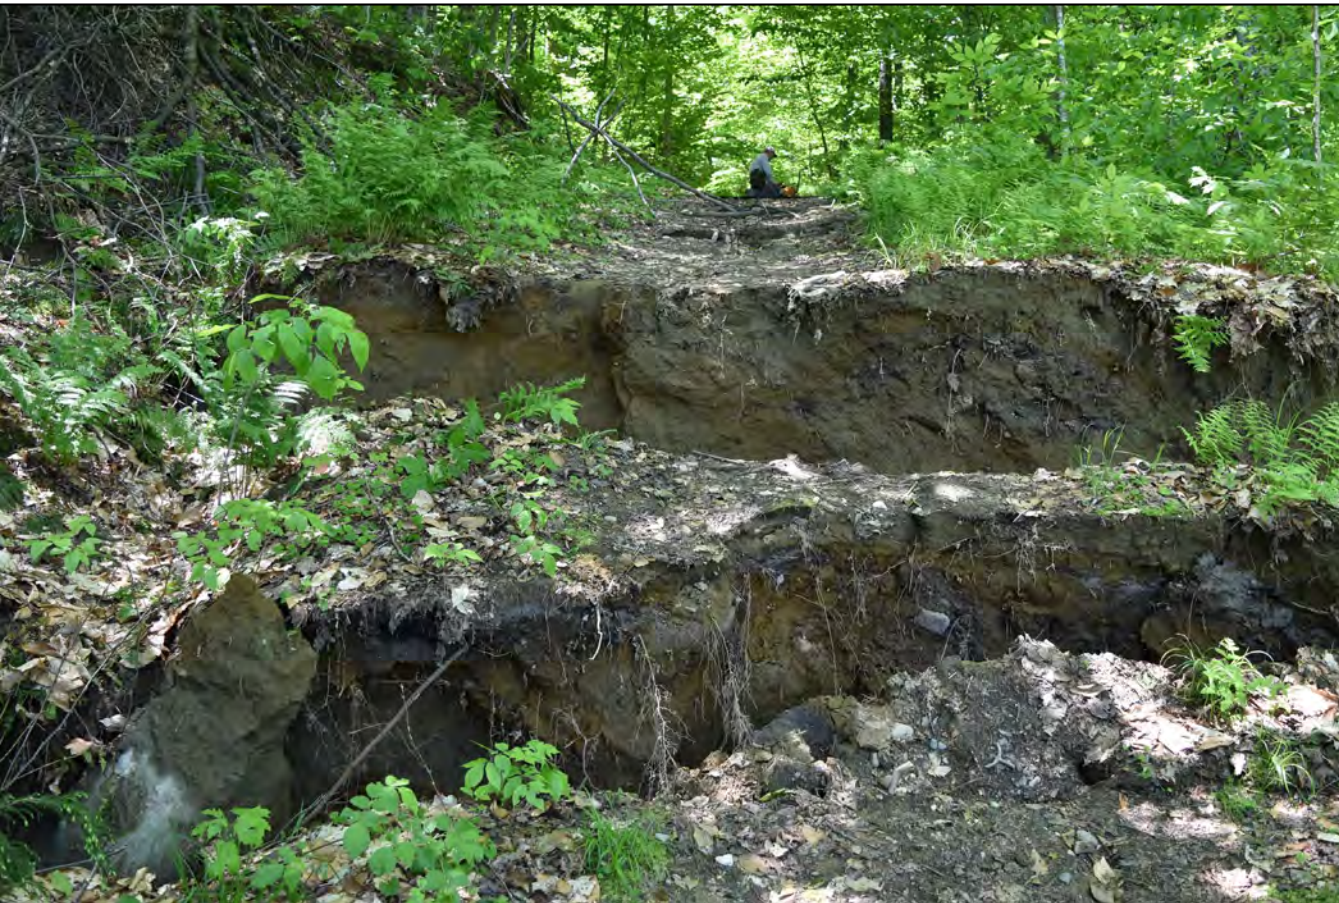
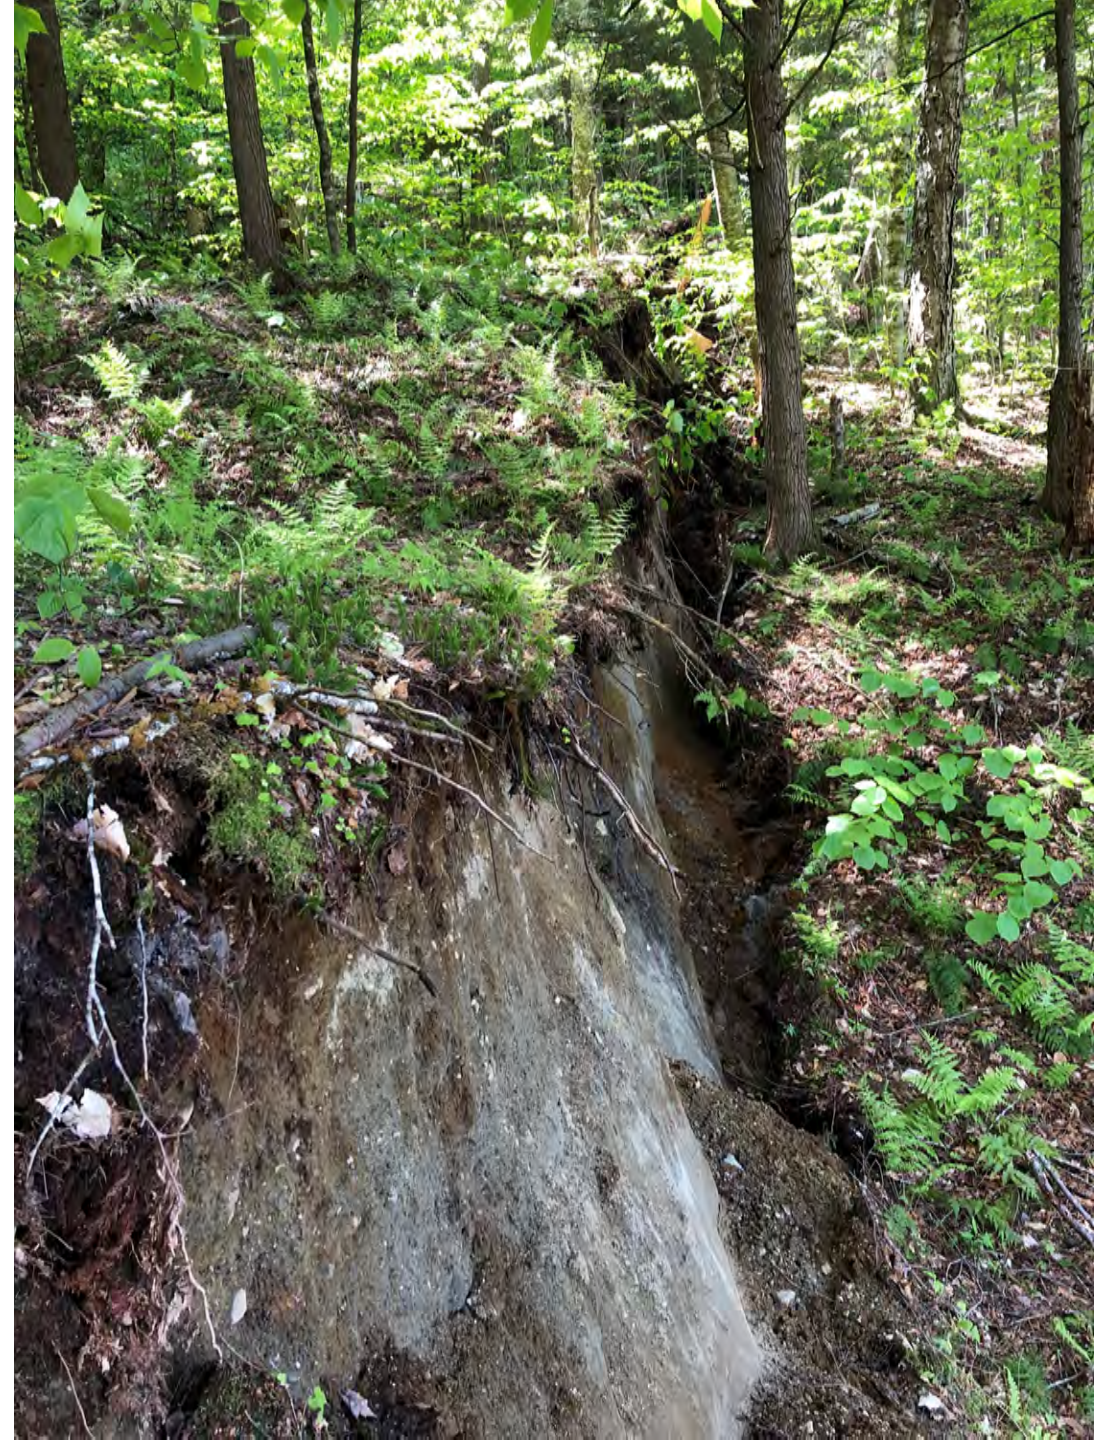
6/4 - Mud flows, sand, falling trees, sliding boulders and potential for larger failure make the site dangerous.

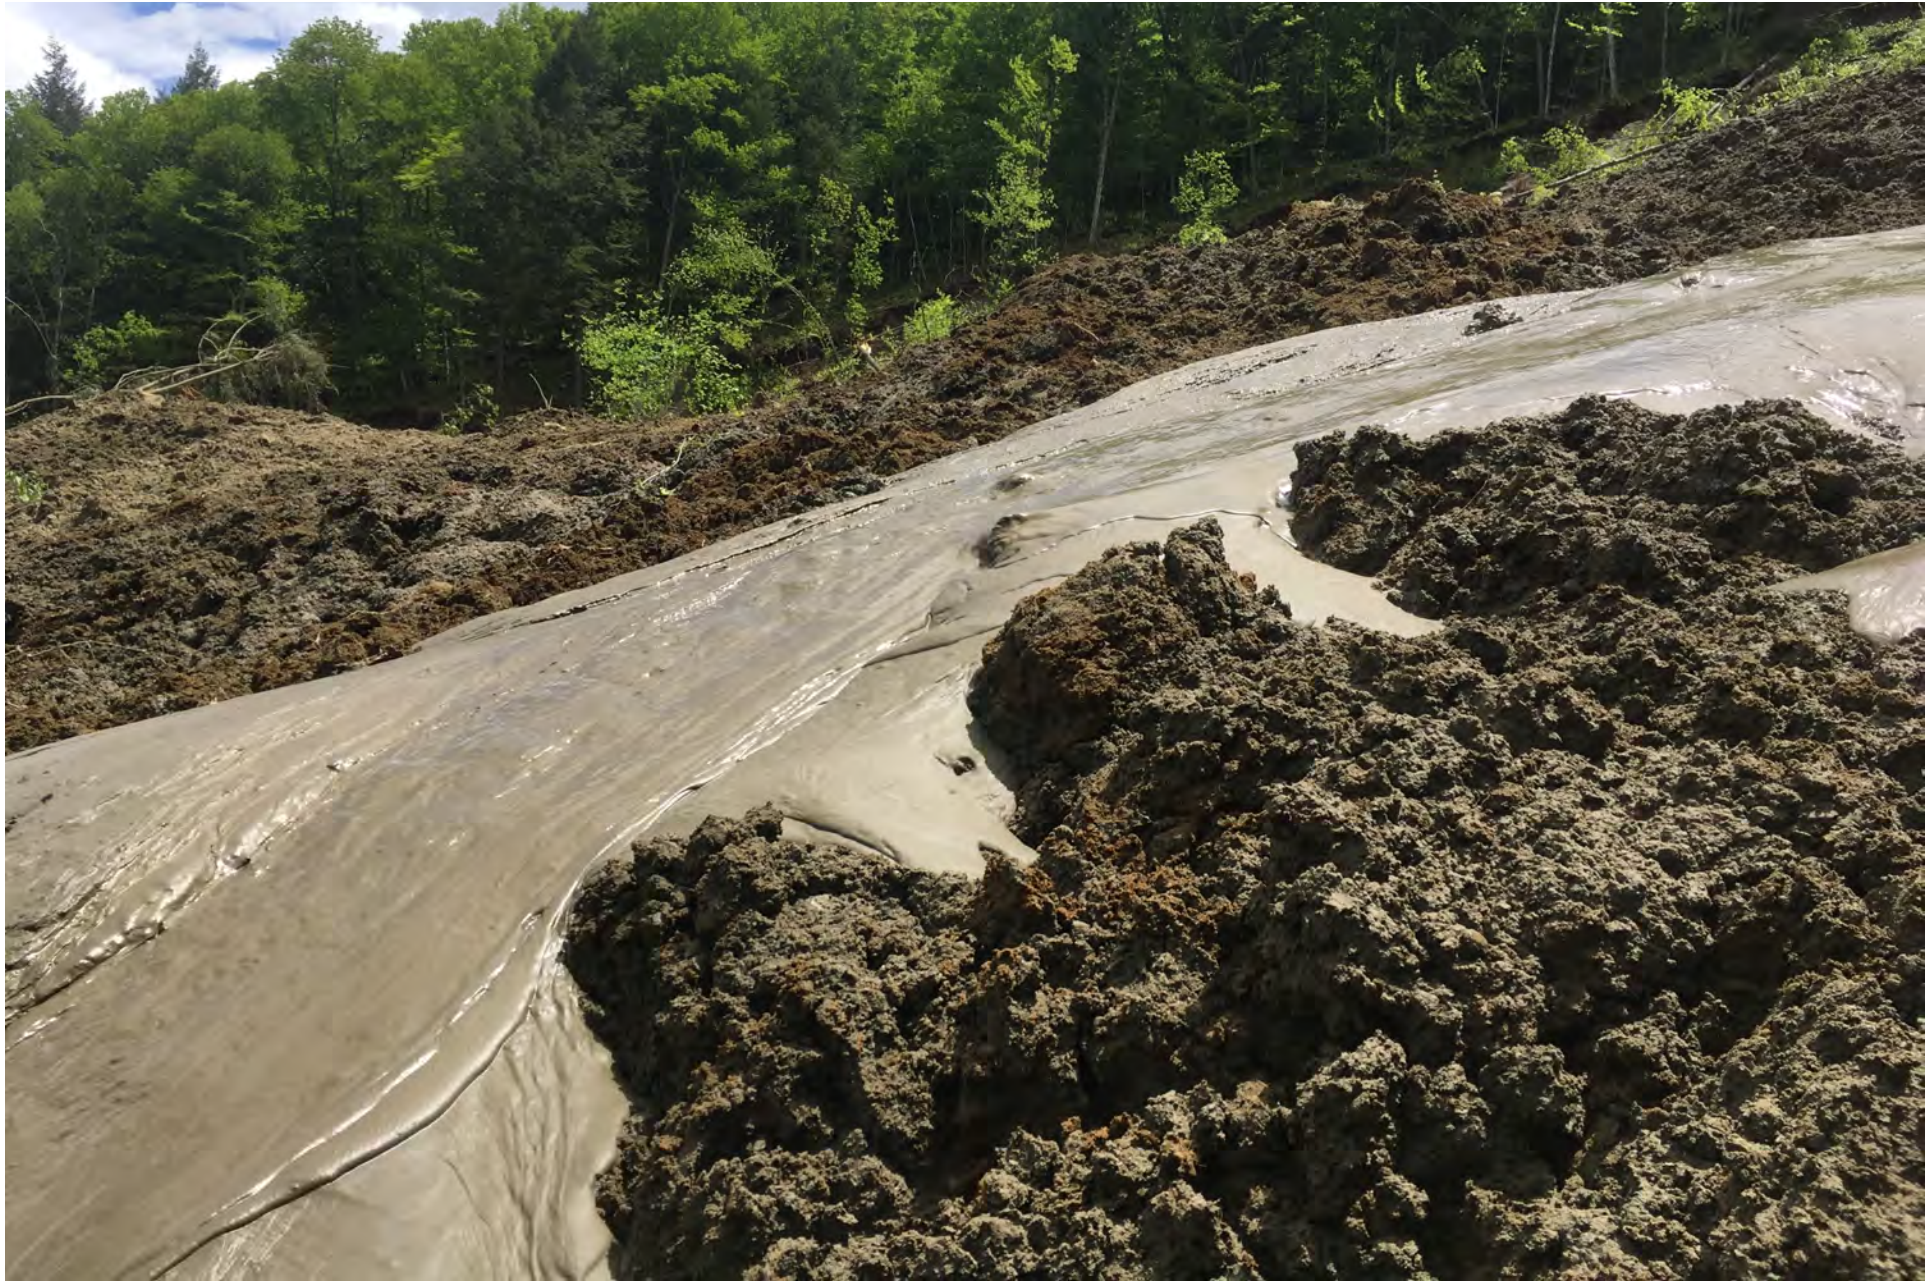
6/12 - New delta in Waterbury Reservoir, ~2.8 acres

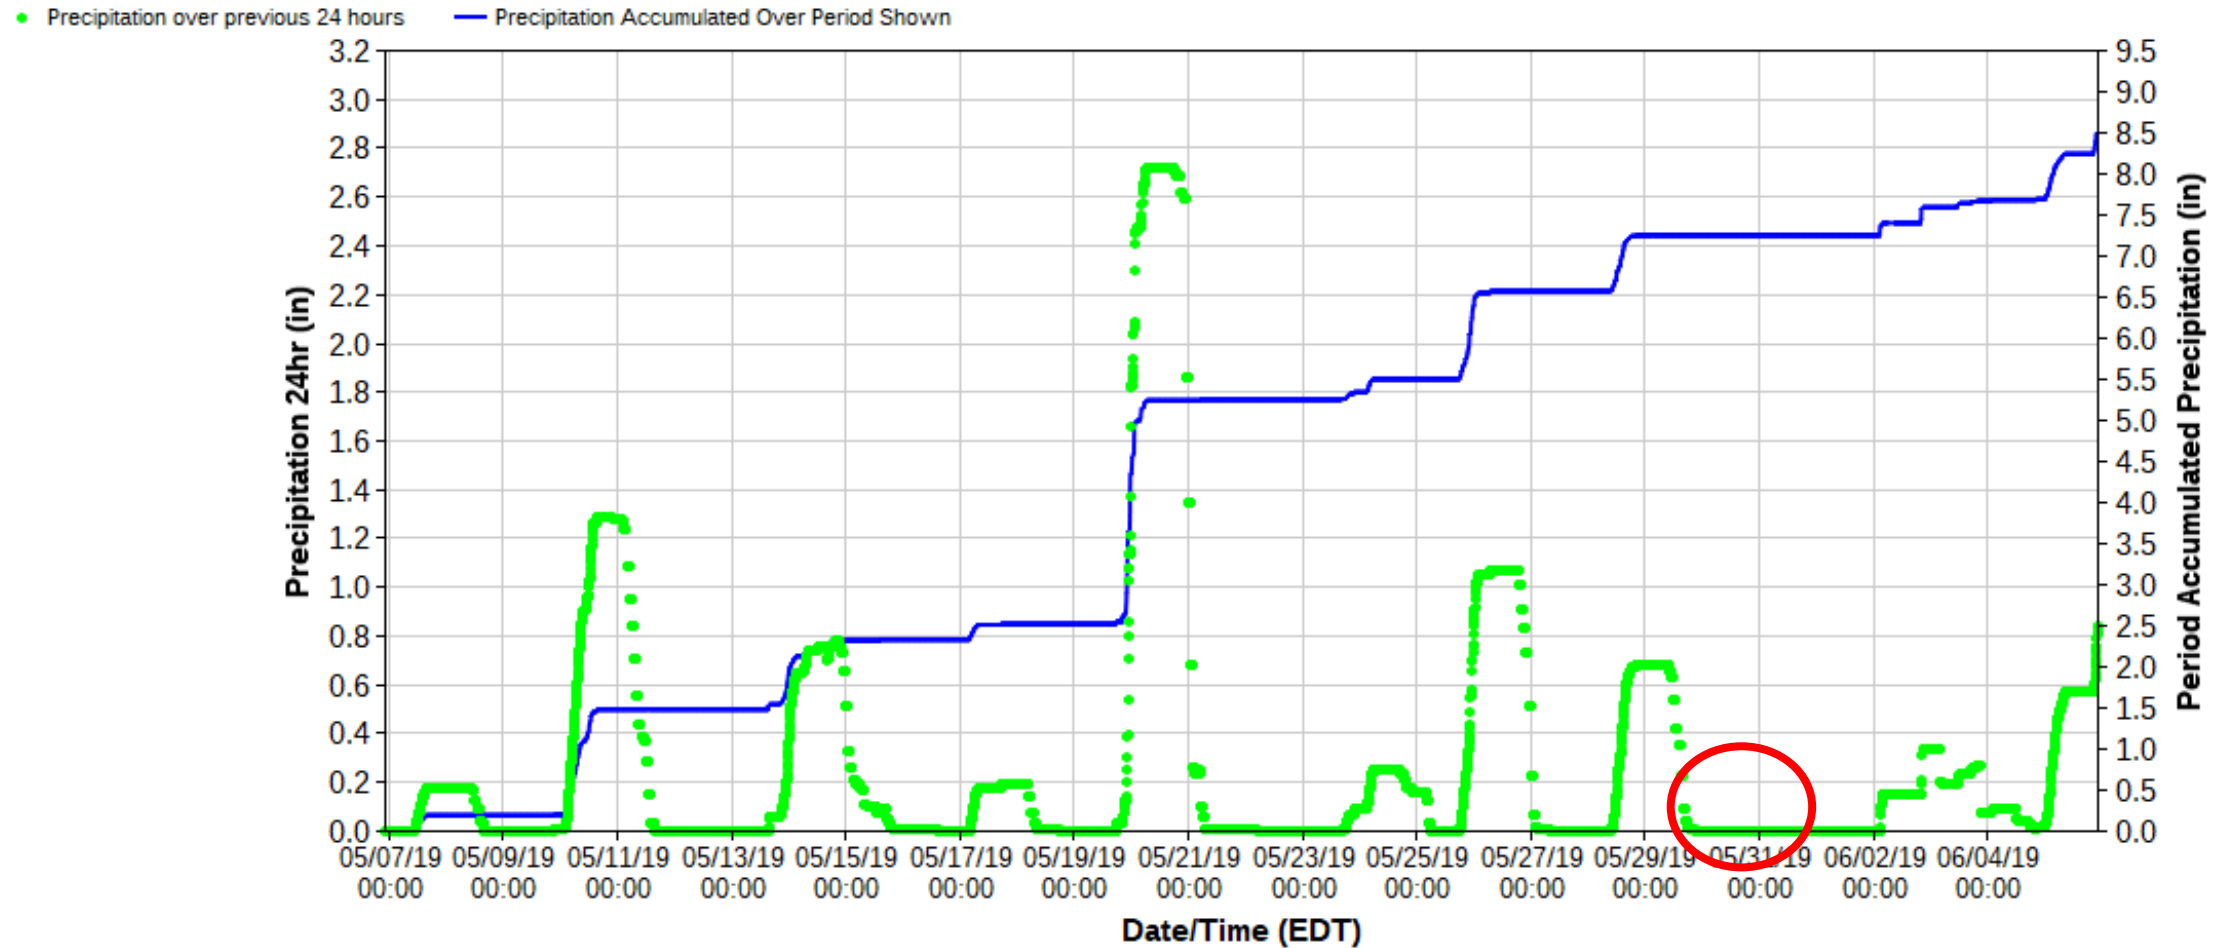
Green: Precipitation over previous 24 hours

Blue: Precipitation accumulated since 5/7/2019

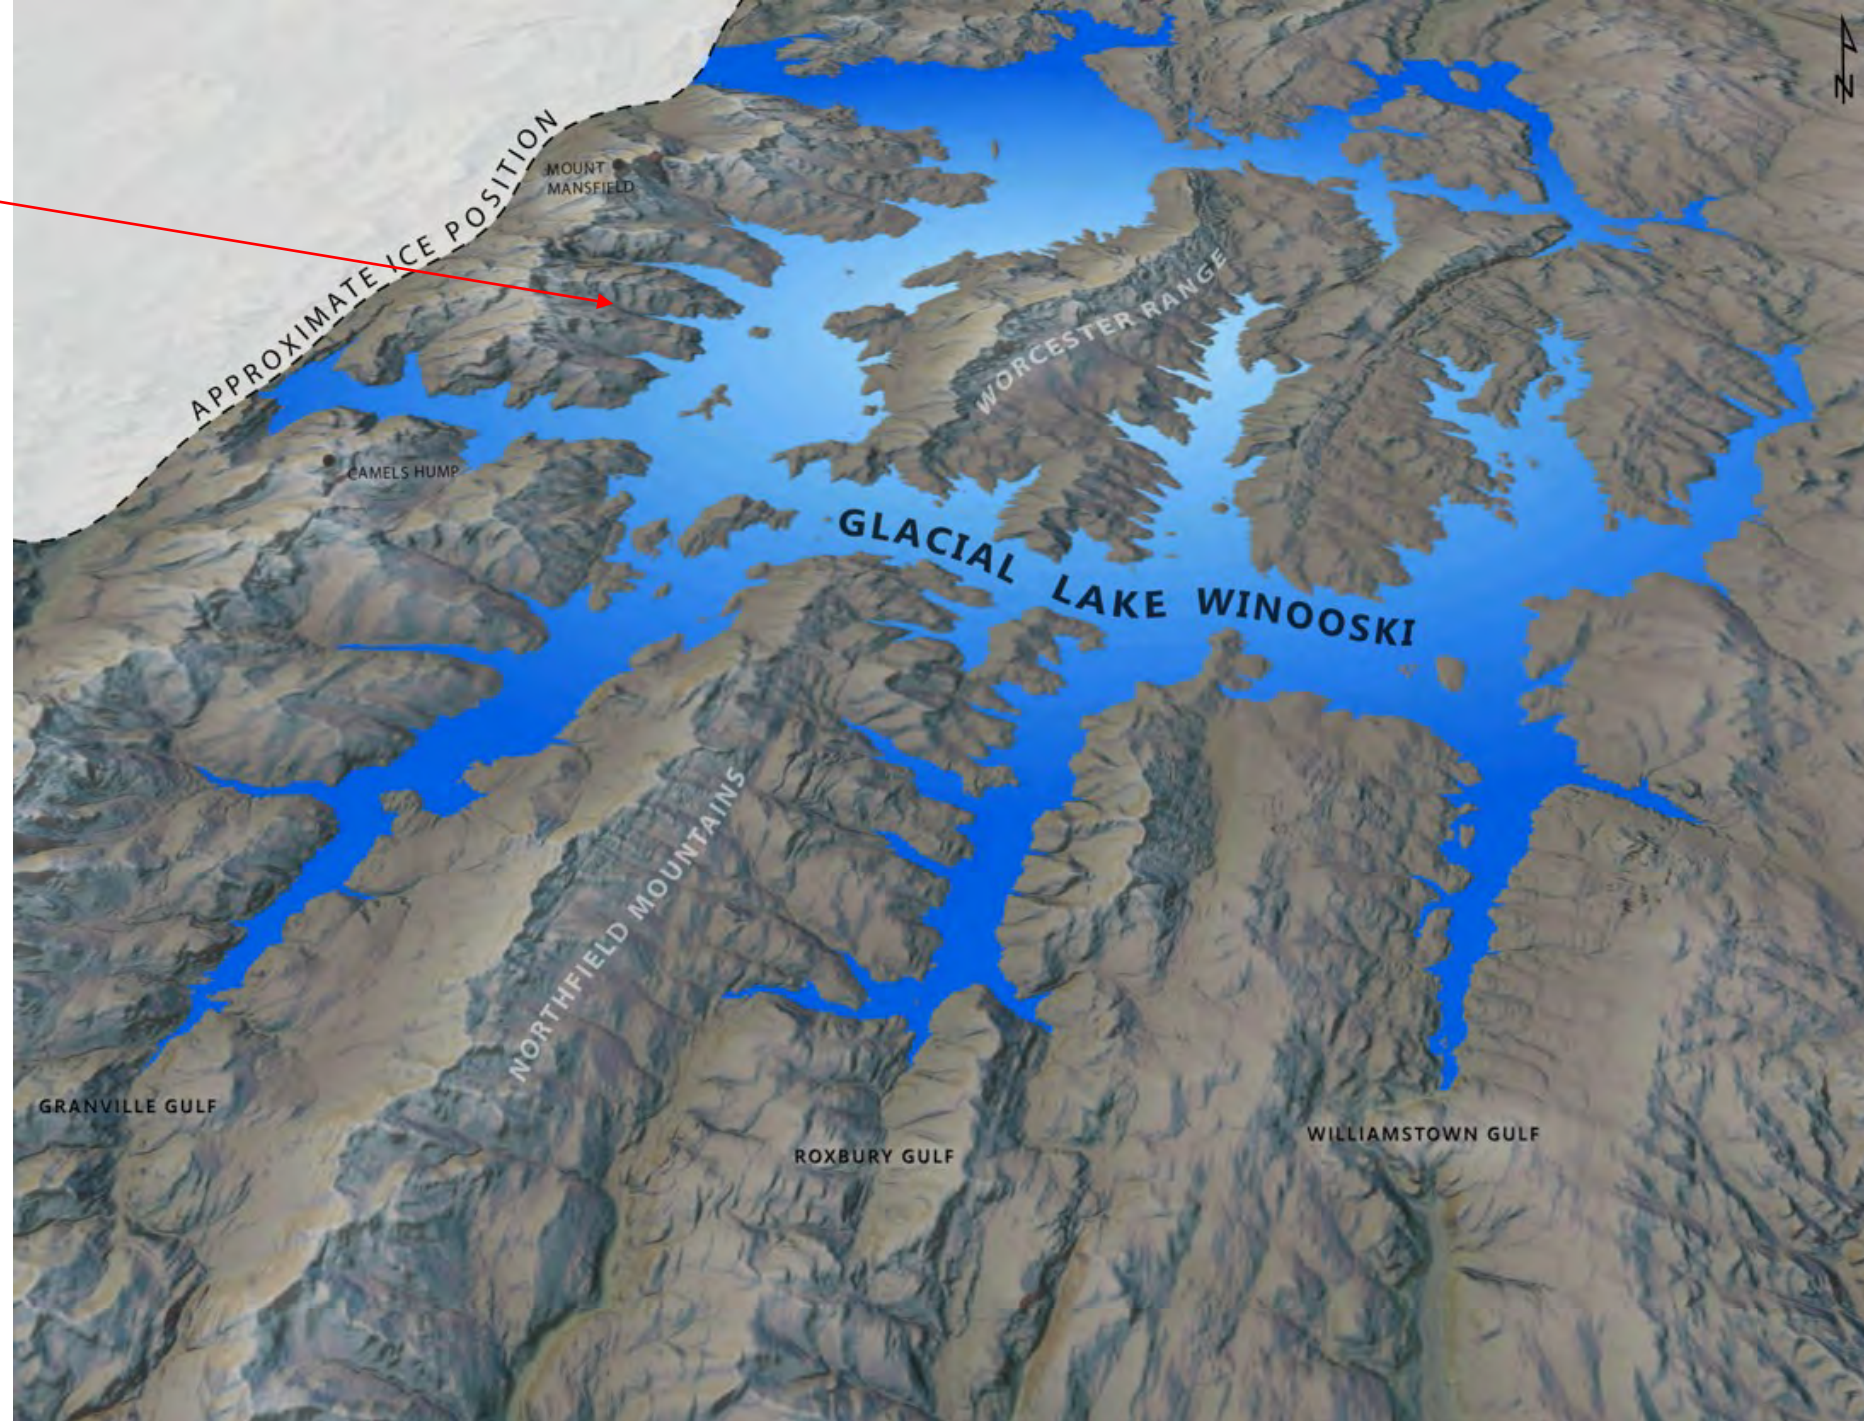
7/1, 8 pm

Game camera images record change

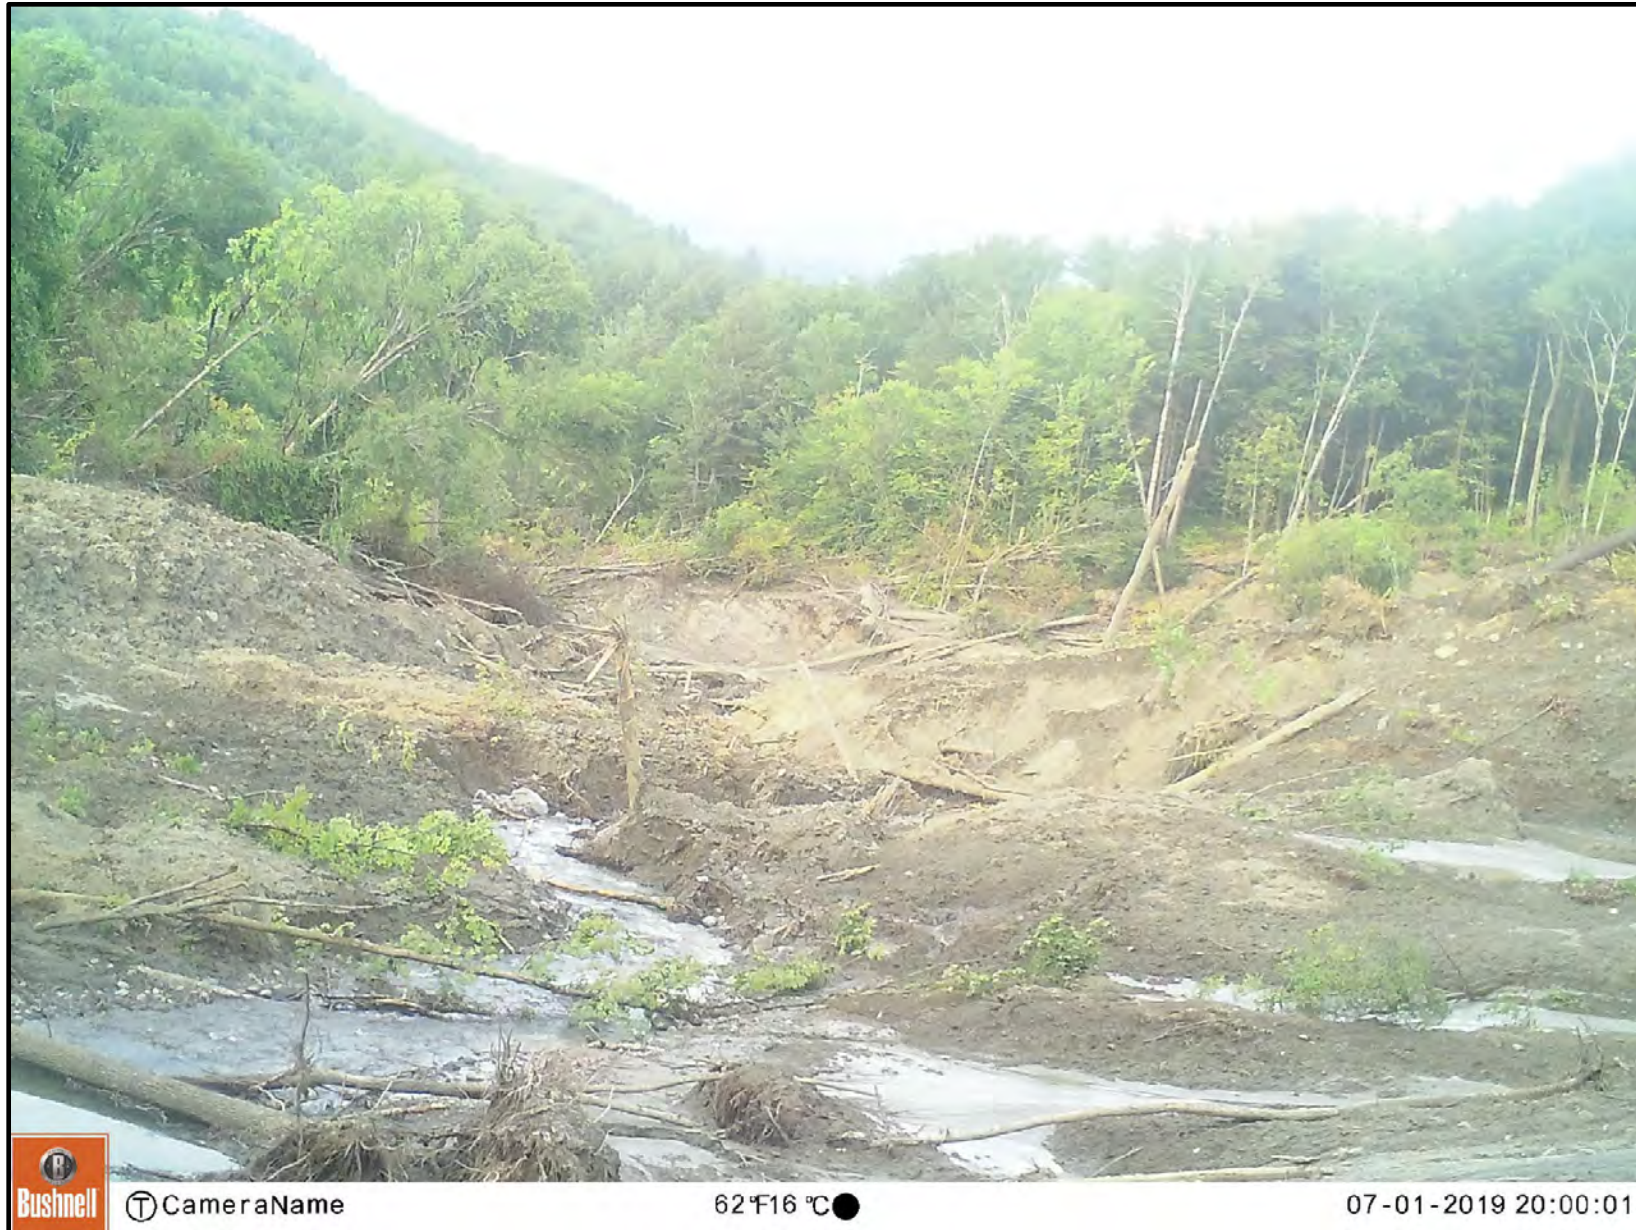
7/2, 6 am

New material dams the brook

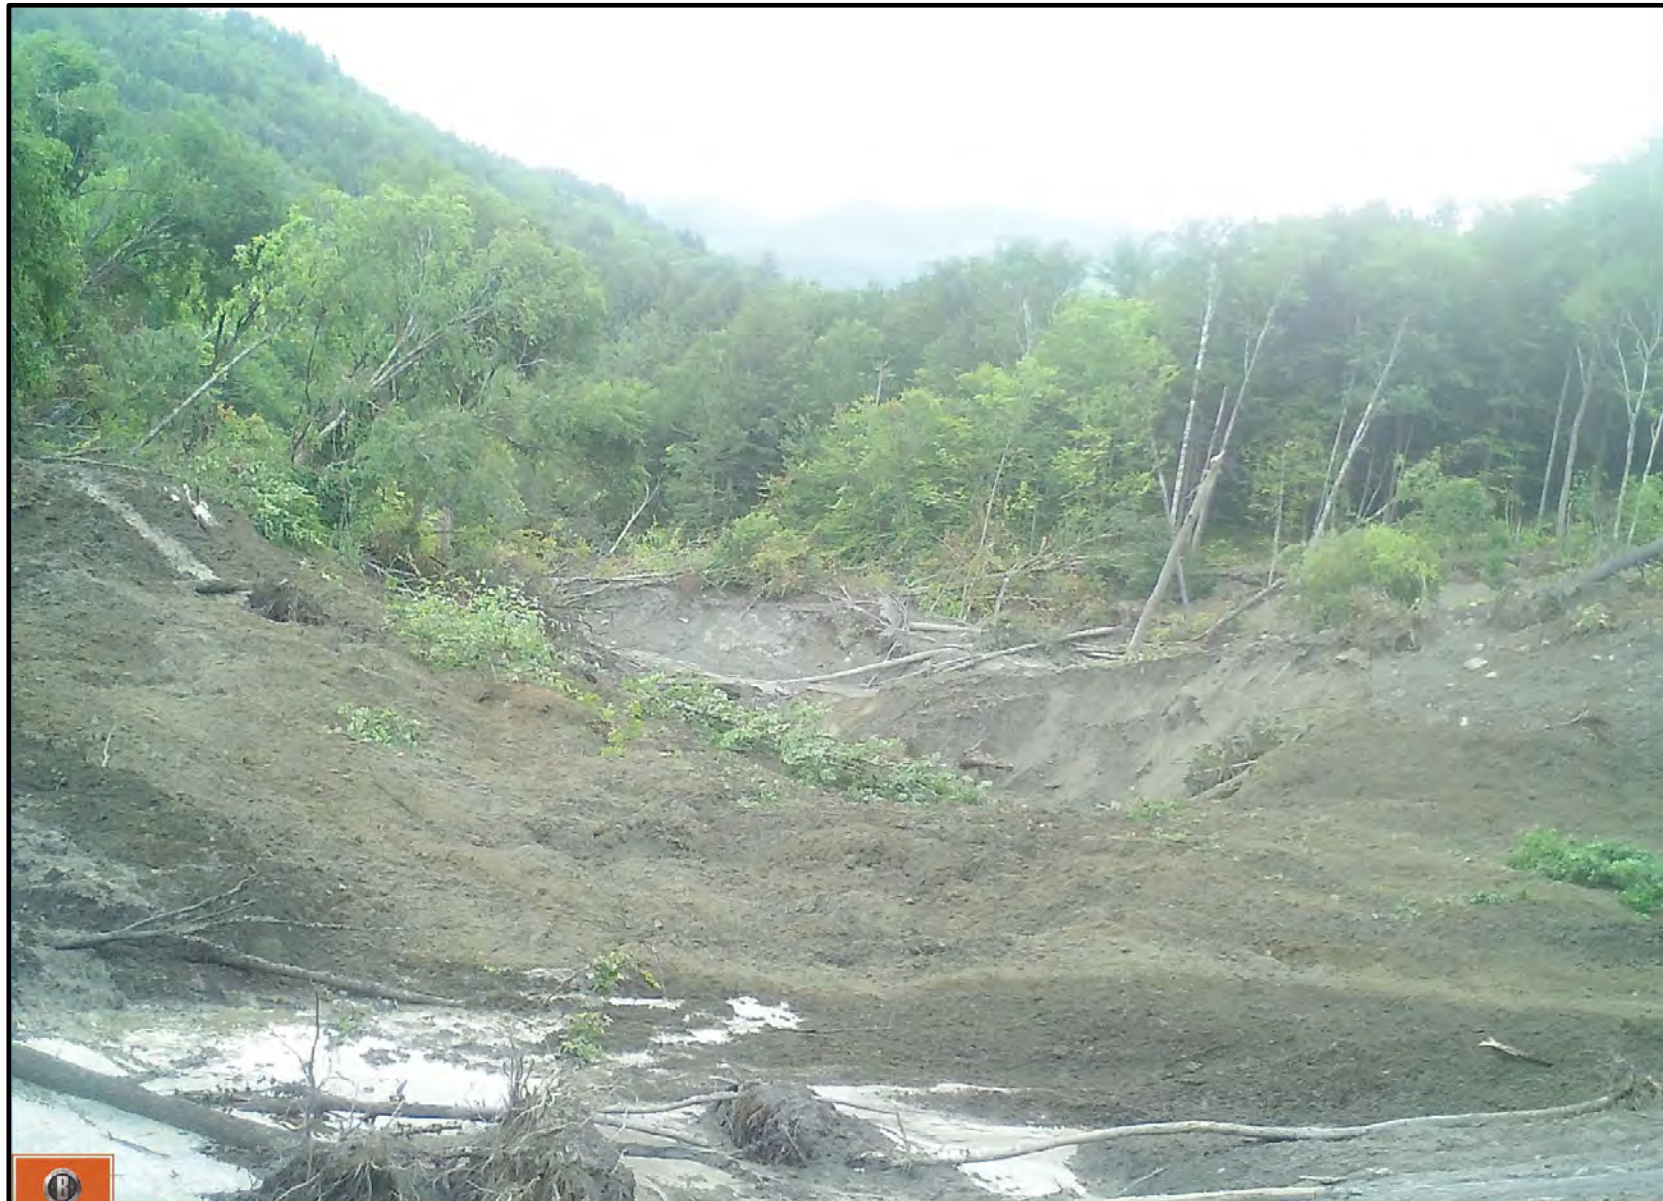
7/6, 9 am

Material erodes, mud increases, tree on sediment block slides in

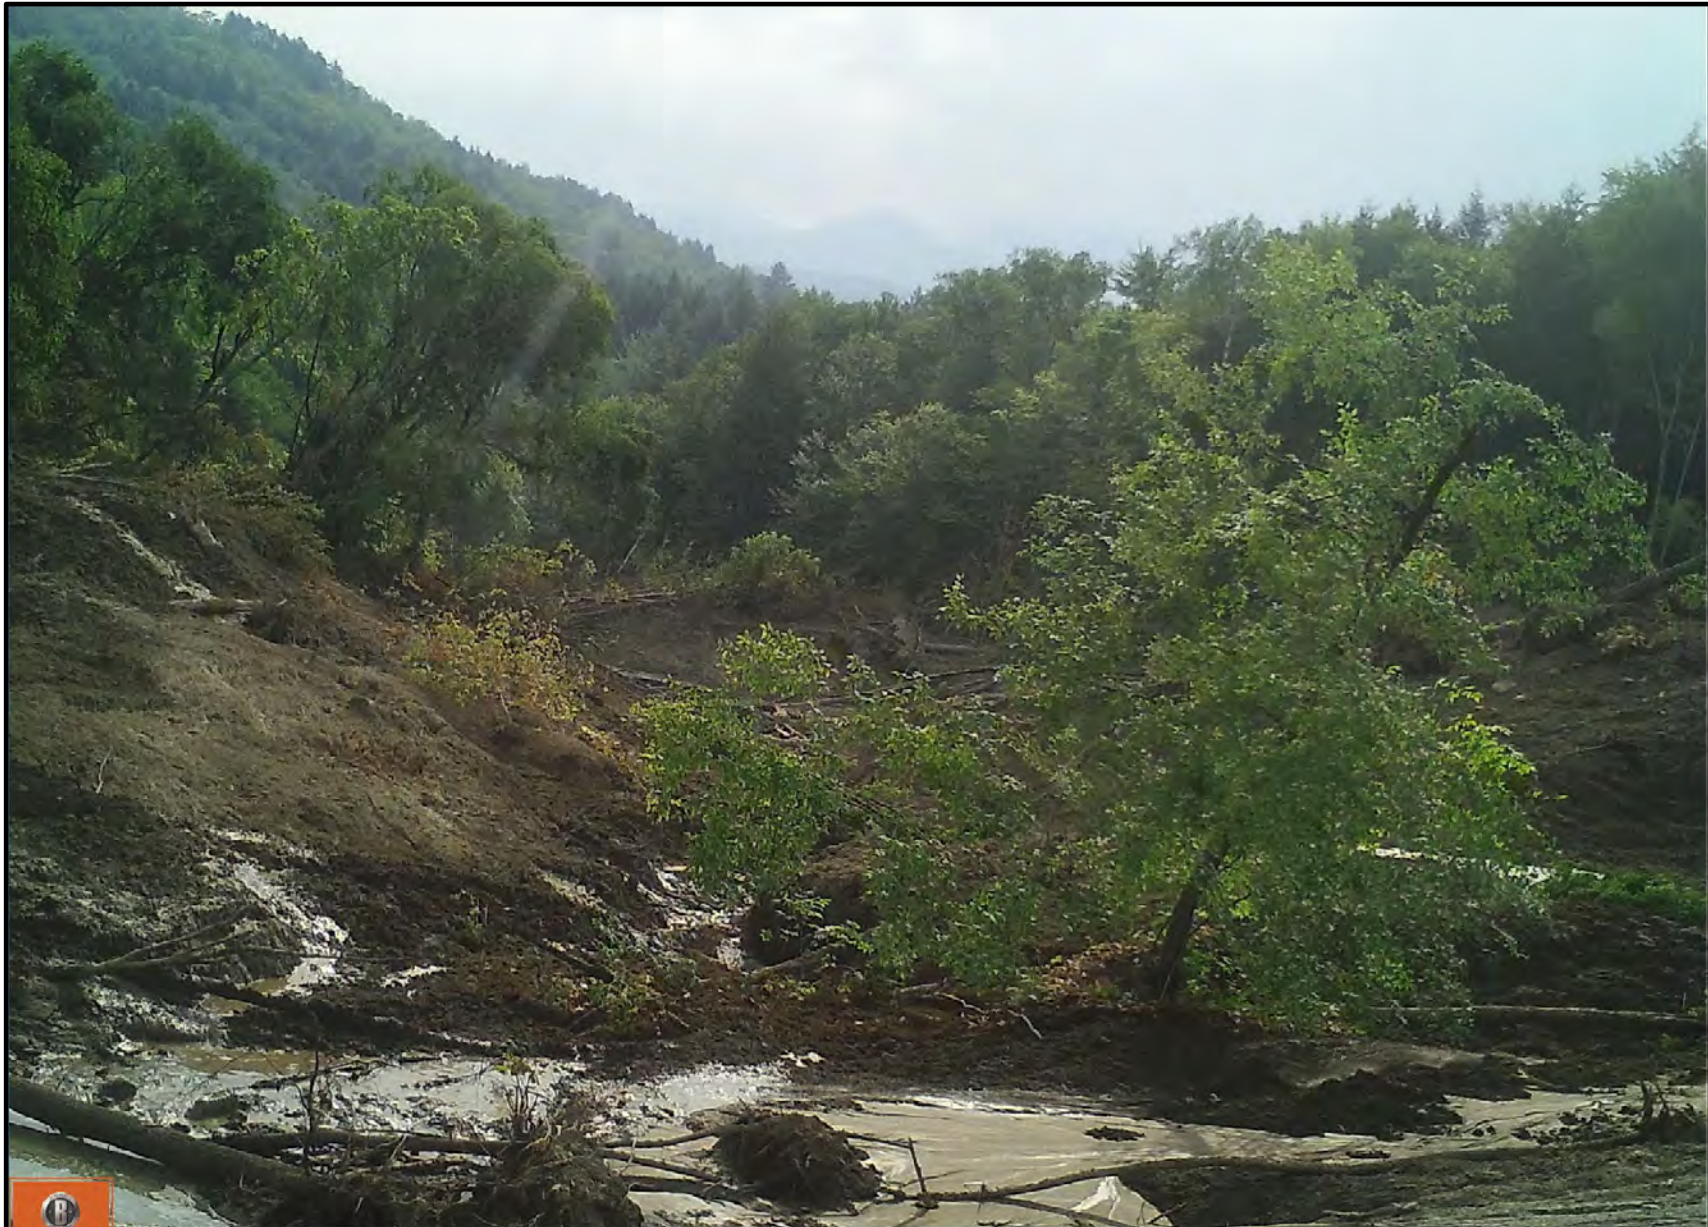
7/6, 6 pm

Brook cut through sediment and is flowing again
