UST TALK

A Newsletter for Underground Storage Tank Owners / Operators

Hurricane Irene Damage to USTs

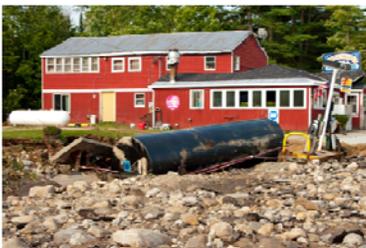
Upper Valley Grill and General Store in Groton sits beside the Wells River, which is normally a pleasant trout stream. The store had picnic tables on the grassy lawn beside the river, and during the warmer months

patrons would regularly sit beside the river enjoying their lunch. But Irene turned the normally placid Wells River into a raging torrent which jumped its banks and completely destroyed the store's parking lot and gasoline fueling area. As the parking area was scoured by the raging water the concrete slabs over both tanks were washed away. Ironically, the concrete slab over one tank ended up atop the second tank, while the first tank was completely lifted on to the ground surface. Most of the gasoline was washed out of the USTs, as when the storm was over, they were found to be filled with mostly water – just a few inches of free gasoline floated on several feet of water in both tanks. The UST system was completely destroyed, but remarkably, the store itself suffered only modest interior damage.

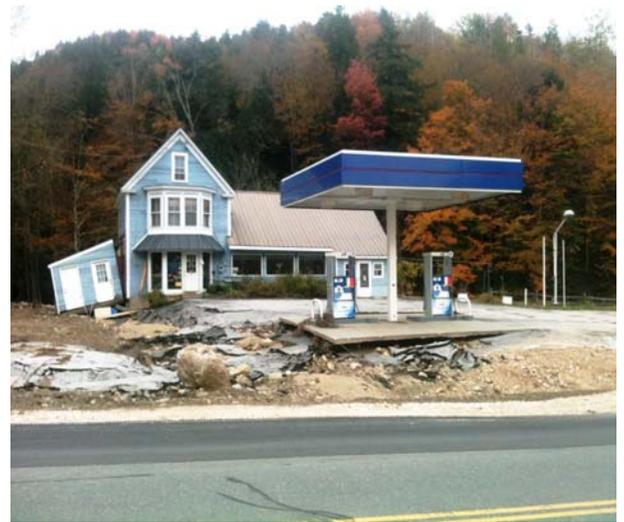
Blackie's General Store, in West Bridgewater, is in the narrow Ottaquechee River valley. Irene turned this river into another raging torrent, which very heavily damaged the store building, the parking lot, and the underground piping to the dispensers. The tanks themselves suffered no damage (or at least none that could be seen by looking down any of the risers).

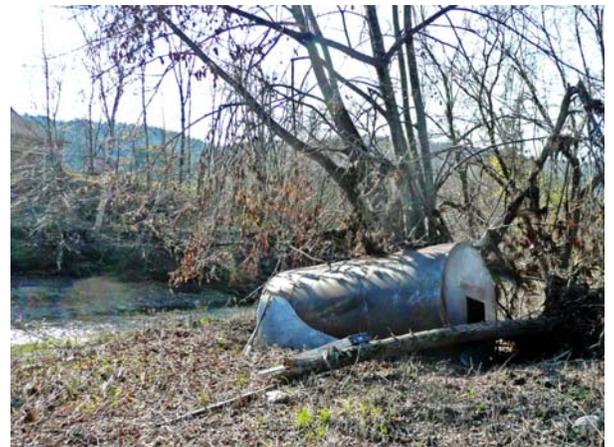
Orphan tank in the Winooski River: Even USTs that had been properly closed were subjected to Irene's fury. This tank had been pulled and cleaned, and was sitting on the ground in a salvage yard beside the Winooski river. When the river flooded, the tank (and dozens of old tires) were carried several miles downstream and ended up stranded on this island in the middle of the river.

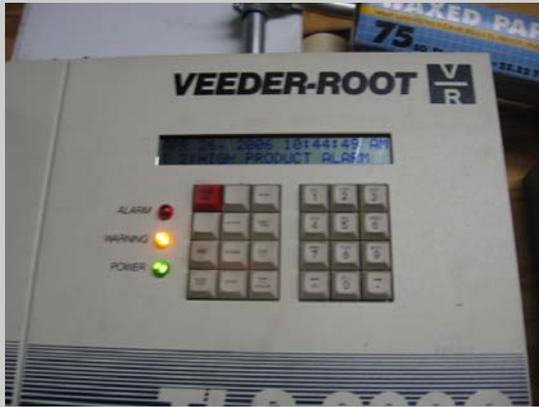
MONITORING SYSTEM VEEDER ROOT IN ALARM

If you have one of these, it should not normally be lit up like a Christmas tree! In this case, the monitor's yellow light is warning that the product level in the tank needs is too high, and is nearing an overflow condition. The red alarm light usually warns of a serious condition such as a sensor in alarm, which could indicate a leak.

Pay attention to the alarms and lights. There is a reason for them. Check sensors before and after the snow season.

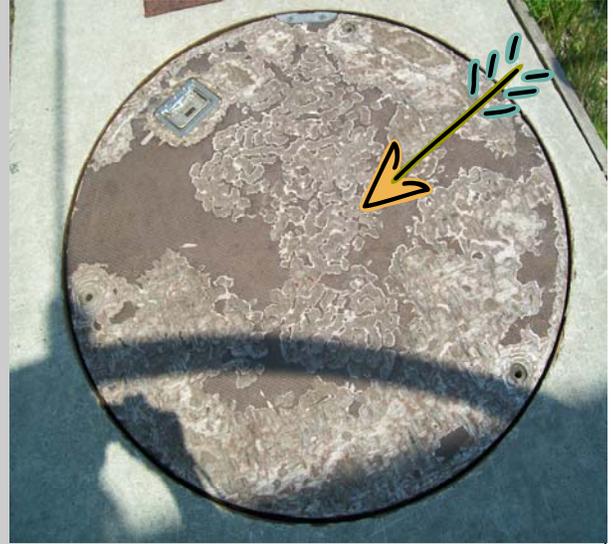
QUESTION #1:
What caused the fancy pattern
on the manhole cover shown above?
Answer: on page 2

Answer from page 4: Porcupines
