**ALLEN BROOK-MUDDY BROOK STORMWATER  
MANAGEMENT EVALUATION**

Prepared For:  
Lake Champlain Basin Program  
54 West Shore Rd  
Grand Isle, Vermont 05458

December 1997

Prepared By:  
James Pease  
Vermont Department of Environmental Conservation  
Water Quality Division  
10 North Building  
103 S. Main Street  
Waterbury, VT 05676

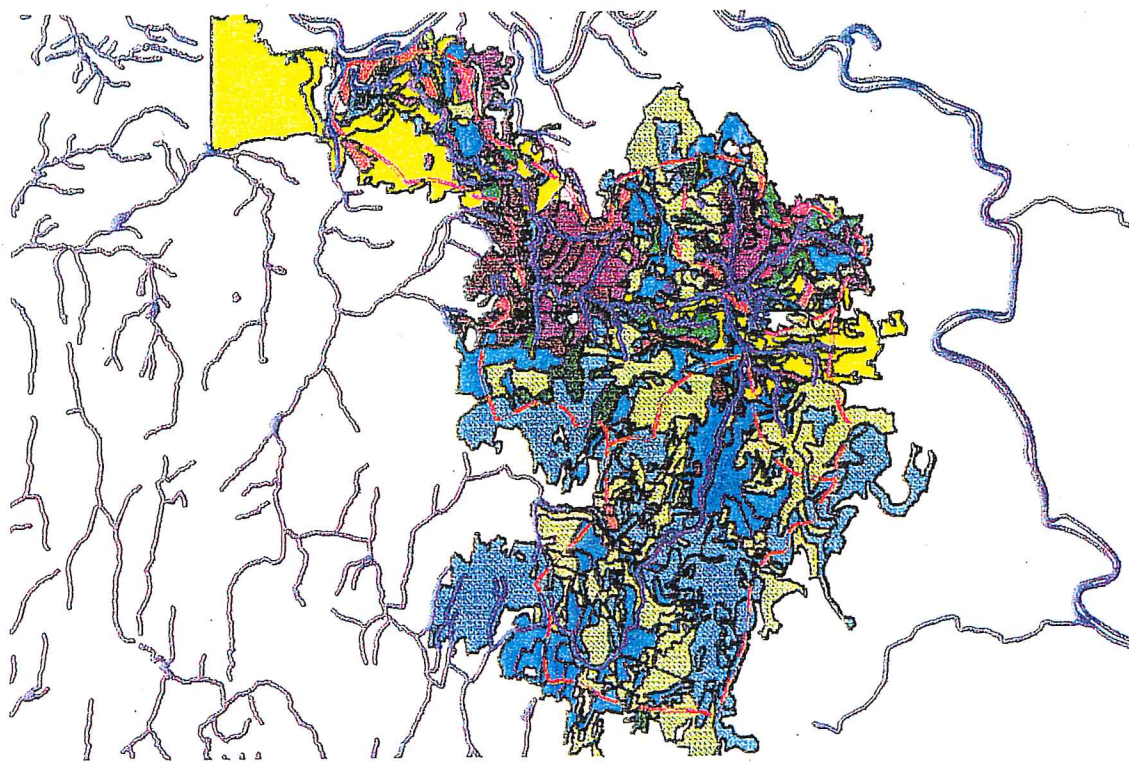
Figure A1-3: Allen Brook generalized soils map.

Adams-Windsor sandy loams are predominant in the area bounded by Industrial Ave-Route 2a and could provide excellent opportunities for stormwater infiltration treatment. Soils suitable for stormwater ponds are also abundant throughout the lower developing areas of both drainages. Highly erodible soils exist to a very limited extent. However these soils are predominant near Taft Corners; construction BMP's for erosion control of these soils should be required as this subregional growth center expands. These soils are also predominant in the developing north west corner of the Muddy Brook watershed. Wetpond/wetland soils are also present and could provide sites for stormwater BMP's for the proposed large scale residential developments in this area. (**Figures Al:3-5, Mu:3-5**).

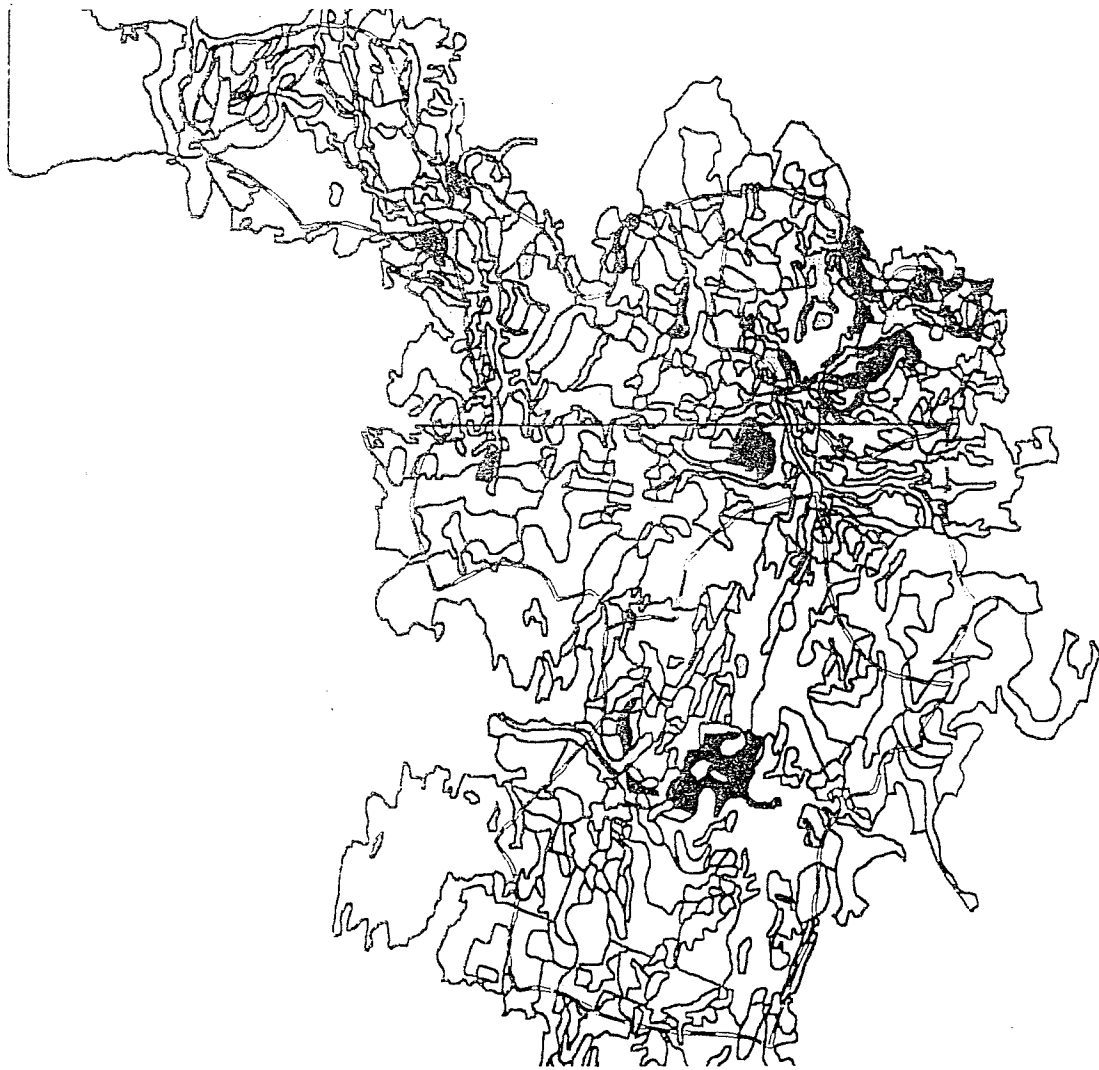
Figure A1-5: Allen Brook watershed - wetpond/wetland soils.

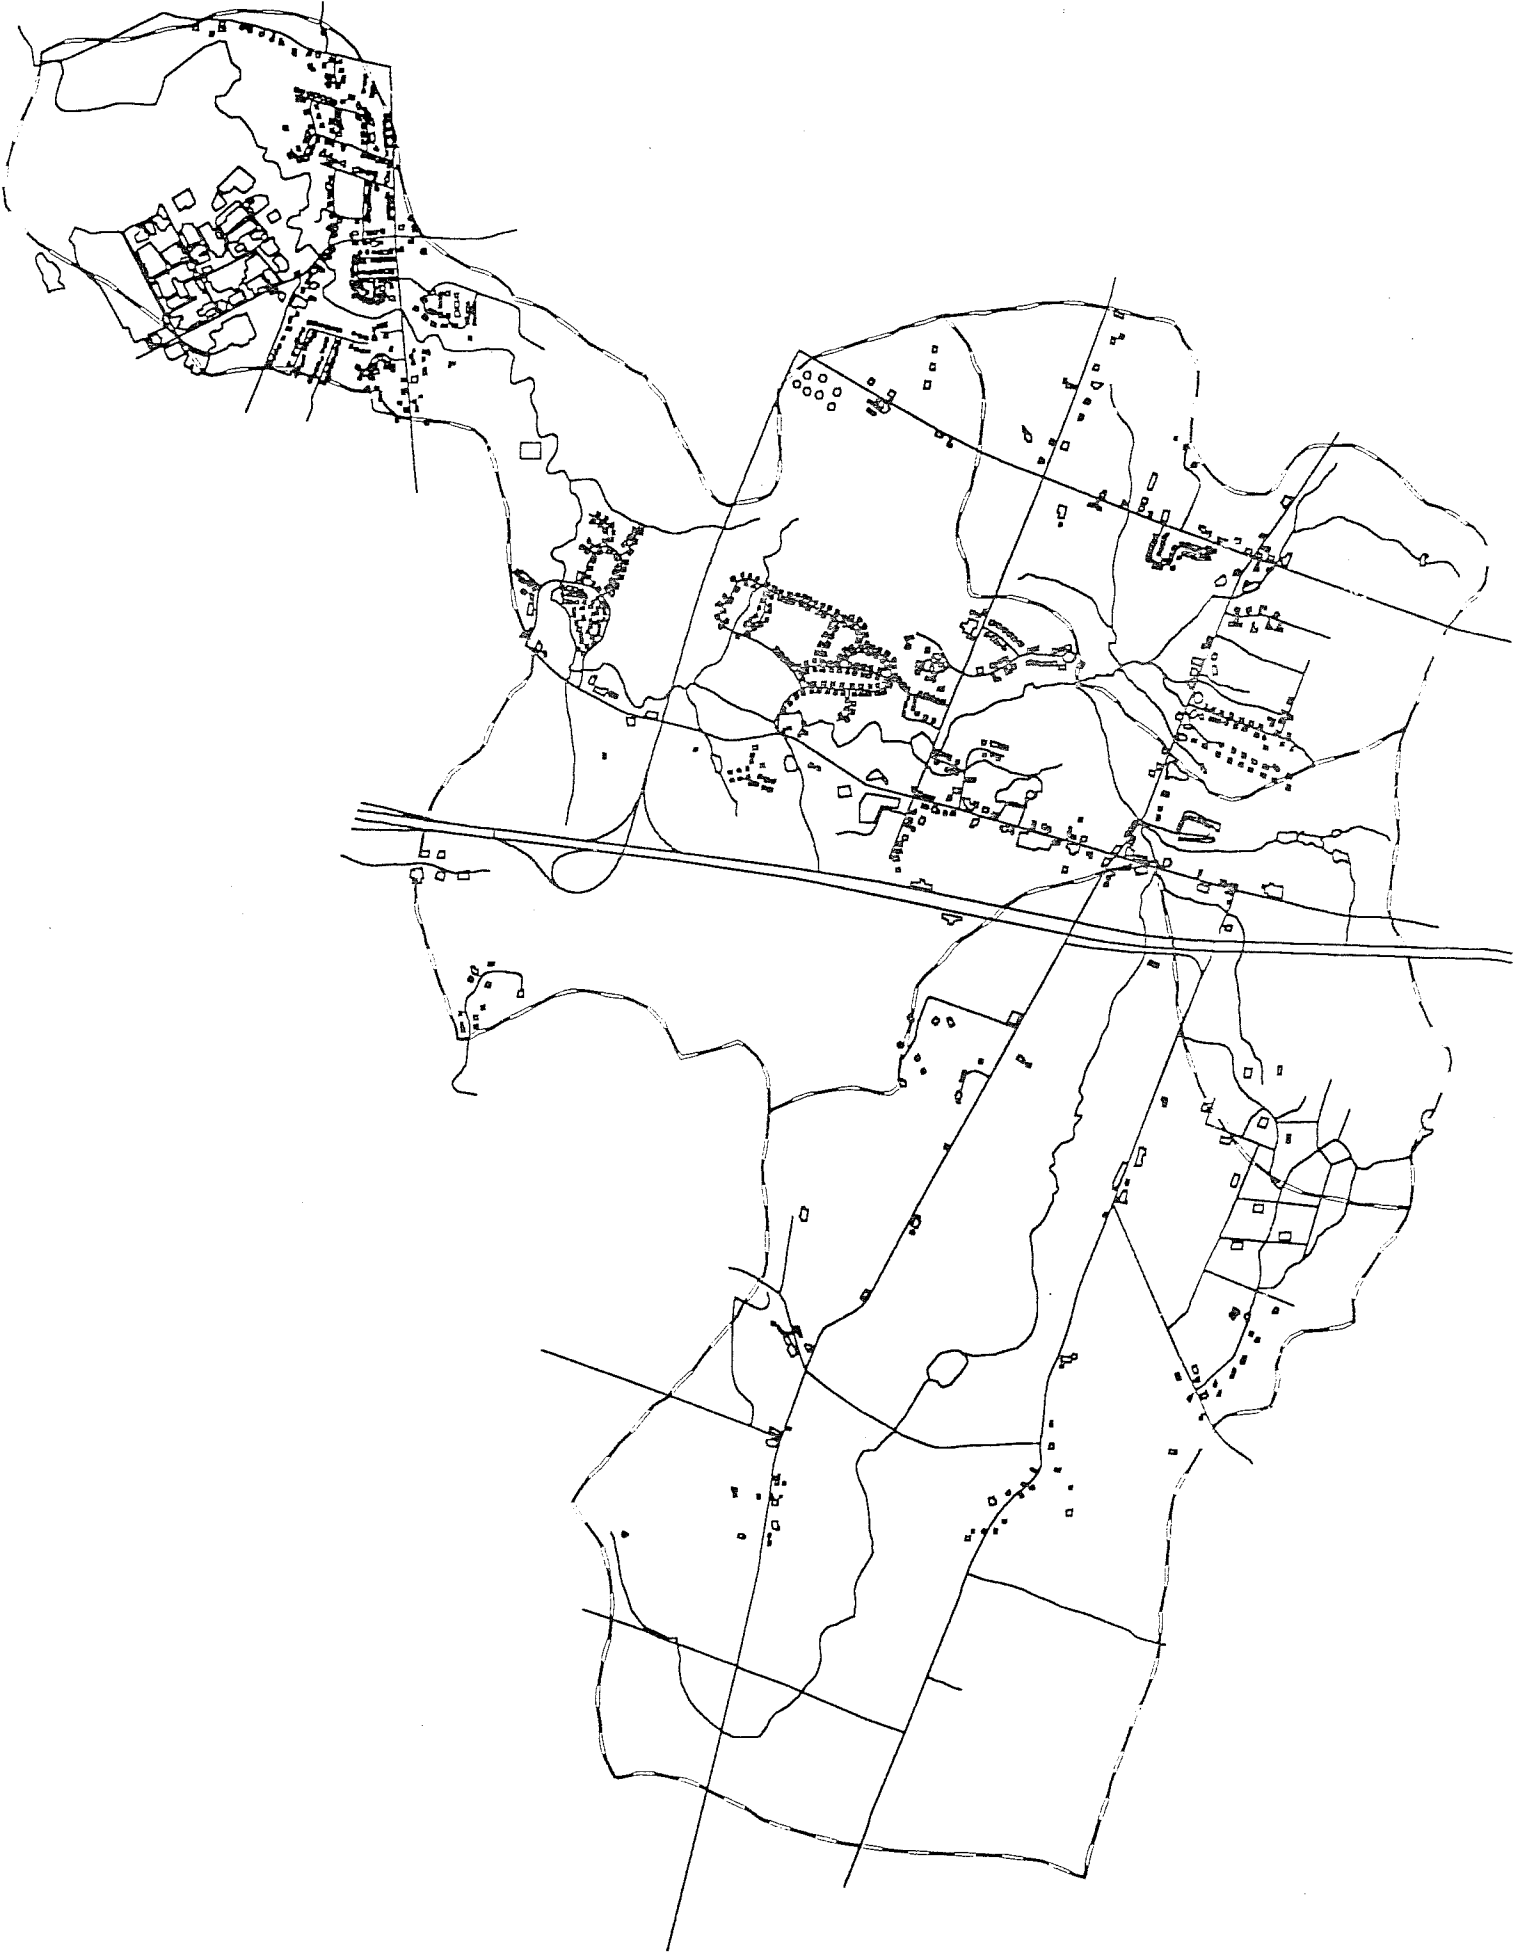
Figure A1-9: Allen Brook watershed mapped impervious surface - 1996.

Potential nonpoint sources of pollution in the Allen and Muddy Brook watersheds were inventoried and mapped as described in Part 1 of this report. **Figures Al:9 and Mu:9** show impervious surface; **Figures Al:10 and Mu:10** show outlines of stormwater sewersheds; **Figures Al:11 and Mu:11** show VTDEC stormwater discharge permit locations and nonpoint sources such as eroding stream banks identified during the course of this project. **Figures Al:12 and Mu:12** show various natural features of the watershed, including wetlands and public lands.

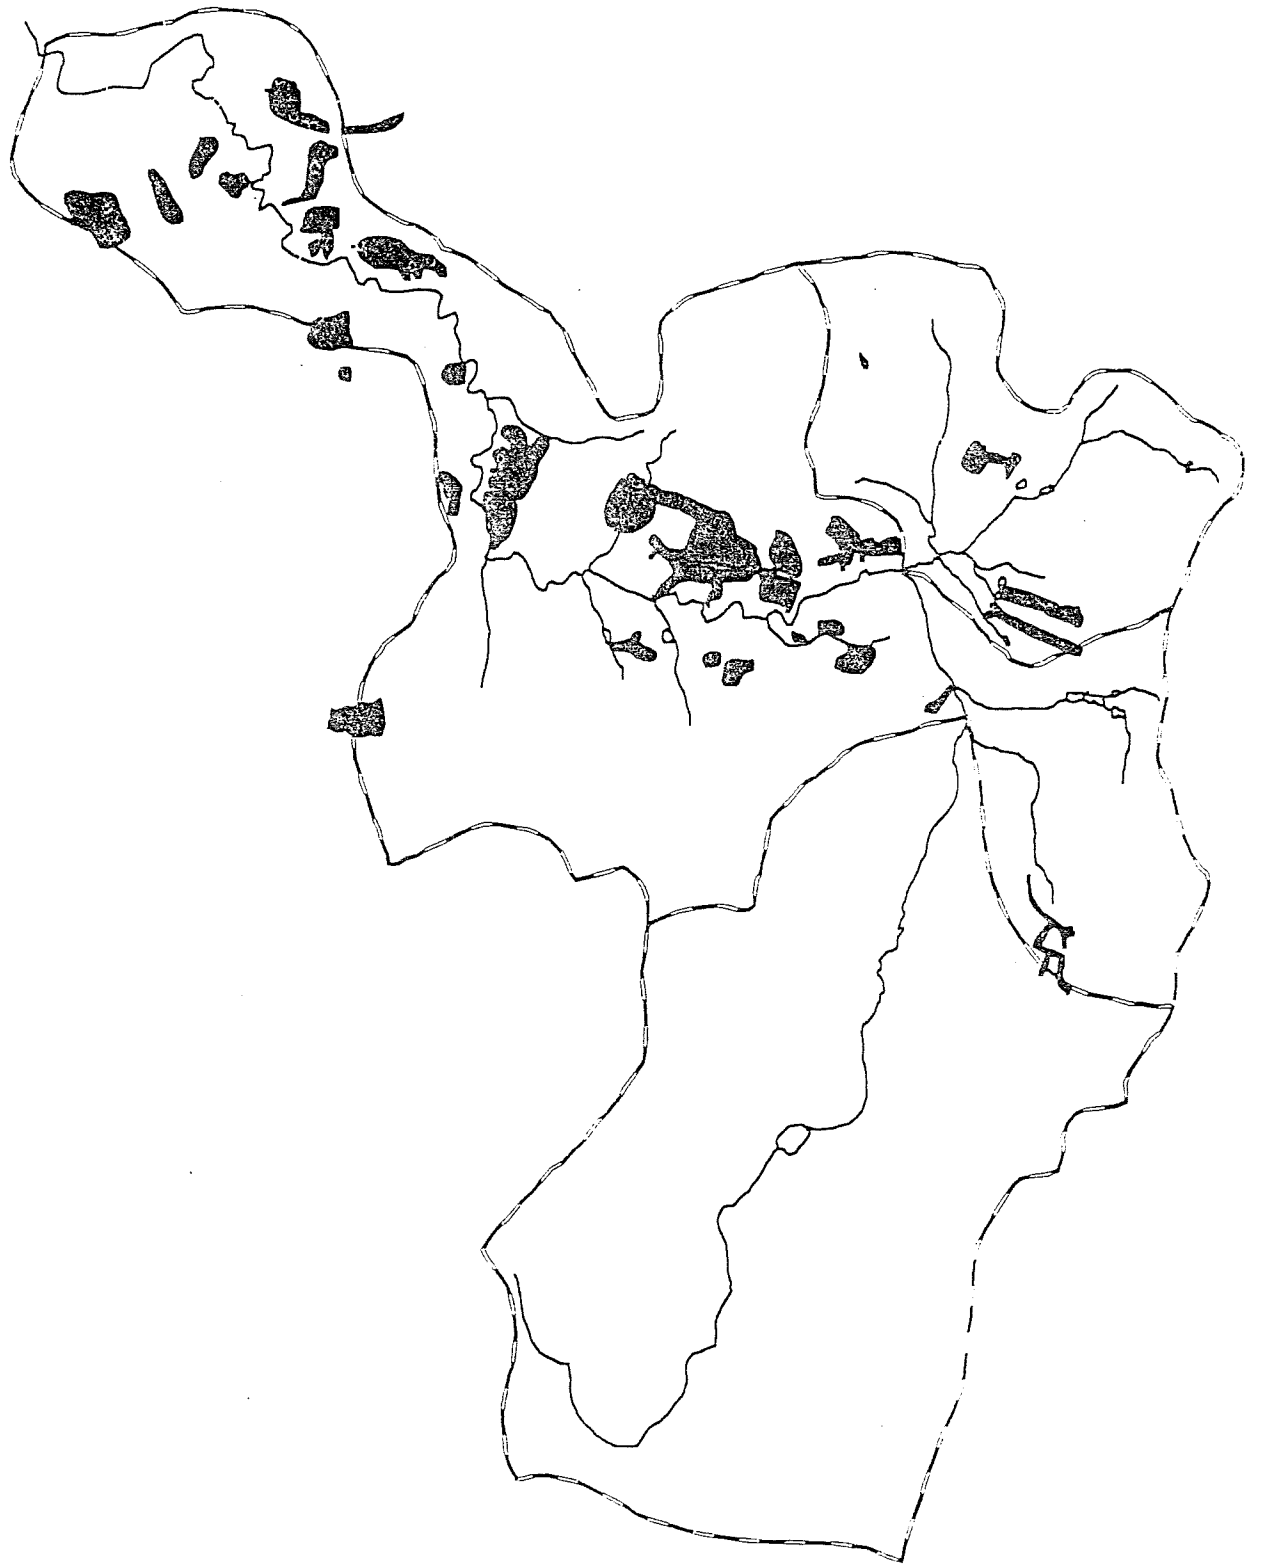
Figure A1-10: Allen Brook watershed mapped sewersheds - 1996.

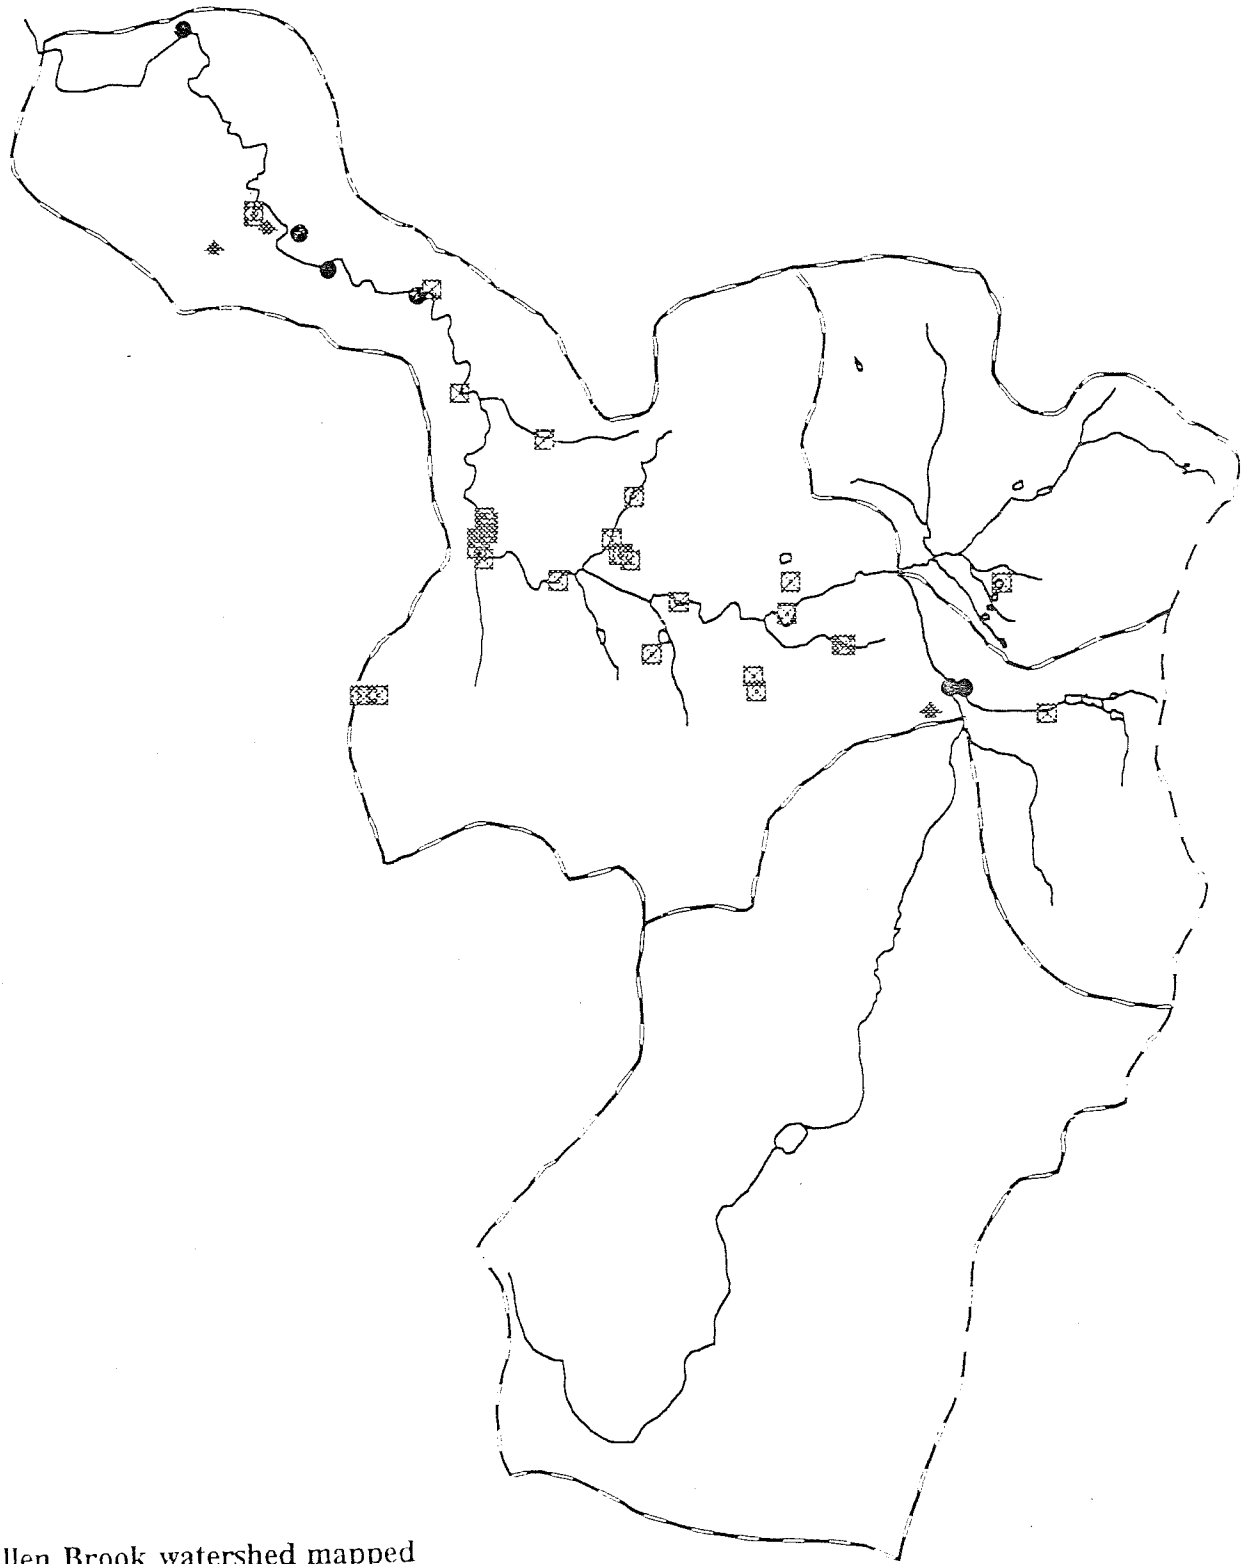
Figure A1-11: Allen Brook watershed mapped non-point sources. Mapped sources include: nonpoint sources such as eroding banks identified during RCE; stormwater permitted discharges; EPA hot landuses (quik-stops with gas pumps, gas stations).

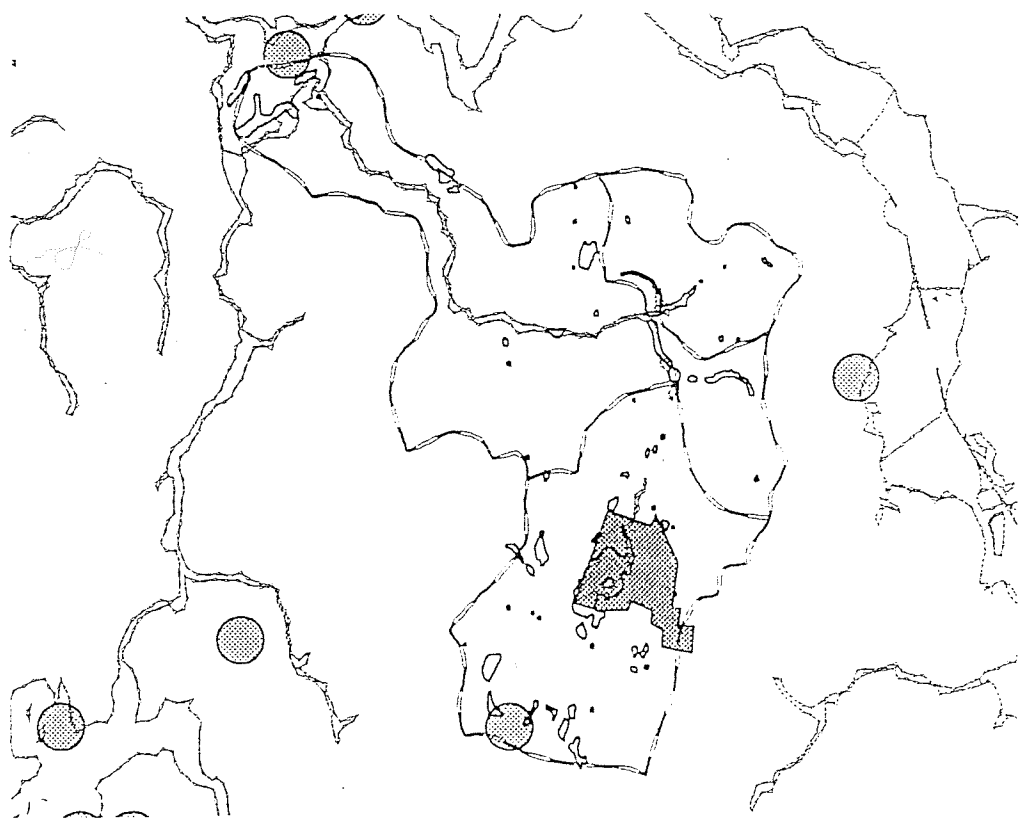
Figure A1-12: Allen Brook watershed - mapped wetlands, 100 yr. floodplain, public land, and Natural Heritage sites.

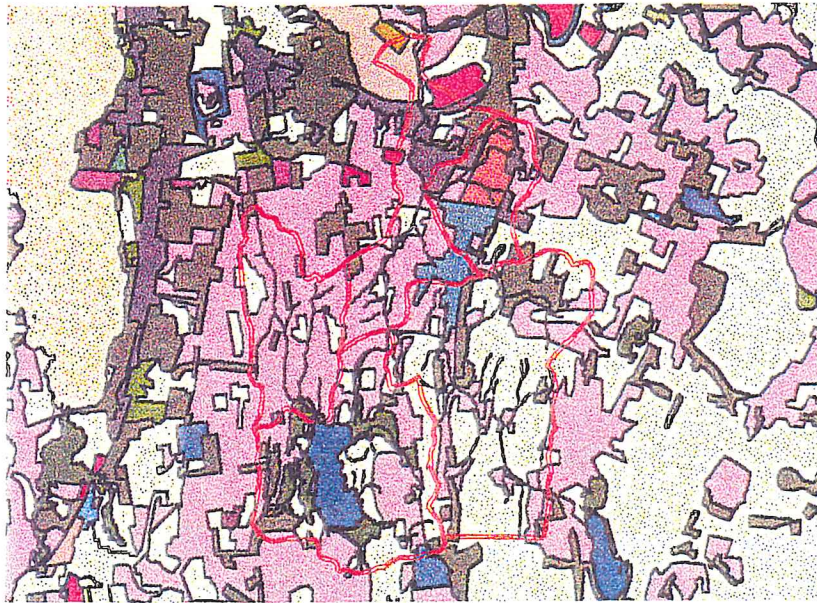
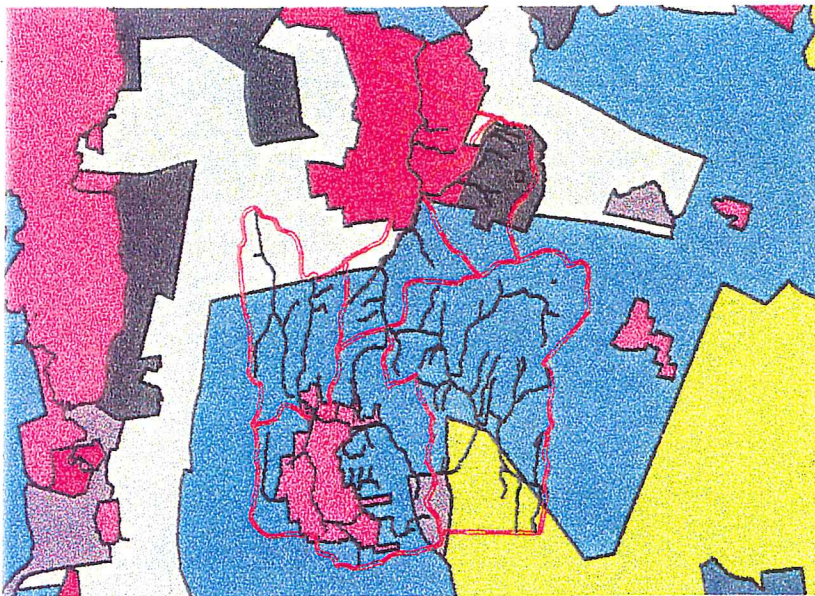
Figure Mu-2: Muddy Brook watershed 1995 actual land use; and future landuse as defined by zoning designation.

In 1995 the land use of upper Muddy Brook (Sucker Brook and Shelburne Pond) was approximately 50% agricultural (idle and active farmland), 30% forest and 20% residential. The lower watershed was approximately 30% commercial/industrial, 30% residential and 40% agricultural (idle and active farmland). Projected future land use in the upper watershed is 20% urban mixed use, 20% open space, and 60% agricultural. In the lower watershed, projected land use is 30% mixed industrial/commercial, 20% subregional growth center, 10% mixed urban use, and 40% agricultural. Muddy Brook watershed is approximately 4% impervious; the Taft Corners tributary is approximately 14% impervious (**Figure Mu:2**).

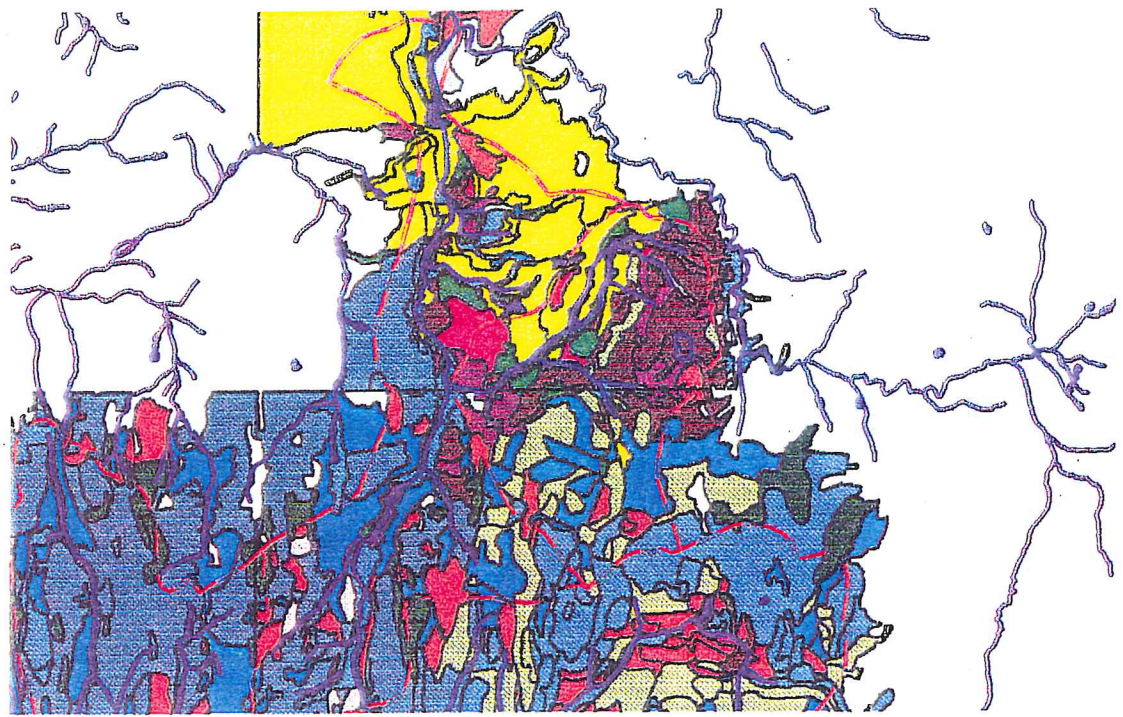
**Figure Mu-3: Muddy Brook generalized soils map.**

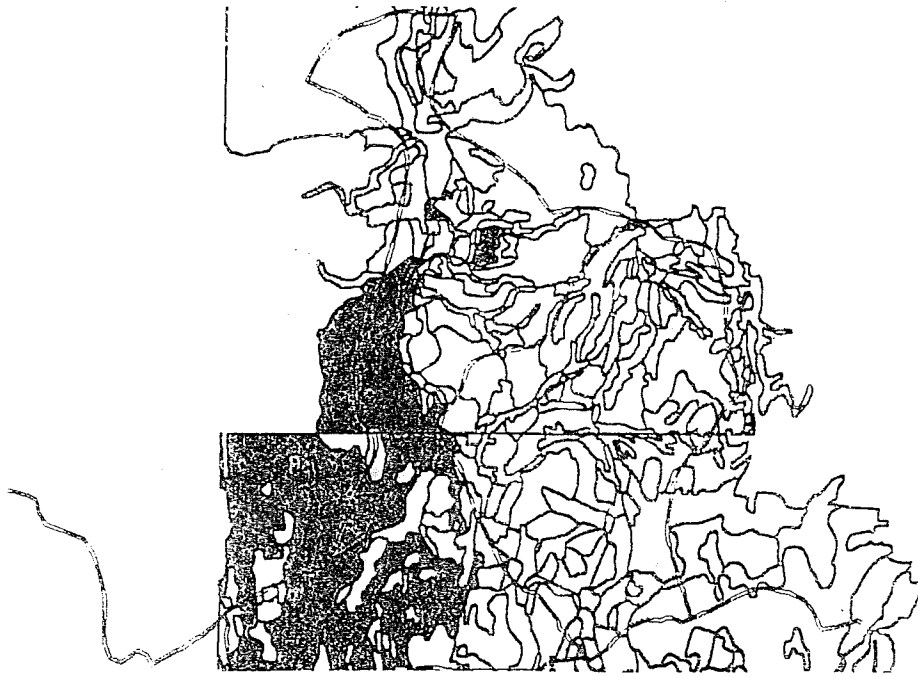
Figure Mu-4: Muddy Brook watershed - areas of highly erodible soils. These soils are easily displaced.

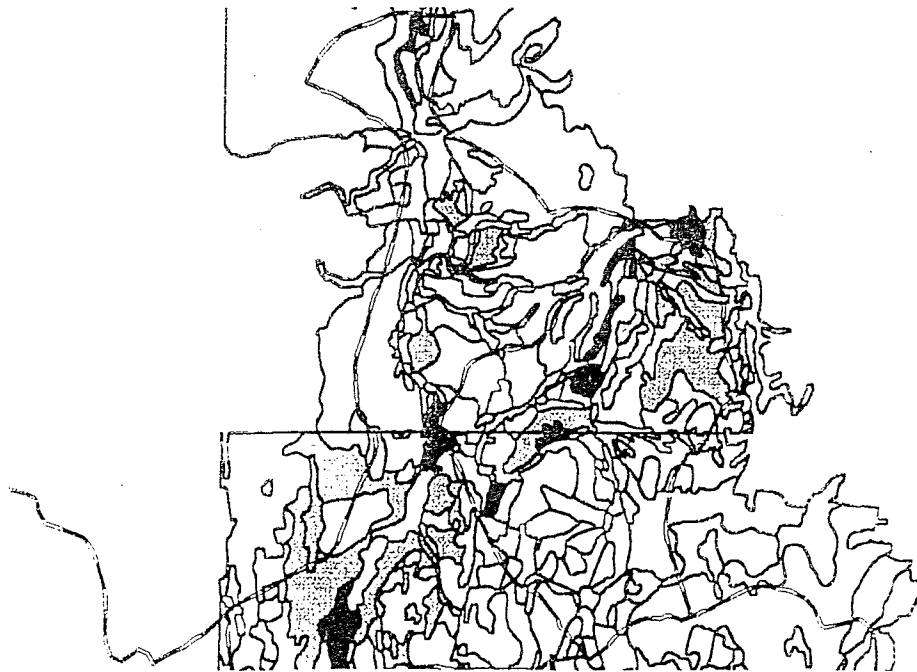
Figure Mu-5: Muddy Brook watershed - wetpond/wetland soils.

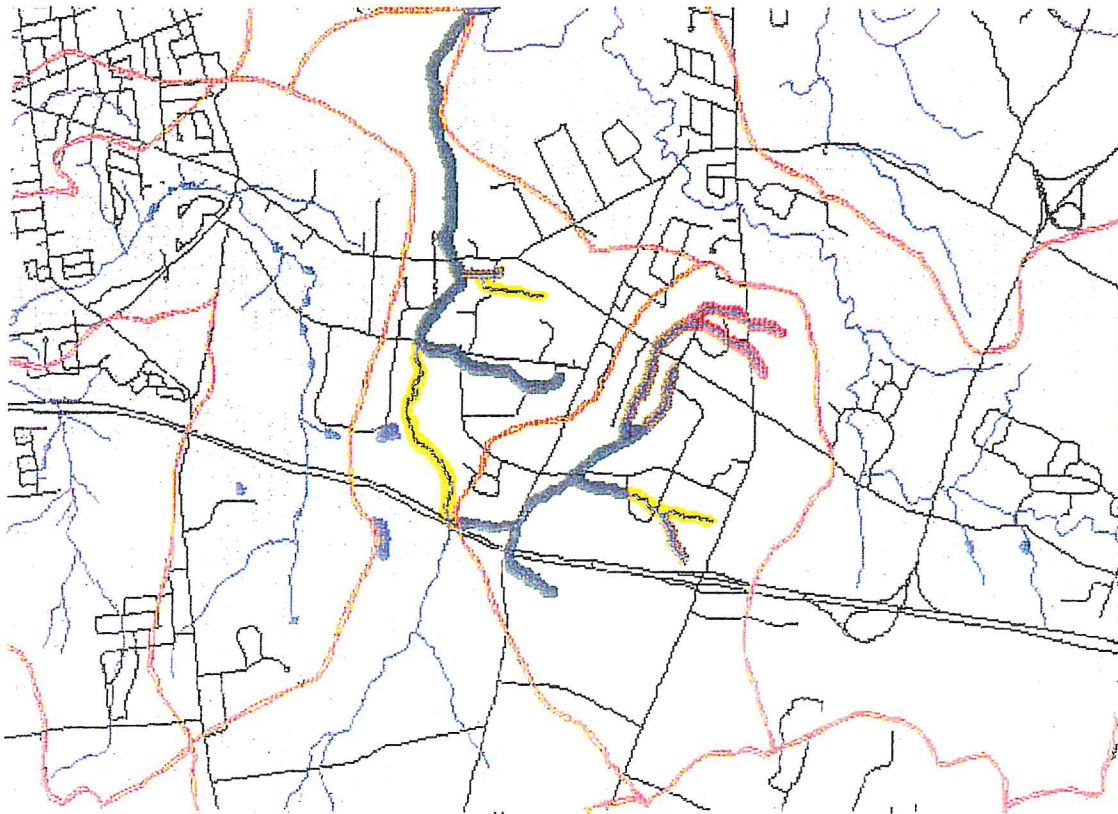
Riparian Corridor Evaluation (RCE)  
Red=Poor, habitat structure gone  
Brown=Fair, major habitat alteration  
Yellow=Good, minor habitat alteration  
Green=Very Good, monitor for changes  
Blue=Excellent, protect existing status

**Figure Mu-6: Muddy Brook Riparian Corridor Evaluation. Evaluation was conducted using the Riparian Corridor Evaluation methodology (Petersen, 1992). A series of measurements and observations are recording while walking the stream channel.**

In Muddy Brook, only the corridor in the lower watershed was assessed (**Figure Mu:6**). Although the main stem appears to have a relatively healthy riparian corridor, the tributaries are being paved over, piped, channelized, or otherwise developed relatively quickly. Degradation of these tributaries is reflected in the overall health of the aquatic biota in the main stem.

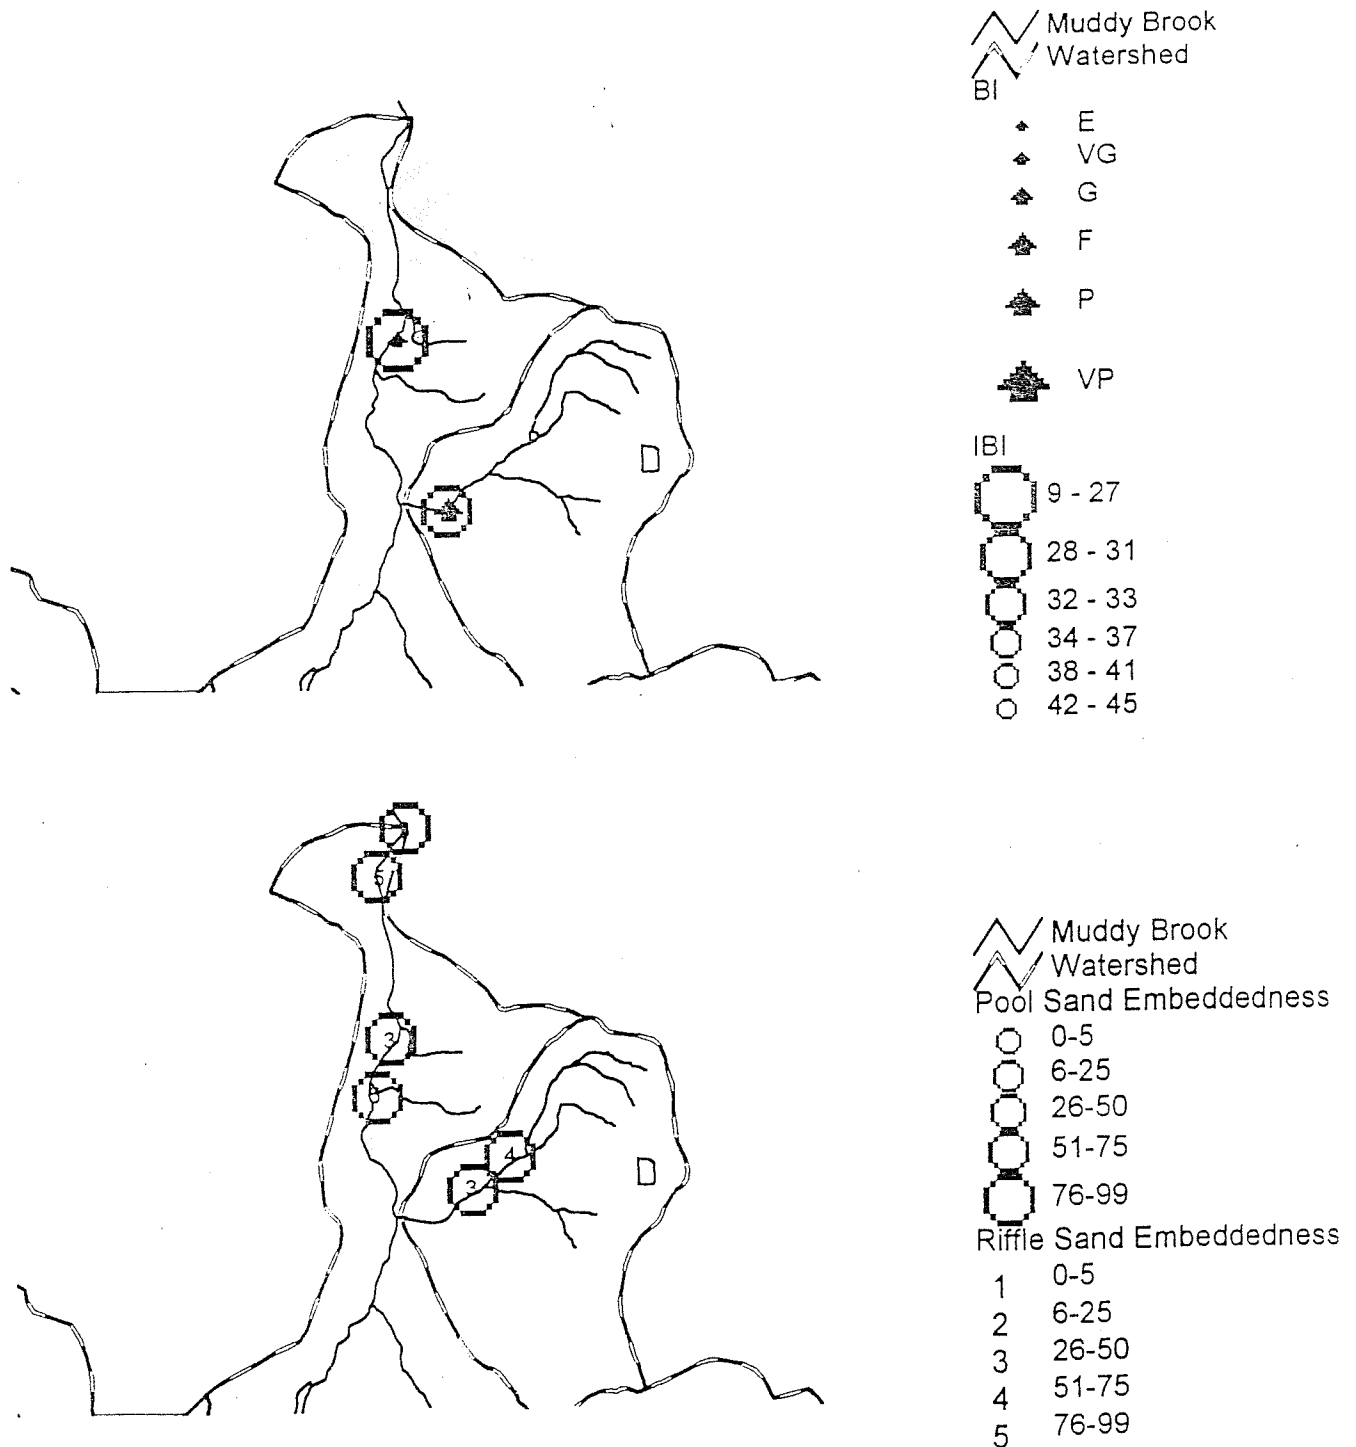
Figure Mu-8: Lower Muddy Brook watershed measure of pool and riffle sedimentation. A high degree of sand embeddedness indicates excessive erosion and impairs aquatic habitat and the biological communities that are supported by that habitat.

Sediment levels in Muddy Brook were moderate given the sand plain character of the stream, although silt levels were excessive in the study tributary and the channel below Kimball Drive (**Figure Mu:7**). Construction in the Taft Corners Commercial Parks and along Kimball Drive are the most likely source for this sediment. A high frequency of occurrence of black spot parasite in nongame fish in the main channel may be indicative of environmental stress (Langdon, personal communication). Macroinvertebrate sampling indicates that enrichment is occurring in the brook. The Muddy Brook tributary watershed (Taft Corners) and the main brook do not currently meet Class B standard for biological condition at the sites sampled (**Figure Mu:8**).

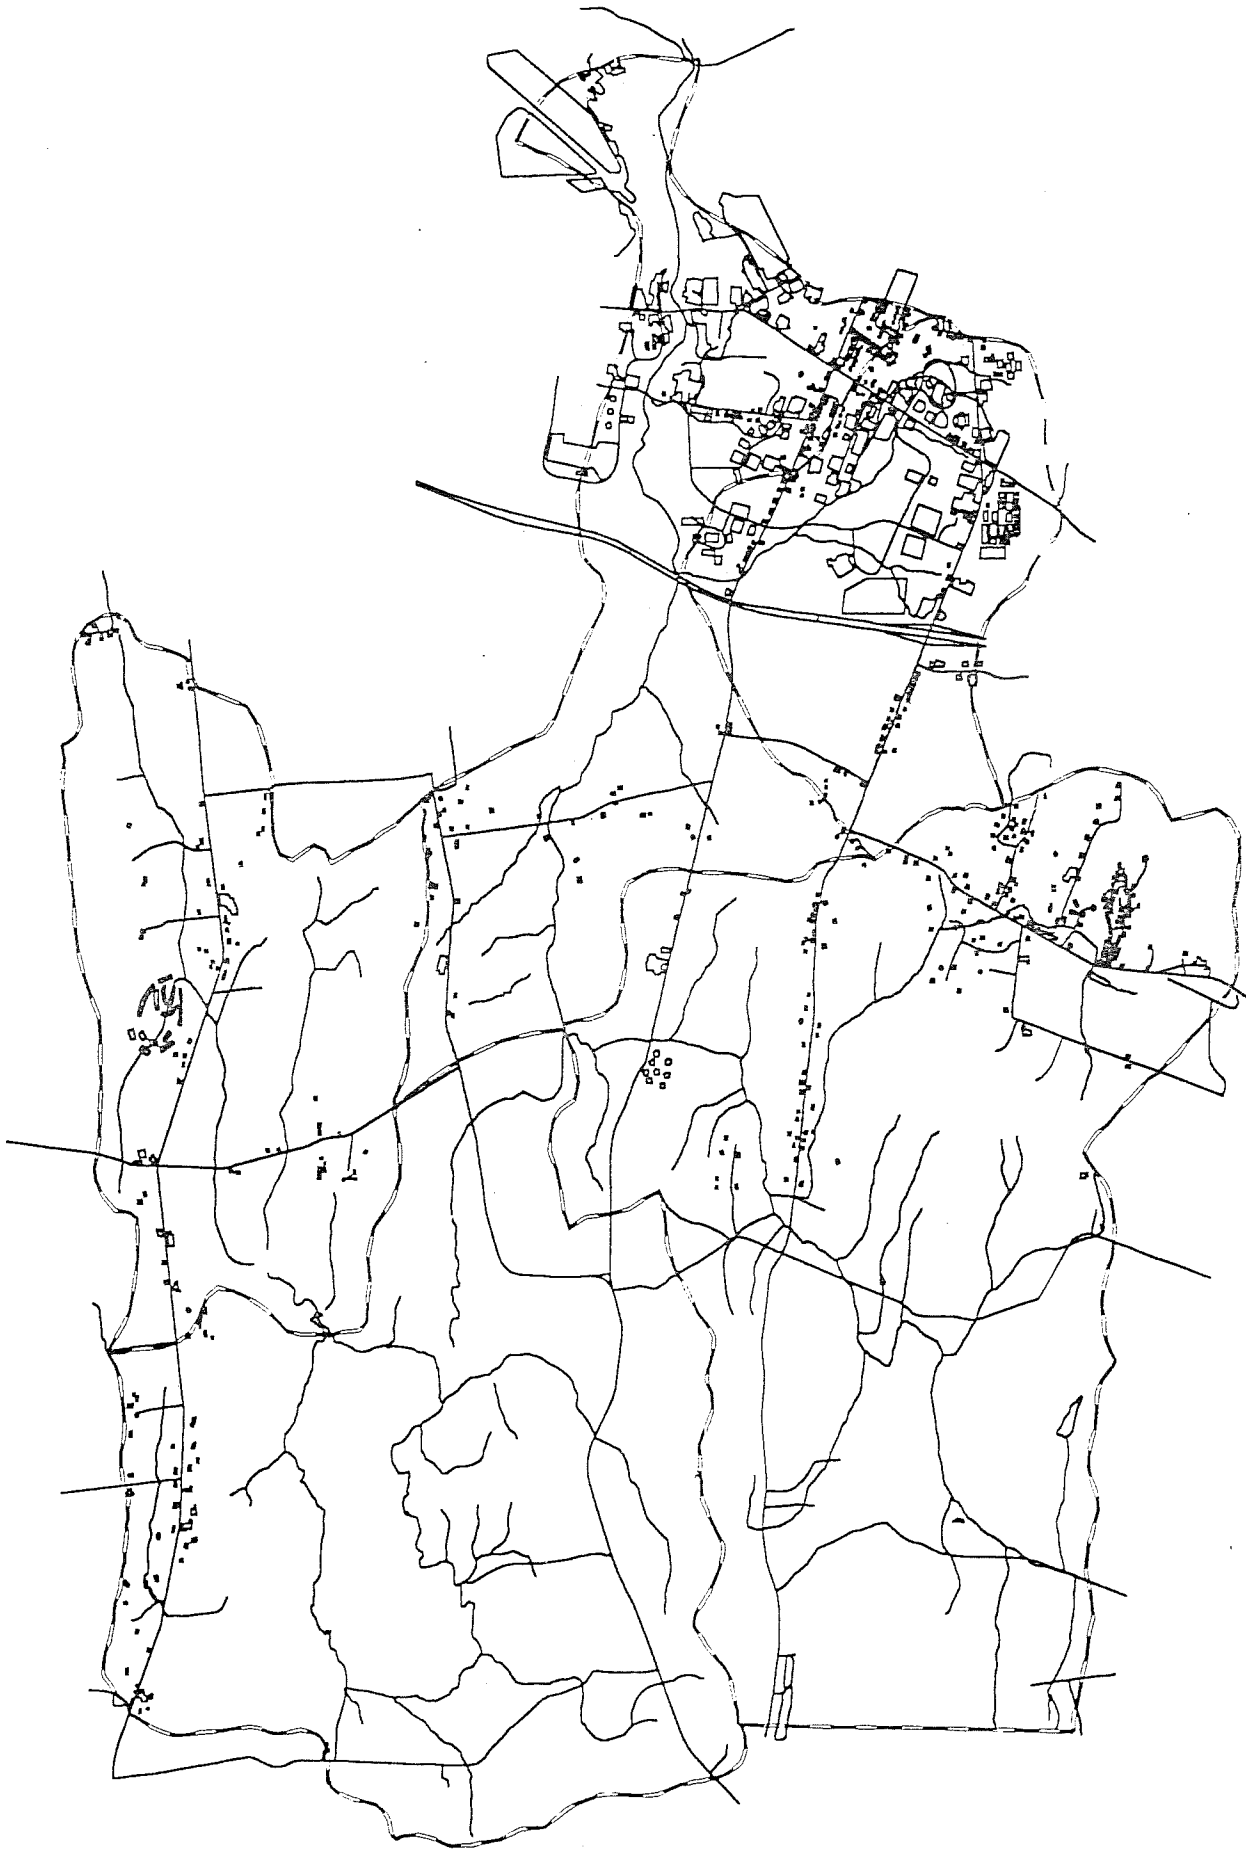
Figure Mu-9: Muddy Brook watershed mapped impervious surface - 1996.

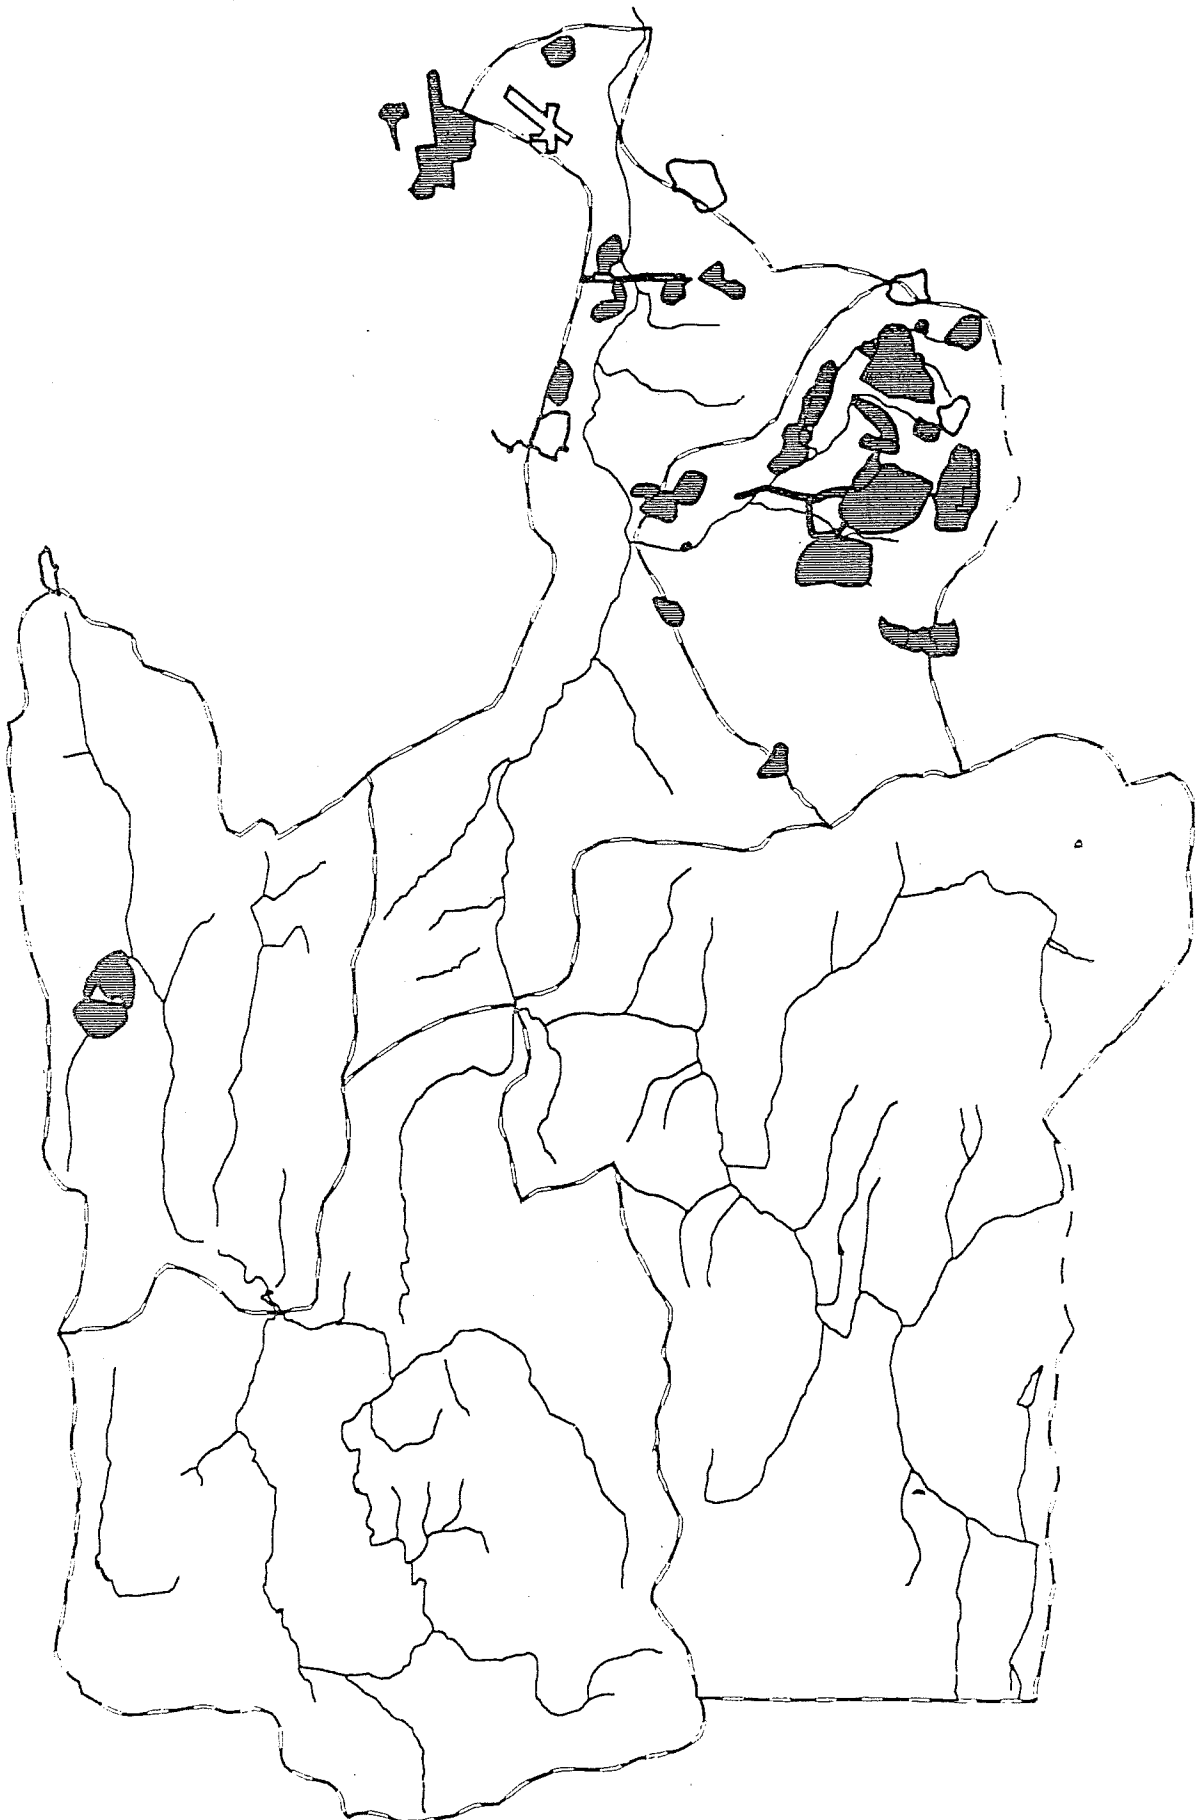
Figure Mu-10: Muddy Brook watershed mapped sewersheds - 1996.

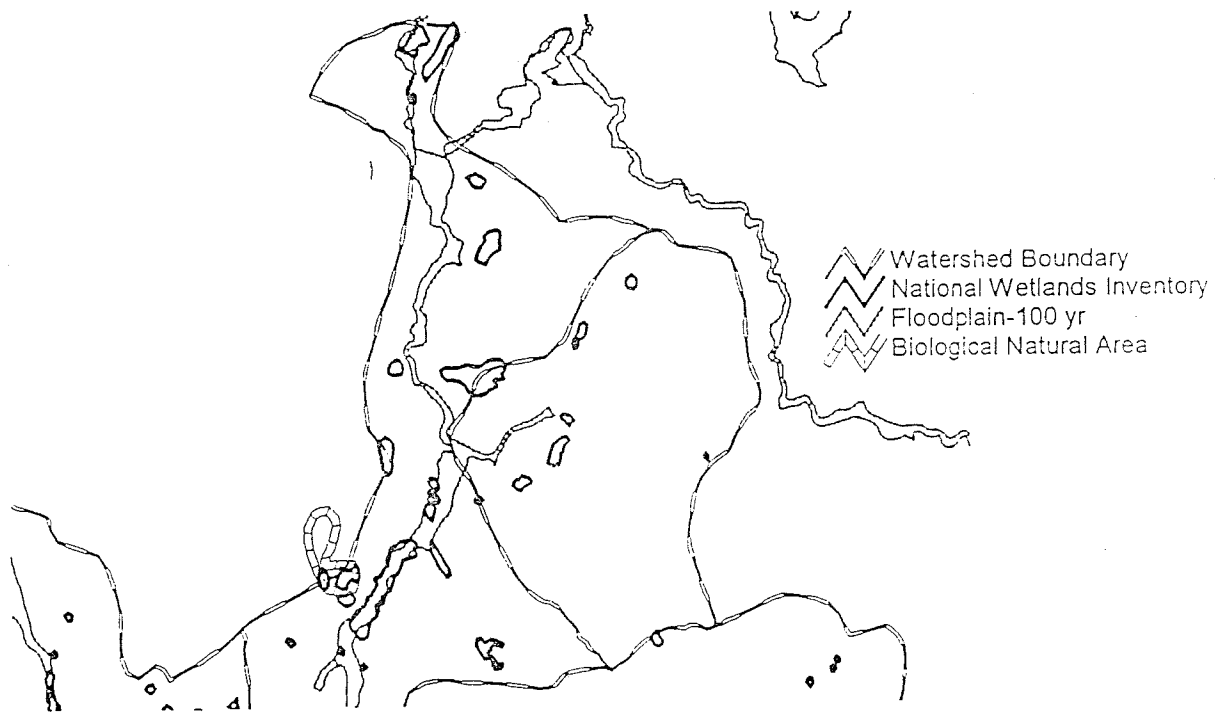
Figure Mu-12: Lower Muddy Brook watershed - mapped wetlands, 100 yr. floodplain, public land, natural areas, and Natural Heritage sites.
