**ALLEN BROOK-MUDDY BROOK STORMWATER  
MANAGEMENT EVALUATION**

Prepared For:  
Lake Champlain Basin Program  
54 West Shore Rd  
Grand Isle, Vermont 05458

December 1997

Prepared By:  
James Pease  
Vermont Department of Environmental Conservation  
Water Quality Division  
10 North Building  
103 S. Main Street  
Waterbury, VT 05676

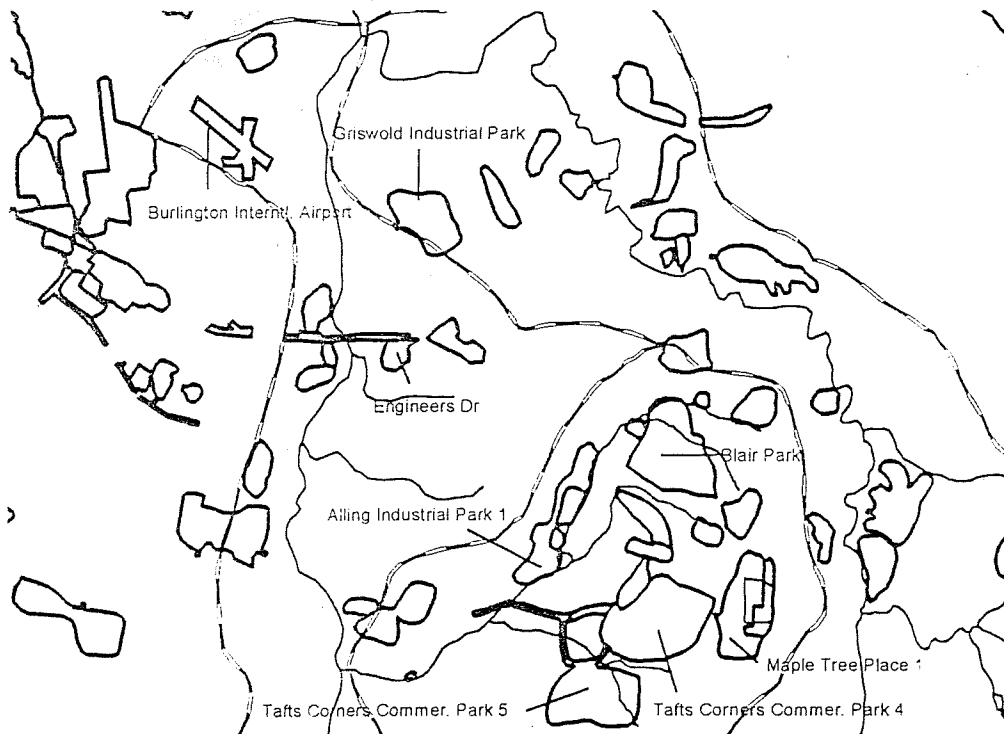
Targeted Stormwater Sewersheds  
Muddy Brook Watershed

**Figure 1.1: Targeted Stormwater Sewersheds in Muddy Brook Watershed - Sewersheds** were targeted based on exceedences of loading thresholds as described in Table 1.2. BMP recommendations are made for each targeted sewershed. Eight sewersheds in the Muddy Brook watershed have been targeted.

As described in Part 1 of this report, annual pollutant loadings for total phosphorus, total suspended solids, total metals, and fecal coliform were calculated for each sewershed and the sewersheds ranked; sewersheds exceeding threshold criteria were targeted for further evaluation (**Table 1-2, Figures 1.1-1.4**).

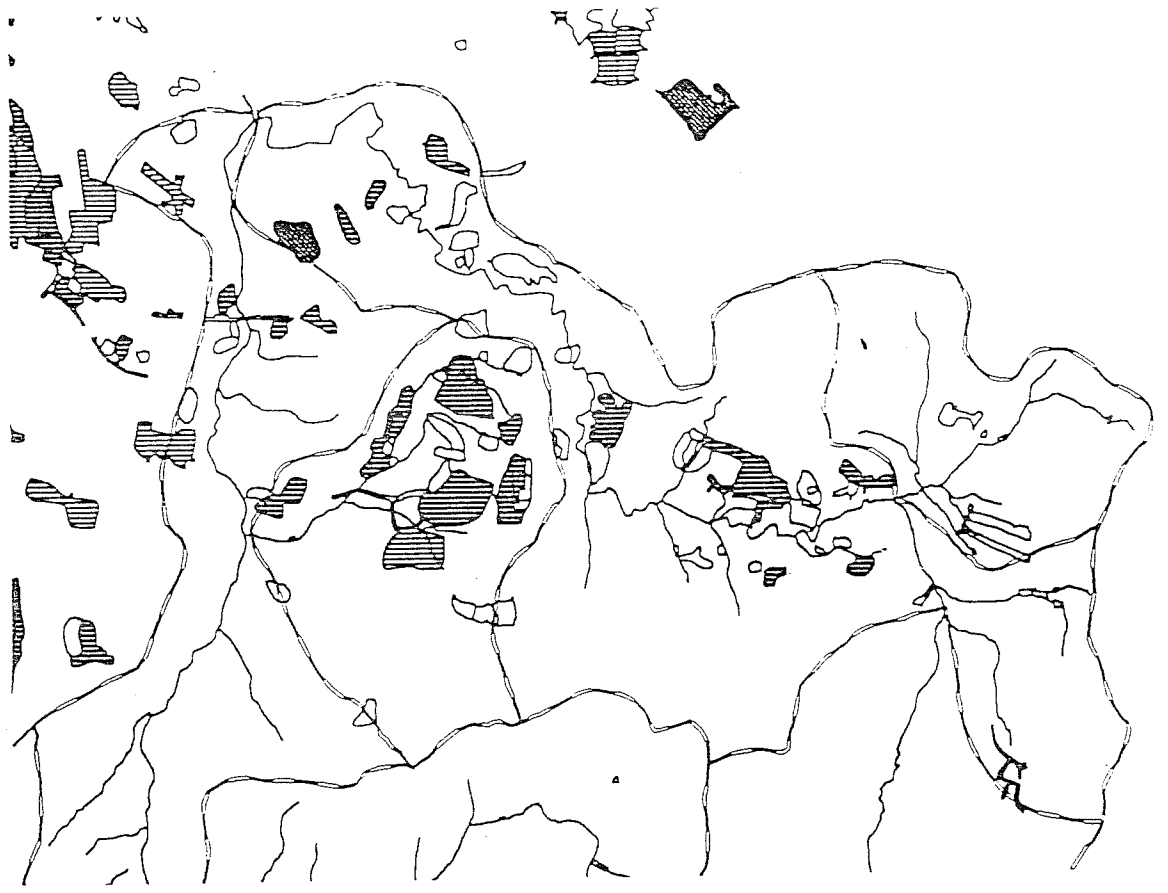
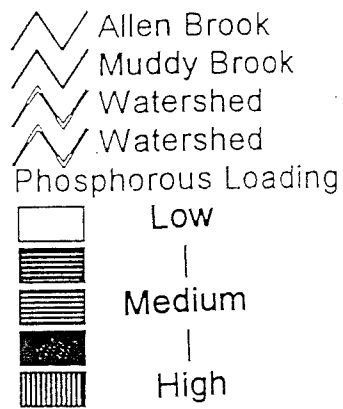
Figure 1.2: Estimated total phosphorus loading from sewersheds in the Allen and Lower Muddy Brooks watersheds.

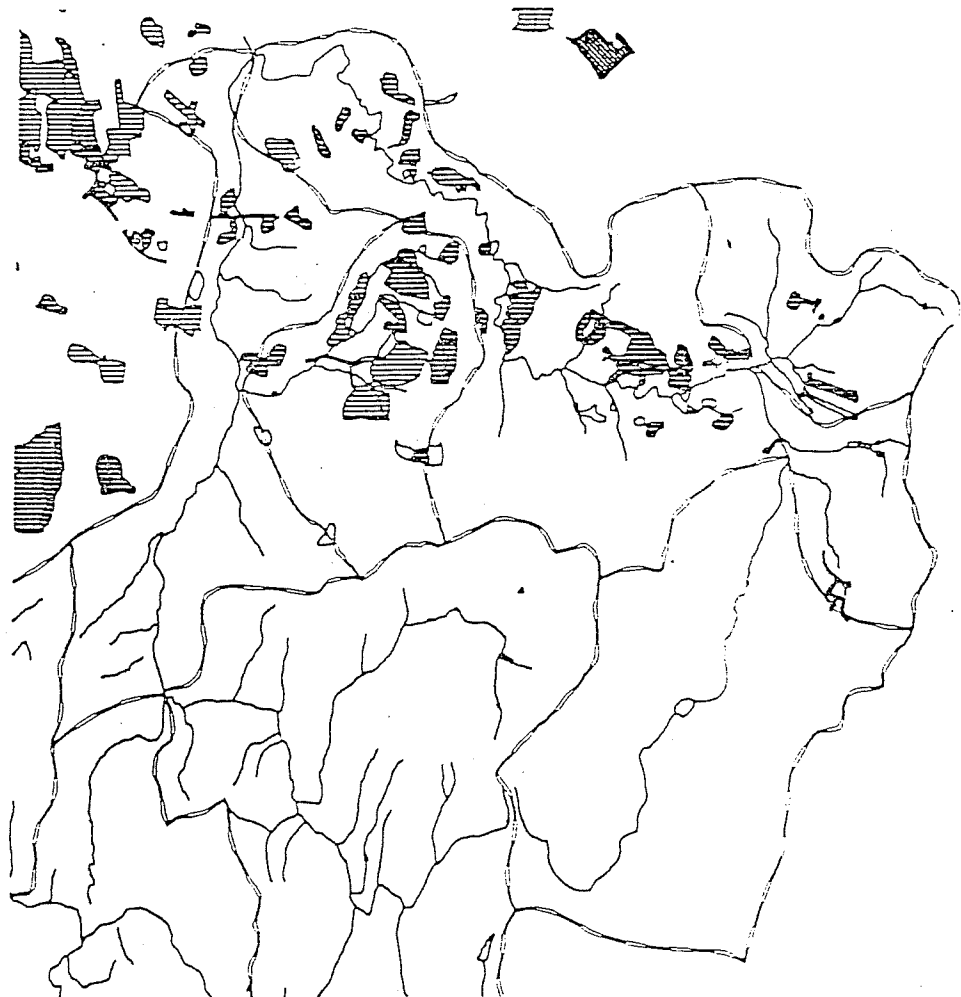
Figure 1.3: Estimated total suspended solids loading from sewersheds in the Allen and Lower Muddy Brooks watersheds.

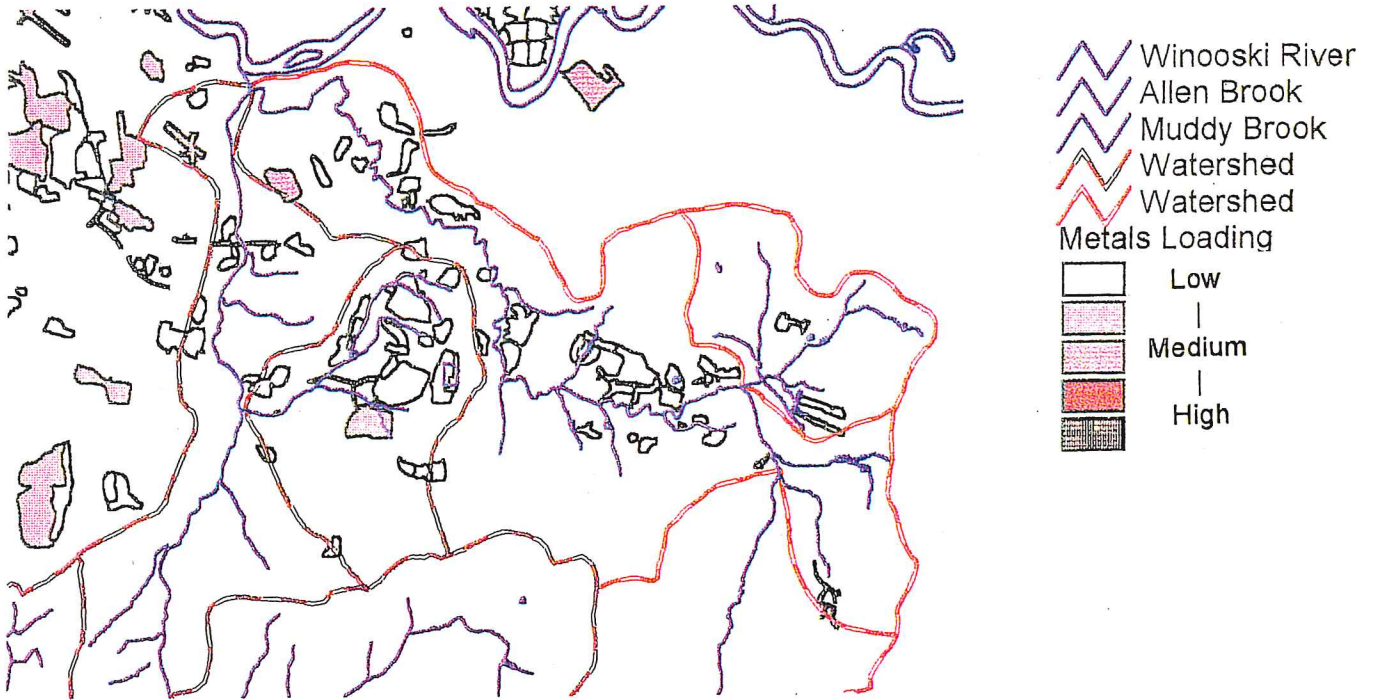
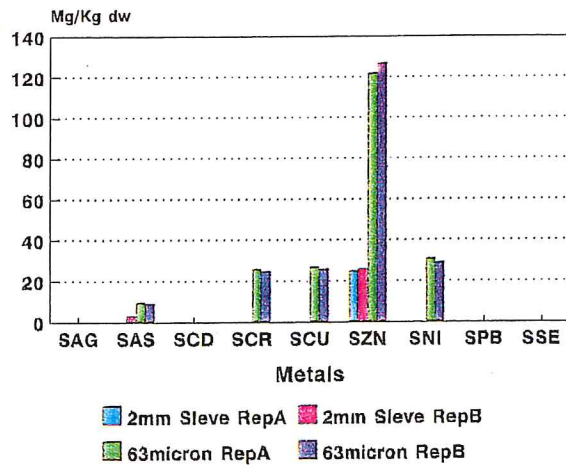
**Figure 1.4: Estimated total metals loading from sewersheds in the Allen and Lower Muddy Brooks watersheds.** Graph at bottom shows concentrations of metals in whole (2mm) and fine fraction (63u) sediments at the mouth of the Muddy-Allen watershed. Samples collected in 1995.
