**ENGLESBY BROOK
STORMWATER MANAGEMENT EVALUATION**

December 1997

Prepared By:
James Pease
Vermont Department of Environmental Conservation
Water Quality Division
10 North Building
103 S. Main Street
Waterbury, VT 05676

Englesby Brook Stormwater Management Evaluation

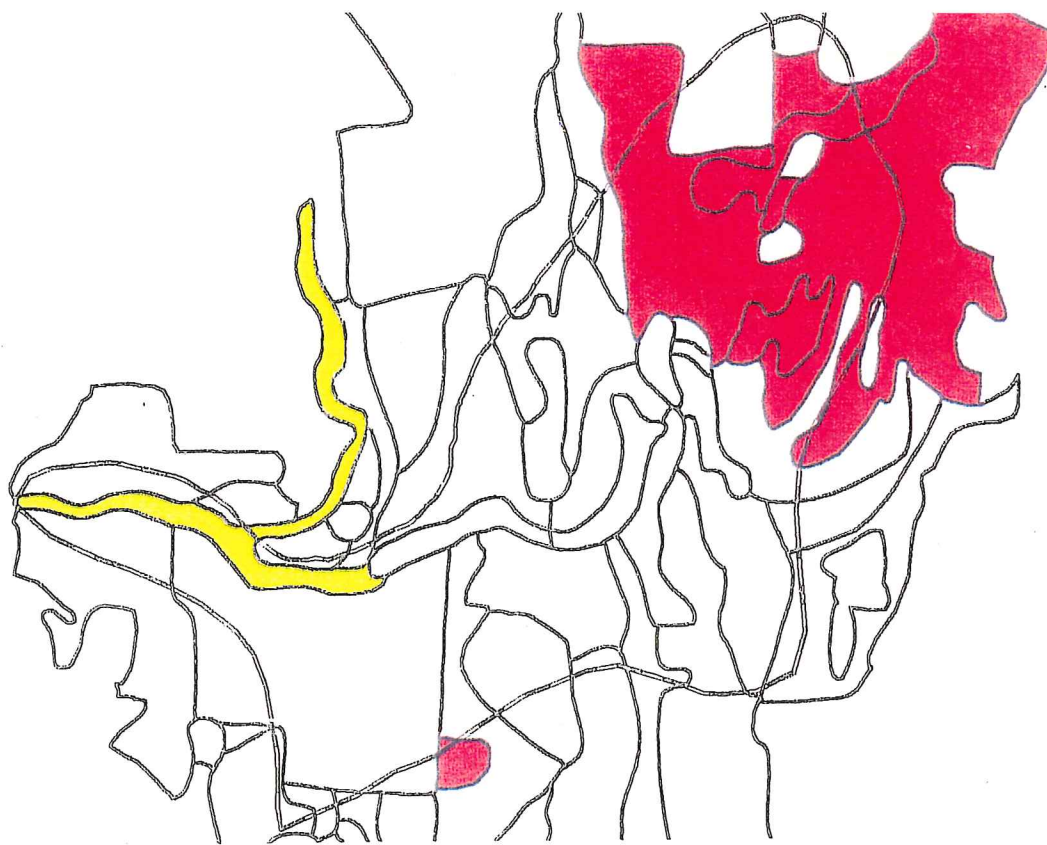
Figure 4.4: Englesby Brook watershed - areas of highly erodible soils. These soils are easily displaced.

Englesby Brook experiences frequent bank-full flooding as a result of stormwater runoff. This flooding accelerates erosion of the lower stream channel which is a highly erodible Munson soil type. Channel cutting has lowered the channel up to 10 feet in several places. Erodible Vergennes Clay also exists in the headwaters on the expanding UVM Redstone-Gutterson campus. Several wet pond sites exist on the Burlington Golf Course which could provide excellent sources of groundwater recharge for the stream. Soils suitable for infiltration practices are rare but do exist along Crescent St in the hill section. Soils suitable for a wet pond exist near the targeted Shelburne Road storm sewers, the soil types are Scantic B and Belgrade B, and the site is on public land. Instream wetponds below Shelburne Road as proposed (Havens and Emerson, 1990) may not adequately retain water without a constructed liner due to the loamy soil type (Figures 4.3-5).

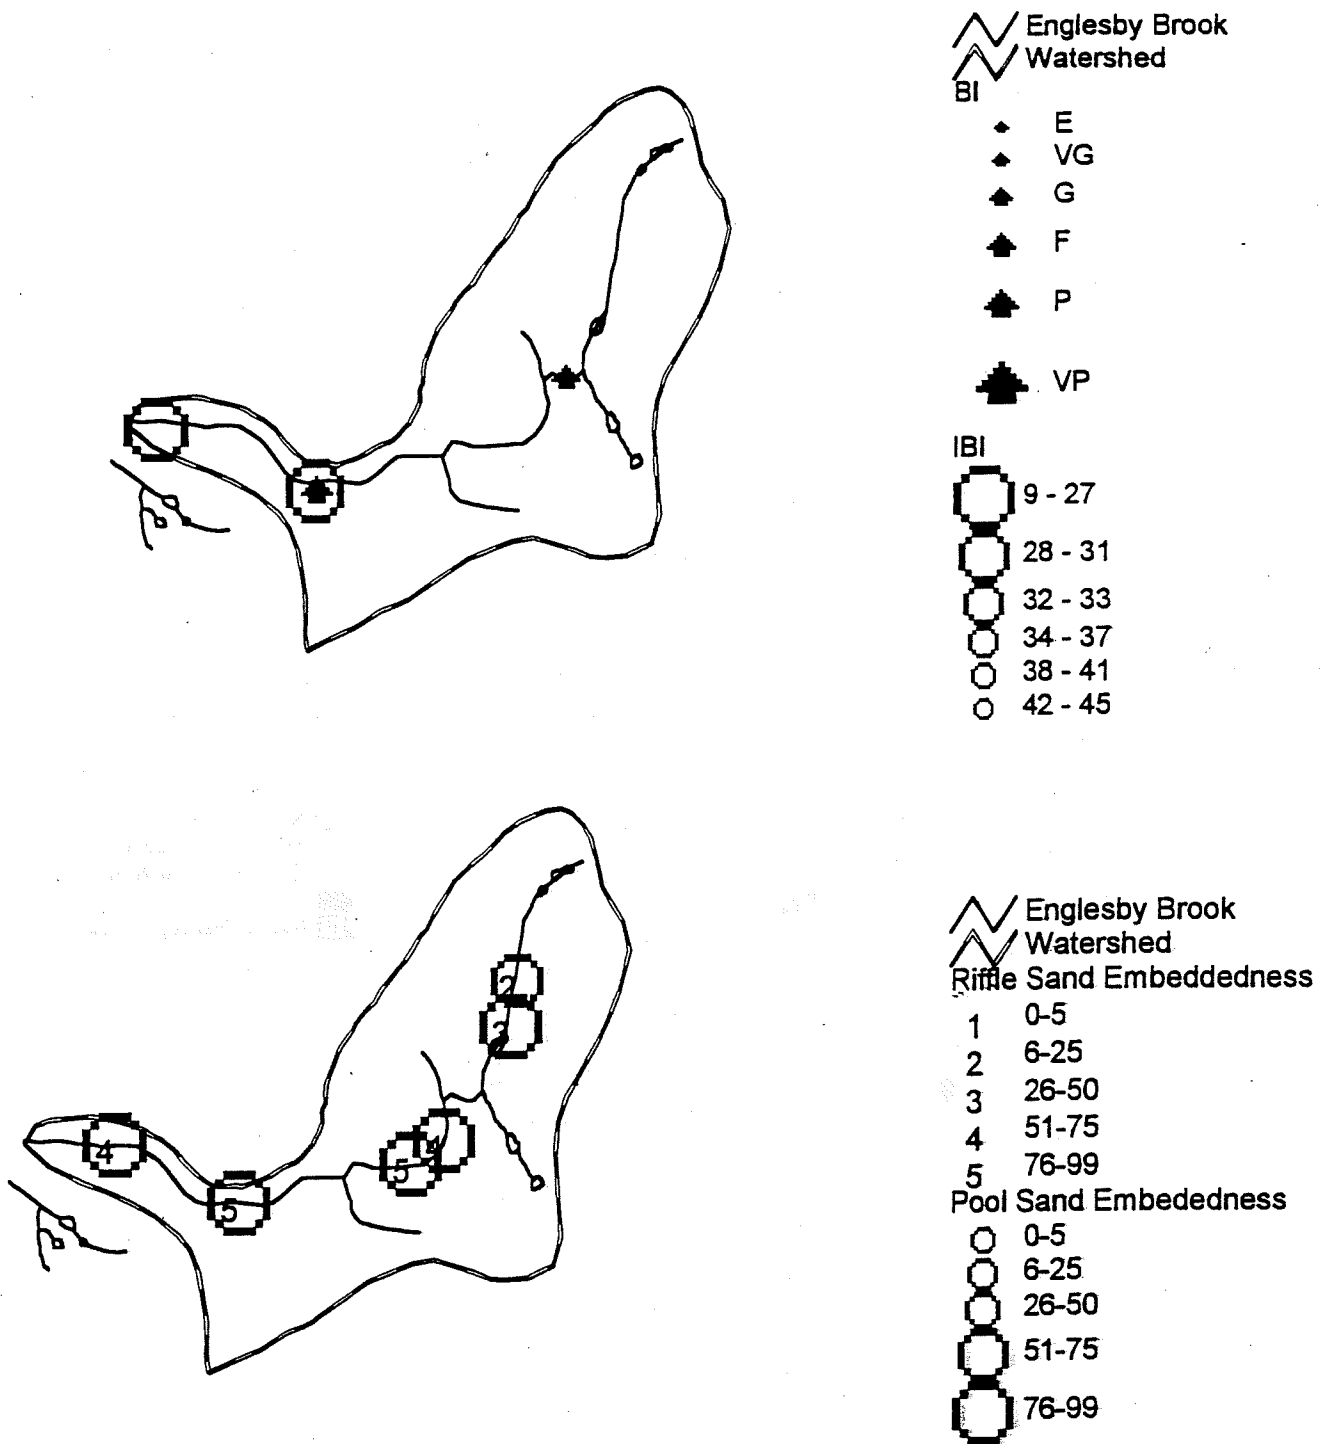
Figure 4.7: Englesby Brook watershed - biological condition. Fish and macroinvertebrate community measures of integrity. A macroinvertebrate biotic index (BI) rating of less than good is indicative of sub-Class B condition. A fish Index of Biotic Integrity (IBI) rating of less than 31 is indicative of sub-Class B condition.

Shelburne Road however have severely limited biological life in this reach. Sedimentation in the brook is extremely severe. Stormwater flows fluctuate between 0-50 cfs (Cassell, 1994) and have caused large sediment "plugs" to move downstream. Because of the scouring, little silt appears to accumulate throughout most of the channel. However, immediately below the UVM Redstone Campus stormwater ponds, where Covington Clays have been exposed by construction, silt constituted 70% of the channel sediment fraction. A significant decrease in macroinvertebrate density and richness occurs below the Shelburne Road-Outlet Mall storm drains. No fish populations have existed in the stream in the last 4 years although transient fish from Lake Champlain inhabit the mouth. The stream does not currently meet the Class B water quality standard for biological integrity (Figure 4.7).

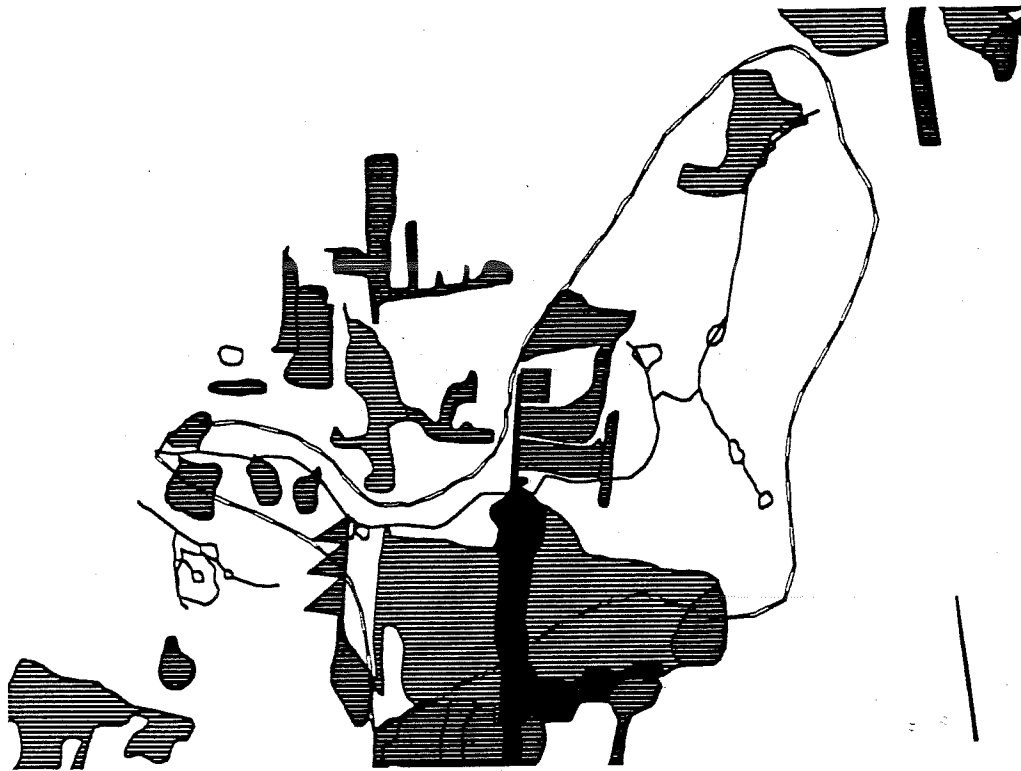
Figure 4.10: Estimated total suspended solids loading from sewersheds in the Englesby Brook watershed.

Recwater	Storm sewershed	Treatment (Appendix 4)	EIA %	Loading kg/yr
Highest Total Suspended Solids (Figure 4.10)				
Englesby	Shelburne Rd.-Outlet Mall	CB	60.8	19,774
Englesby	Richardson Terrace	CB/CF	12.5	7,754
Englesby	Proctor St-Hadley St	CB	11.1	7,448
<i>Englesby</i>	<i>Redstone Campus</i>	<i>DP/CB</i>	35.4	6,144
Highest Total Phosphorus (Figure 4.11)				
Englesby	Shelburne Rd.-Outlet Mall			31
Englesby	Richardson Terrace			12
Englesby	Proctor St-Hadley St			12
<i>Englesby</i>	<i>Redstone Campus</i>			10
Highest Total PAH (Figure 4.12) (Commercial Landuses Only)				
Englesby	Shelburne Rd.-Outlet Mall			212
<i>Englesby</i>	<i>Redstone Campus</i>			66
Highest Total Metals (Figure 4.13)				
Englesby	Shelburne Rd.-Outlet Mall			24
Englesby	Richardson Terrace			9
Englesby	Proctor St-Hadley St			9
<i>Englesby</i>	<i>Redstone Campus</i>			7
Highest Total Fecal Coliform (Colonies/year)				
Englesby	Shelburne Rd.-Outlet Mall			3.1 x 10 ⁶

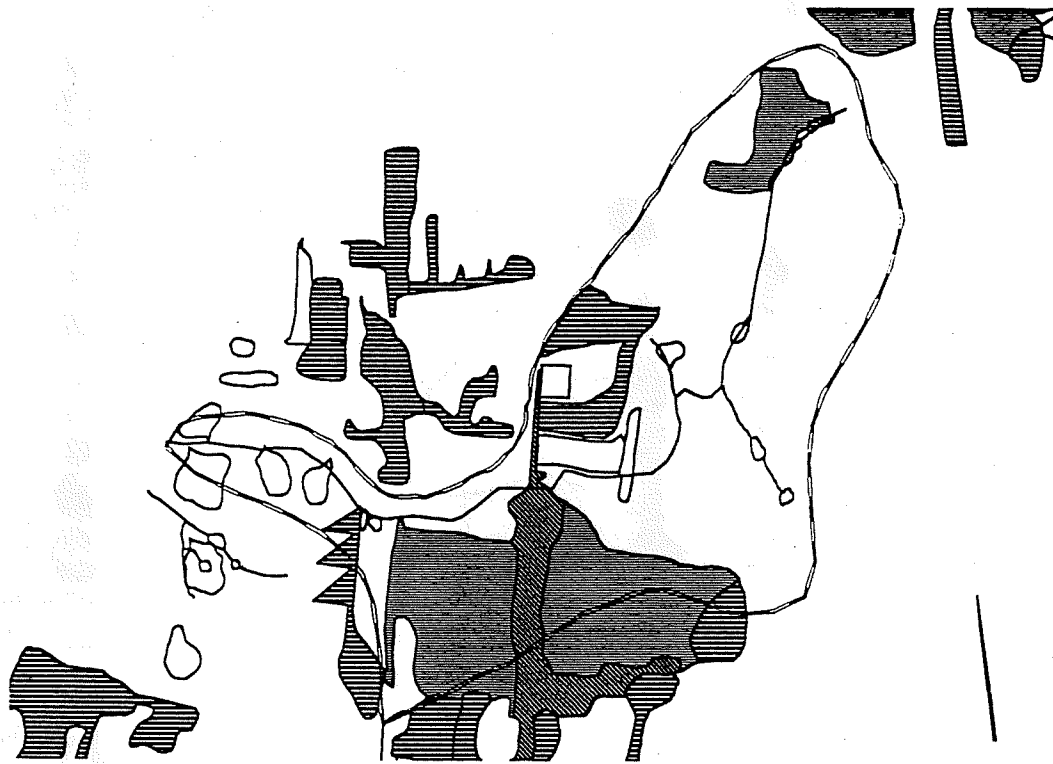
Figure 4.11: Estimated total phosphorus loading from sewersheds in the Englesby Brook watershed.

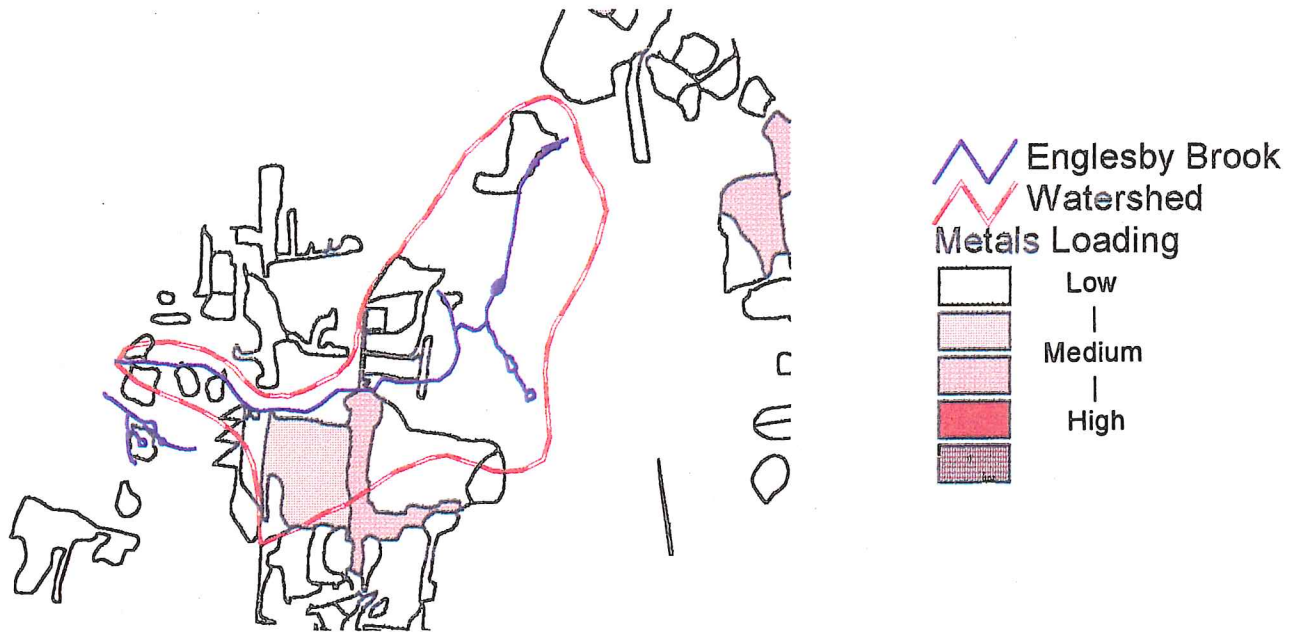
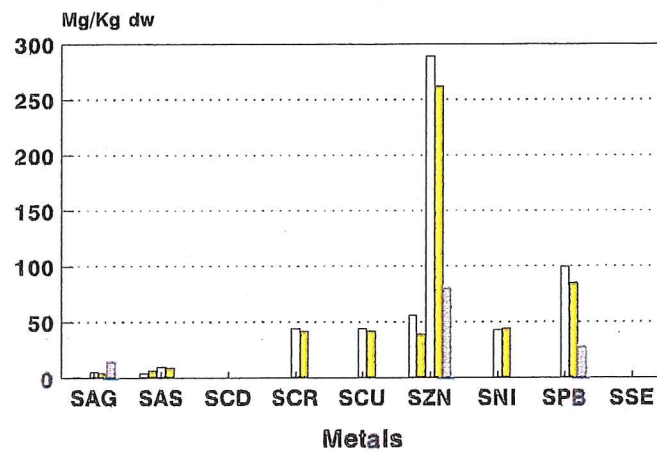
Figure 4.13: Estimated total metals loading from sewersheds in the Englesby Brook watershed. Graph at bottom shows concentrations of metals in whole (2mm) and fine fraction (63u) sediments at the mouth of the Englesby watershed. Samples collected in 1995.

2mm Sieve RepA
 2mm Sieve RepB
 63micron RepA
 63micron RepB
 Algae

Collected at mouth

- Investigations into the sources of toxic contaminants in the storm sewer system, primarily silver, should be continued.
