2022 Lake Morey Water Quality Monitoring Results

Mark Mitchell, Lake Monitoring and Community Outreach Coordinator
VT Department of Environmental Conservation, UVM Lake Champlain Sea Grant

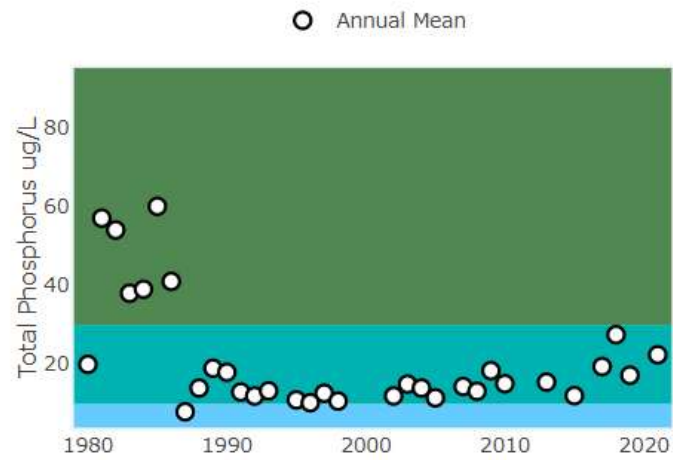
Spring Phosphorus

Trend: Stable (p-value=0.3637)

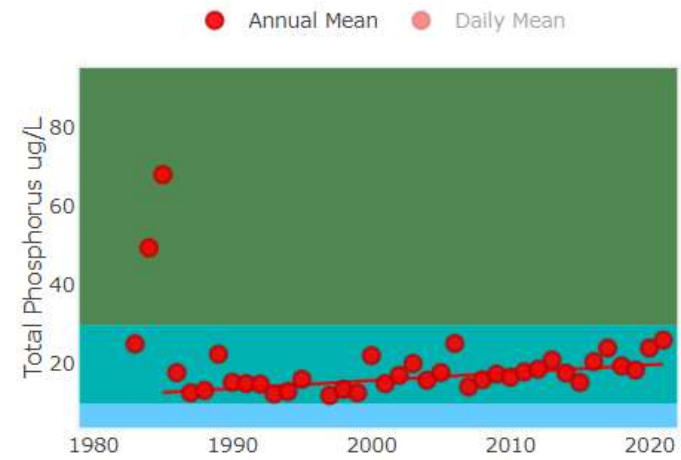
Summer Phosphorus

Trend: Highly Significantly Increasing (p-value=0.0016)

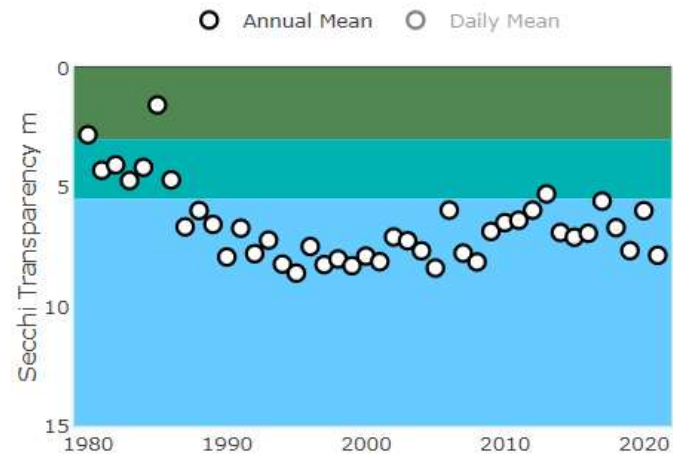
Summer Secchi

Trend: Stable (p-value=0.4177)

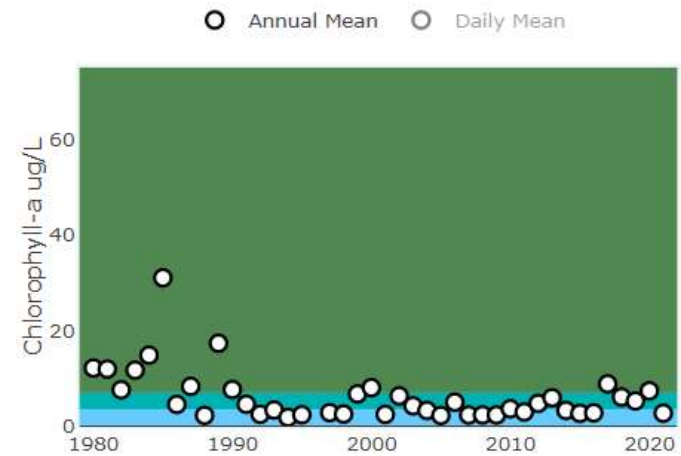
Summer Chlorophyll-a

Trend: Stable (p-value=0.1413)

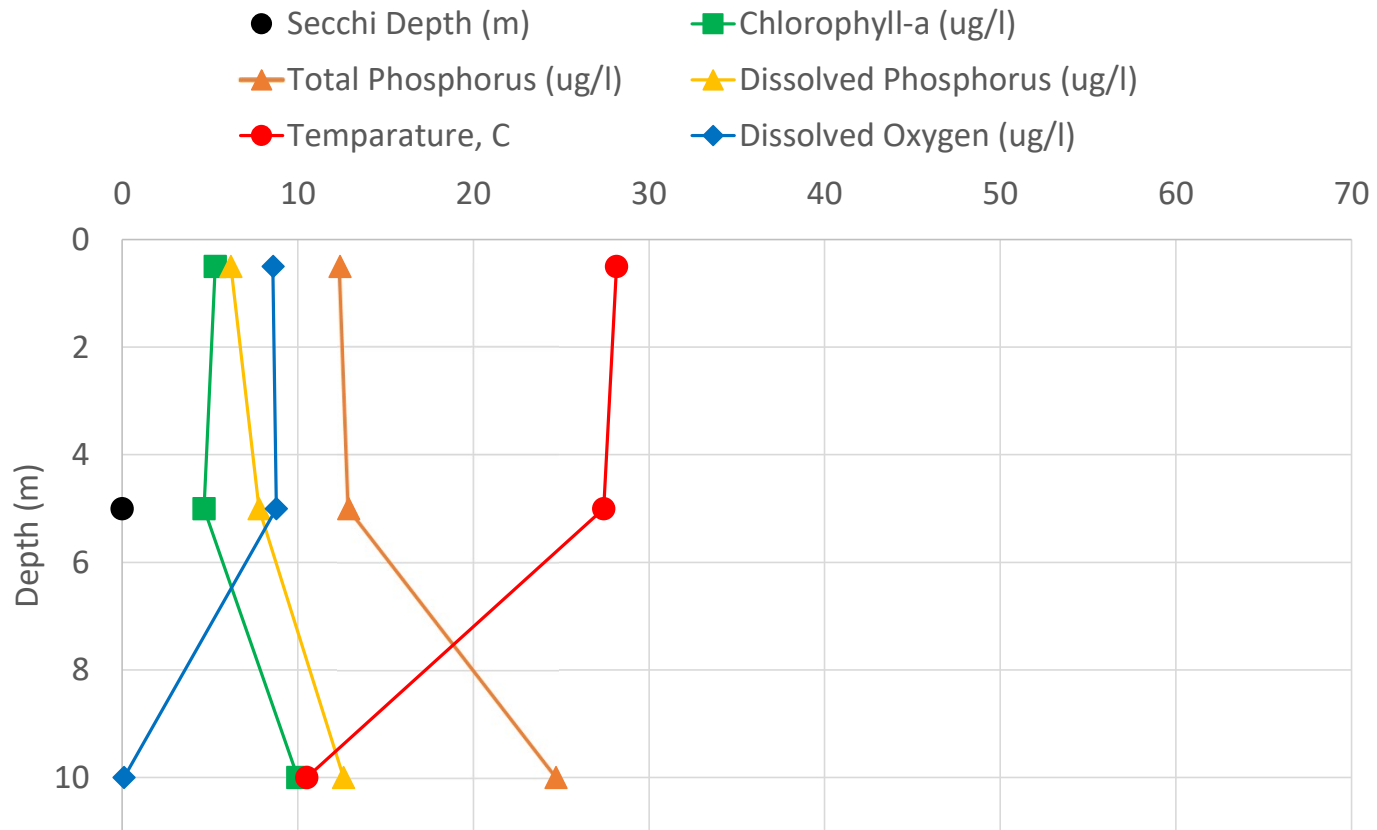
Lake Morey Water Quality Vertical Profile 8/8/2022

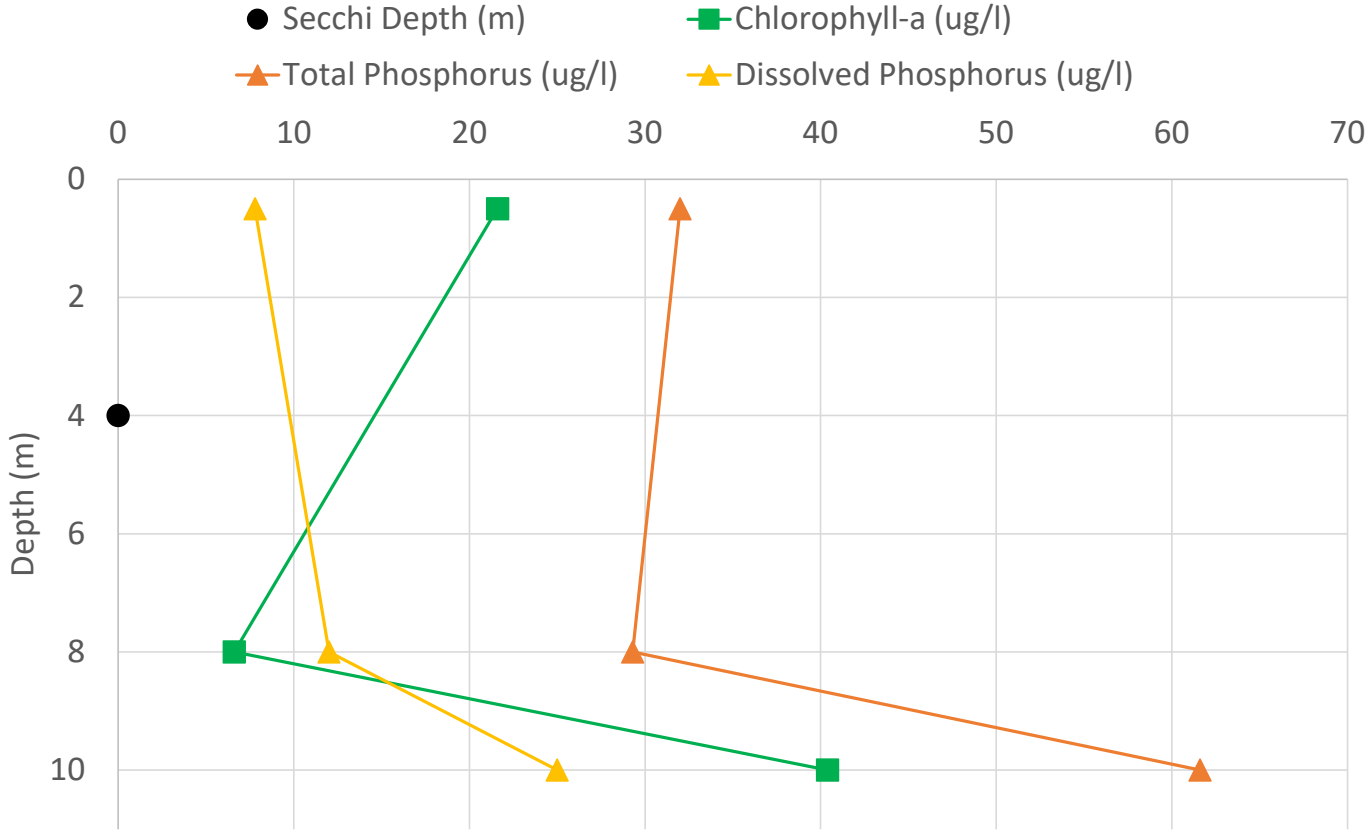
Lake Morey Water Quality Vertical Profile 9/12/2022

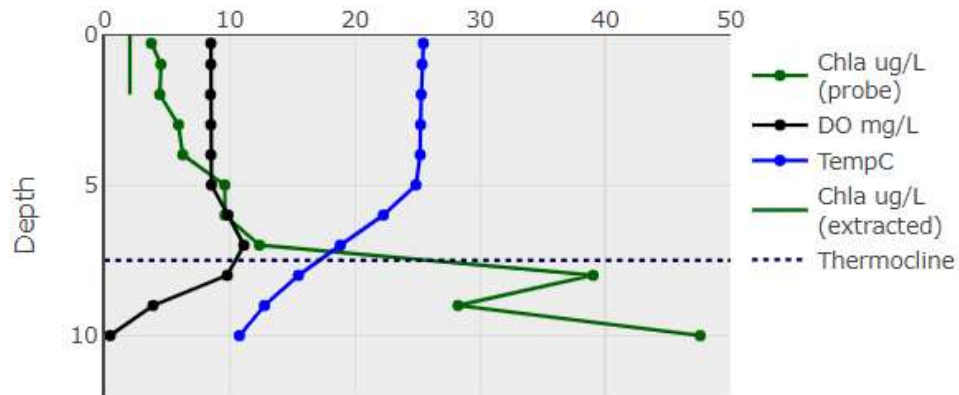
Lake Morey Next Generation Lake Assessment 8/24/2022

Temperature, Dissolved Oxygen, Chlorophyll-a

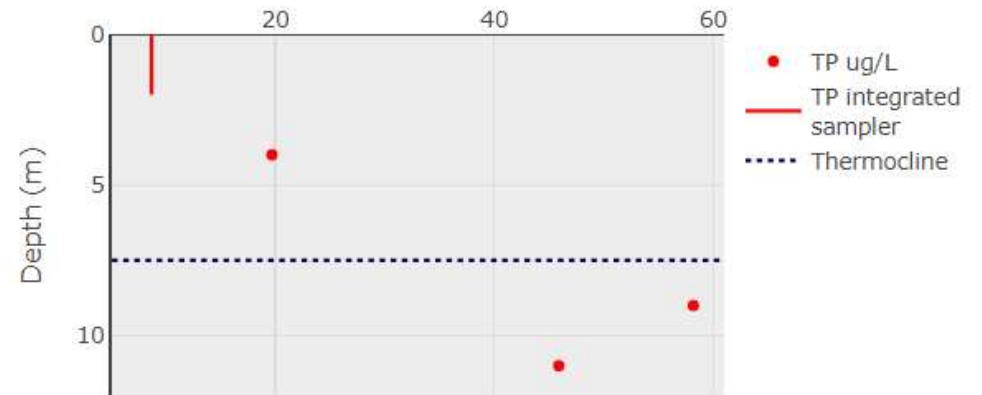
Total Phosphorus

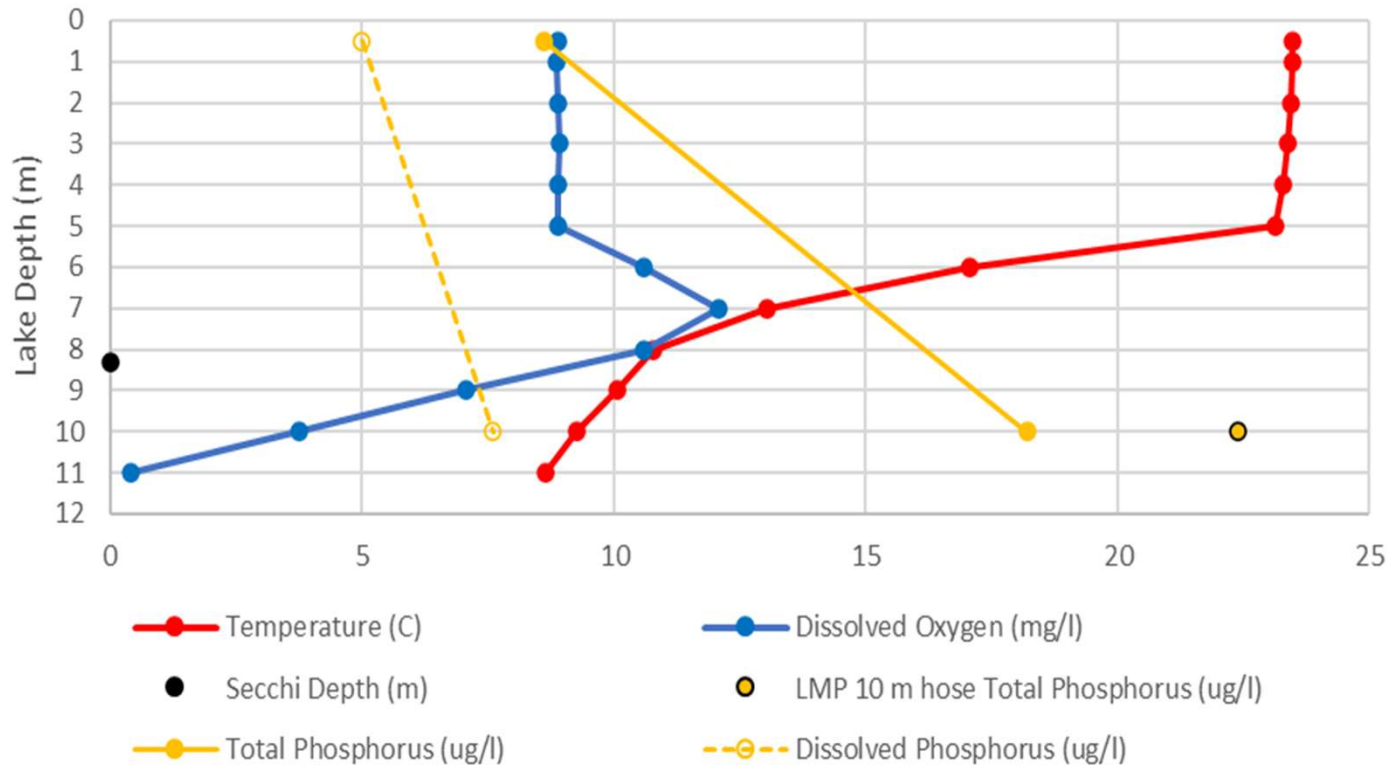
Lake Morey Station 1 Vertical Water Quality Profile 7/6/2021

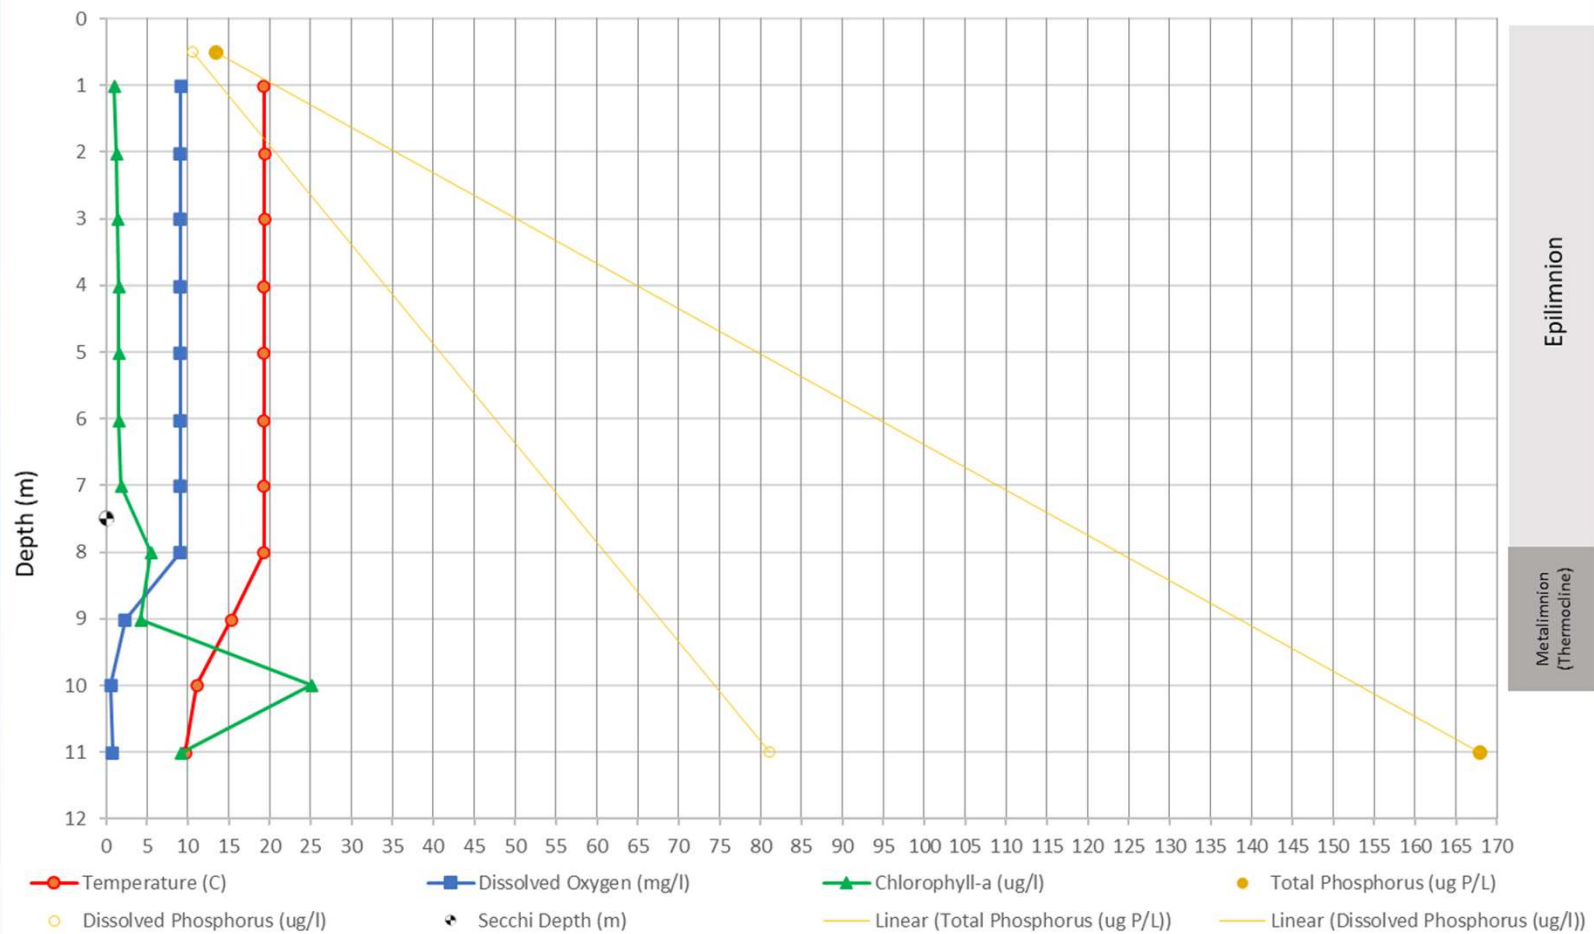
Lake Morey Station 1 Temperature, Dissolved Oxygen, Chlorophyll-a and Phosphorus Vertical Profiles on 9/28/2018

Anoxia in the hypolimnion and large increase in phosphorus concentration from surface (0.5 m) to bottom (1 m above sediment) water indicates internal loading from sediments. Note the chlorophyll-a (algae/cyanobacteria) maximum in the hypolimnion.

- Lay Monitoring Program (LMP)
 - 2022 Summary: Internal phosphorus loading from lake bottom sediment is main driver of cyanobacteria blooms and benthic mats forming in Lake Morey
 - 2023 Next Steps: LMP volunteers collect biweekly lake surface samples while LMP coordinator collects monthly water quality vertical profiles
- LaRosa Partnership Program (LPP)
 - 2022 Summary: Pine Brook, Bonnie Oaks and Aloha Manor have high TP during stormflow events; Bonnie Oaks and Aloha Manor have high Chloride
 - 2023 Next Steps: LPP volunteers continue collecting biweekly samples for same parameters (add DP?) at same sites but extend through August

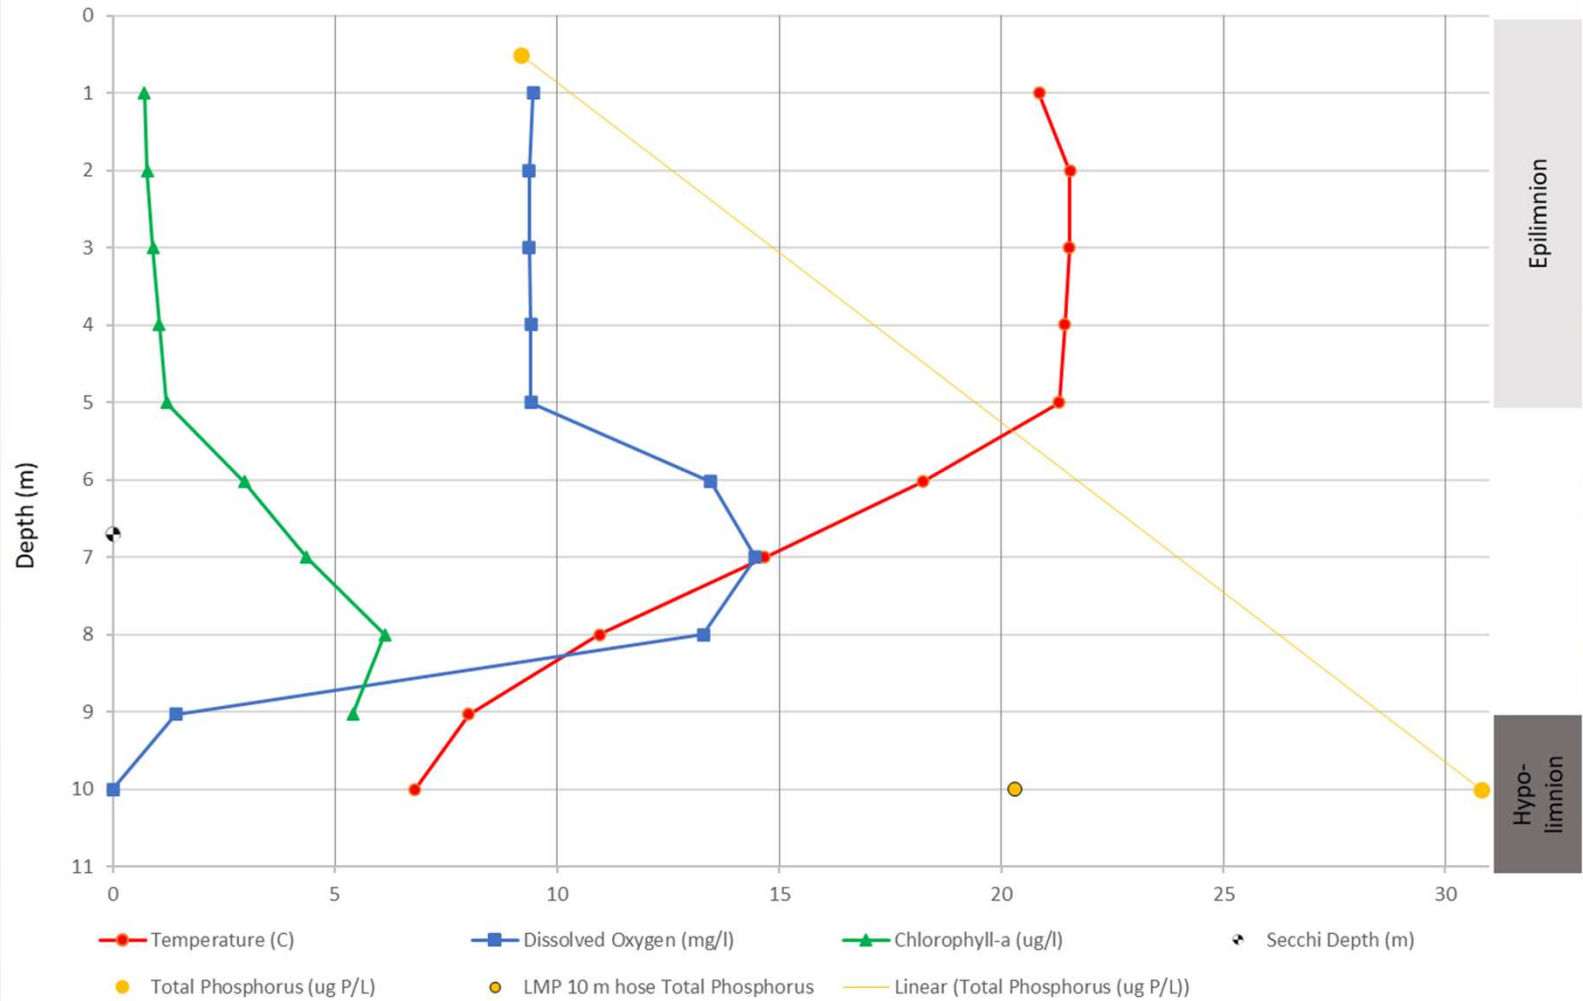
Lake Morey Station 1 Temperature, Dissolved Oxygen, Chlorophyll-a and Total Phosphorus
Vertical Profiles on 6/27/2018

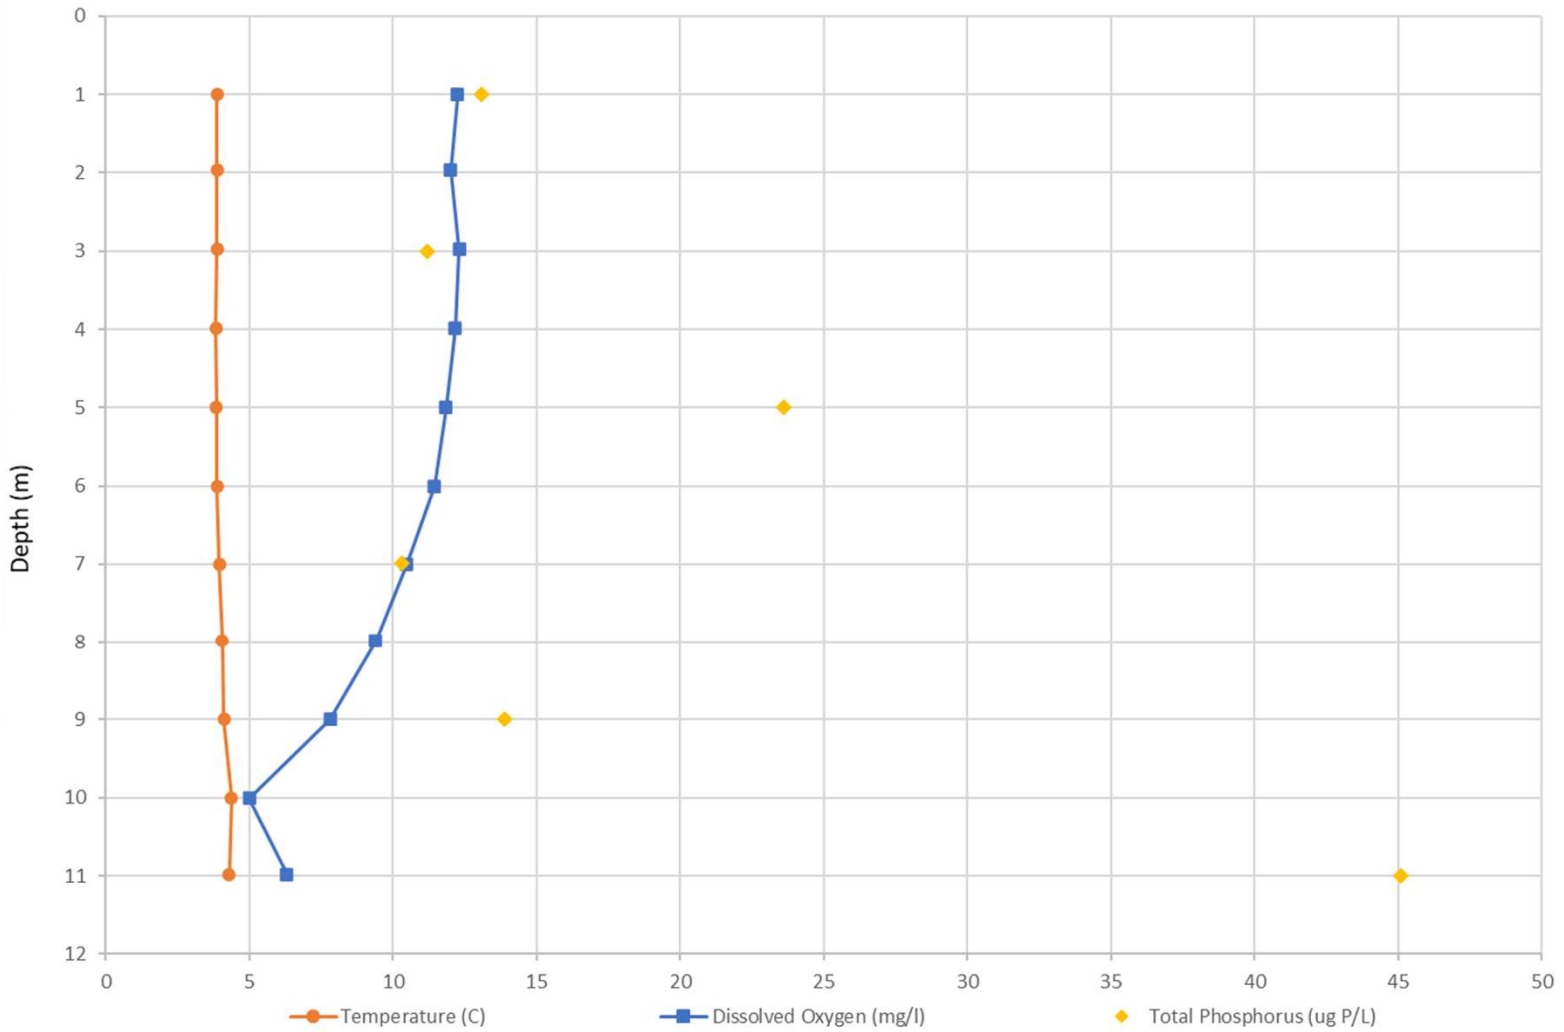
Lake Morey Station 1 Temperature, Dissolved Oxygen, Total Phosphorus and Total Nitrogen Profiles on 3/5/2018 (Under Ice Cover)

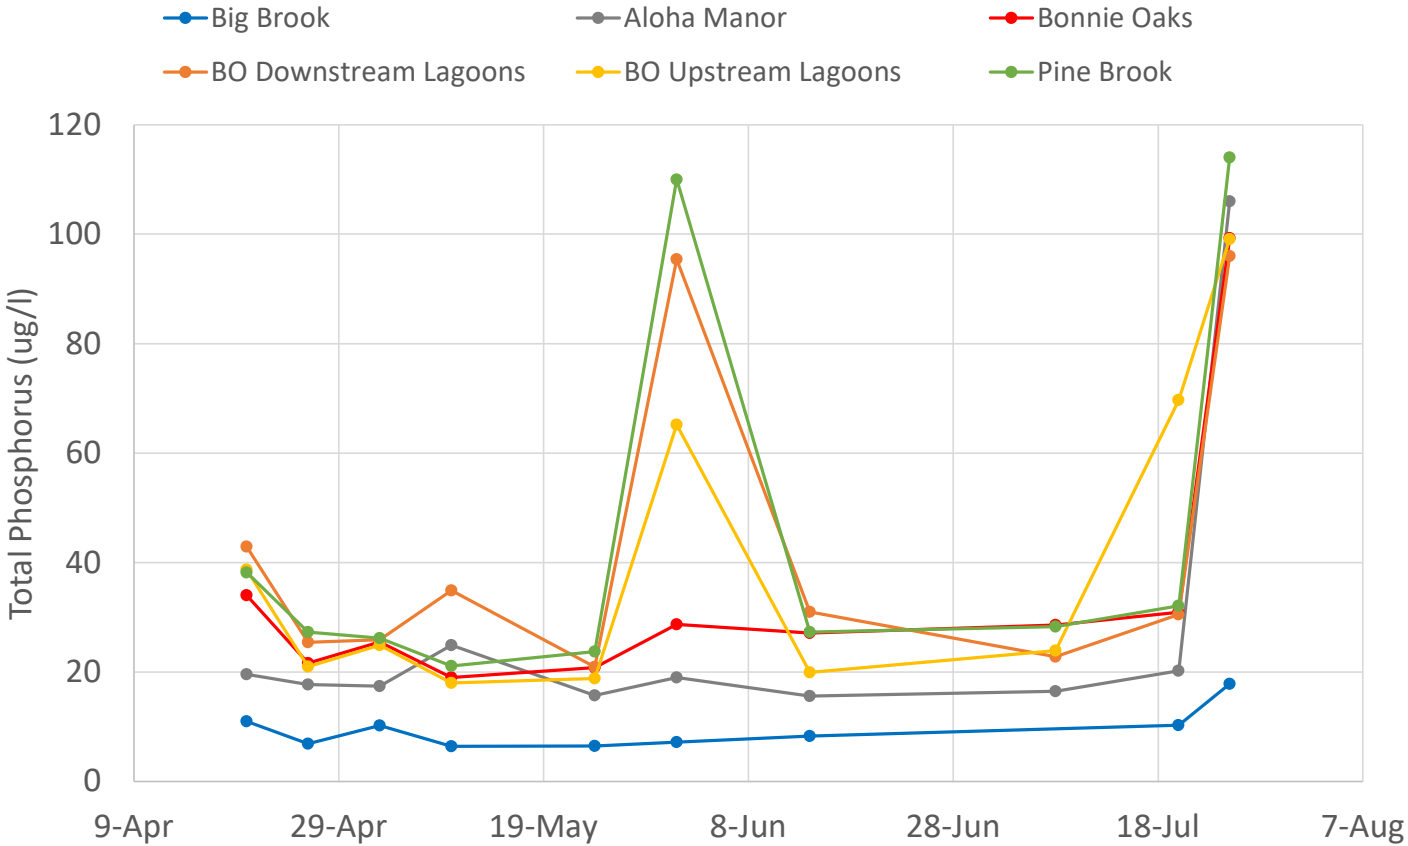
2022 Lake Morey Tributary Total Phosphorus Results

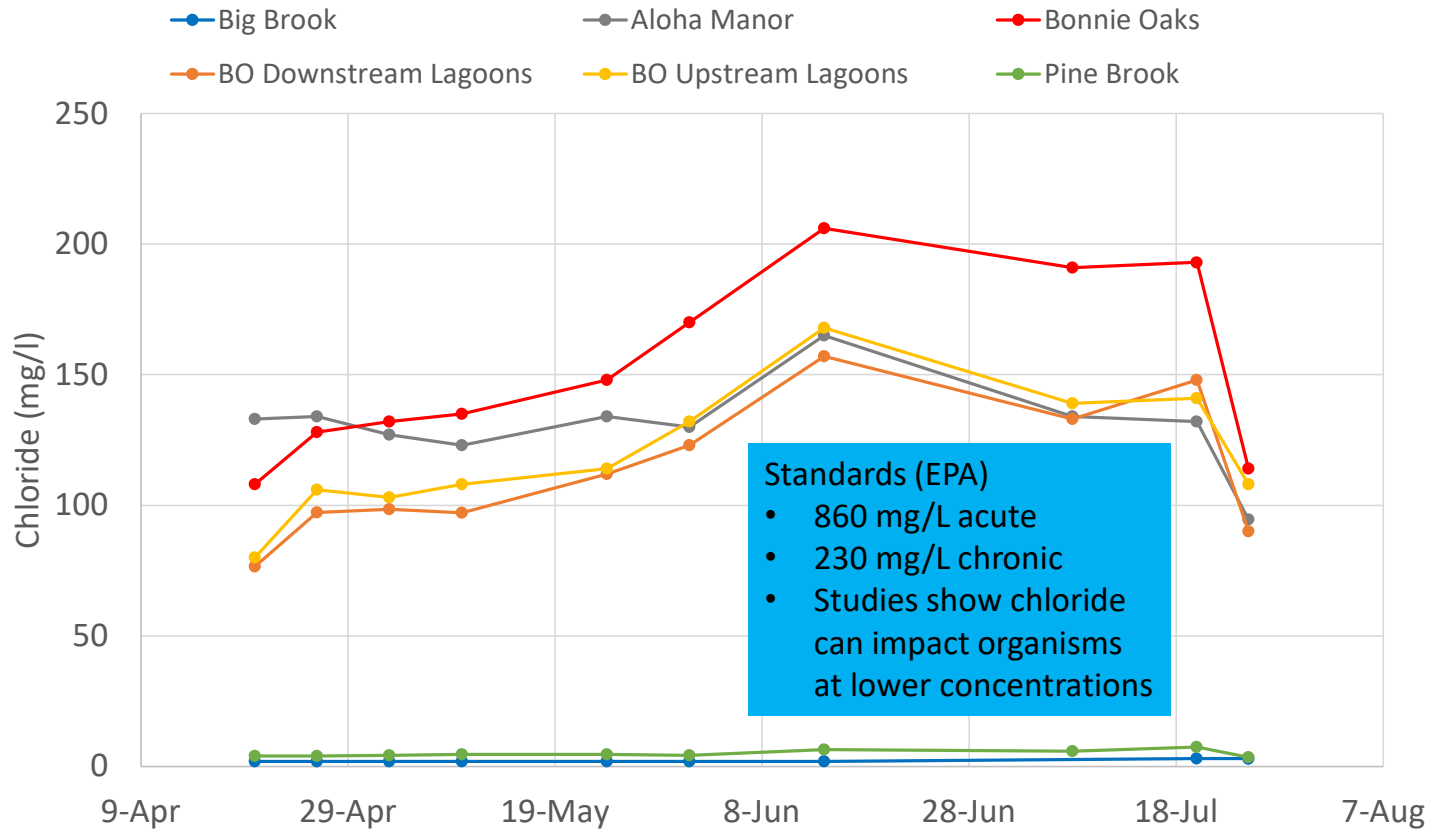
2022 Lake Morey Tributary Chloride Results

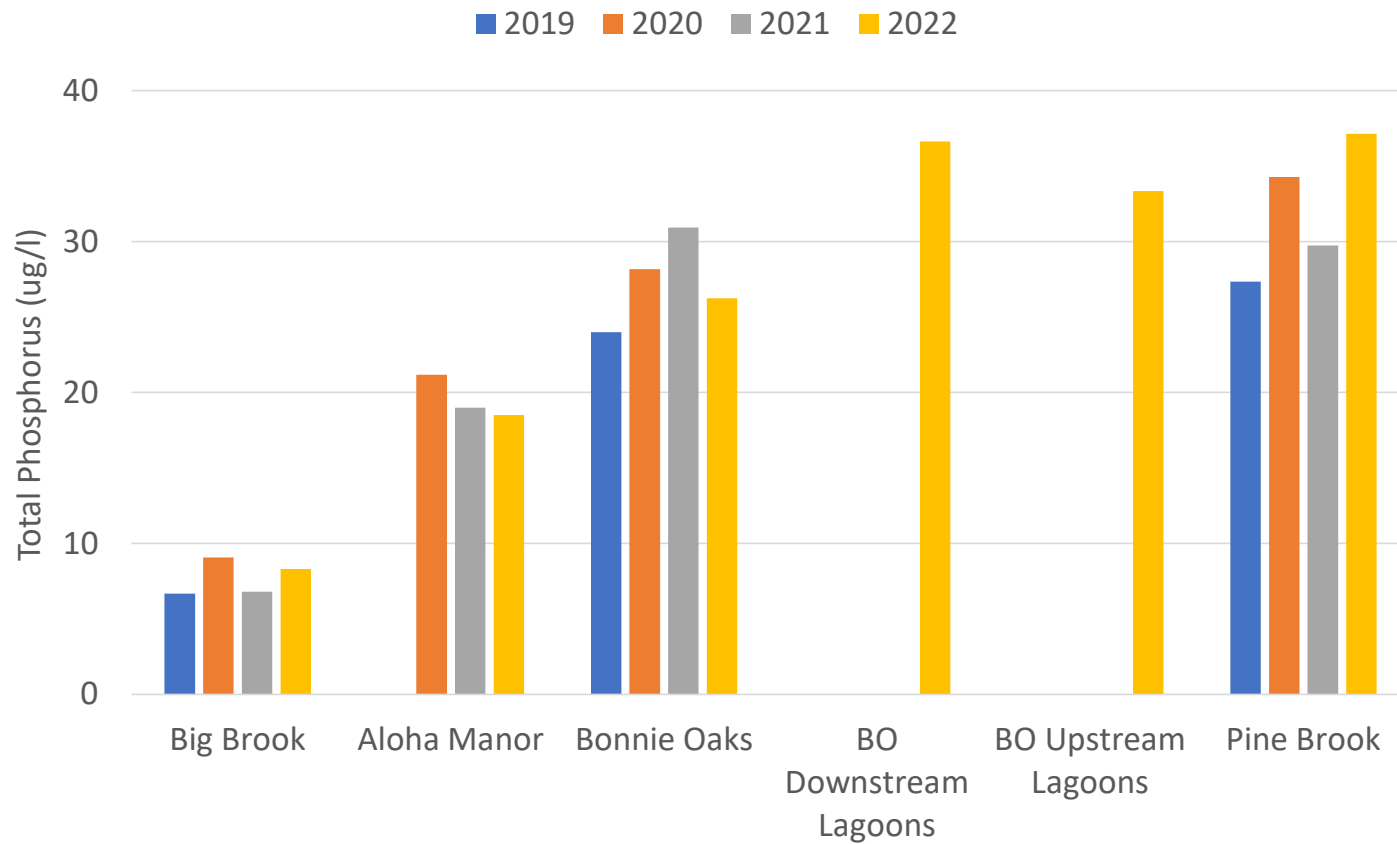
2019-2022 Lake Morey Tributary Base Flow Total Phosphorus Annual Means

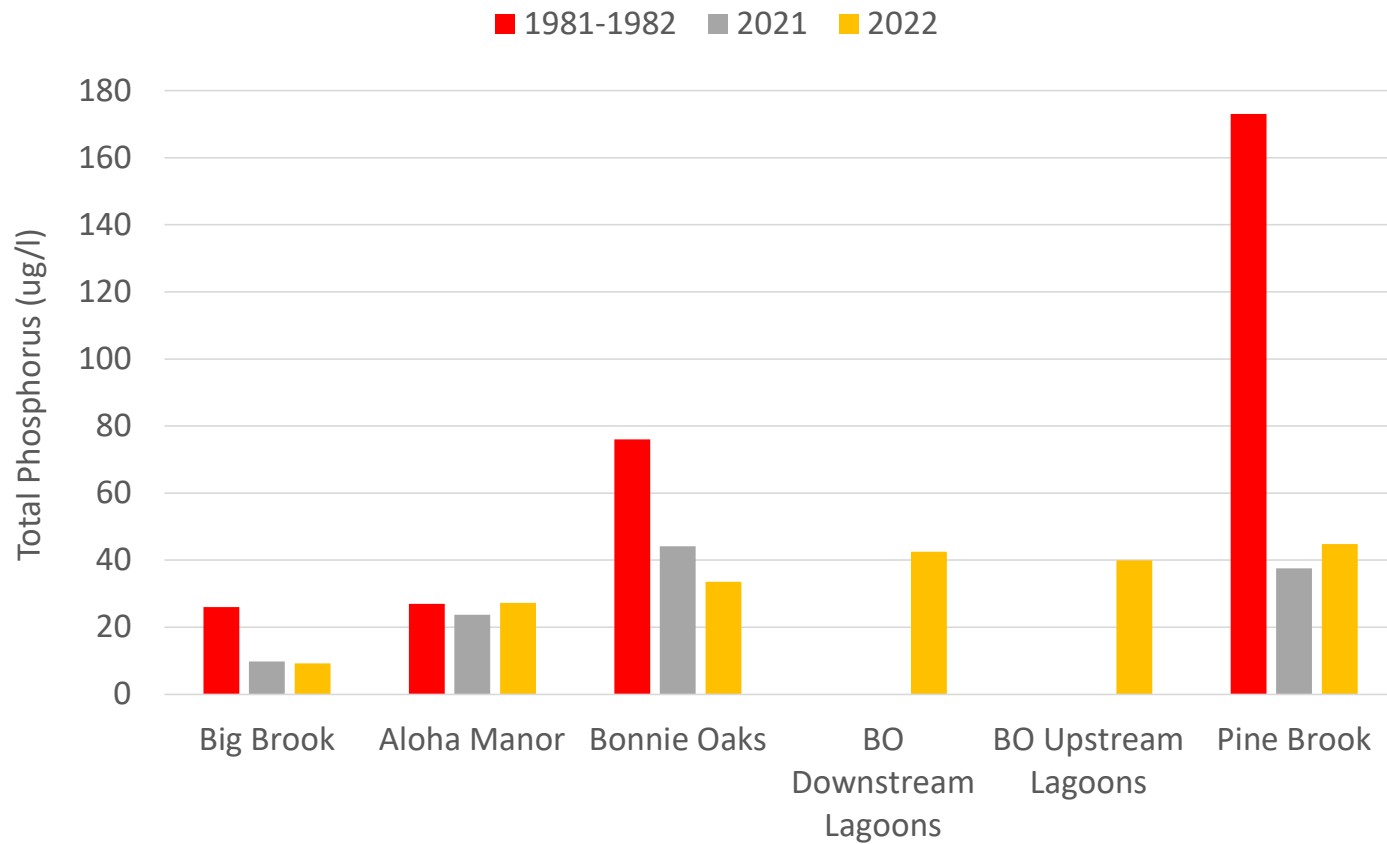
1981-2022 Lake Morey Tributary Base + High Flow Total Phosphorus Annual Means
