# ECHO & SEYMOUR LAKES WATERSHED ACTION PLAN

## FINAL REPORT

**DECEMBER 2024**

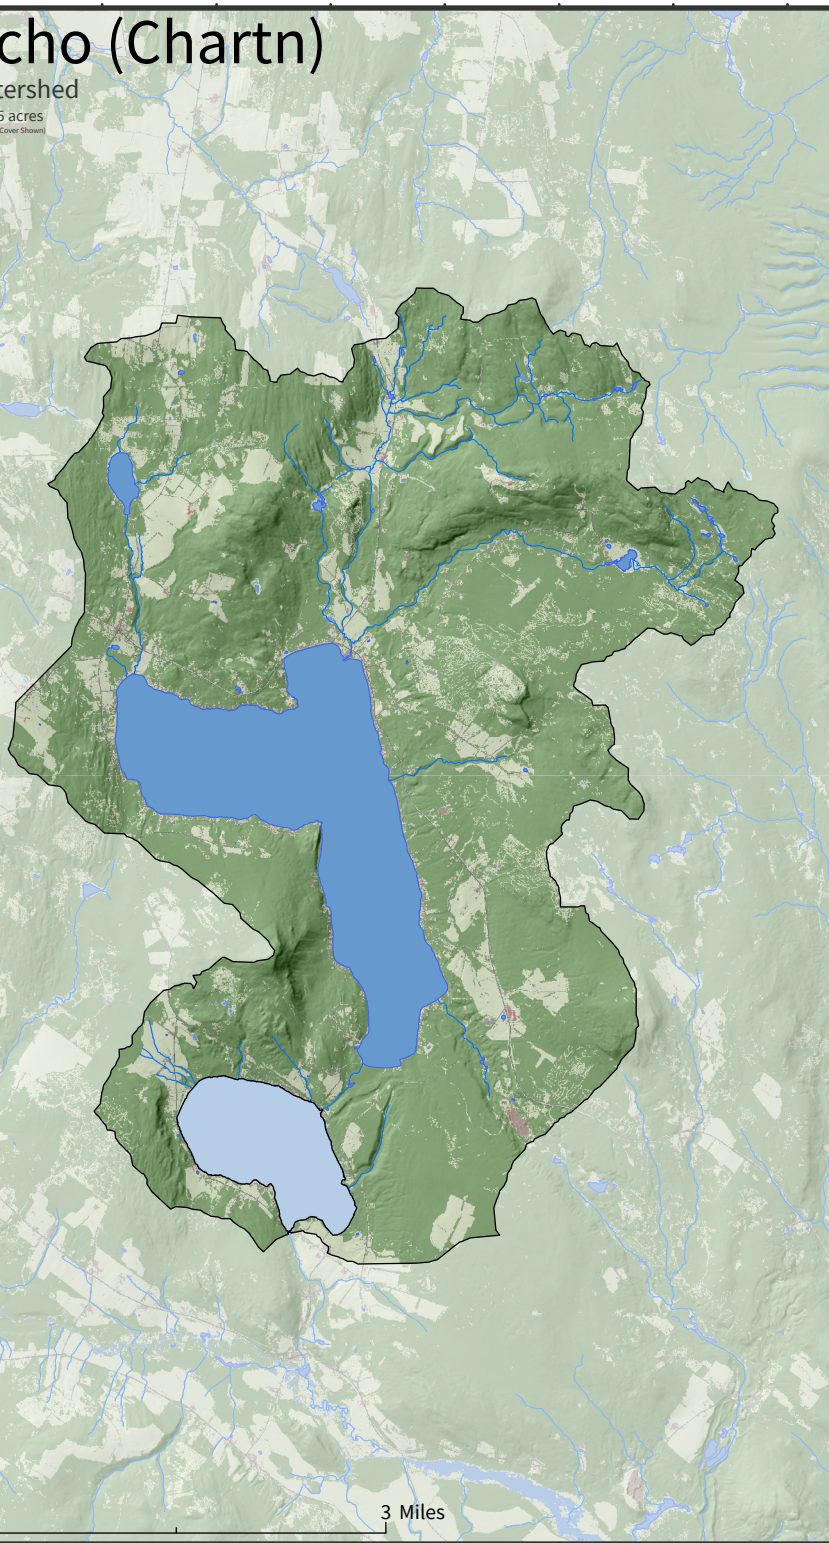
## High-Resolution Land Cover Summary **FIGURE 3**

Watershed  
14,575 acres  
(Base Land Cover Shown)

External Data Sources: UWM SAL High-Resolution (0.5m) Land Cover Dataset, VCGI Vermont State LIDAR, National Hydrography Dataset

Analyses performed by VTDEC and reported in the Lake Land Cover Maps indicates 70% of the Echo-Seymour Lakes watershed is forested (Figure 3). Other dominant land cover types include grass/shrubs (~16%), open water (~13%), and impervious surfaces (1.4%). Of those impervious surfaces, bare soil accounts for 28 acres, buildings account for 35 acres, roads account for 111 acres, and parking lots and driveways account for 105 acres (VTDEC, 2022a).
