WILLOUGHBY LAKE WATERSHED ACTION PLAN

FINAL REPORT

MARCH 2024

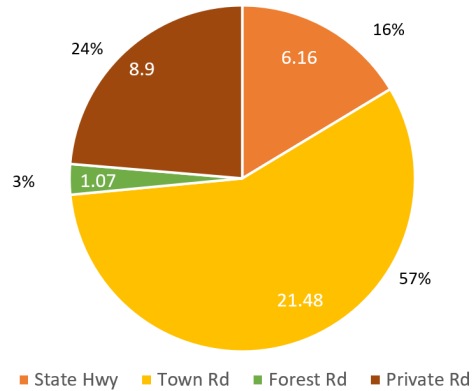
Total Road Miles by Ownership in Willoughby Watershed

Figure 3. Breakdown of road length by ownership in the Lake Willoughby watershed.

Within the lake’s contributing drainage area is 37.6 linear miles of roads, based on the VT Agency of Transportation’s (AOT) Road Centerline dataset (Figure 3). Of these, the majority are Town roads (57%, 21.48 miles), followed by Private roads (24%, 8.9 miles), State Highways (16%, 6.16 miles) and forest roads (3%, 1.07 miles).

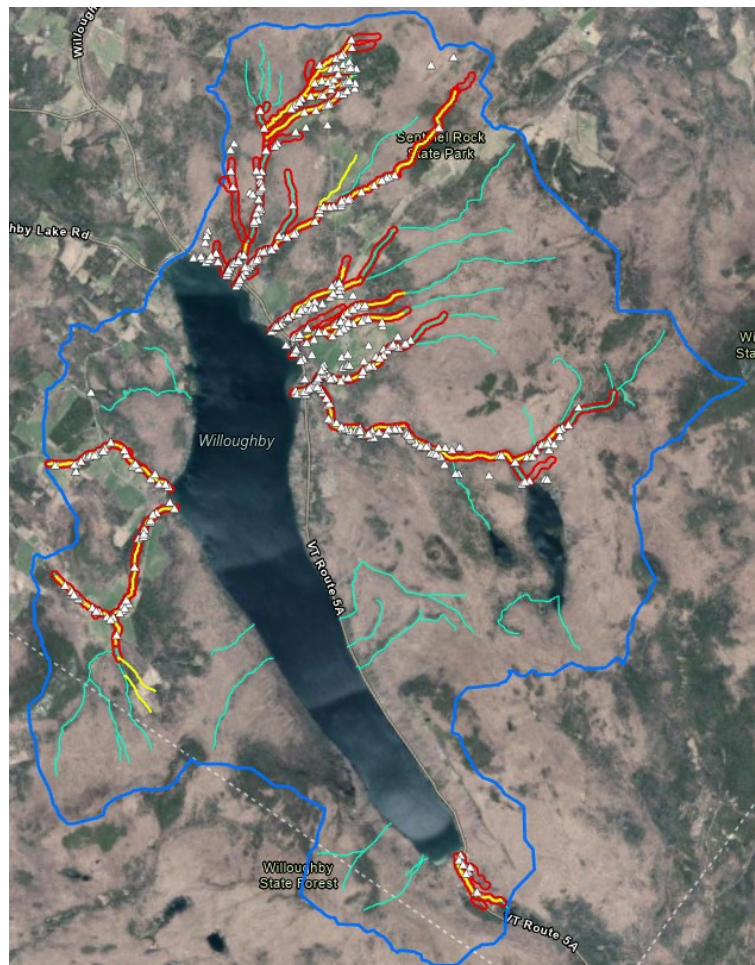
Figure 5. Map illustrating all major streams and tributaries (cyan), stream reaches that were proposed for assessment (yellow) and reaches that were assessed (red). Over 530 field observations were recorded during stream walks (white triangles).

MWA proposed to complete 15.3 miles of stream assessments across the Willoughby watershed. Ultimately, over 21.5 miles of streams were assessed on foot, spanning 137 individual properties and amounting to over 530 geotagged observations (Figure 5). This included eight major tributaries to the lake and numerous small perennial and ephemeral streams. MWA identified numerous opportunities to improve water quality, enhance aquatic organism passage, manage stormwater runoff, and reduce fluvial erosion and flood risk hazards. In general, findings indicate the best opportunities for improving water quality and habitat to protect the health of the lake lie in improving riparian buffers, promoting geomorphic stability, and managing runoff from developed and agricultural lands.

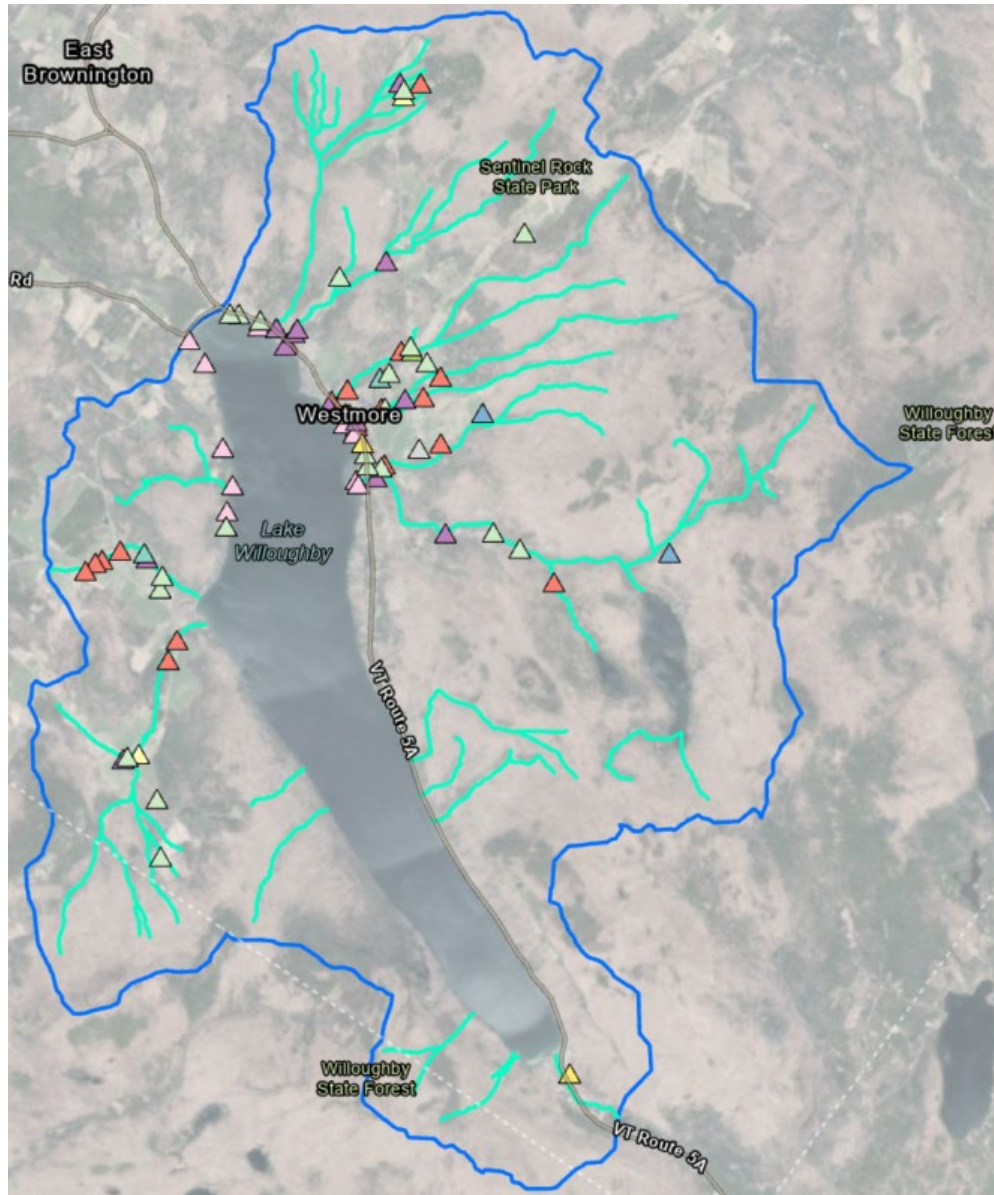
Figure 13. Project locator map of 75 potential water quality and habitat improvement projects that were summarized into a Batch Import File for uploading to the VT Watershed Projects Database.

Field assessments identified 75 potential project opportunities across the landscape that varied from Agricultural, Road Erosion and Stormwater BMPs to Floodplain/Stream/Wetland and Lakeshore Restoration (Figure 13). These potential projects were summarized in a Batch Import File (BIF) and will be uploaded to DEC's Watershed Projects Database for future project partners to develop, design, and implement. During the development of the BIF, the LWAP Team ranked each project (HIGH-MEDIUM-LOW) based on our best professional judgment. Our Team evaluated each potential project and assigned a ranking that reflects the assumed potential water quality benefits. From this list of 75 projects, the LWAP Team selected 30 HIGH and/or MEDIUM priority projects for more in-depth prioritization based on the methodology we developed in partnership with DEC and Westmore stakeholders.

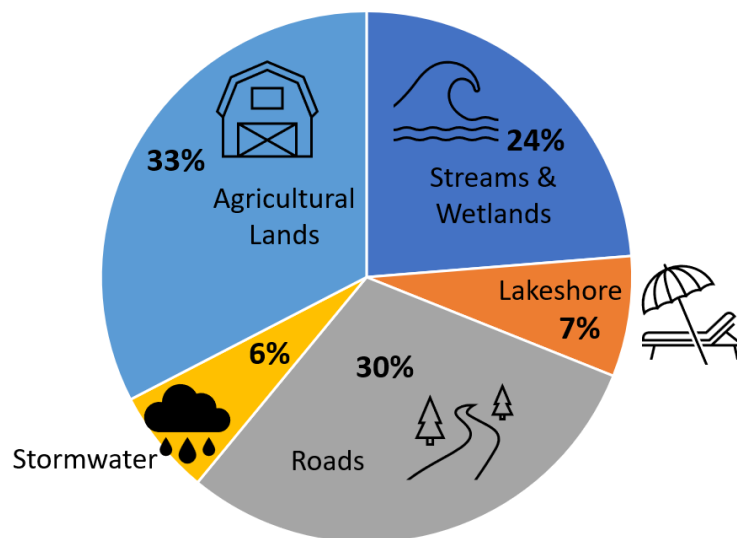
Relative Contribution of Phosphorus Loading to Lake by Sector

■ AGRICULTURE ■ LAKESHORE ■ ROADS ■ STORMWATER ■ STREAMS/WETLANDS

Figure 14. Relative contributions of phosphorus loading to Lake Willoughby by project work sector based on the 30 prioritized projects.

Given the rocky and naturally armored shoreline of Lake Willoughby, the LWAP Team was not surprised by the small proportion that shoreland erosion contributes to excess P loading. Similarly, the Willoughby watershed is 80% forested and only approximately 1% impervious, therefore, stormwater runoff from developed lands was not anticipated to be a major contributor to excess sediment and P loading. However, that does not suggest that meaningful water quality benefits cannot be obtained through improved stormwater management and shoreland BMPs along the most heavily developed sections of the lakeshore.

Based on field assessments and visual indicators of erosion, scour, runoff, channel migration, and farming activities, the LWAP Team agrees with the relative contributions of excess P to the Lake by roadways, agricultural runoff, and stream instability. Large deltas of recently deposited sediments were observed at the outlets of all major tributaries to the Lake. These sediments are believed to be primarily originating from 1) road & ditch erosion, 2) streambank erosion/mass wasting, 3) farm drainage ditches, and 4) geomorphically incompatible culverts. Agricultural runoff was evident downgradient of several farms where field assessments identified manure-laden drainage ditch outflows, filamentous algae, and 'froth' that resembles organic-rich pollution. Unpaved roads throughout the watershed are typically very steep, run alongside perennial streams, and are narrowly confined by hillslopes, thus limiting the potential for roadside BMPs. Lastly, the lower reaches of most of the major tributaries are exhibiting substantial channel migration and bank erosion; this trend is believed to be the result of steep-gradient headwater systems, artificially armored banks (field stone and boulder riprap), confined floodplains (from existing development), and a climatically driven increase in the frequency and intensity of rainstorms.

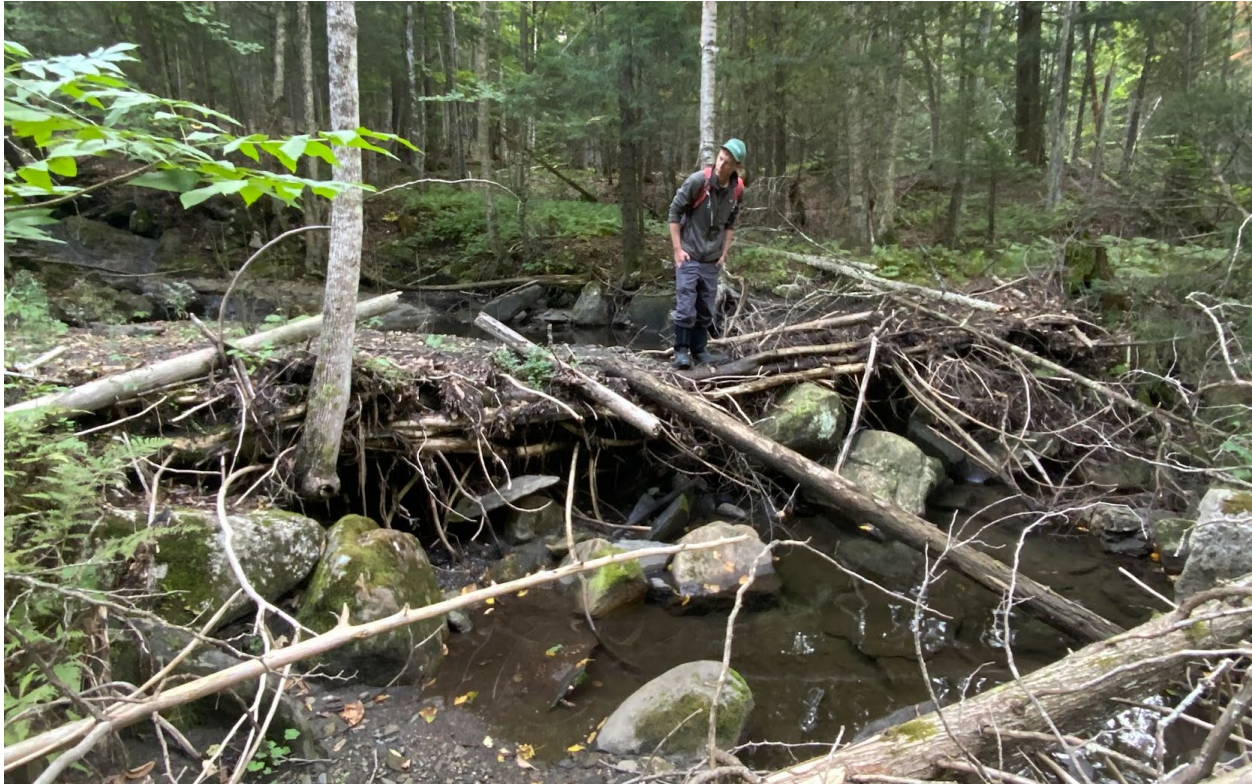
Figure 15. Natural log jams retain sediment and provide diverse aquatic habitat on Stoney Brook.

In forested stream settings, natural inputs of large wood help to stabilize the channel and regulate sediment fluxes. In general, MWA observed less bank erosion and geomorphic instability where large wood and natural debris jams were present, even though these were typically on steep, high energy reaches. In some cases, MWA estimated natural wood debris jams were retaining 1-2 tons of sediment (Figure 15) and providing significant in-stream habitat for fish by creating scour pools and bars, sorting sediment by size class, and trapping leaf litter and organic detritus. When comparing the locations of bank erosion and mass wasting observations with the apparent distribution of large wood in Willoughby watershed streams, a disconnect appears to occur on the lower reaches of many of the east side drainages. A lack of natural woody vegetation, active removal of large wood (per conversations multiple landowners), bank armoring, and other stream alterations appear to coincide with signs of channel and bank instability. Additionally, MWA observed an abundance of bank armoring – typically in the form of field stone piles – in the lower reaches of these streams (Figure 16). It is possible that over the last century, the lowest reaches of Willoughby’s east side tributary streams were cleared of large wood and armored with field stone to reduce flooding and channel migration. **While** these alterations were put in place to protect development and infrastructure, they ultimately fail over time, require expensive maintenance, and act to transfer stream energy and flood damages downstream. This can result in accelerated bank erosion rates, reduced sediment retention capacities, and lower quality aquatic habitat. **Therefore, the LWAP Team recommends replenishing large wood stocks in both steep and shallow stream reaches where risks of entrainment and downstream impacts are low.**
