Lake Fairlee

Lake and Watershed Action Plan (LWAP)

Fairlee, West Fairlee, & Thetford, Vermont

June 16, 2023

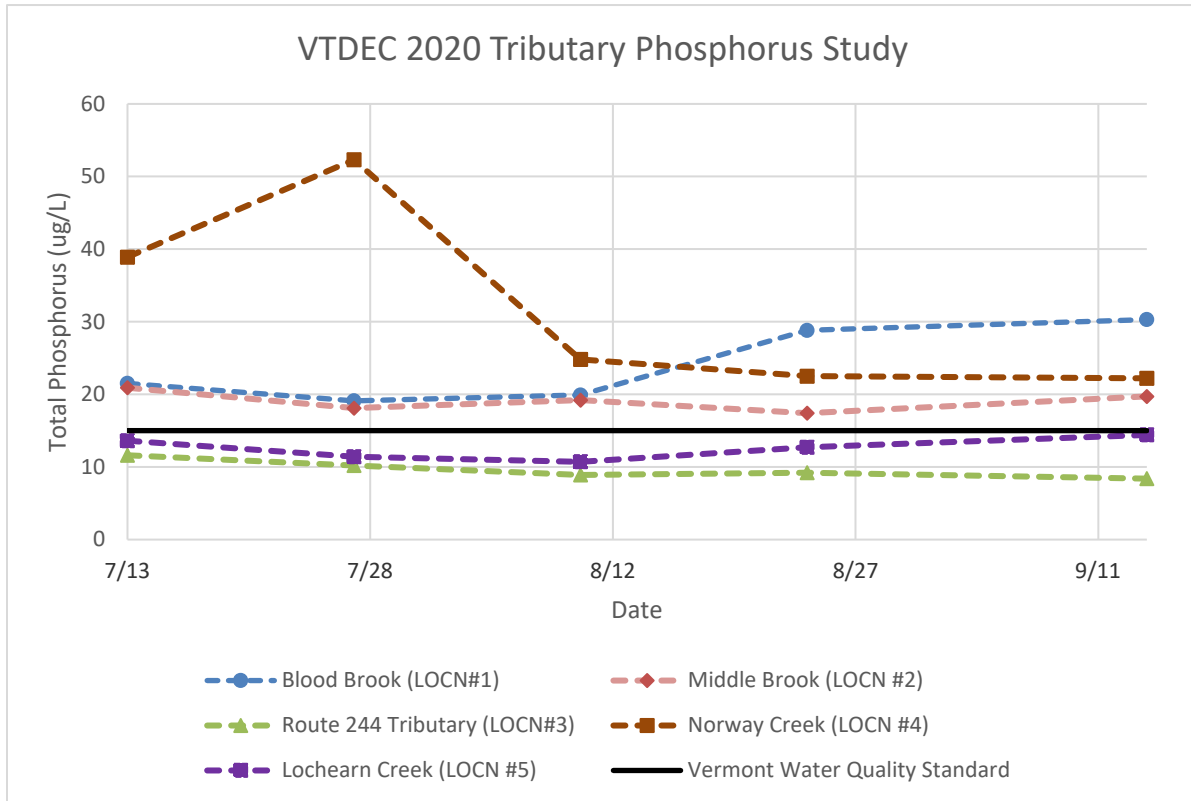
Figure 3. 2020 Water Quality Phosphorus Results for Five Inlet Streams

2020 Results: The results of the 2020 water quality monitoring of the five inlet streams are provided in Figure 3. The total phosphorus concentrations were compared to the Vermont Water Quality Standard of 15 µg/L for medium high gradient streams (MHG). Blood Brook, Middle Brook and Norway Creek had reported total phosphorus concentrations of greater than 15 µg/L on all five sampling dates. The total phosphorus concentration for Lochearn Creek and the Route 244 tributary did not exceed 15 ug/L on any of the five sampling dates. Samples were collected under low flow conditions; however, no flow data are available for those sampling dates. Therefore, the water quality data could be used to screen for elevated concentrations in the grab samples during the summer, but could not be used to understand the loading of phosphorus to the lake from the inlet tributaries.

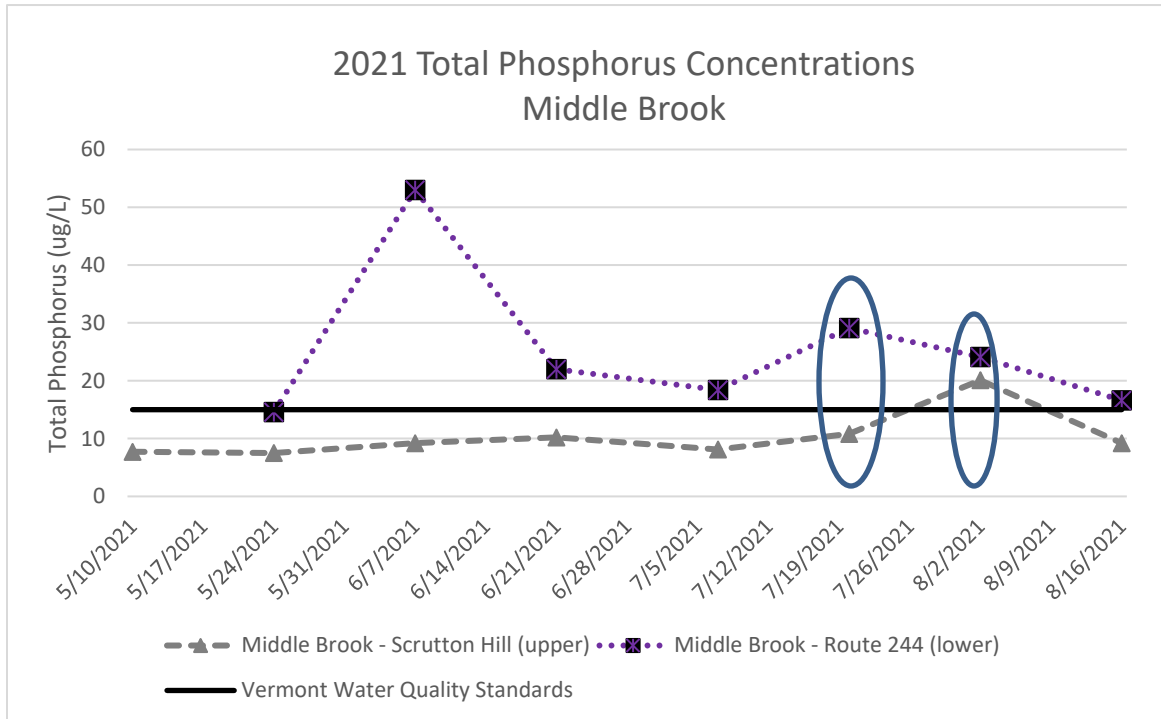
Figure 4. 2021 Total Phosphorus Concentrations on Middle Brook

2021 Results: The 2021 Middle Brook and Blood Brook total phosphorus results are provided below in Figures 4 and 5. Based on information provided by VTDEC, samples were collected under baseflow conditions with the exception of the samples from July 20 and August 2, which were collected during a rain (freshet) event. For Middle Brook, the station at the lake inlet had noticeably higher total phosphorus concentrations than the upper station in the headwaters. All of the concentrations at the mouth of Middle Brook were at or above the VWQS of 15 µg/L, indicating there are sources of phosphorus between the two monitoring stations. On Blood Brook, total phosphorus concentrations were below the VWQS of 15 µg/L on all sampling dates with the exception of the two freshet events on July 20 and August 2 (circled in Figures 4 and 5).

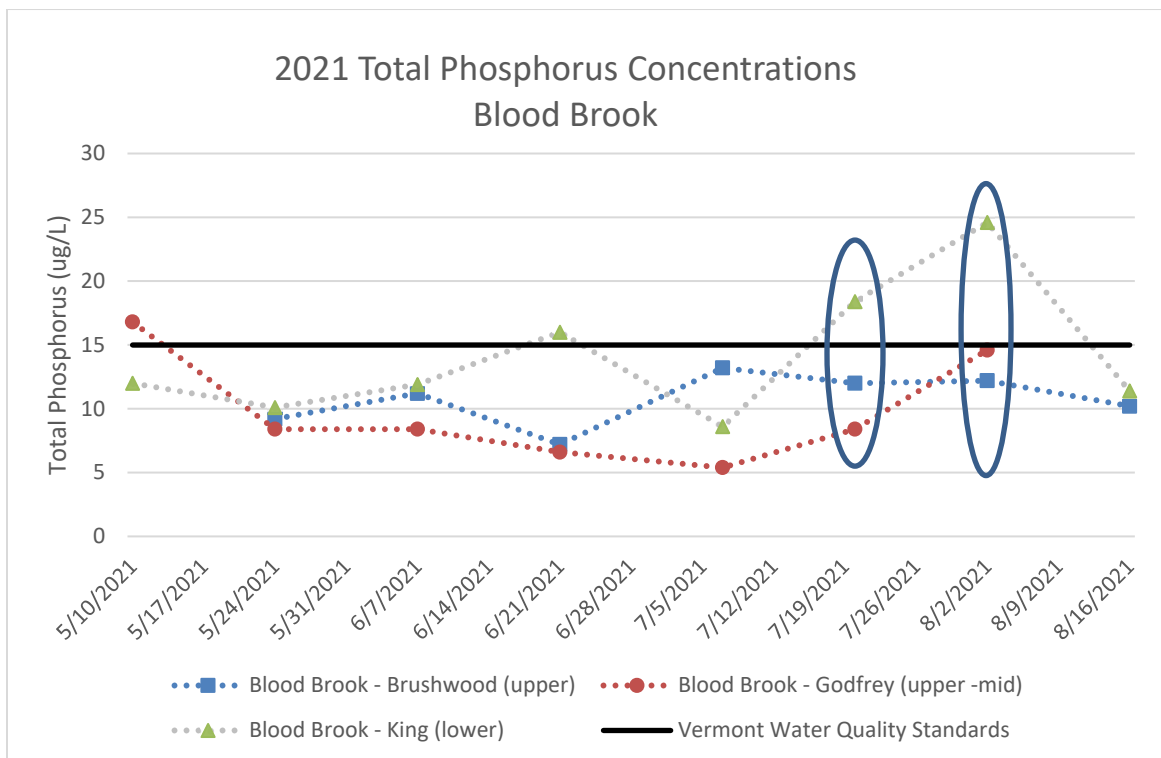
Figure 5. 2021 Total Phosphorus Concentrations on Blood Brook

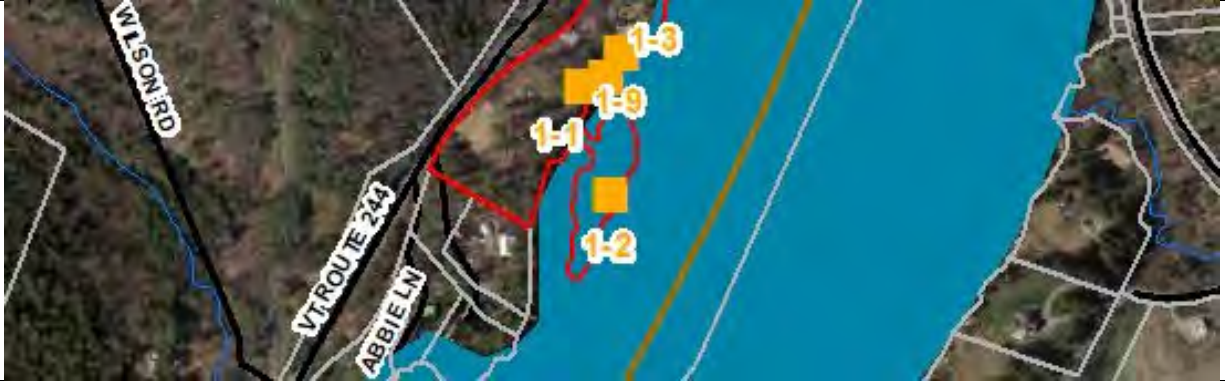
<p>Project Number and Name: 1-3 Treasure Island Stormwater Improvement at Outlet Pipe</p>	
<p>Land Ownership (E911): Town of Thetford, Treasure Island Recreation Area</p>	
<p>Site Location: -72.21493, 43.89654</p>

<p>Site Description: There is some minor beach erosion at the outlet pipe that carries water from the perforated pipe on the beach. A rain garden could be installed to provide a place for the water to dissipate and infiltrate. Some rilling of the sand was noted in October 2022.</p>

<p>Cost Estimate Range: \$10,000 - \$20,000</p>	
<p>Restoration/Water Quality Improvement Objectives: Reduce sediment and phosphorus reaching Lake Fairlee by reducing erosion and allowing infiltration.</p>	
<p>Level of Landowner Commitment: The Town of Thetford has expressed an interest in reducing erosion on the beach.</p>

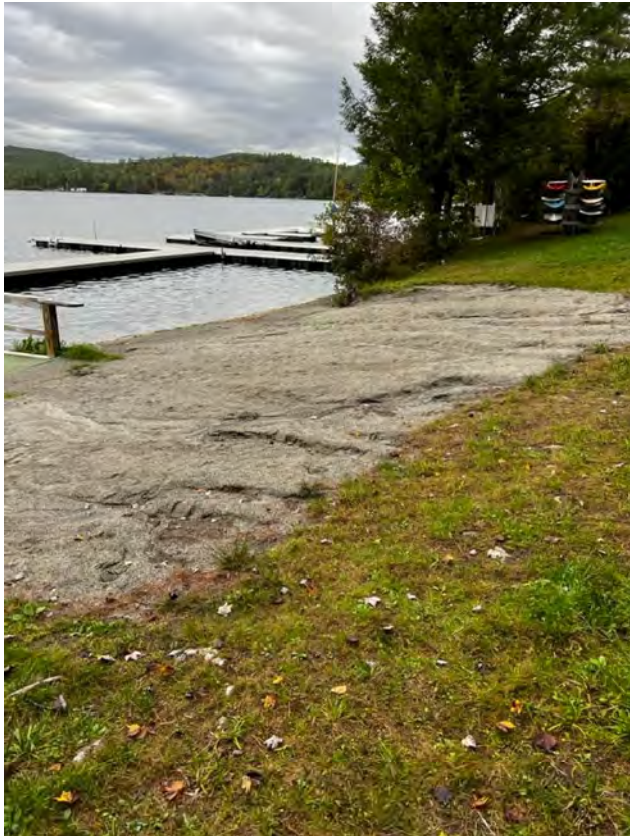
Project Number and Name: 1-5 Beachfront Sand Containment at Ohana Family Camp	
Land Ownership: Aloha Foundation, Ohana Family Camp	
Site Location: -72.22880, 43.88204

Site Description: The sand on the beach at the Ohana Family Camp is at risk of washing into Lake Fairlee. Perforated pipe could be installed to help contain the sand by creating a French drain.

Site Design Considerations: This is a high usage area.
	Permitting Needs: A Vermont Shoreland Permit may be required if work is performed within 250 feet of the mean water level of Lake Fairlee.
	Cost Estimate Range: \$5,000 - \$10,000
	Restoration/Water Quality Improvement Objectives: Reduce sand reaching Lake Fairlee by containing the sand through improved stormwater management.
	Level of Landowner Commitment: The Aloha Foundation supports this project. Restoration of the sand area has been an ongoing issue.

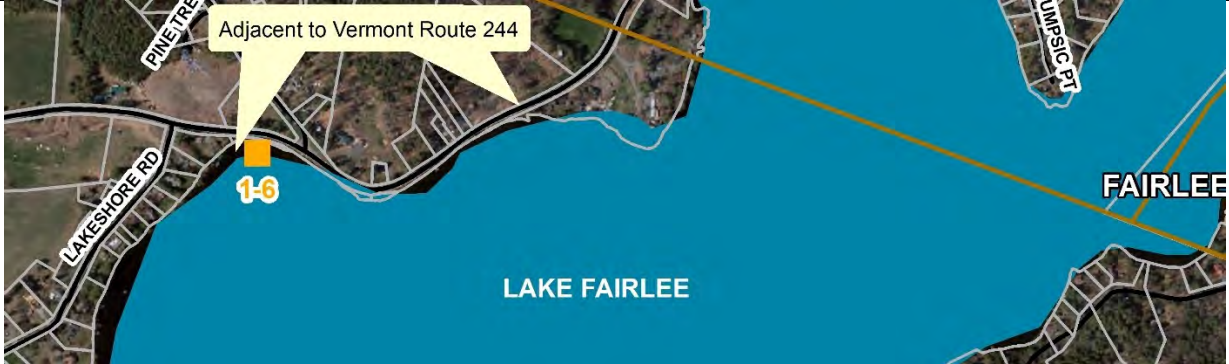
<p>Project Number and Name: 1-6 Route 244 Buffer Improvement (Project Development)</p>	
<p>Land Ownership: State of Vermont (Within road right-of-way), possibly private landowners</p>	
<p>Site Location: -72.24012, 43.88745 (North side of Lake Fairlee along Vermont Route 244)</p>

<p>Site Description: Vegetated buffers are narrow or are lacking on the north side of the lake along VT Route 244. Complete a study to determine ownership of properties and willingness of landowners to improve buffers.</p>

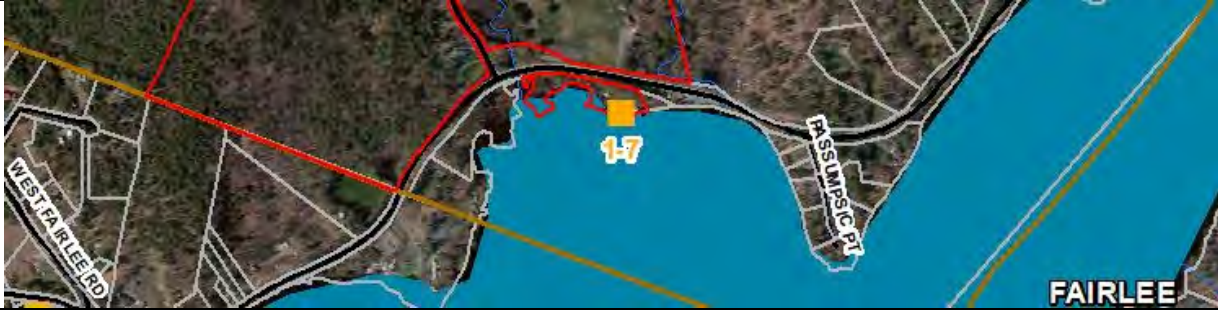
Project Number and Name: 1-7 Lakeshore Retaining Wall at Horizons Day Camp	
Land Ownership: Aloha Foundation, Inc., Horizons Day Camp	
Site Location: -72.22857, 43.89038

Site Description: The retaining wall along the lakefront at the Horizons Day Camp has deteriorated and could be replaced with a bioengineered retaining wall that provides a vegetated buffer and wildlife habitat.

- Project 1-4 – Replace a deteriorated seawall at a camp off of Anna Dodge Road with a bioengineered solution that offers vegetation (see conceptual design).
- Project 1-7 – Replace deteriorated retaining wall at Horizons Day Camp with a bioengineered solution that offers vegetation (see conceptual design)

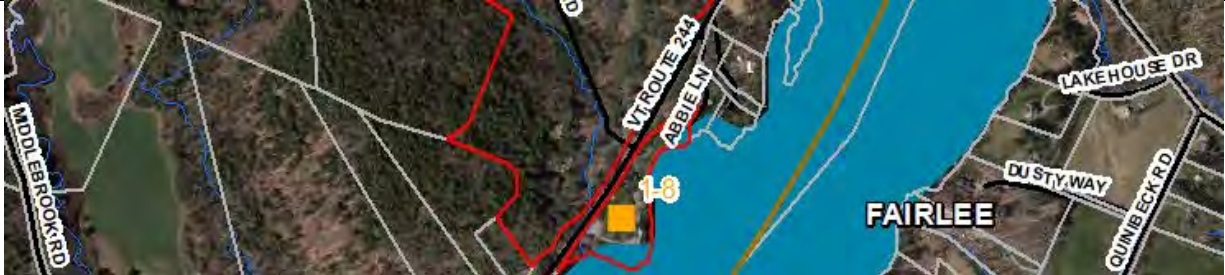
Project Number and Name: 1-8 Aloha Hive Stormwater Improvement at Wash Station	
Land Ownership: Aloha Foundation, Inc., Hive Camp	
Site Location: -72.21906, 43.89268

Site Description: Stormwater is causing erosion in the vicinity of a building (wash station) that is close to the Lake Fairlee Shoreline. Infiltration steps (constructed with timbers and filled with crush stone) will help reduce erosion down a steep bank.

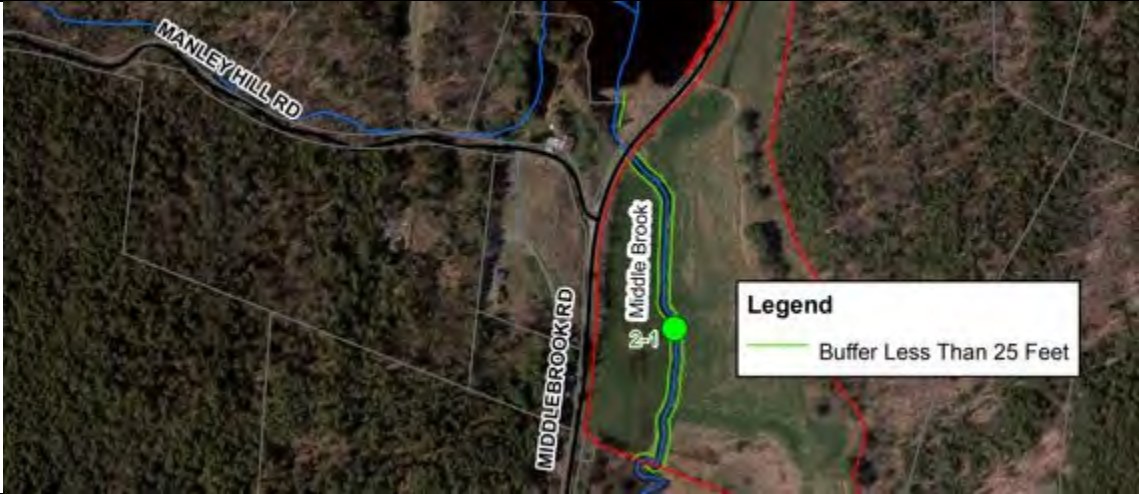
Project Number and Name: 2-1 Buffer Improvement Along Agricultural Fields	
Land Ownership: Private	
Site Location: -72.23571, 43.91317	
Stream Name: Middle Brook

Site Description: Increase buffers along agricultural fields where there are currently narrow buffers with limited trees and shrubs growing.

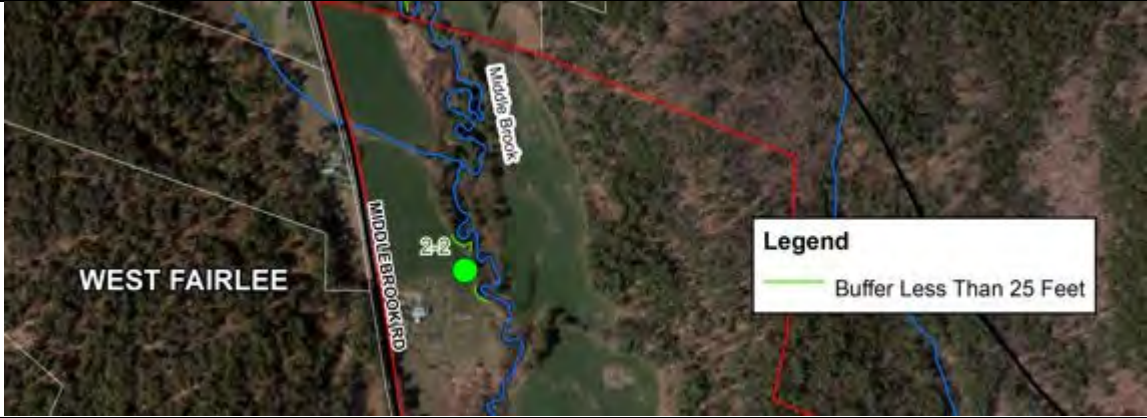
Project Number and Name: 2-2 Buffer Improvement	
Land Ownership: Private	
Site Location: -72.23291, 43.90115	
Stream Name: Middle Brook

Site Description: Create no mow zone where stream bank is eroding and migrating toward backyard

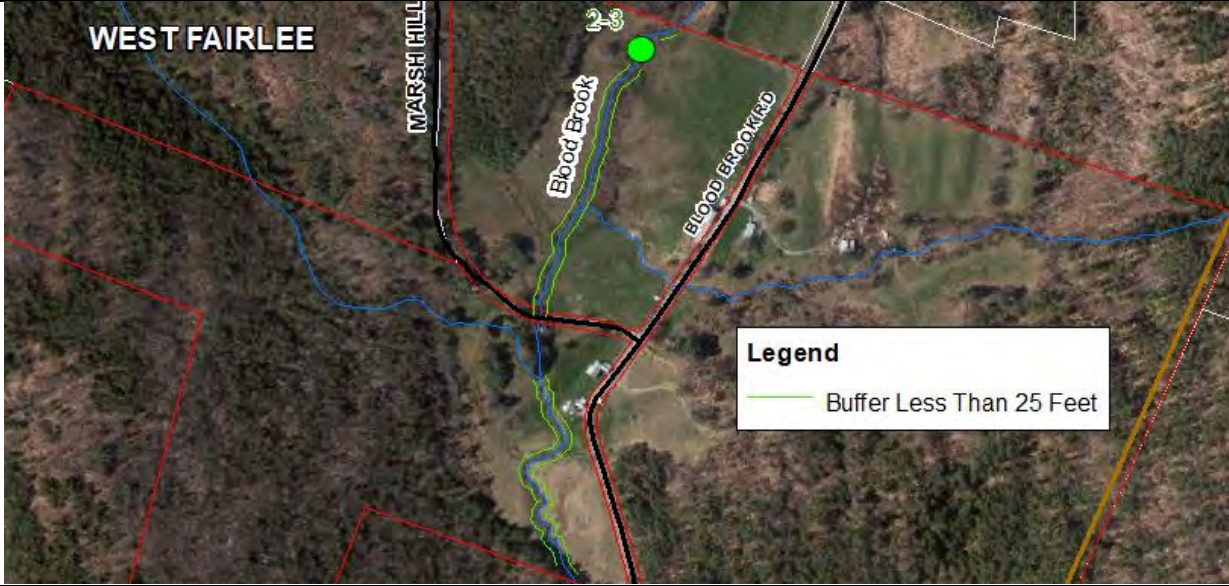
Project Number and Name: 2-3 Buffer Improvement and Reduce Animal Crossings	
Land Ownership: Private	
Site Location: -72.21007, 43.92401	
Stream Name: Blood Brook

Site Description: Reduce number of horse crossings to prevent further erosion and increase buffers along stream.

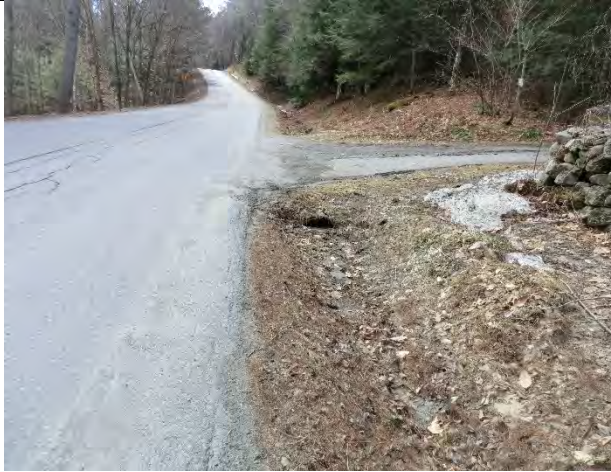
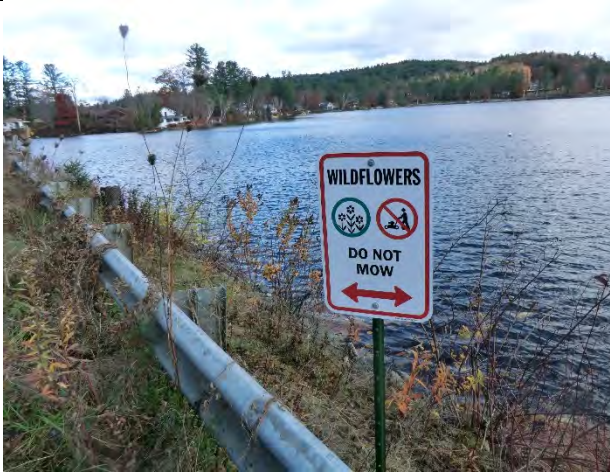
Site Description: The road is muddy during the spring, and is contributing sediment to Lake Fairlee. This project includes four components: a) paving of approximately 650 linear ft, b) installation of new cross culvert to improve drainage, c) debris control at outlet of pond, and d) continuing the “no mow” zone adjacent to the Lake.

Robinson Hill Road is in close proximity to Lake Fairlee. The road can be muddy during the spring, and was particularly troublesome during the 2022 mud season when residents observed

Site Design Considerations: Robinson Hill Road is in close proximity to Lake Fairlee. Paving of the road is expensive.	
Permitting Needs: Permits from the ACOE and ANR may be required depending upon the design.	
Cost Estimate Range: \$100,000 - \$150,000 for design and construction

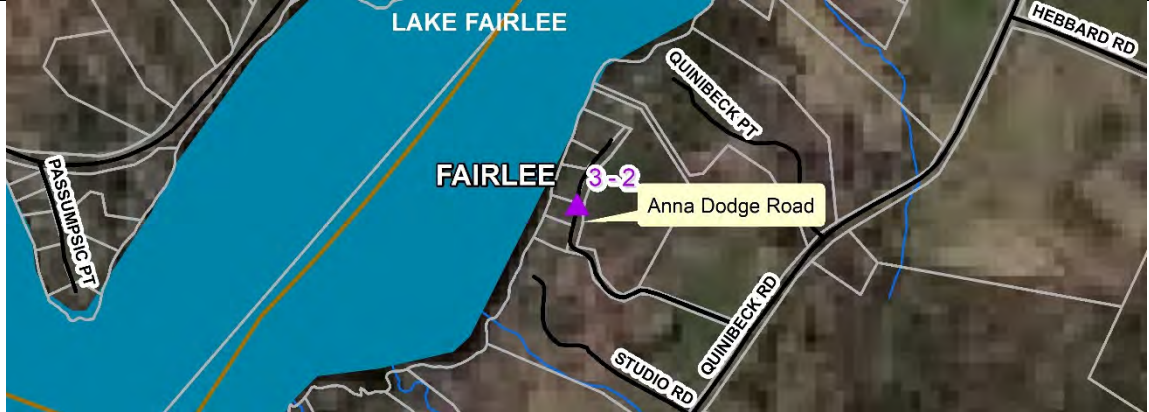
Project Number and Name: 3-2 Anna Dodge Stormwater Improvement	
Land Ownership: Private	
Site Location: Lower end of Anna Dodge Road, which is off of Quinibeck Rd in Fairlee

<p>Site Description: Road runoff is contributing sediment to a roadside ditch that discharges through a culvert into Lake Fairlee. The road side ditch is currently trapping sediment where it flattens in slope. The preferred alternative for the project is to install a cross culvert to dissipate the flow and reduce erosion of the ditch. An alternative solution, which would require maintenance, is to install check dams to aid in sediment retention.</p>

Anna Dodge Road has a steep section that is just upslope of a culvert that drains to Lake Fairlee. The roadside ditch is currently trapping some sediment where it flattens in slope. However, stormwater improvements are recommended to reduce the amount of sediment and phosphorus reaching Lake Fairlee. There are two possible means for achieving this goal. The preferred solution is to install a cross culvert to break up the runoff and reduce erosive forces. The second option is to install check dams to improve sediment retention. The check dams will require maintenance. The two options for Anna Dodge Road stormwater improvements are included in the conceptual design for project 3-2.

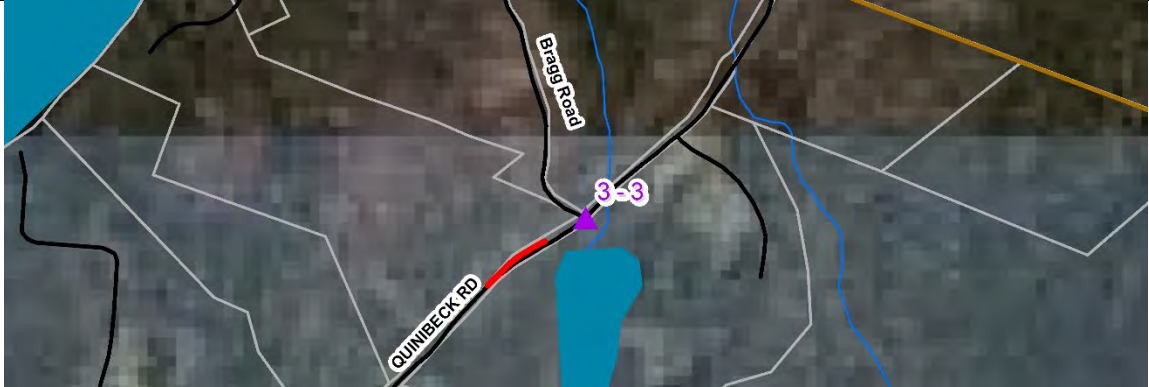
Project Number and Name: 3-3 Quinibek Road Stormwater Improvement	
Land Ownership: Town of Thetford	
Site Location: Quinibek Road in the vicinity of Bragg Road

Site Description: Berms have developed at the edge of Quinibek Road and have blocked the drainage of water off the road. Poking holes in the berms to provide turn outs is recommended. This will disperse the runoff and reduce erosion.

Quinibeck Road has developed berms at the edge of the road from grading operations. The berms have blocked the drainage of water off the road. Poking holes in the berms to provide turn outs is recommended as part of Project 3-3. This will disperse the runoff and reduce erosion.

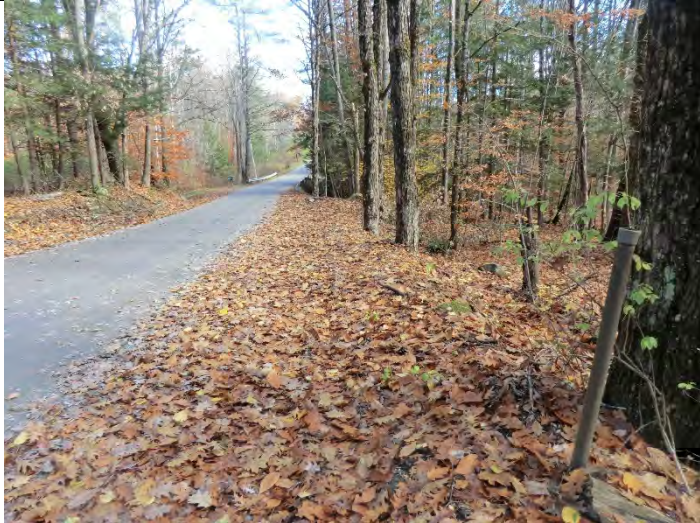
Site Design Considerations: A road segment (shown as red line above) to west of this area on Quinibek Road had been previously rated as "Does not Meet" under the Municipal Road General Permit. Recent stone line ditching was observed on the north side of the road in this location.	
Permitting Needs: No permits are required for this project	
Cost Estimate Range: \$500 - \$1,000	
Restoration/Water Quality Improvement Objectives: Reduce sediment and phosphorus reaching Lake Fairlee by dissipating road runoff.

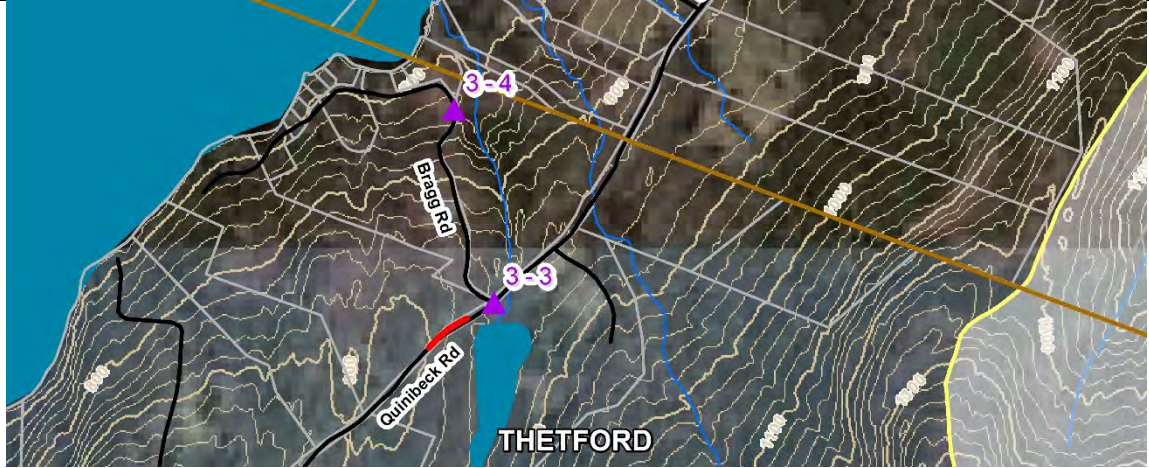
Project Number and Name: 3-4 Bragg Road Stormwater Improvement	
Land Ownership: Town of Thetford	
Site Location: Municipal section of Bragg Road

Site Description: Water is concentrating in the drainage ditches and contributing sediment to a nearby stream. Install turn outs or determine other means of diverting water off of the road to reduce erosion and sedimentation.

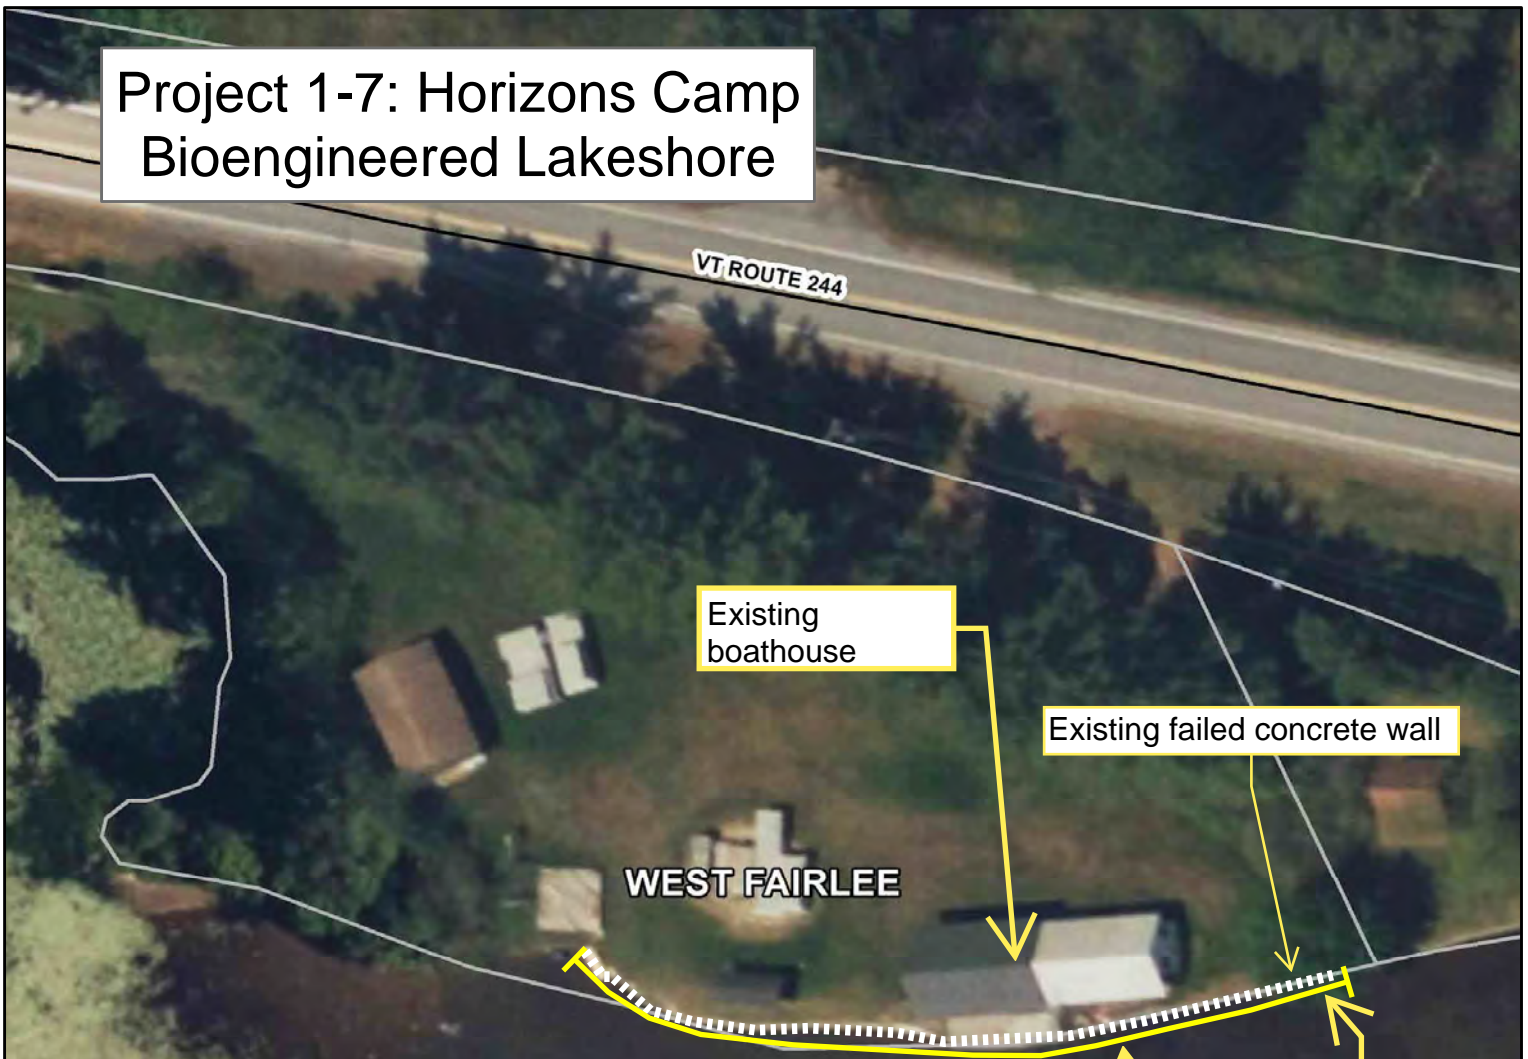
Project 1-7: Horizons Camp Bioengineered Lakeshore

Existing boathouse

Existing failed concrete wall

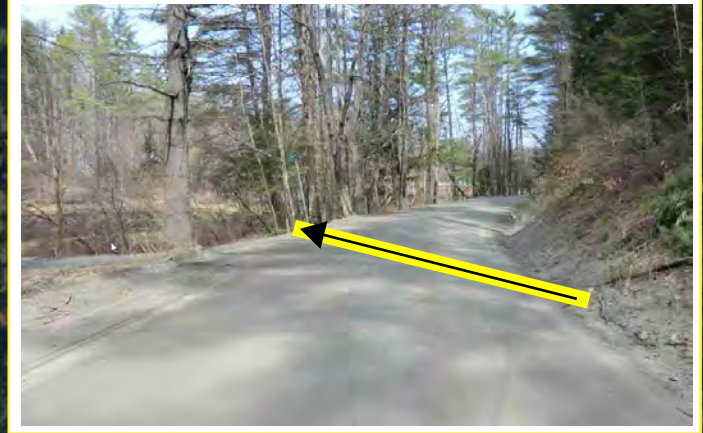
Start of flow toward new culvert

New Culvert Location

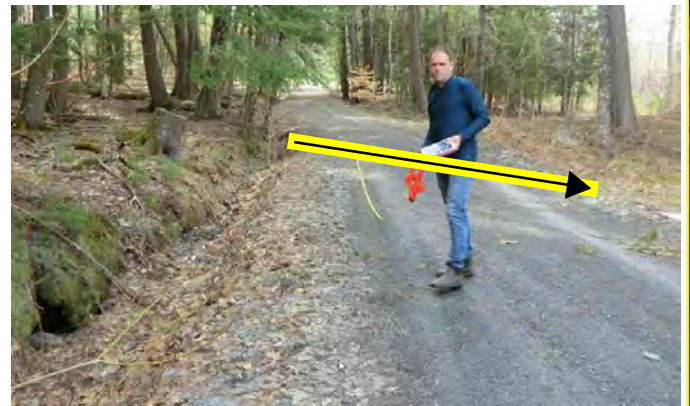
Existing Culvert

New Culvert Location

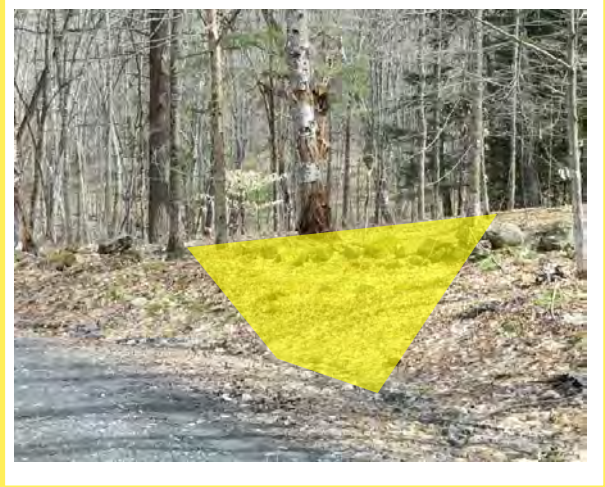
Alternate Project:
NEW TURNOUT
 * Intended to reduce flow and erosion at outlet of existing ditch.
 * Turnout provides location for water to infiltrate and sediment to deposit.

Preferred Project:
NEW 18" CROSS CULVERT
 * Intended to reduce flow and erosion at outlet of existing ditch.
