Watershed Action Plan

Lake Eden Watershed

Eden, Vermont

December 20, 2019

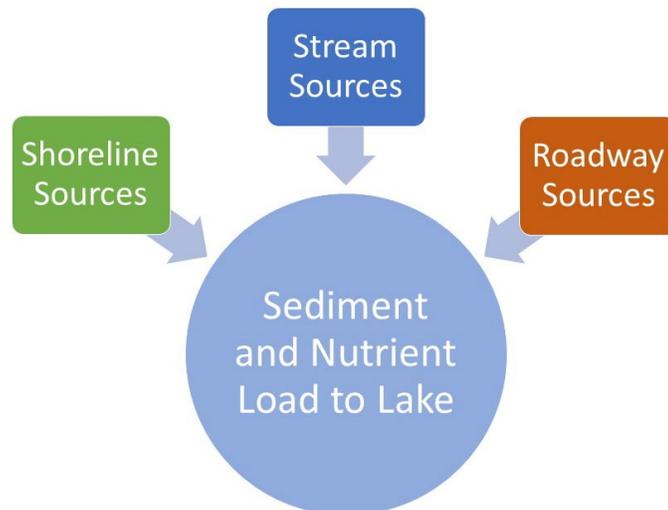
Figure 1: Conceptual diagram of primary water quality stressors on Lake Eden.

The Lamoille Tactical Basin Plan found that Lake Eden is exhibiting a decline in water quality due to increased sedimentation and total phosphorus (ANR, 2016, page 37). The goal of the Lake Eden Watershed Action Plan was to identify and evaluate water quality stressors to Lake Eden, and to identify projects to mitigate inputs of sediments and nutrients. Environmental concerns and stressors identified by the group of stakeholders included channel erosion, flow alteration, lakeshore encroachment, invasive species, soil erosion, nutrient loading, and thermal stress. The watershed assessment focused on the evaluation of the lakeshore, tributary, and roadway sources of sediment and nutrients (Figure 1), as well as other concentrated sources of stormwater runoff in the watershed.

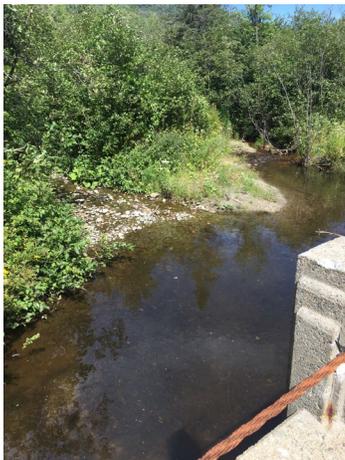
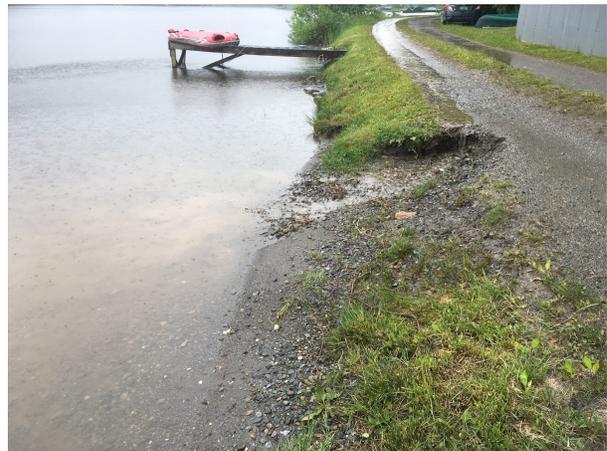
Figure 4: A culvert on the Gihon River with poor channel alignment had the lowest problem area score (left photo, Project SC-3). Erosion and transport of sediment from Lake Shore Road directly to the Lake was the highest problem area score (right photo, Project SW-11).

4. **Project SW-11/17: Lake Shore Road** – This Class 4 Town Road lacks a lakeshore buffer and is concentrating runoff. A seasonal gully may form on the eroded embankment, that directly inputs sediment into the lake. A steep stretch of road lacks drainage ditches, causing severe rill erosion for approximately 150 feet near the eastern bend in the road. This runoff continues to the lakeshore, exacerbating the gully erosion on the stretch of road without a lakeshore buffer.

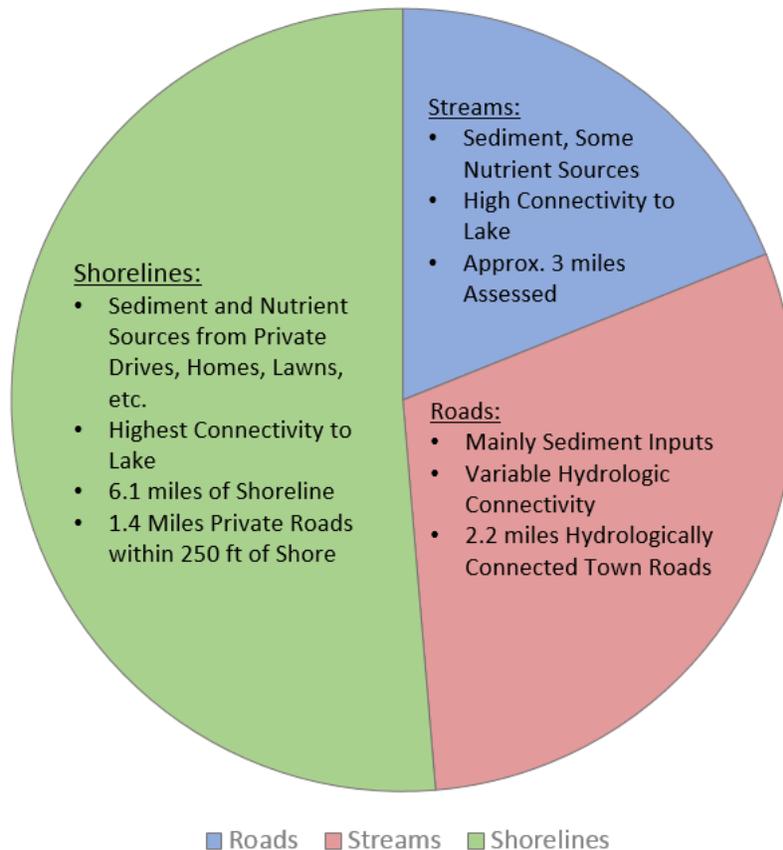
Figure 5: Relative contribution of sediment/nutrients to Lake Eden from various sources.

Based on the distribution of project types, as well as each project’s watershed location, size, and existing nutrient/sediment load, we estimated the relative load from each of the primary “sectors” of the Lake Eden watershed. Given the high degree of development along much the lake’s shoreline, as well as the extensive network of private gravel roads and driveways near the lakeshore, it is our opinion that the lakeshore represents the largest contribution of sediment and nutrients to the Lake. Municipal roadways and associated drainage from roadways likely represents greater than ¼ of the load, while stream bed and bank erosion appears to represent less than ¼ of the load (Figure 5).

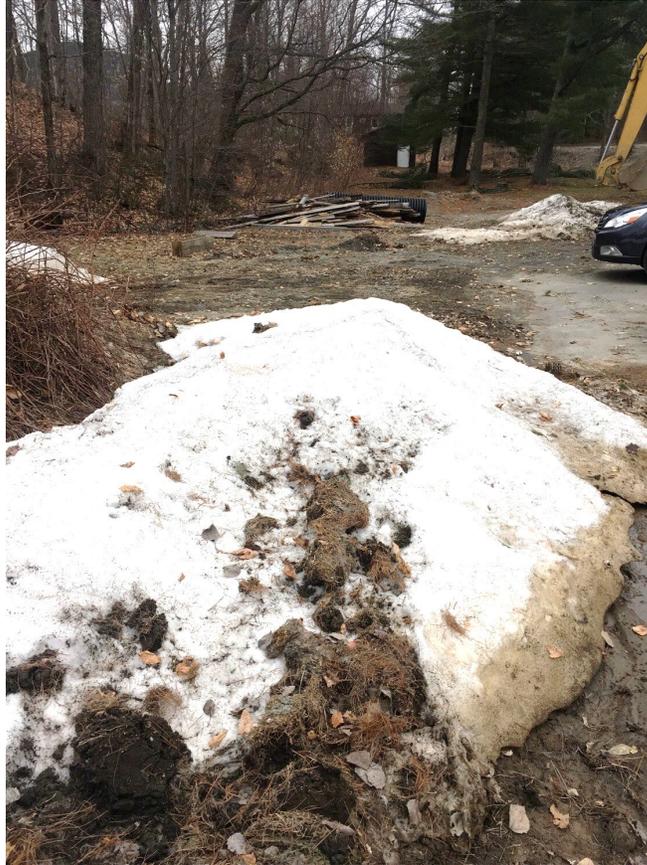
Figure 6: Part of a large paved parking lot at the Boy Scout Camp.

parking area at the Boy Scout Camp. Total impervious area at the Camp exceeds 1 acre, and significant drainage problems around the facility have been noted by Camp staff. The location of snow storage for the parking lot may be contributing extra runoff to the channel.

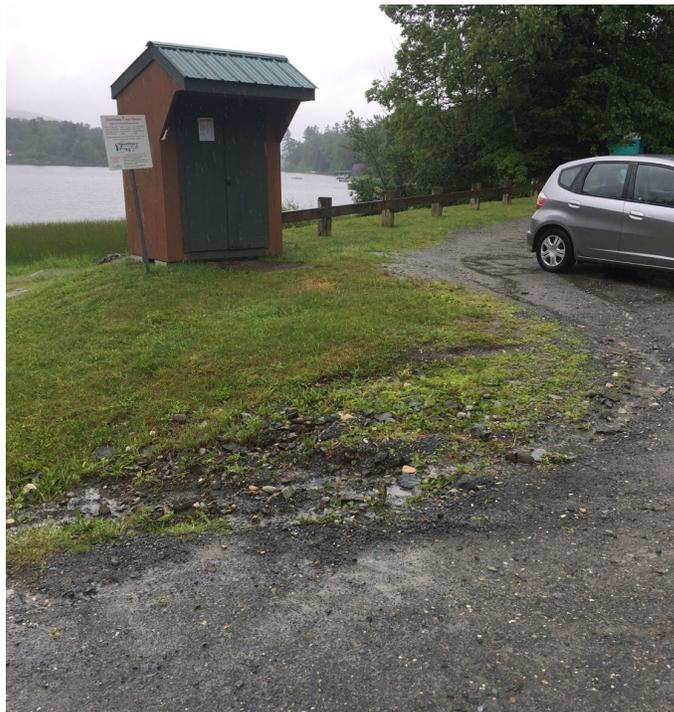
1. **Project SW-4: Vermont Fish and Wildlife Boat Launch** – Concentrated runoff from Route 100 is causing rill erosion near the cross-culvert inlet conveying water to the adjacent wetland, and directly to the lake. The recent addition of water bars has helped intercept flow from Route 100, but opportunities remain to improve infiltration and sediment retention on-site. The sediment load at the site may be exacerbated by accumulation of gravel in the winter from plowing.
2. **Project SW-5: Boy Scout Camp Parking Lot** – An eroded channel and gully where the channel enters the stream is forming from stormwater runoff concentrated along the western side of the

Figure 7: Erosion at the VT Fish and Wildlife Boat access observed during a storm event in June 2019. The concept design for this area (SW-4) describes a BMP that would treat this runoff.

- Project SW-4: Vermont Fish and Wildlife Boat Launch (30% design already complete)
- Project SW-5: Boy Scout Camp Parking Lot (30% design already complete)
- Project SW-8: Eden Recreation Area (30% design already complete)
- Project SW-11/17: Lake Shore Road (30% design already complete)
- Project SW-14: Griggs Road Near #187 (30% design already complete)
