# Bioengineering case study:

Planting Approaches  
for Bank Regrade &  
Erosion Control

**Holly Greenleaf**  
**January 8<sup>th</sup> & 10<sup>th</sup>, 2025**  
**NSECC Training**

# 4 PLANTING APPROACHES TO RESTORE & STABILIZE THE BANK

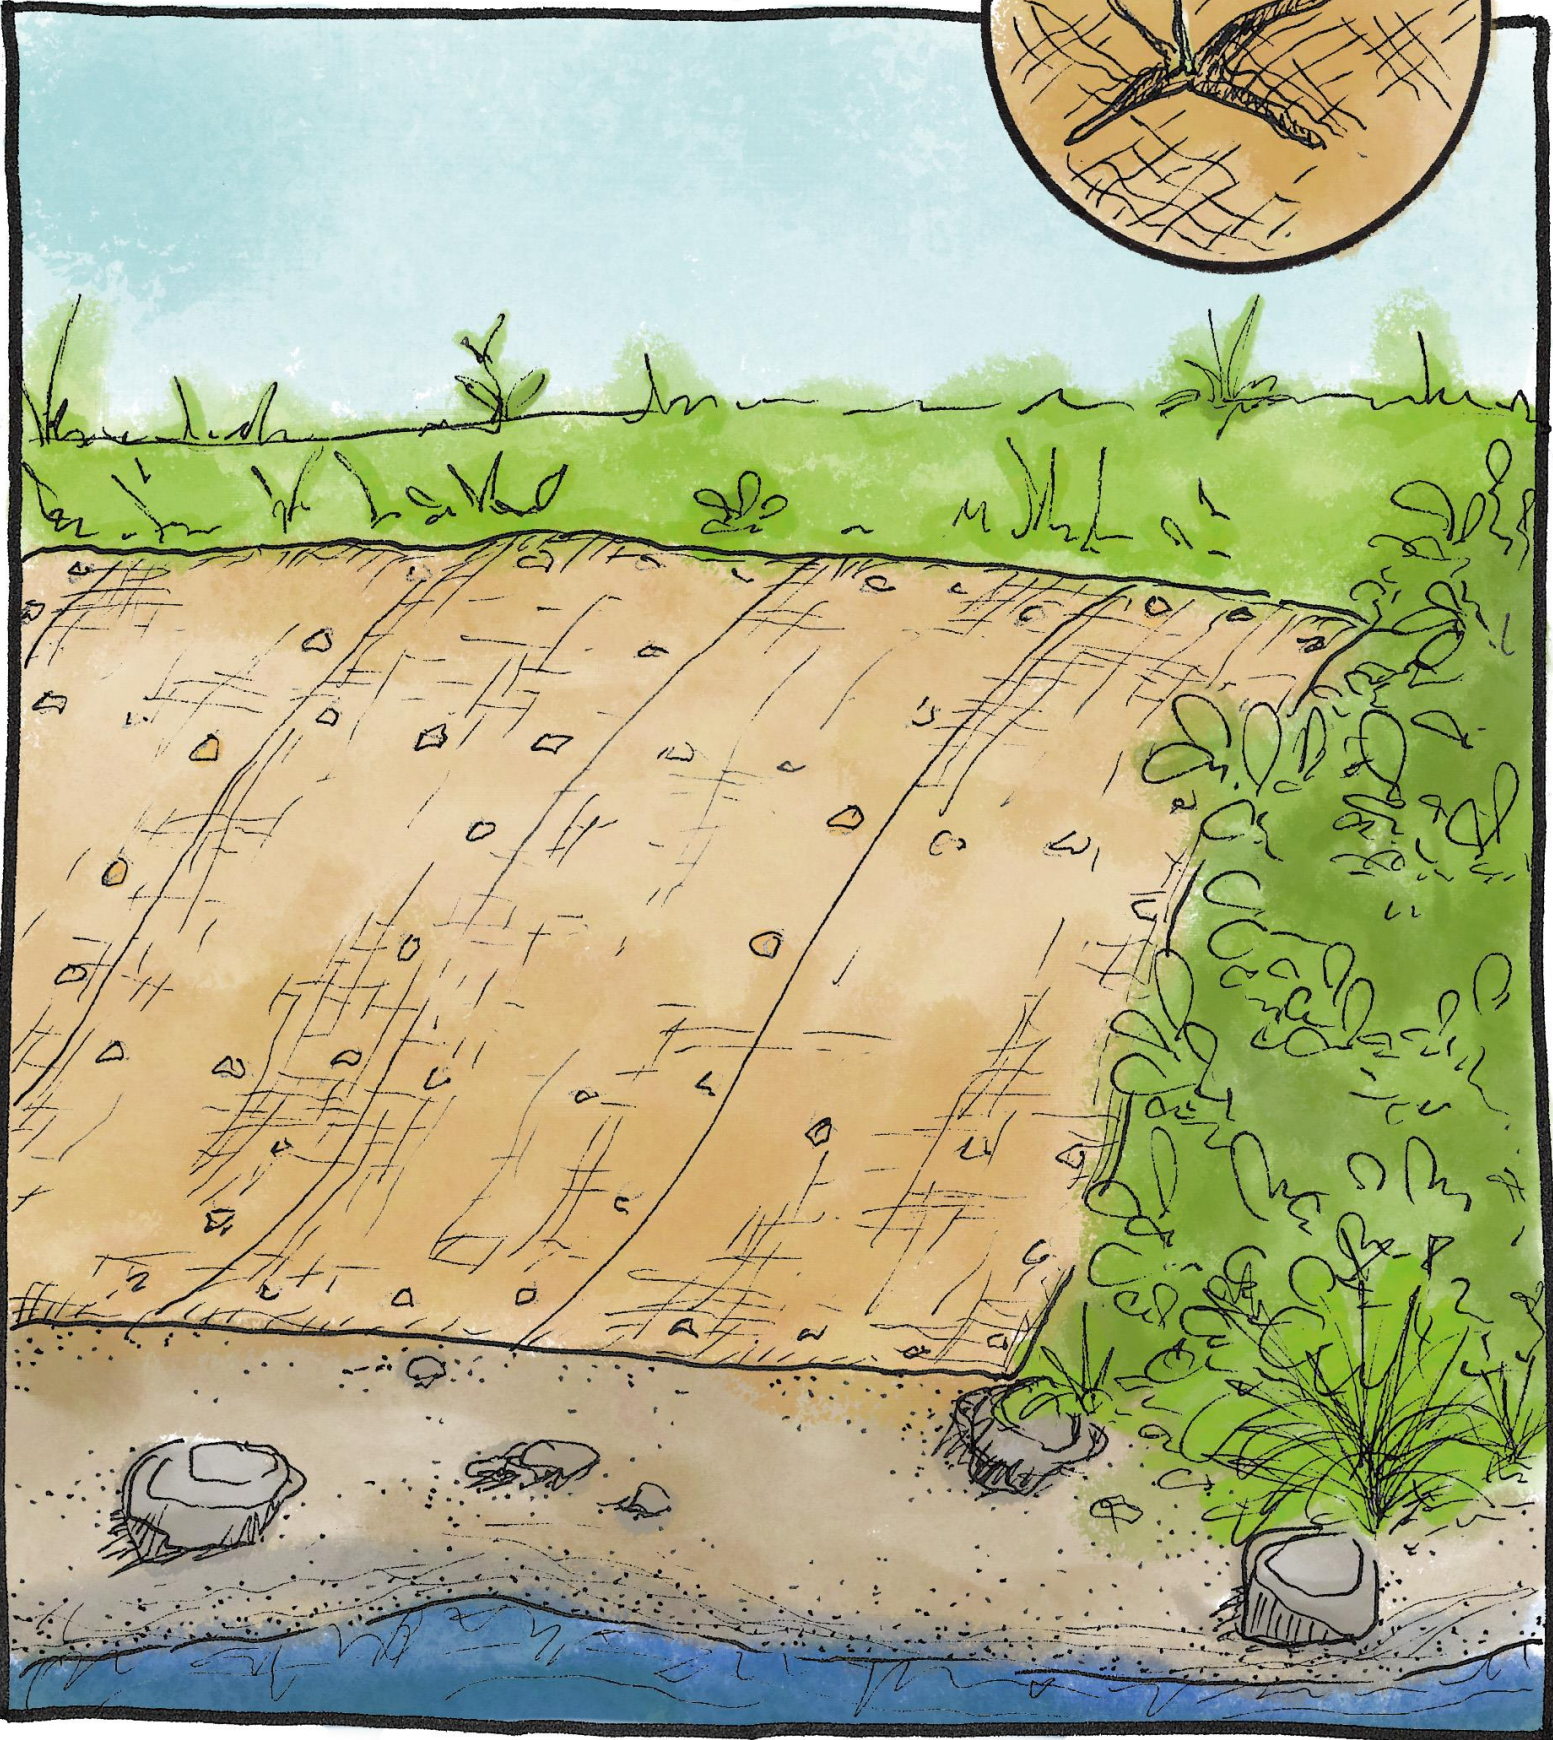
**ADD TOPSOIL & SEED**  
Select screened, weed-free topsoil

Seed with native species

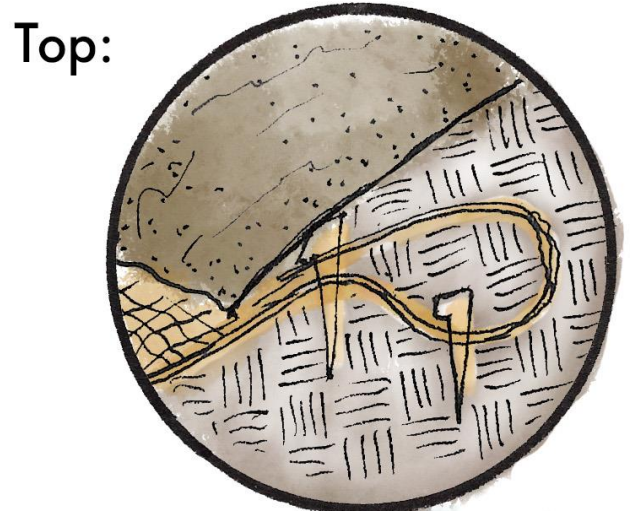
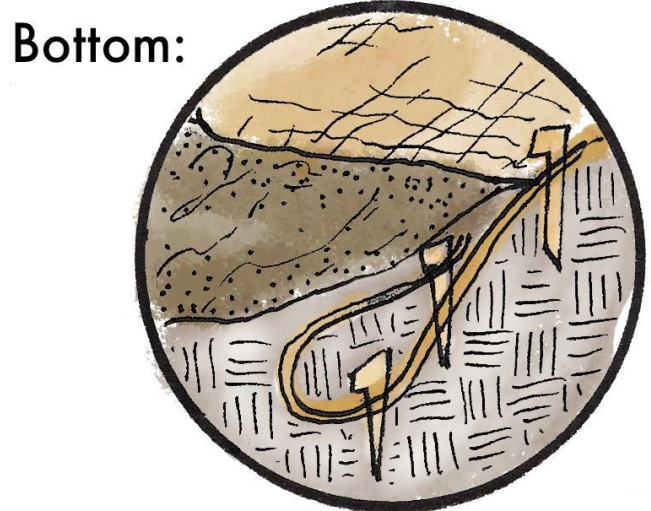
**PLACE & SECURE EROSION CONTROL BLANKETS (ECB)**  
Anchor top & bottom in trenches, use biodegradable pins

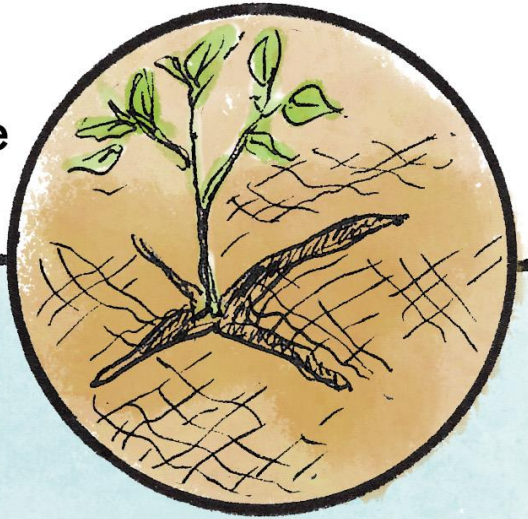
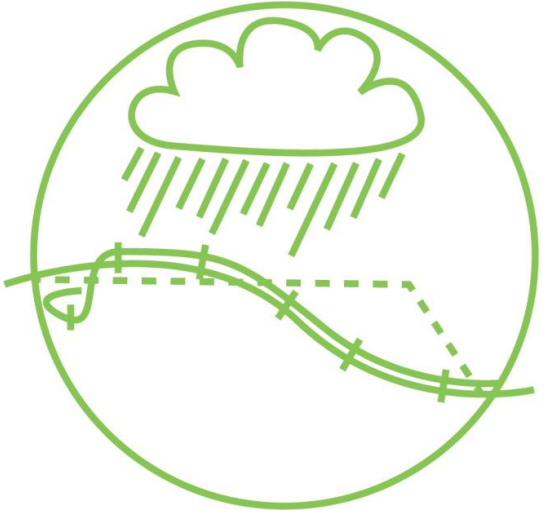
Cut "X" or burn hole in ECB to plant

\*ECB can be placed horizontally along more gradual slopes

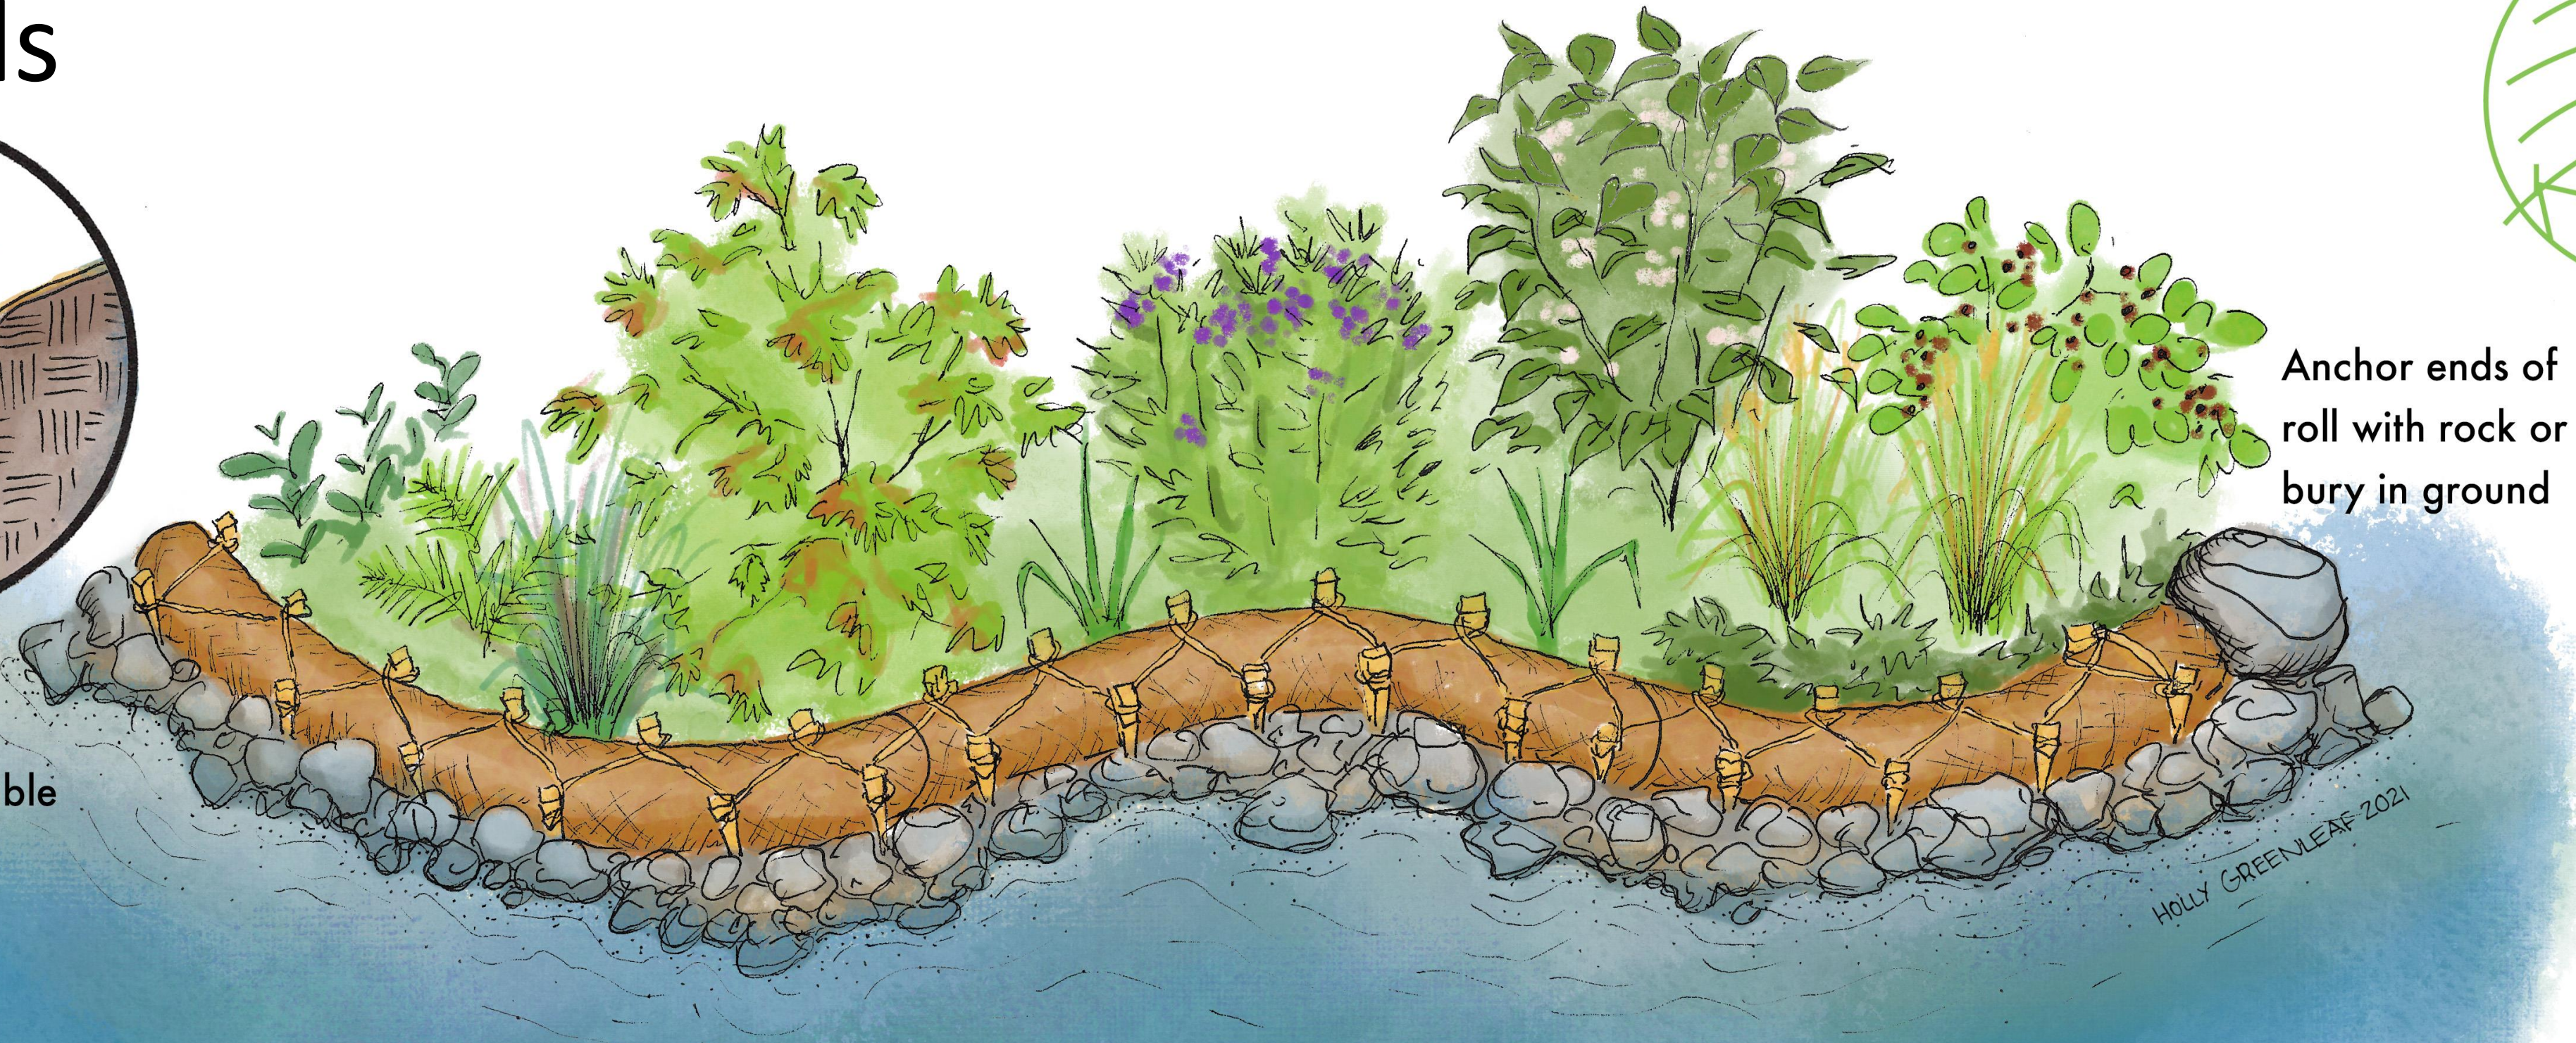
Lay roll in 6" deep trench, lay ECB in trench first if applicable

Anchor ends of roll with rock or bury in ground

Pound stakes on either side of roll perpendicular to ground level every couple feet

Notch outer side of stake with reciprocating saw at the level where the stake and roll meet

Tie fiber rope in tight zig-zag pattern (jute, coir, manila, sisal fiber)

Pound again to tighten rope

Cut off excess stake to be level with the top of the roll and prevent ice push

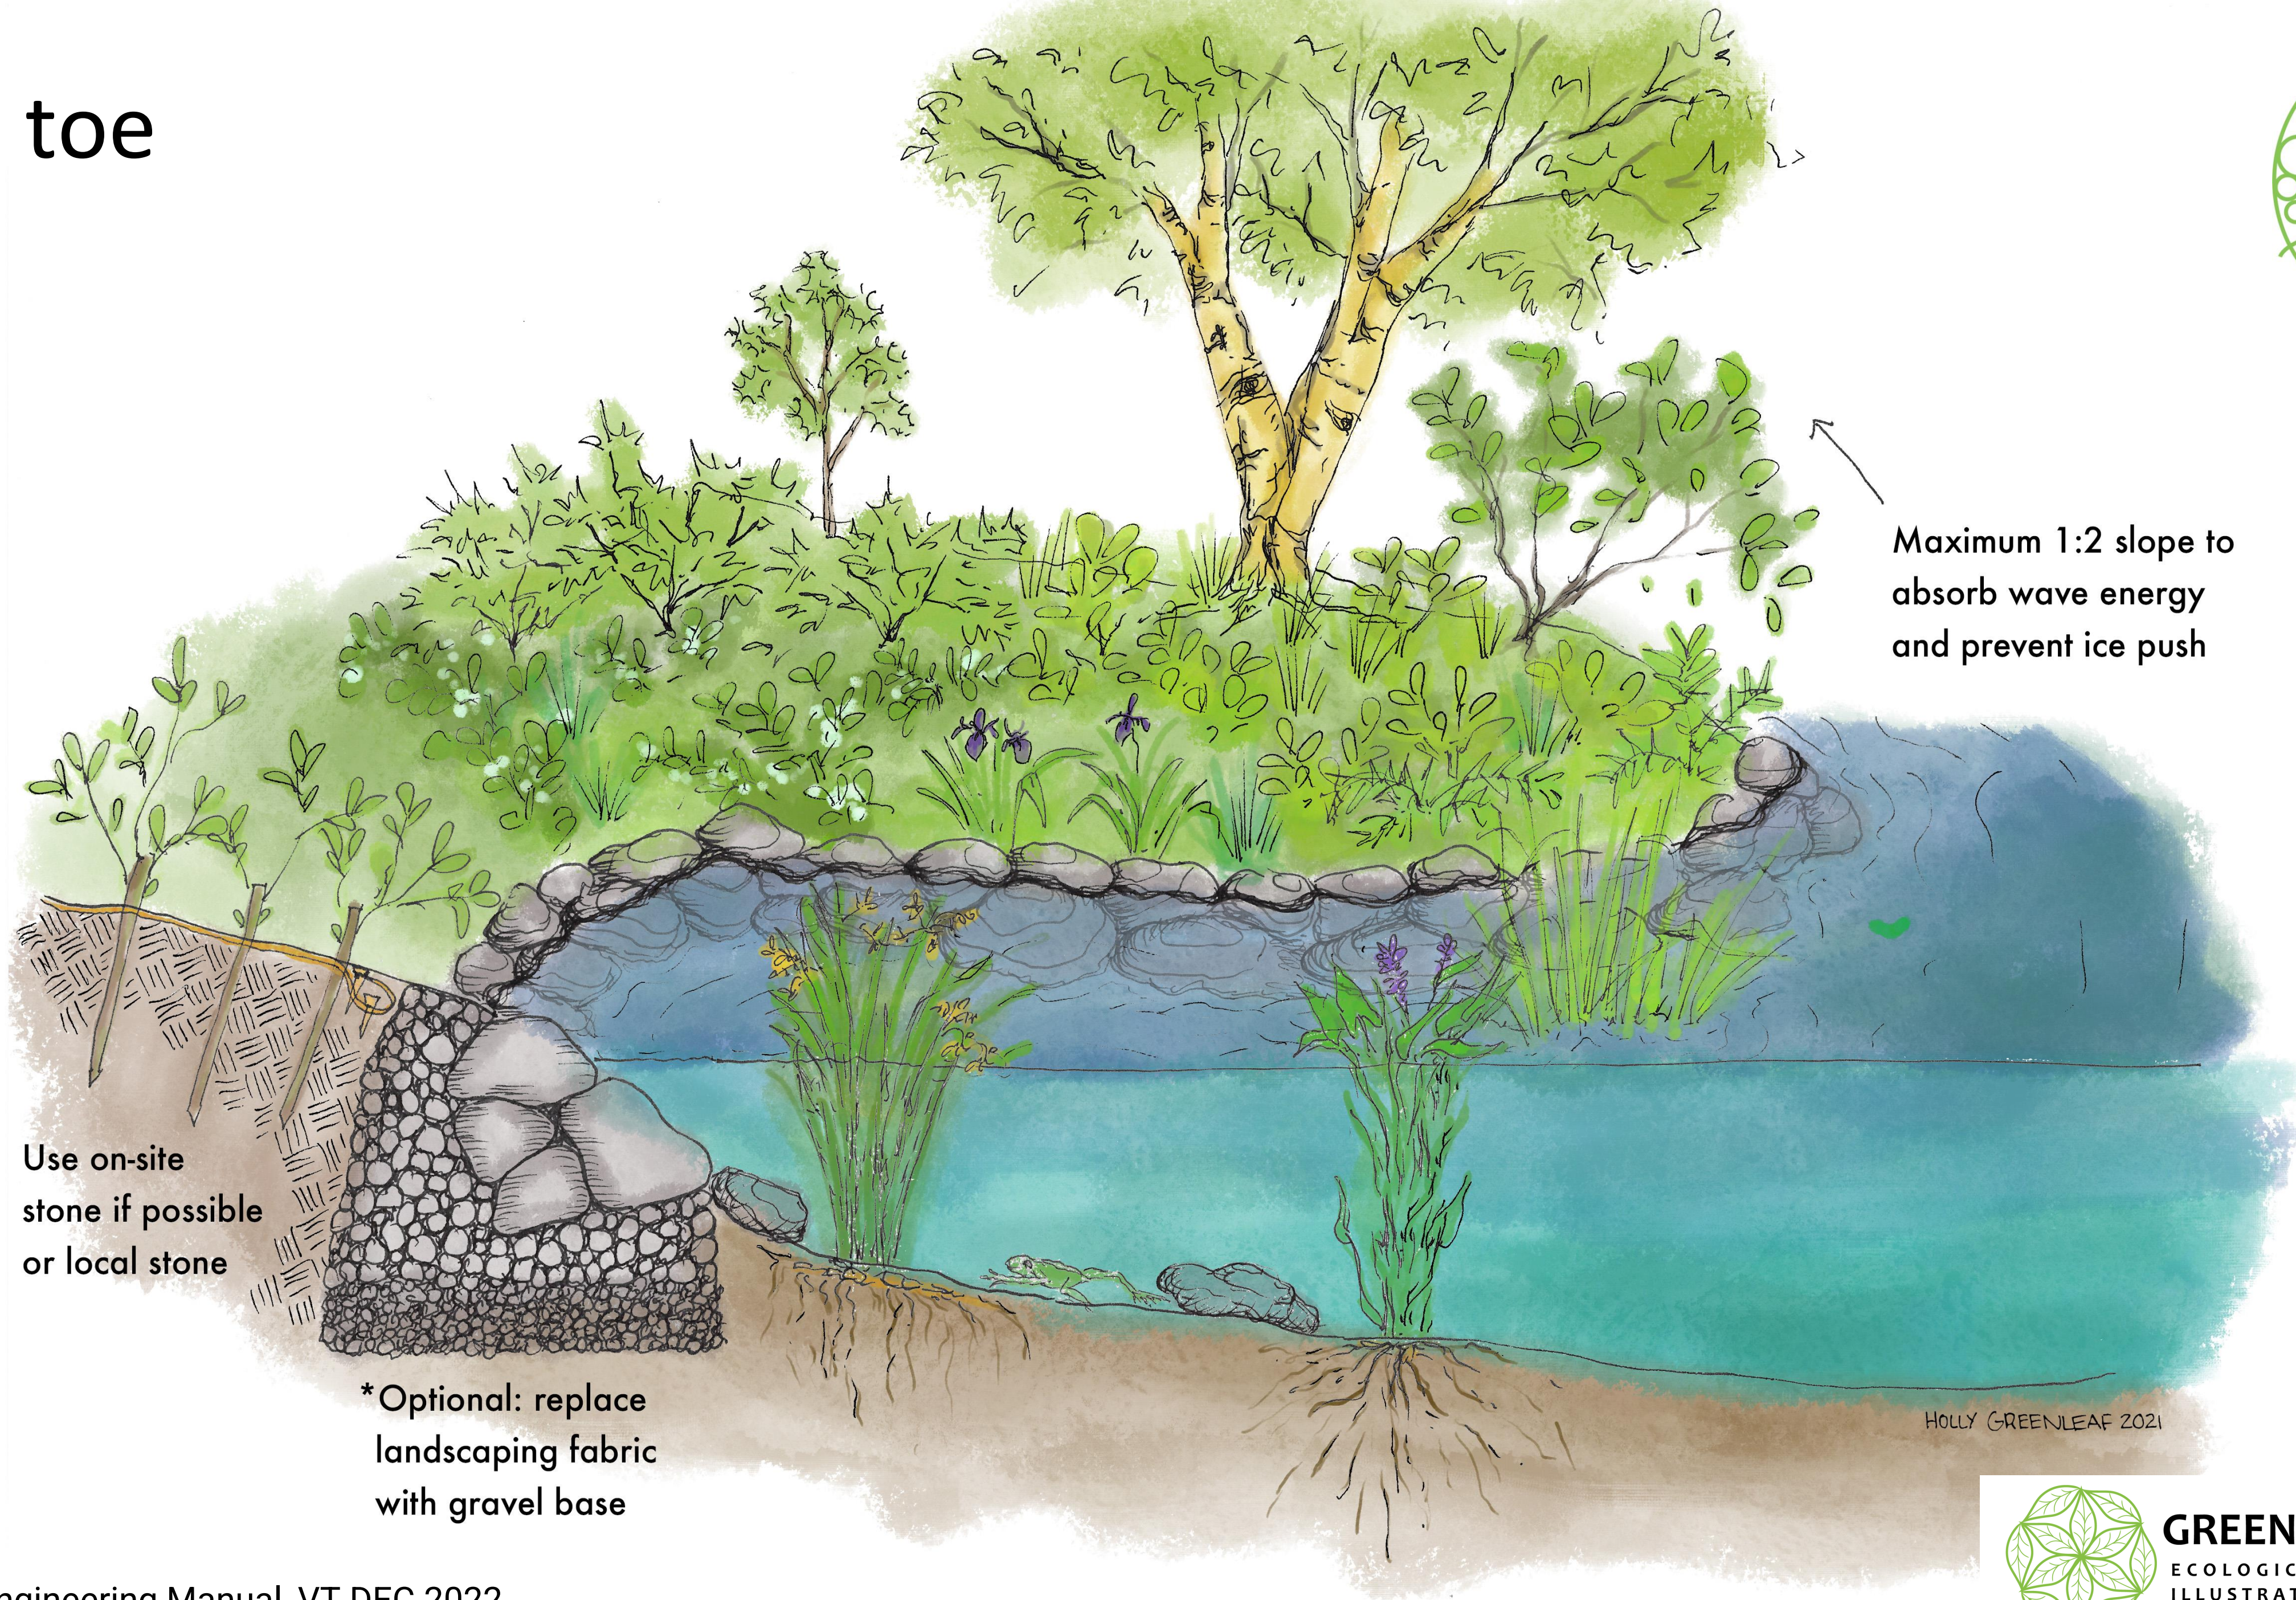
Maximum 1:2 slope to absorb wave energy and prevent ice push

Use on-site stone if possible or local stone

\*Optional: replace landscaping fabric with gravel base

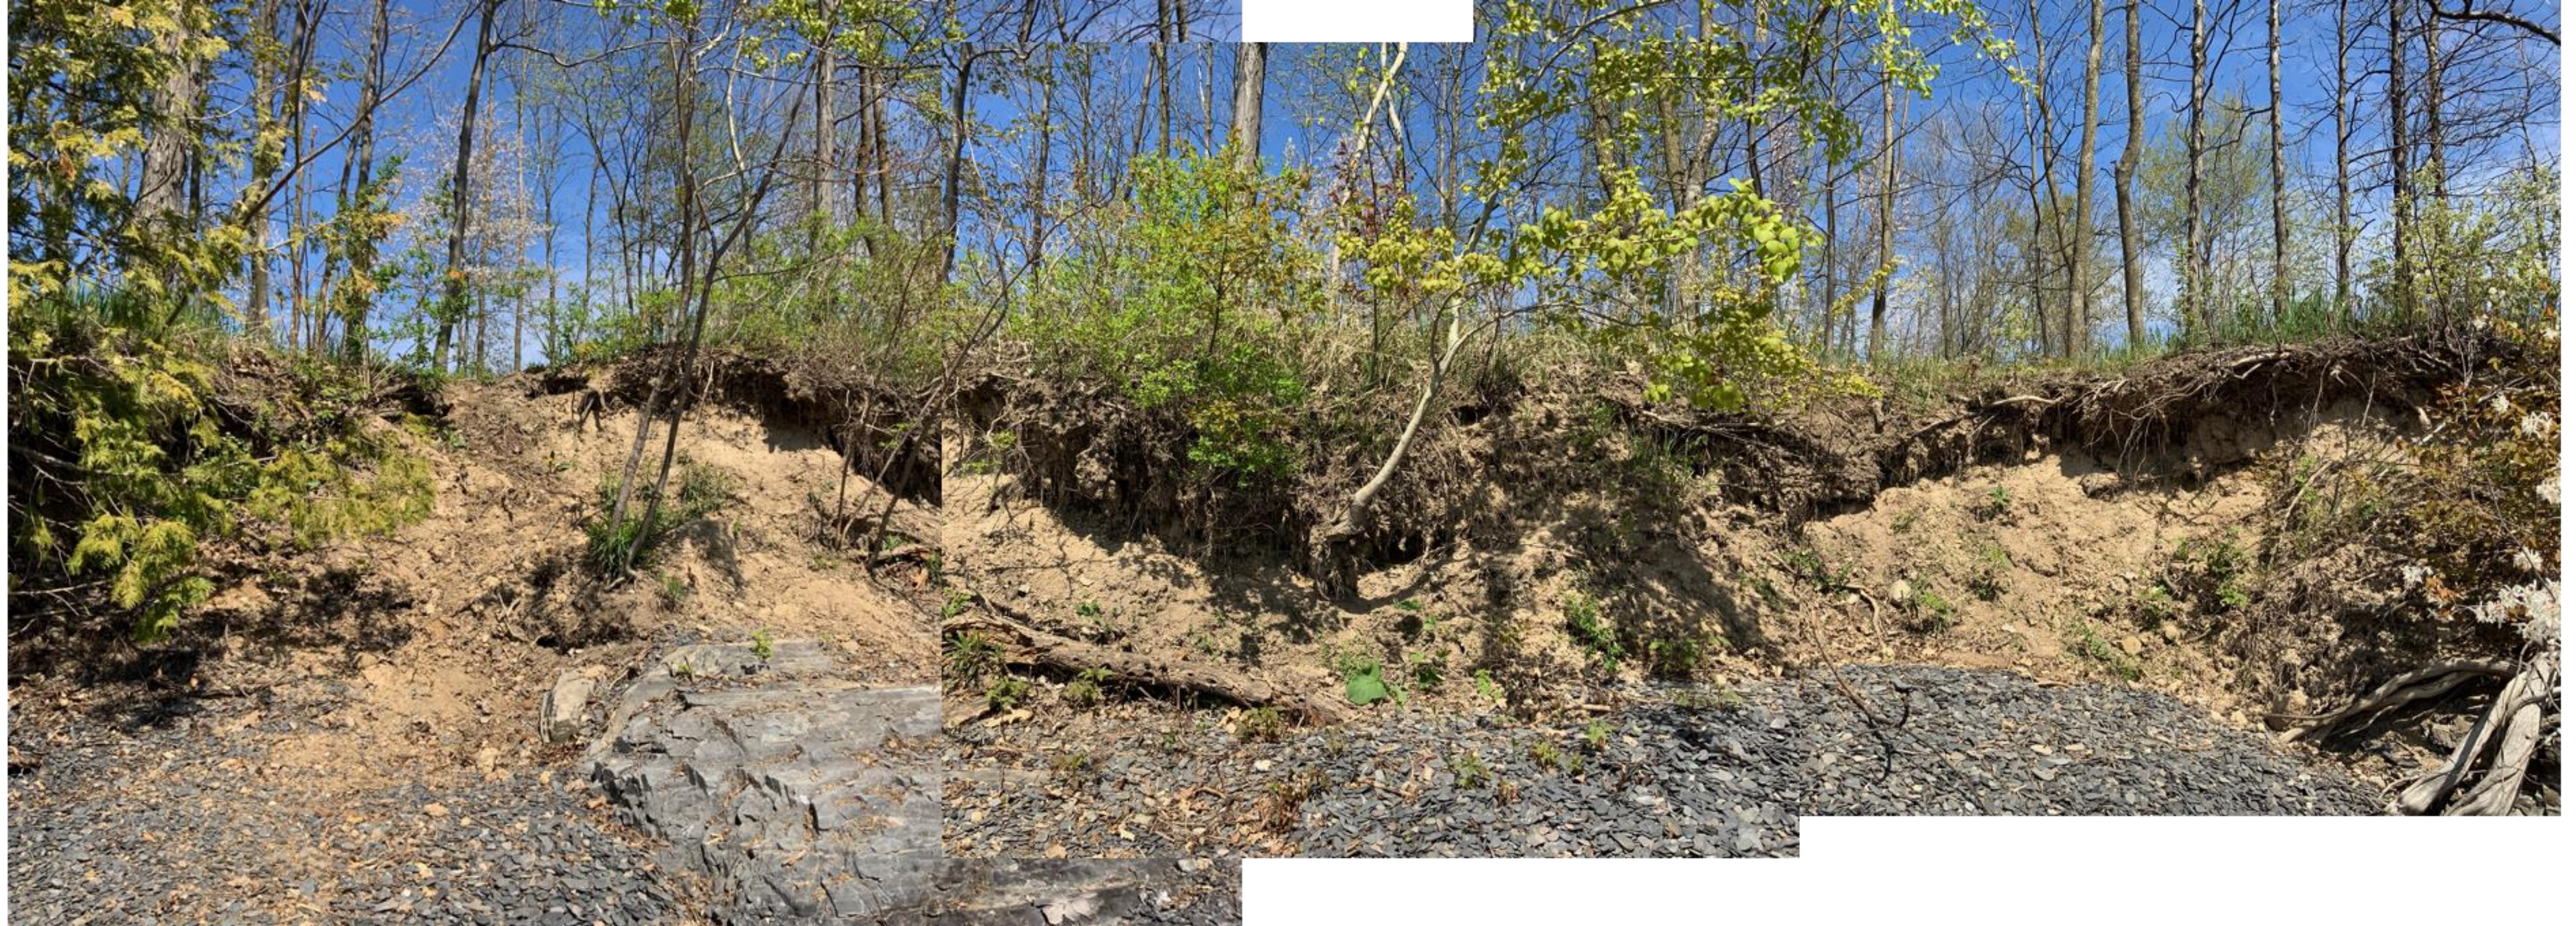
Lake Champlain

# UNDERCUT, Eroding lakeshore

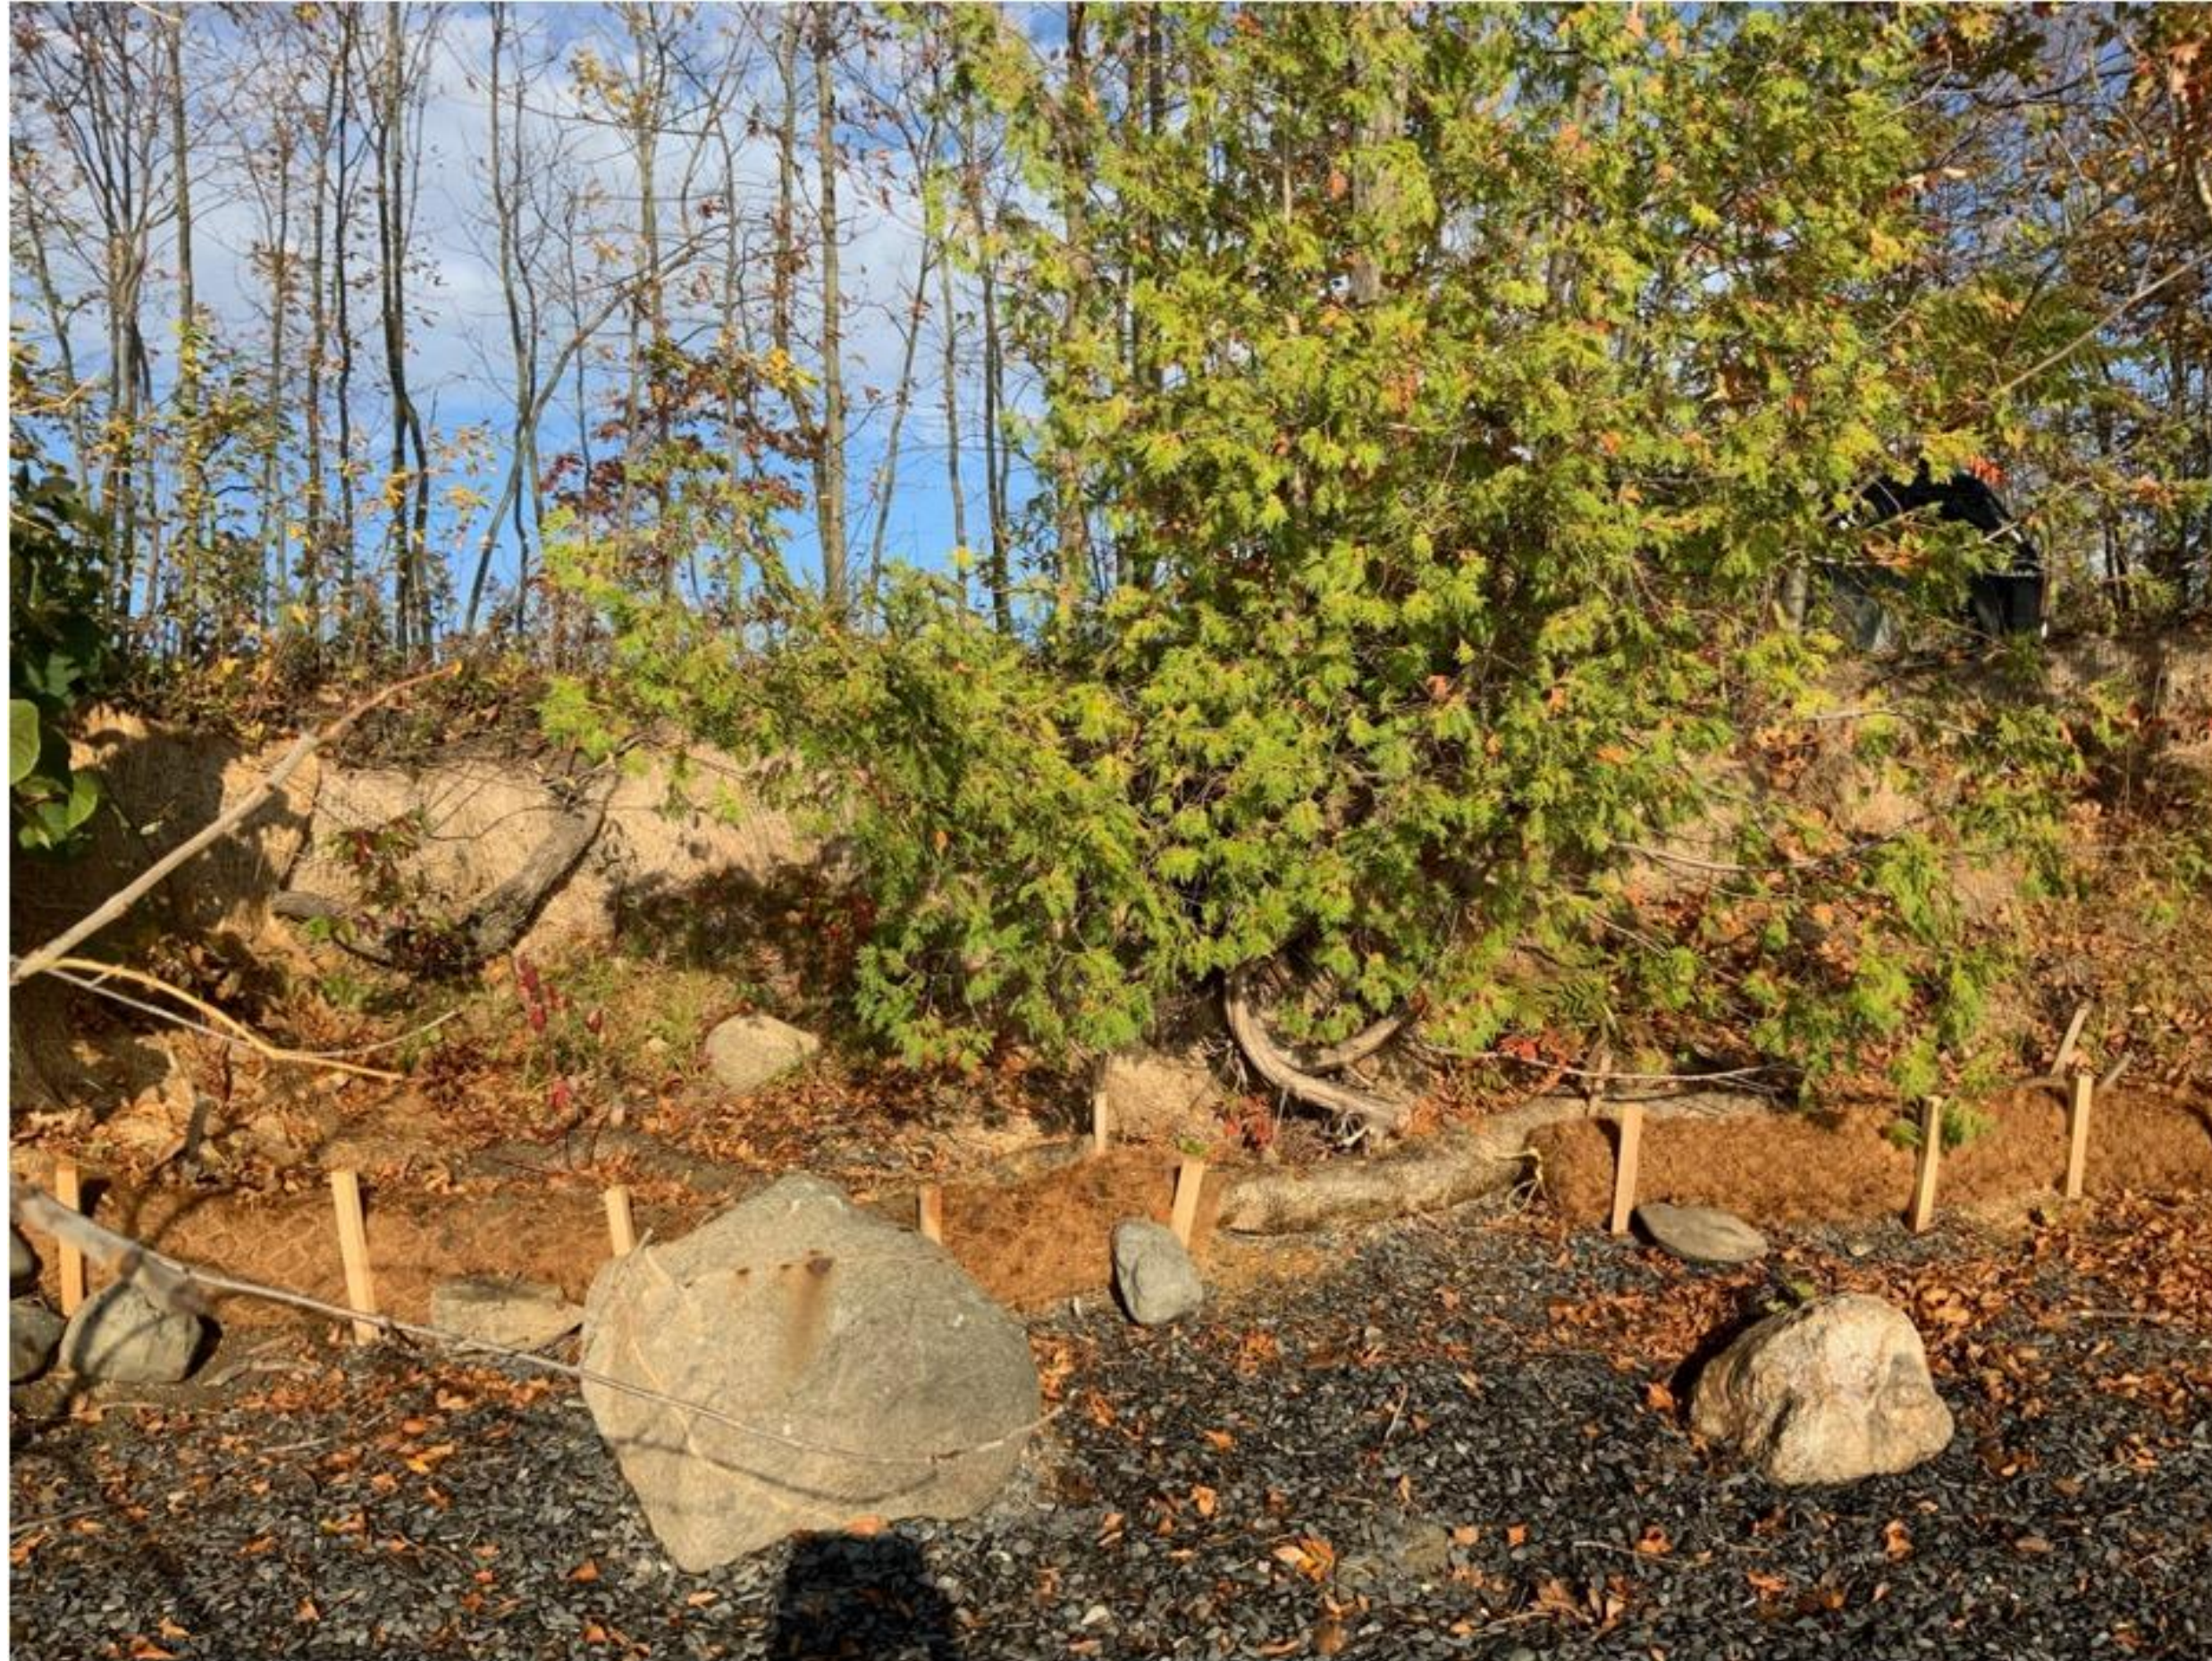
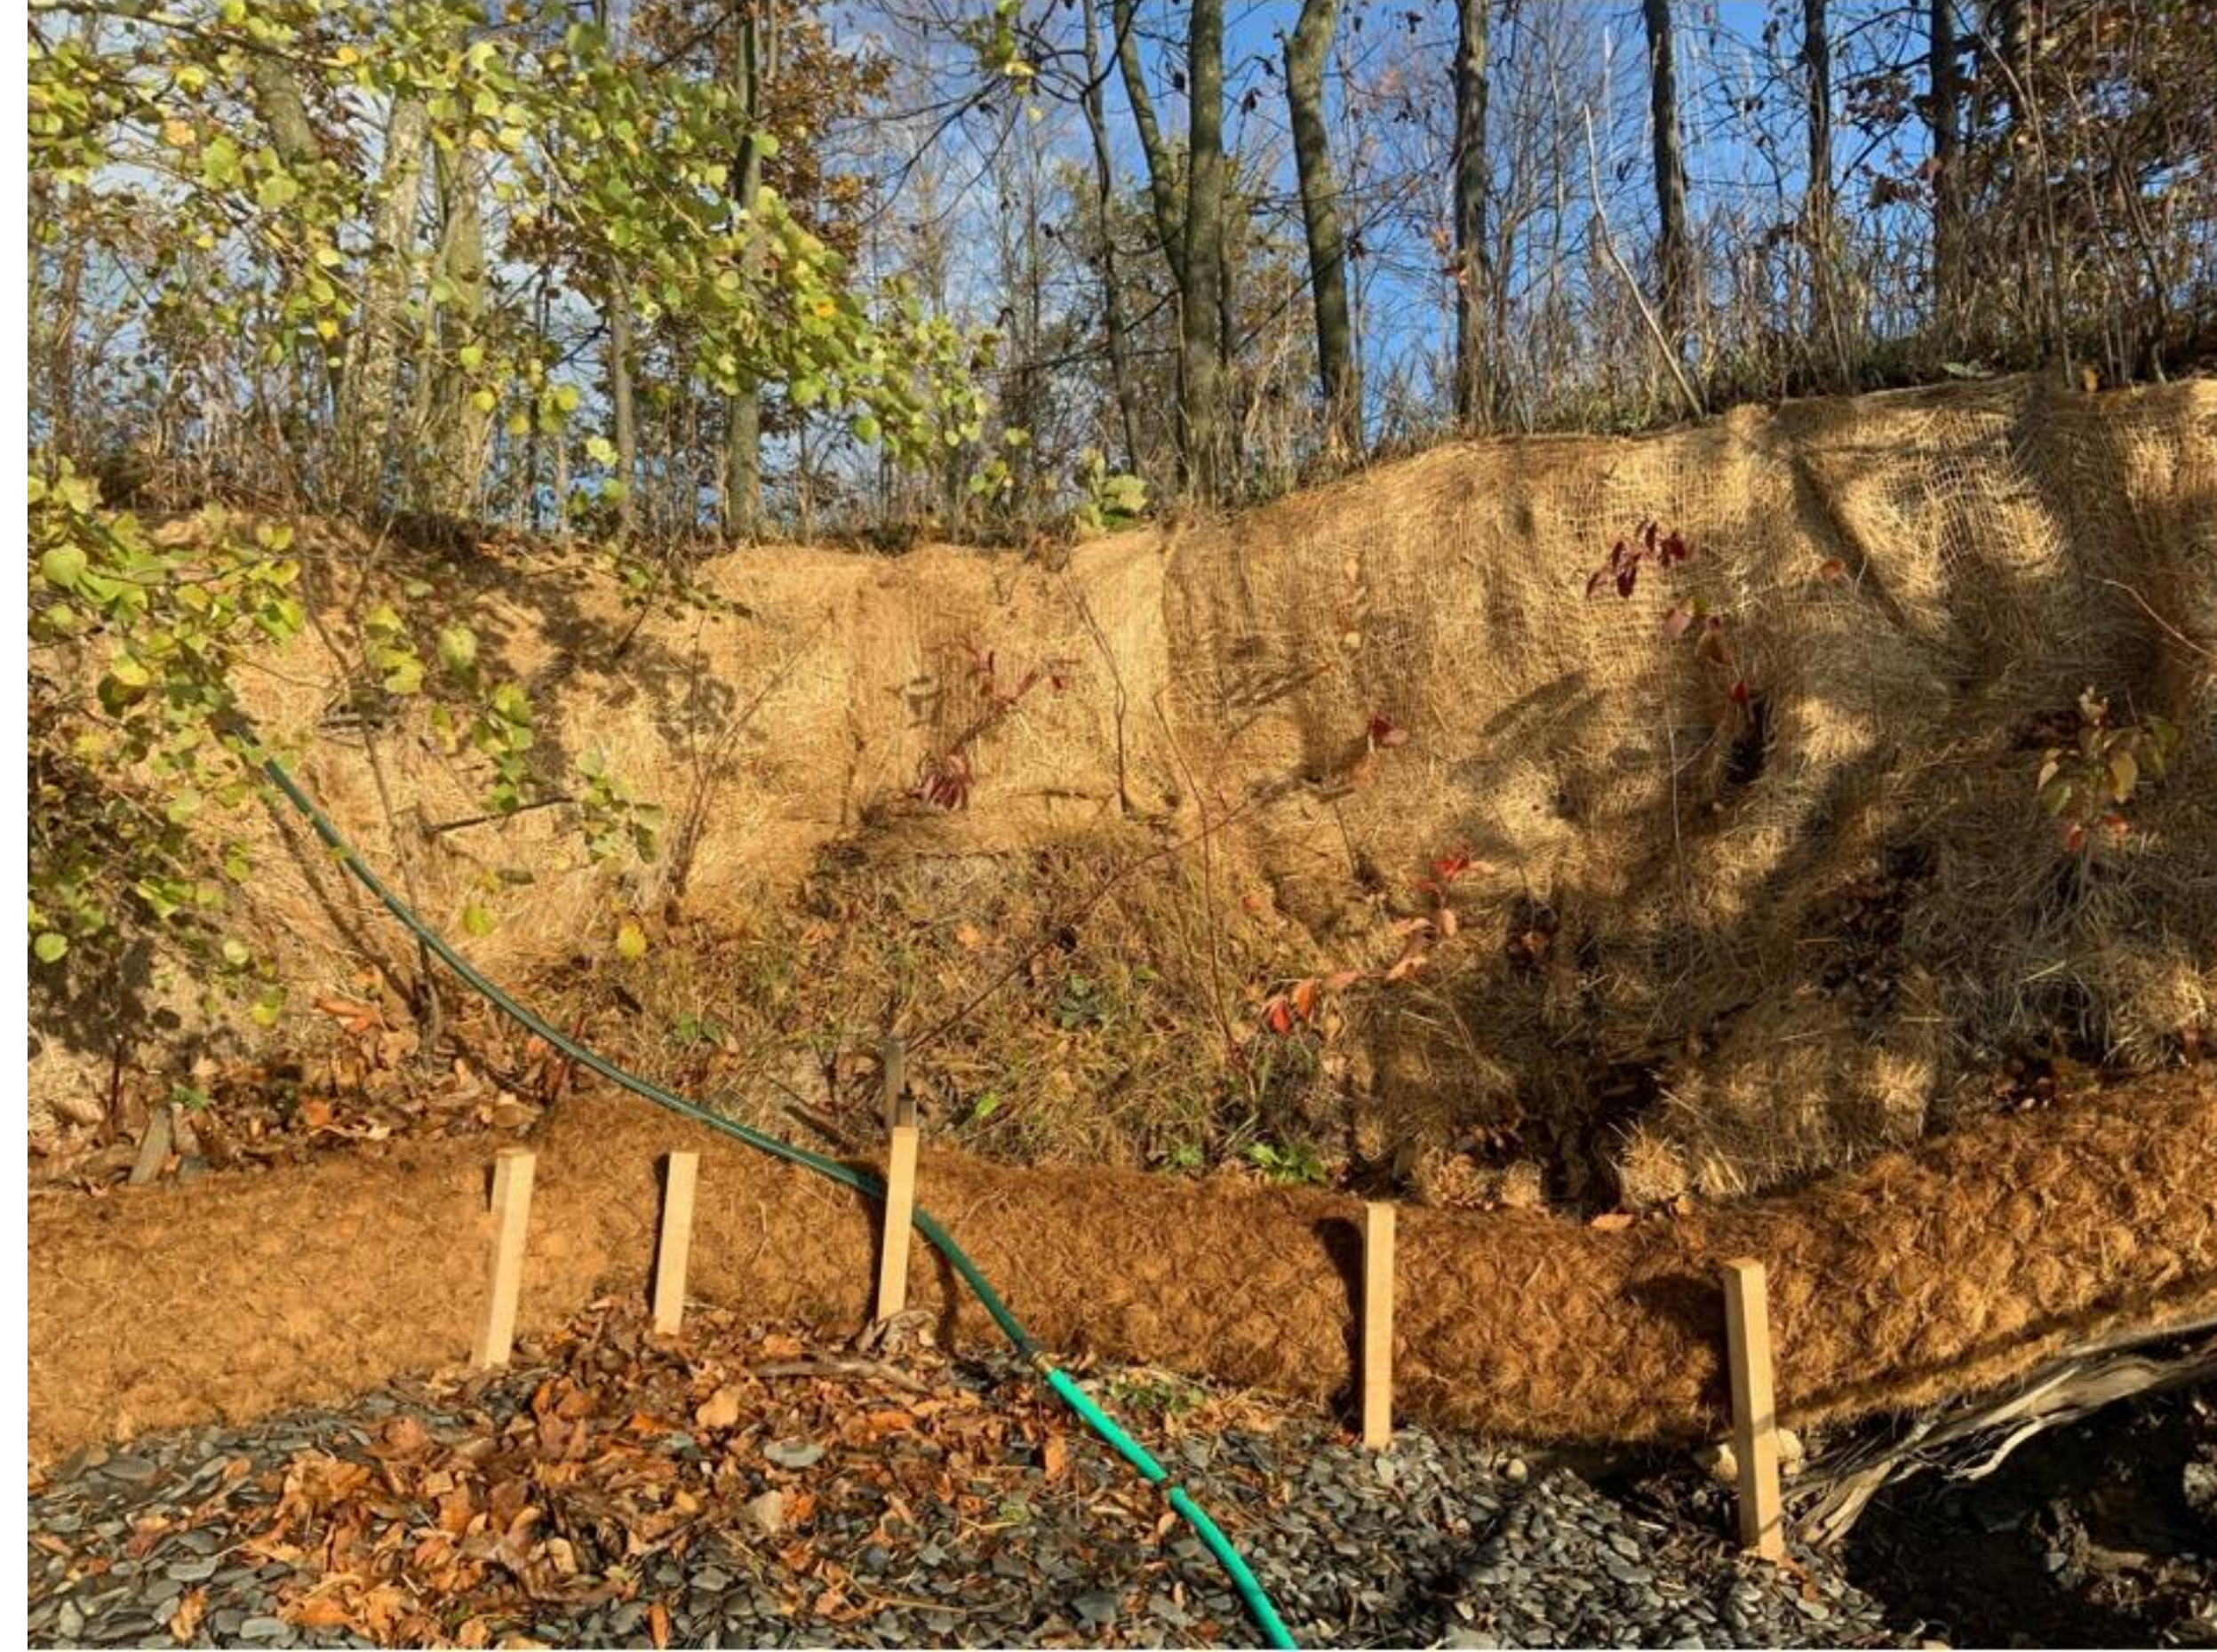
# Minimal disturbance solution: Erosion Control Materials + LIVE STAKES

Erosion Control Matting/Blankets (ECB), Coconut coir rolls, Live stakes, plugs/tree pots of woody trees and shrubs, seed with native flower and grass mix

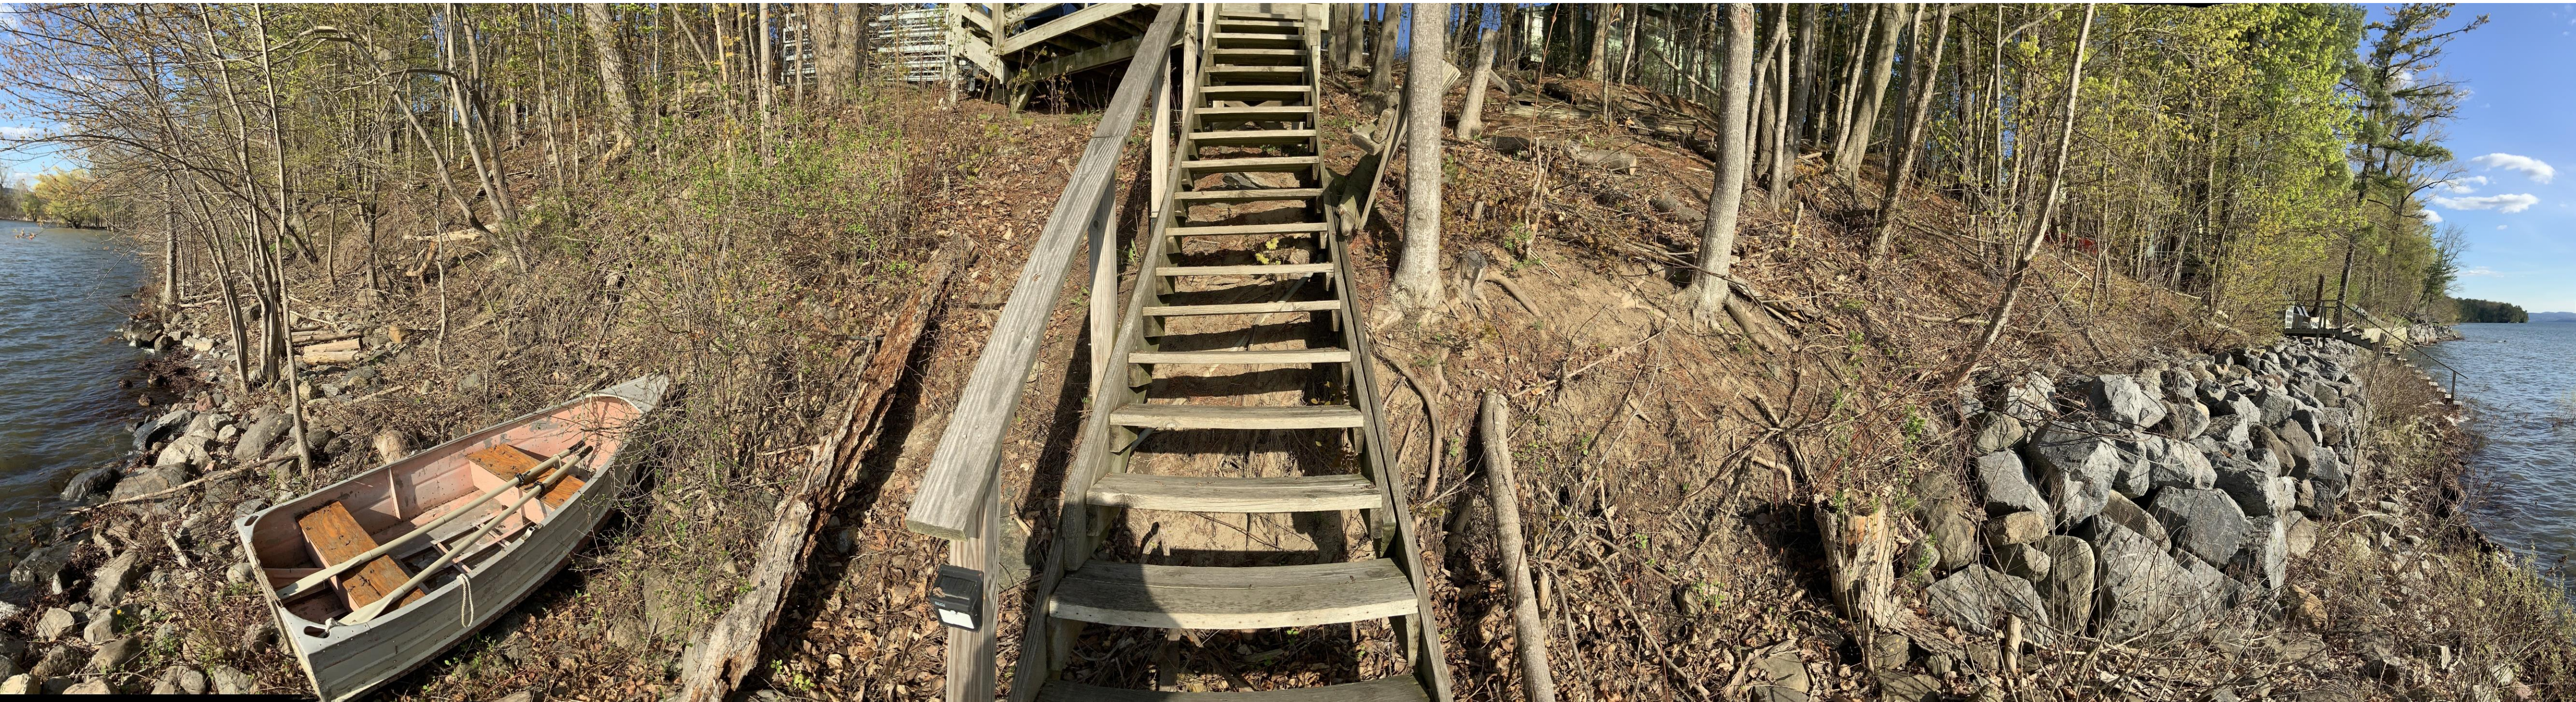
Lake Champlain

# Common Problem: Eroding lakeshore
