# Bioengineering case study:

Planting Approaches  
for Bank Regrade &  
Erosion Control

**Holly Greenleaf**  
**January 8<sup>th</sup> & 10<sup>th</sup>, 2025**  
**NSECC Training**

# 4 PLANTING APPROACHES TO RESTORE & STABILIZE THE BANK

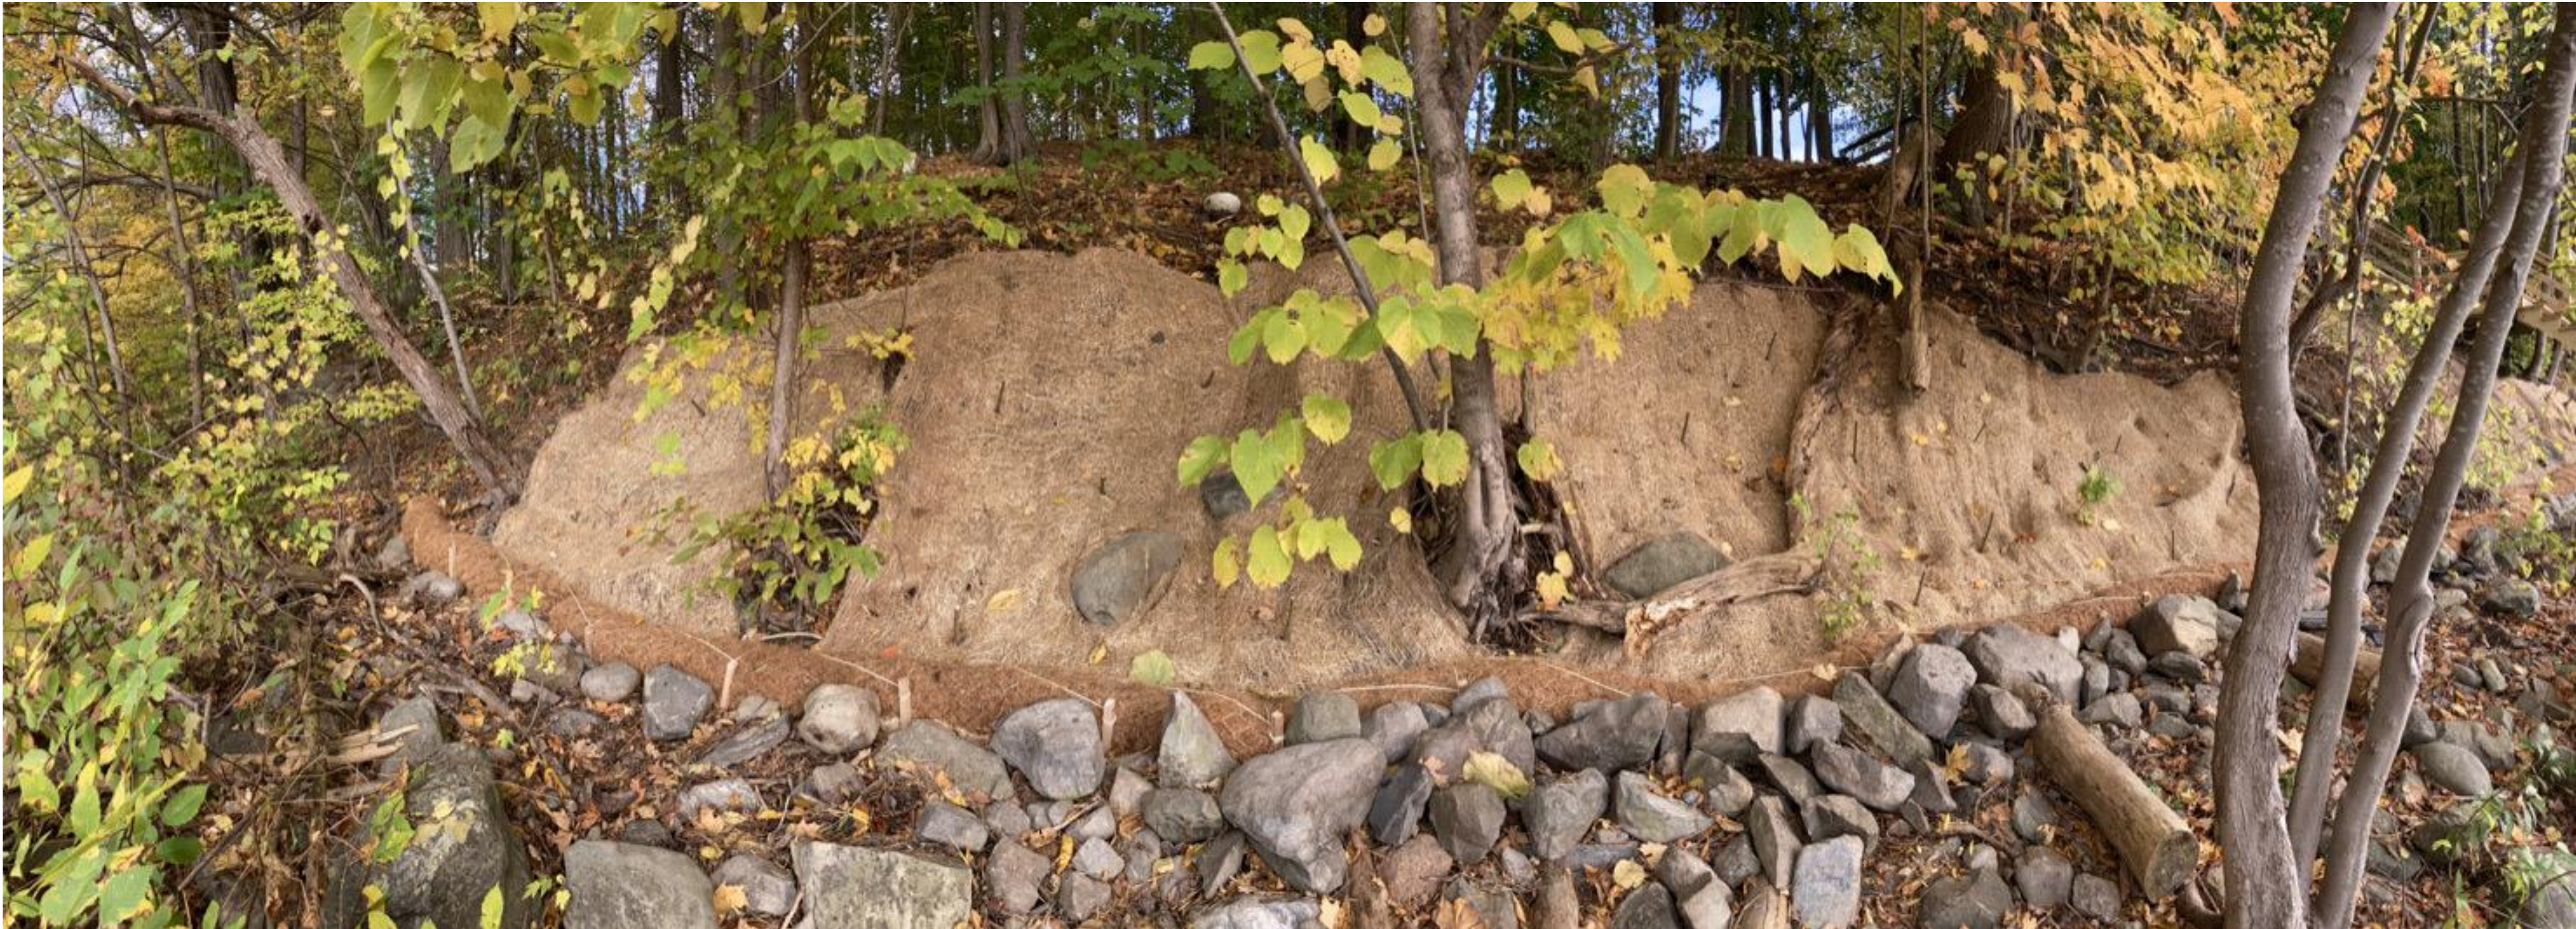
# Solution: Stabilize & Live Stakes

Understory stabilization

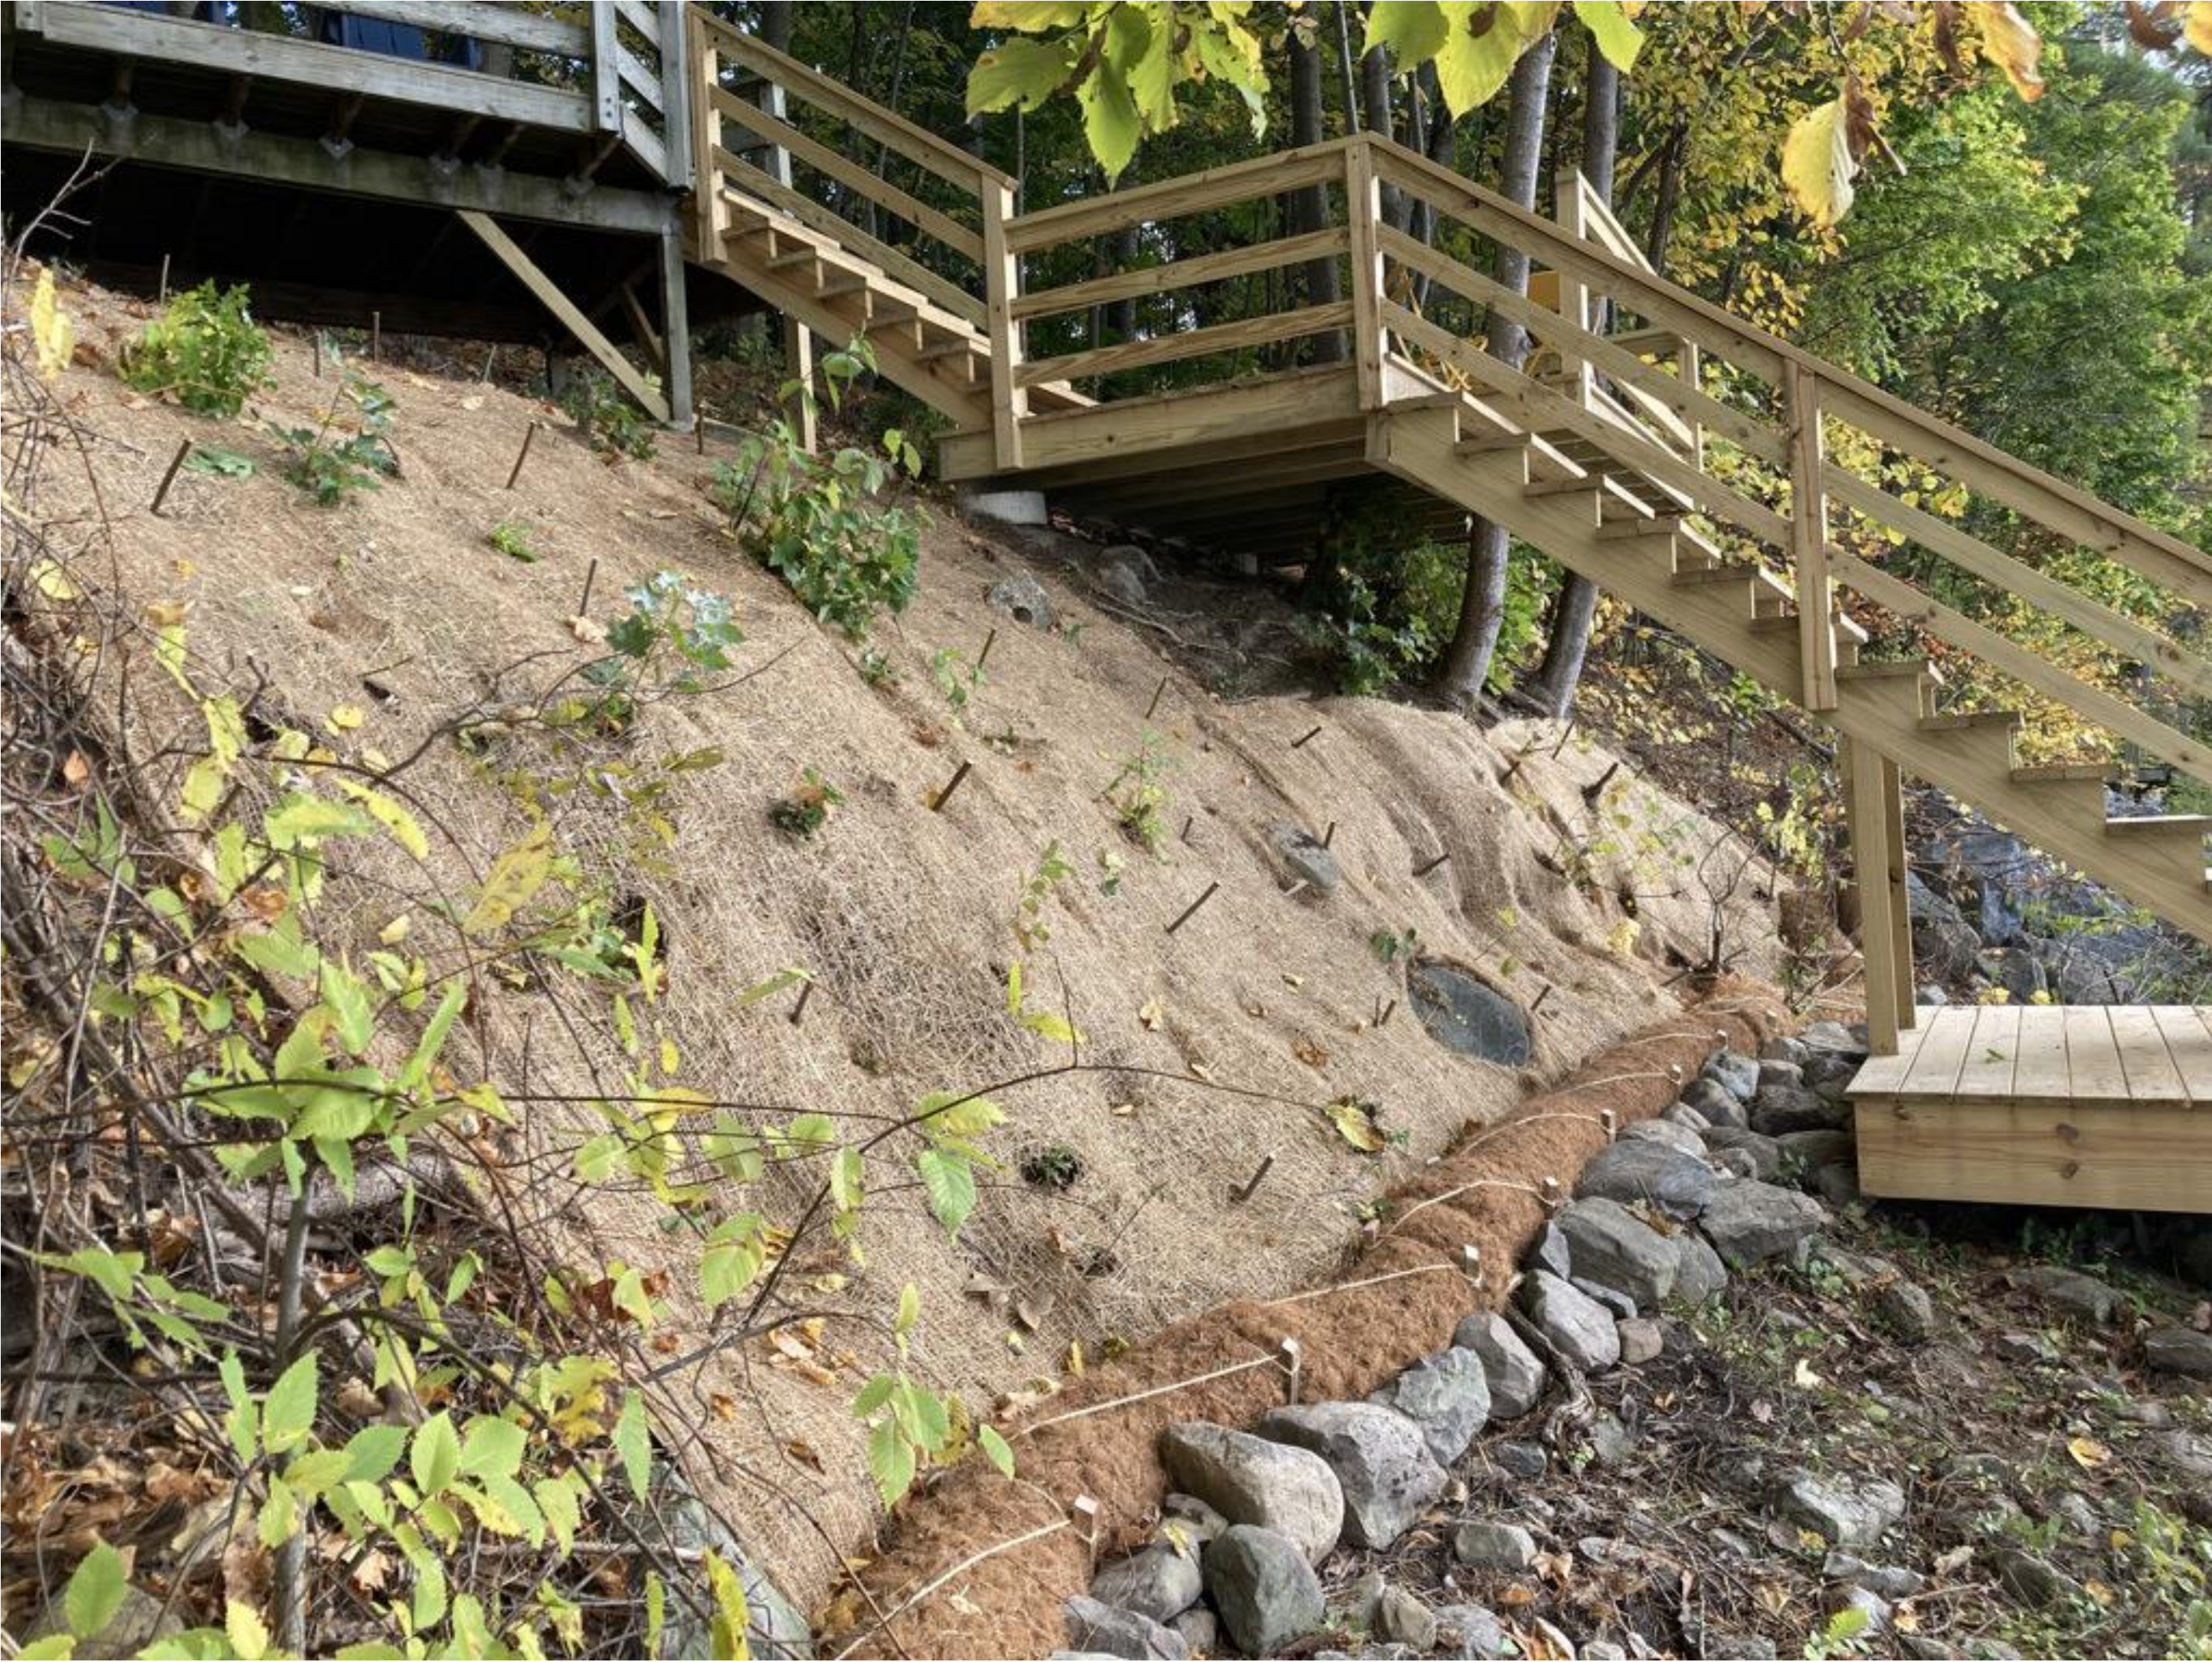
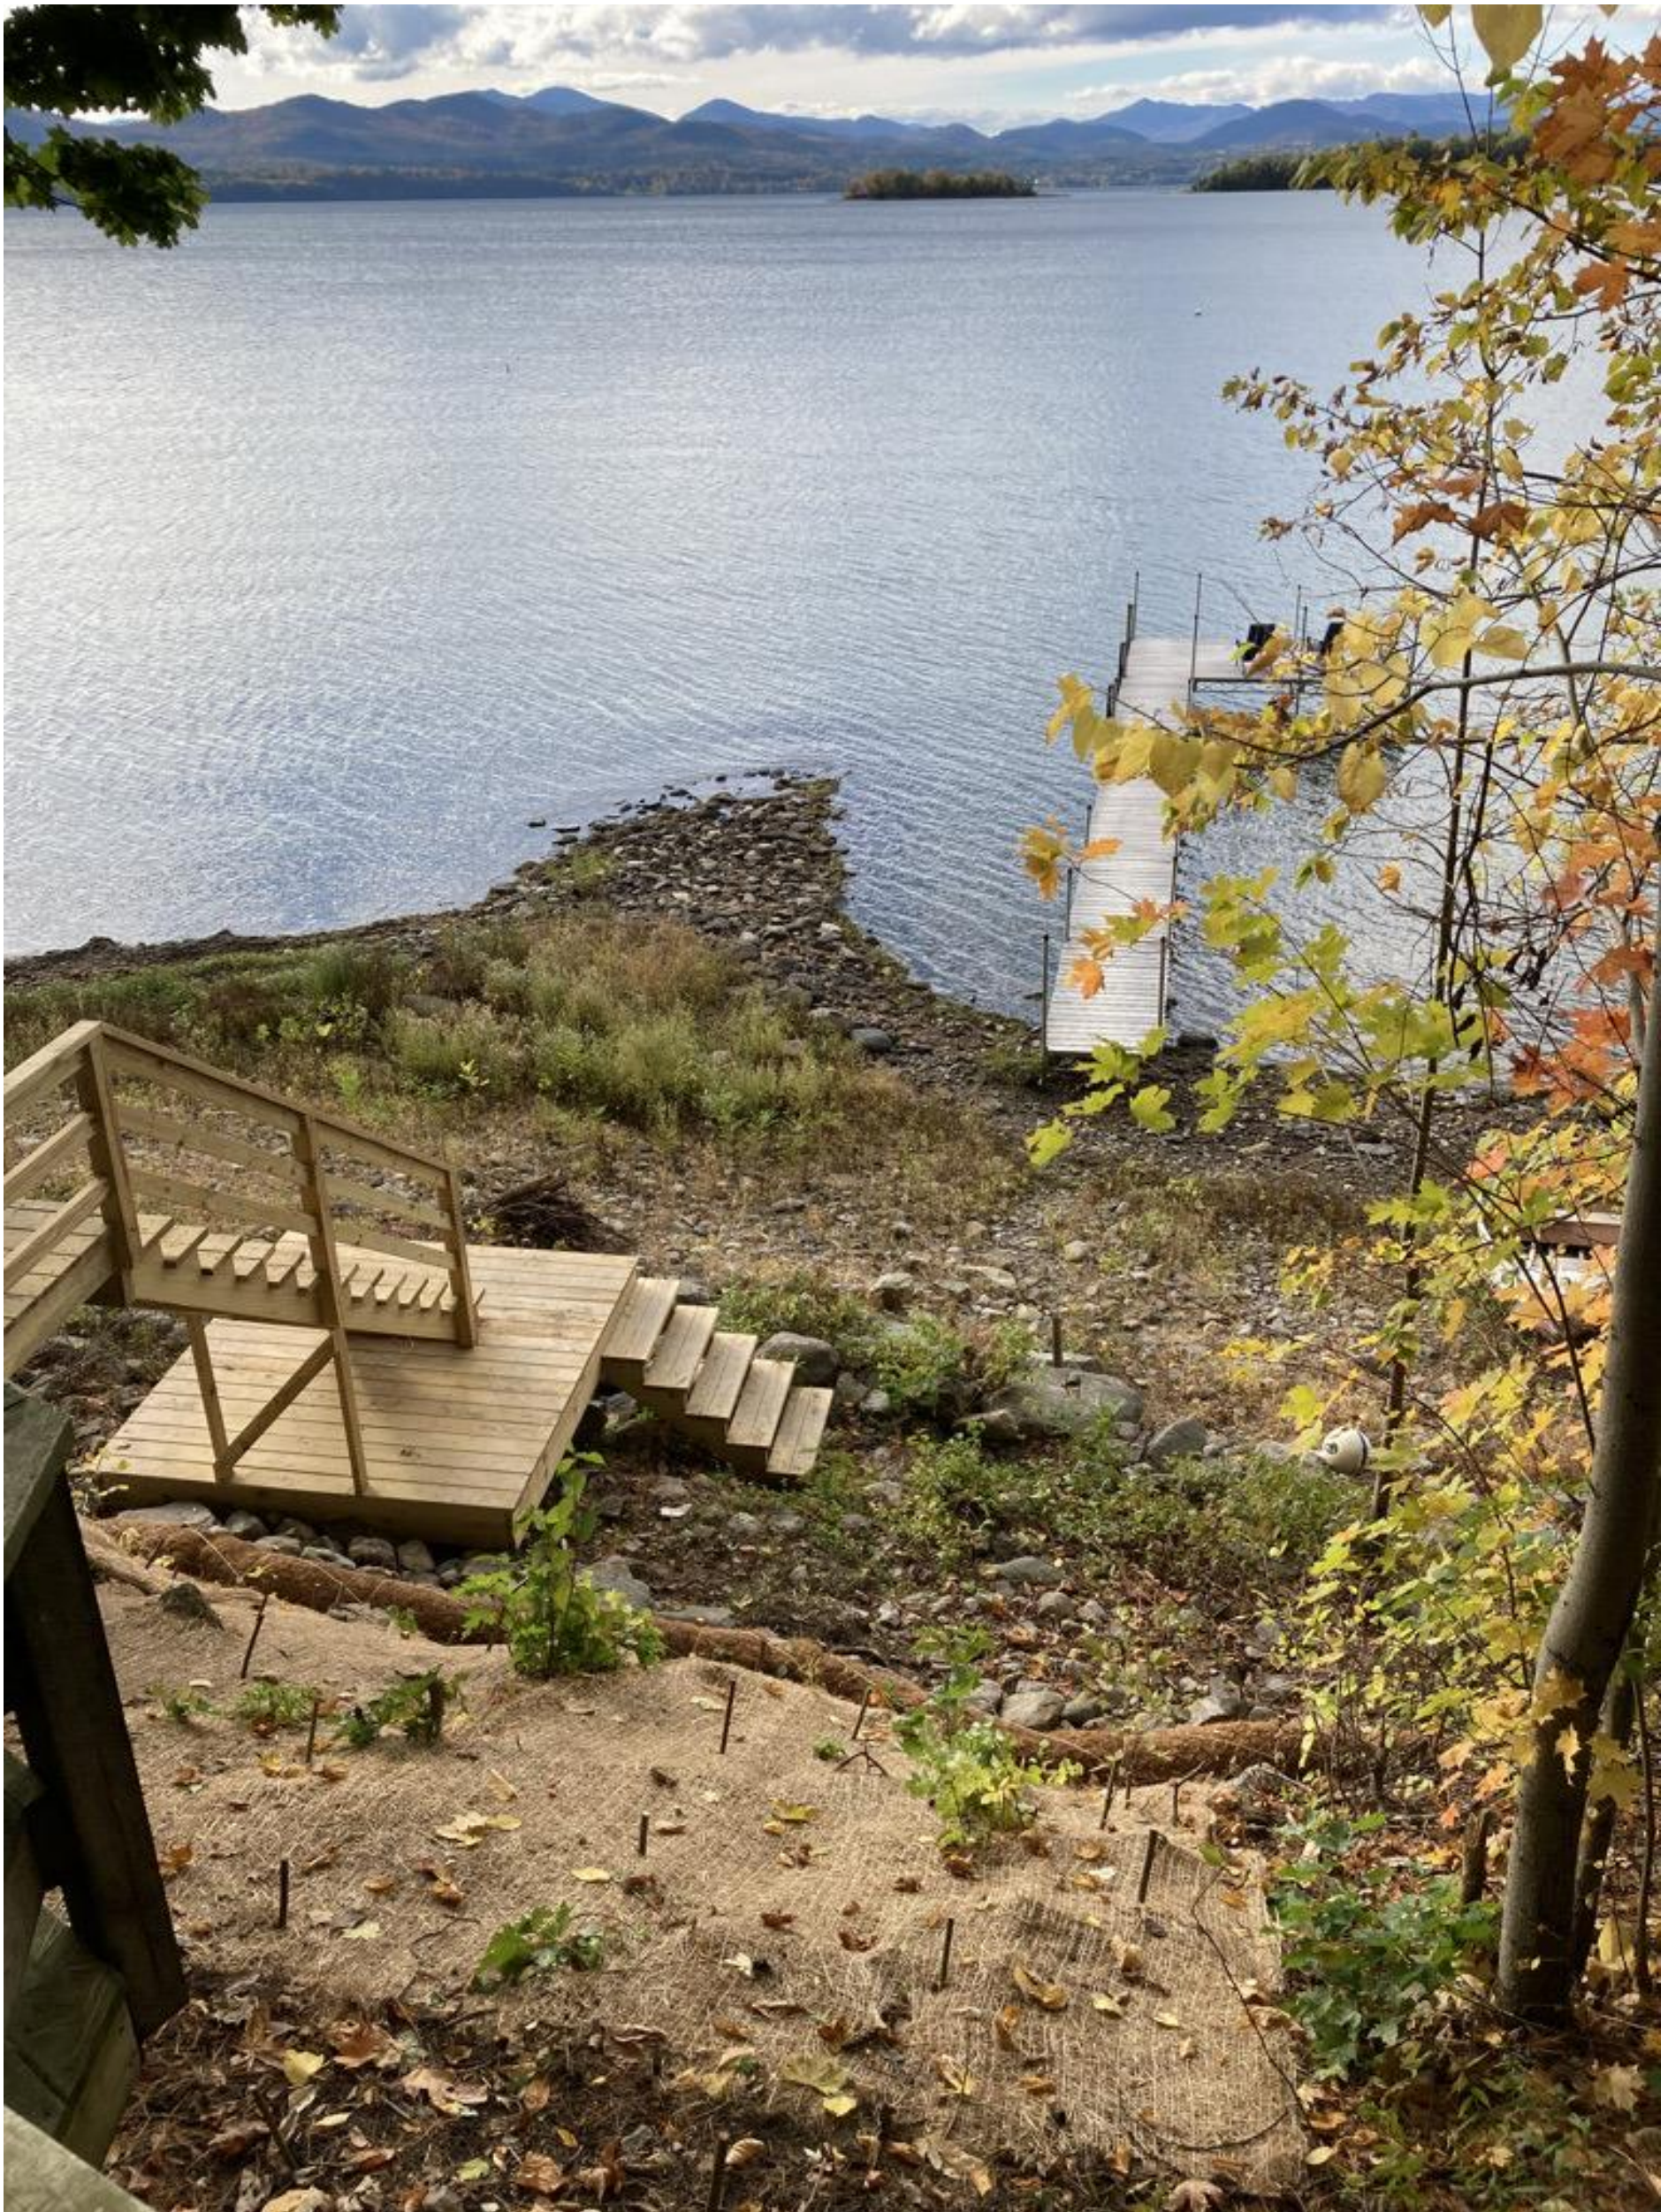
Willow & Dogwood Bank, stone toe, ~ 75% survival - replacement

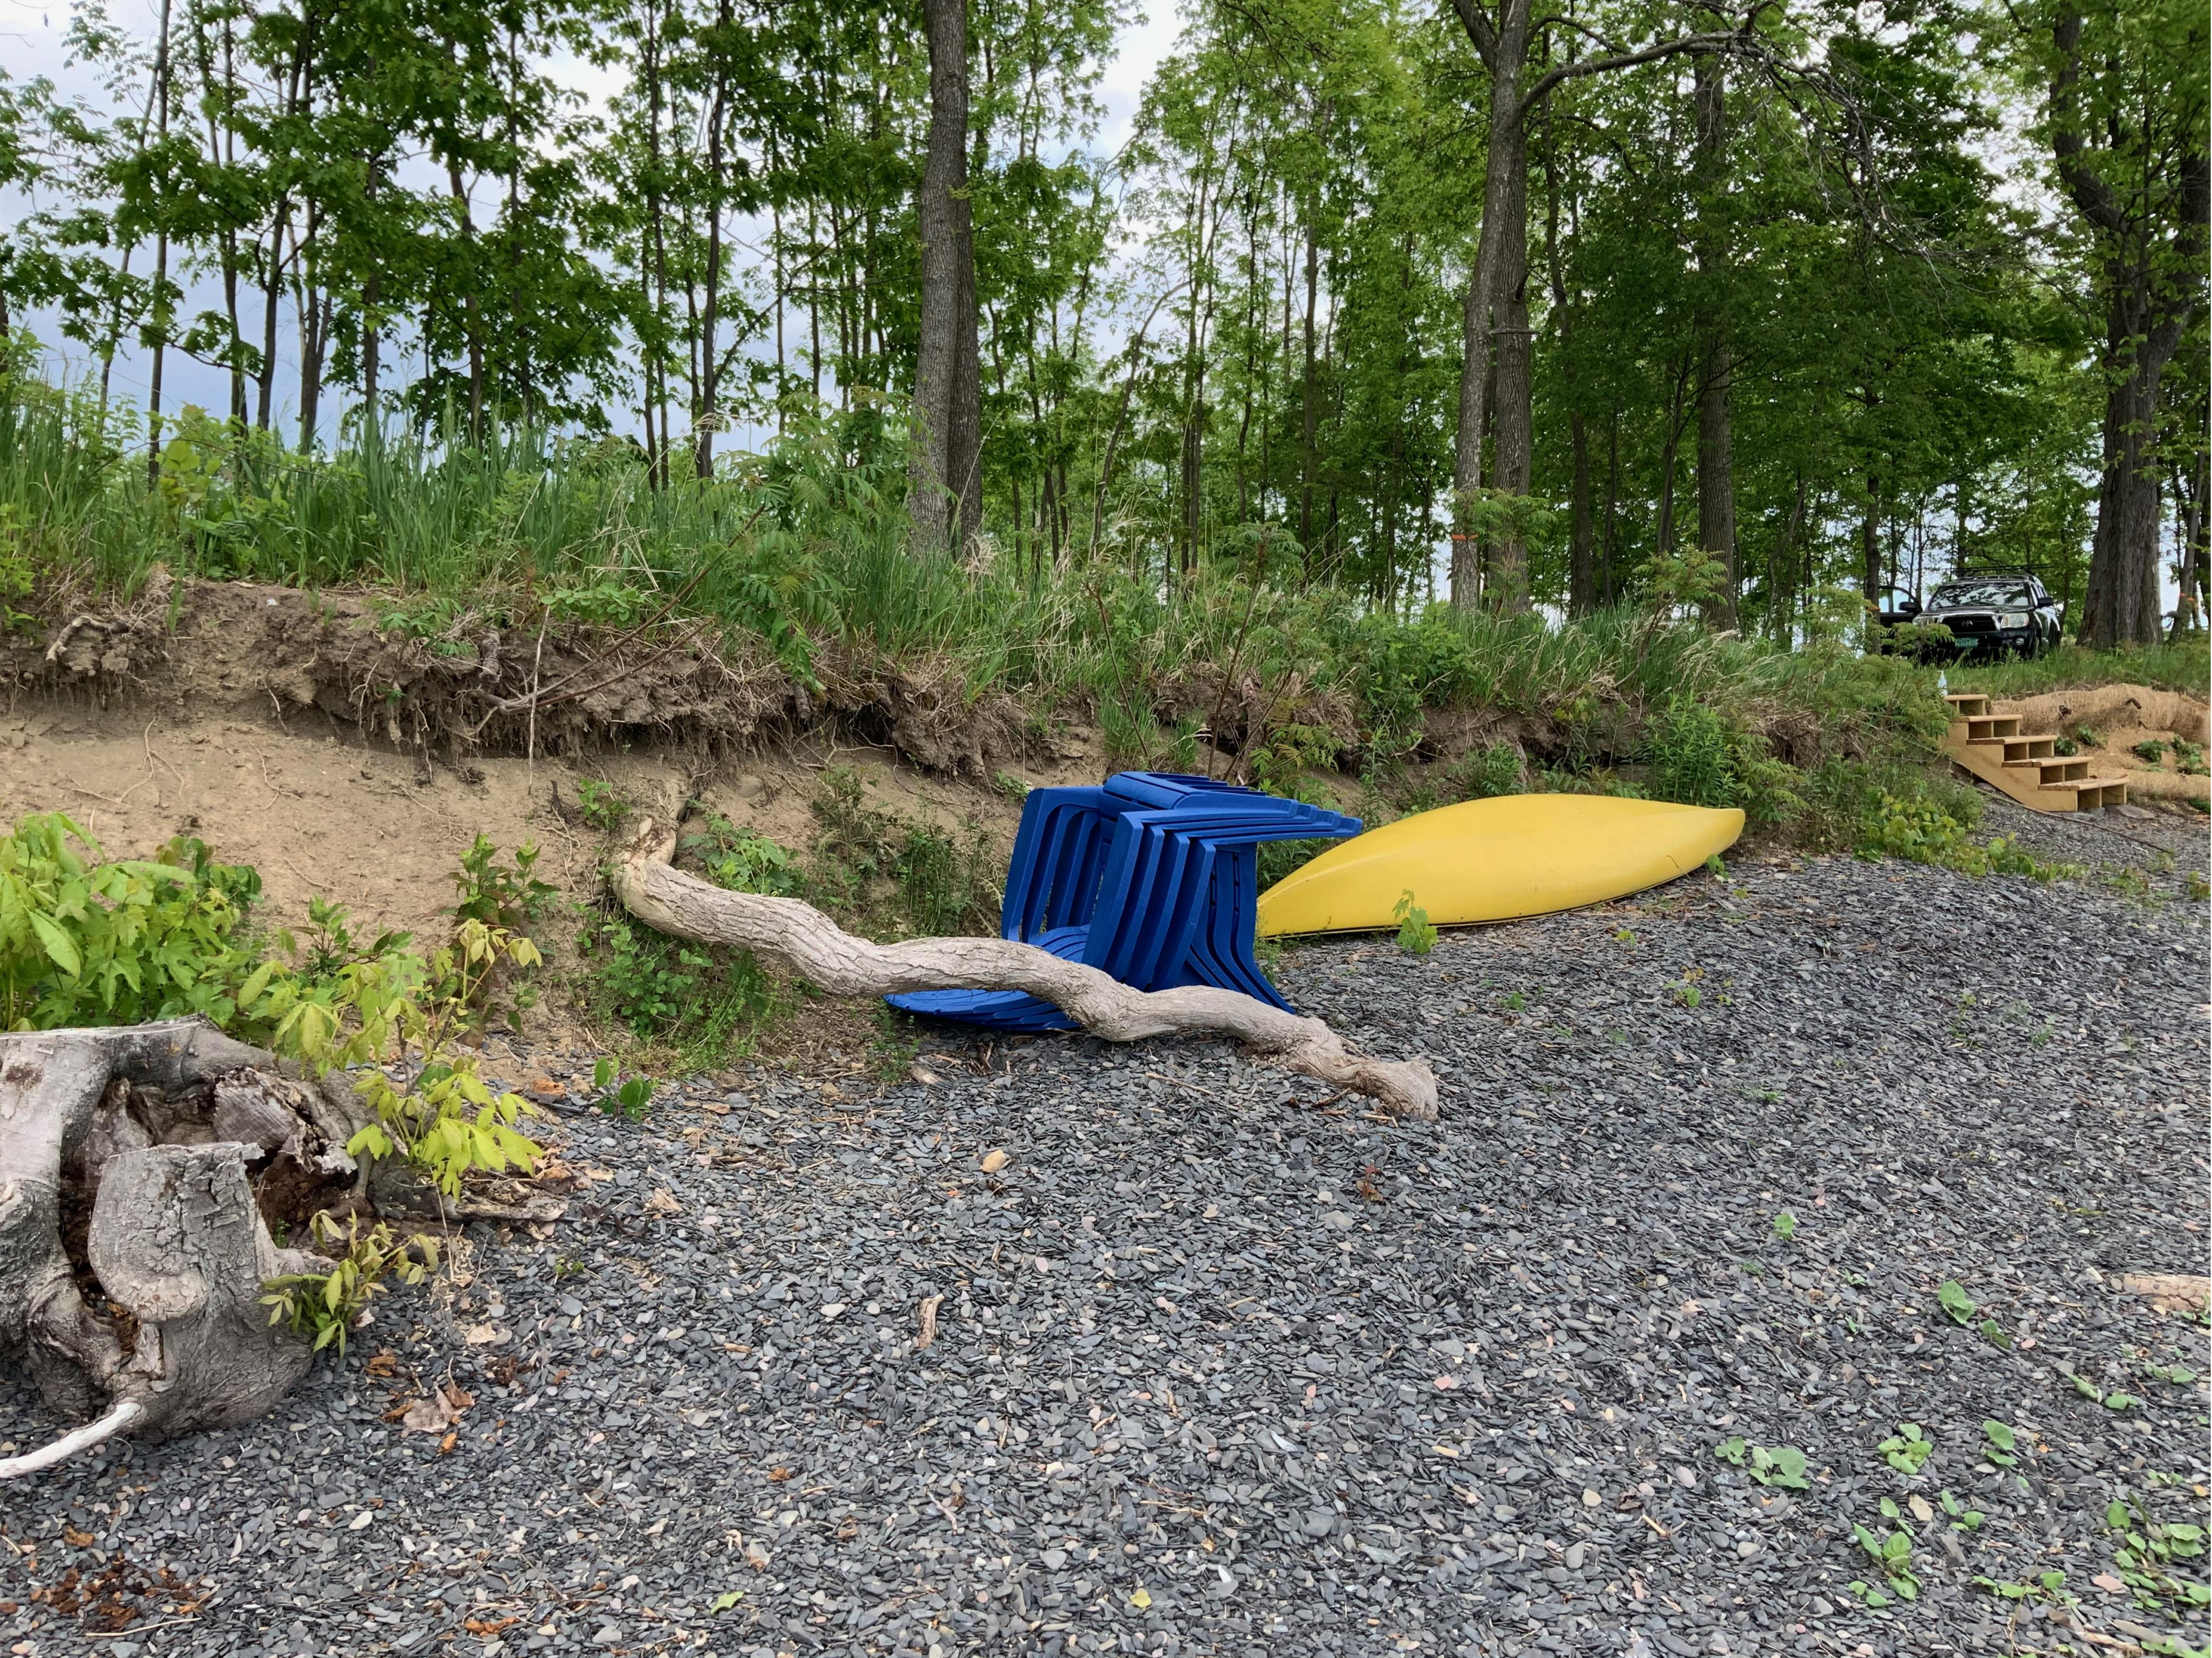
# Eroding, undercut bank from 2011 floods

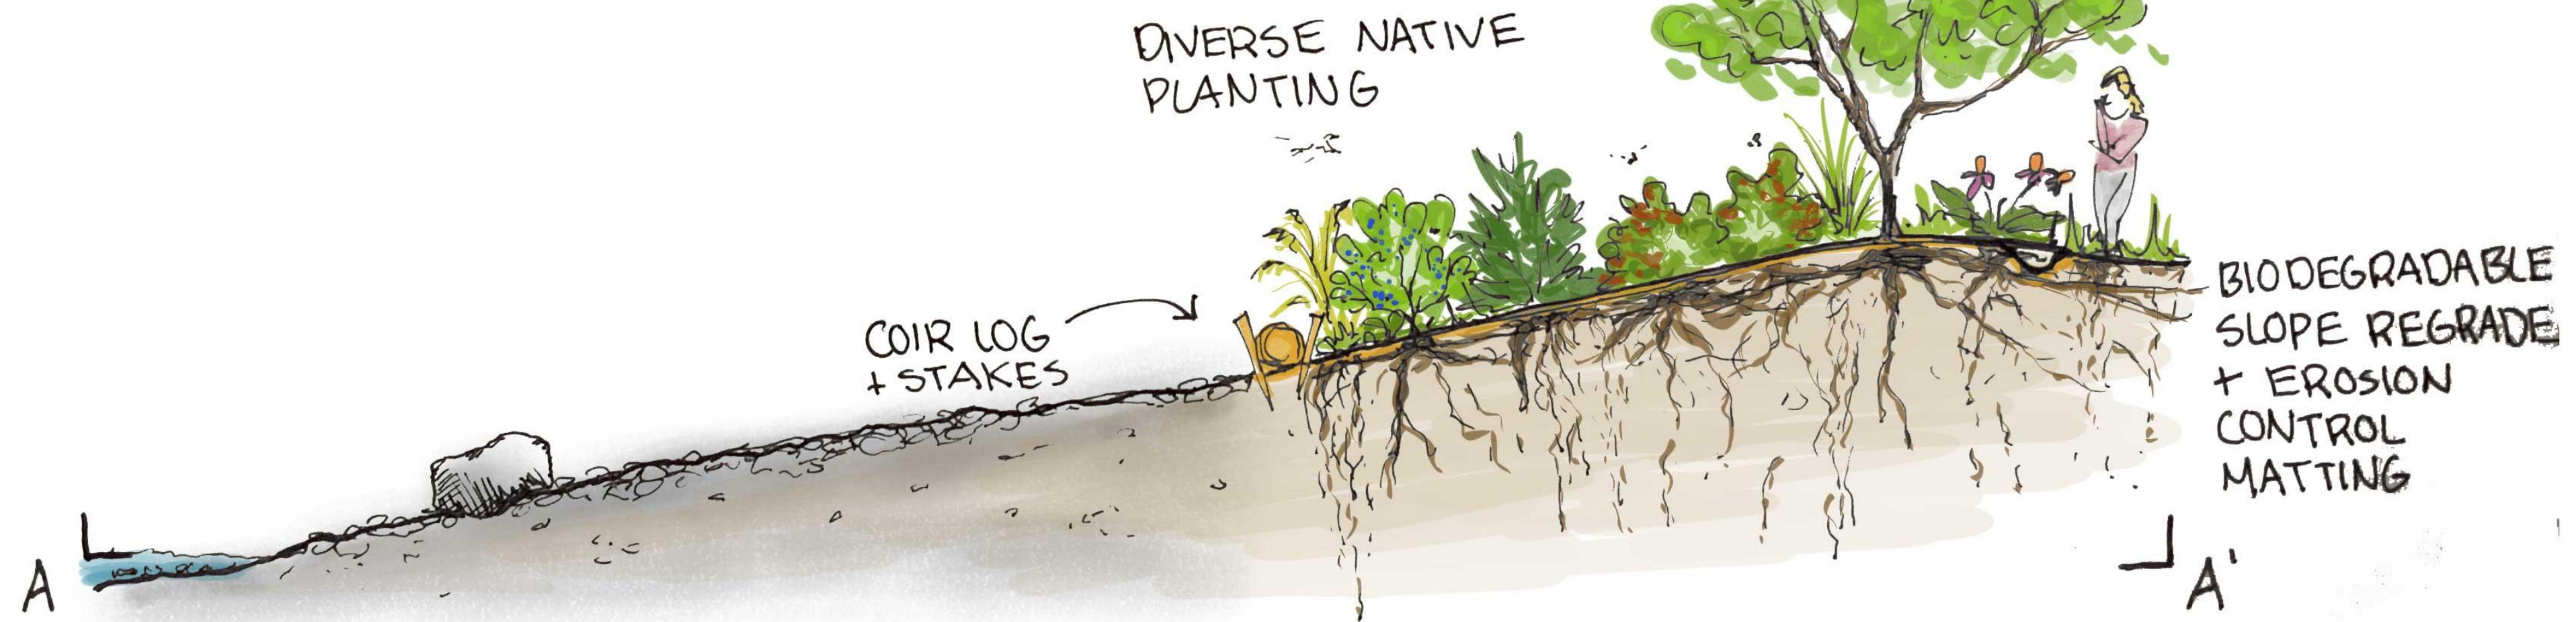
SECTION A-A' : PROPOSED BANK REGRADING & VEGETATION

SCALE: 1" = 5'

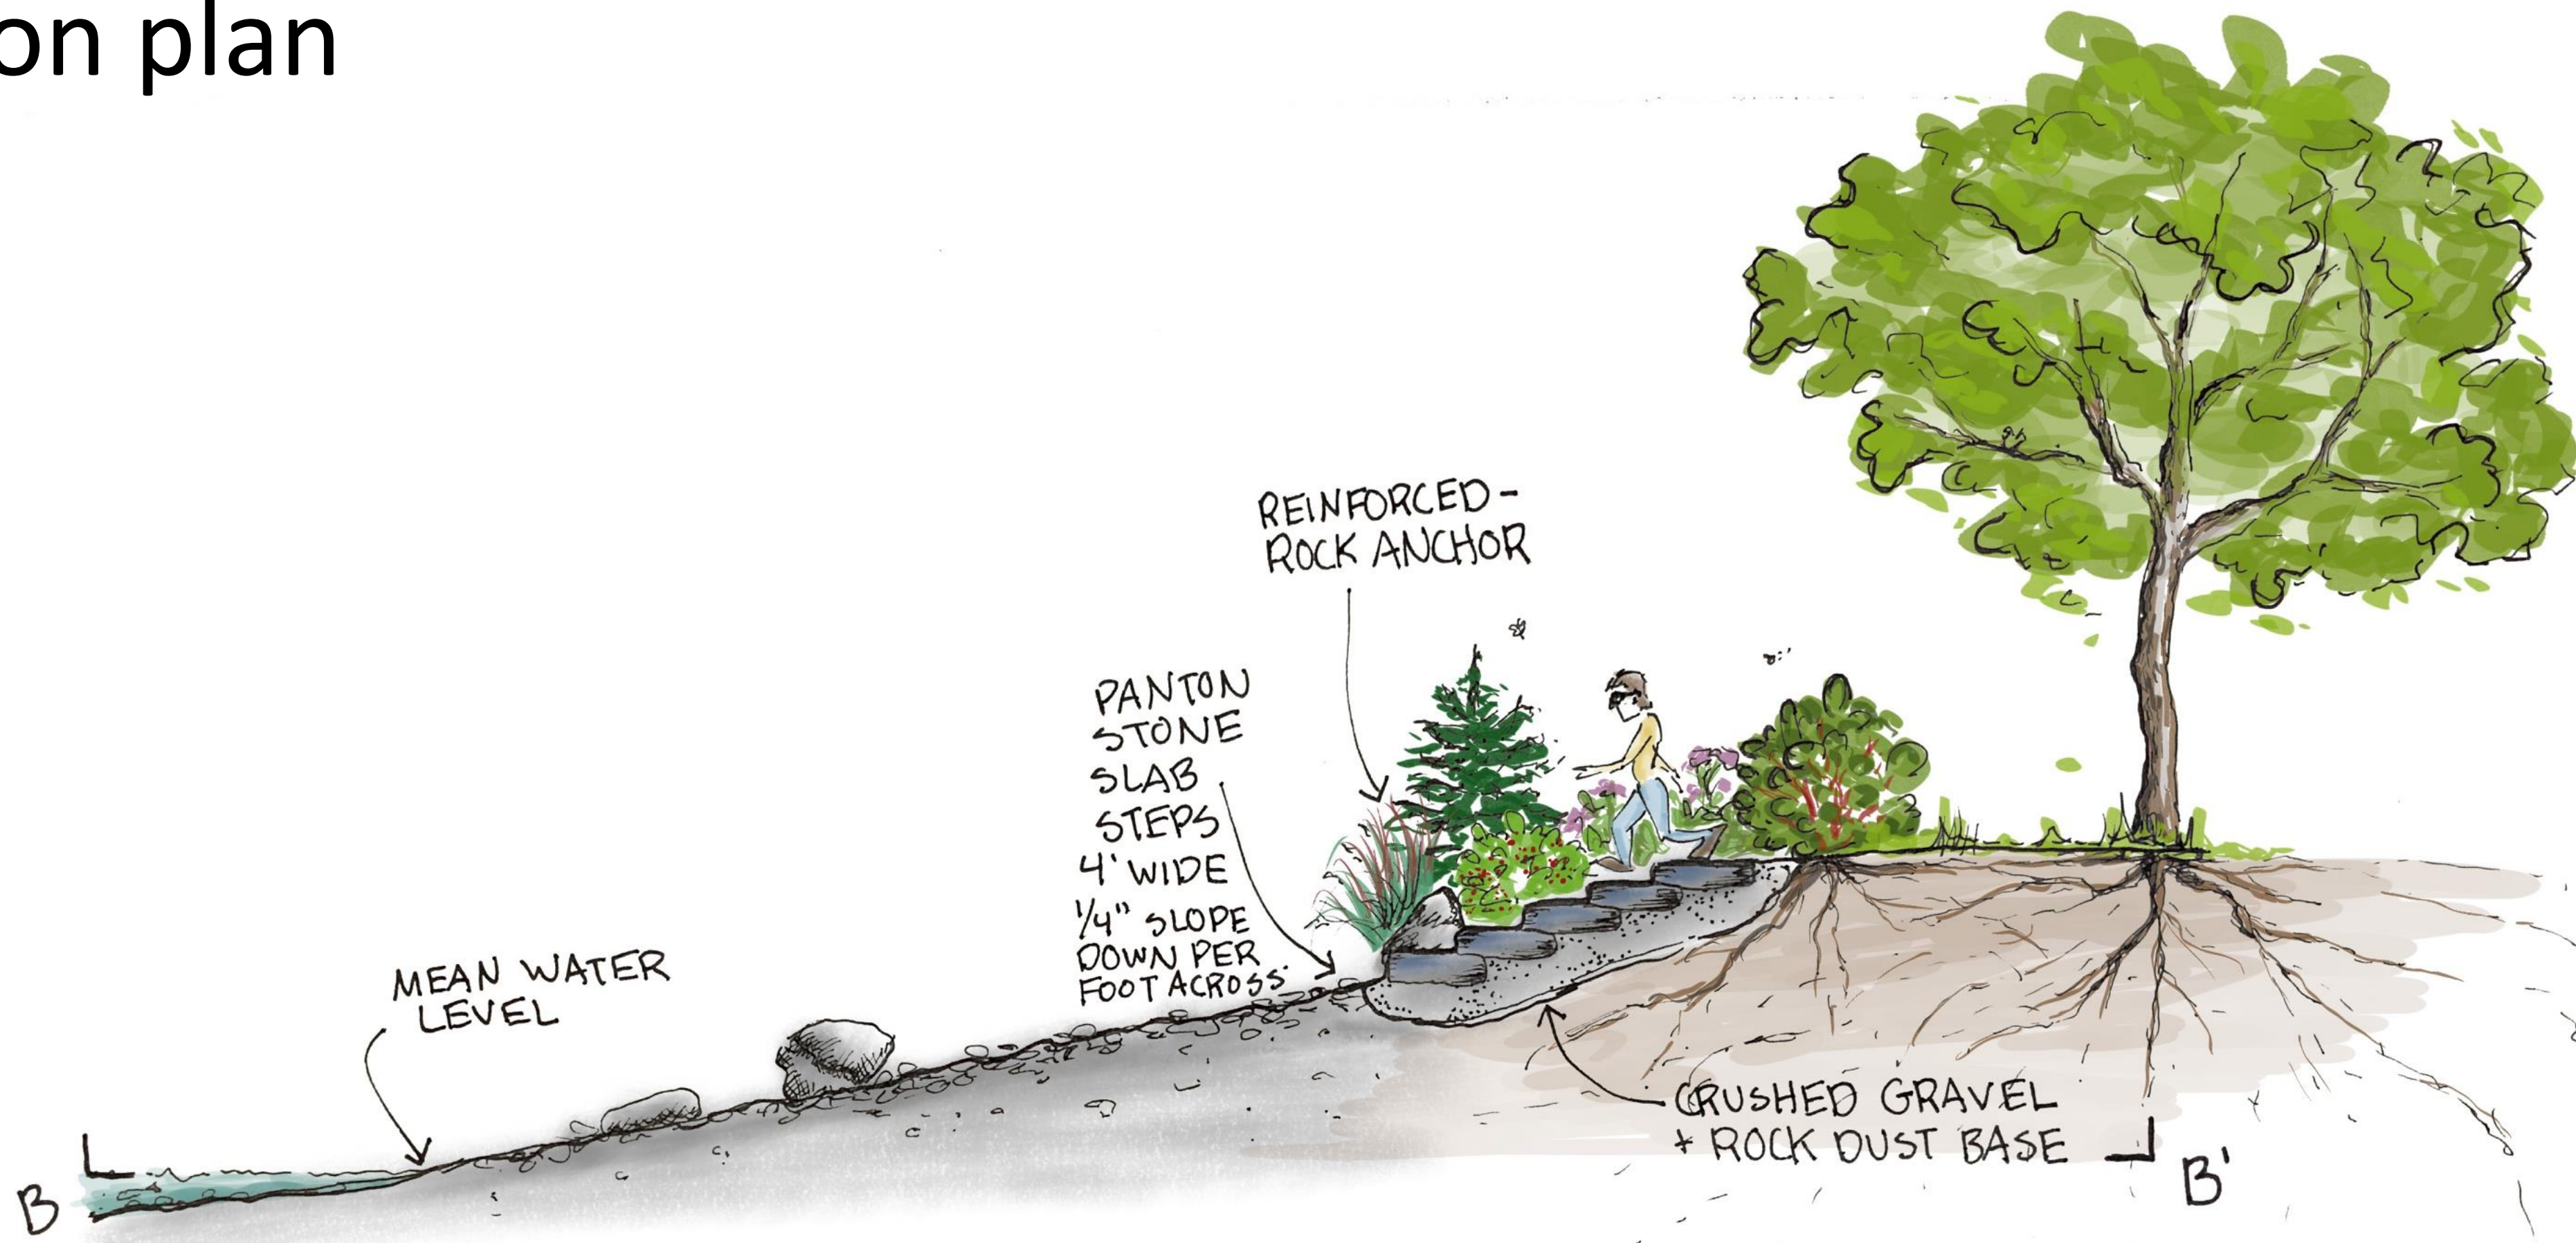
SECTION B-B' : PROPOSED STONE SLAB STAIRWAY

SCALE: 1" = 5'

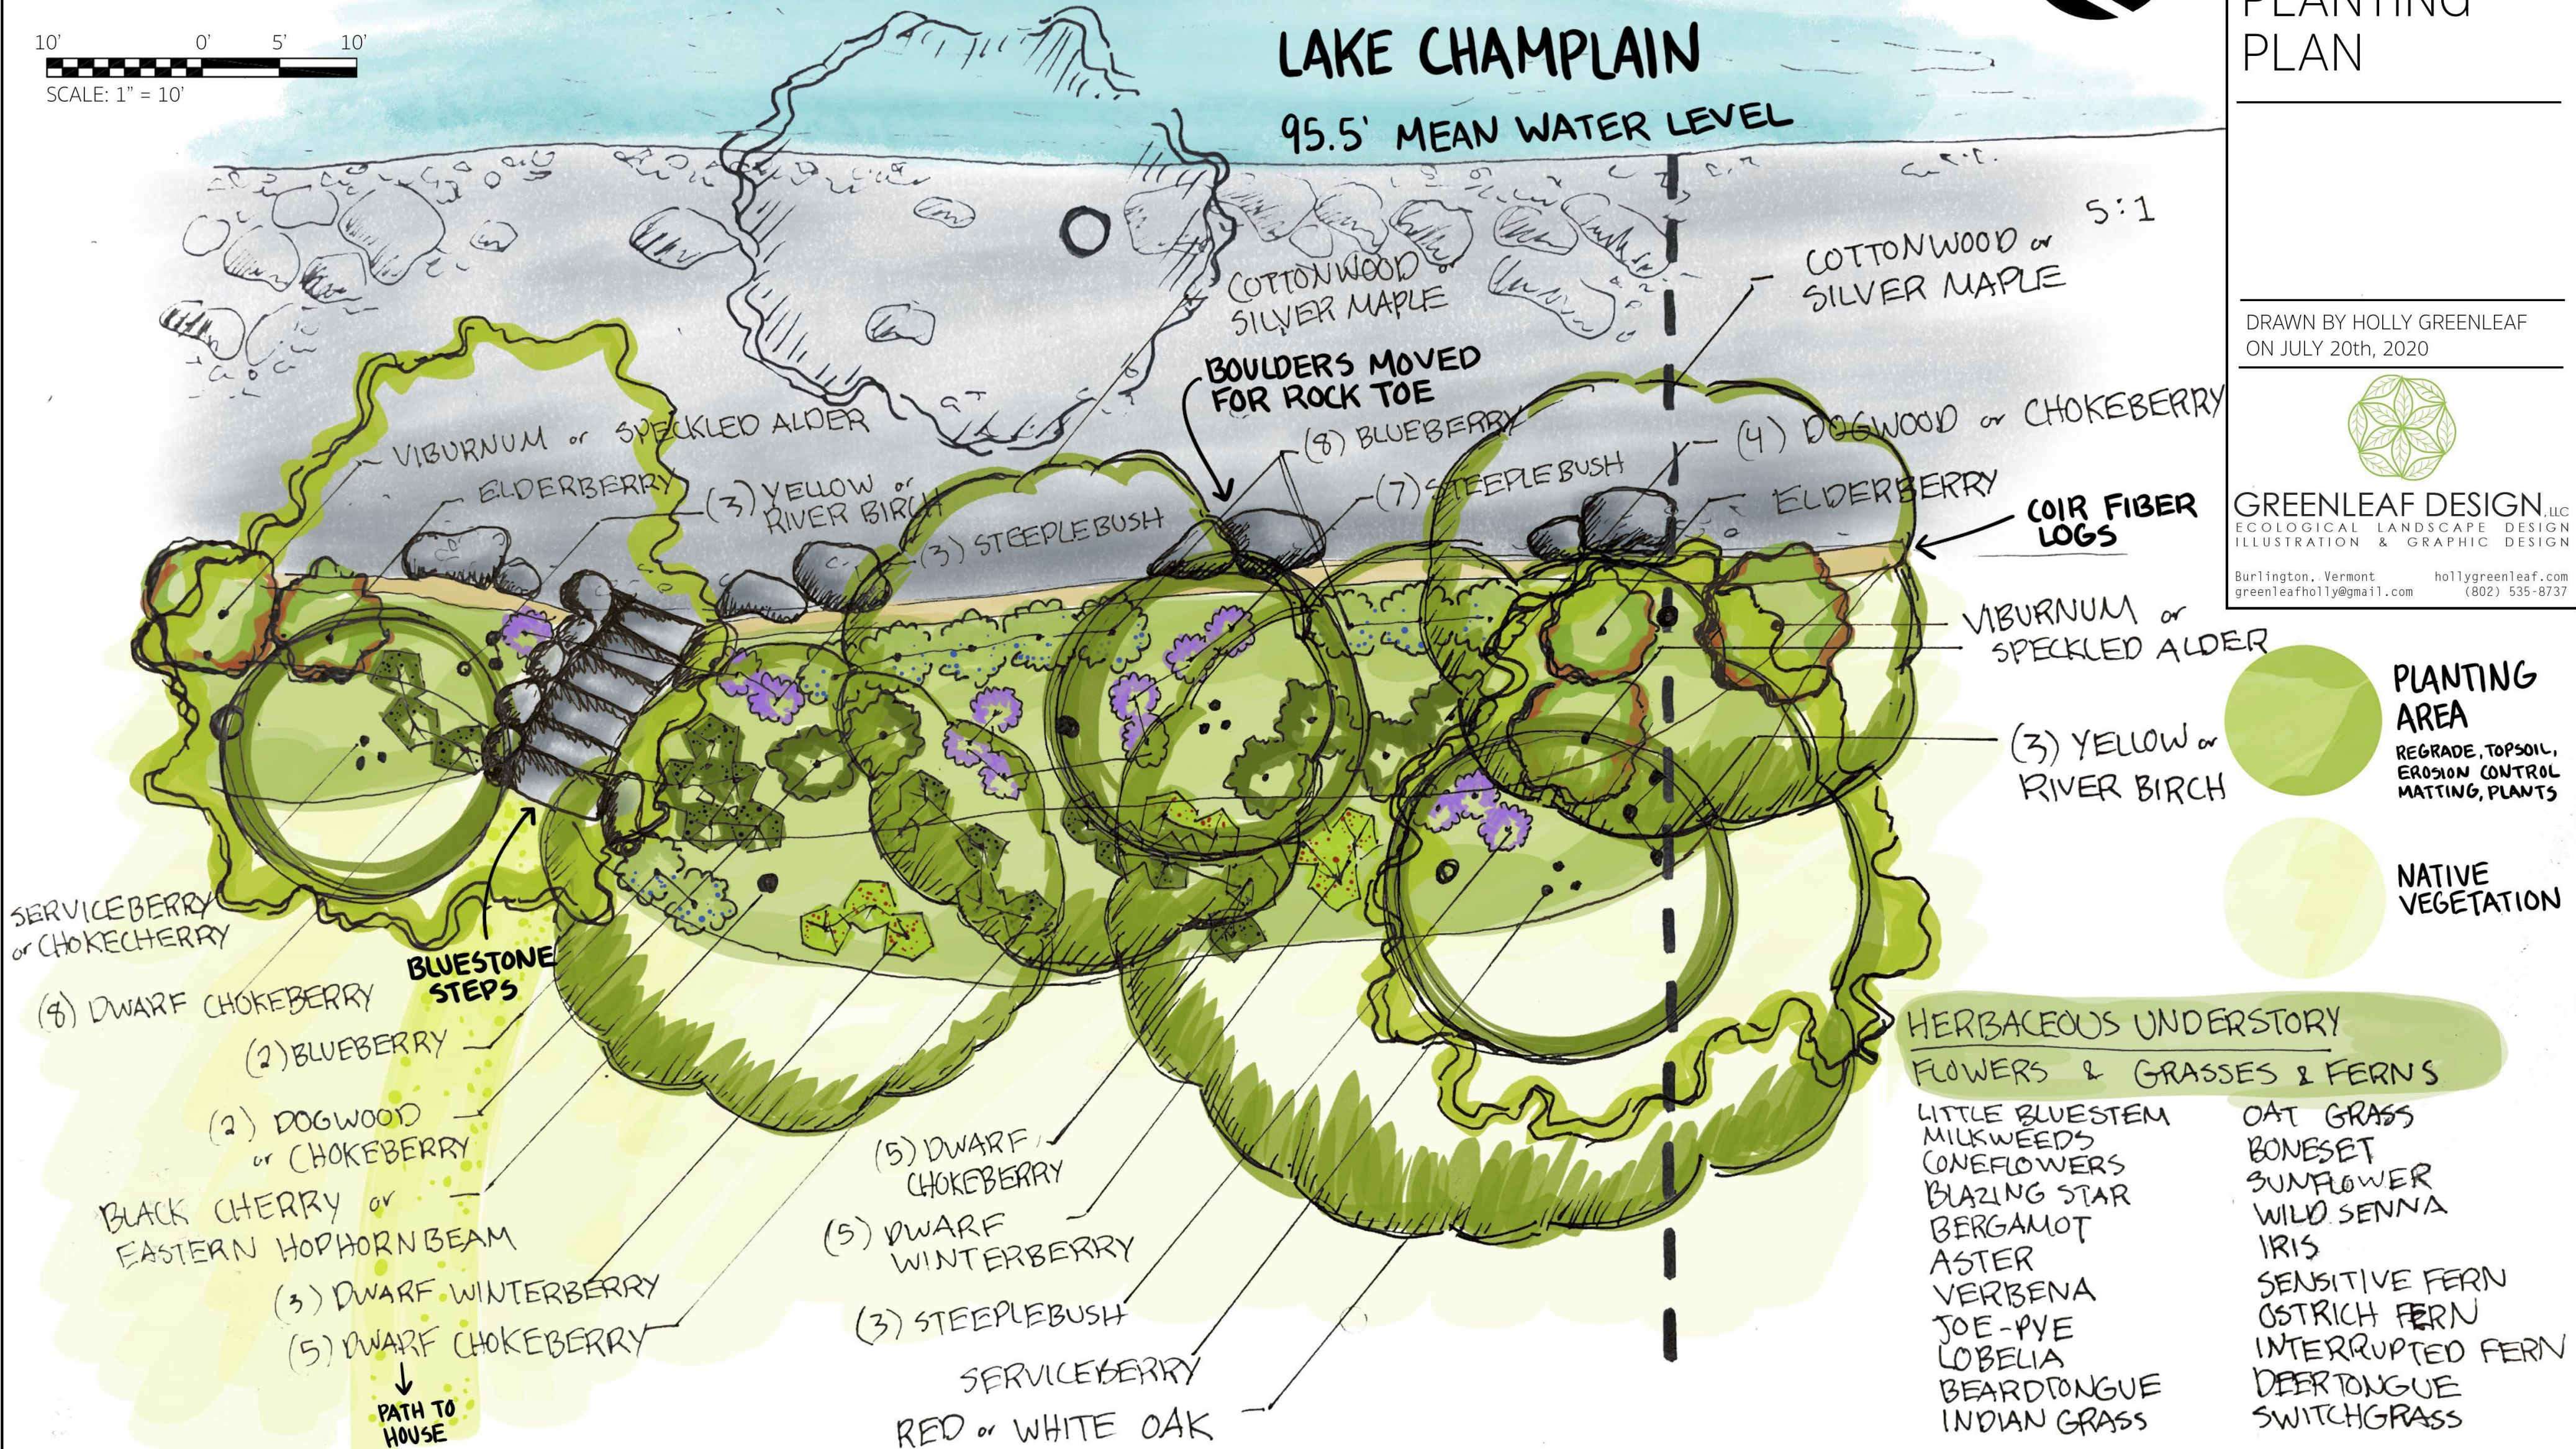
# LAKESHORE RESTORATION PLANTING PLAN

10' 0' 5' 10'  
SCALE: 1" = 10'

95.5' MEAN WATER LEVEL
