# Bioengineering case study:

Planting Approaches  
for Bank Regrade &  
Erosion Control

**Holly Greenleaf**  
**January 8<sup>th</sup> & 10<sup>th</sup>, 2025**  
**NSECC Training**

# 4 PLANTING APPROACHES TO RESTORE & STABILIZE THE BANK

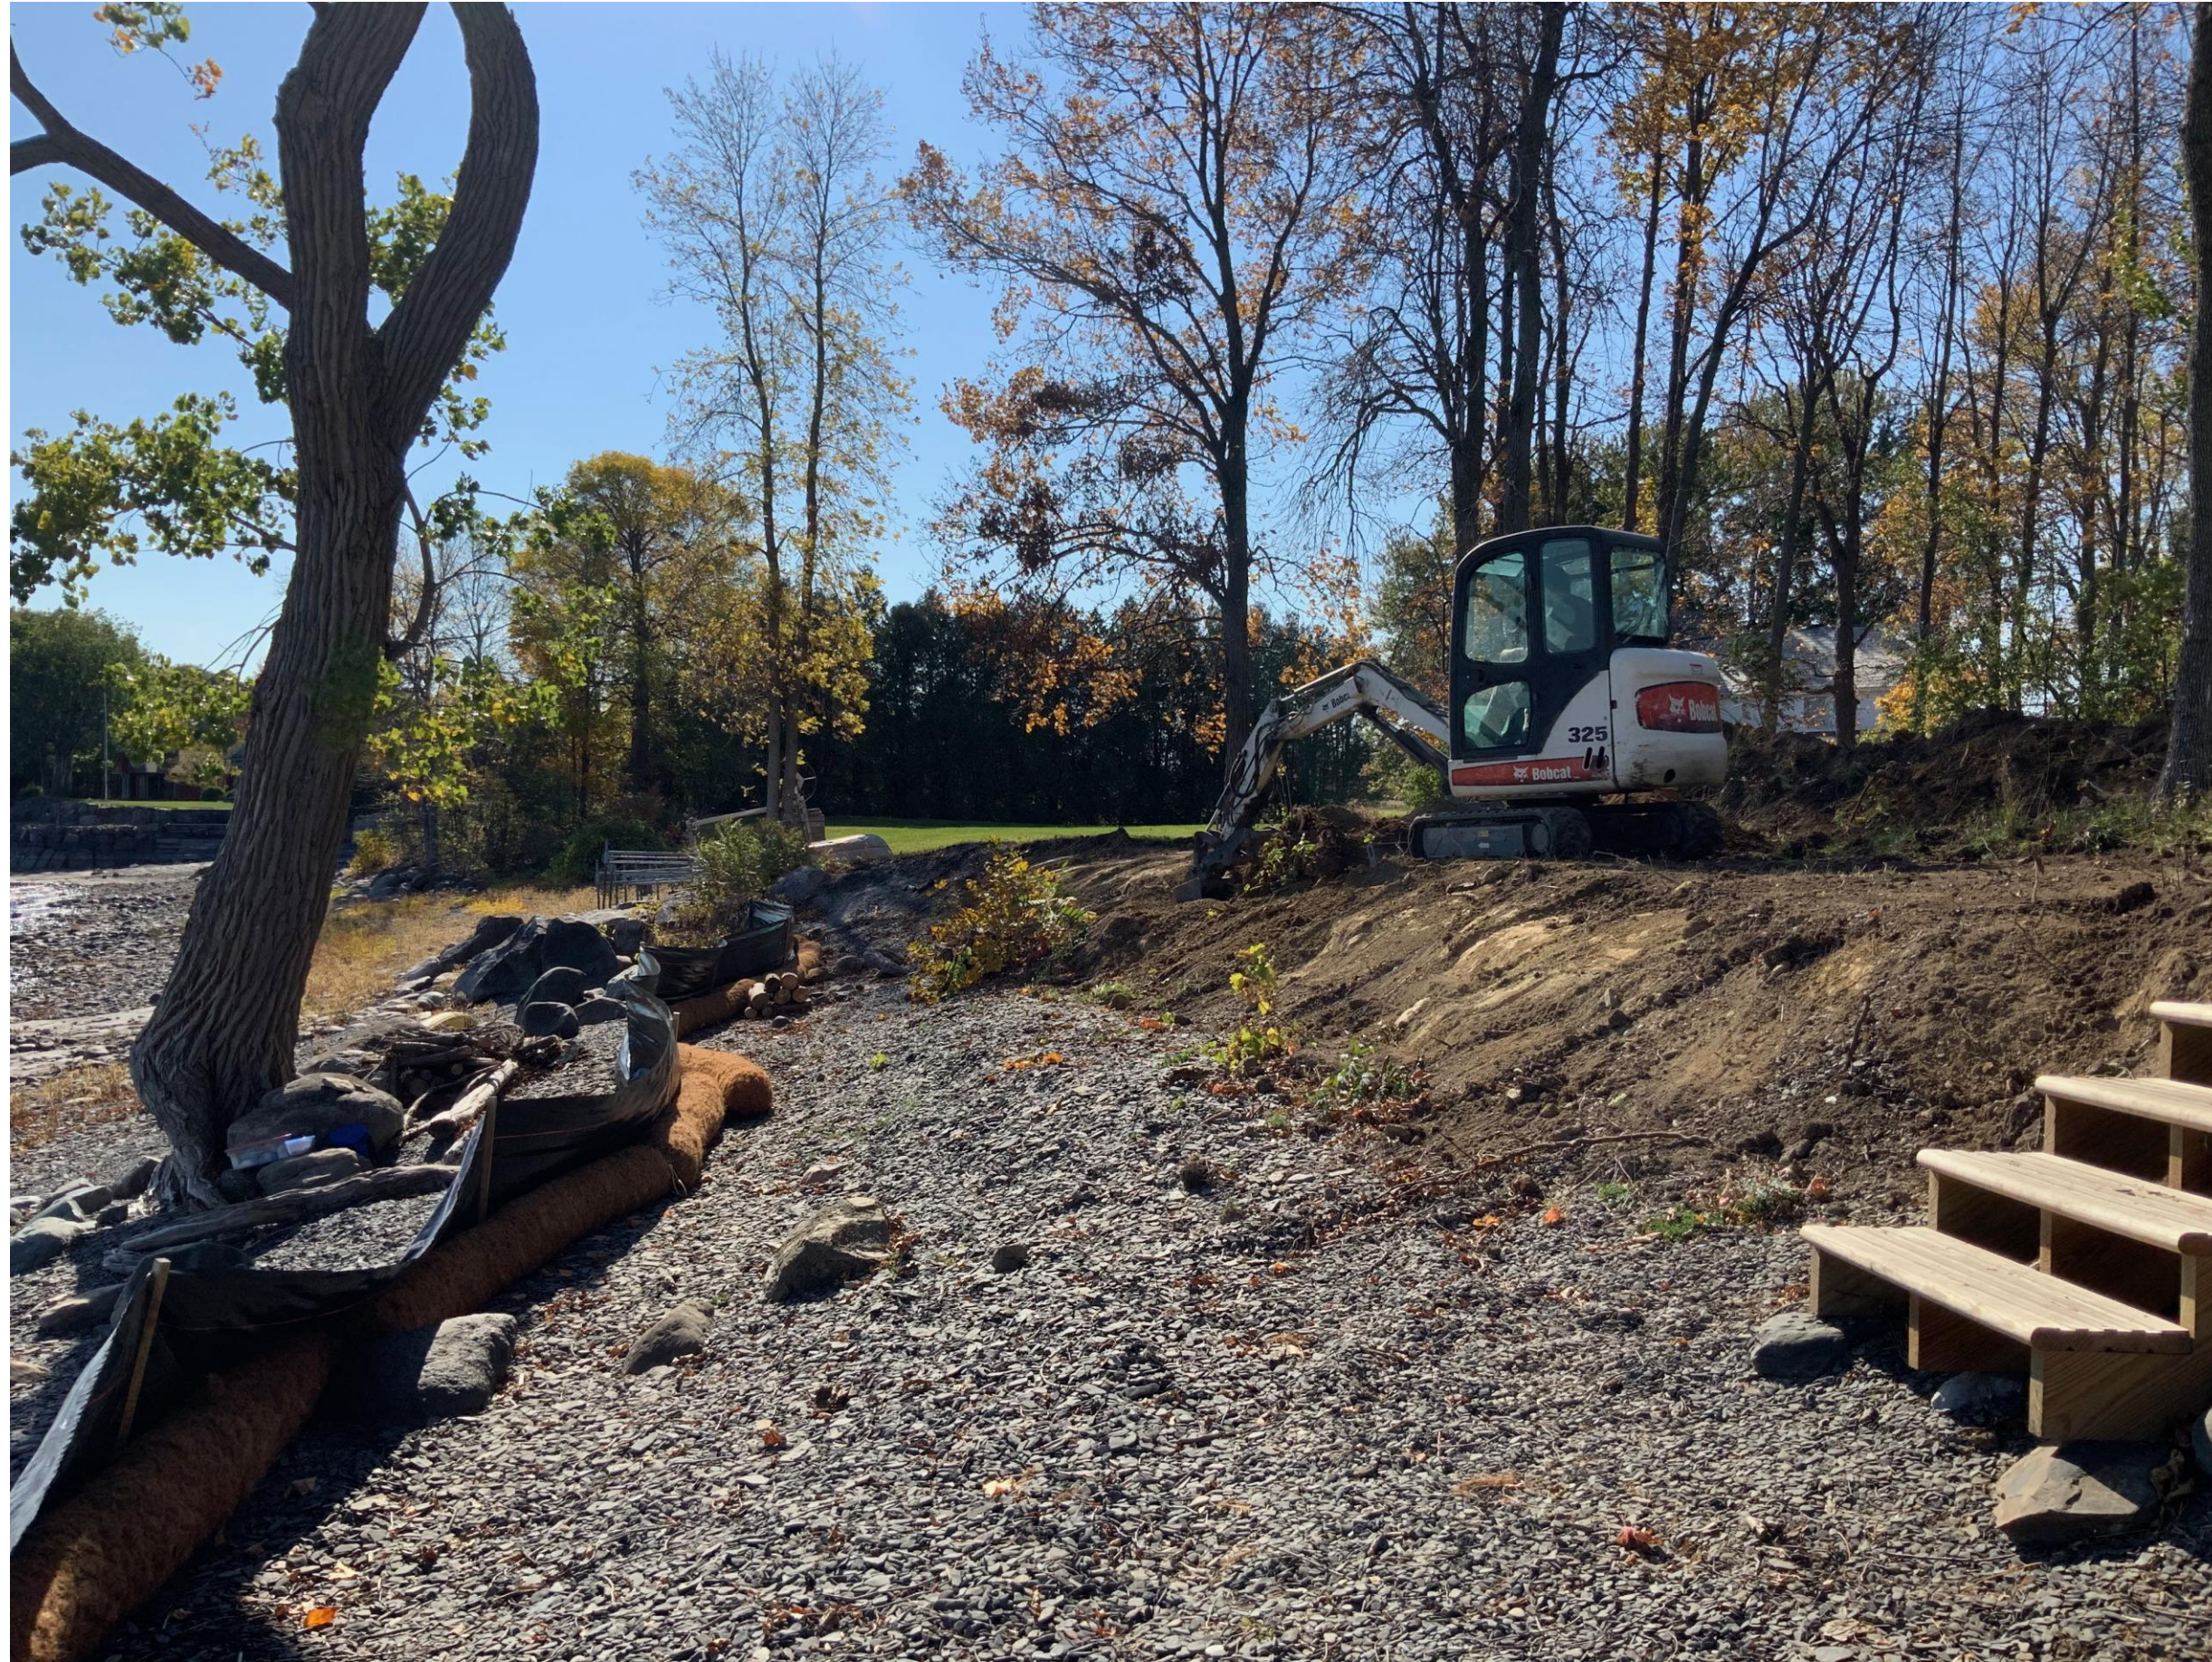
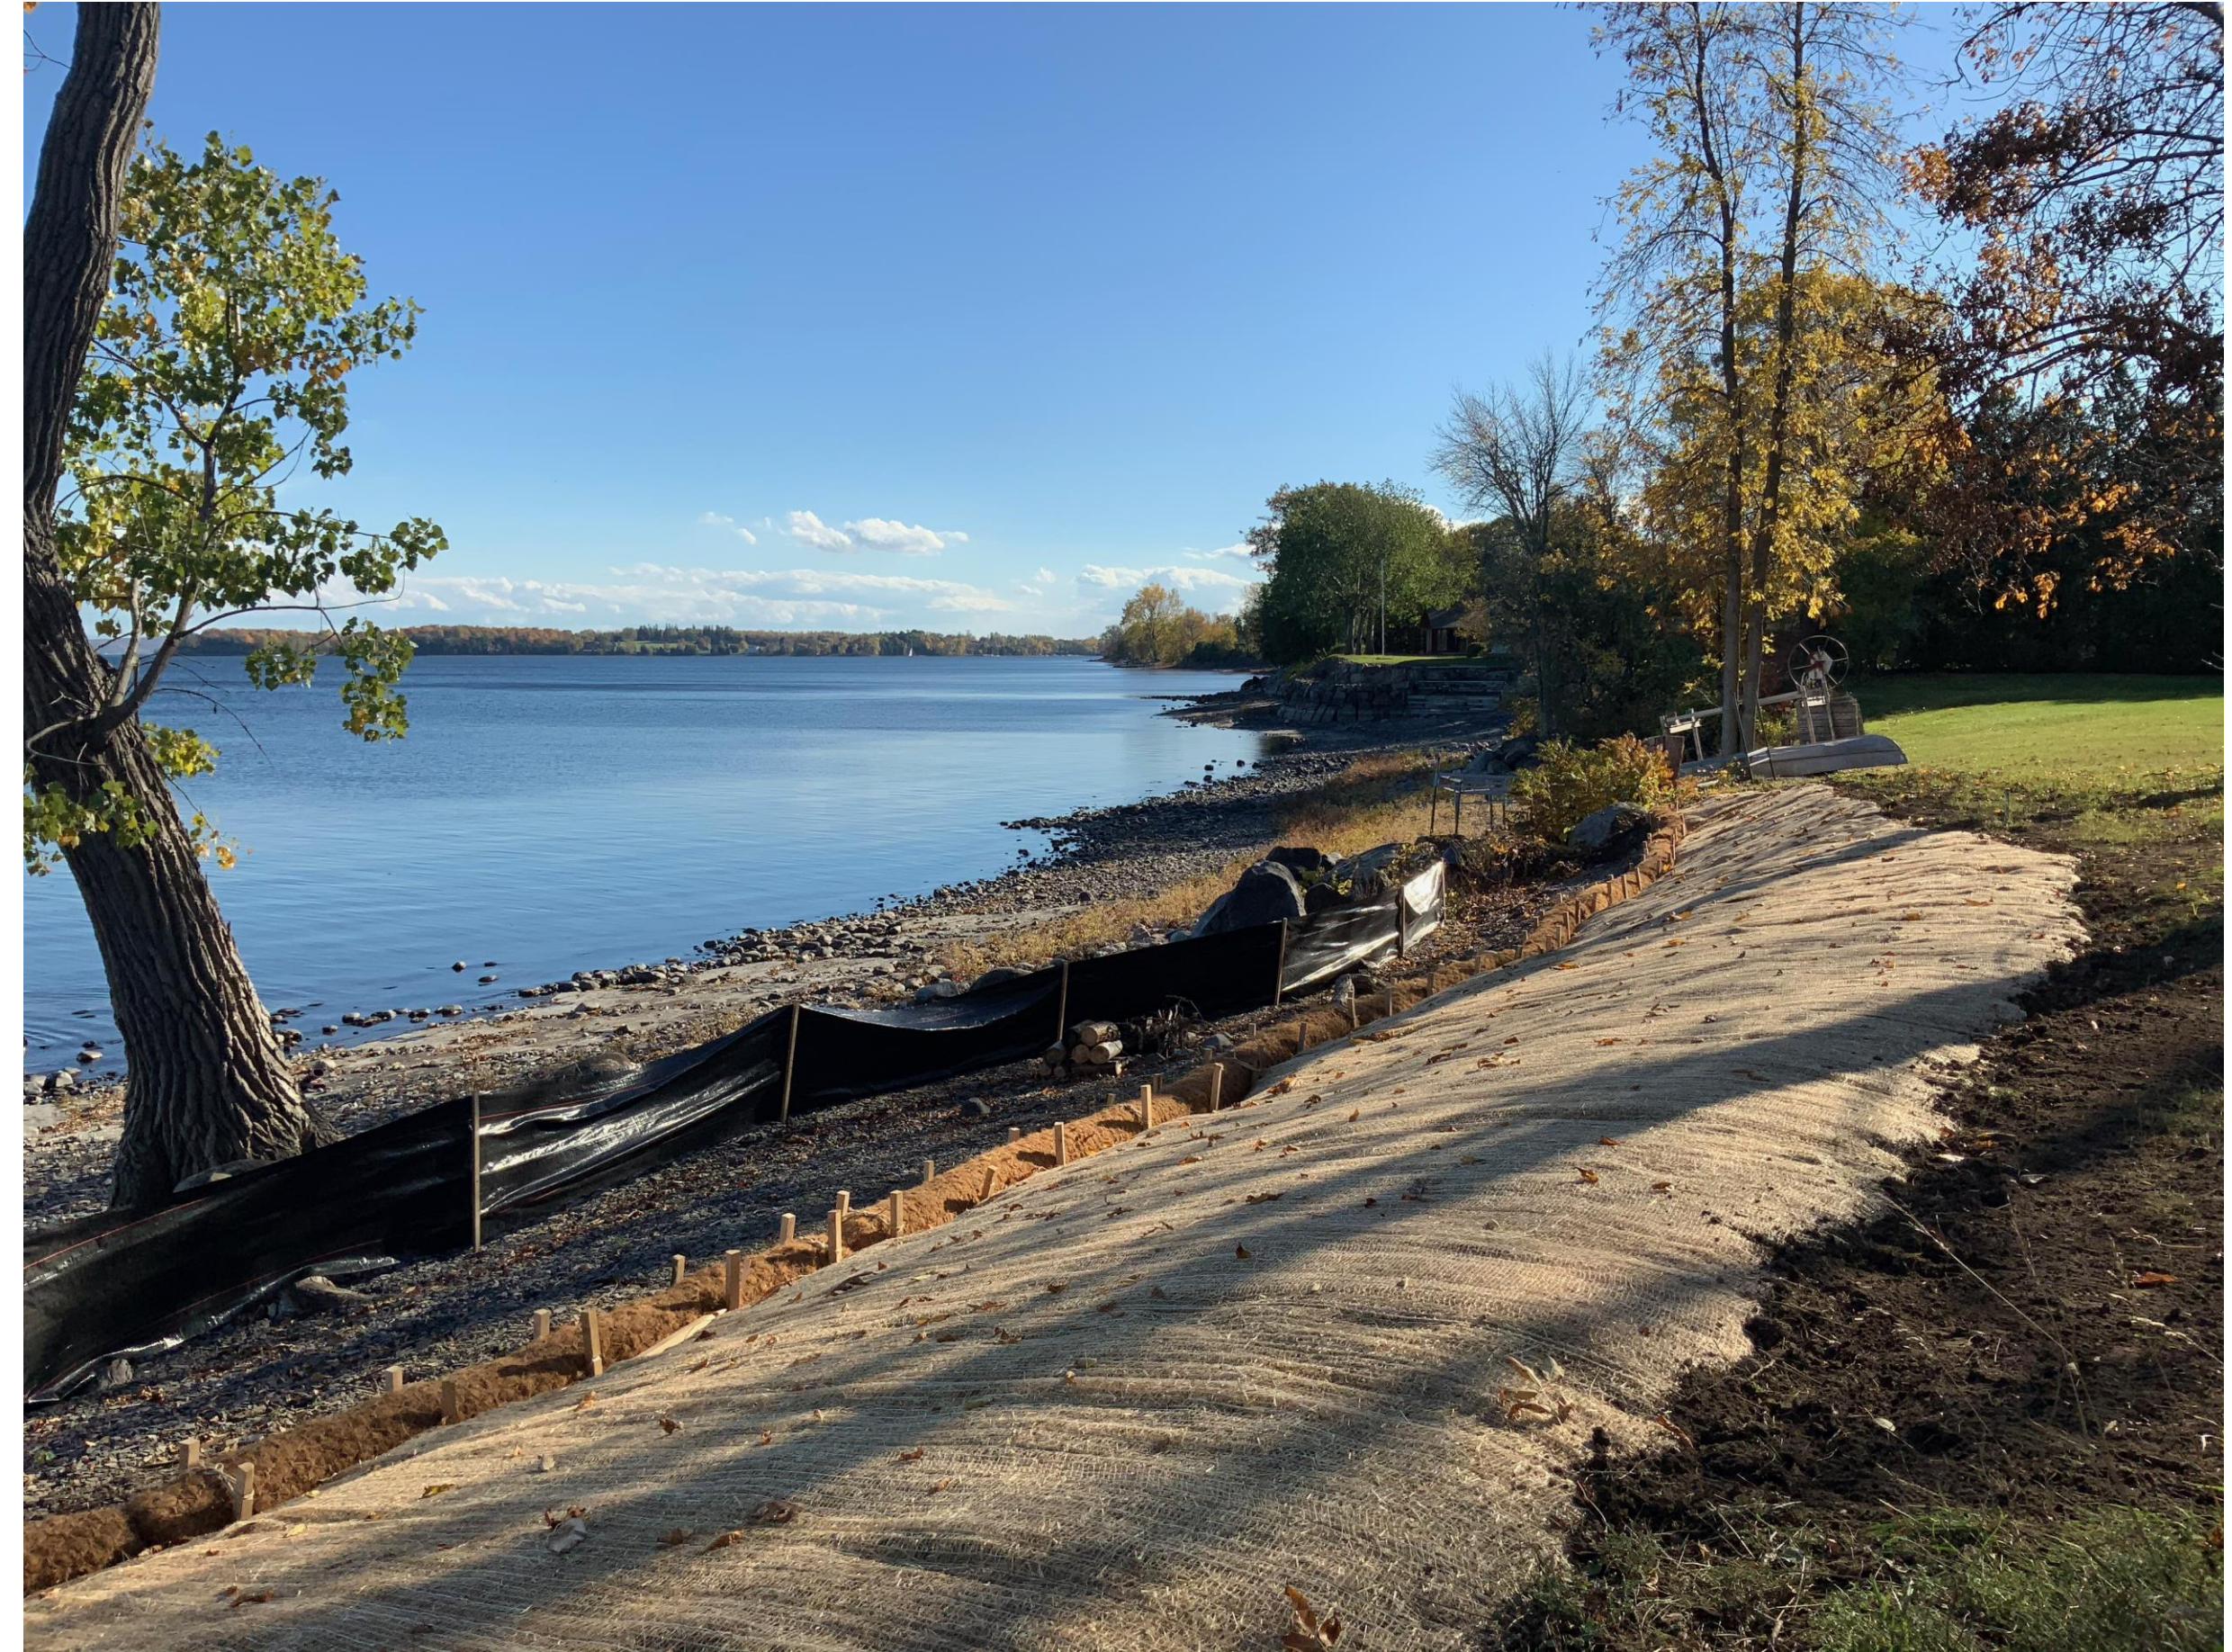
# Regrade, EROSION CONTROL, plant

Topsoil, Erosion Control Matting/Blankets (ECB) (SC 150BN), Coconut coir logs (12" diameter x 10' long)

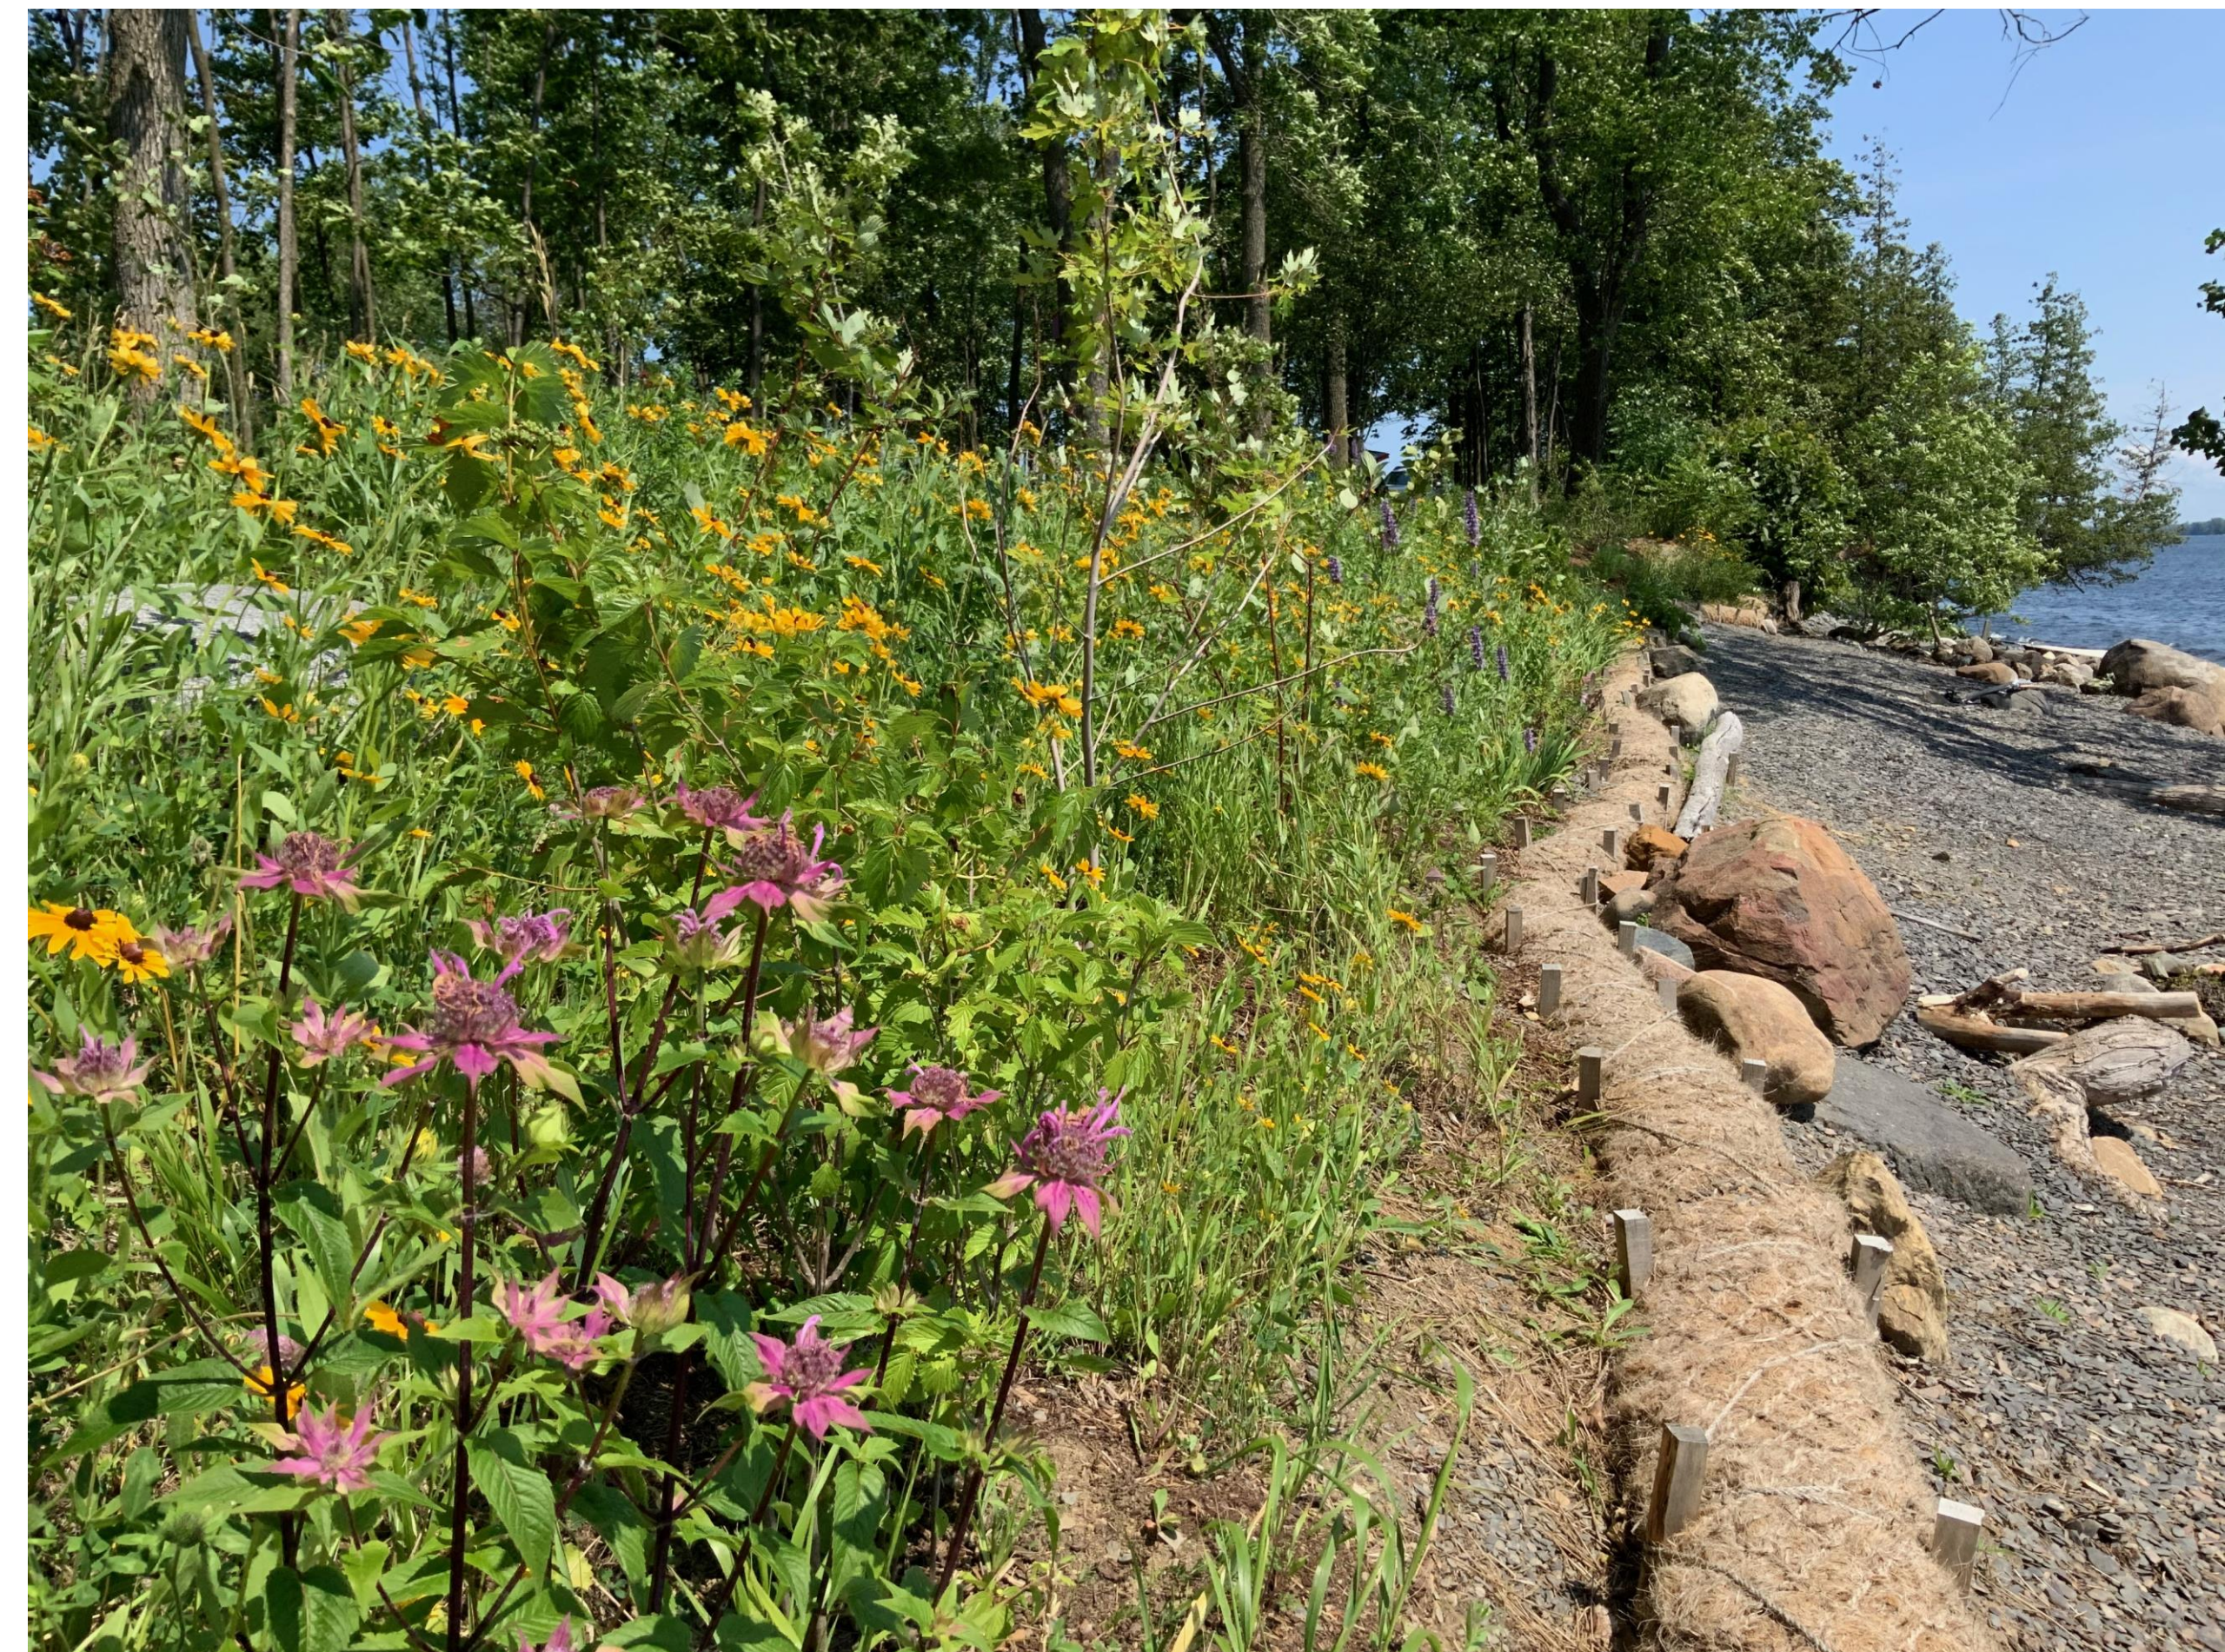
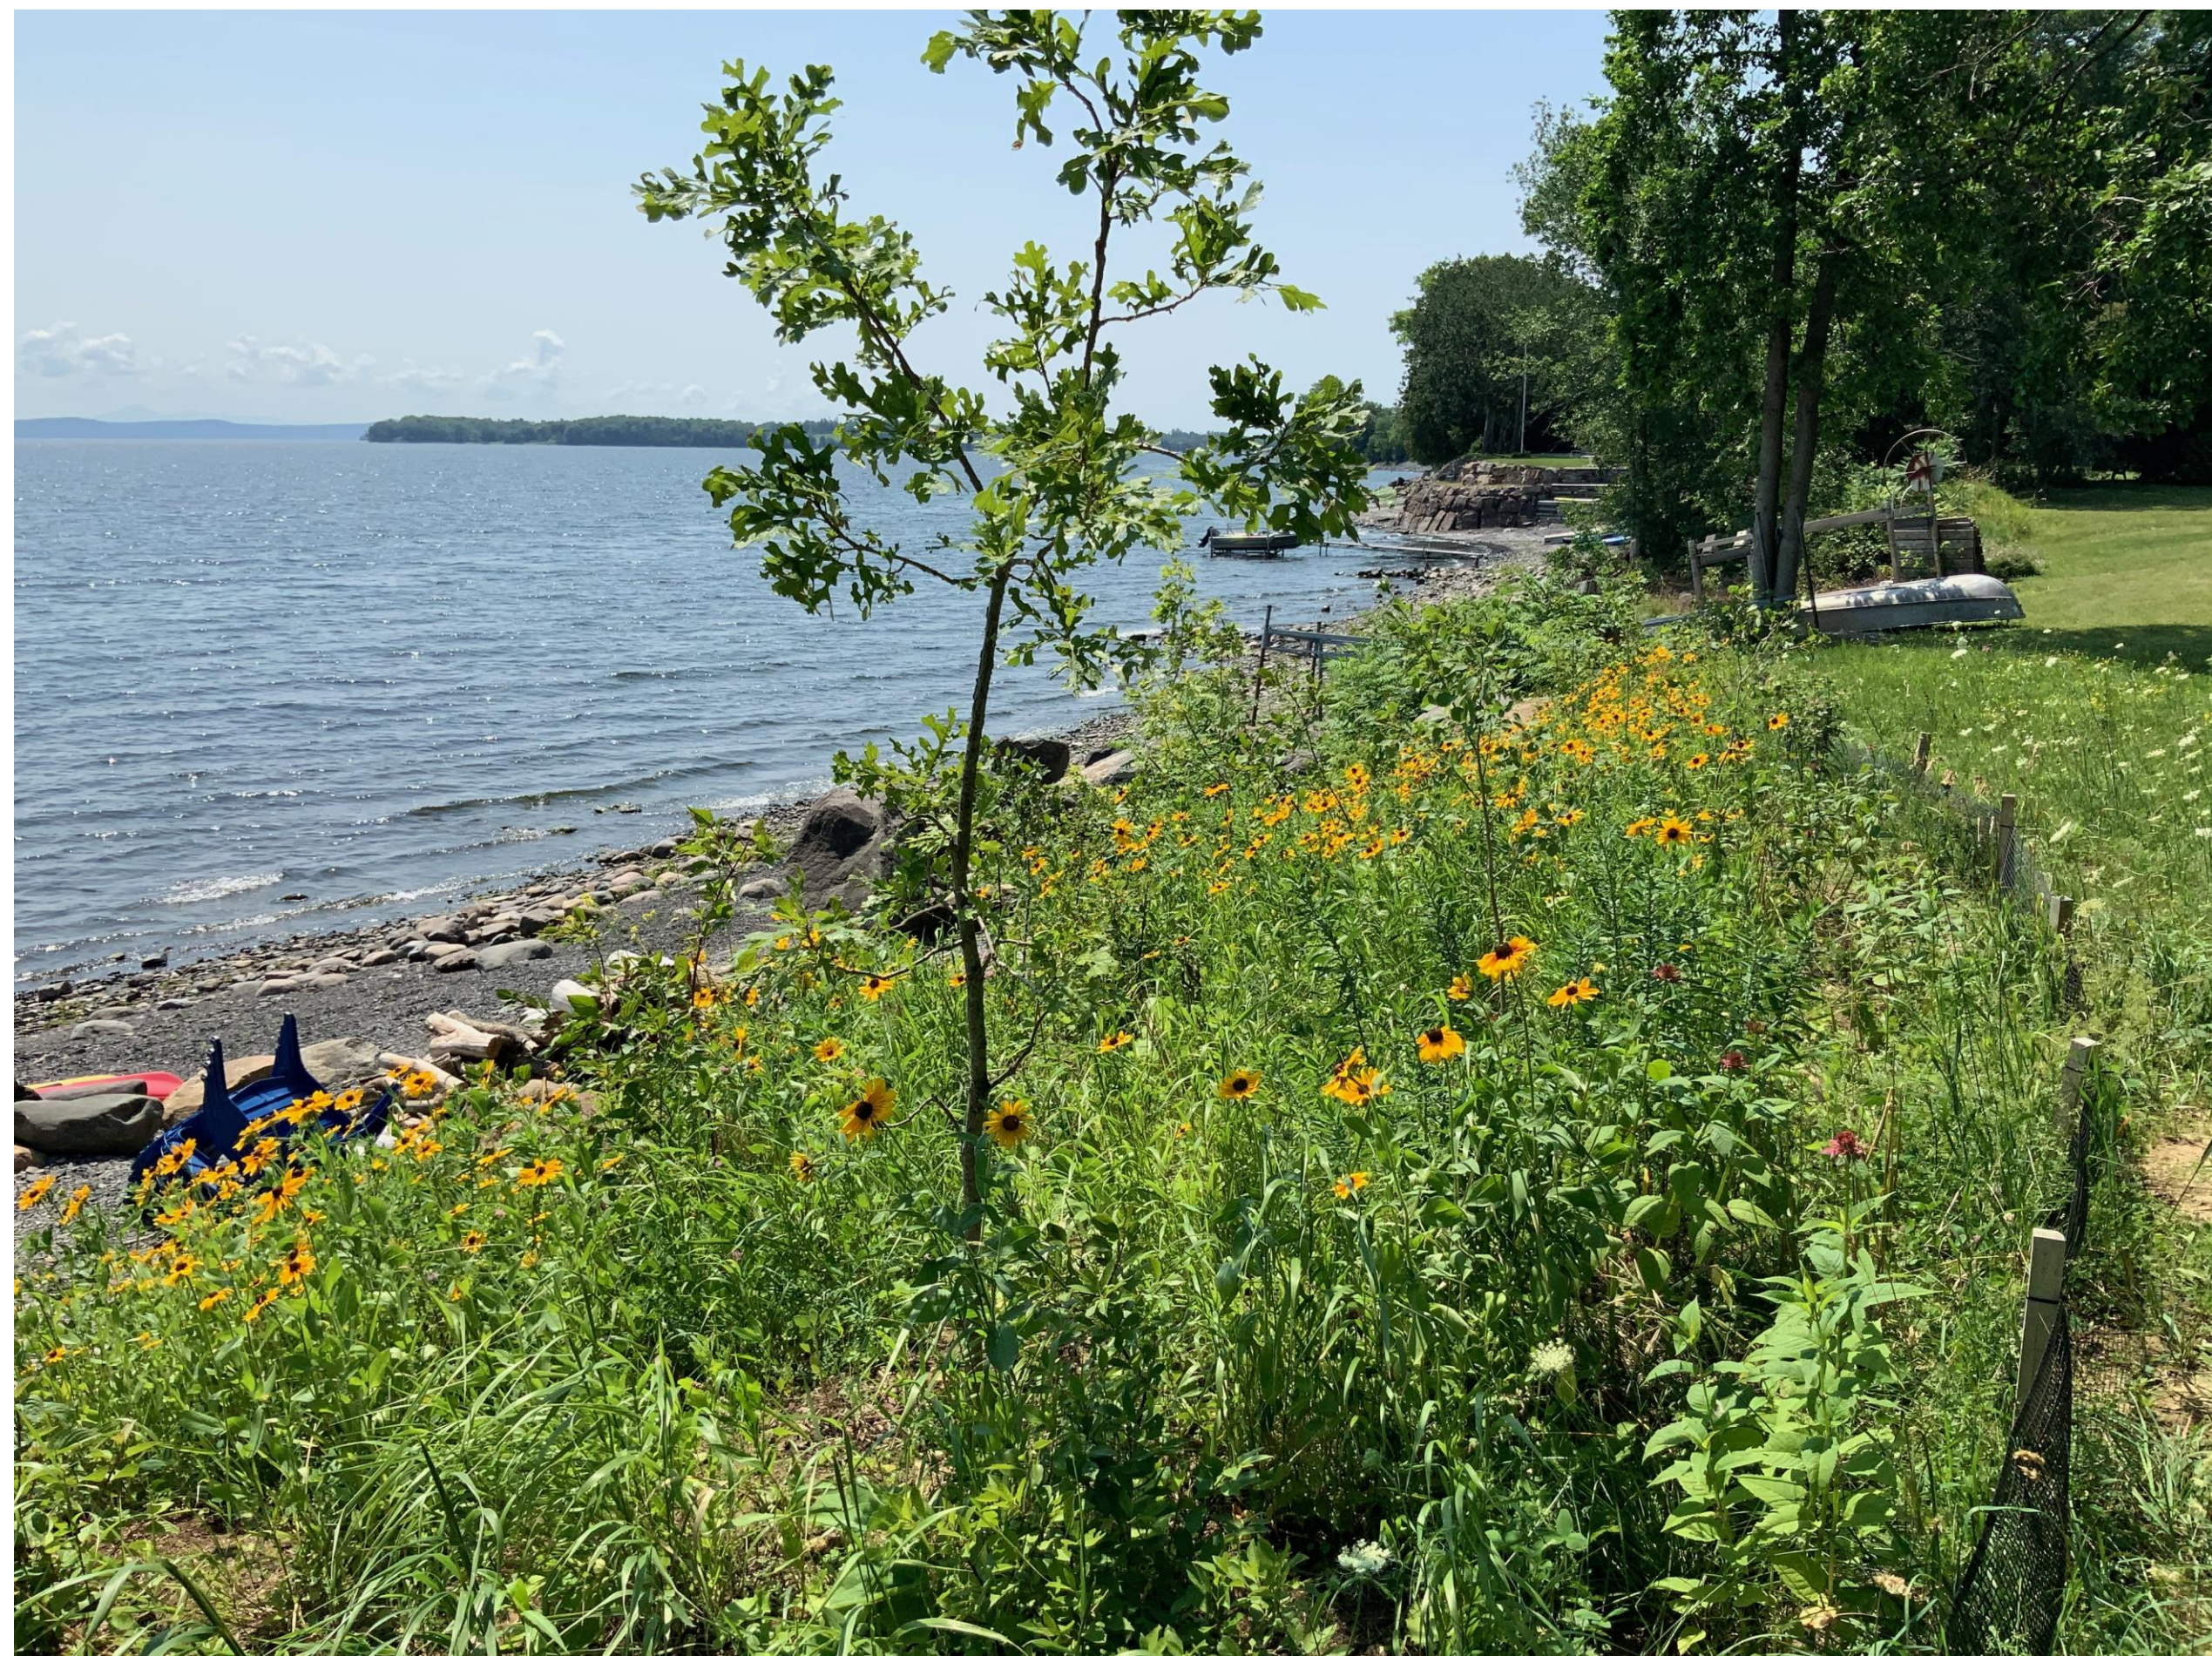
# Successional meadow > woodland

Native Perennial Flower & Grass Mix, Native Trees & Shrubs

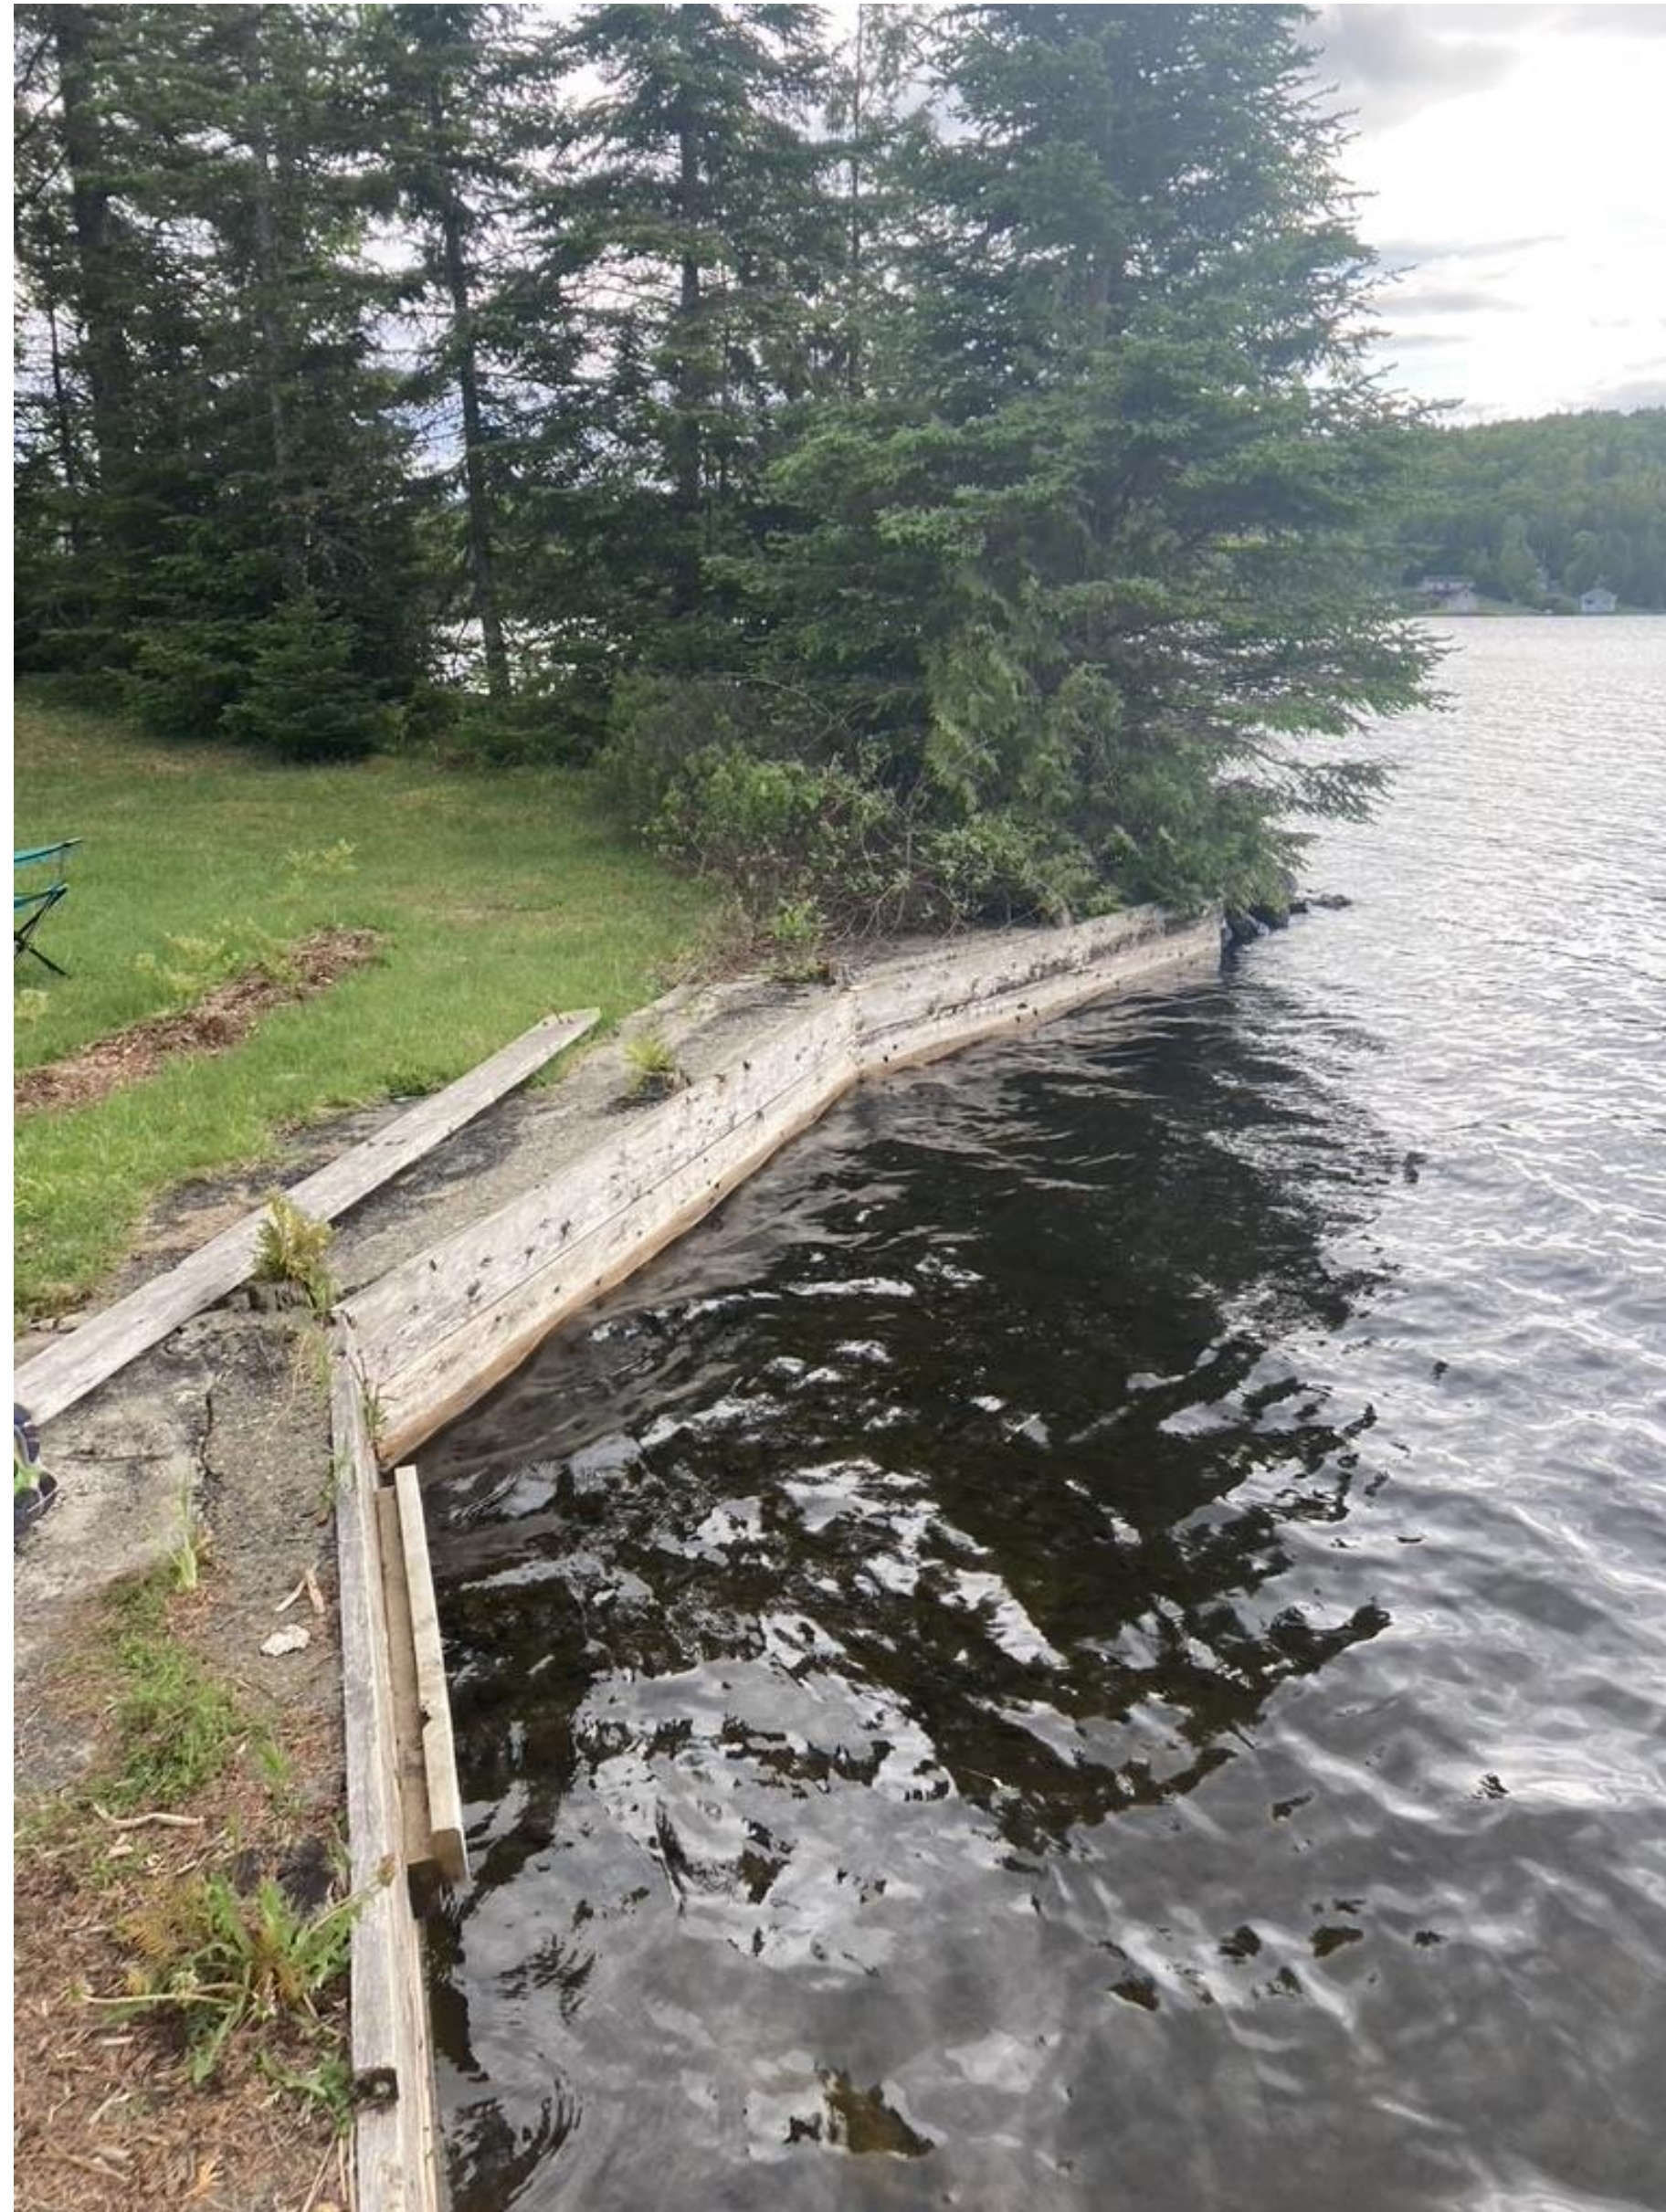
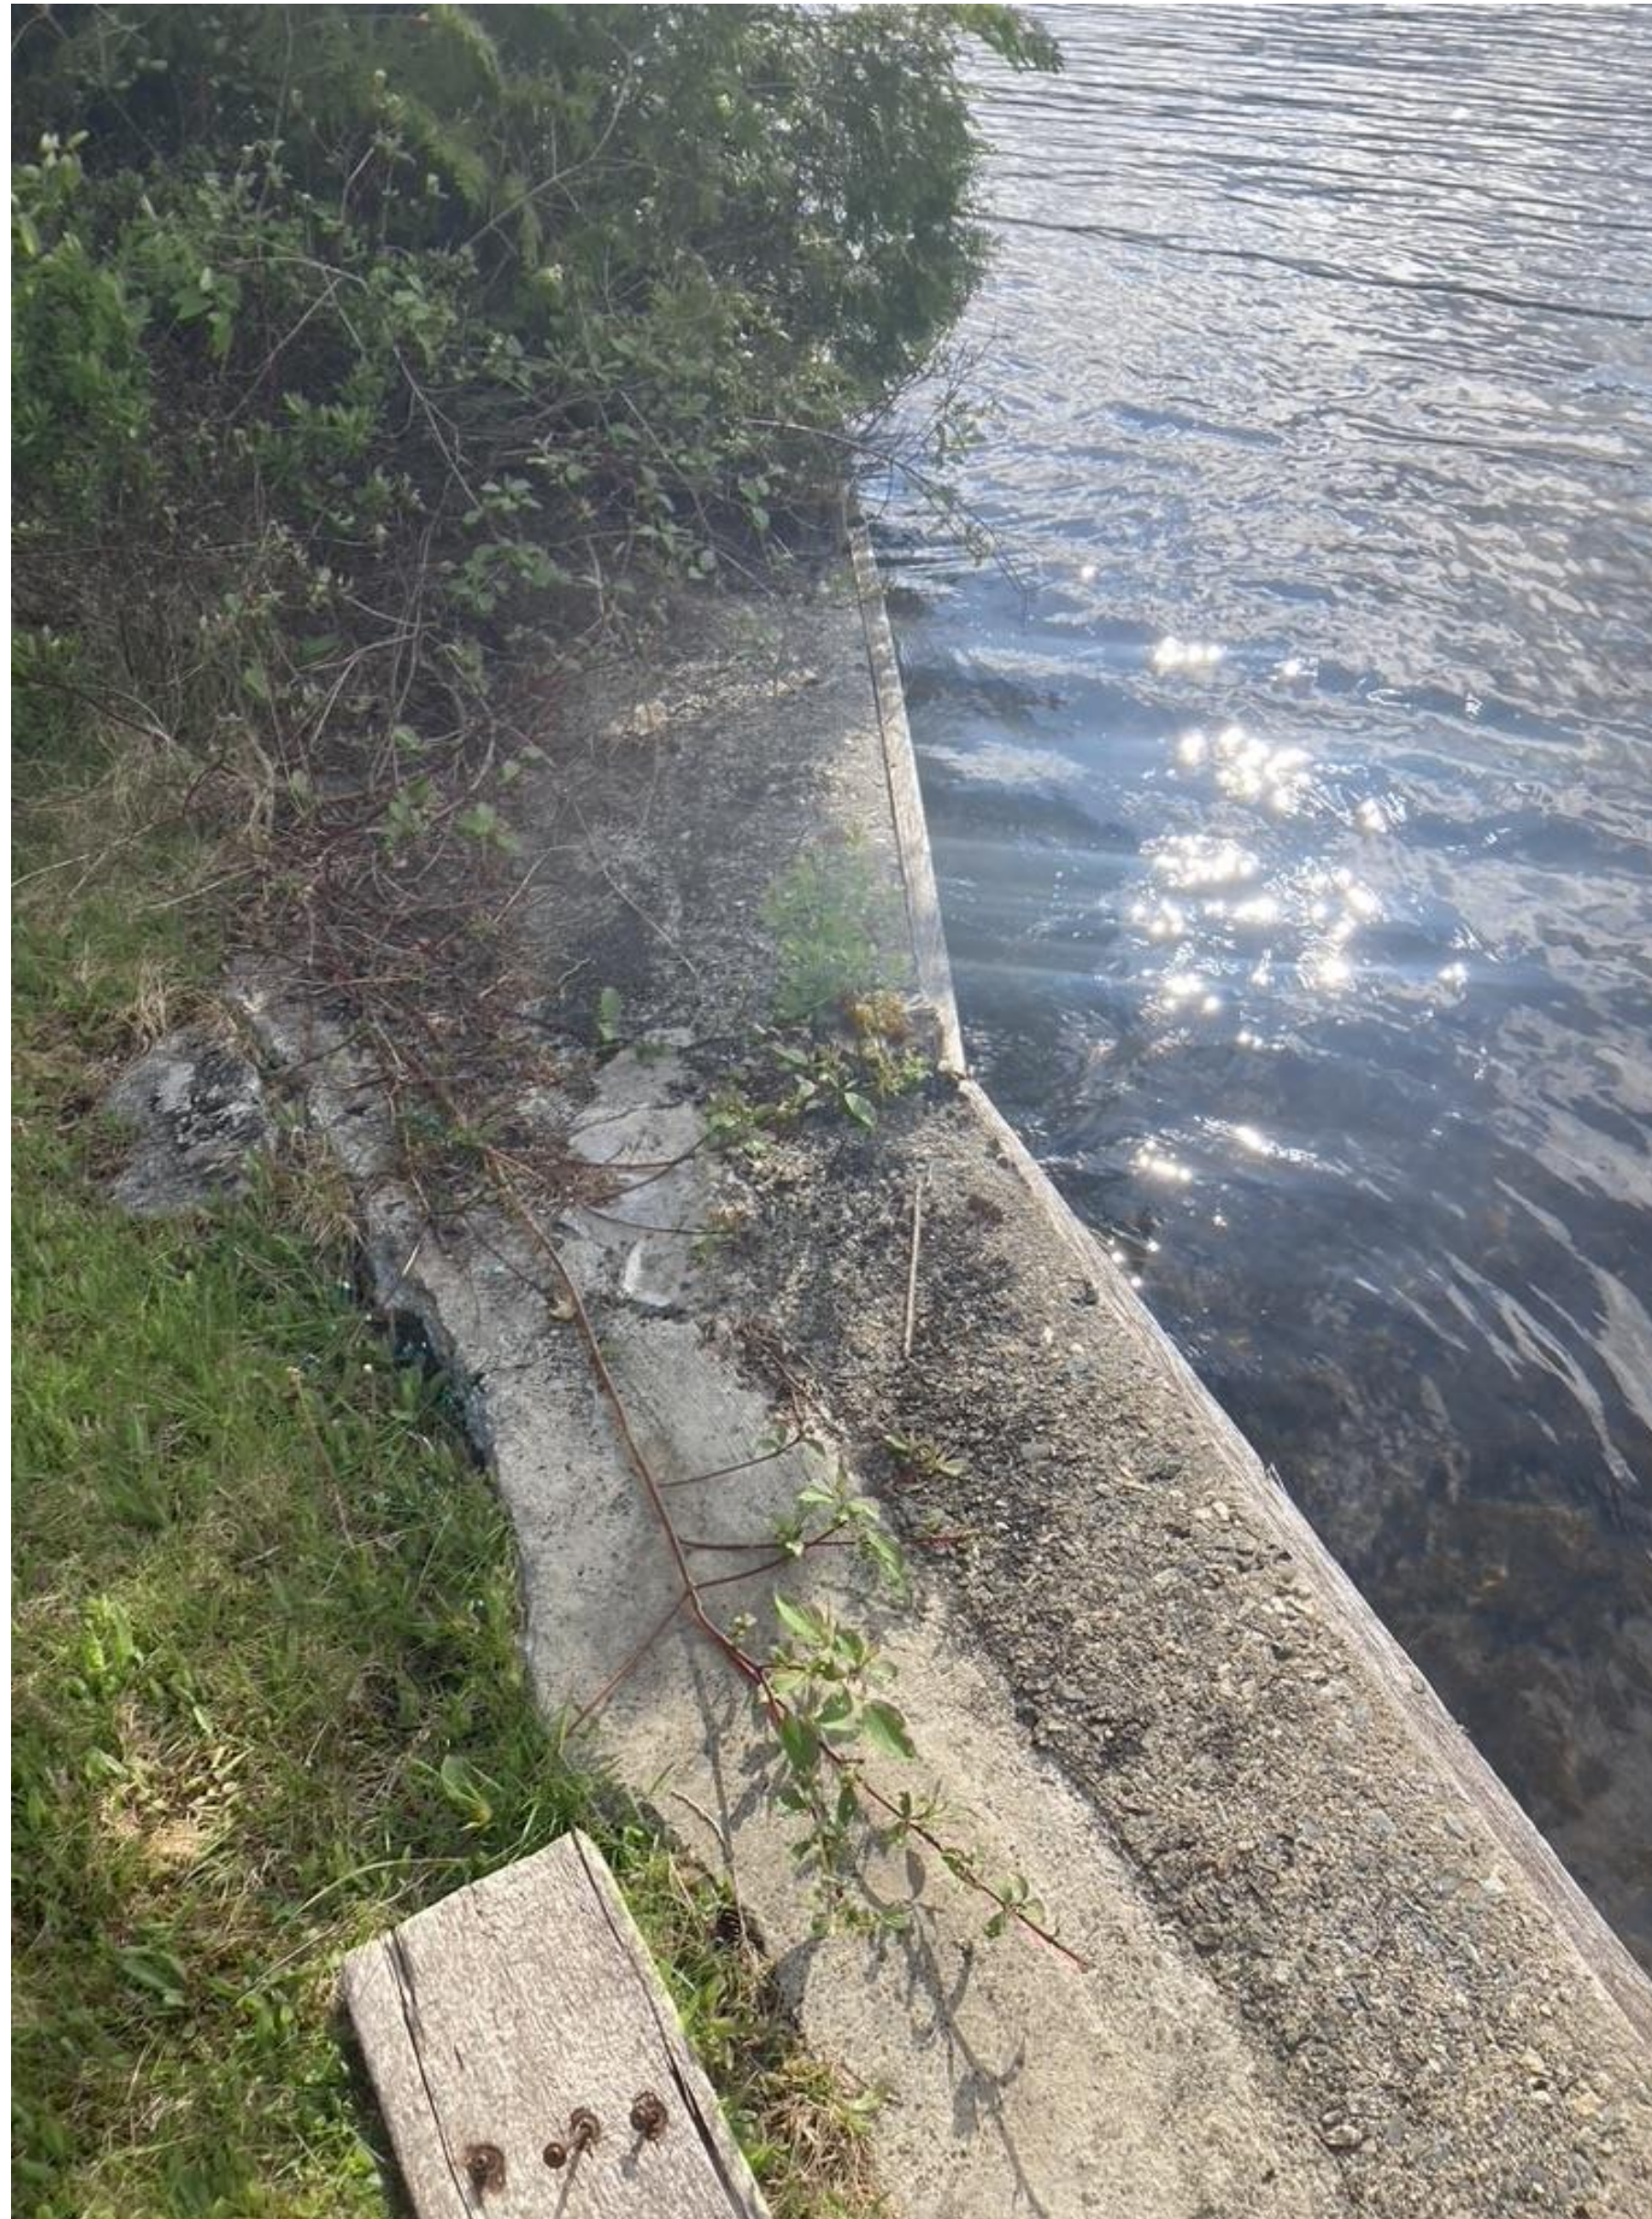
# Failing retaining wall, sink holes, erosion
