# Bioengineering case study:

Planting Approaches  
for Bank Regrade &  
Erosion Control

**Holly Greenleaf**  
**January 8<sup>th</sup> & 10<sup>th</sup>, 2025**  
**NSECC Training**

# 4 PLANTING APPROACHES TO RESTORE & STABILIZE THE BANK

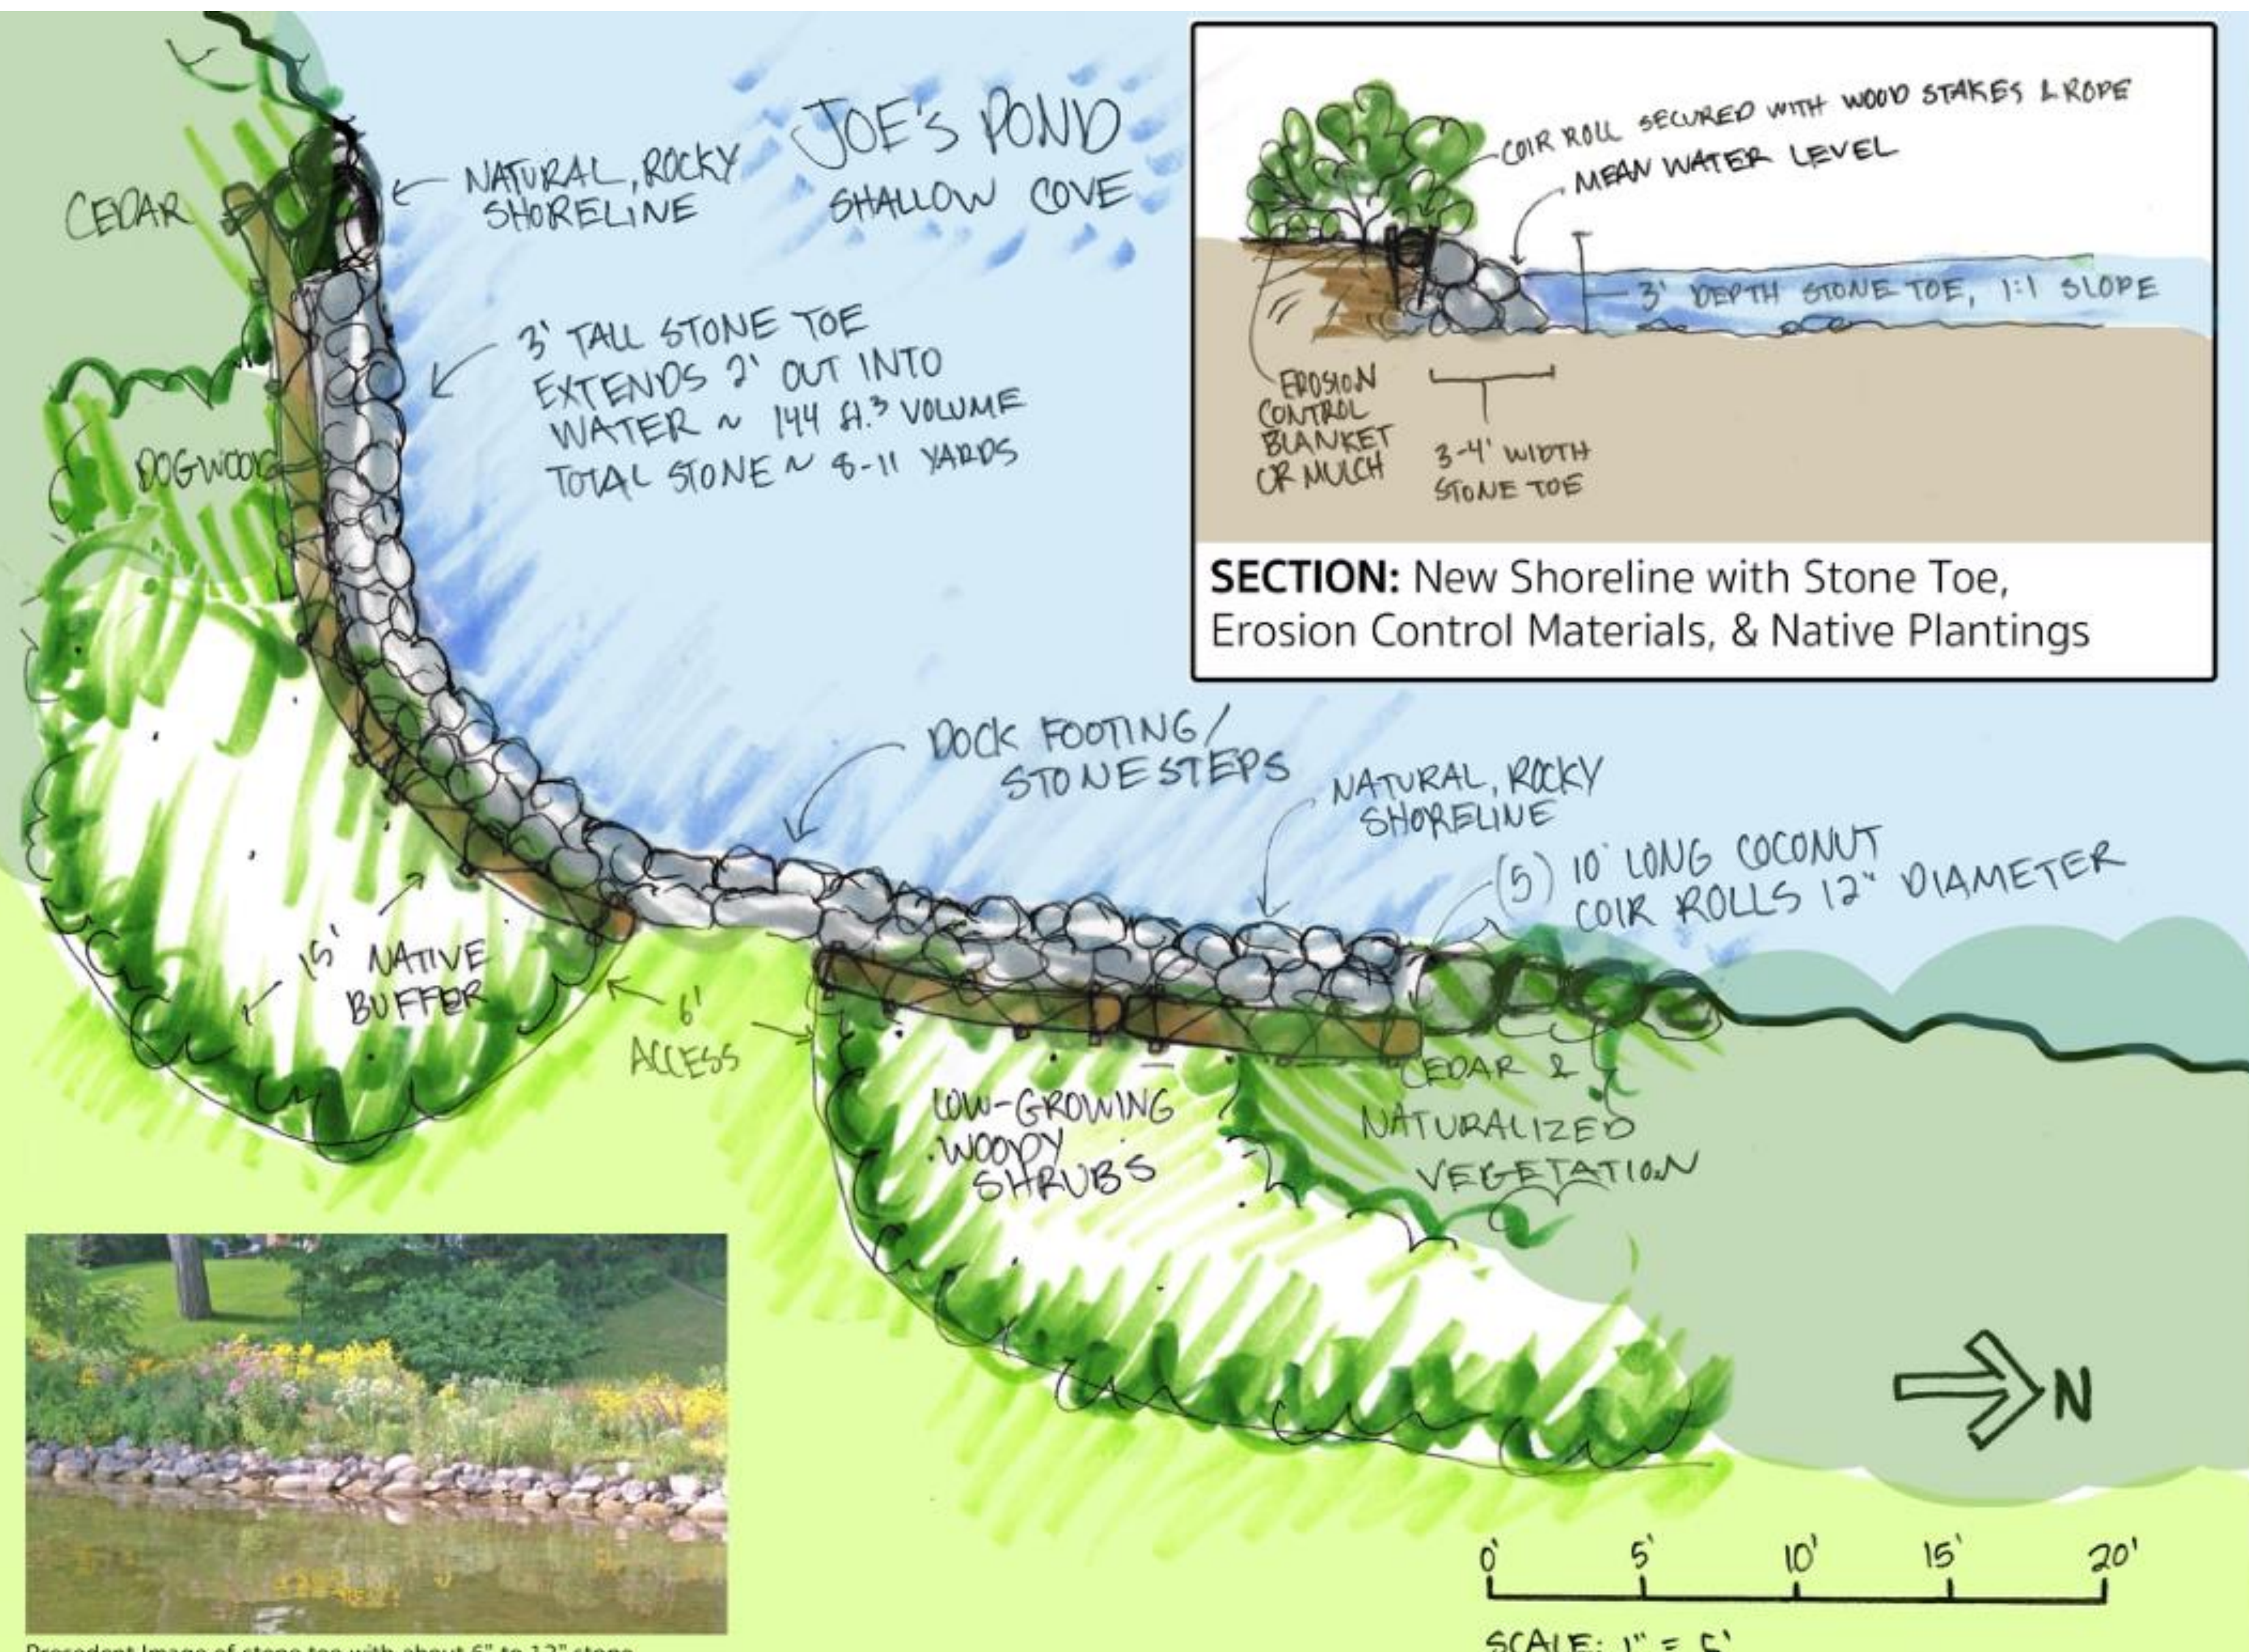
# SITE PLAN: Shoreline Restoration & Bio- engineering

Precedent Image of stone toe with about 6" to 12" stone

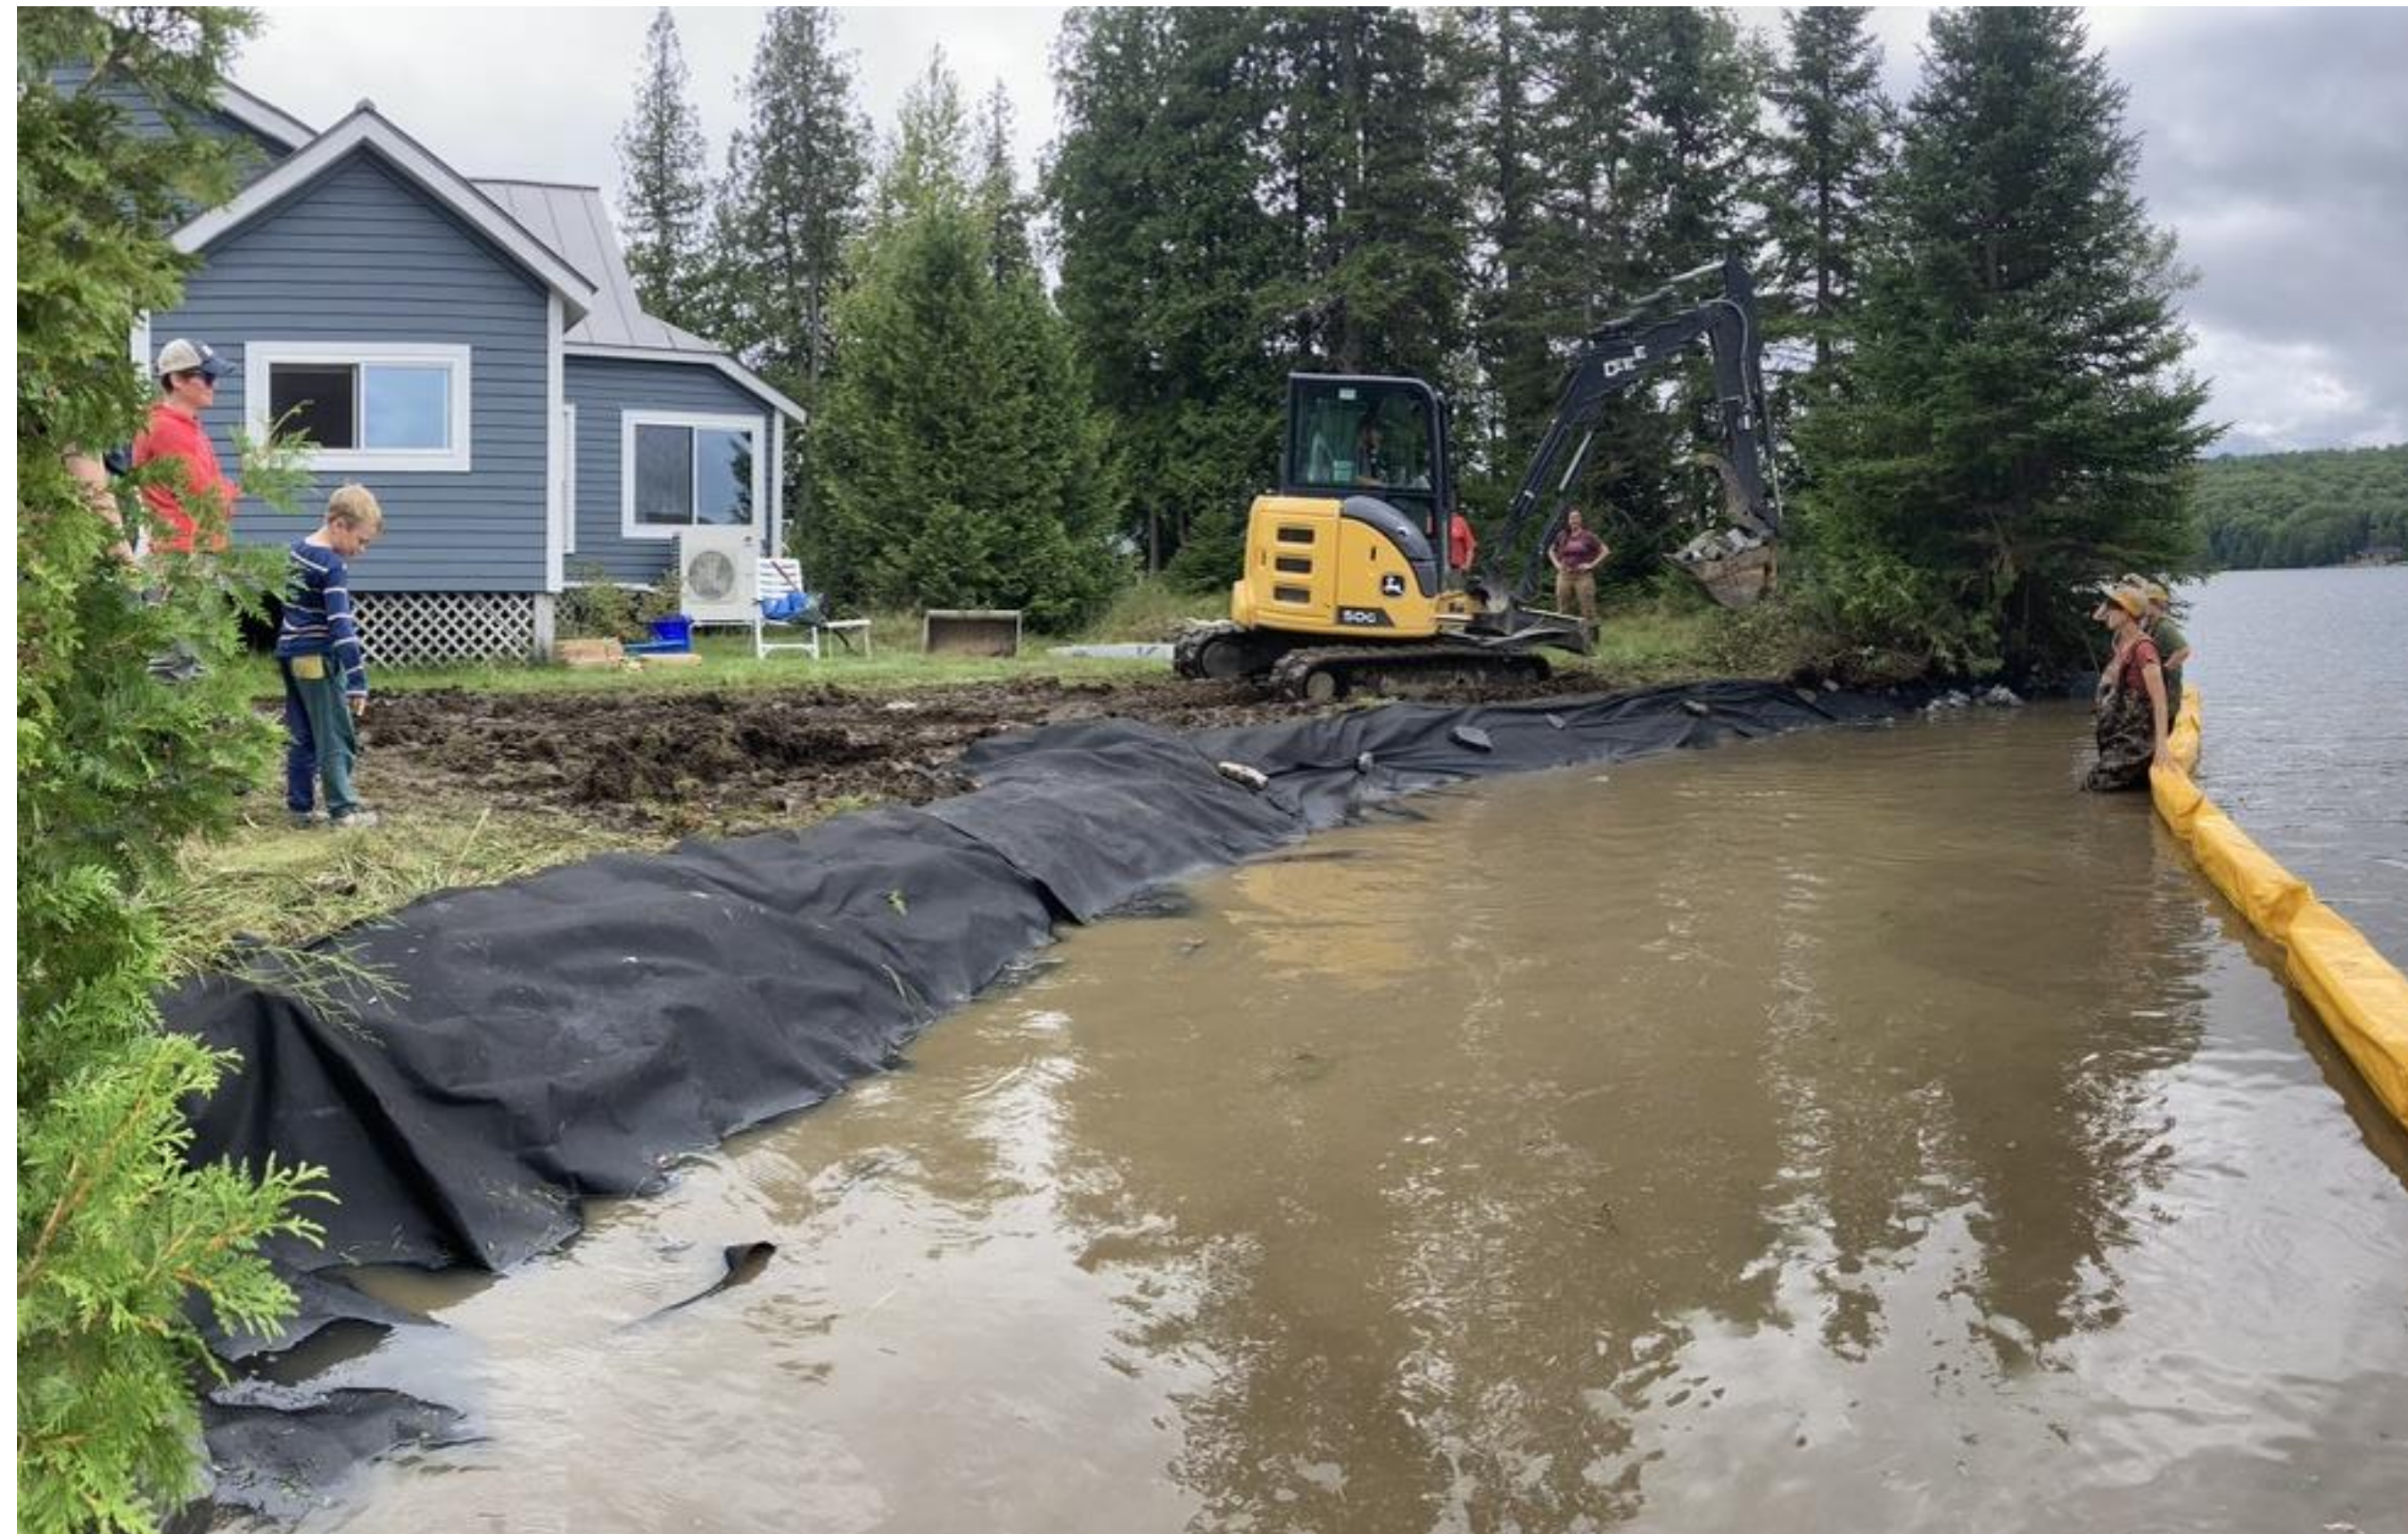
# Remove retaining wall, build stone toe

Nonwoven geotextile filter fabric

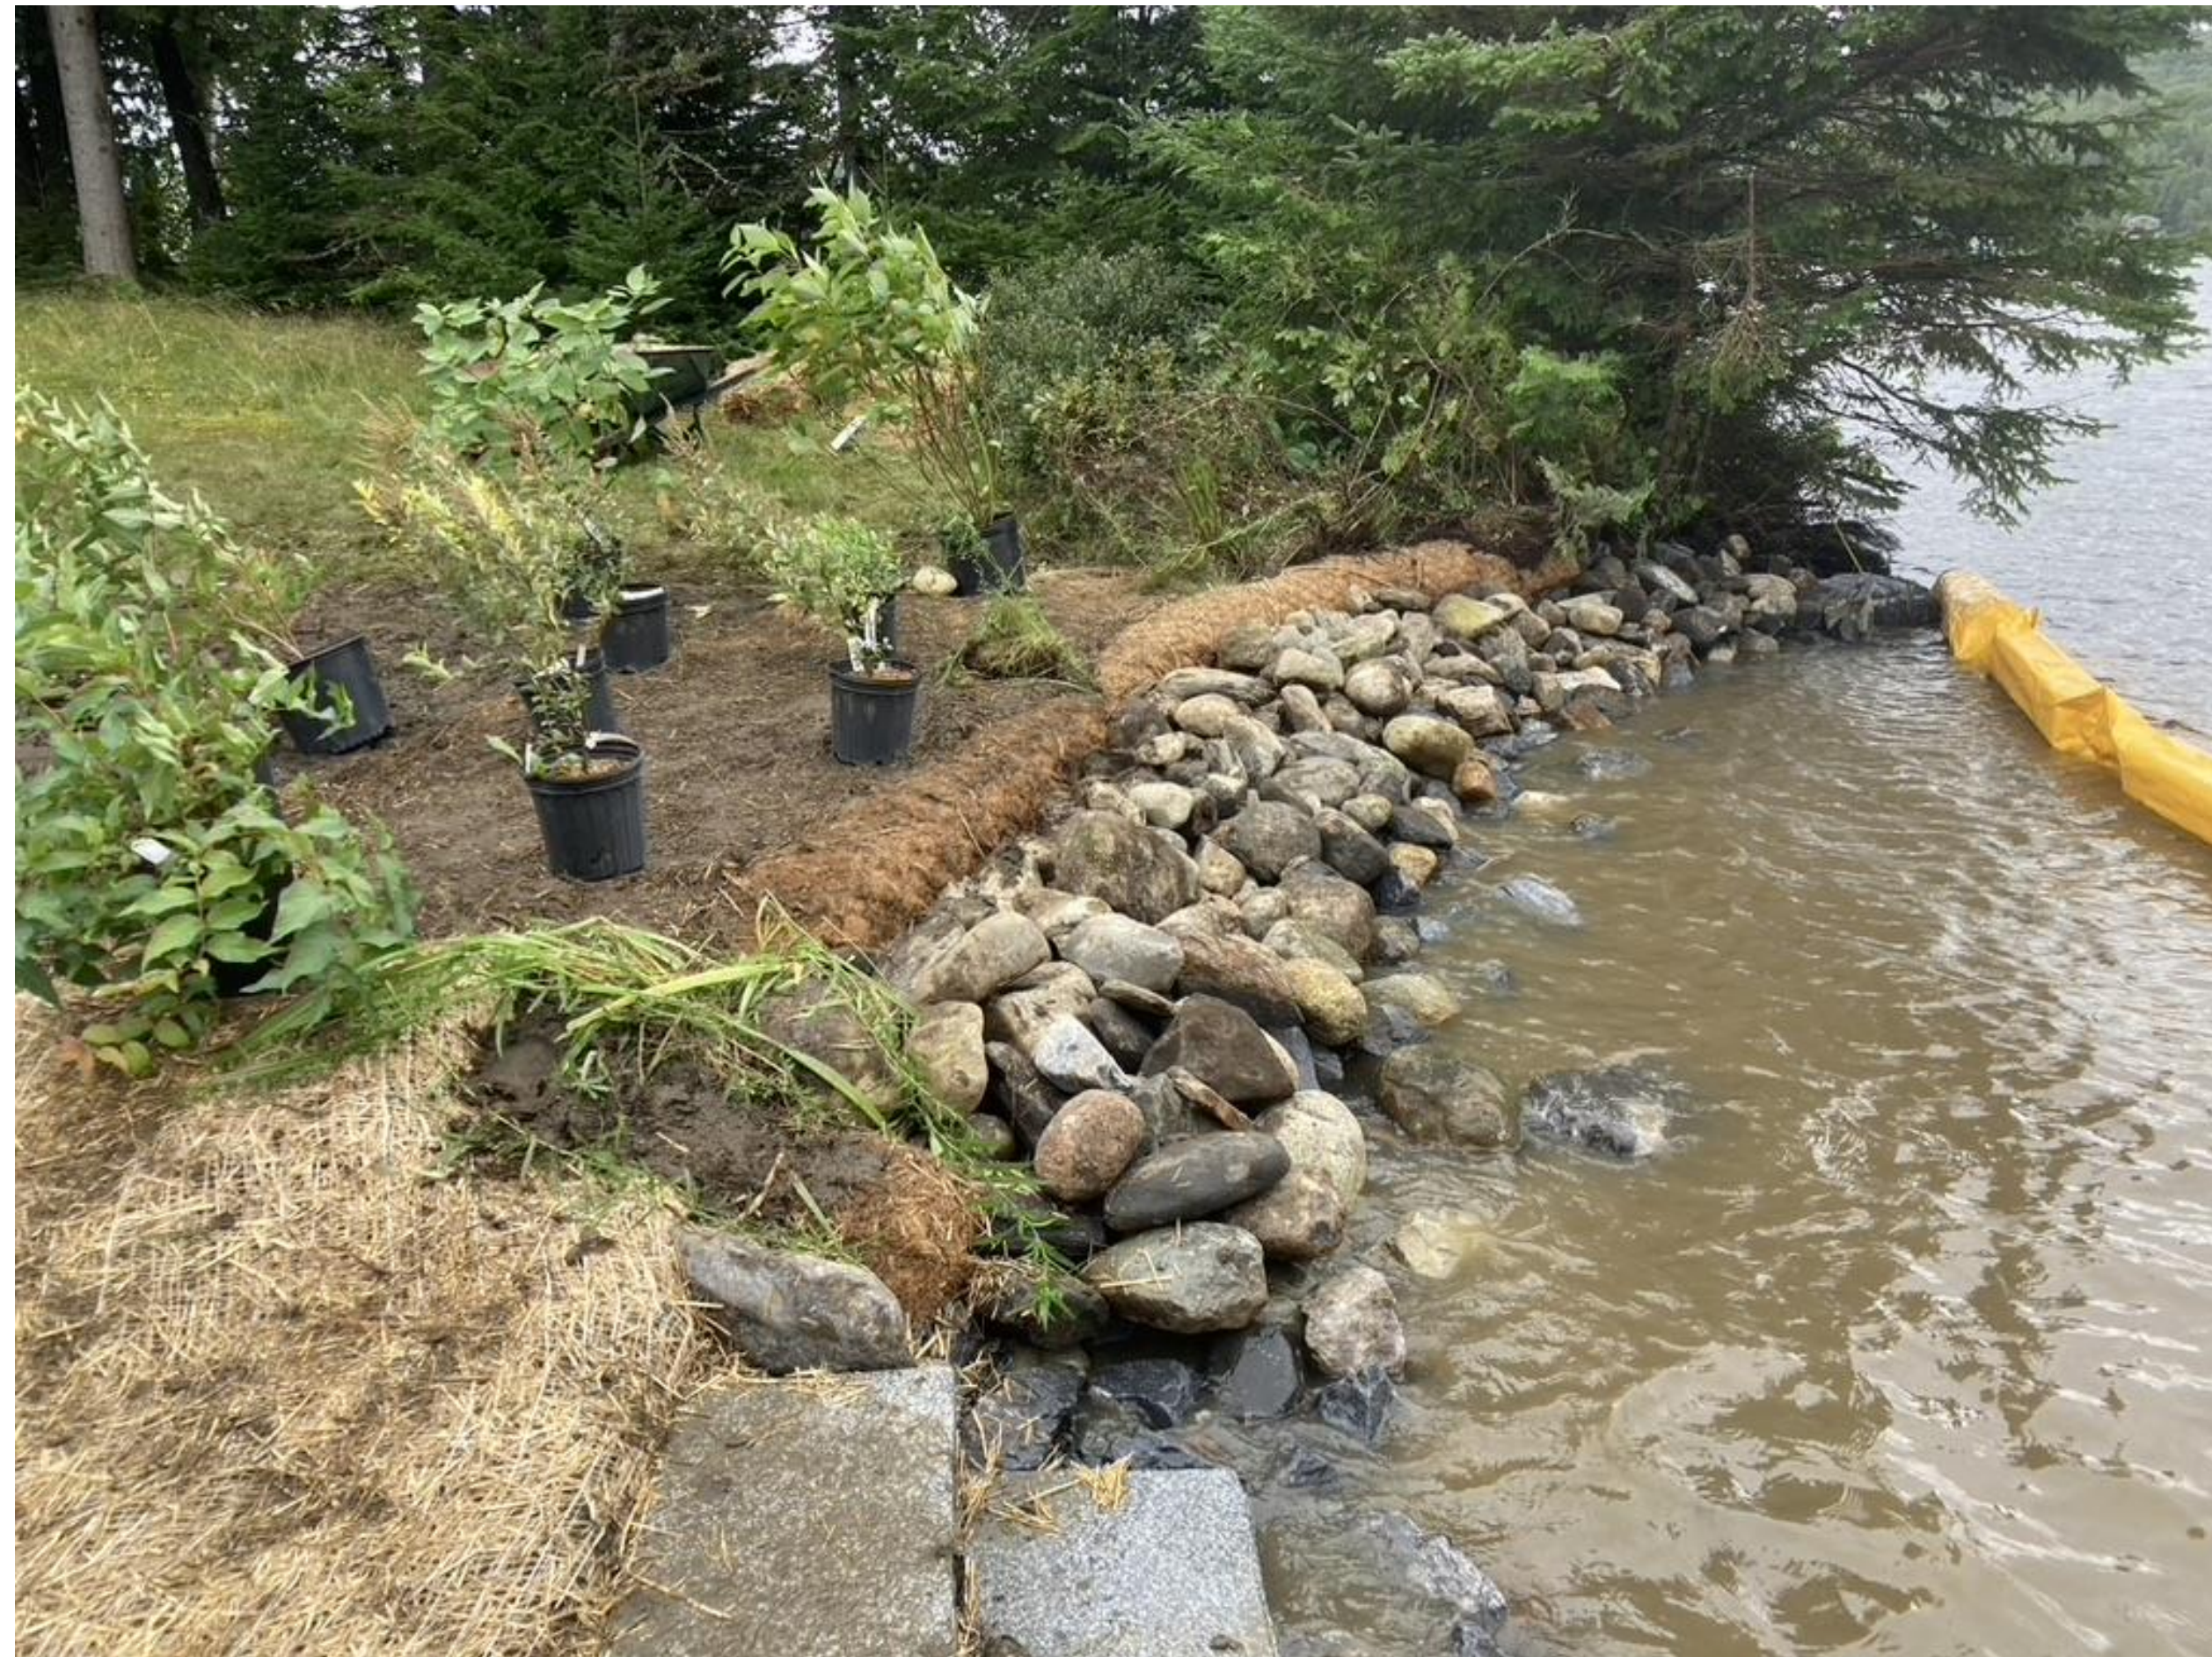
# stone toe, erosion control

Washed 12" minus erosion stone + on-site rounded rock

Topsoil, Erosion Control Matting/Blankets (ECB) (SC 150BN),  
Coconut coir logs (12" diameter x 10' long)

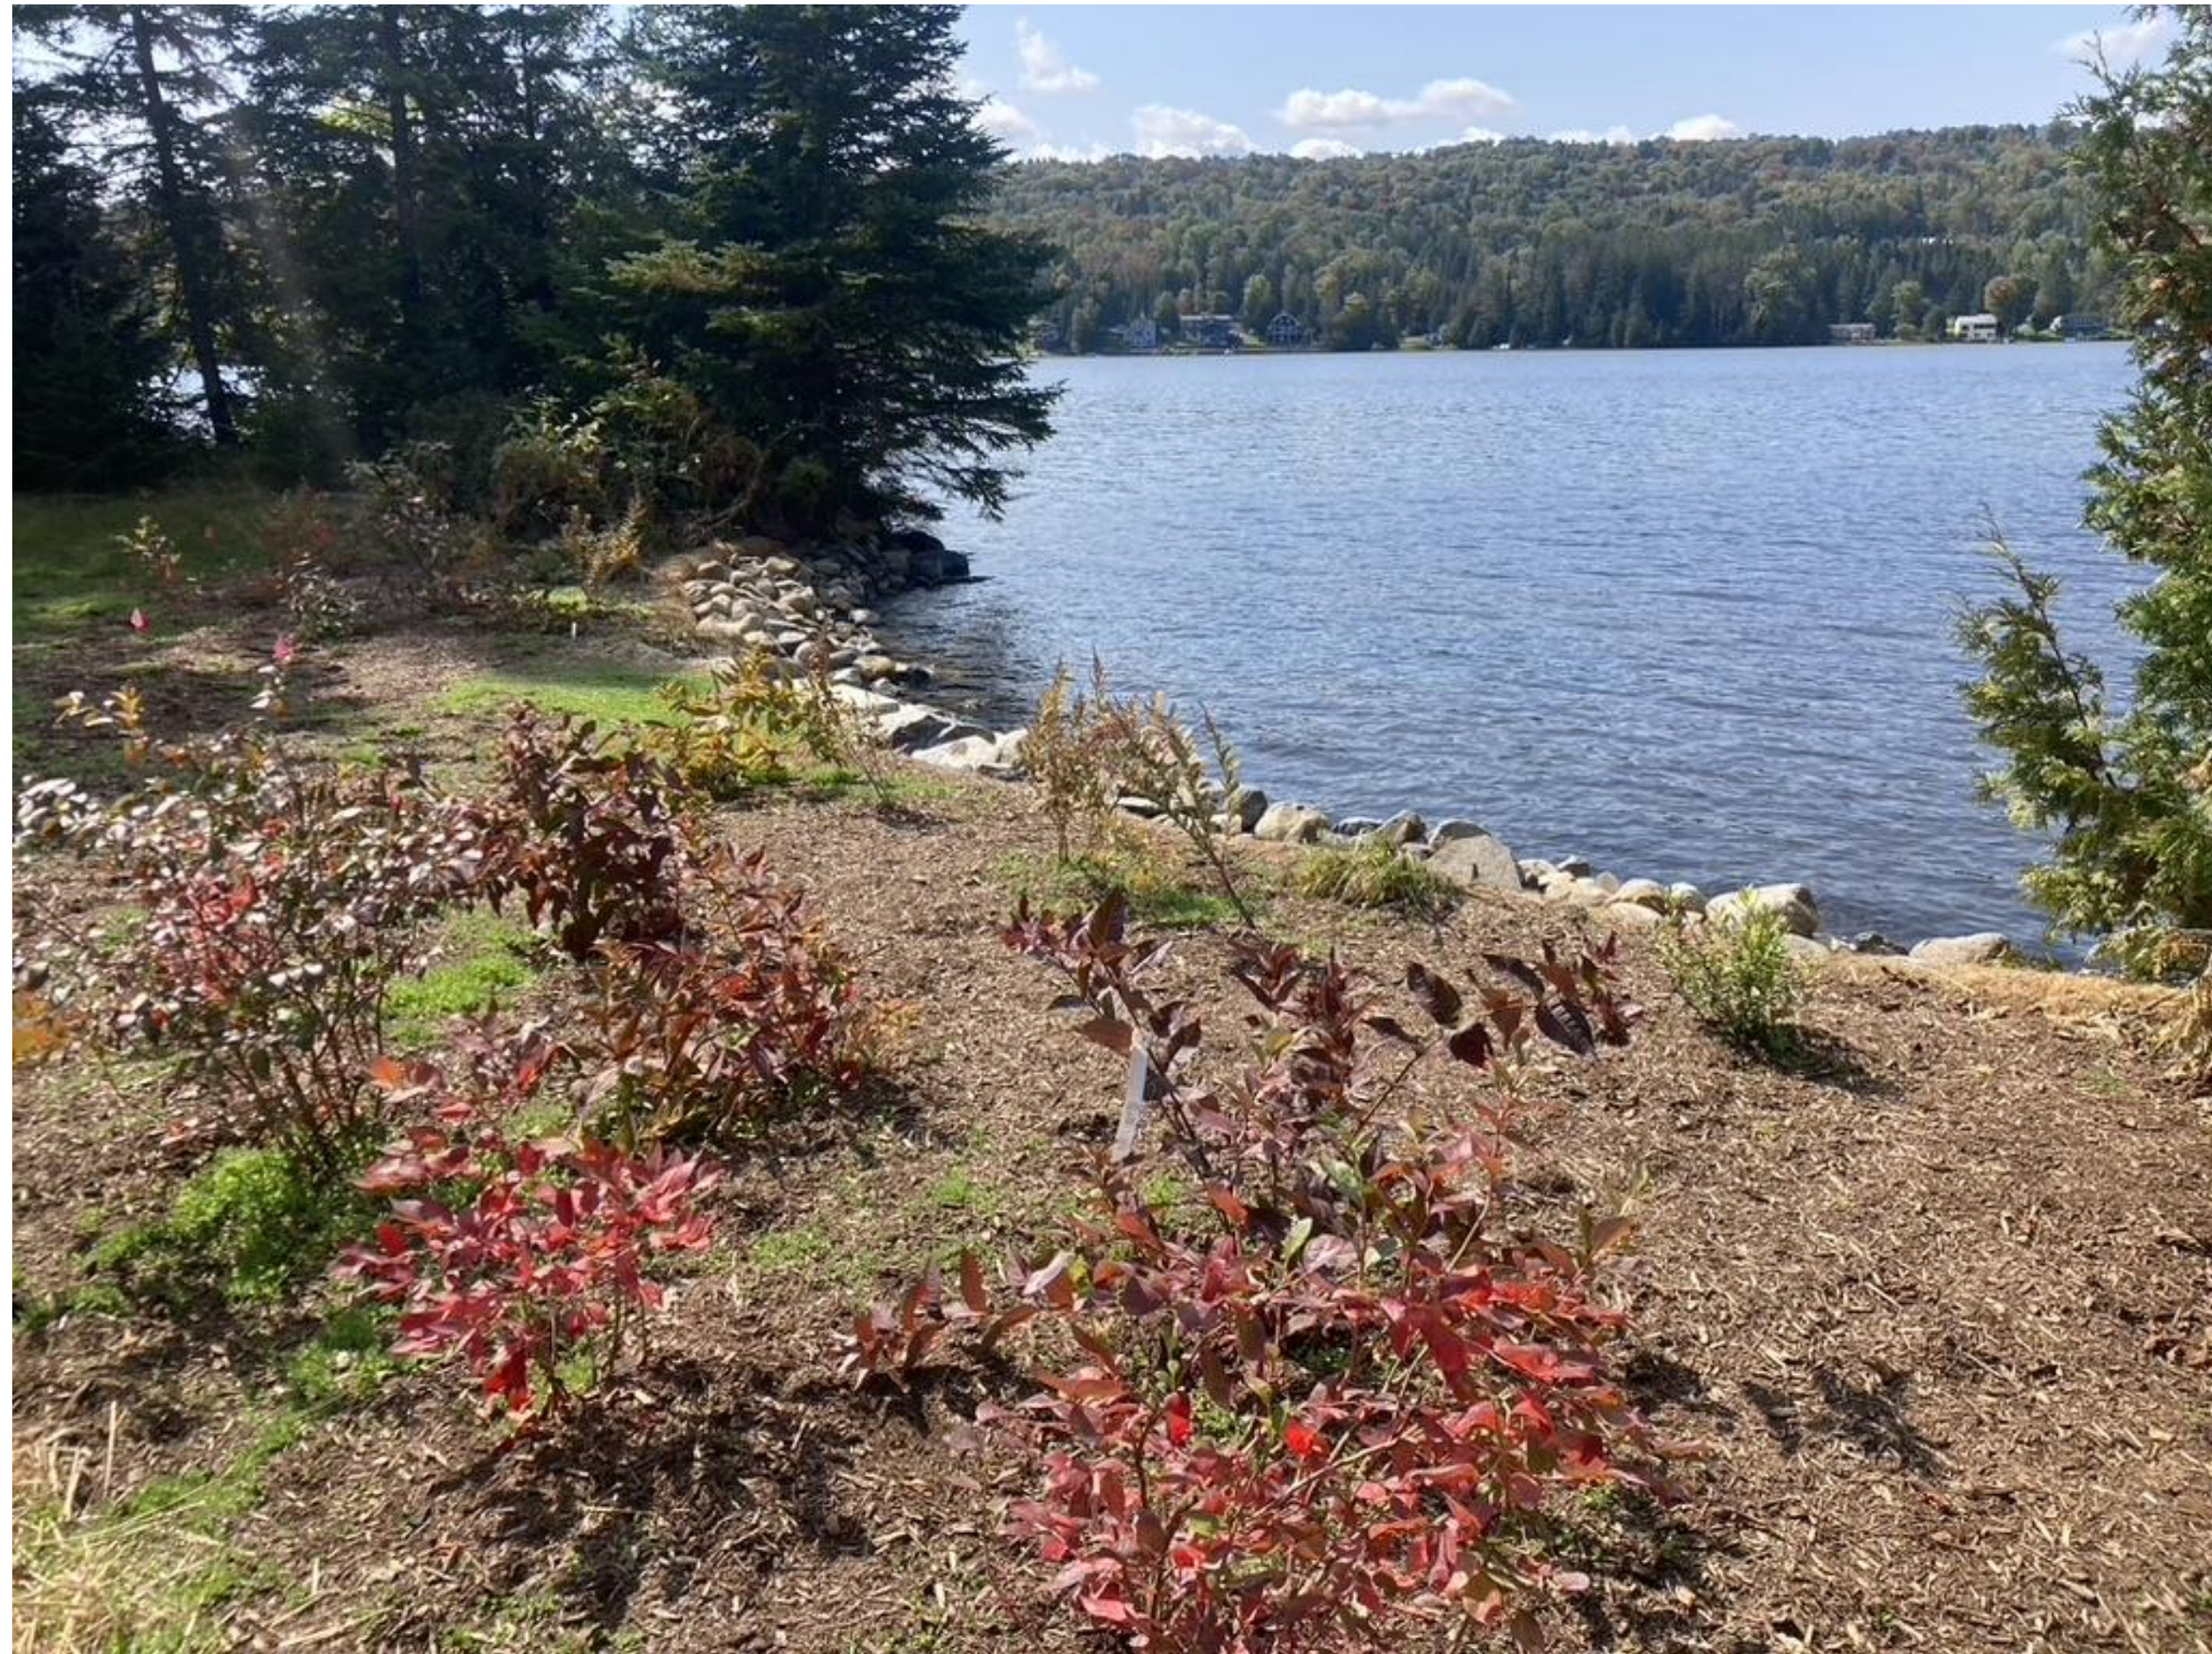
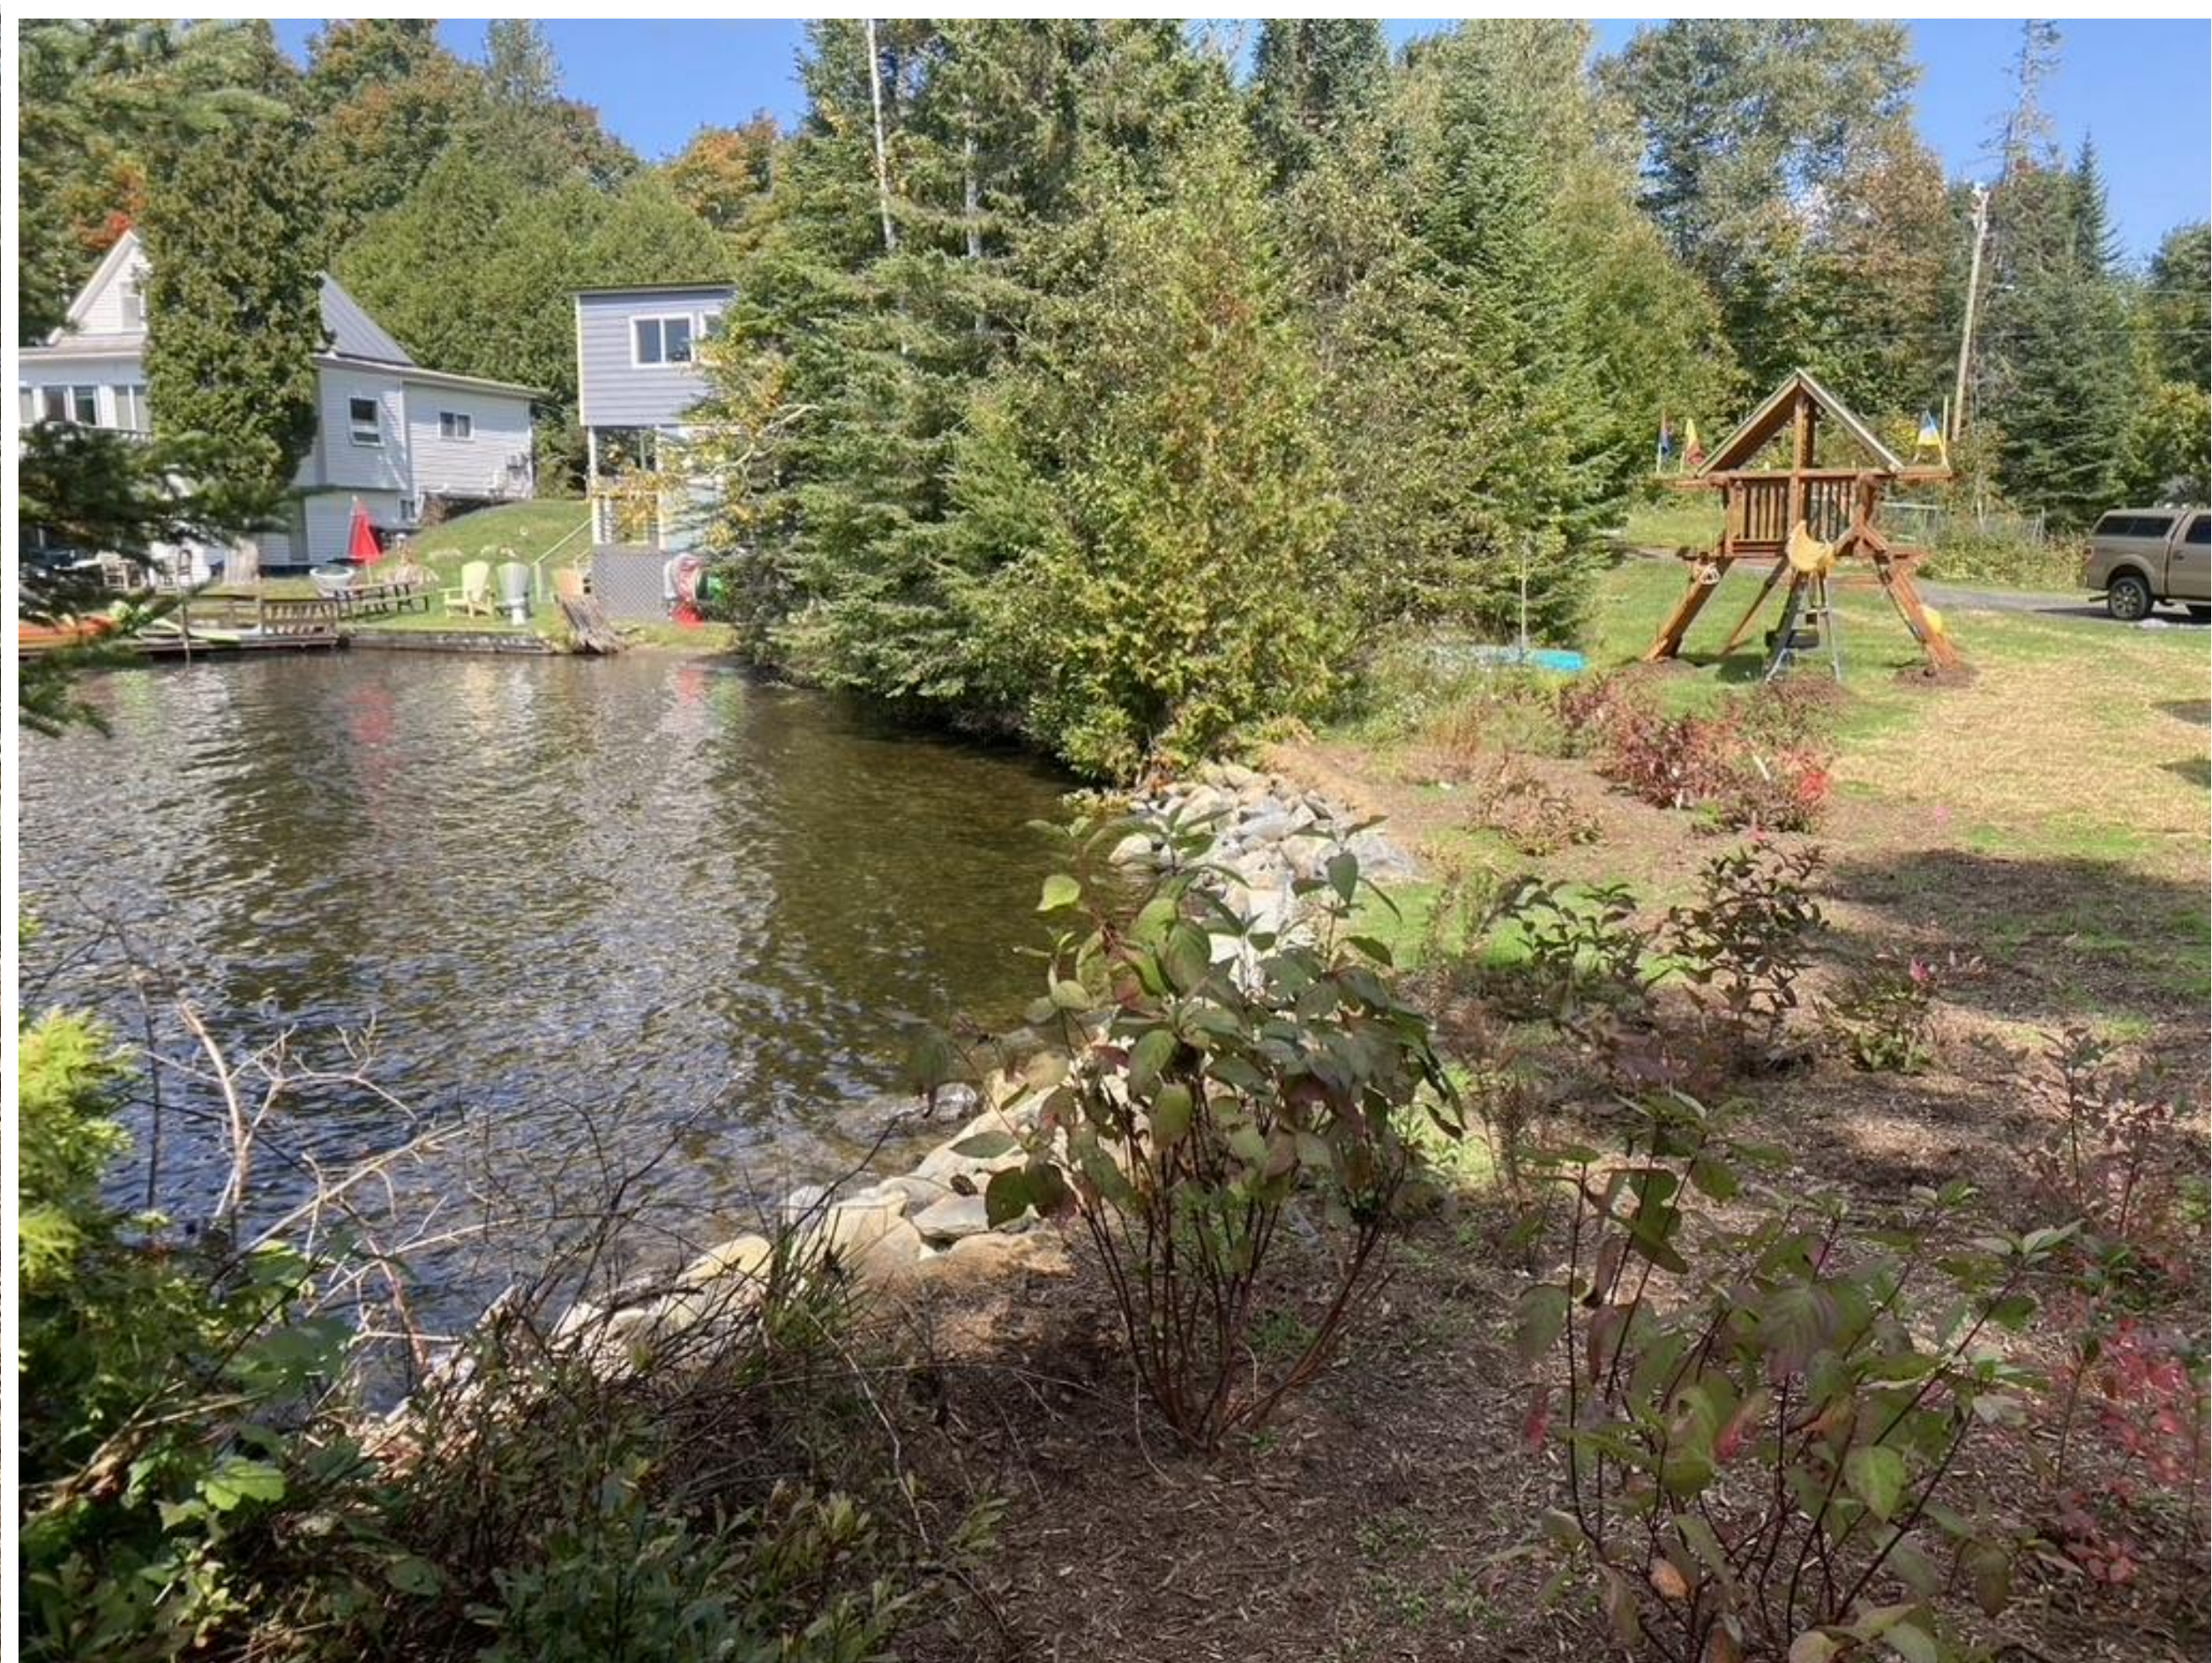
Native Shrub Containers, Spot Compost, Mulch, Red Clover Seed
