# Bioengineering case study:

Planting Approaches  
for Bank Regrade &  
Erosion Control

**Holly Greenleaf**  
**January 8<sup>th</sup> & 10<sup>th</sup>, 2025**  
**NSECC Training**

# 4 PLANTING APPROACHES TO RESTORE & STABILIZE THE BANK

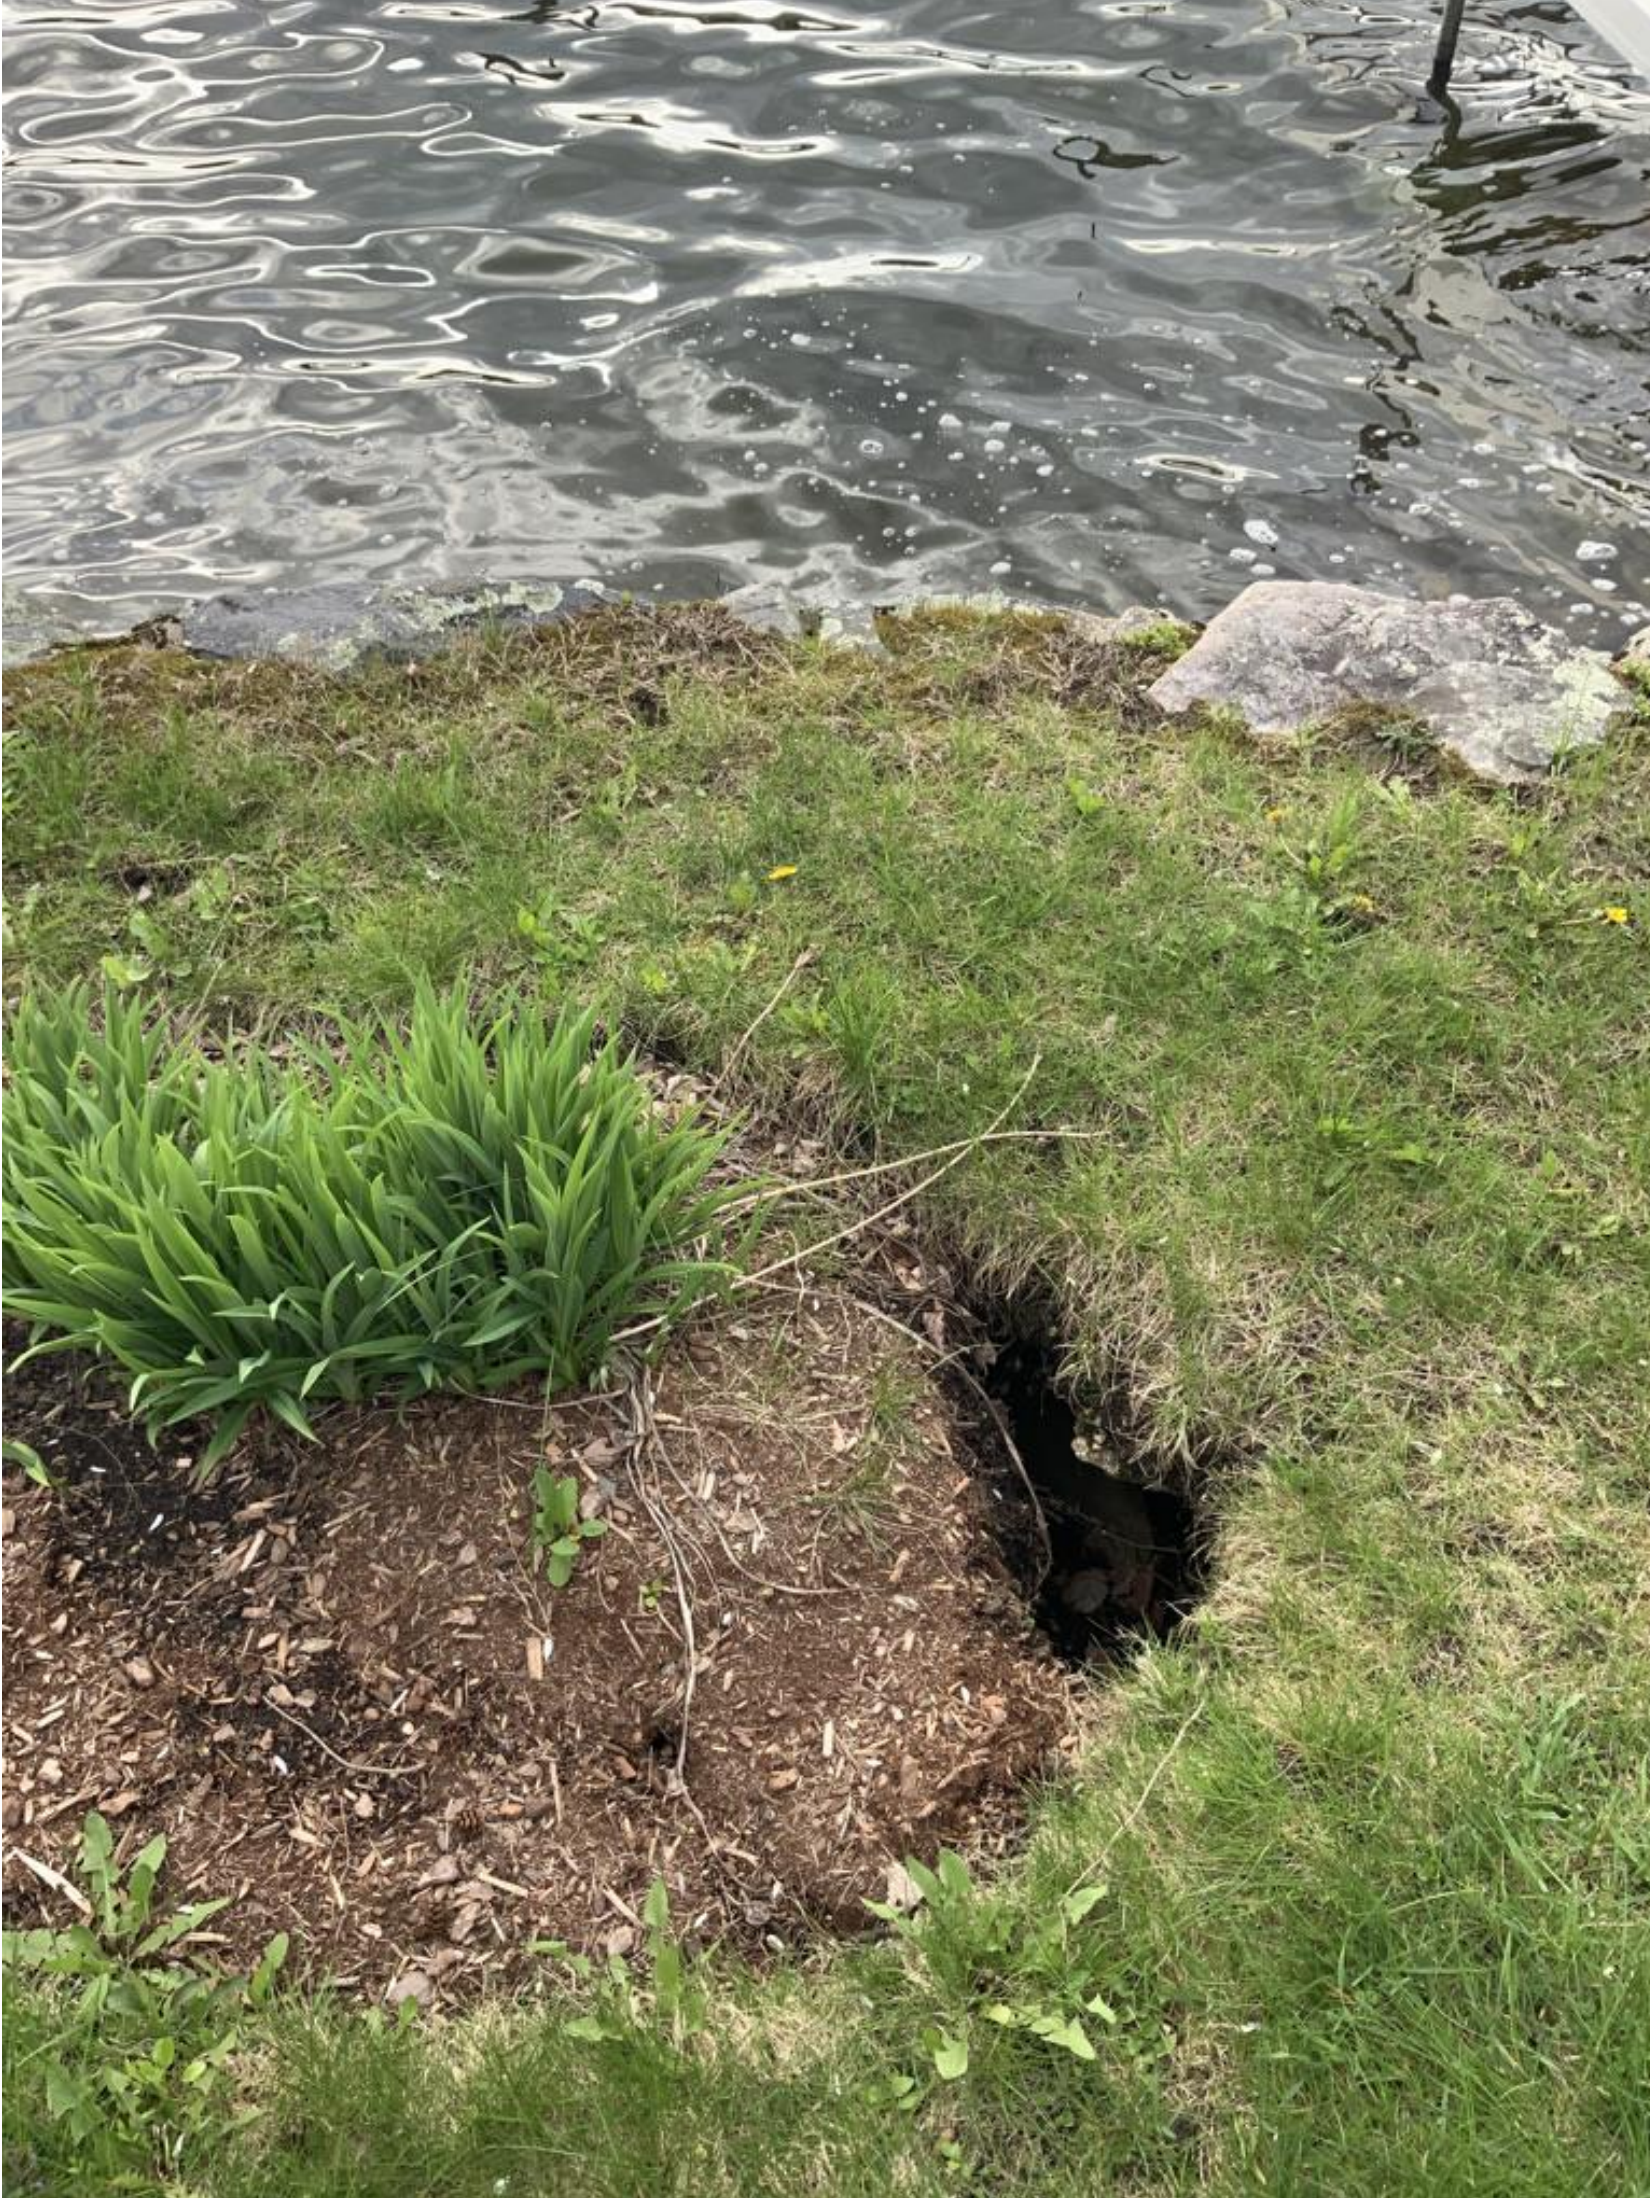
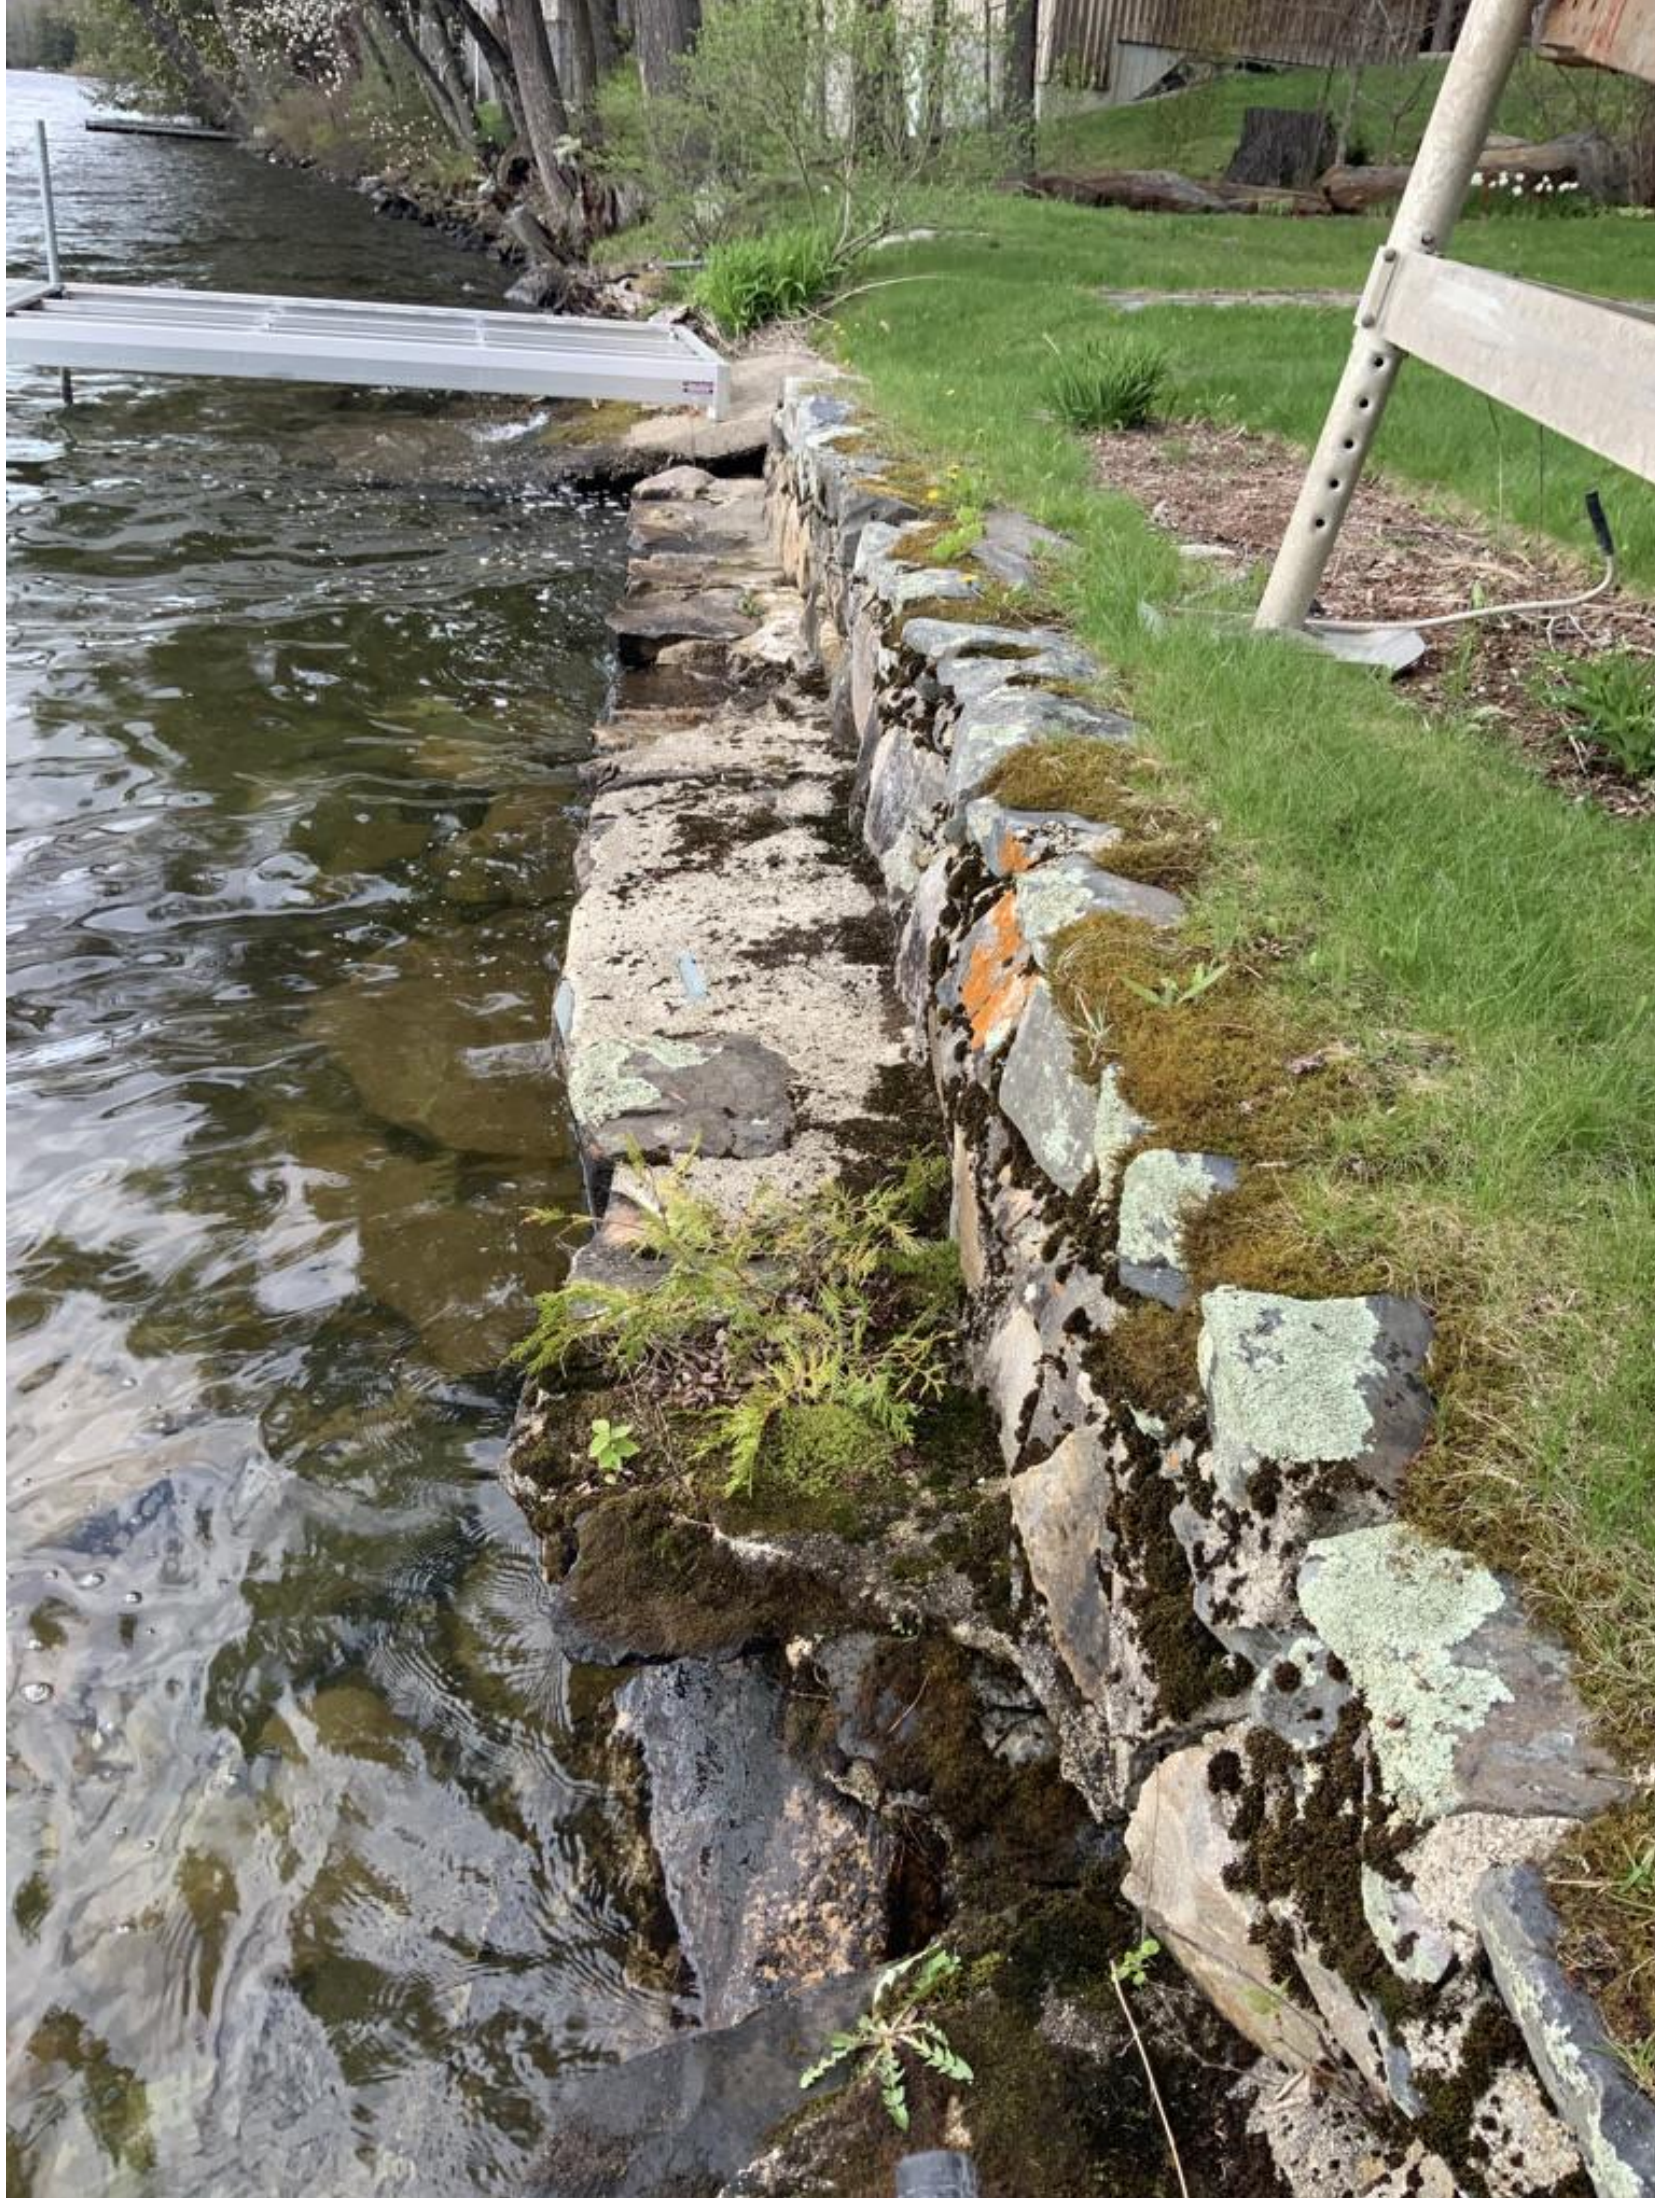
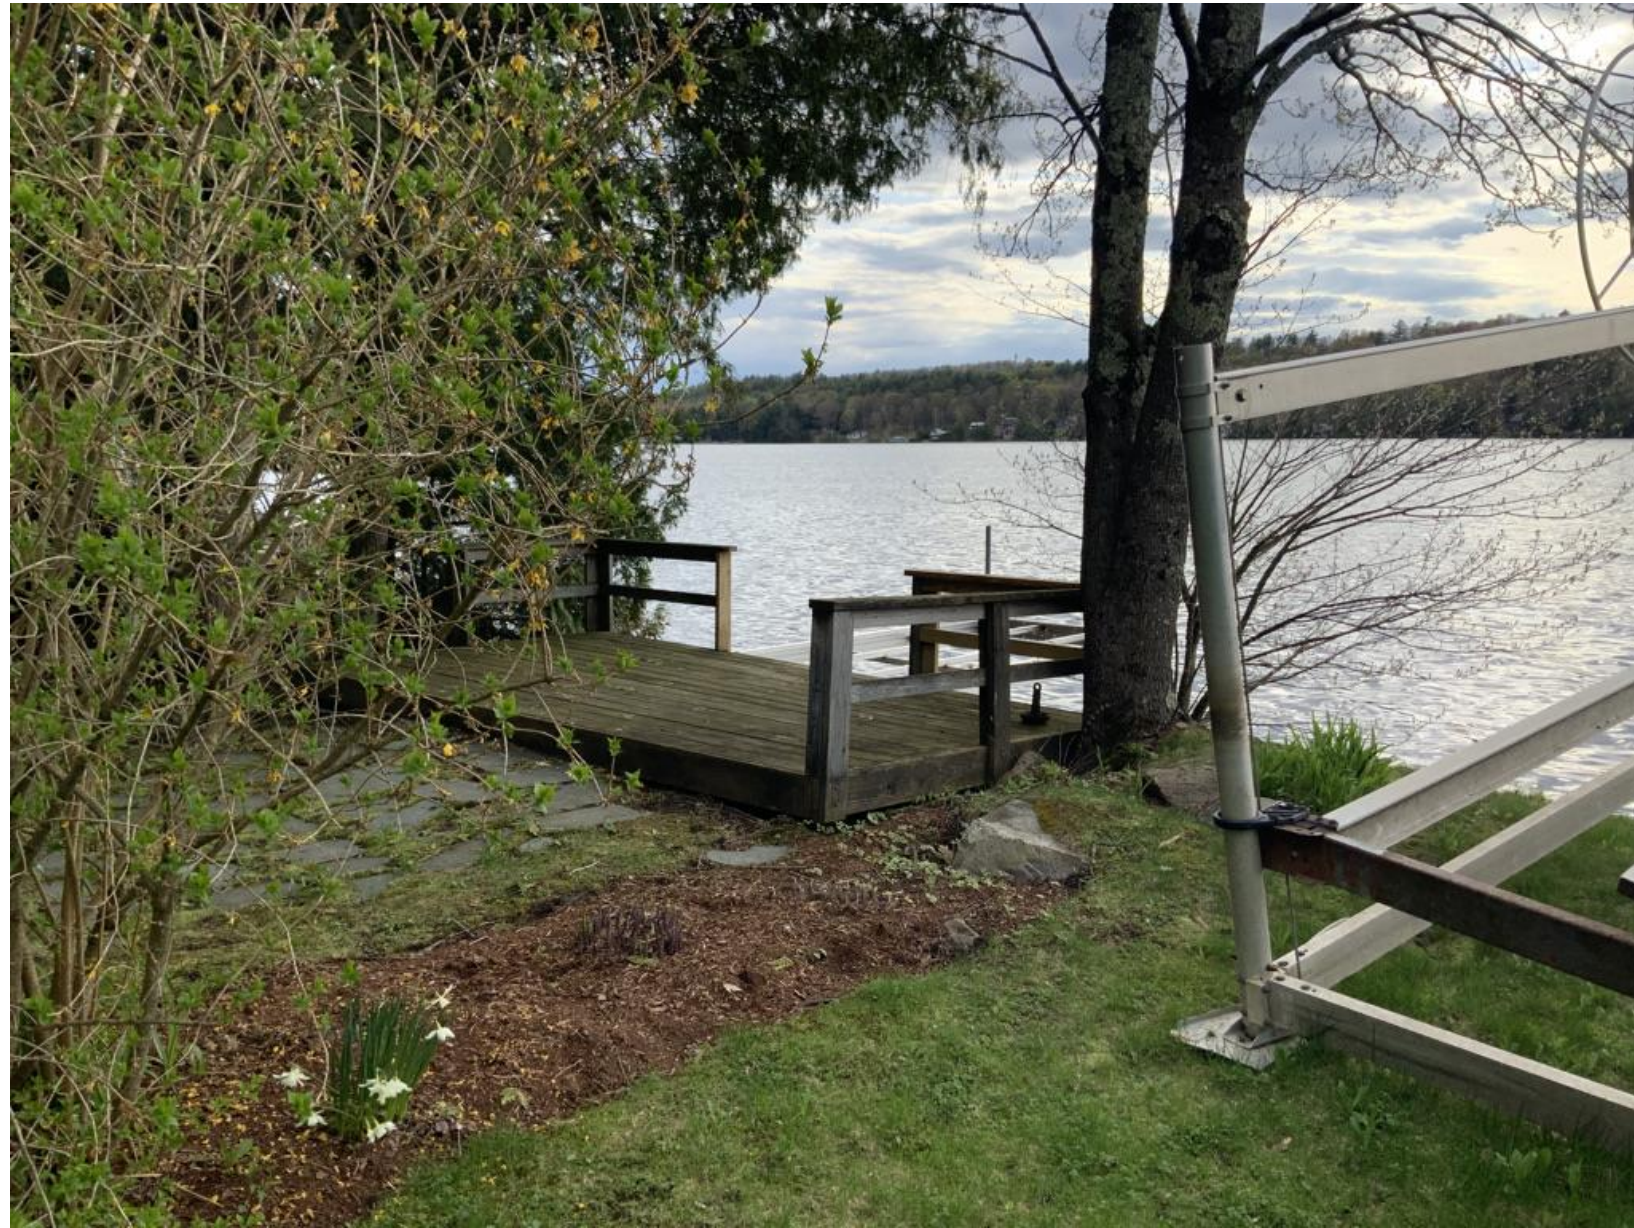
# Failing retaining wall, sink holes, erosion

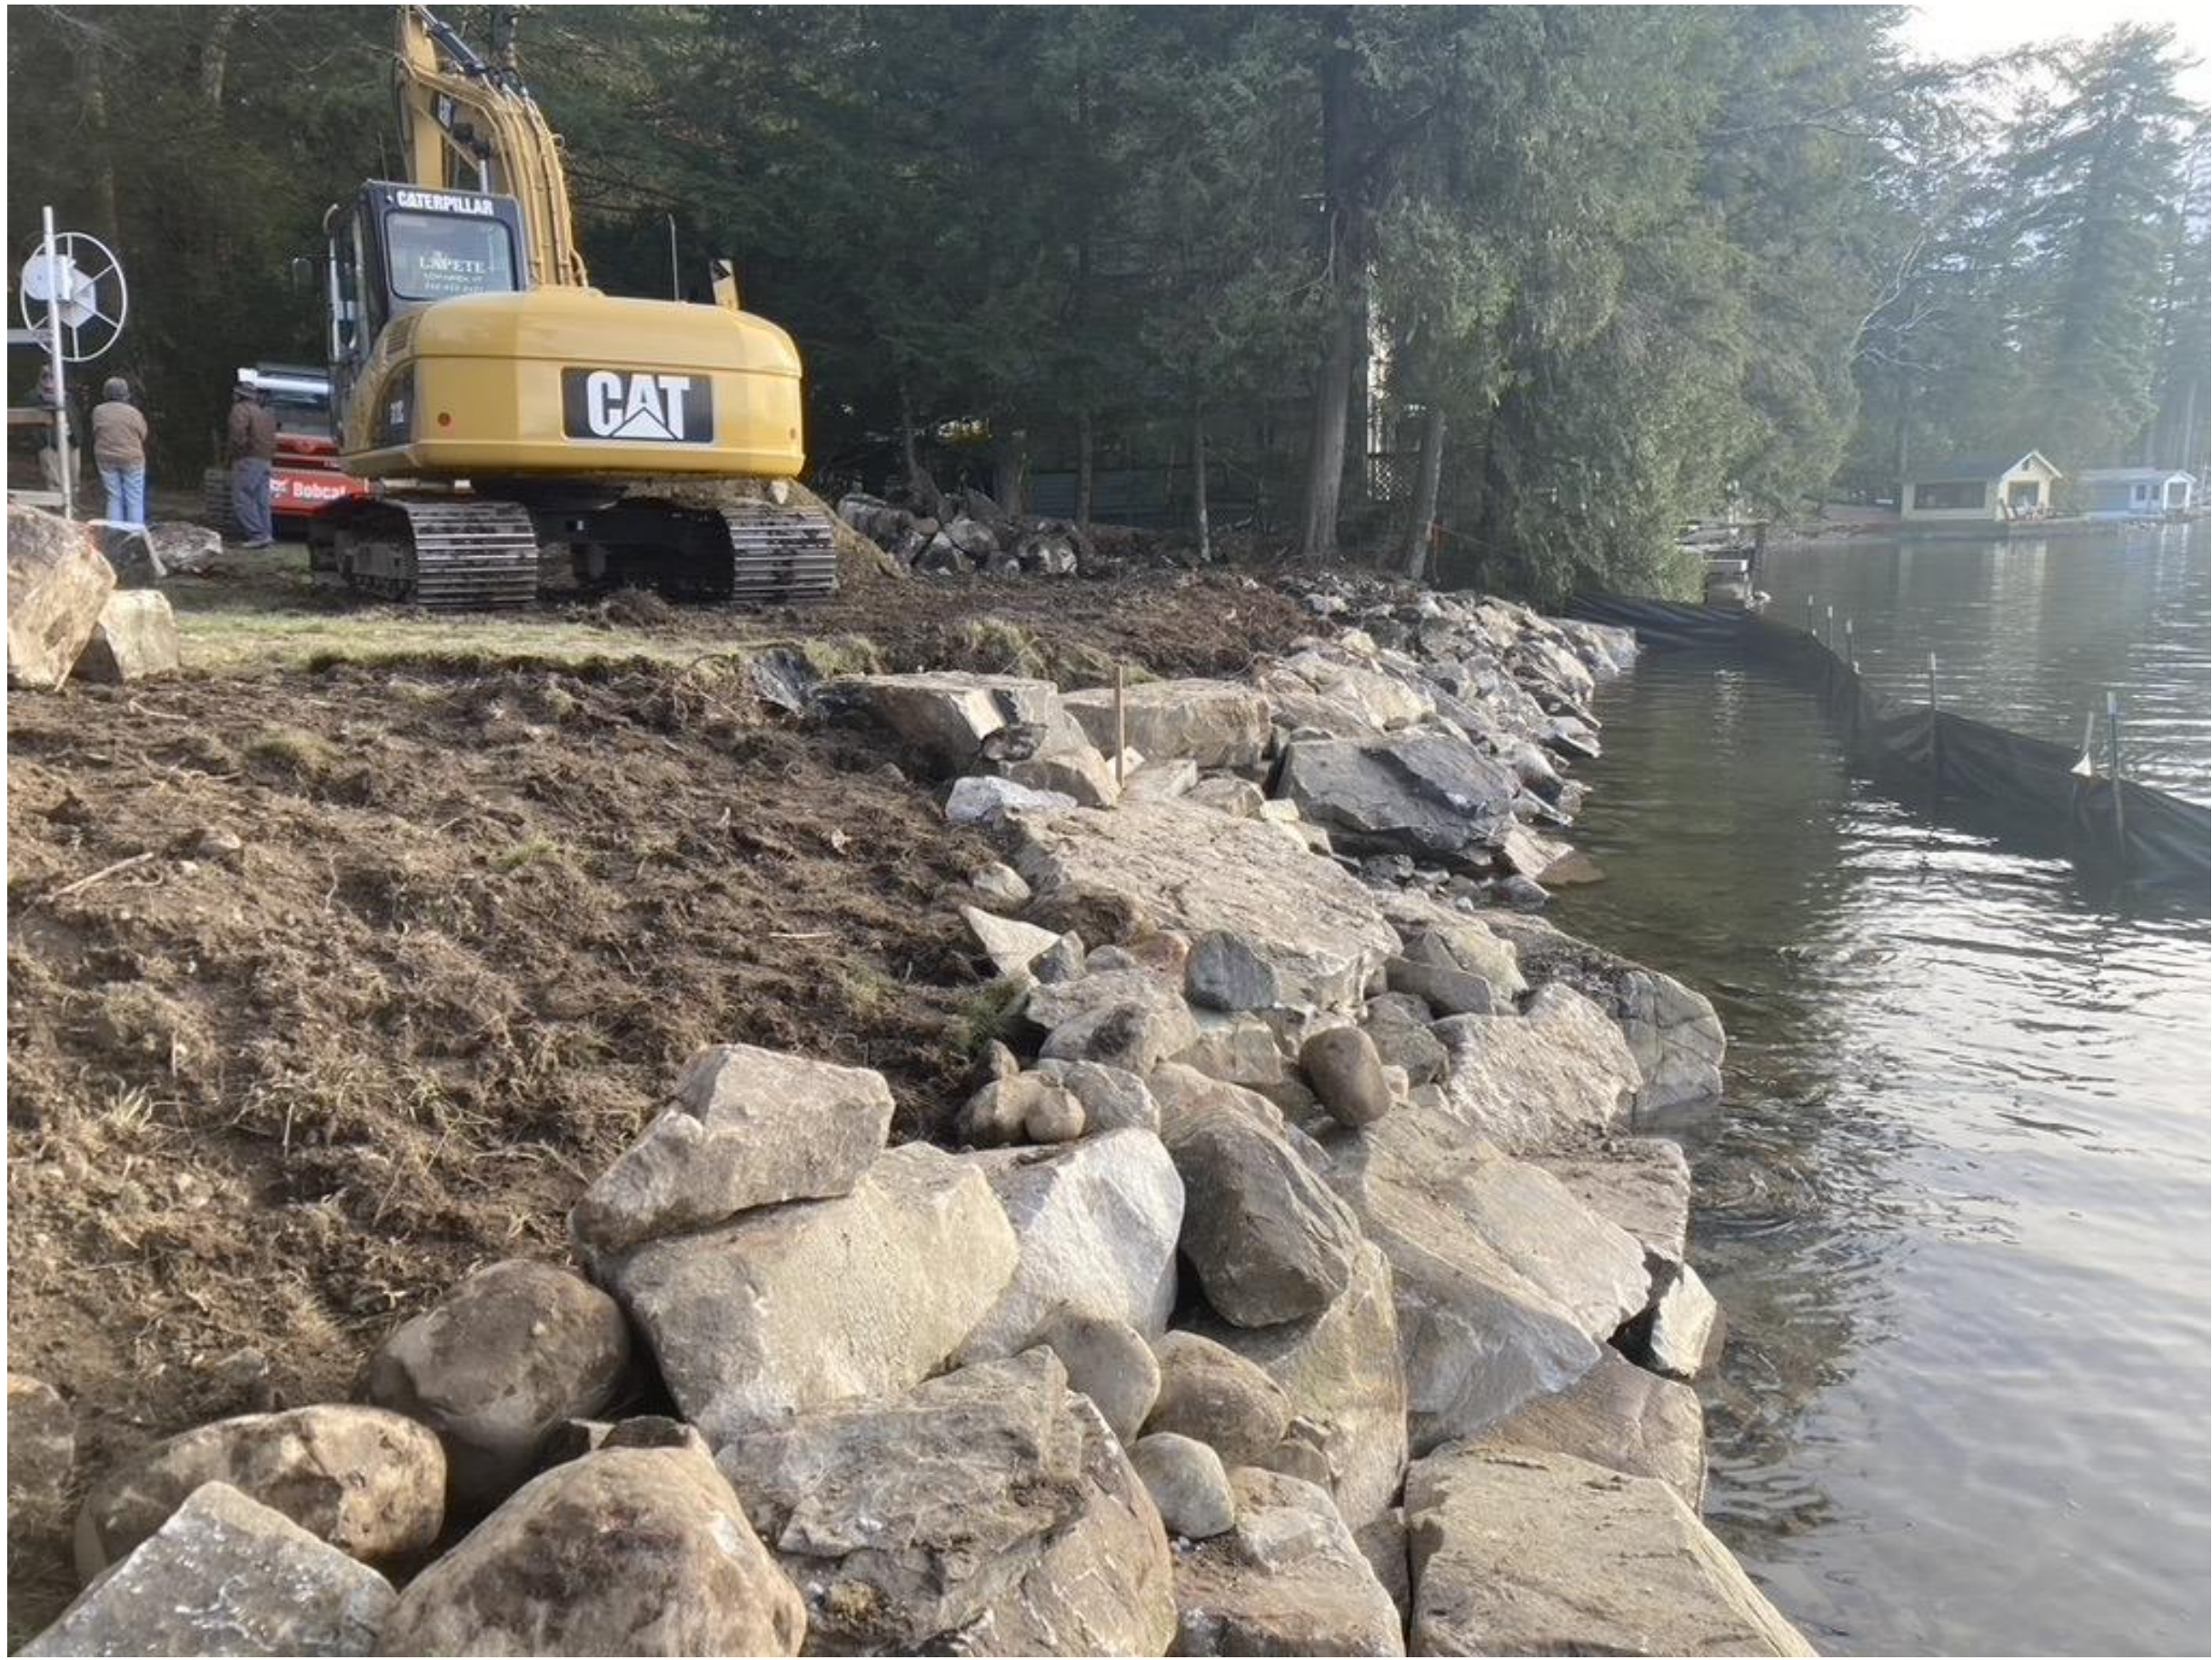
# Remove retaining wall, Regrade, Stone Toe

On-site stone, Erosion Control Matting/Blankets (ECB) (SC150BN), Coconut coir logs (12" diameter x 10' long)

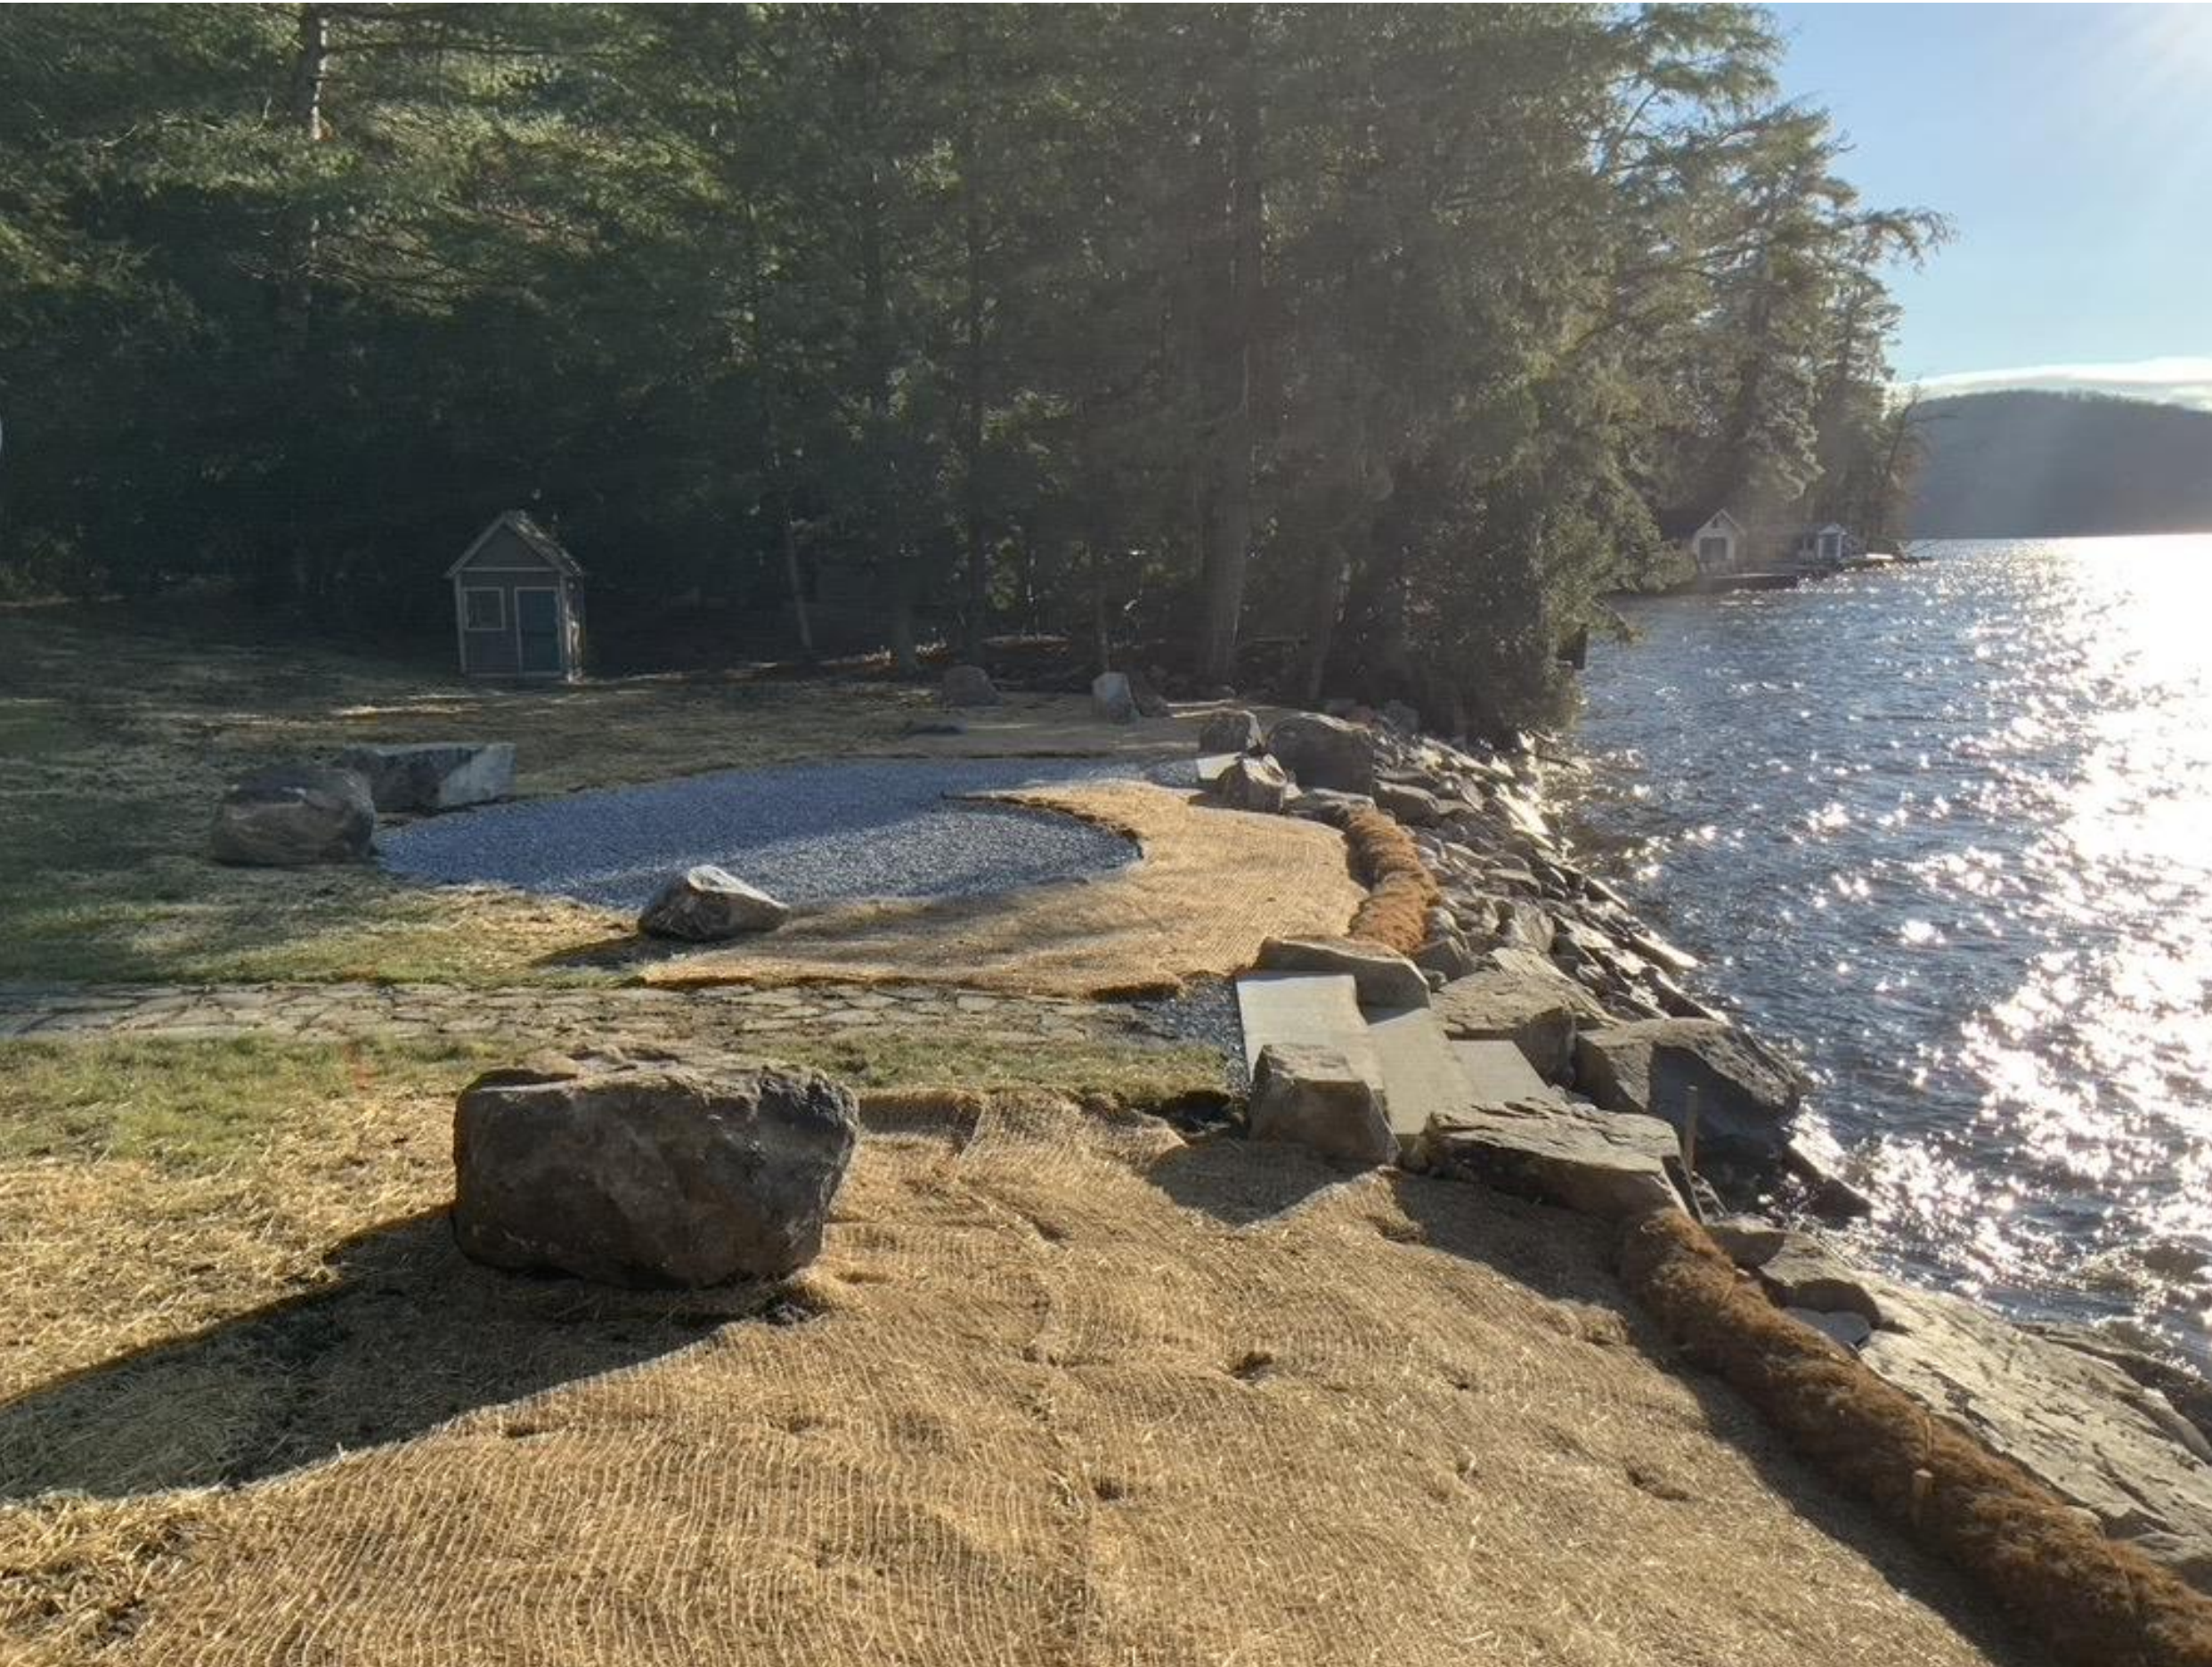
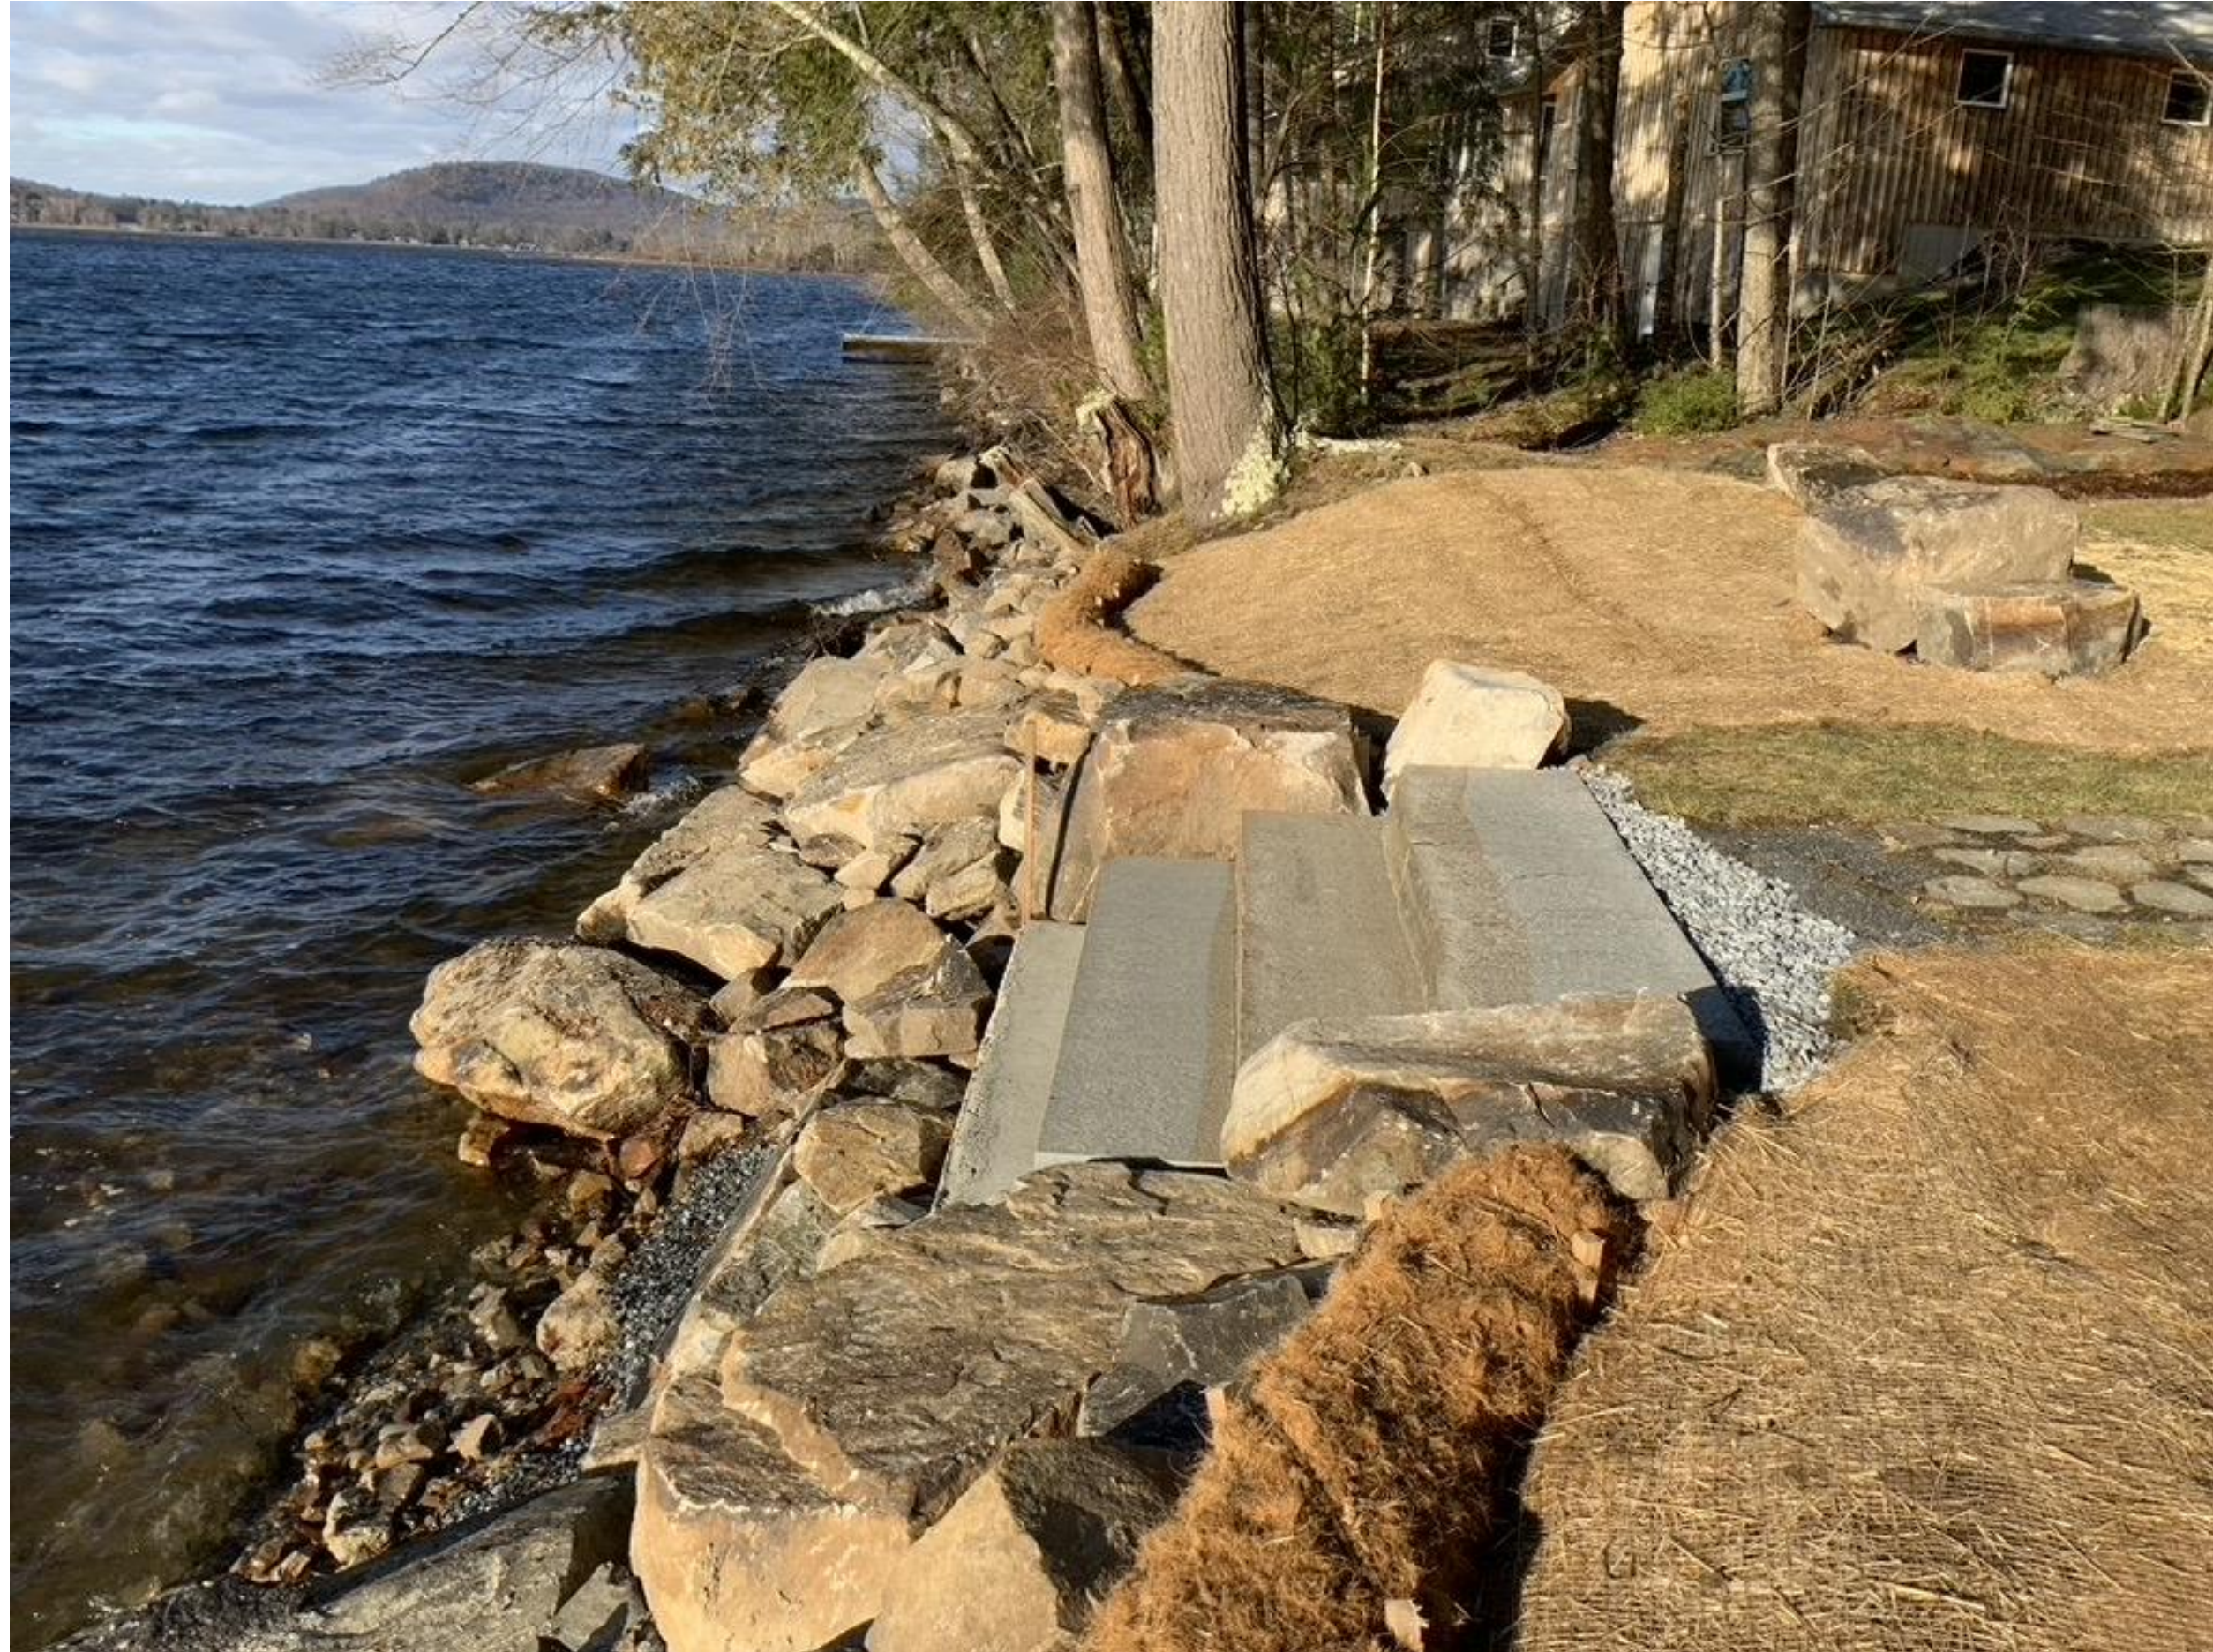
# Fall: Erosion control

B&b Red Maples, Shrub & Perennial Containers, Low-P Compost, Mulch
