Lake Wise Info Sheet

Shoreland Best Management Practices for Lake-friendly Living.

BEACHES & RECREATION AREAS

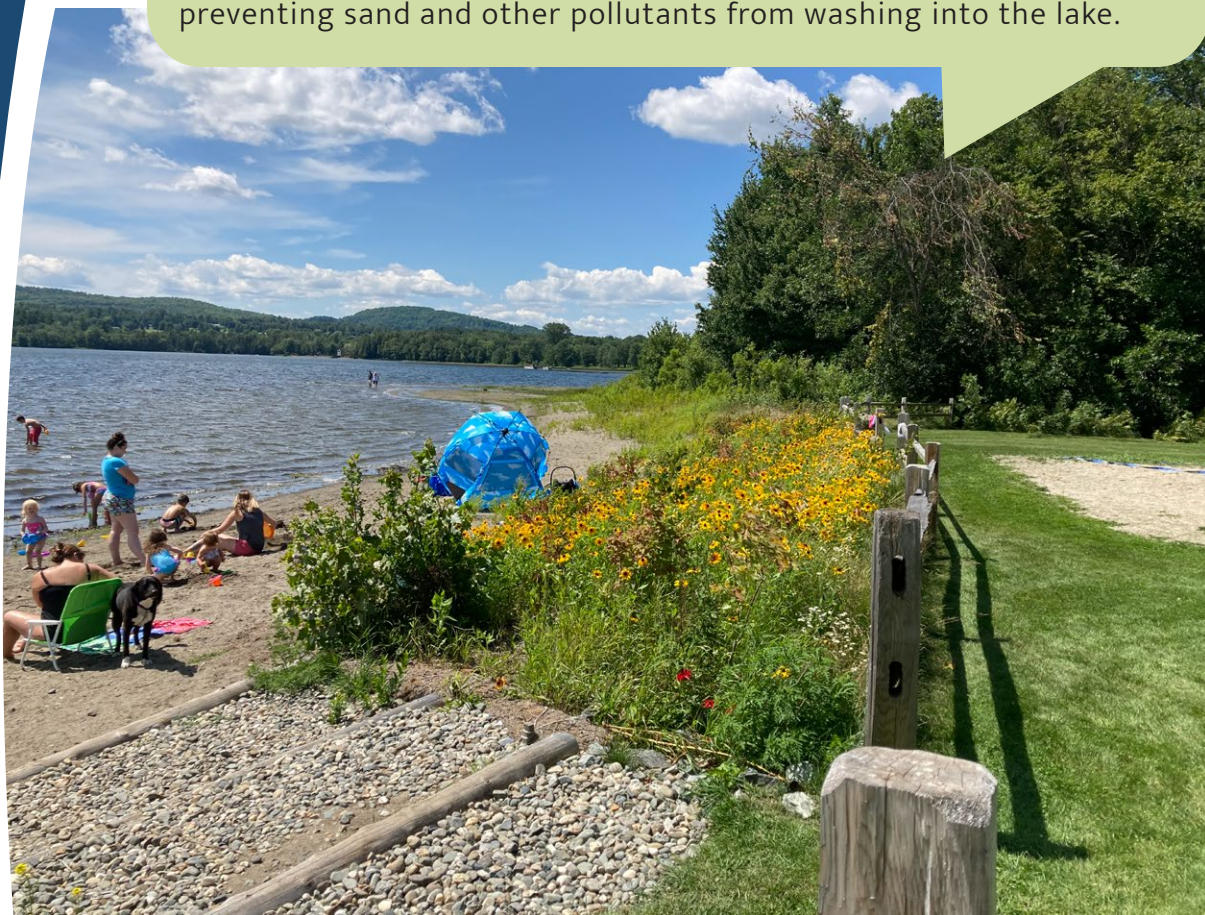
Beach stabilization at Salem Town Beach in Derby with native plantings, infiltration steps, a split rail fence, and biodegradable erosion control materials to prevent erosion and delineate access while protecting a vegetated lakeshore buffer and wildlife.

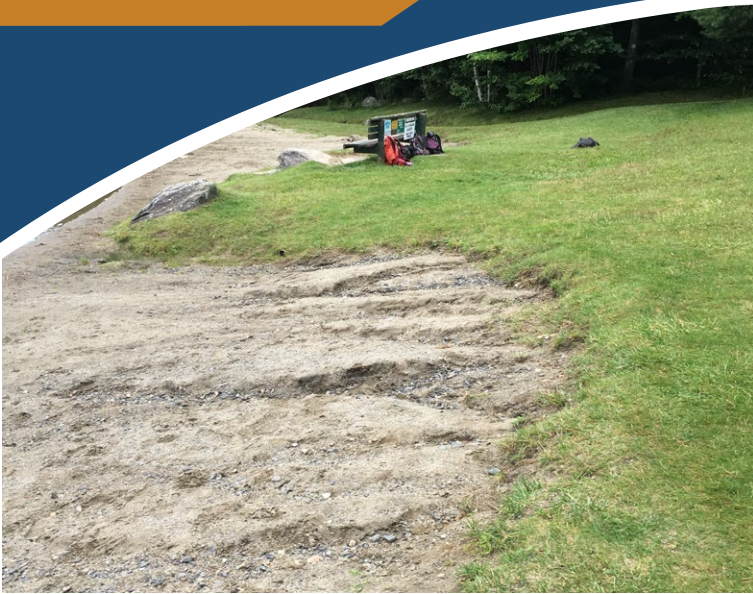
BEFORE. Lake Reponda beach in Wilmington was undefined and eroding from upland stormwater runoff.

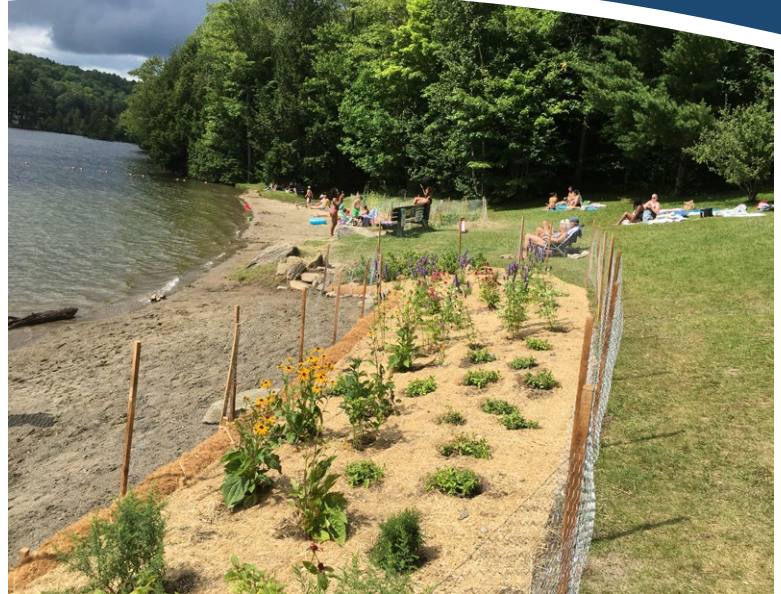
INSTALLATION. Stabilized with fiber coir rolls, erosion control blankets, native plantings, and stone step access.

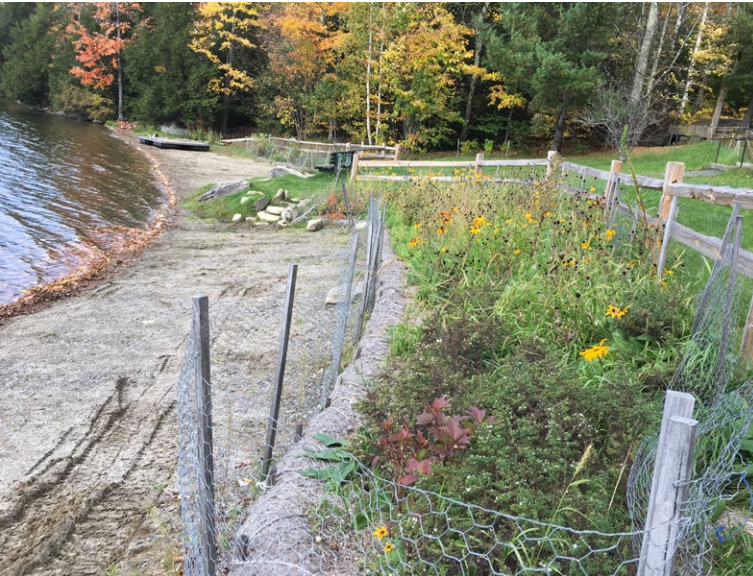
1 YEAR LATER. Split-rail fence to delineate and protect.

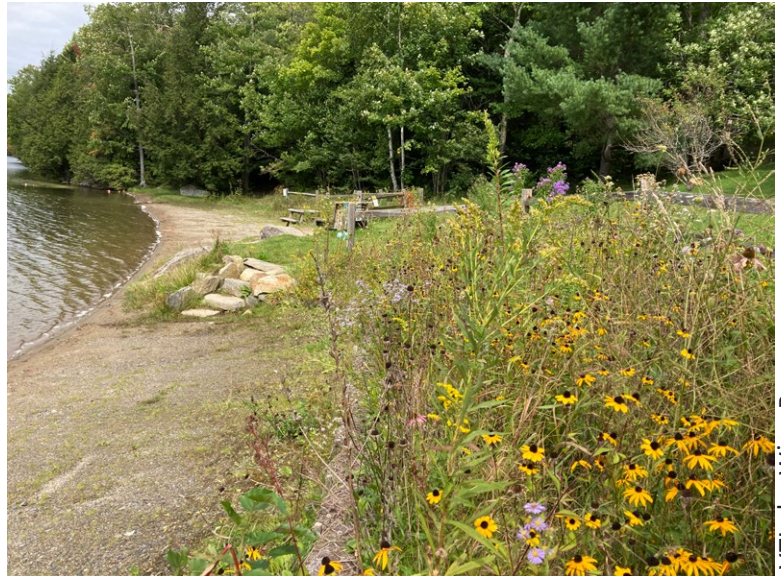
3 YEARS LATER. Native plants flourish and no erosion!

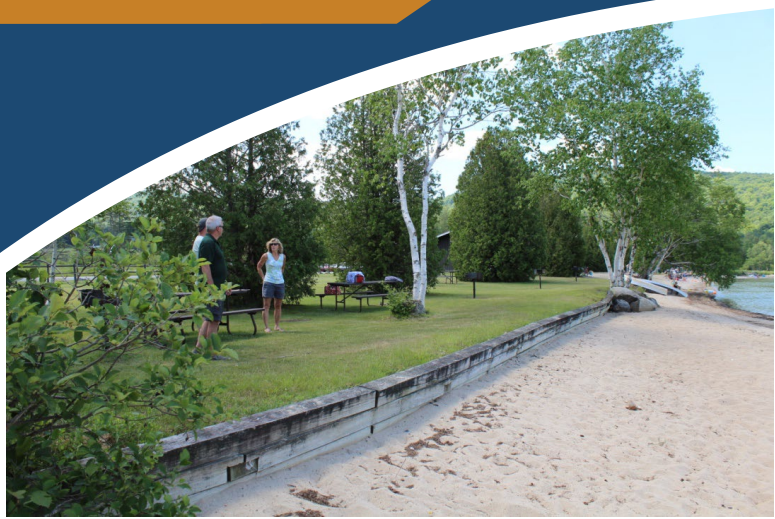
Failing retaining wall at Brighton State Park, Island Pond.

- ❖ Failing retaining walls from high energy wave action, ice push, and sink holes and heaving from upland stormwater runoff.
- ❖ Compaction of lake access areas from high foot traffic that tramples native vegetation and causes stormwater runoff and erosion of shoreland soils.
- ❖ Bank erosion, undercutting, and sloughing from cleared vegetated and lawns, undefined pathways, wave action, ice push, and stormwater runoff.

- ❖ Replace retaining walls with more cost-effective and sustainable **bioengineering practices**, such as a slope regrade, fiber coir rolls, erosion control blankets, stone toe, and native plantings.
- ❖ Minimize and define **pathways** with peastone, mulch, **permeable pavers**, fencing, **infiltration steps**, stone steps, or mown paths.
- ❖ Reduce lawn areas and replace with delineated and stabilized **native restoration plantings**.

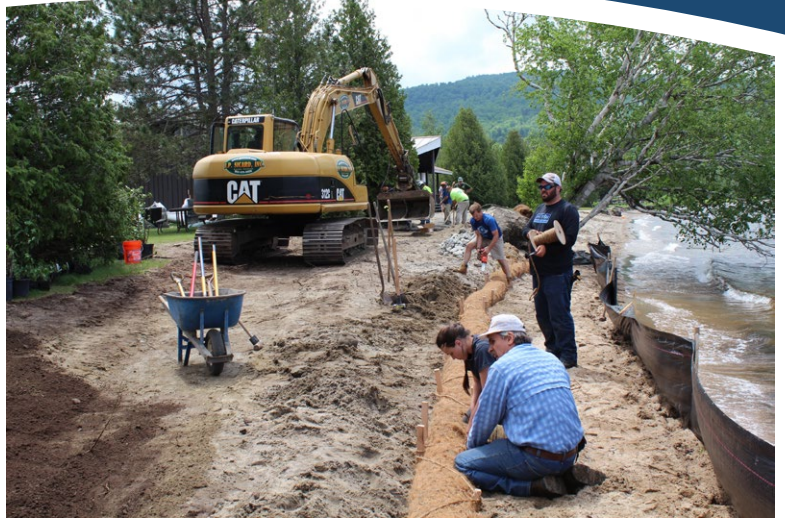
INSTALLATION. Erosion control with fiber coir rolls.

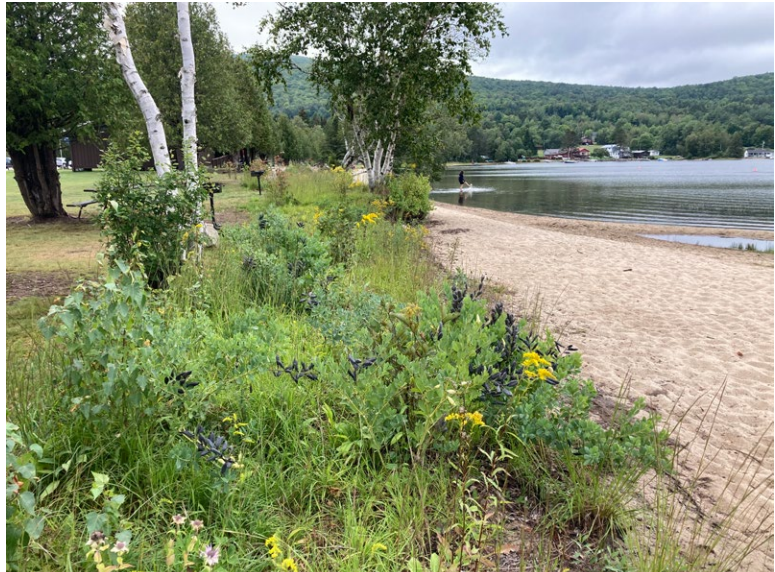
AFTER. Stabilized beach border with native plantings.

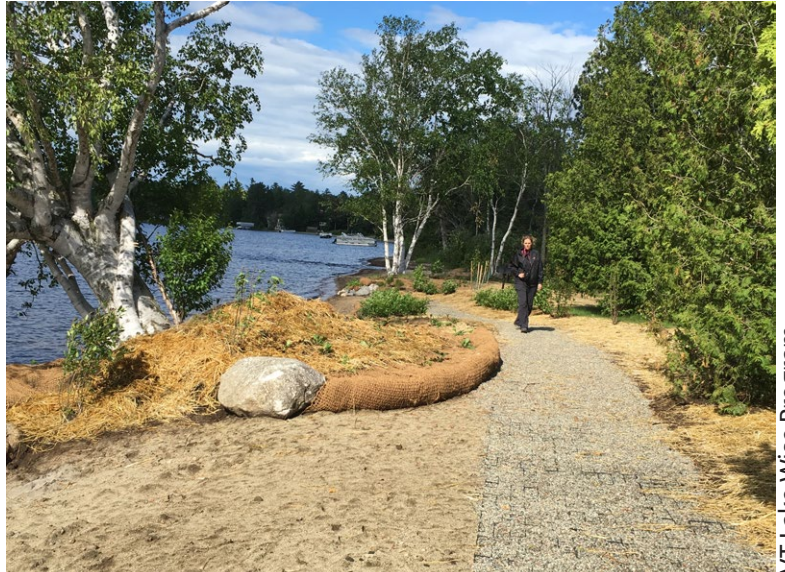
ADA compliant permeable geogrid and peastone pathway.

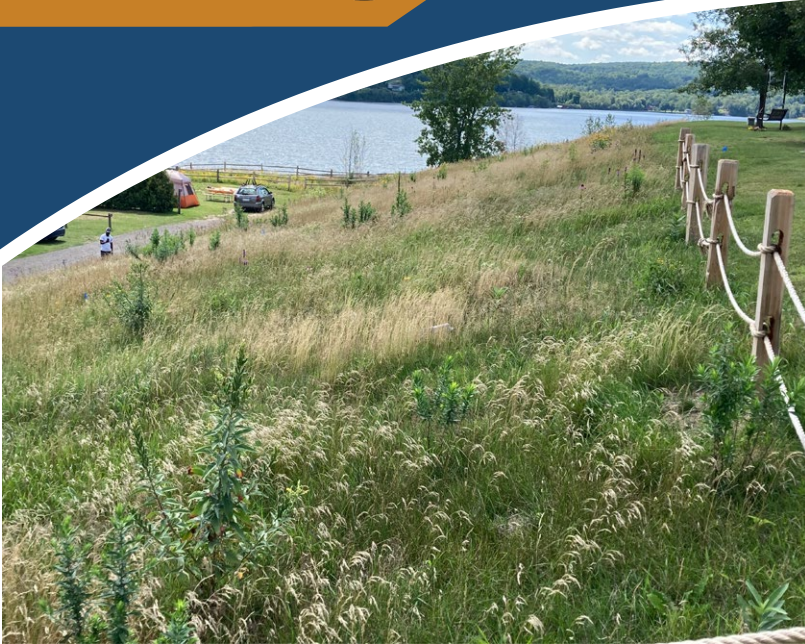
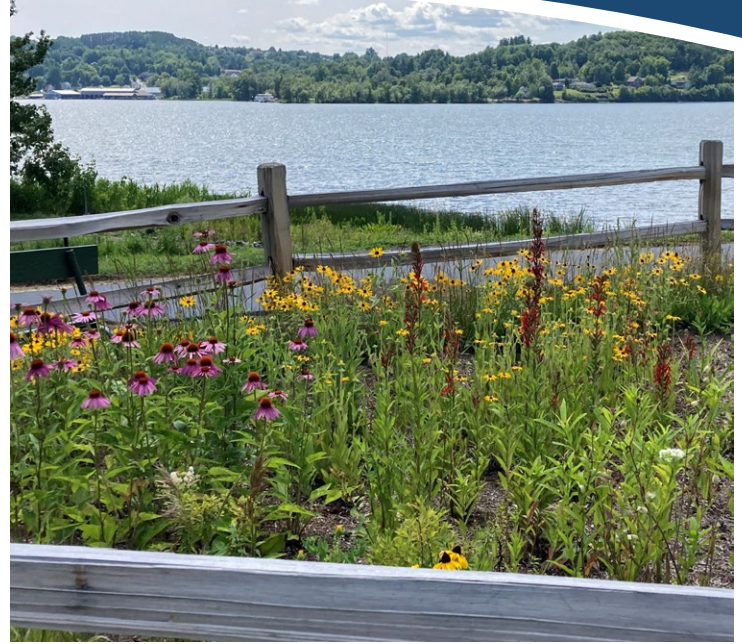
An upland meadow and rain garden slow down and soak up stormwater at steeply sloped Prouty Beach in Newport.

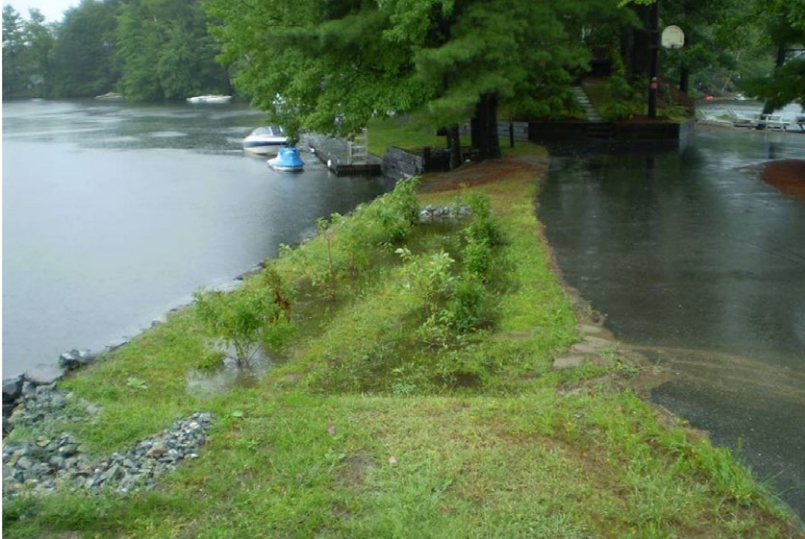
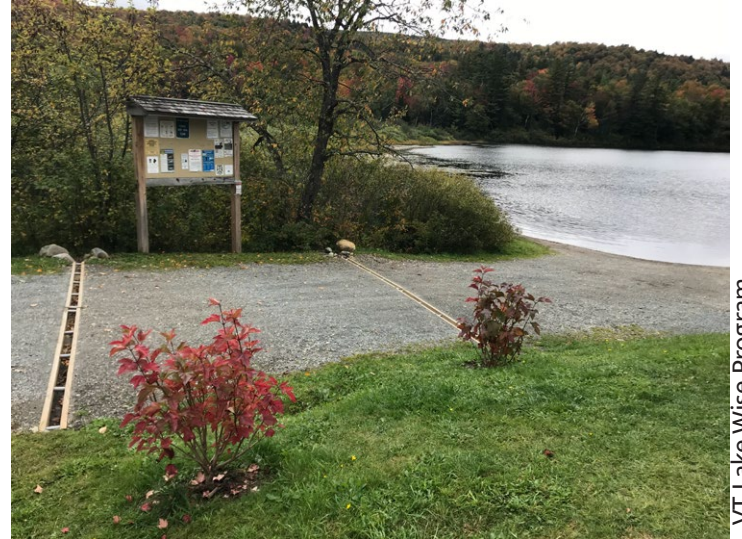
A vegetated swale at Lake Shirley, MA and open-top culverts at Lake Eden F&W Access intercept road runoff.

- Capture upland stormwater runoff and soak it into the ground to protect lake health with **vegetated swales, rain gardens, infiltration trenches, filter strips of meadow plantings, filter berms, water bars, and other stormwater treatment practices.**
- Reduce lawn areas and replace with **meadows, 'no-mow' areas** (natural succession of native plants), or **native plantings**. Be sure to monitor for and remove any **invasive species**.
