WATER CHESTNUT HAND HARVEST PROGRAM 2017

Vermont Department of Environmental Conservation
Montpelier, Vermont

A report prepared for the Lake Champlain Basin Program on water chestnut hand harvest activities in Lake Champlain and other waterbodies in Vermont

April, 2018

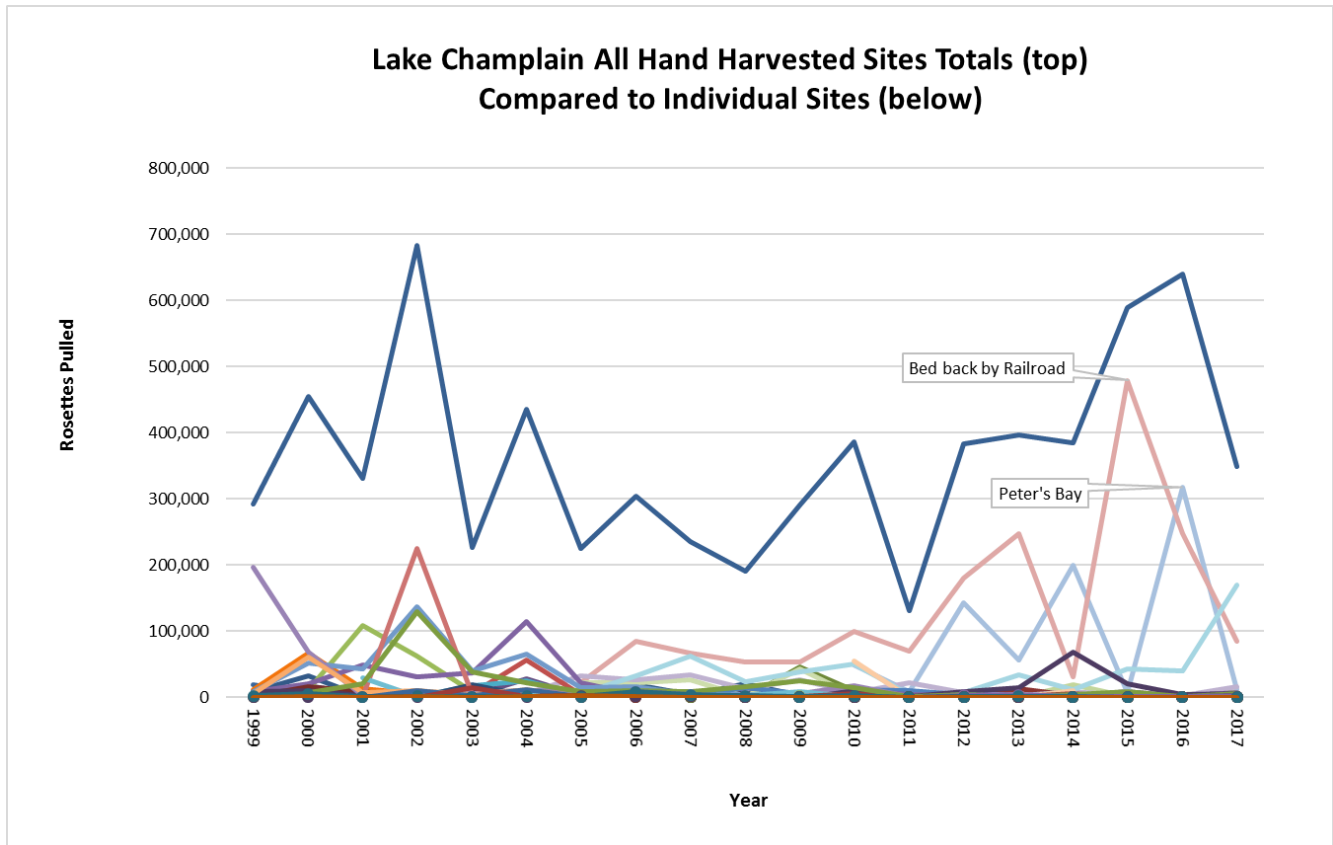
Figure 2. Number of rosettes removed by handpullers from Lake Champlain yearly (top blue line), and from individual sites (other lines).

The number of hand harvested rosettes from Lake Champlain steadily declined from 1999-2011 in the majority of locations (Figure 2), which demonstrates the effectiveness of this technique. As handpulling crews were deployed further south into areas previously managed only by mechanical harvesting, such as Peter's Bay, the number of rosettes pulled annually has risen. As handpulling continues in these areas in 2018 and beyond, the expectation is that the water chestnut populations in these areas will continue to decline.

Generally, locations that have been consistently managed by handpullers show a yearly decline in rosettes harvested. However, other factors can cause variability on a year-to-year basis, including funding availability, weather, and water levels. For example, the Otter Creek Region has exhibited significant declines in water chestnut populations since 1999 (Figure 3). However, abnormally low water levels in 2016 made access to many sites impossible by mid-summer. Therefore, some sites were not adequately covered, which probably contributed to the uptick in the number of rosettes harvested in 2017. This trend is mirrored in other regions and highlights the fact that managing water chestnut populations is a long process.

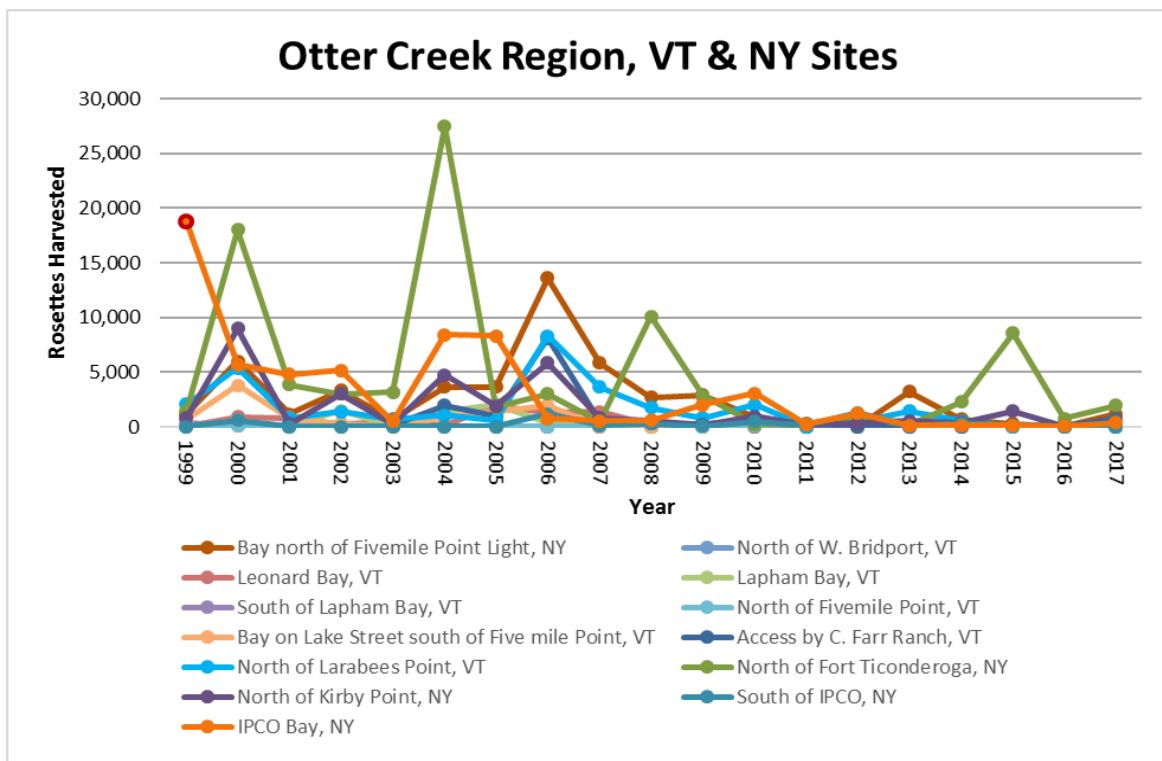
Figure 3. Number of rosettes removed by handpullers at all sites in the Otter Creek Region.

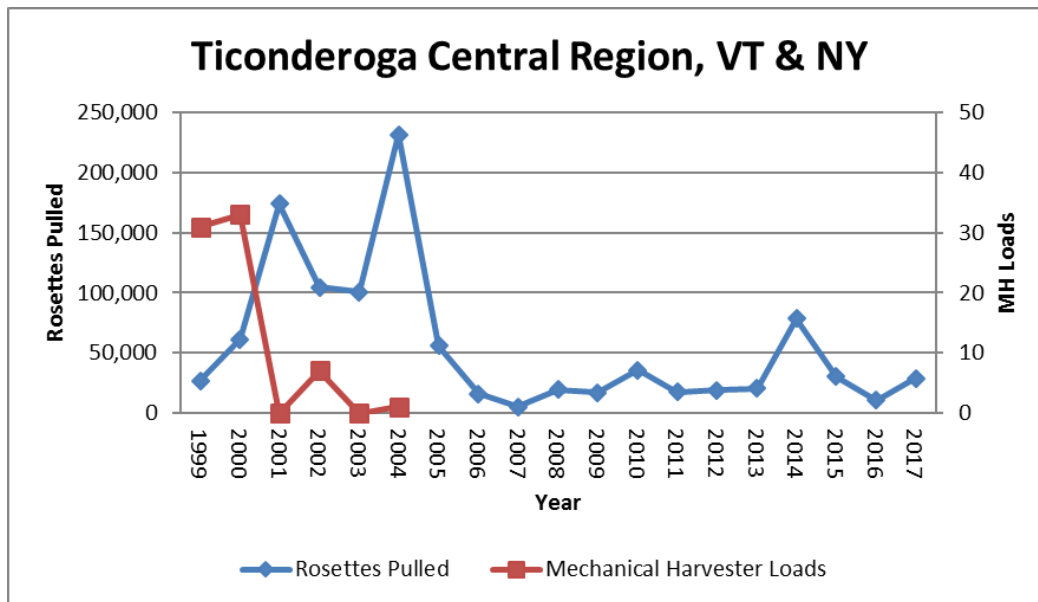
Figure 4. Control trends for Ticonderoga Central Region in Vermont and New York, including mechanical harvesting and handpulling data.

Of the 65 sites visited by contractors in 2017, 0 sites were new; 8 had no water chestnut; 15 (up from 11 in 2016) exhibited a decline in the amount harvested, and the remaining 42 sites had an increase in the amount harvested. Of these 42 sites, 26 had less than 1,000 harvested plants. The larger population areas were located in the Ticonderoga Central region (Figure 4) that was most recently phased out of the mechanical harvesting regime, and the South Lake B Region that continues to be managed with both mechanical harvesting and hand harvesting (Figure 5).

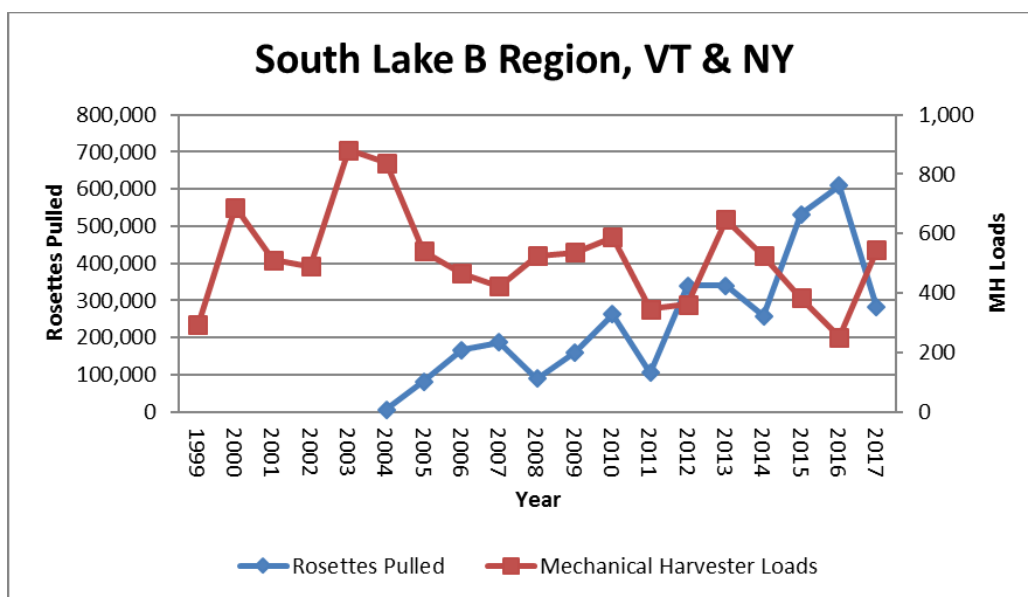
Figure 5. Control trends for South Lake B Region in Vermont and New York, including mechanical harvesting and handpulling data.

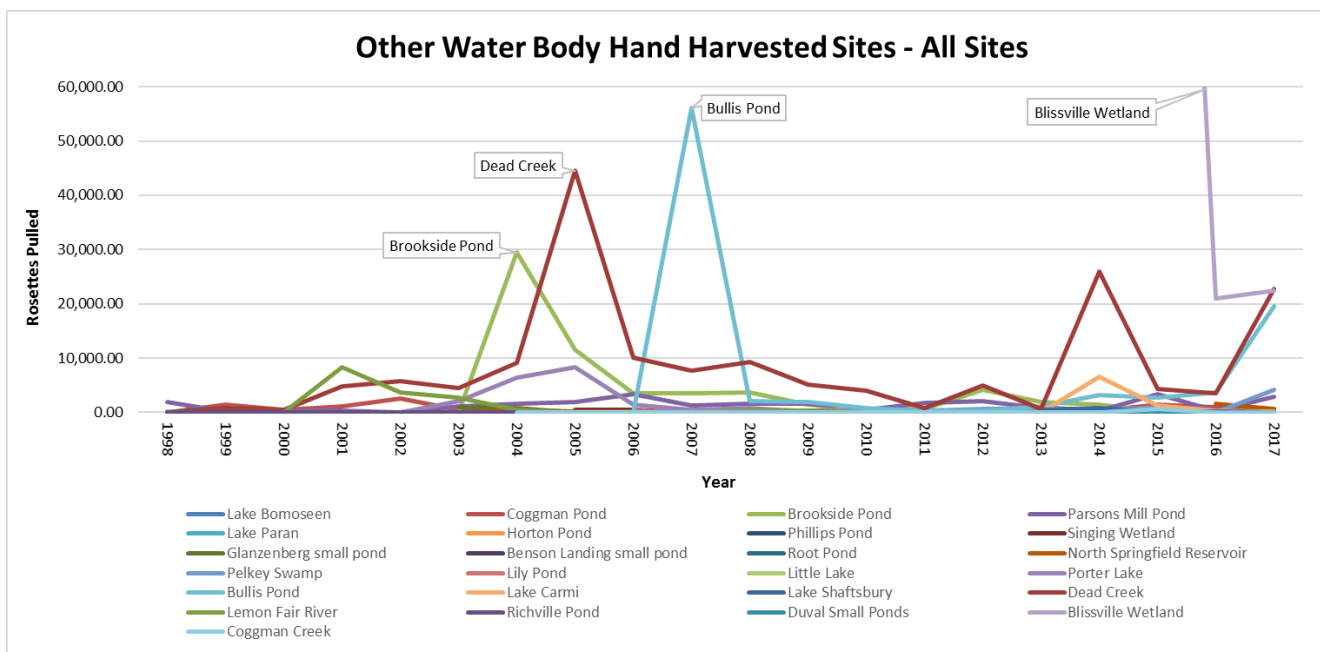
Figure 6. Number of rosettes pulled annually at all non-Lake Champlain sites.

Overall, the amount of water chestnut that is hand harvested in other waterbodies exhibits a steady decline as shown in Figure 6, although populations have spiked in a few locations throughout the years. These spikes often indicate a substantial population found at a new site or in a new area. For example, Brookside Pond, a site of a large infestation, has steadily declined after a major hand pulling effort was completed in 2004. VTDEC leads the efforts to employ volunteers to assist in the hand pulling efforts within these areas annually.

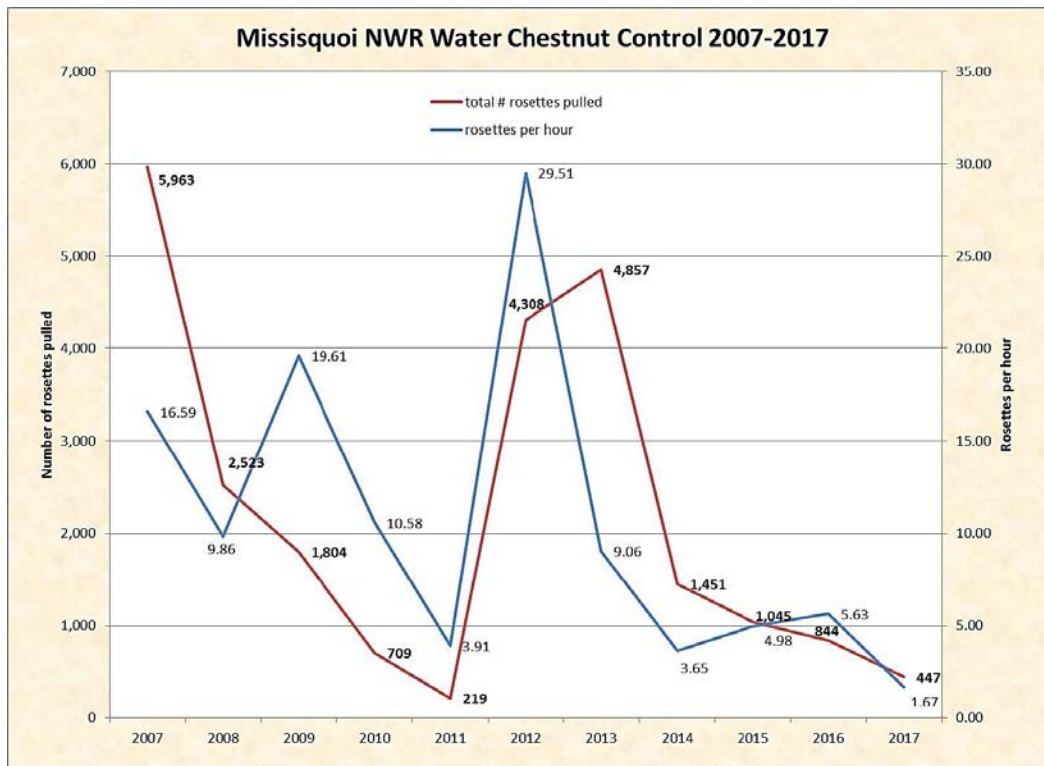
Figure 7. Total number of rosettes pulled and rosettes pulled per hour in the Missisquoi National Wildlife Refuge.

The Friends of Missisquoi National Wildlife Refuge (Friends Group) is another partner organization who works in tandem with US Fish and Wildlife Service (USFWS) staff and has similarly led surveying and hand pulling efforts in one region. The Friends Group initiated work in 2007 using grant funds and in-kind services to survey and harvest the Missisquoi National Wildlife Refuge. Throughout the years, nine sites have been surveyed and harvested. The harvested numbers within these sites is now less than 500 rosettes as the number of plants found each year continues to decline (See Figure 7).
