Cyanobacteria Monitoring on Lake Champlain and Vermont Inland Lakes 2022 Season

Annual Report for the Lake Champlain Basin Program

May 2022

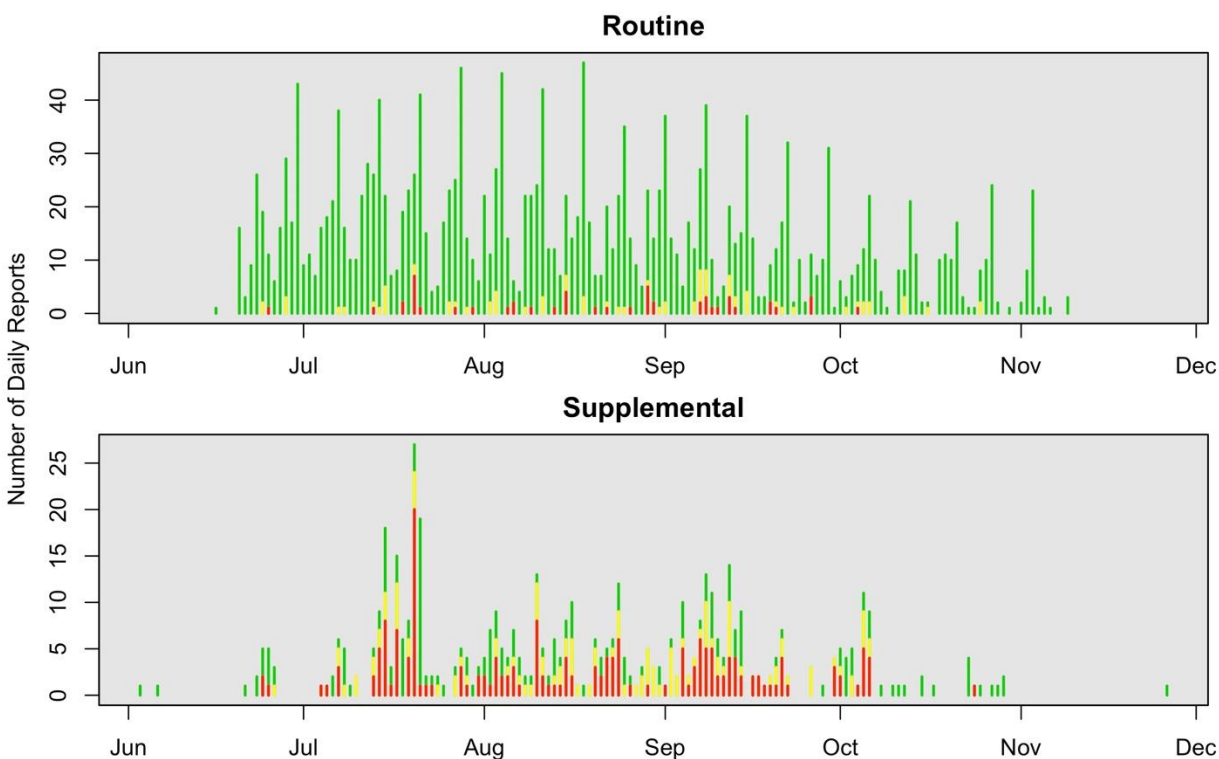
Figure 4. Number of visual assessment reports received on each day of the monitoring period in 2022 in Lake Champlain and Vermont inland lakes. Top panel shows routine reports, bottom panel shows supplemental reports. Green = “Generally Safe”, yellow = “Low Alert”, red = “High Alert”

Summaries of the assessment results from regularly monitored sites in 2022 is presented in Figure 4, showing the progression of the bloom season. The highest monitoring category reached in each region of Lake Champlain and Vermont inland lakes is noted in Table 6. The full list of records is available upon request or can be downloaded from the VDH website (<http://www.healthvermont.gov/tracking/cyanobacteria-tracker>).

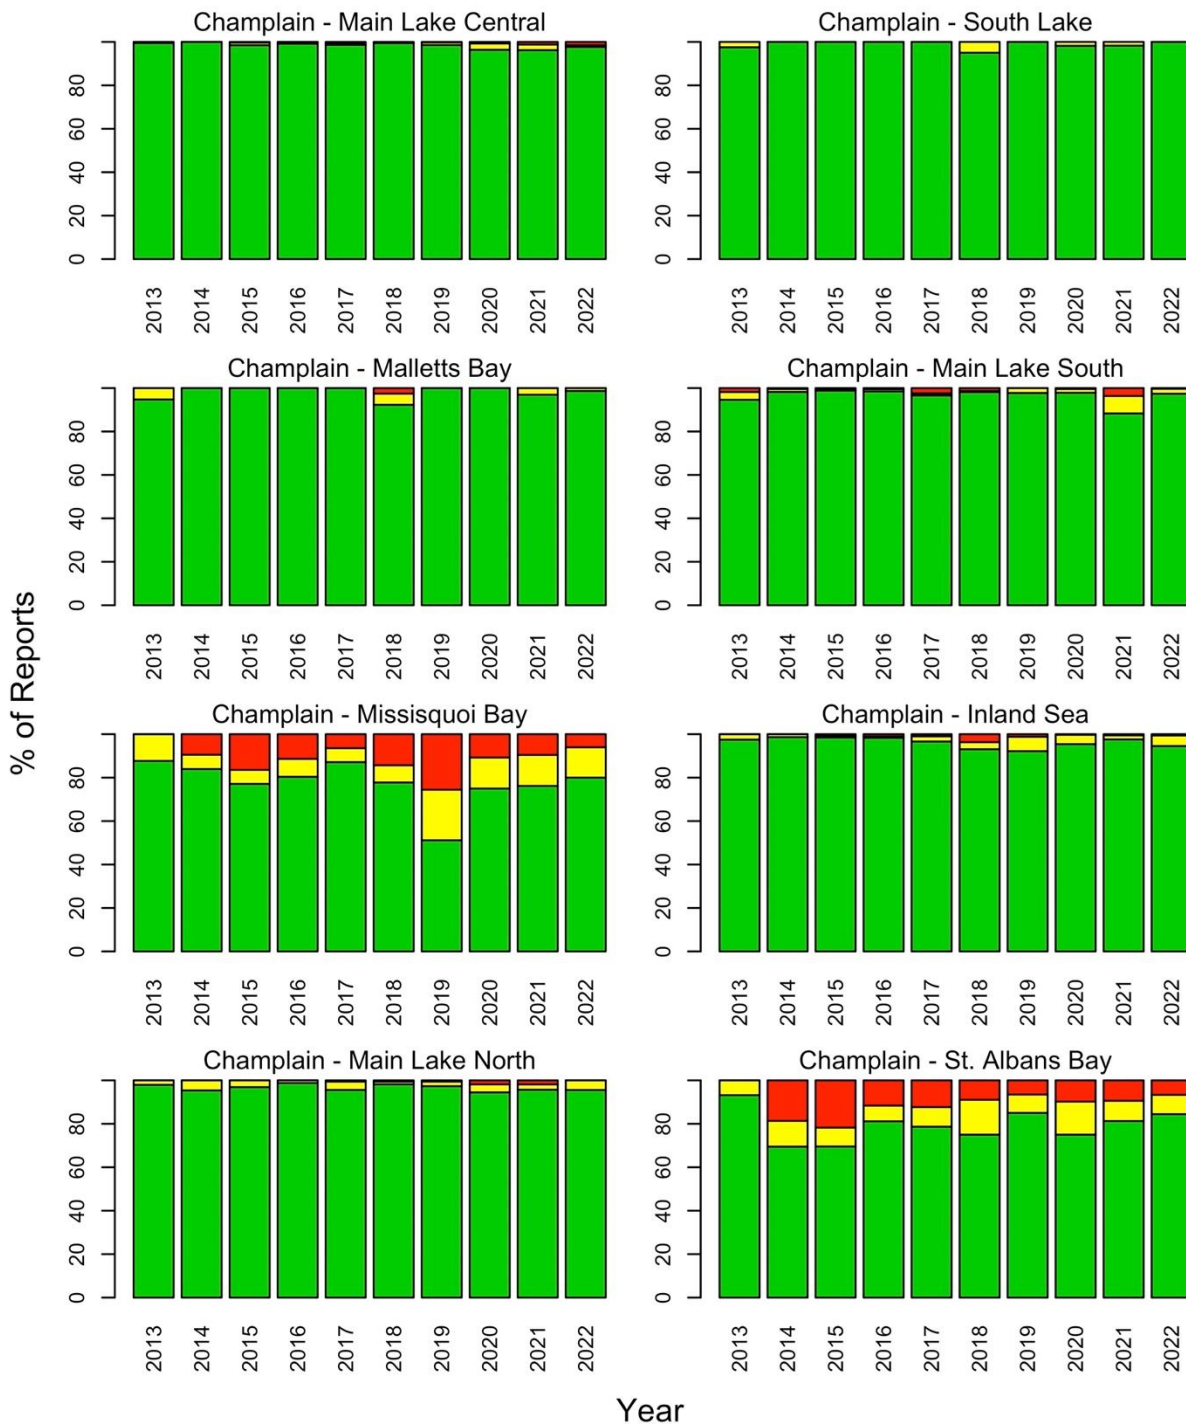
Figure 6: Web Report alert levels from routine reports for the basins of Lake Champlain during the years 2013 – 2022 showing the percentage of reports in each alert category. Green indicates “generally safe” conditions, yellow indicates “low alert”, and red indicates “high alert”.

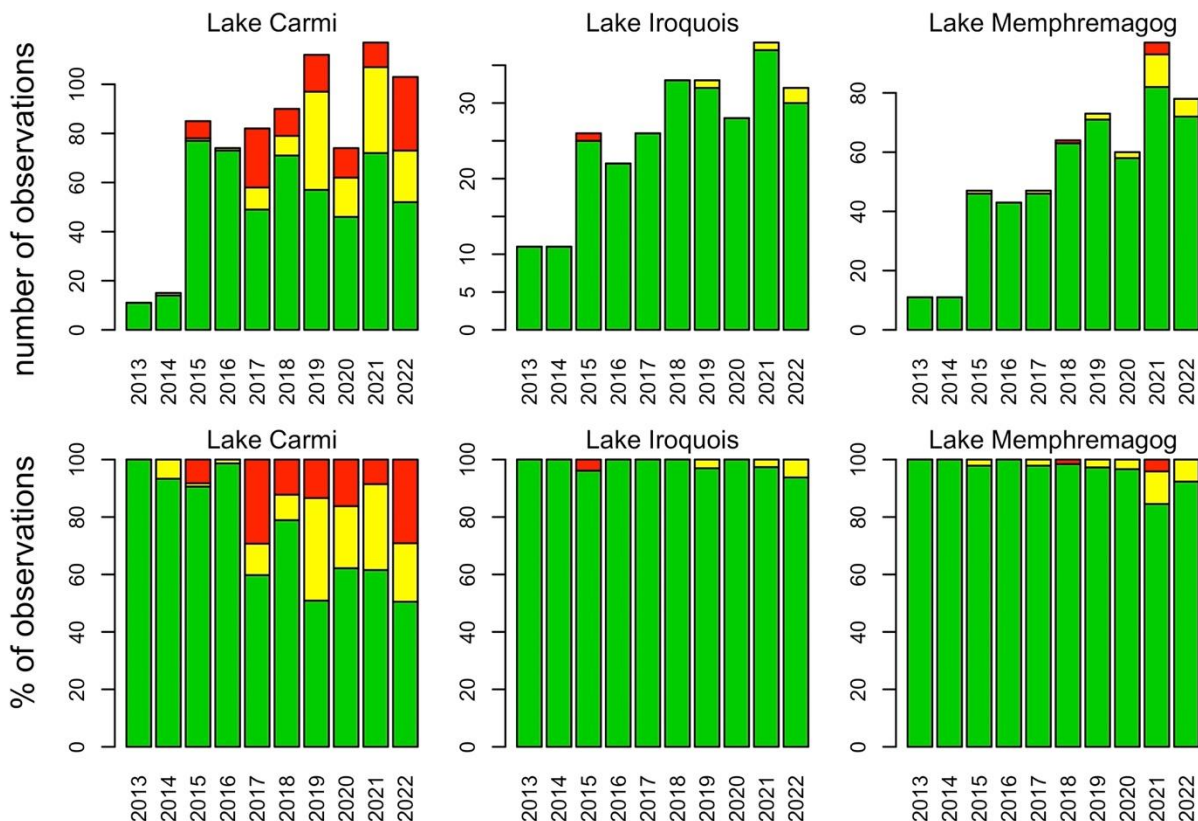
Figure 10: Web Report alert levels for selected inland lakes showing the total number (top) and percentage (bottom) of reports in each alert category. Green indicates “generally safe” conditions, yellow indicates “low alert”, and red indicates “high alert”. Supplemental reports are excluded.

Several inland lakes have consistently high numbers of reports over the 2013-2022 timeframe, providing the opportunity to look at trends. In 2022 Lake Carmi had relatively high incidence of bloom conditions, particularly on a percentage basis, relative to previous years. The difference from previous years was not huge, but is notable because this was the first field season in which the aeration system meant to reduce internal phosphorus loading was fully operational throughout the bloom season, but high incidence of blooms occurred nonetheless (Fig. 10). Lake Memphremagog had a lower number and percentage of alert-level conditions than 2021, when bloom conditions were quite prevalent, but had a higher percentage of low-alert blooms

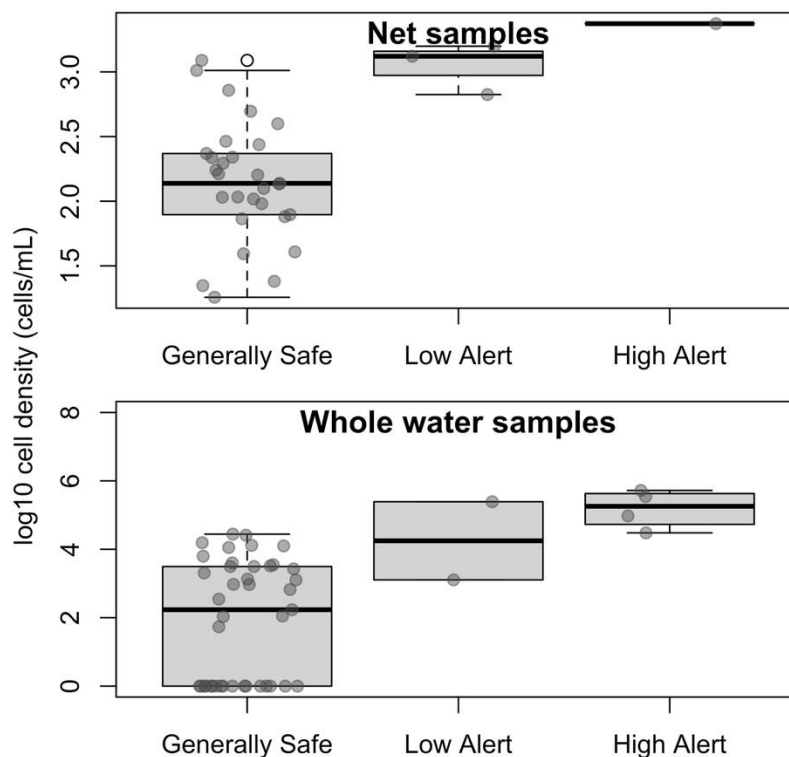
Fig. 11: Box and whiskers plots of cell densities ($\log_{10} n+1$ transformed) for each alert category for whole water and plankton net samples. Dark lines represent median values for each category, top and bottom boundaries of the box represent 75th and 25th percentiles of the data, respectively, and whiskers represent range of the data, except if there are extreme outliers which are represented by open circles. Grey circles represent individual data points.

Quality assurance samples indicated that the visual monitoring protocol was a reasonable indicator of cyanobacteria concentrations. Median cell densities increased from “Generally Safe” through “Low Alert” and “High Alert” in both plankton net and whole water samples. However, there were a wide range of cell densities in samples with “Generally Safe” visual observations (Fig. 10), and there was broad overlap in observed cell densities in all categories using both protocols.

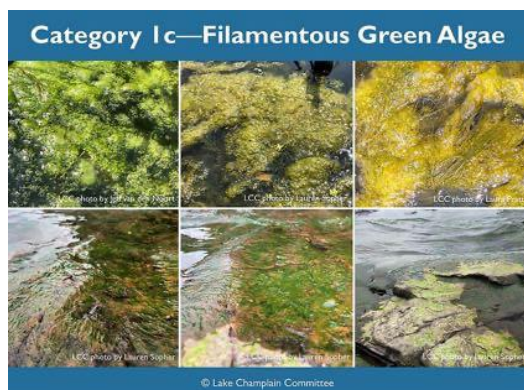
Not sure if you're seeing potentially toxic cyanobacteria or non-toxic filamentous green algae? A stick test is a good way to differentiate cyanobacteria from plant matter. If you can pick it up with a stick or paddle, or see plant leaves, it's generally not cyanobacteria. Keep in mind that the stick test is not 100% reliable because some types of cyanobacteria, like *Scytonema* sp., can be picked up with a stick.

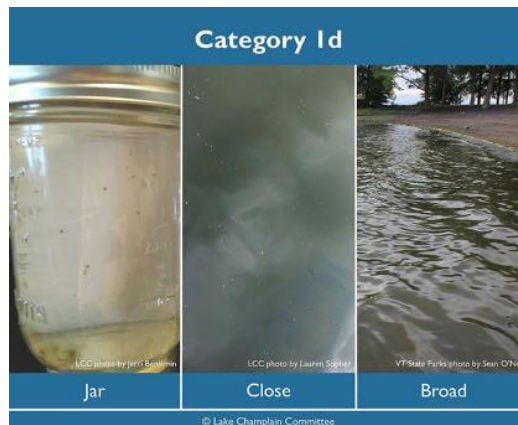
Category 1d: Little cyanobacteria observed—recreation not impaired—tiny specks present, but no streaks or patches—include photos

When cyanobacteria start to be visible in water, they often appear as tiny specks or fuzzy balls; cyanobacteria can occur in densities so low that they do not impair recreational enjoyment of the water,

- Water can appear clear, but green **tiny specks** or fuzzy balls may be visible upon close inspection
- No surface or shoreline accumulations of cyanobacteria

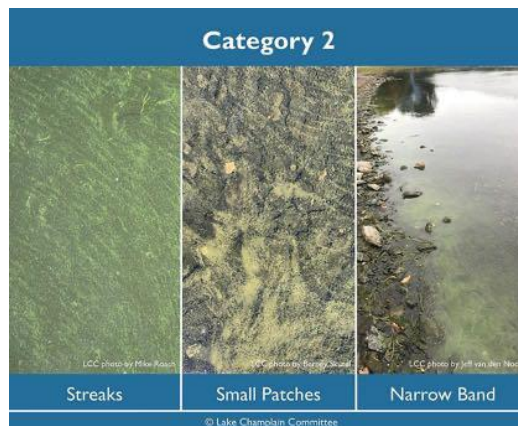
Category 2: Cyanobacteria present, but at less than bloom levels—include photos

Some cyanobacteria accumulation in the water column or on the surface, but not a continuous layer.

- Open water **does not** appear green, blue, or blue-green
- Streaks** of cyanobacteria on the water surface, but not a continuous layer
- Small patches** of cyanobacteria on the water surface, but not a continuous layer
- A **narrow** band of cyanobacteria accumulation at the shoreline

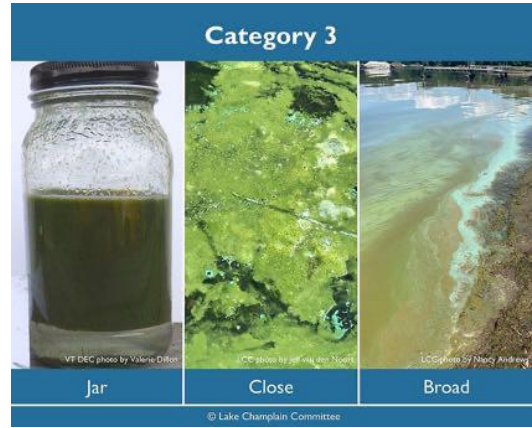
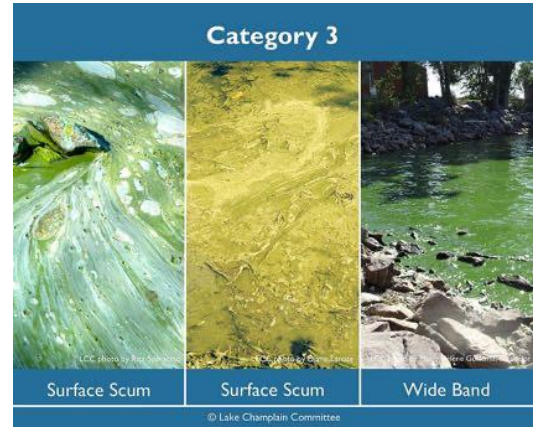
Category 3: Cyanobacteria bloom in progress—include photos

Extensive cyanobacteria accumulation in the water column or on the surface, forming a continuous layer.

- Open water **does** appear green, blue, or blue-green
- Continuous layer of **surface scum** on the water
- A **wide** band of cyanobacteria accumulation at the shoreline that extends at least 10-15 feet offshore
