# Great Hosmer Pond Fact Sheet Series

## Water Quality Summary

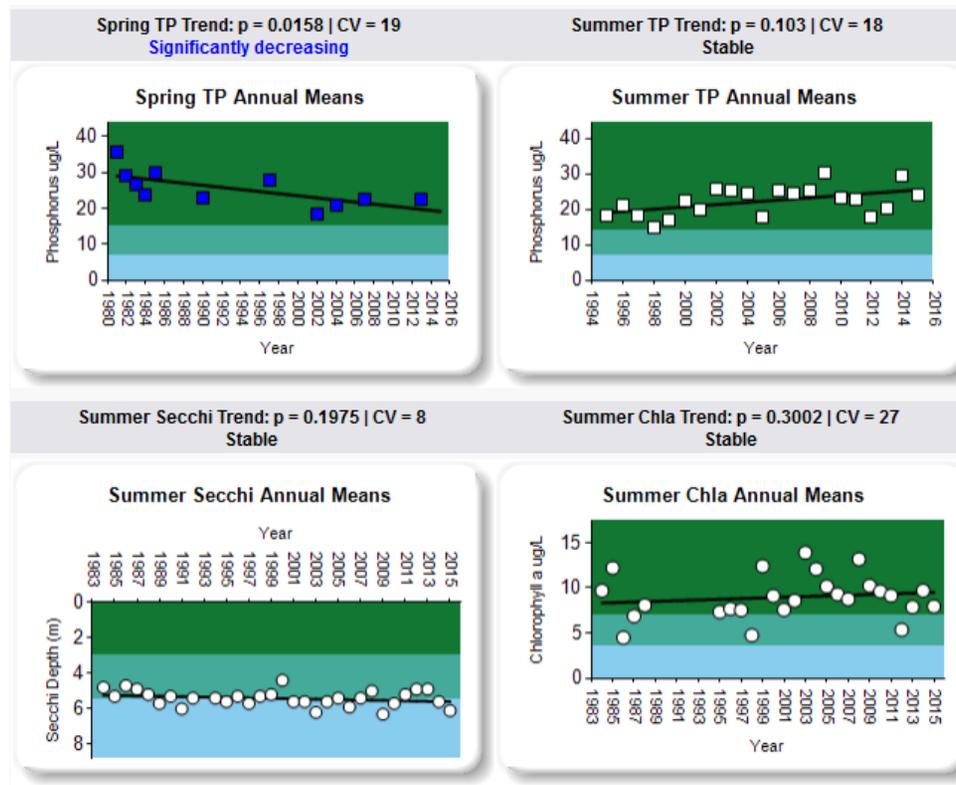
Great Hosmer Pond exhibits relatively high phosphorus concentrations, causing it to be classified as eutrophic. Monitoring by the VT DEC Lakes and Ponds Program and volunteers shows that water quality has improved in recent years (see figures below). Phosphorus concentrations are dropping during spring turnover and the rate of increase during the summer months has slowed. Secchi transparency continues to be excellent and overall water quality is good.

Lakes Program staff speculate that variability in summer phosphorus levels is caused by a combination of external and internal phosphorus loading. External loading can be addressed through watershed and shoreland stewardship. Internal loading is probably a result of legacy phosphorus that accumulated in sediments when lands in Craftsbury and Albany were cleared for forestry and grazing (see reverse). The lake's two deep holes are prone to incomplete mixing and therefore anoxic conditions, promoting phosphorus release from sediments resulting in metalimnetic algal growth. Declining spring phosphorus concentrations suggest the internal phosphorus load is decreasing over time.
