Lake Carmi Crisis Response Plan

Improved Water Quality via State Route 236 Culvert Replacement Project

Vermont Department of
Environmental Conservation

March 2, 2020

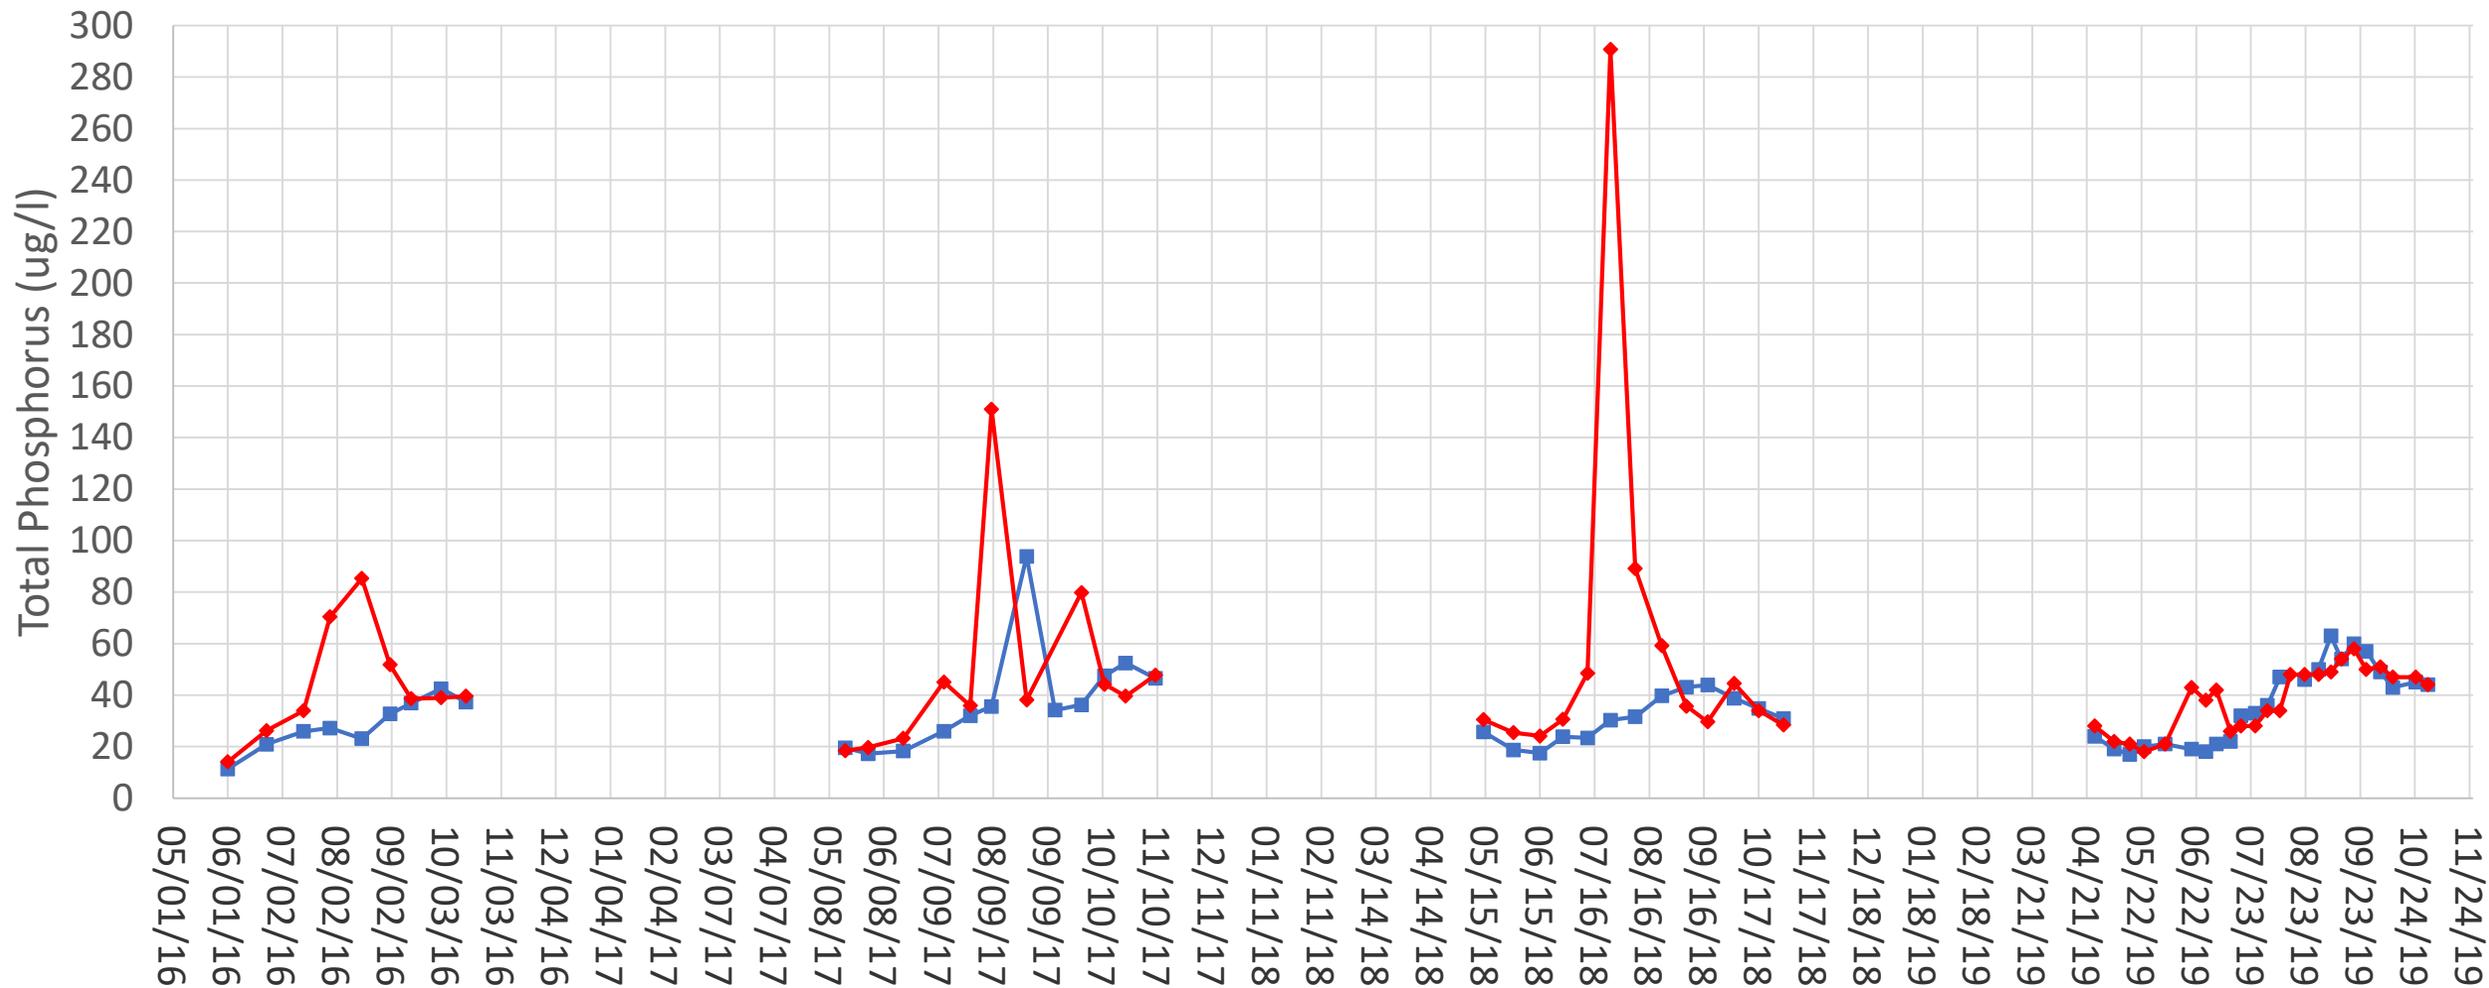
2016-2019 Lake Carmi Station #1 (UVM Mid-Lake Buoy) VTDEC TMDL Monitoring Lake Bottom Total Phosphorus

■ 0.2 m (surface grab sample) ◆ 8.0 m (~2 m above bottom grab sample)

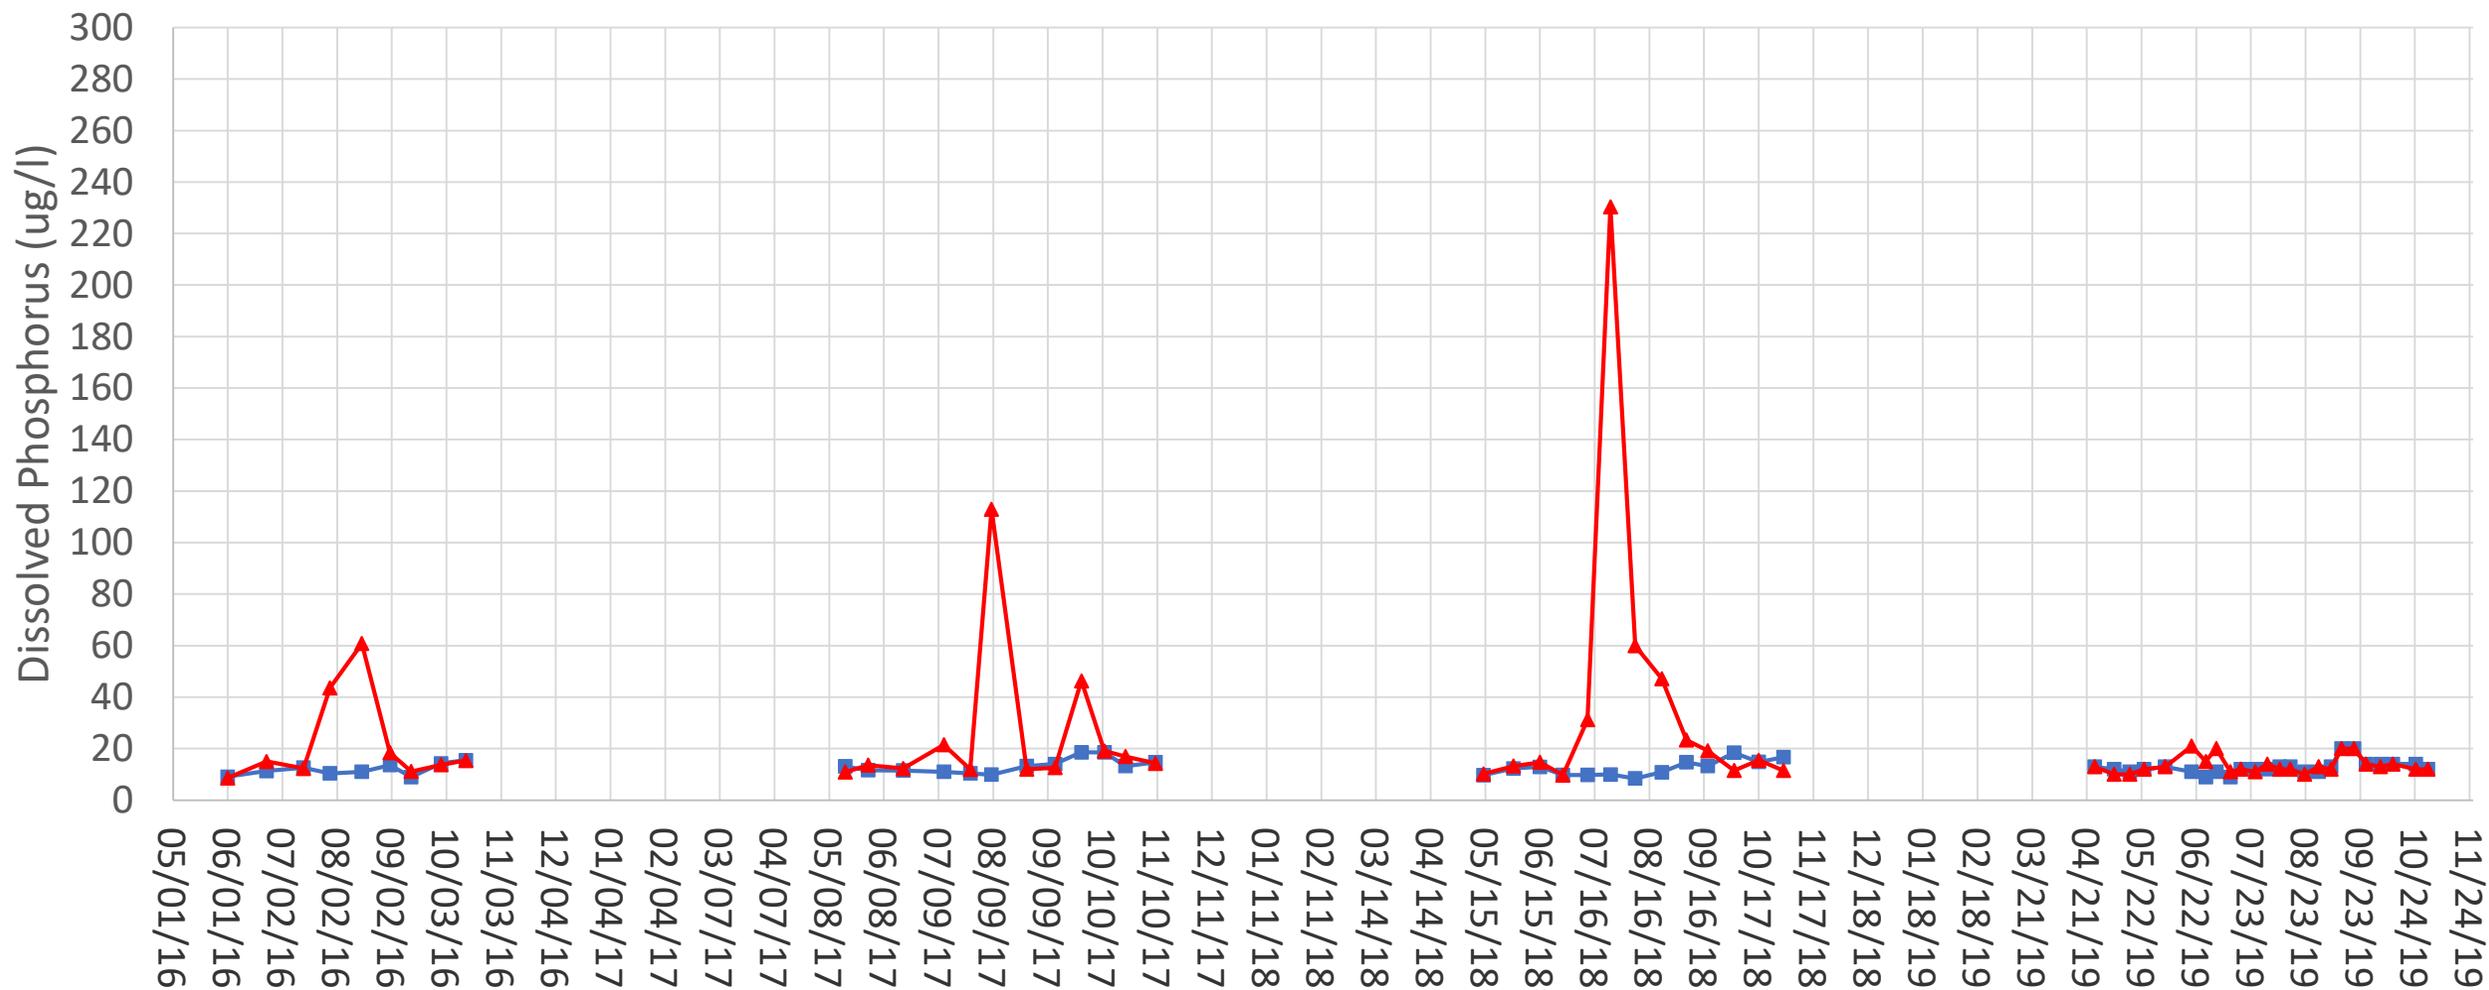
2016-2019 Lake Carmi Station #1 (UVM Mid-Lake Buoy) VTDEC TMDL Monitoring Lake Bottom Dissolved Phosphorus

■ 0.2 m (surface grab sample) ▲ 8.0 m (~2 m above bottom grab sample)

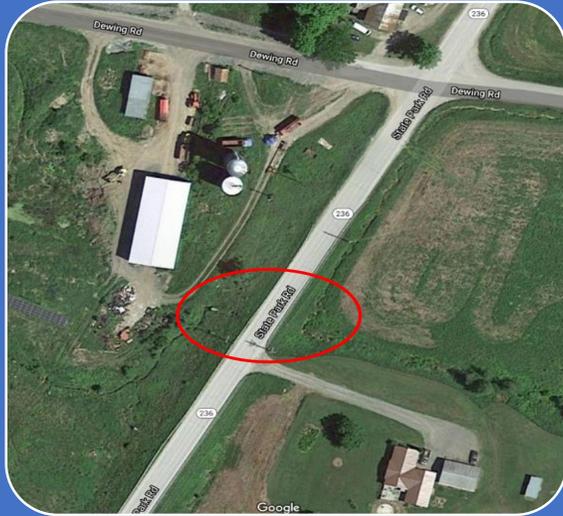
Culvert PID 65818

- **Project Definition:** Eligible nonpoint source pollution reduction project in the watershed of a Lake in Crisis
- Culverts transport surface water runoff (stormwater) under roads
- Culvert is 350 feet south of Dewing Rd on Rt 236, half a mile from Lake Carmi
- Culvert flows into Dewing Brook, 3rd largest tributary to lake

Crisis Response Plan & Franklin Stormwater Master Plan: Culvert is problematic for erosion & sediment-rich runoff

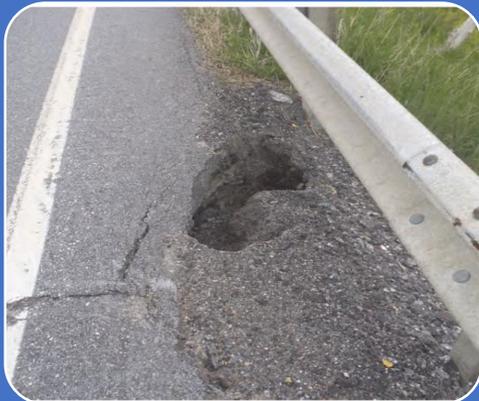
- High levels of bank erosion up and downstream; scouring threatens culvert upstream and downstream; downstream bank armor failing; large pool d/s, culvert footer is slumping in
- Sinkhole in the road shoulder has formed above the upstream end of culvert; rocks have been installed to stabilize the scour pool at downstream end of culvert.
- Culvert replacement is one alternative as confirmed in the Hydraulic Study

Technical Rationale for Culvert Replacement from Hydraulic Study

Existing culvert specifications:

- Drains 2 intermittent stream channels with a slope of 7.0%
- Made of corrugated metal pipe with a diameter of 3 feet (7 square foot opening)
- Does not meet the current standards of the VTrans Hydraulic Manual

Failure of existing culvert:

- A 2-foot vertical drop and scour pool now present at outlet
- A section of pipe has separated, creating a 9-foot wide sinkhole on the downslope of VT-236 allowing sediment to enter structure from overhead
- Separation of pipe section has also resulted in sediment scouring from beneath the structure
- Structure constricts the channel width, resulting in an increased potential for debris blockage

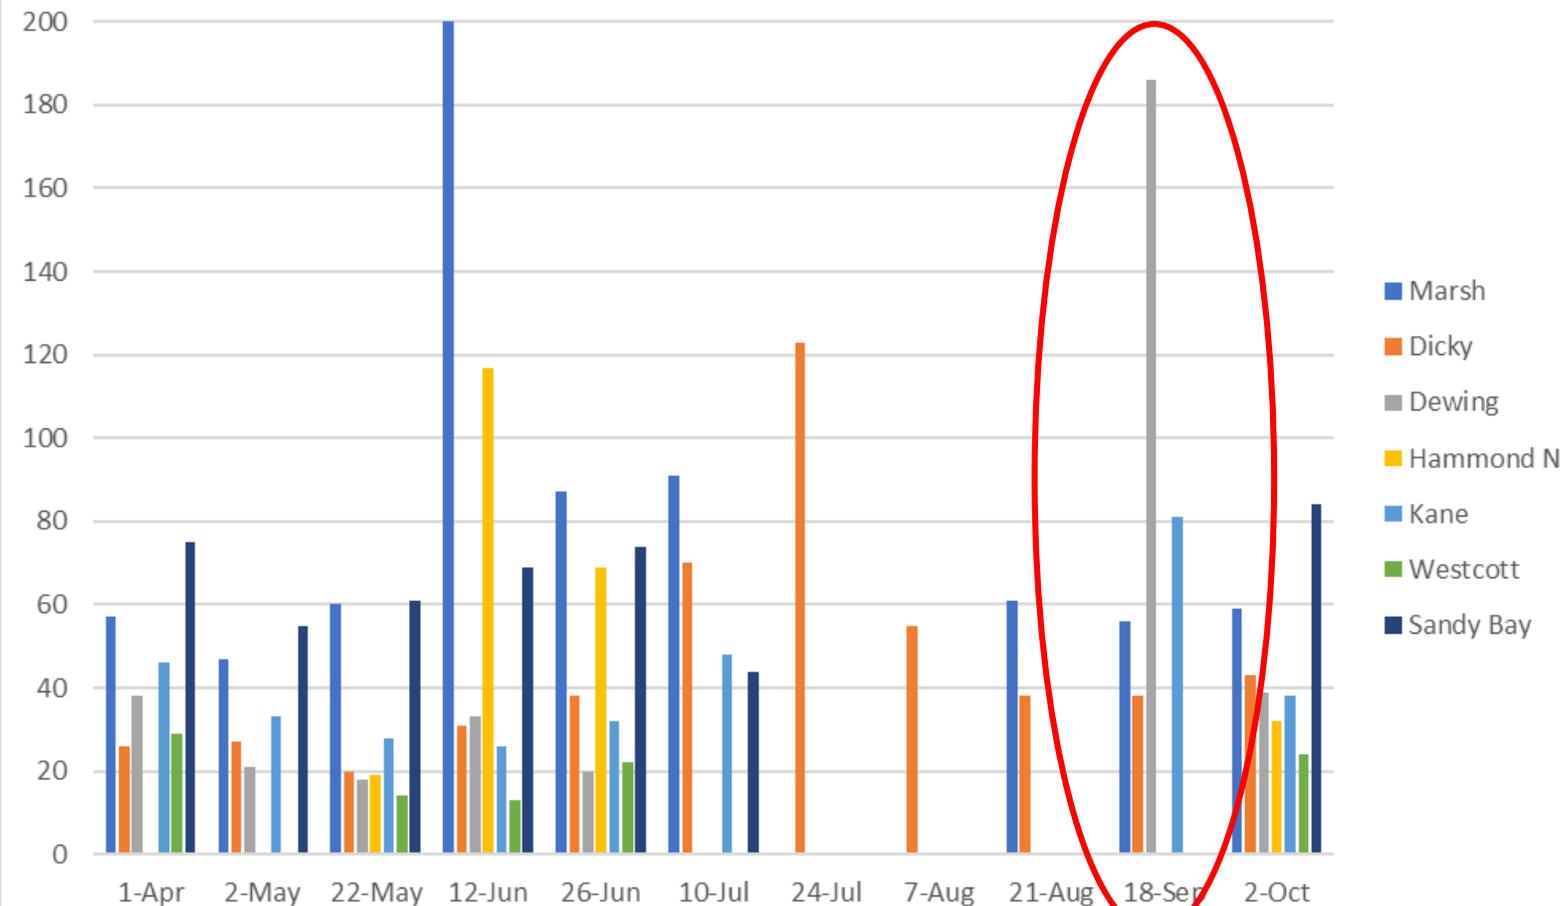
2019 Phosphorus Concentrations at Tributary Mouths

- Dewing Brook had 2nd highest phosphorus concentration at tributary mouth in 2019
- In storm events, high velocity flow transports phosphorus rich sediment from scour pool and sinkhole into Lake Carmi, leading to increased phosphorus loading
- Presence of blooms in NE corner of Lake Carmi can be partially attributed to P loading from sediment-laden tribs in this area
