**WELLS RIVER WATERSHED
RIVER CORRIDOR MANAGEMENT PLAN**

**WELLS RIVER WATERSHED OF THE CONNECTICUT
RIVER BASIN**

ORANGE AND CALEDONIA COUNTIES, VT

May 27, 2009

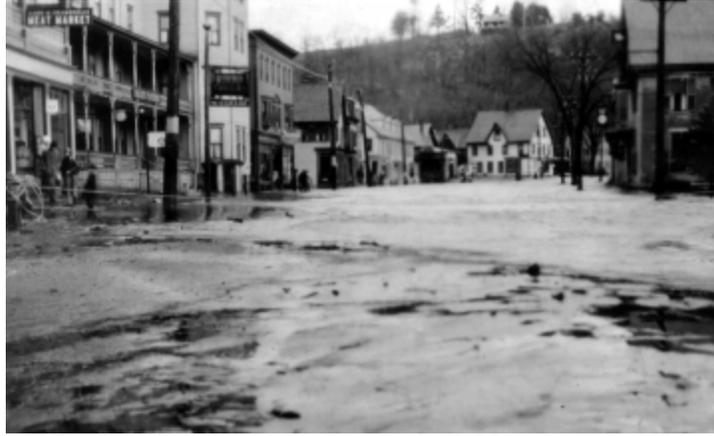
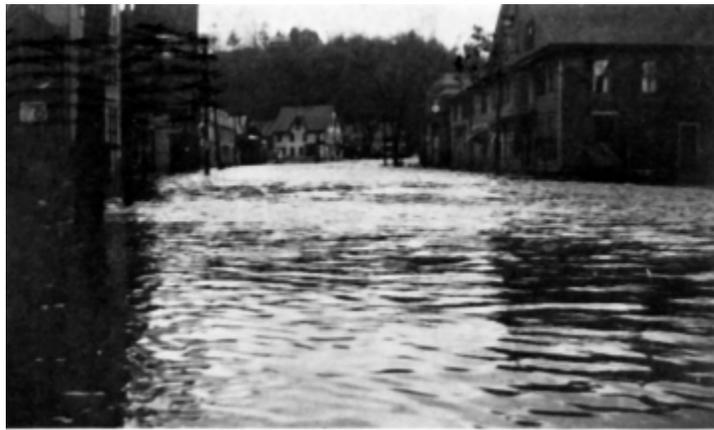
Figure 3. Pictures of Wells River village valley during floods during the late 1800s (top) and in 1927 (middle). Views of distant hills behind Wells River village in the late 1800s show signs of extensive forest clearing (bottom).

As Wells River village is located on a flood plain (alluvial fan) at the mouth of the Wells River, flooding has inevitably also been part of its history. Major flooding in the village has been recorded for: the late 1800s (Figure 3), 1927, and 1973.

Although there is common acknowledgement of significant flood events in the Wells River basin (Fig. 3 in this report shows photos of Wells River village during two different flooding events), scientific documentation of impact levels throughout a watershed can be harder to obtain. Streamflow statistics and basin characteristics estimated for the entire watershed area, available from the USGS stream statistics interactive-map internet site mentioned above, are found in the Report below, and in Figure 7. Stream peak flow characteristics can help in flood history comparison with other watersheds. Basin characteristics and stream peak flow statistics for the Wells River drainage basin are summarized in Figure 10.

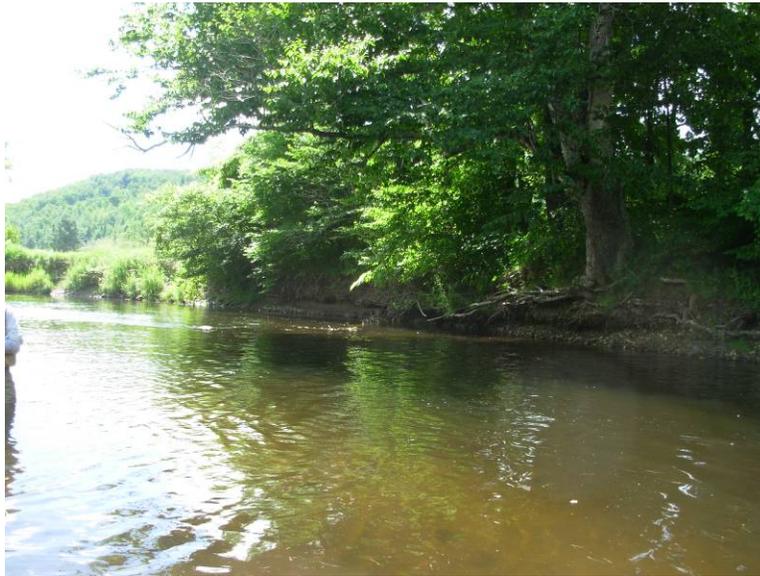
Figure 19: Bank contrast in M09, showing an intact bank in a forested area next to an eroding bank in an agricultural area.

Bed materials were coarse in seven of the 12 segments assessed on the Wells River mainstem, and one of the two segments assessed on the unnamed tributary to M04. Stretches of coarse bed material tend to alternate with stretches of fine bed materials. This can be explained by the presence of bedrock grade controls in the upper part of the project area; where sands naturally drop out upstream of a slope-modifying barrier. Upper bank materials are often more easily eroded in flood flows than the bed and lower banks. Sands dominated the upper banks in all but M01 (which has a man-made bank), M04A, M08A, and M04S3.01D. Bank erosion was noted fairly extensively in areas where riparian buffers lack significant vegetation and banks are not armored. Small mass failures were found in a few reaches that have steep valley walls and where the stream channel pushed up against the valley wall. Figure 18 illustrates the importance of a forested buffer to bank stability.

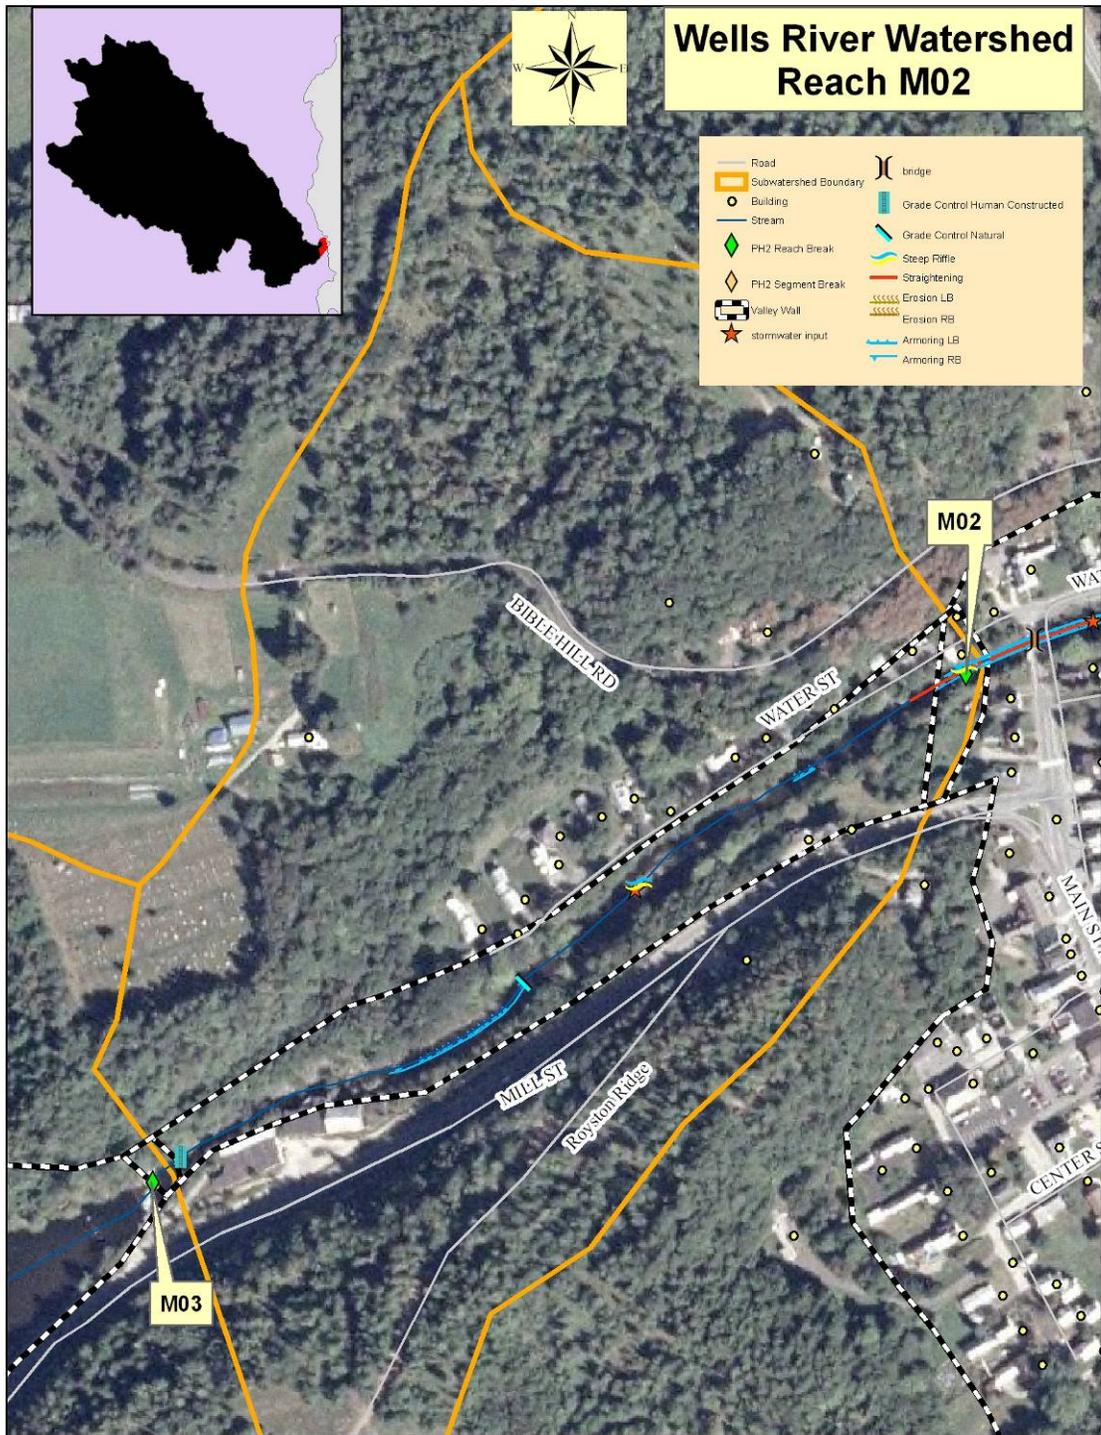
Figure 27: Reach M02 of the Wells River mainstem.

Reach M02 comprises 1,977 feet (0.37 miles). It begins upstream of the Water Street bridge and continues to the hydroelectric dam impoundment (Figure 27). The reach was not segmented during the Phase 2 process. The valley for this reach is narrow and straight. The entire length of stream has been encroached upon, and the development of a run-of-the-river hydroelectric dam in 1912 has, over time, altered flow and sediment load into the reach. The Phase 1 process classified this reach as a Bc riffle-pool with a cobble substrate and the Phase 2 assessment retained this classification.

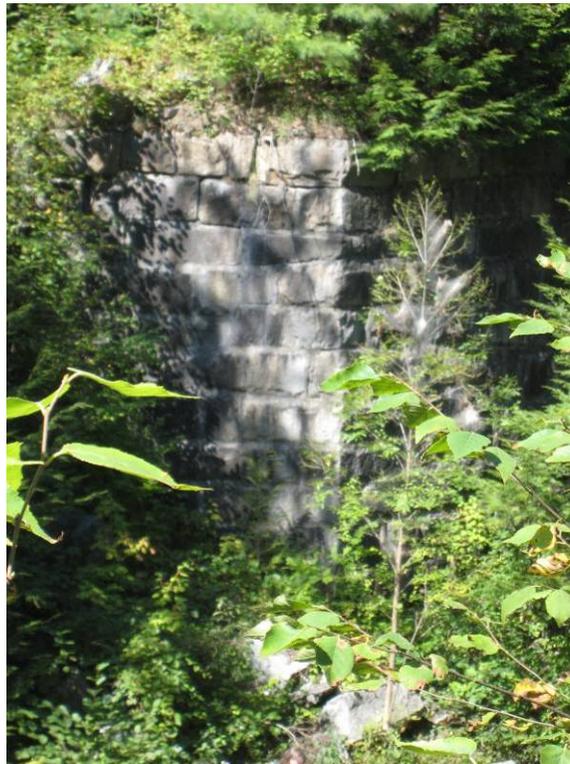
Figure 28: Wells River mainstem, Reach M04, old railroad bridge abutment.

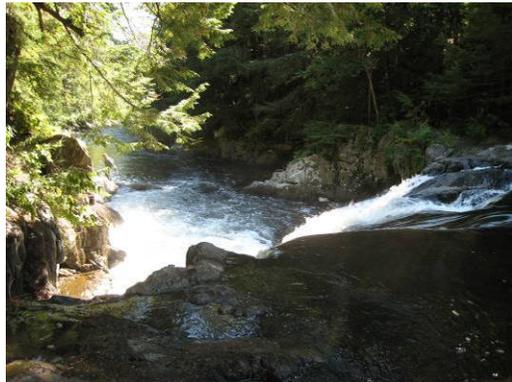
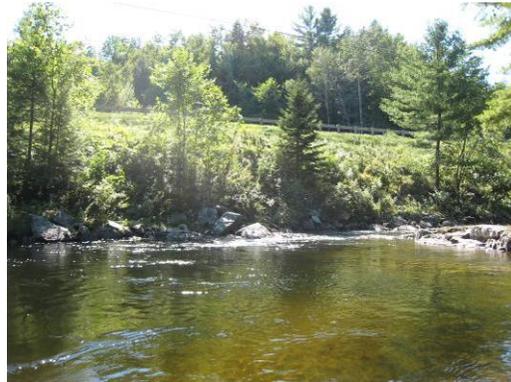
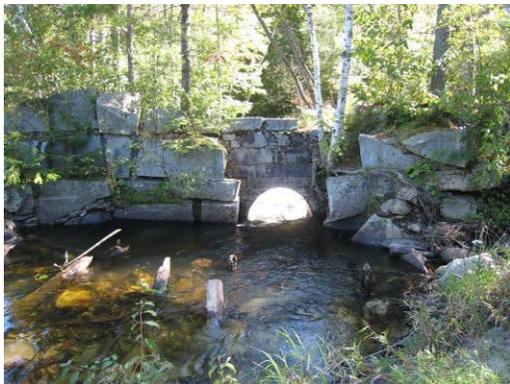
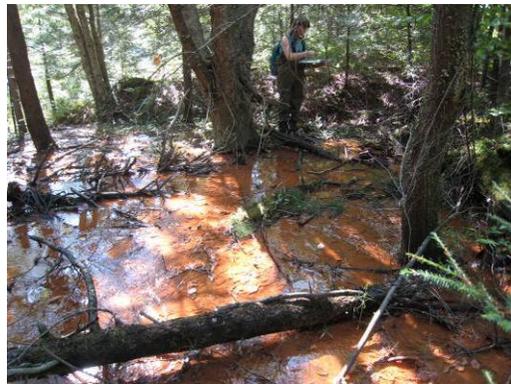
Figure 30: Reach M04 Segment A has numerous grade control features, some of which are large (upper left), a fair amount of road encroachment and armoring (upper right), a historic dam site (lower left), and some potentially problematic leachate (lower right).

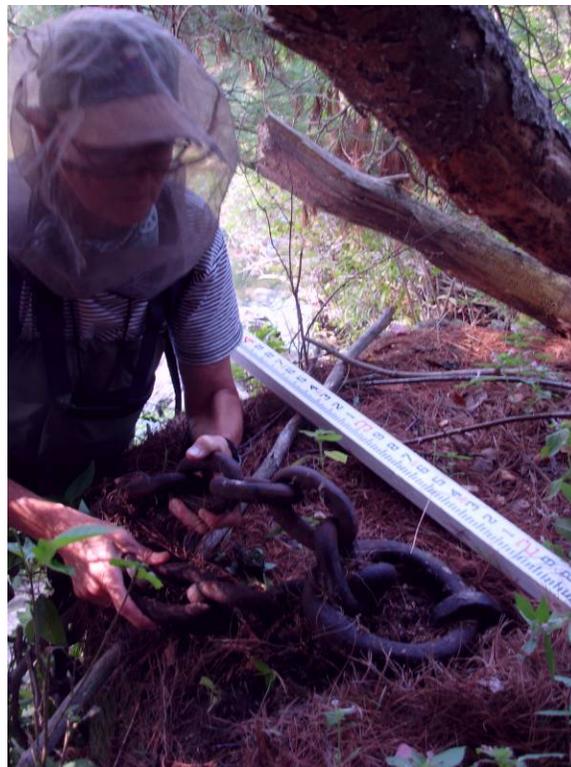
Figure 31: Reach M04 Segment B has embedded iron features, such as this chain, that indicate historic activities that might be related to log storage before loading onto rail cars.

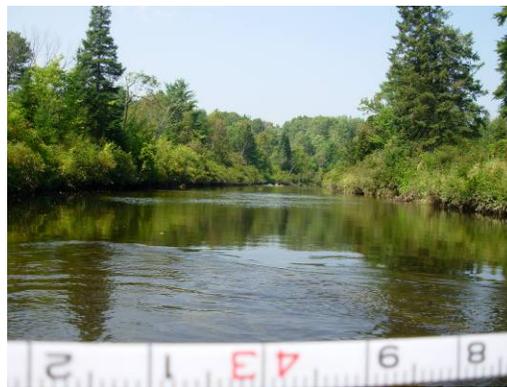
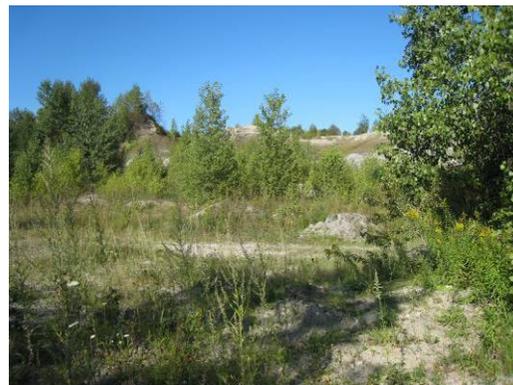
Figure 32: Reach M04 Segment B is characterized by having fairly low gradient (top), except where there are bedrock grade controls, such as that found under the now-defunct gravel pit bridge (bottom left). The gravel pit (bottom right) stretches along the entire left bank of this segment, but is no longer actively being used

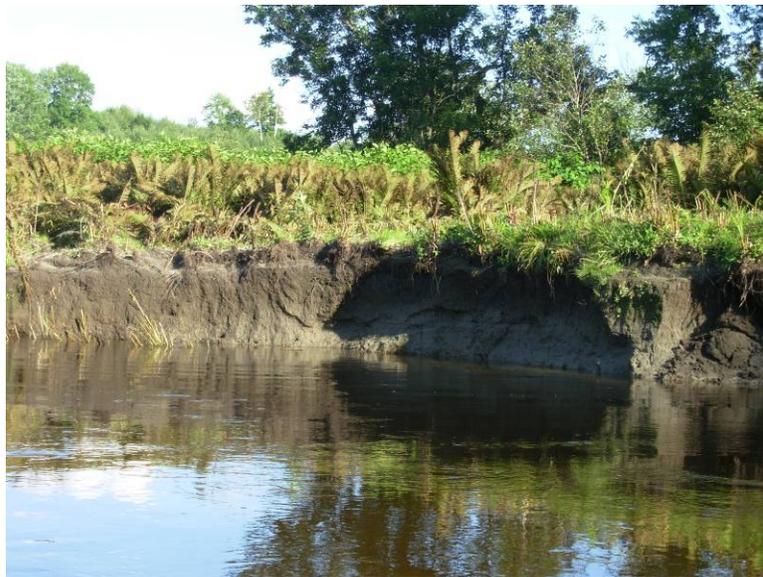
Figure 37: Reach M06 Segment A is characterized by having fine grained substrates and a large amount of bank erosion

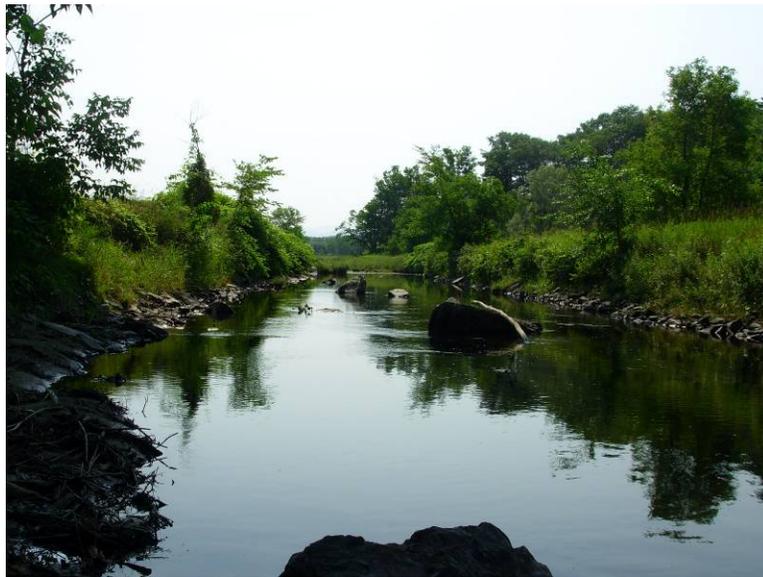
Figure 39: Reach M06, Segment A has been channelized and straightened under Interstate 91.

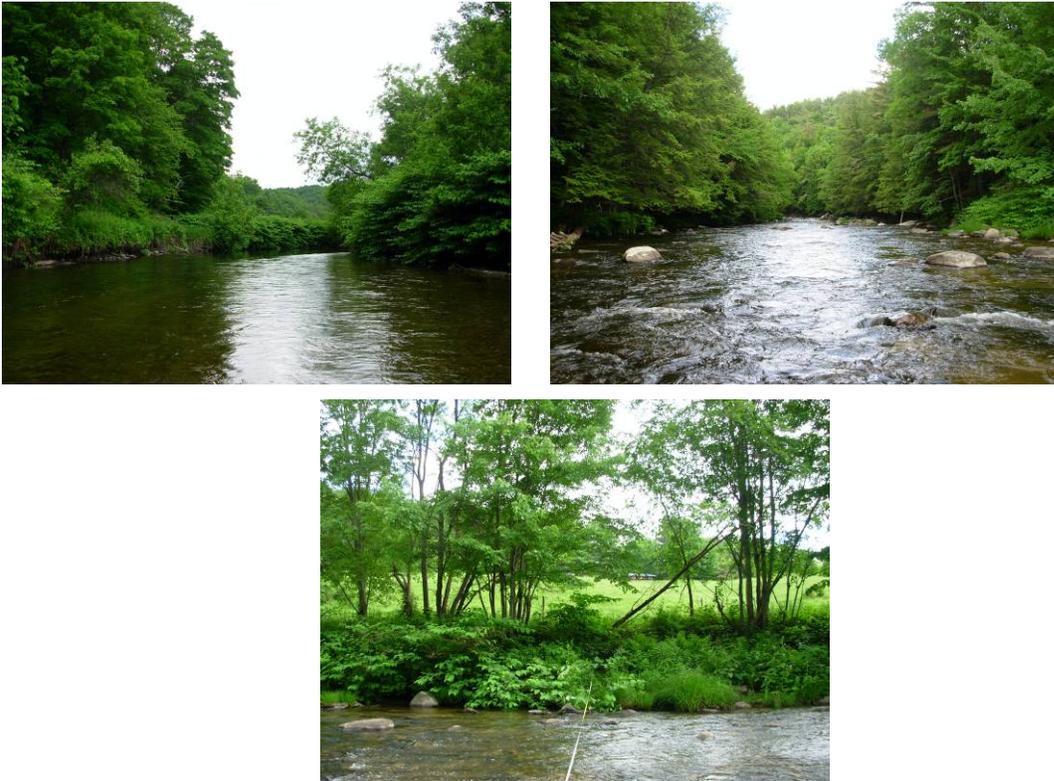
Figure 41: Reach M07 has a gentle slope and gravel substrate in Segment A (top left) that shifts to a steep grade and coarser substrate upstream in Segment B (top right). Segment B has undergone a stream type departure, but entrenchment is not extreme (bottom).

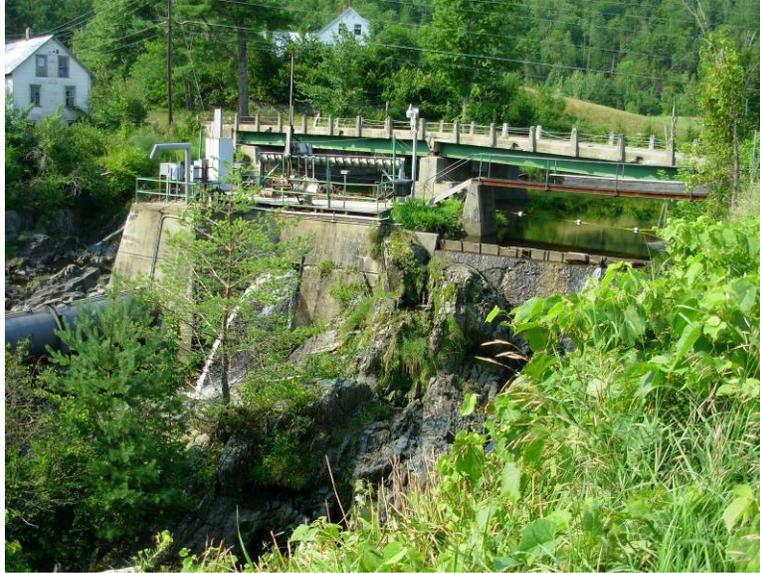
Figure 42: Reach M08, Segment C has a hydroelectric dam (above) and impoundment located at the top of the segment. It was not included in the Phase 2 assessment process.

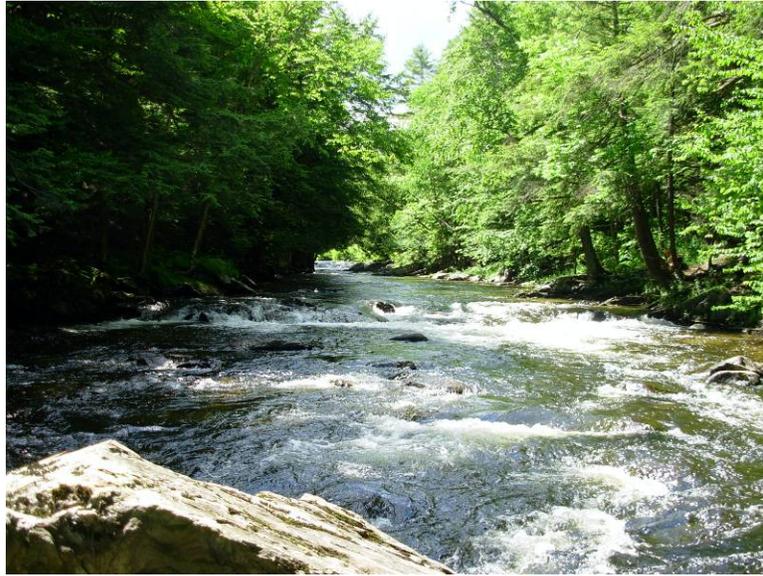
Figure 44: Reach M08 Segment A is characterized by bedrock in the bed and banks, and a forested buffer.

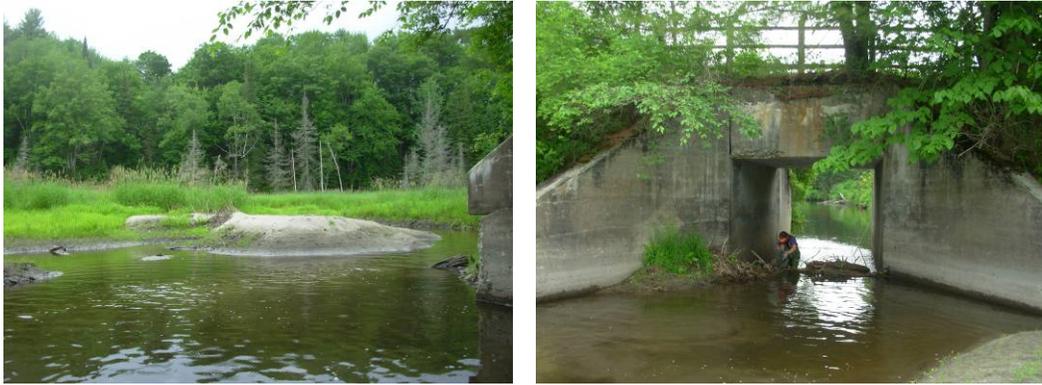
Figure 48: Tributary Reach MO4S1.01 Segment A is characterized by a Very Broad valley with historic (and some current) beaver use (left). The bridge for the railroad bed trail at the mouth of the tributary constitutes a significant constriction (right).
