### **West Branch of the Ompompanoosuc River River Corridor Management Plan Strafford, Vermont**

# **West Branch of the Ompompanoosuc River River Corridor Management Plan Strafford, Vermont**

October 30, 2006

Prepared by:

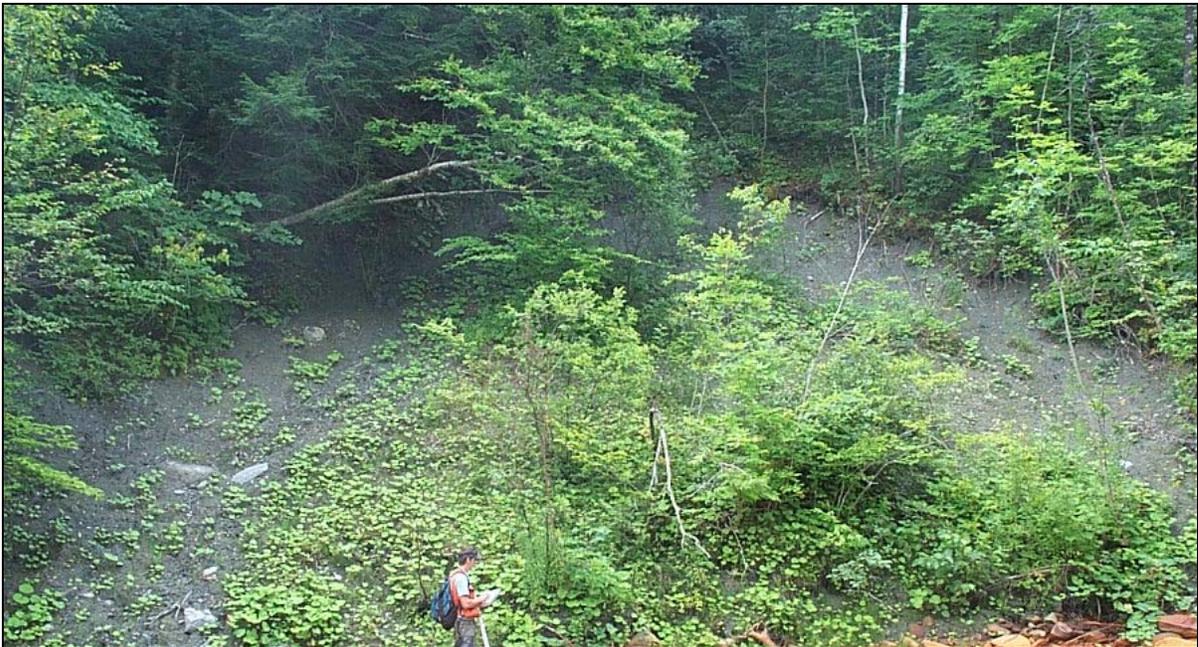
**Figure 2: Glacial lake deposits are found in the lower reaches of the study area.**

As the glaciers retreated, numerous lakes formed between the ice and the high ground. In the Connecticut River basin the very large glacial Lake Hitchcock was formed; it extended all the way up the Connecticut River Valley with fingers reaching up into the Ompompanoosuc River Valley. The shorelines of these lakes were often the receiving area for copious fine sediments shed from the melting ice and surrounding barren landscape. These glacio-lacustrine deposits, as they are known, are often prone to unpredictable shifting and shearing. Near the Strafford/Thetford town line glacial clay deposits begin to appear, evident by the large massive streambank failures that occur when they fail (Figure 2).

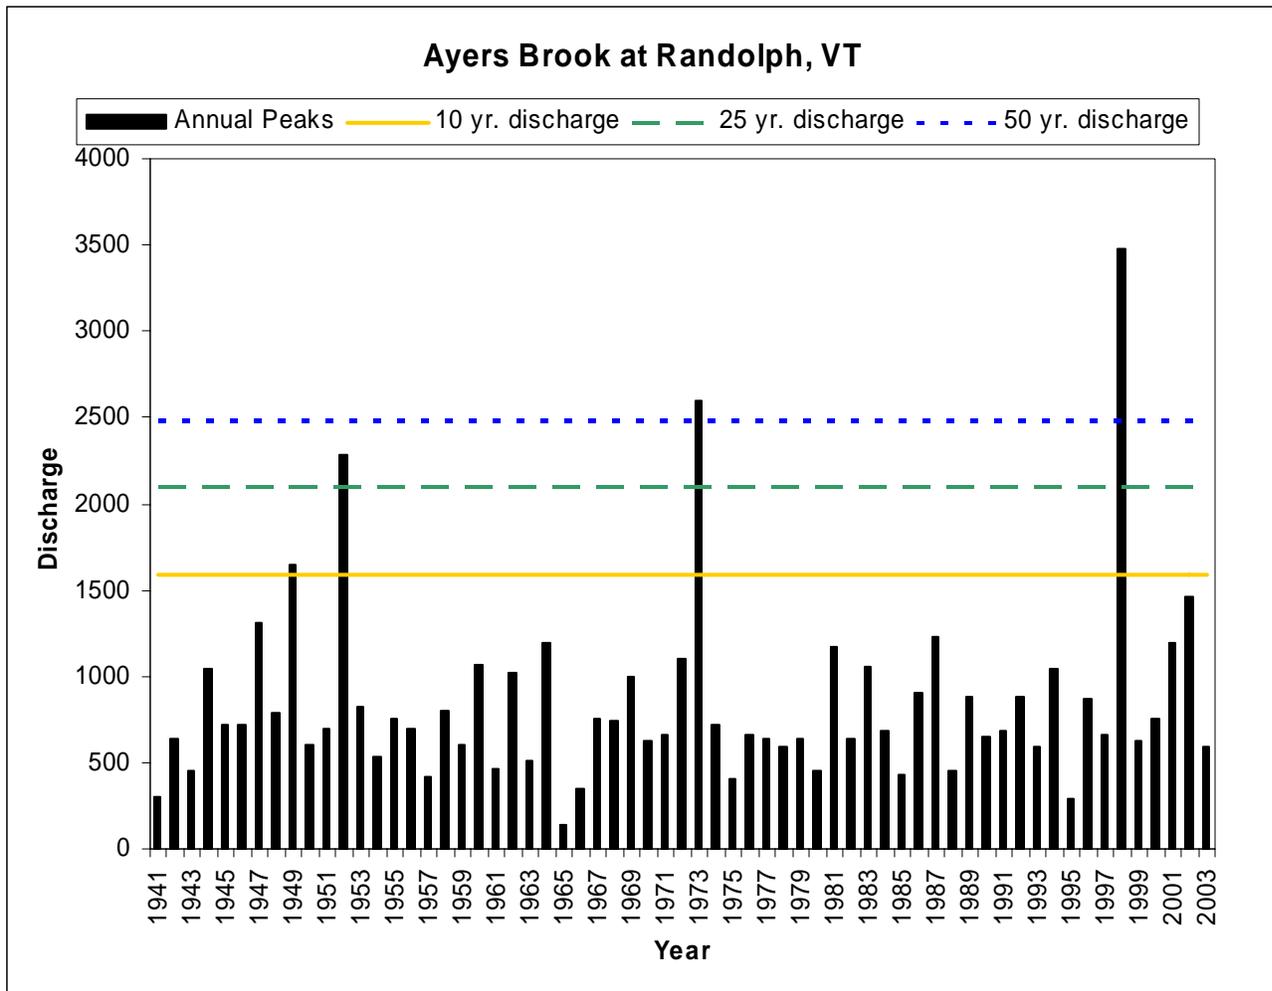
Figure 3: Flood frequency analysis for USGS 01142500 Ayers Brook at Randolph Vermont. Peak streamflow data from 1940 through 2003 were used in the analysis.

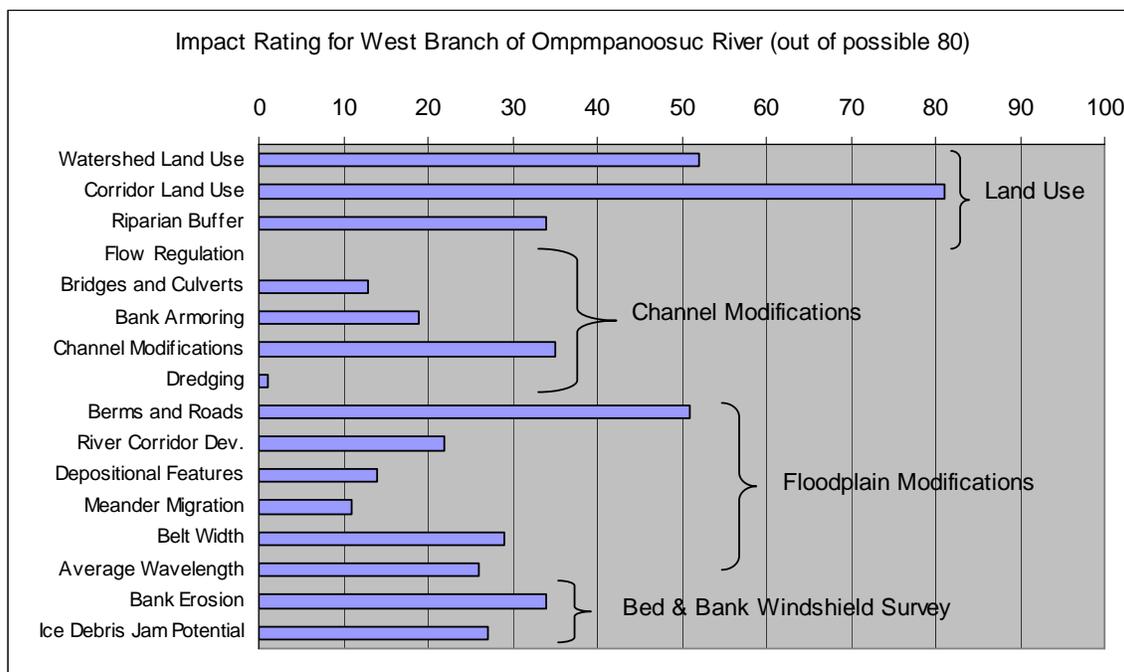
**Figure 4. Impact Rating for West Branch Ompompanoosuc River Watershed by Parameter and Category**

The Phase I geomorphic assessment evaluates parameters that may cause channel adjustment. These parameters are grouped into four major categories: land use, instream modifications, floodplain modifications, and bed and bank windshield survey. On the West Branch, fourteen of the reaches had high impact ratings for channel modifications; these reaches were mostly on the main stem and near the mouths of the tributaries (Figure 4). The West Branch also had high impact scores for berms and roads, channel migration, and bank erosion. Figure 5 shows a general trend of decreasing impact rating (i.e. improved geomorphic stability) upstream of reach M11 and downstream of M06 on the mainstem.

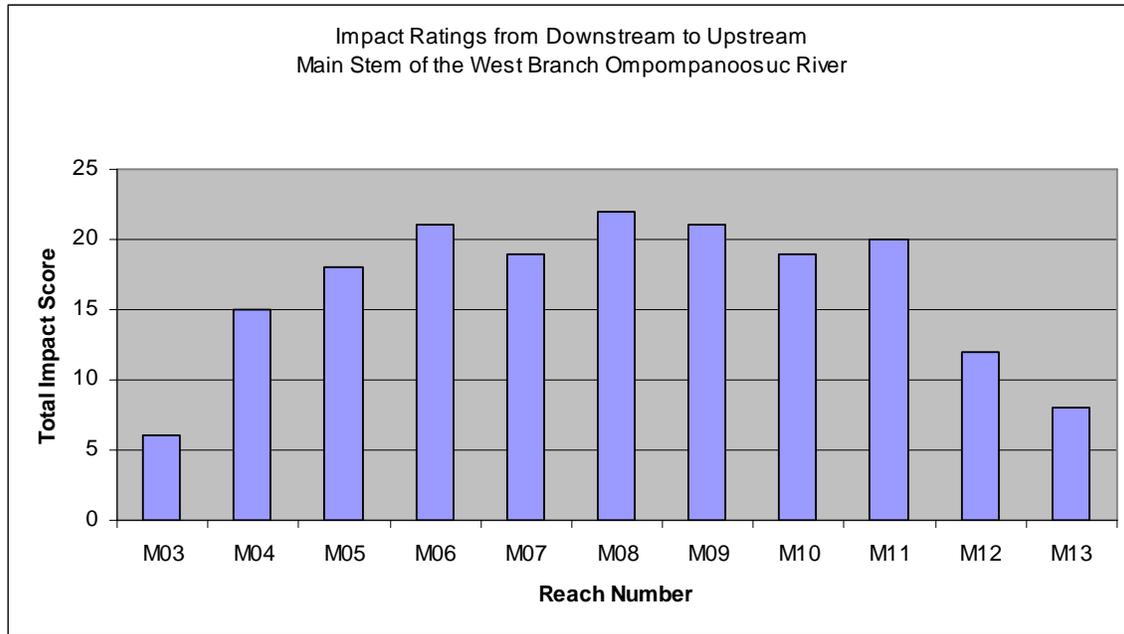
**Figure 5. Impact Ratings from downstream to upstream on the main stem of the West Branch of the Ompompanoosuc River**

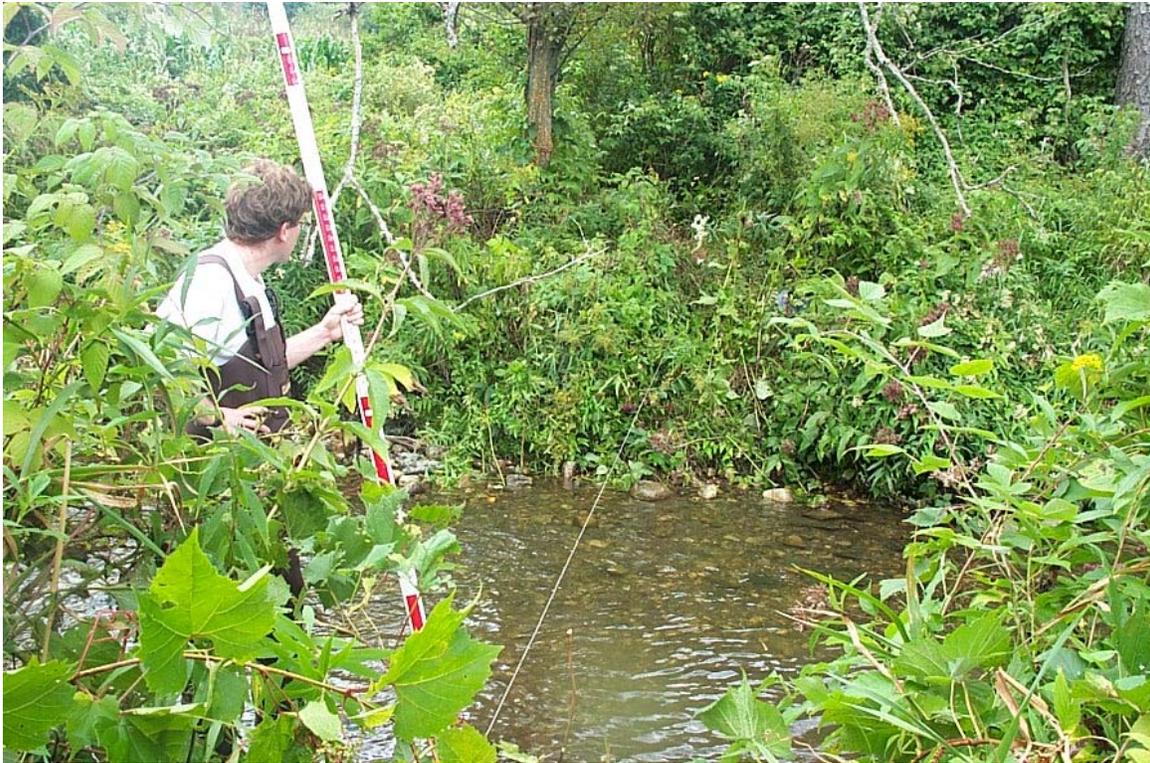
**Figure 6. Ben Copans of the Vermont DEC measures the cross-sectional area of the Upper West Branch during summer 2005.**

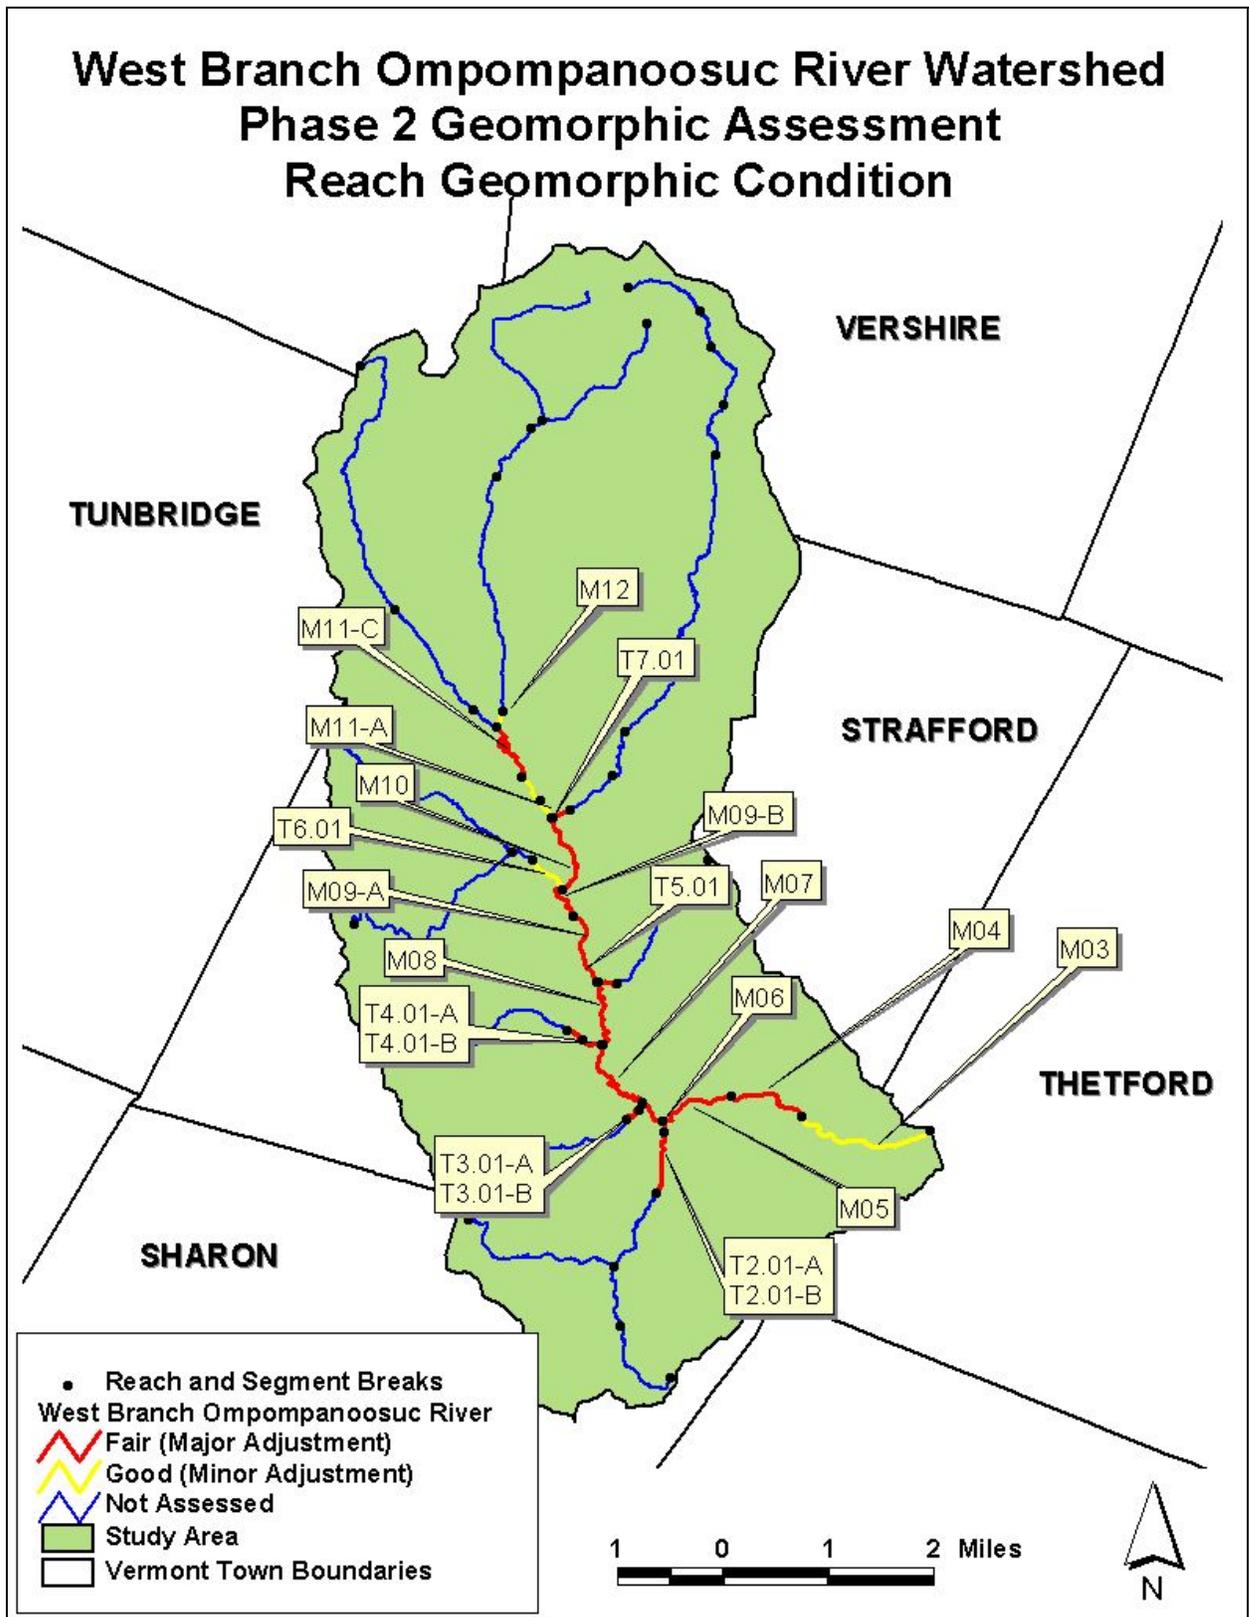
Figure 7: Phase 2 Geomorphic Condition of the West Branch Ompompanoosuc Watershed

The Phase 2 Rapid Geomorphic Assessment (RGA) provides information on the geomorphic condition of each segment within the study area (Figure 7 and Table I). The condition rating relates to the degree of adjustment a channel is undergoing. A channel in “Reference” condition is not undergoing significant adjustment. “Good” condition indicates some minor adjustments are occurring. The majority of Strafford streams fall into the “Fair” geomorphic condition rating indicating major active adjustments are occurring. In the worst scenario a “Poor” rating indicates extreme geomorphic adjustment. Many of the tributaries and the main stem of the West Branch in Strafford are experiencing high rates of bank erosion. The bank erosion has been accelerated due to land use activities and channel and floodplain modifications. Significant channel straightening, bank armoring, berming, and floodplain encroachment have occurred within this river system both on the mainstem and on the lower ends of the tributaries. These impacts have resulted in the loss of natural

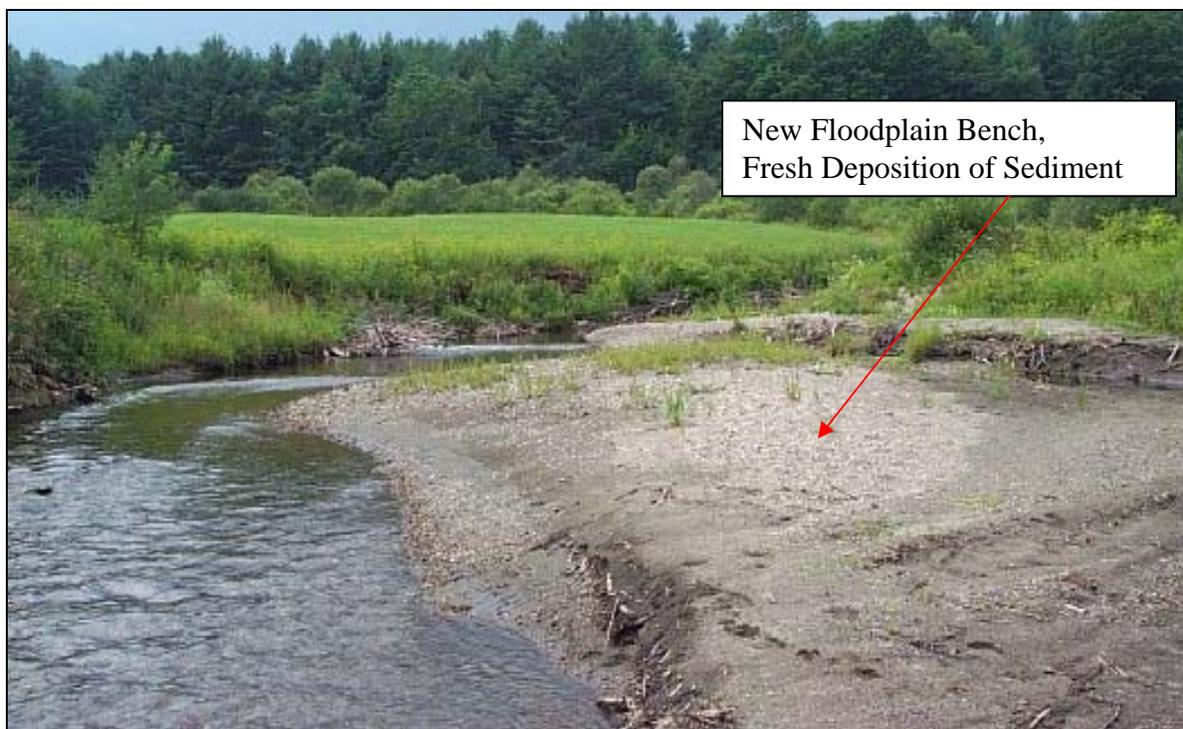
**Figure 8. The West Branch is working to create a new floodplain bench in many areas.**

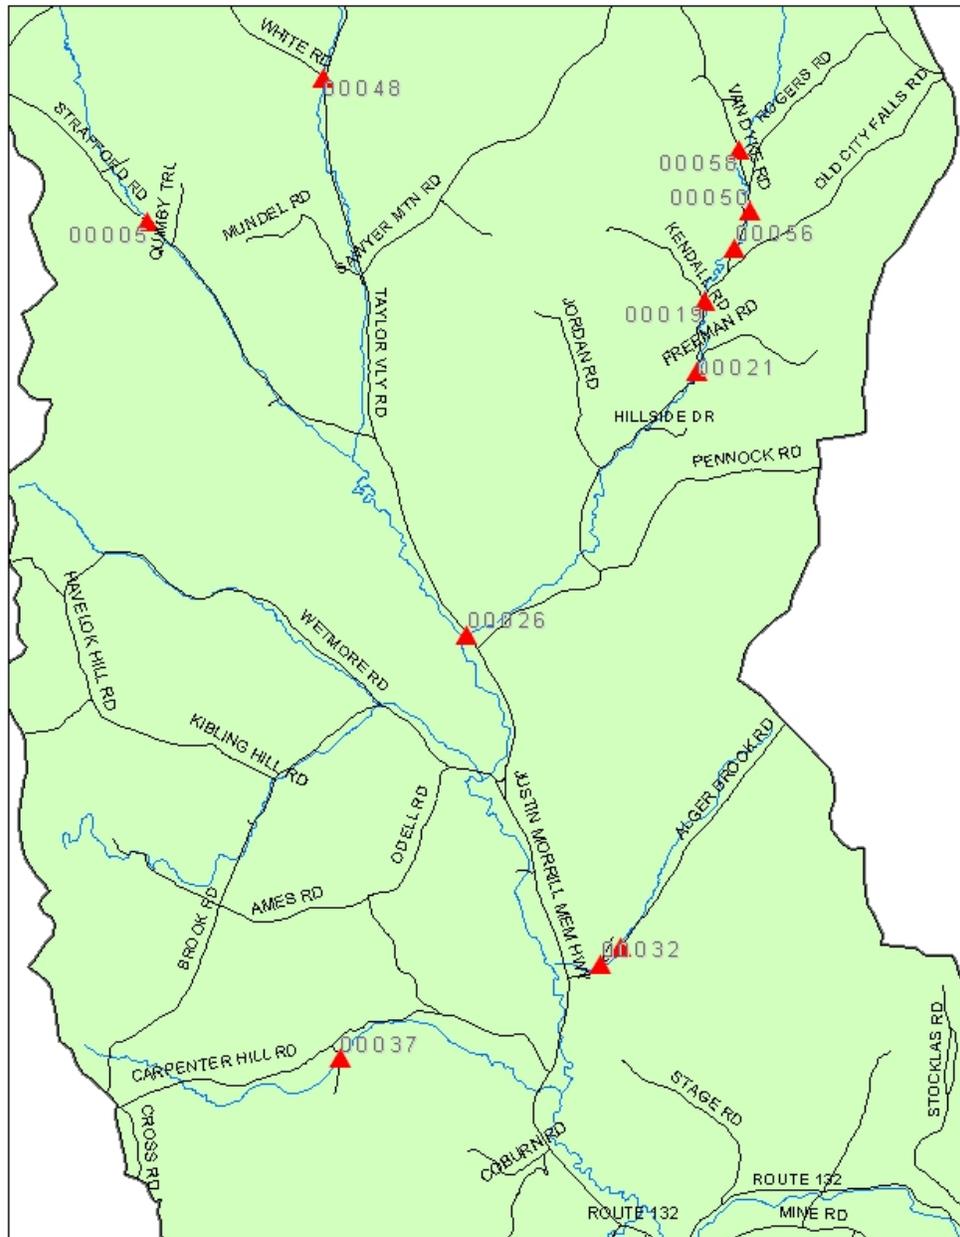
Figure 9: Priority I Structures for replacement in Strafford, Vermont within the Ompompanoosuc River

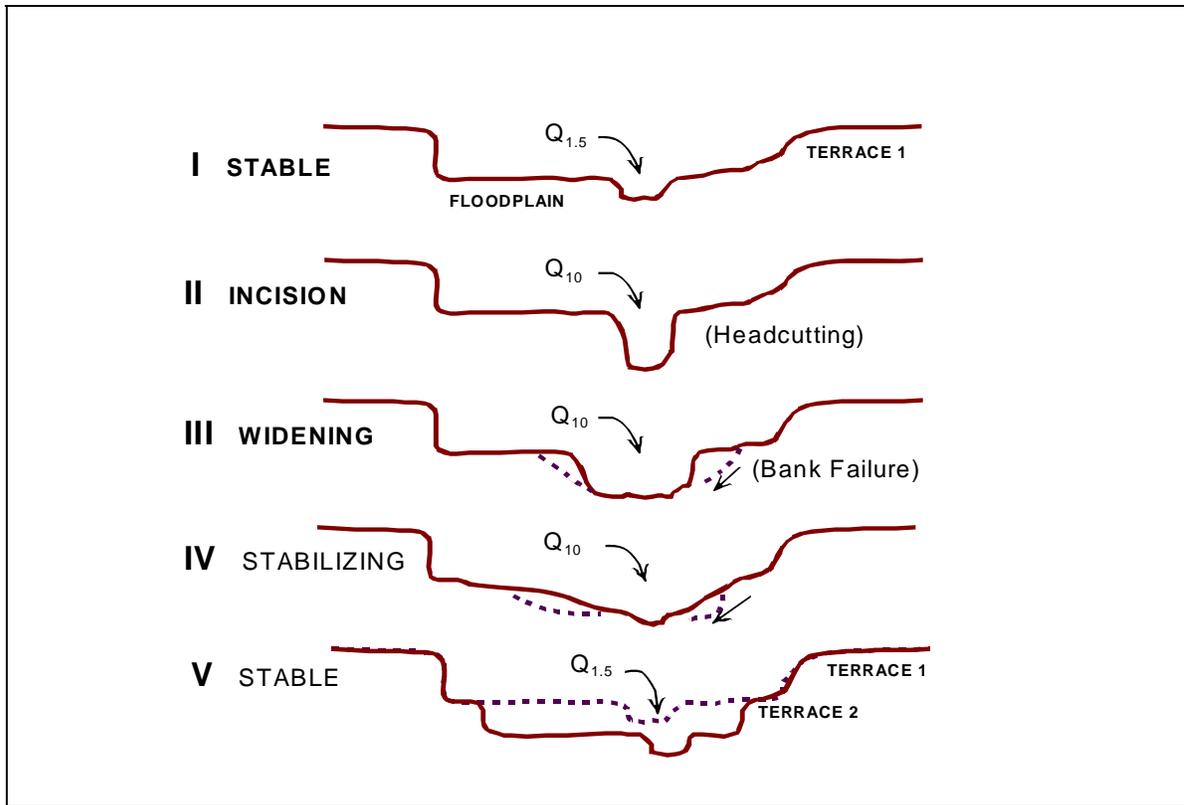
- A pre-disturbance period
- Incision – Channel degradation
- Aggradation and channel widening
- The gradual formation of a stable channel with access to its floodplain at a lower elevation.

**Figure 10: Typical Channel Evolution Model following incision.**

The stability of a stream channel is based on maintaining a certain flow of water, shape and slope of the channel, and sediment load. When any of these change significantly, the river channel must change, typically resulting in erosion of the stream bed or banks. Between the 1700's and the 1800's, the building of roads and railroads within the floodplains, deforestation, and moving streams to accommodate agricultural fields and villages resulted in unstable river channels. Even in recent decades, large-scale channelization practices have been employed to reclaim damaged lands after large flood events. The 1970's and 1980's were also a period of extensive gravel mining in many Vermont streams. Post-flood channel straightening and gravel mining of point bars have the effect of steepening stream channels. A steep channel in a relatively flat valley may initiate a bed degradation, or downcutting process. Once a stream begins to degrade, it will typically erode its way through an evolution process until it has created a new floodplain at a lower elevation in the landscape. The common stages of channel evolution, as depicted in Figure 10 include:

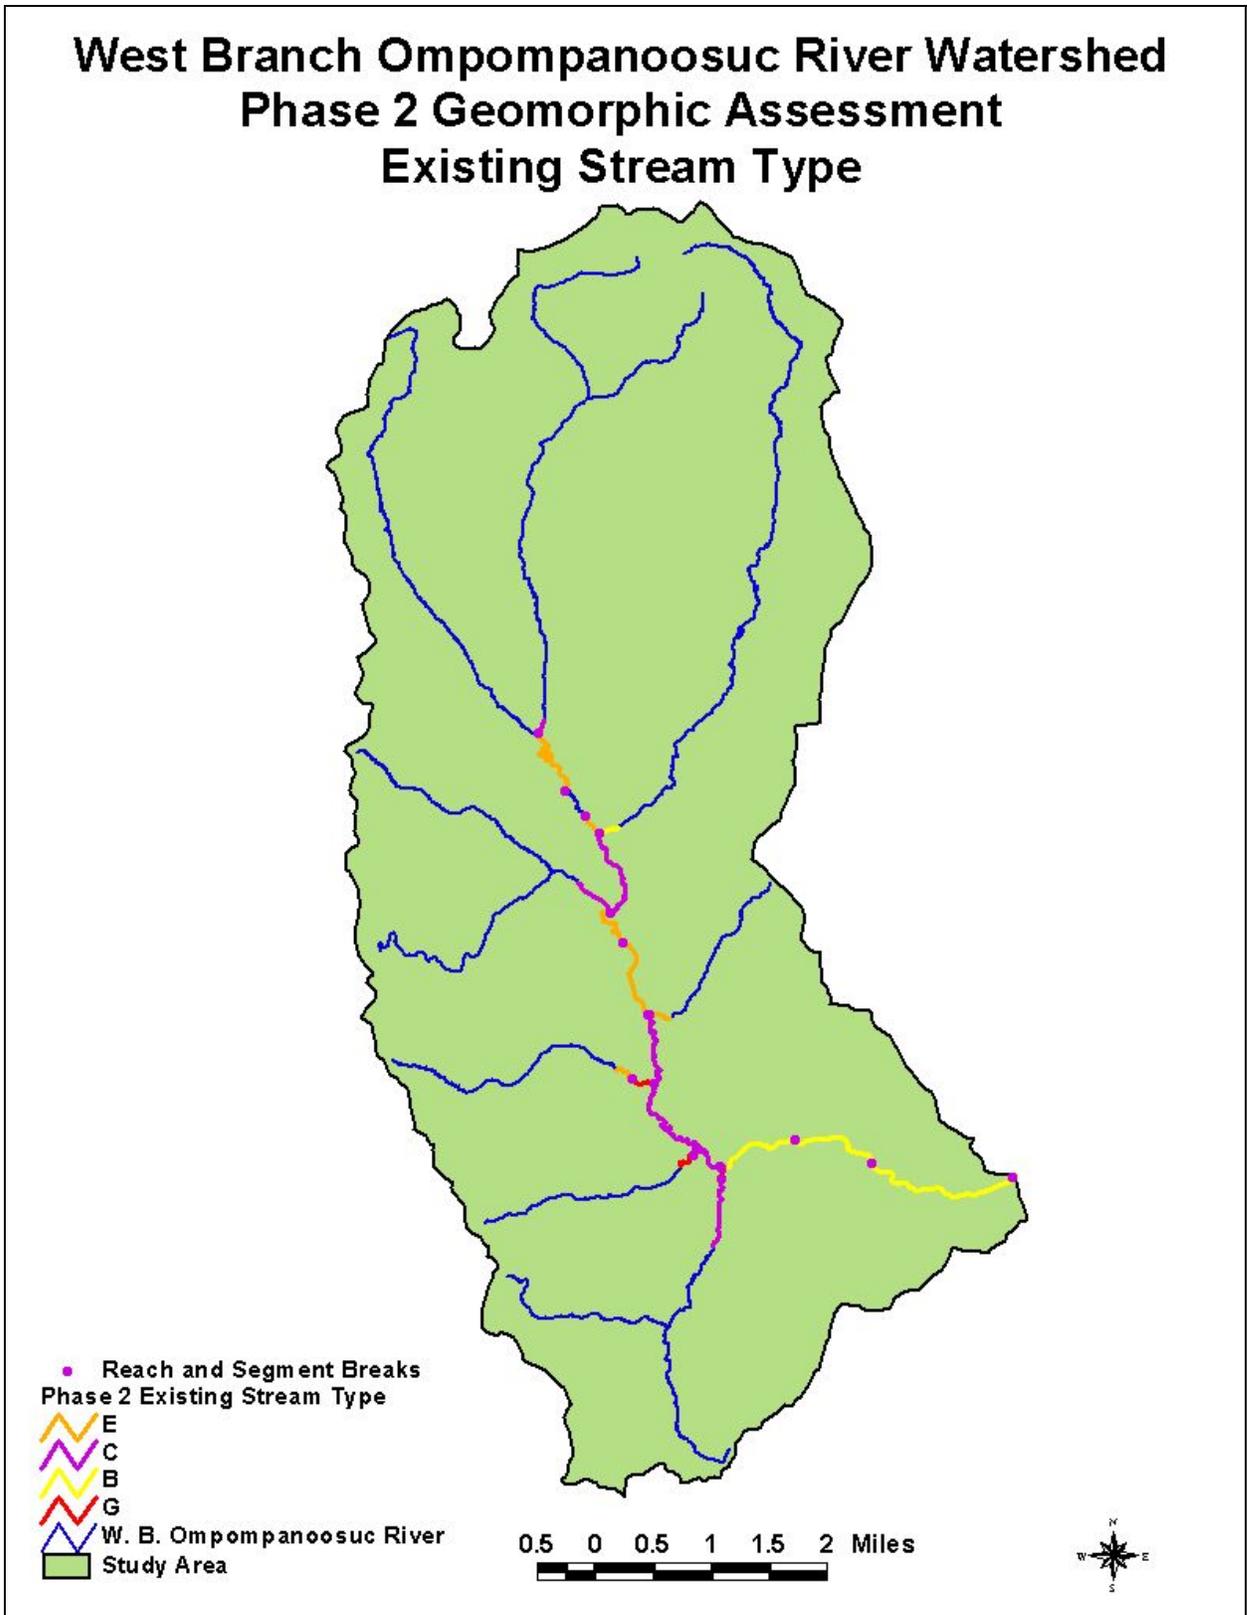
Figure 11. Phase 2 Existing Stream Types

Figure 11 is a map presenting the existing stream types found in the West Branch watershed. Most of the reaches are Rosgen (1996) "E" or "C" channels by reference. E and C channels have wide valleys and moderate to gentle gradients. The difference between E and C channels is largely due to the difference in the shape of the channel. E channels have very low width to depth ratios and are highly sinuous by reference. This means that E channels are narrow and deep and have a long channel length relative to the valley length. C channels are typically wider and shallower and have moderate to high width to depth ratios and sinuosity. B channels have moderate to steep slopes and have narrower valleys than E or C channels. The stream sensitivity of these reaches, generalized according to stream type and condition are depicted in Table 3 and in Figure 12.

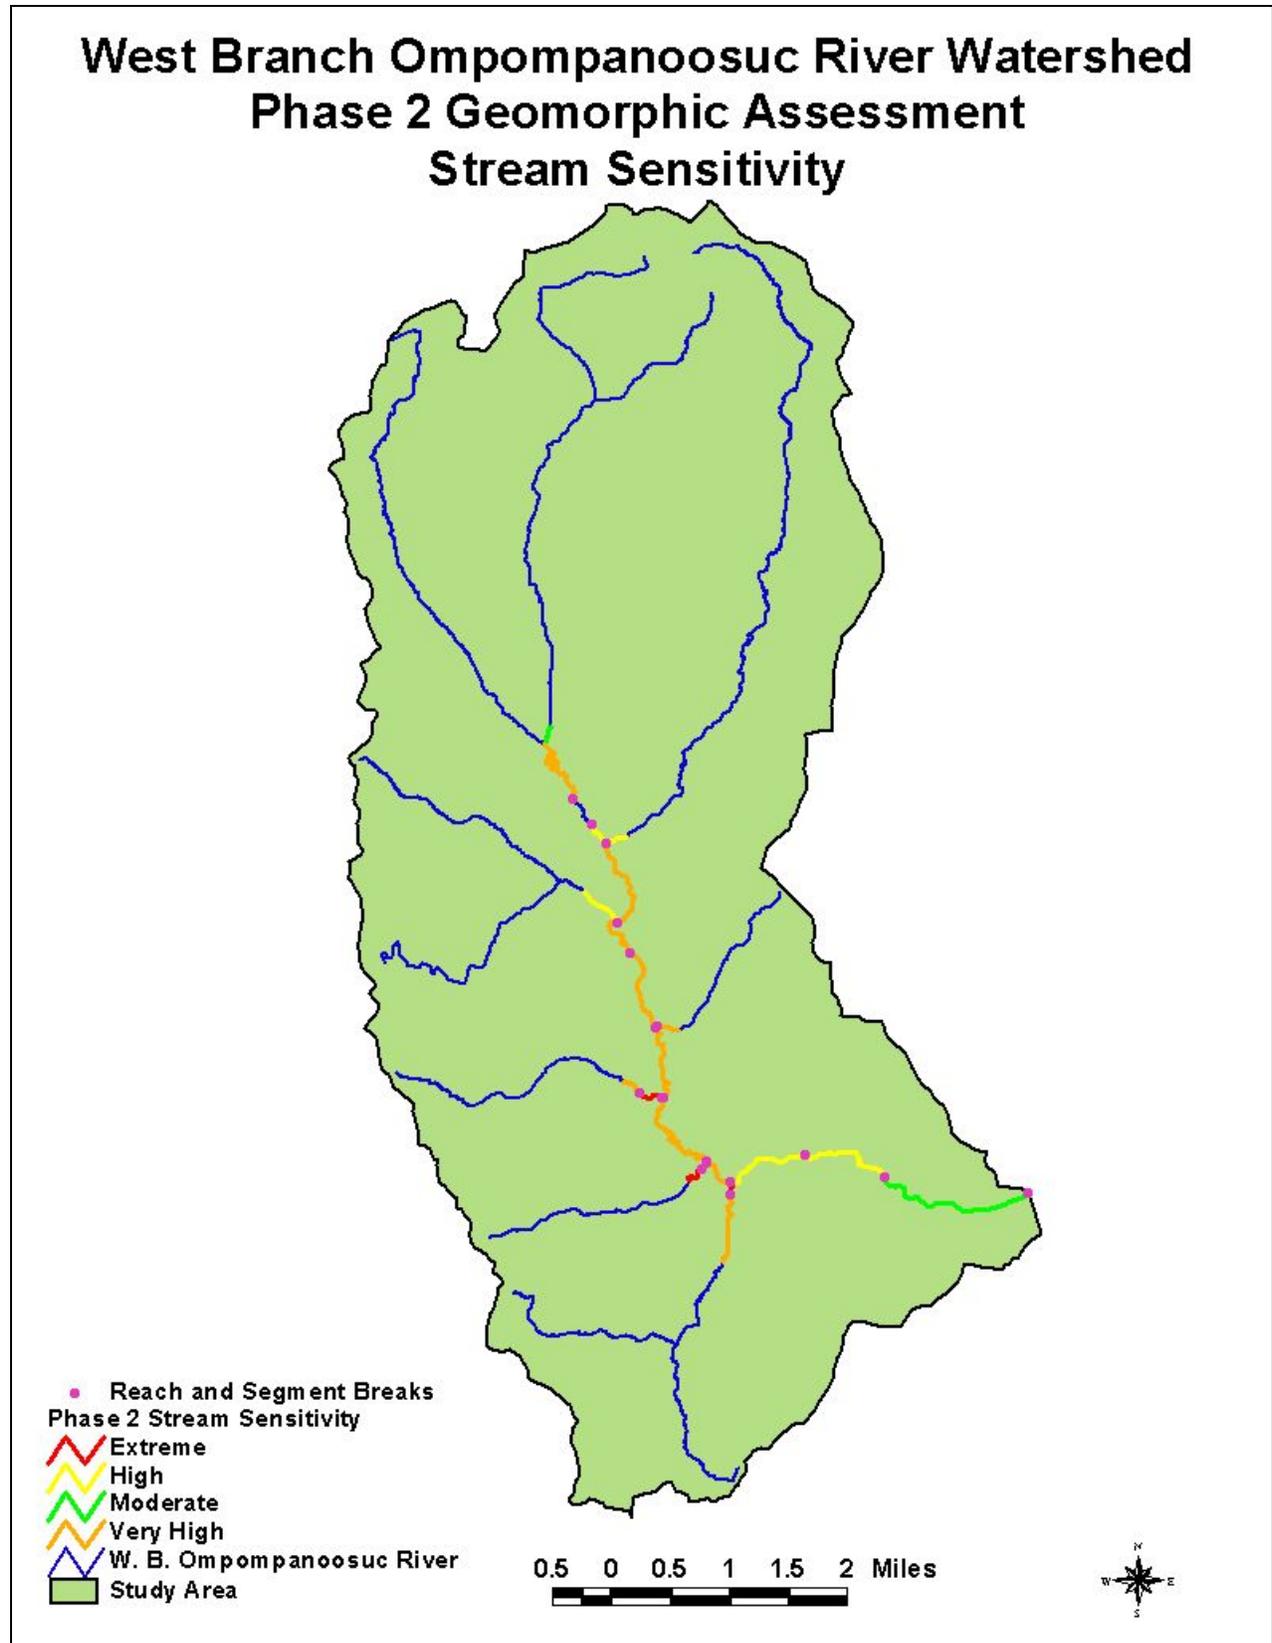
Figure 12: Phase 2 Stream Sensitivity Map

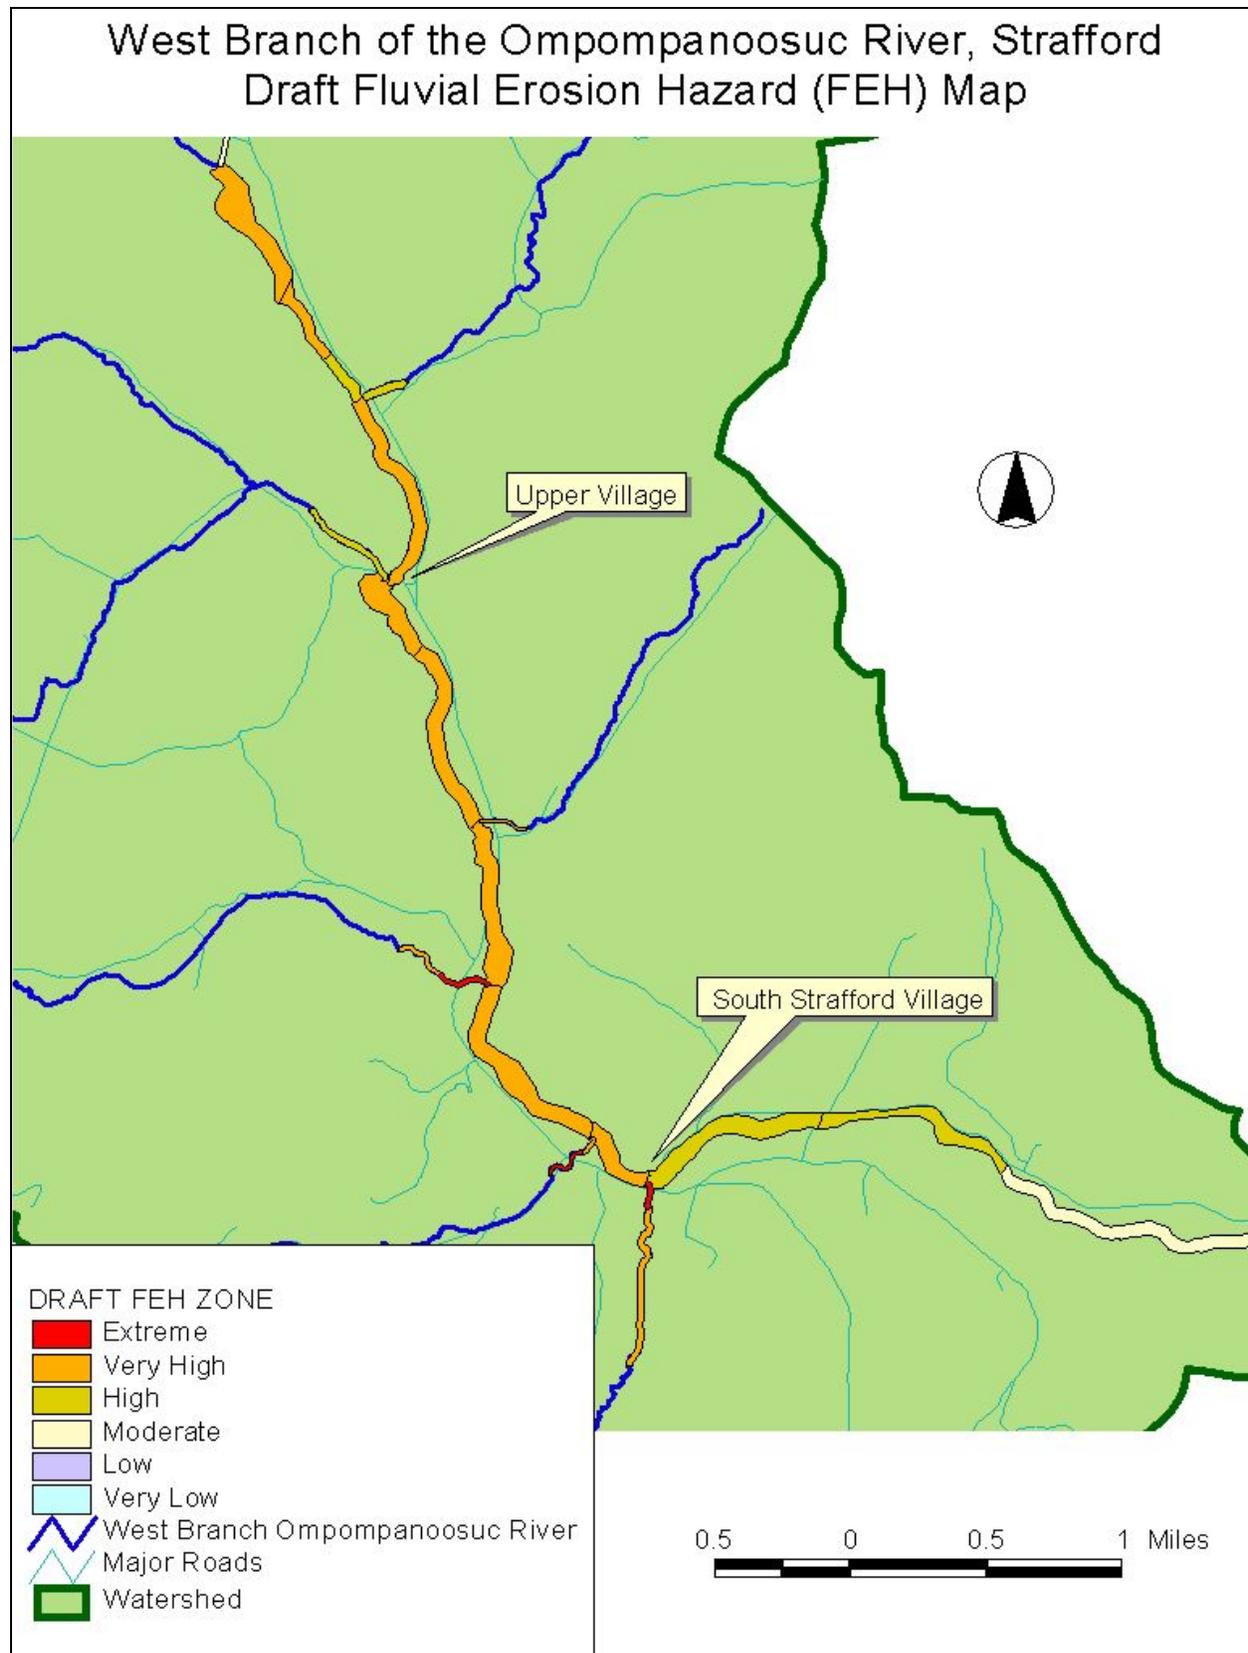
Figure 13: DRAFT Fluvial Erosion Hazard (FEH) Map for Strafford, VT.

The basis of a Fluvial Erosion Hazard Zone is a defined river corridor which includes lands adjacent to and including the course of a river. The width of the corridor is defined by the lateral extent of the river meanders, called the meander belt width, which is governed by valley landforms, surficial geology, and the length and slope requirements of the river channel. The width of the corridor is also governed by the stream type and sensitivity of the stream. River corridors, defined through VDEC Geomorphic Assessments (2004), are intended to provide landowners, land use planners, and river managers with a meander belt width which would accommodate the meanders and slope of a balanced or equilibrium channel, which when achieved, would serve to maximize channel stability and minimize fluvial erosion hazards. Figure 13 represents a draft Fluvial Erosion Hazard Map for the Town of Strafford.

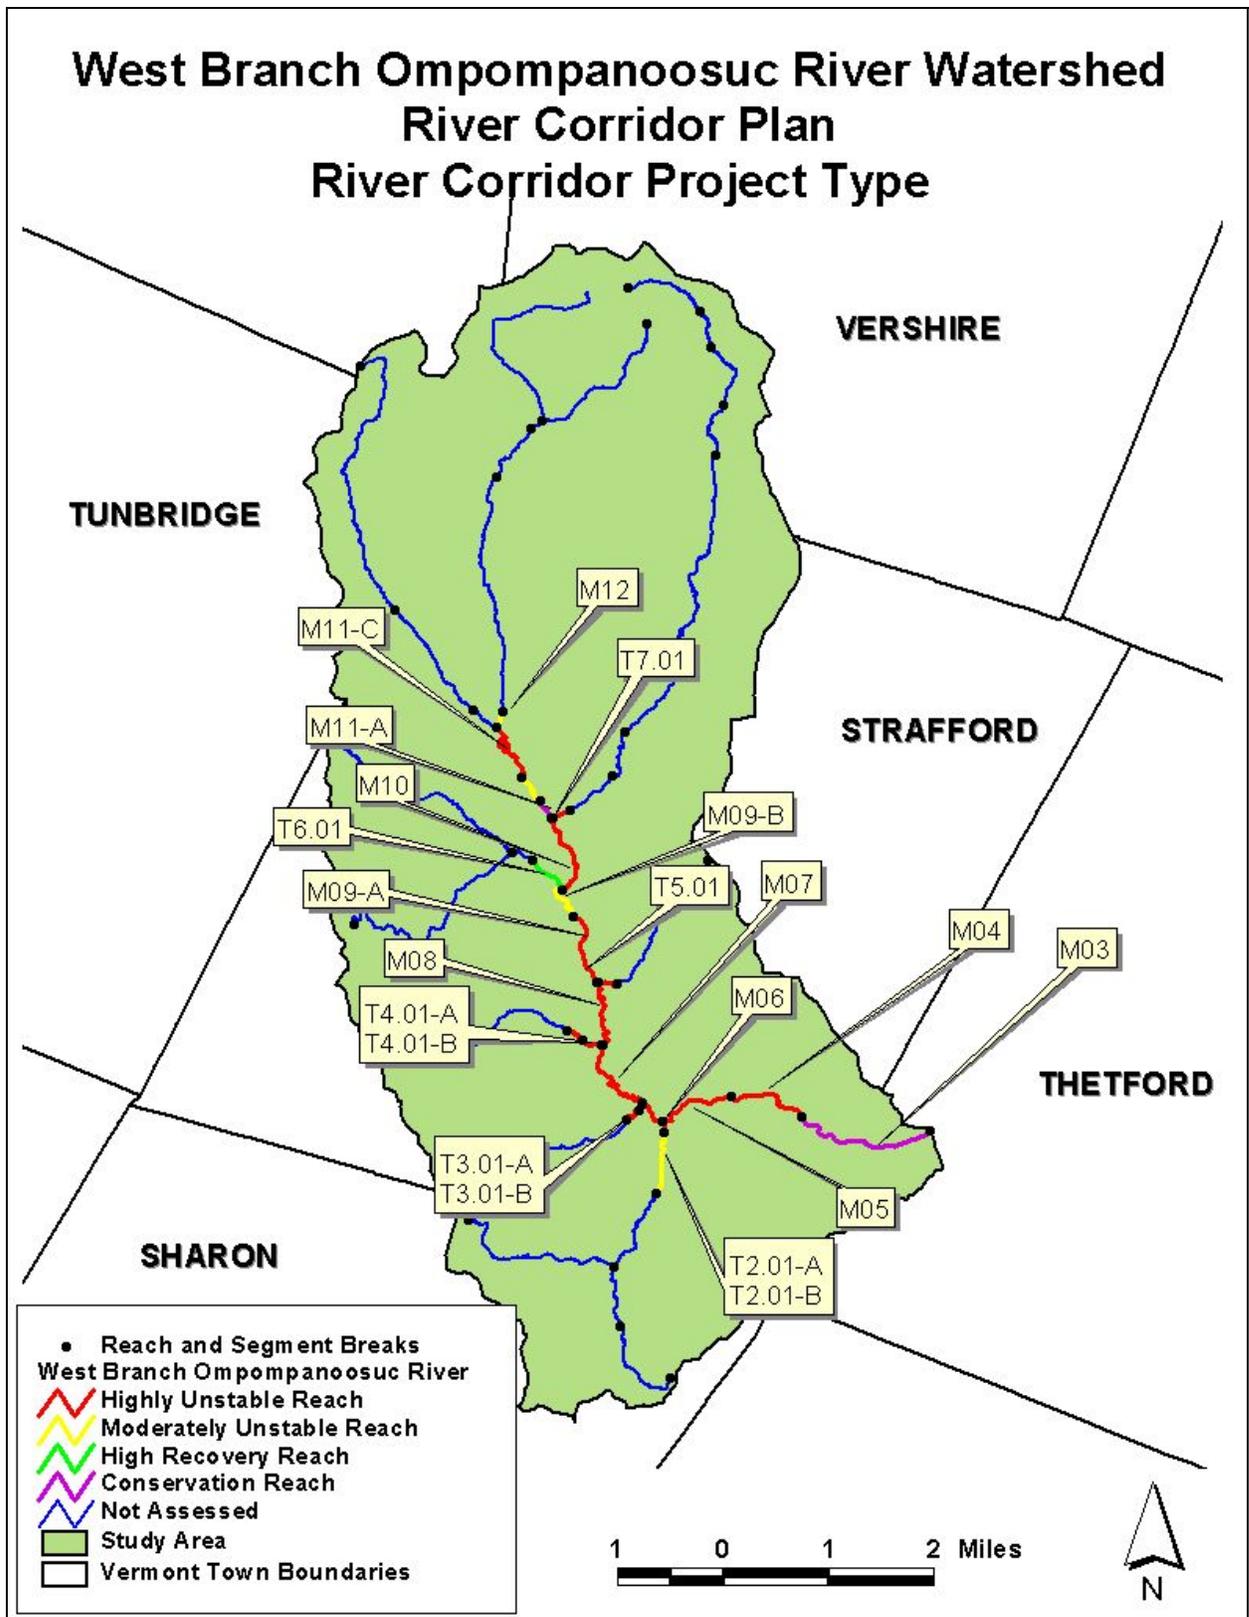
Figure 14: Restoration project types.

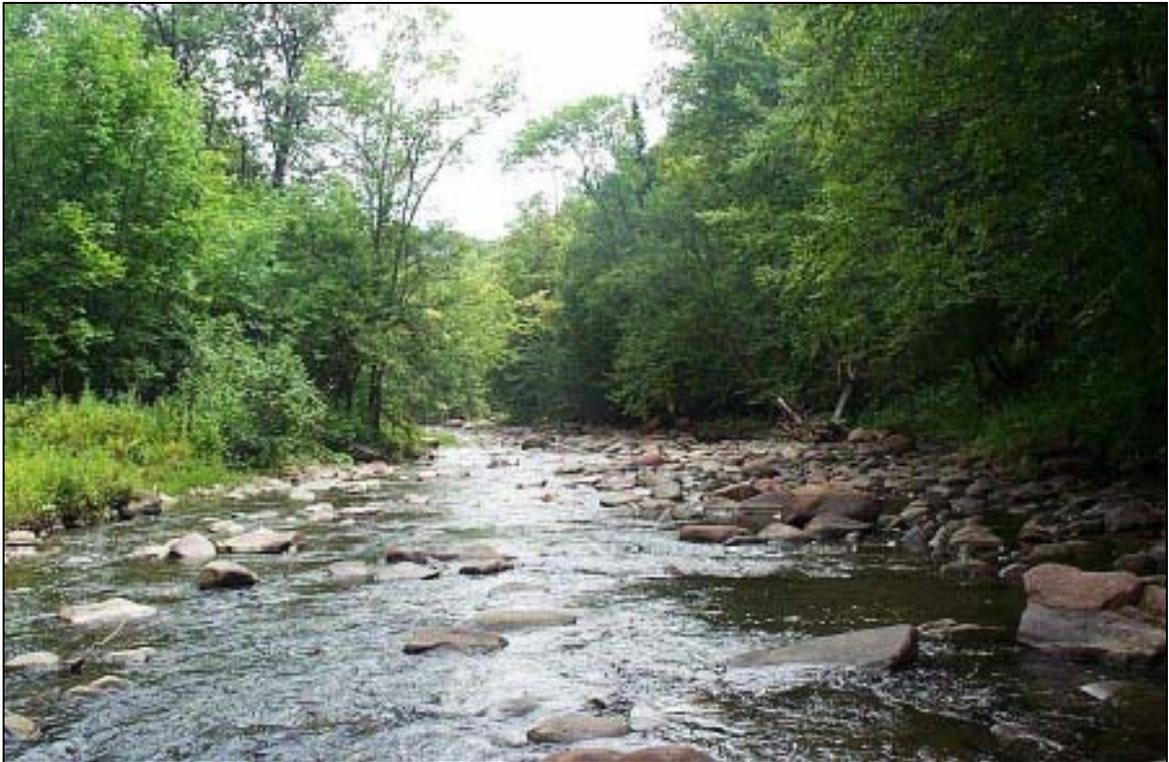
**Figure 15: Reach M03, has a healthy riparian buffer that provides an opportunity for conservation.**

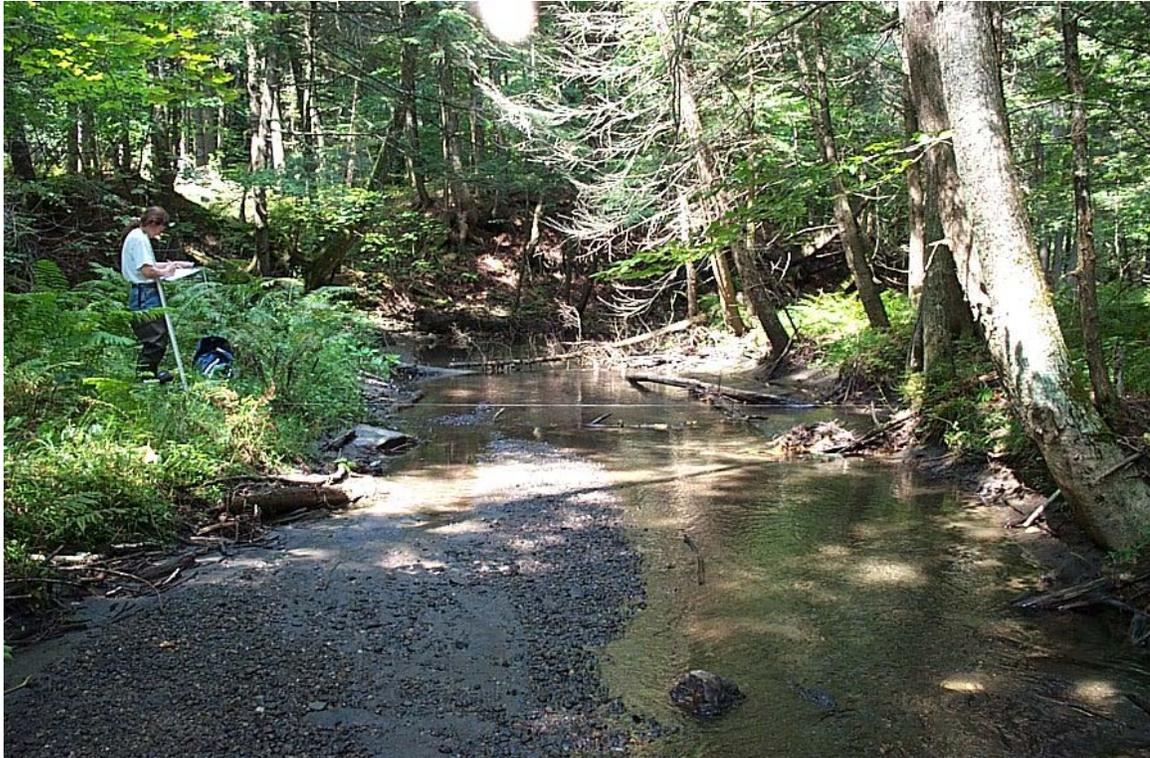
**Figure 16: Reach T2.01-B, Downer Forest Brook, is an exemplary high recovery reach.**

High recovery reaches are generally in good to fair geomorphic condition and exhibit expected channel dimensions, profile, and patterns (Figure 16). These reaches may have already undergone significant adjustment or may be prevented from undergoing a major adjustment process through proactive work. Restoration of these reaches is best approached with a passive or light active approach to restoration. General strategies for returning these river segments to health may include the following:

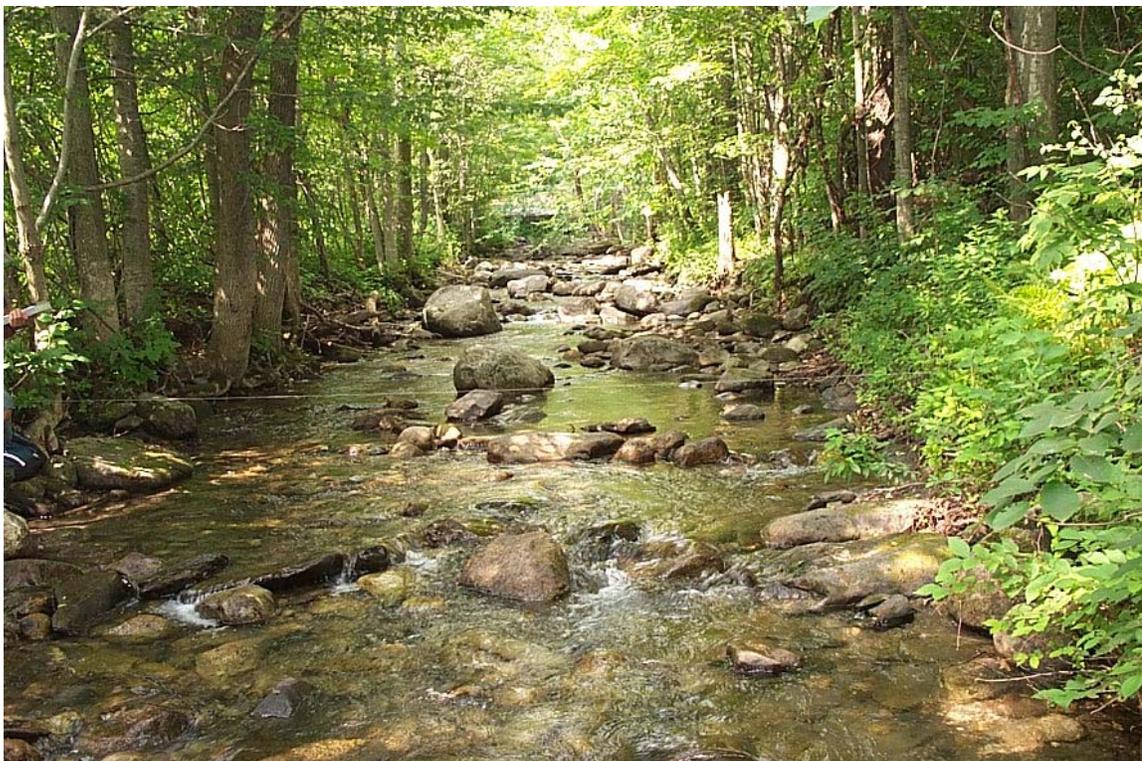
**Figure 17: Reach M12, which begins at the confluence of Tunbridge Brook, is moderately unstable.**
