### **West Branch of the Ompompanoosuc River River Corridor Management Plan Strafford, Vermont**

# **West Branch of the Ompompanoosuc River River Corridor Management Plan Strafford, Vermont**

October 30, 2006

Prepared by:

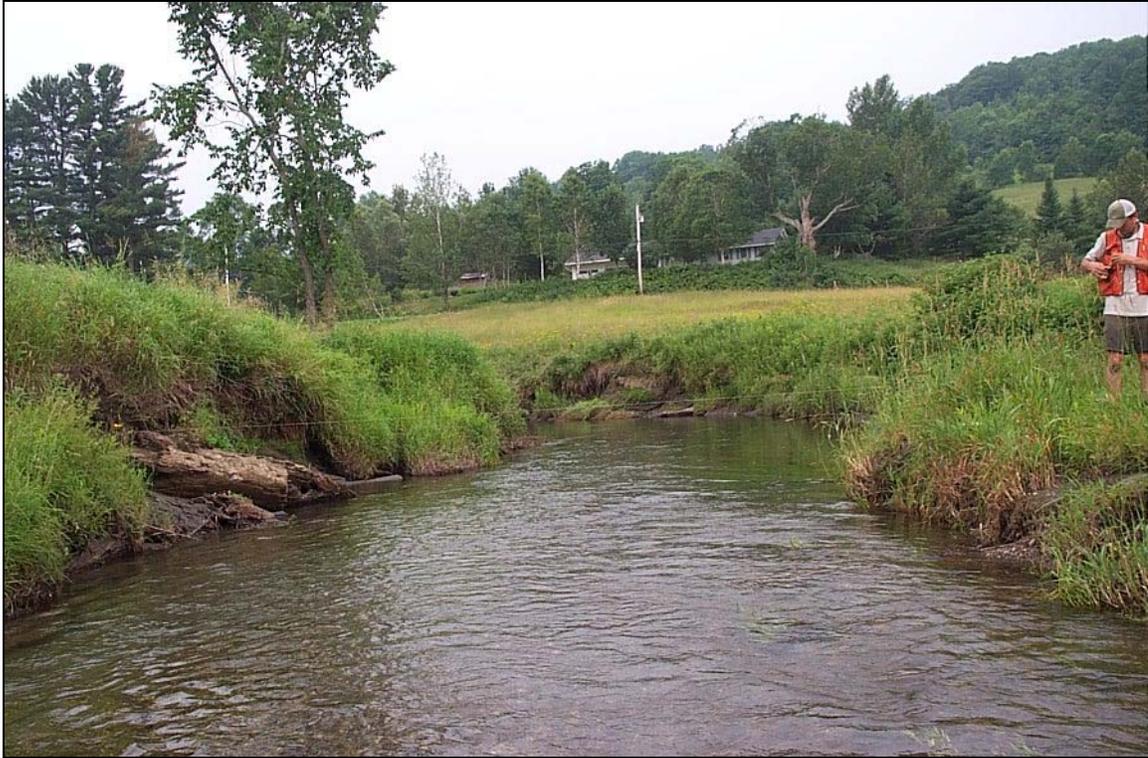
Figure 18: M07 is a highly unstable reach that is undergoing major geomorphic adjustment.

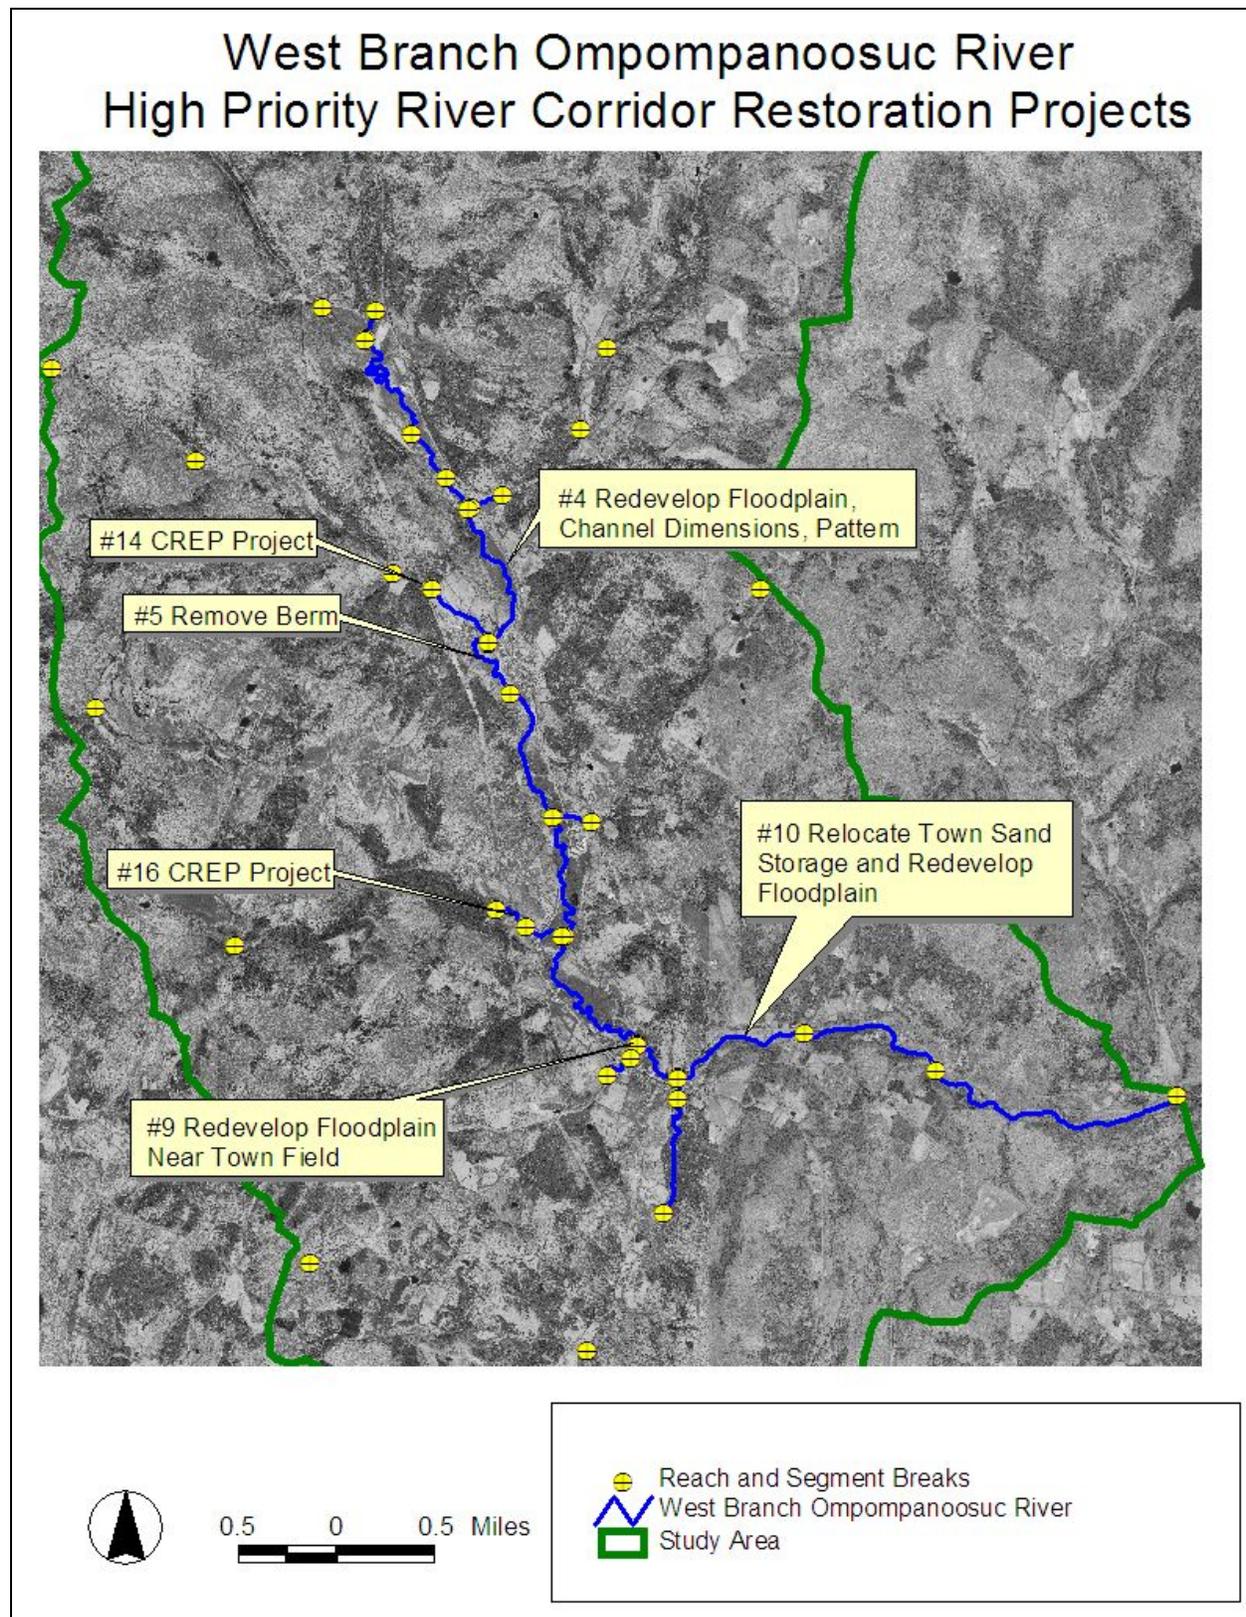
Figure 19: Project study area map of recommended projects.
