**WAITS RIVER WATERSHED**  
**PHASE 1 and 2**  
**STREAM GEOMORPHIC ASSESSMENT**  
**2007-2009**

January 12, 2010

Prepared by:  
Daniel Ruddell, Elisabeth McLane,  
and Courtney Haynes,  
Staff Scientists, and  
Ben Machin, Principal  
Redstart Consulting

Prepared for:  
Bradford and Corinth Conservation Commissions,  
Waits River Watershed Council, and  
Vermont Agency of Natural Resources/  
Department of Environmental Conservation  
River Management Program

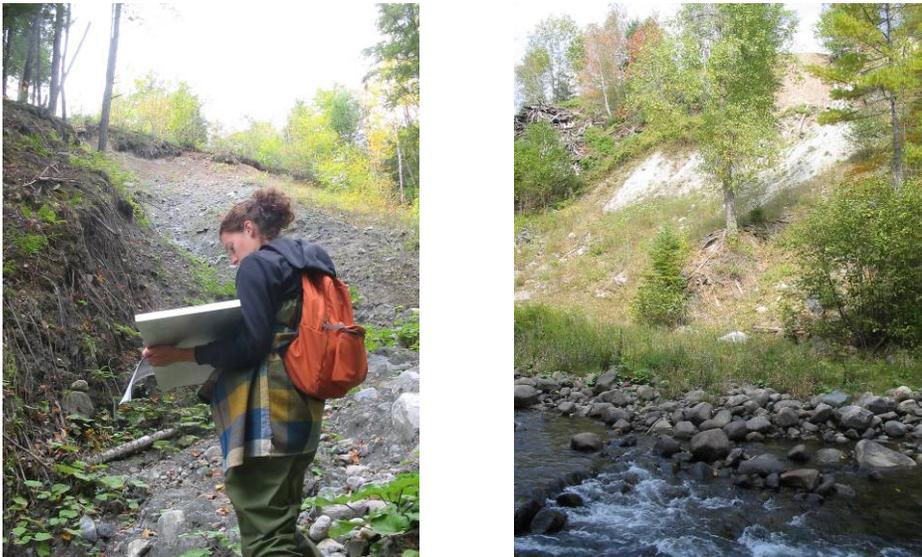
**Figure 4. Sand and gravel deposits in valley walls along the South Branch of the Waits are likely related to the former presence of a high elevation glacial lake, and have been prone to mass failures and gully formation.**

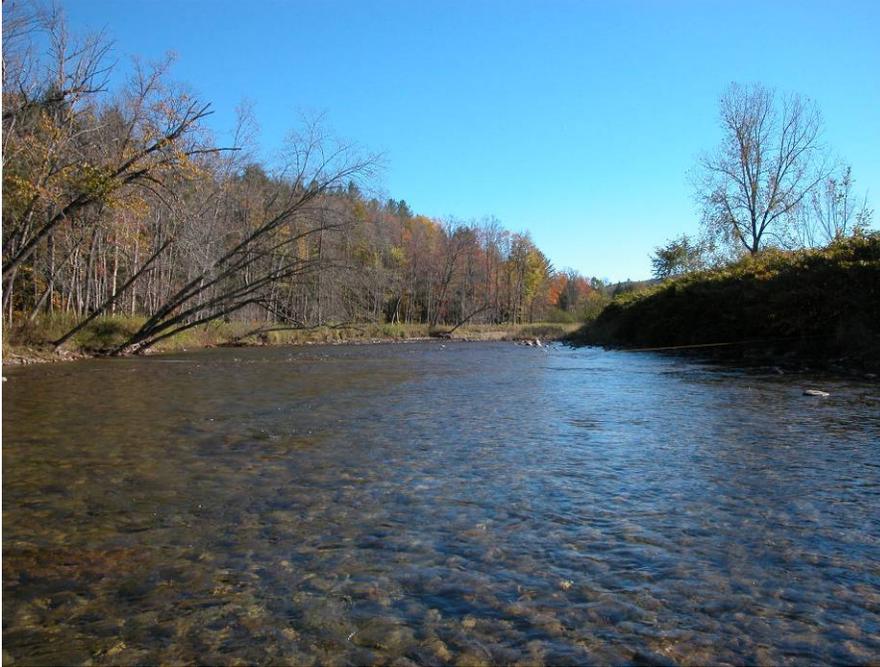
**Figure 6. Cobble “planebeds” lacking many riffle or pool features were frequently observed in the assessed areas.**

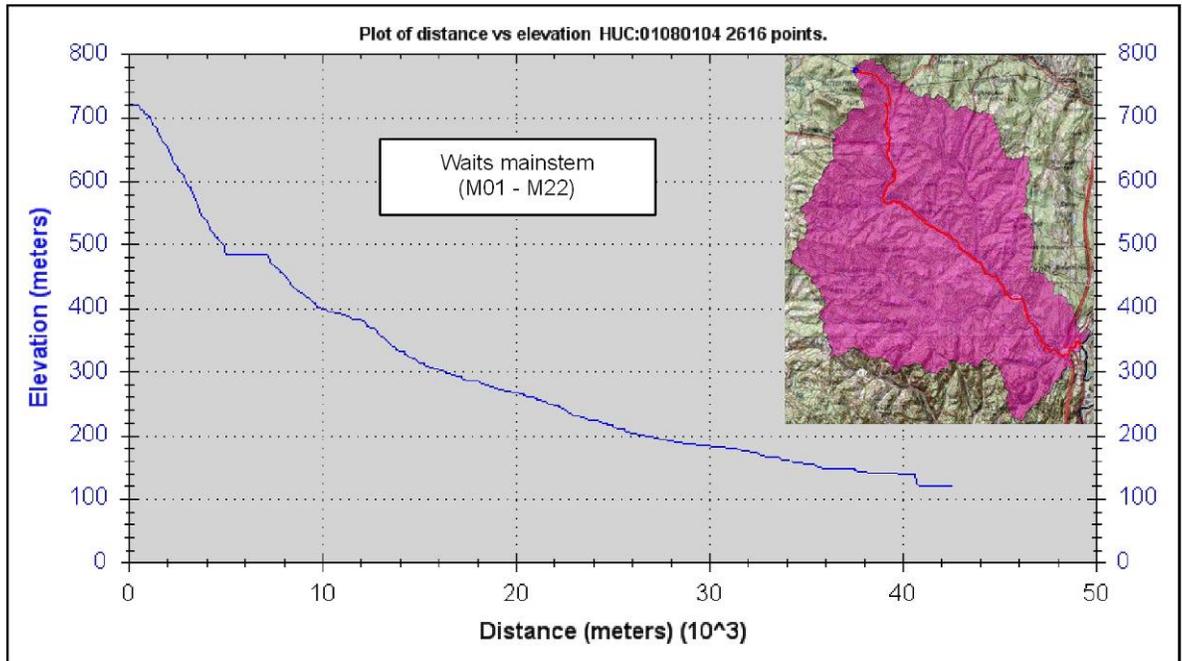
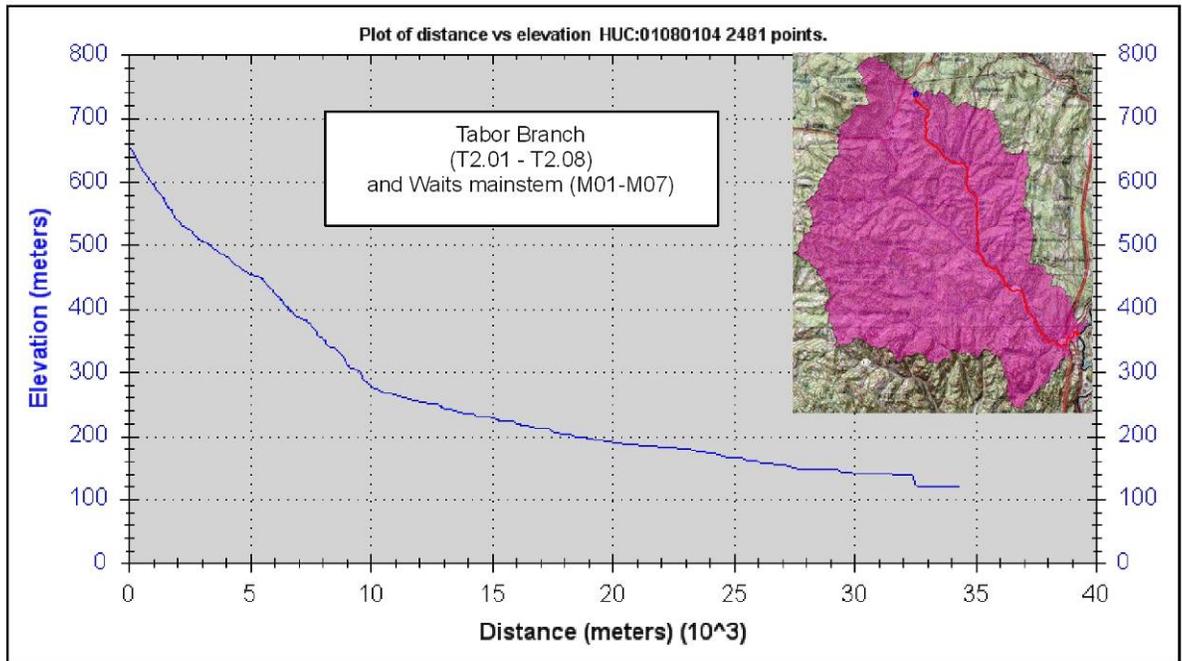
Figure 8. Longitudinal profiles for the Waits mainstem and Tabor Branch (graphics courtesy USGS streamstats website)..

Longitudinal profiles of the streams included in Phase 2 assessments (Figs. 8 and 9) indicate gentle gradient reaches alternating with steeper gradient reaches throughout the watershed, contributing to the mixture of stream types noted above. The Waits River watershed is typical of the Northern Piedmont area (as described by Thompson and Sorenson 2000), having rolling hill topography that is frequently dissected by narrow stream valleys. Relatively steep gradient ridges narrowly flank the downstream reaches of the Waits mainstem in Bradford and the South Branch in western Bradford and eastern

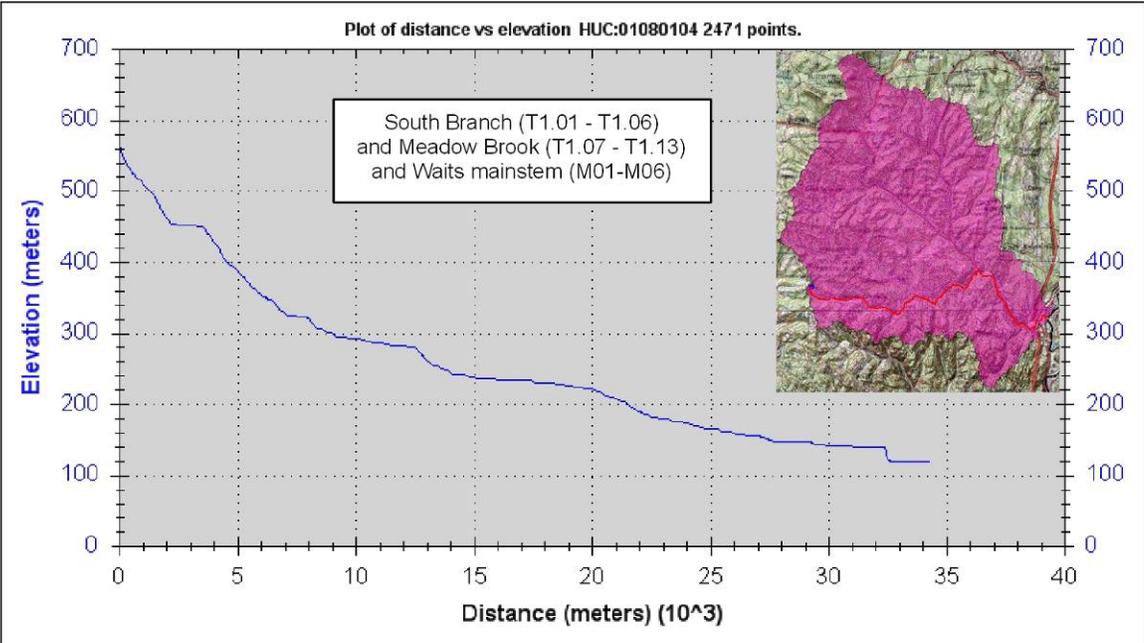
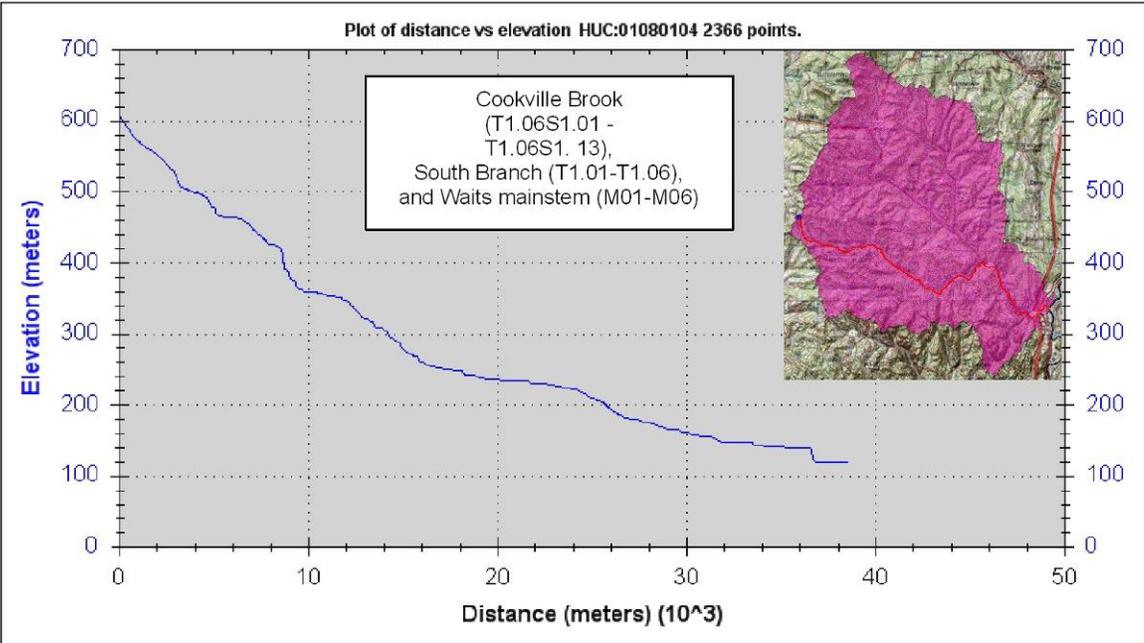
**Figure 9. Longitudinal profiles for the South Branch/Meadow Brook and Cookville Brook (graphics courtesy USGS streamstats website).**

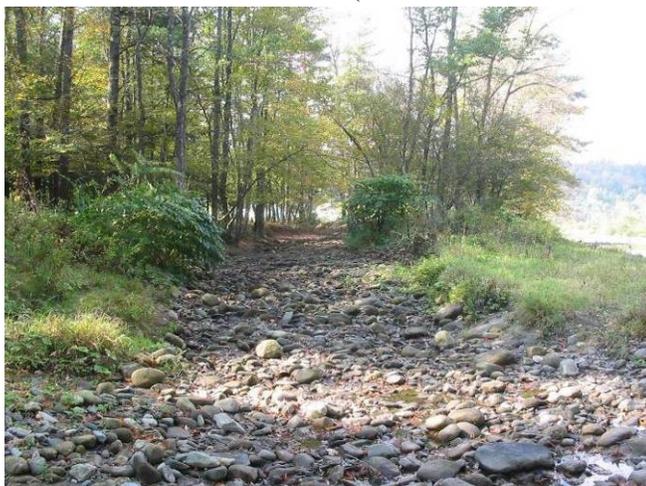
**Figure 10. Sediment “slugs” from a flood on Rowell Brook in 1998 now plug the mouth of Mill Pond Brook (into which Rowell Brook flows) at low flows, as shown here. This means that Mill Pond Brook now enters the Waits mainstem further upstream if water levels are low.**

In reviewing the records at these stream gages, it is important to recognize the often localized nature of floods that can have significant impacts. While the 500-year peak streamflows of the November 1927 flood were experienced in the Waits watershed as throughout Vermont (Johnson 1928), the sometimes steep topography and often narrow valleys of the watershed predispose the Waits River basin to “flashy” flows in heavy precipitation events. The stream gage located on a small tributary of the South Branch (a limited ten year dataset) recorded its highest flows on April 3, 1967 and April 14, 1974. These dates do not even appear as annual high flows a short distance away on the East Orange Branch (Fig. 11, next page), indicating the localized nature of these events. While this is in part related to weather patterns, it is also important to recognize the impact of the topography and geology as well as changes in hydrology over time, as further discussed in Section 5.1 (Watershed hydrologic stressors) of this report. These are highly pertinent factors in the Waits watershed, as flood history related by watershed residents indicates localized flash floods as the predominant type of flooding in the watershed. Several residents noted flooding on Rowell Brook in 1998 that caused two ponds to overflow, snowballing to cause enough gullying and erosion that sufficient sediments were carried downstream to plug the mouth of Mill Pond Brook (into which Rowell Brook flows) at its confluence with the Waits mainstem in Bradford (Fig. 10).

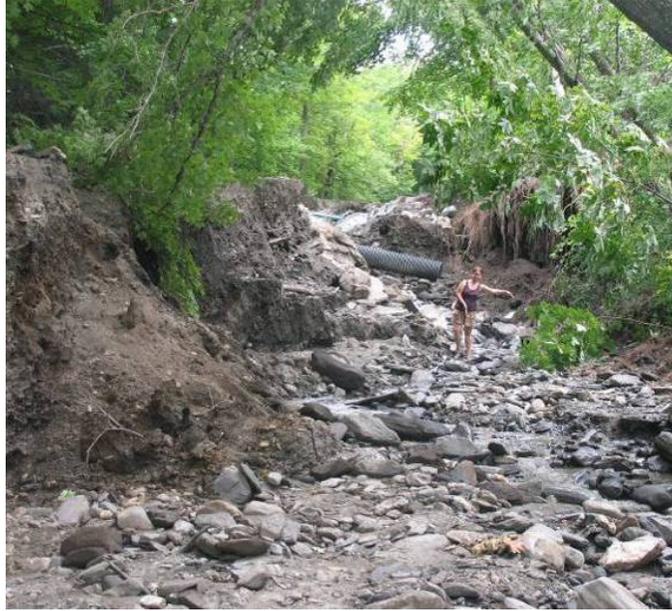
**Figure 12. Sediment from a road taken out by this small tributary off of Ayers Brook in Randolph suddenly became a significant contributor to stream dynamics after an intense thunderstorm in July 2007. The woman at center right is indicating the post-flood width of the stream by her armspan.**

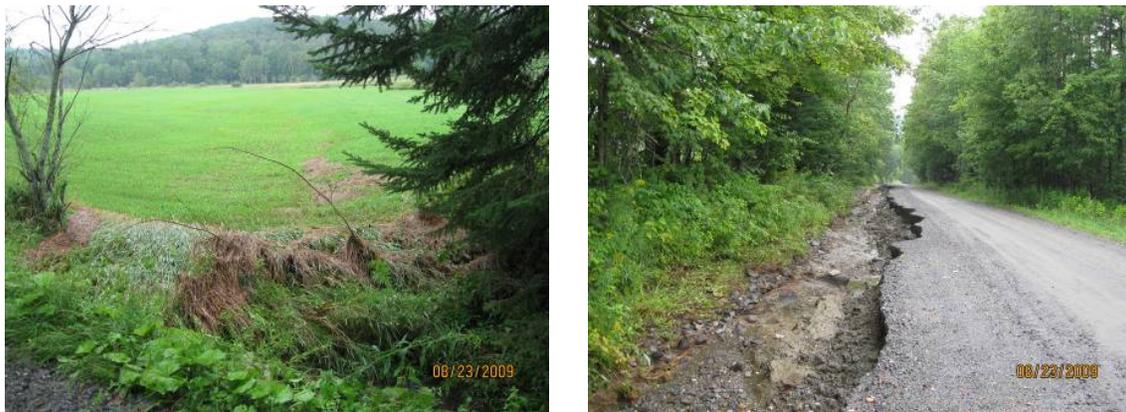
**Figure 15. The field swale at left contributed sufficient water in a heavy downpour to initiate gullying along the road (right), eventually combining with a tributary downhill to wash out a 6 ft. culvert and a section of the road.**

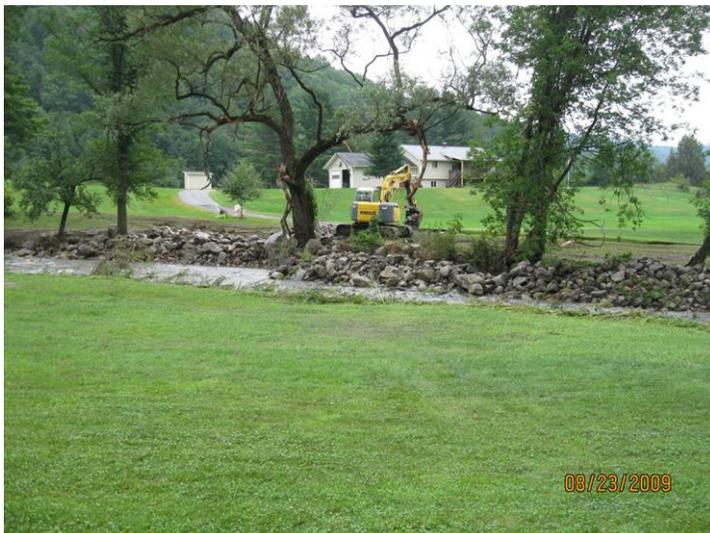
**Figure 17. Windrowing of sediments following flash flooding, particularly upstream of undersized bridges and culverts and similar constrictions, is not uncommon and is frequently undocumented. This can complicate understanding channel evolution and the movement of sediment in a stream system.**

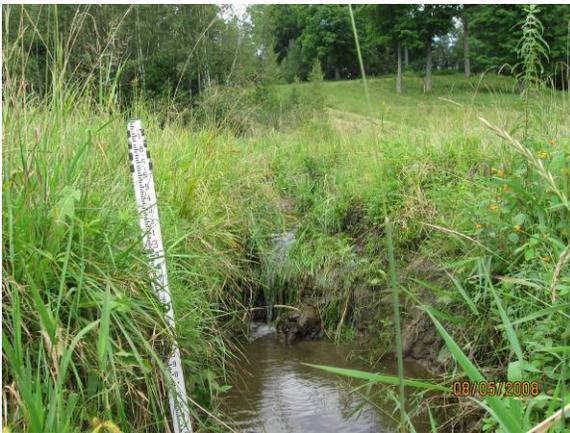
**Figure 18. Tributary rejuvenation contributes sediments to a stream when nick points or headcuts move back up a tributary, as the adjoining trib (such as the small one pictured here) begins to lower its elevation to meet the new elevation of a receiving stream that had previously cut down into its bed.**

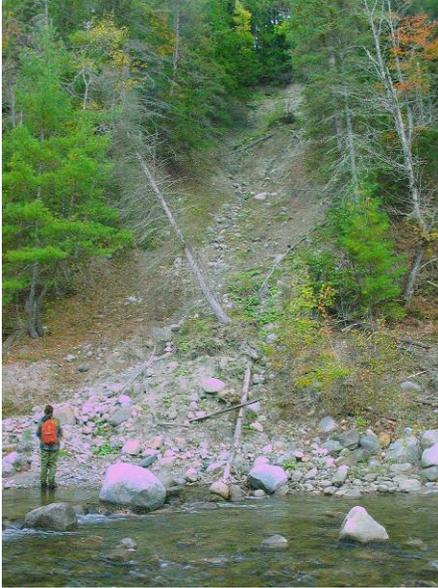
**Figure 19. Sediment contributions from mass failures and gullies were relatively common along the South Branch of the Waits. Pink cast to rocks is just an artifact of poor photo quality.**

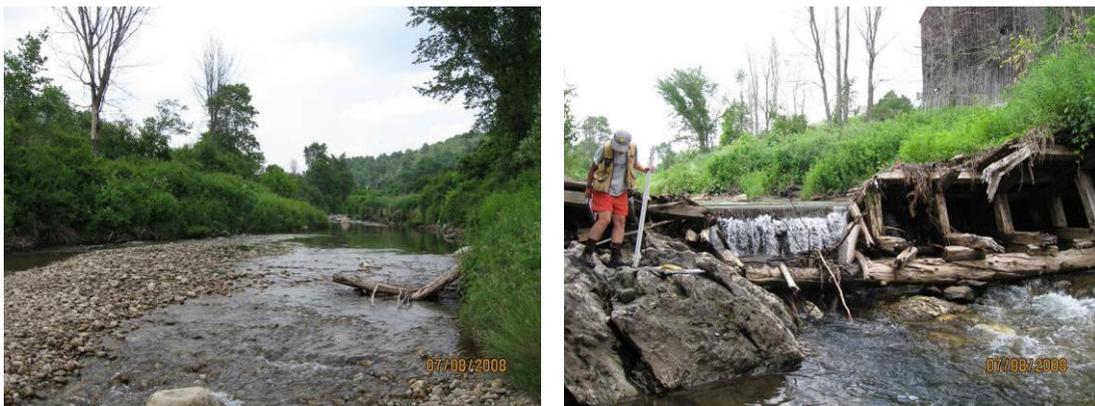
**Figure 20. Aggradation upstream (left) of a partially breached dam (right) on the Tabor Branch indicates likely ongoing “sediment starving” downstream.**

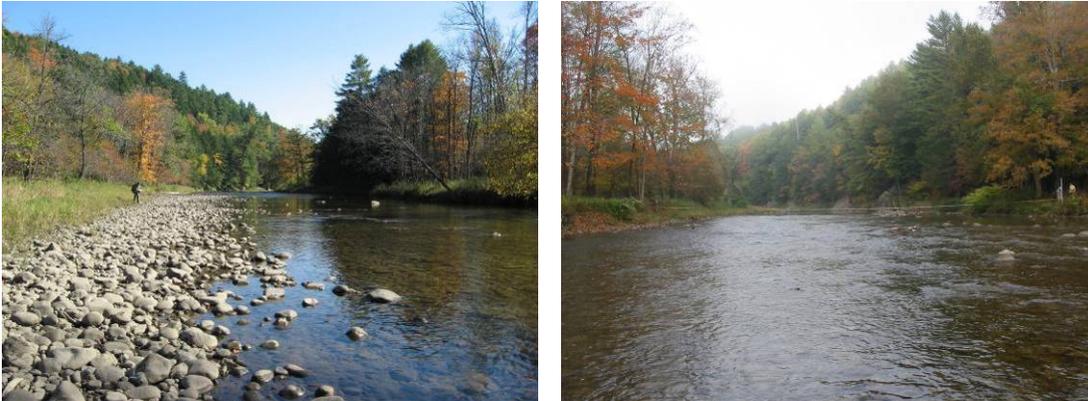
**Figure 23. Frequent alternation of narrow and wide valleys along the Waits mainstem appears to contribute to cycles of channel evolution, with depositional features setting up in moderate flows and at widened areas upstream of constrictions (left, looking downstream) and subsequently being scoured back out in high flows and downstream of constrictions (right, looking upstream).**

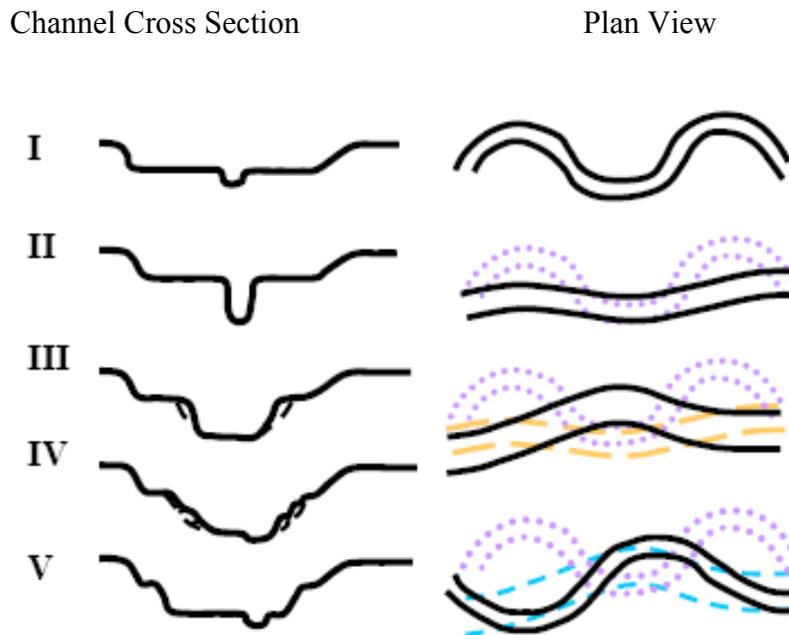
**Figure 27. Channel evolution process showing channel downcutting or incision in Stage II (cross section), widening through Stages III and IV, and floodplain reestablishment in Stage V. Stages I and V represent equilibrium conditions. Plan view shows straightening and meander redevelopment that accompany cross-section changes, a primarily flood-driven process often taking place over decades (VT-RMP RCPG 2007).**

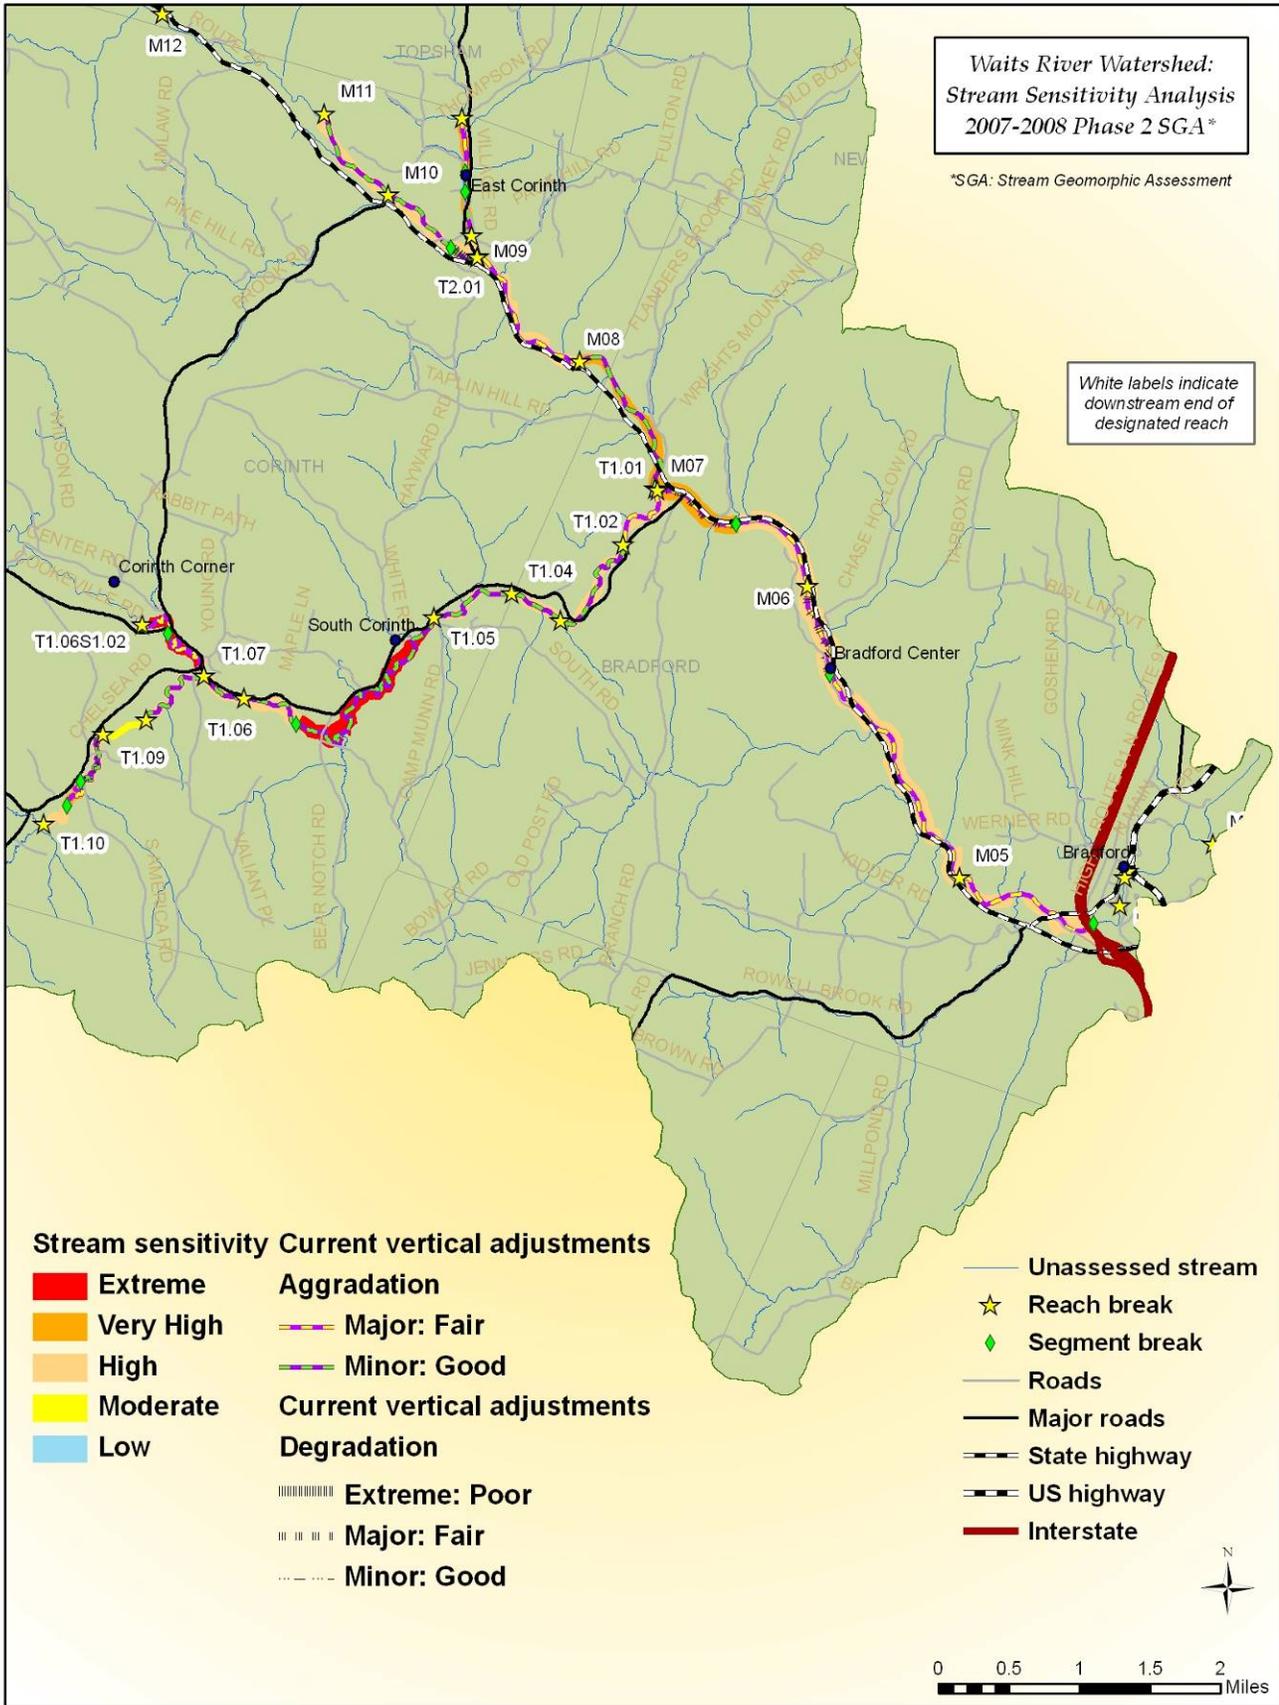
Figure 30. Sensitivity analysis for the 2007-2008 Phase 2 assessment area within the Waits River watershed.

The large majority of Phase 2-assessed reaches in the Waits River watershed are Highly to Extremely sensitive to disturbance and stressors, and thus also capable of a relatively rapid response (channel evolution to reestablish equilibrium conditions) if stressors are addressed (Fig. 30). This is in part due to the selection of mostly C-, Bc-, and E-type streams for Phase 2 assessment, which are by nature relatively sensitive and capable of recovery to equilibrium conditions in response to restoration efforts (Rosgen 1994). In general, the high sensitivity of a majority of reaches throughout the Phase 2 –assessed area indicates good possibilities for success of passive geomorphic projects, which would allow the river to utilize its own energy and watershed inputs to reestablish meanders, fuller access to floodplains, and self maintaining equilibrium conditions over time.

- Low sensitivity was indicated on only one segment in the 2007-2008 Phase 2 assessment area: the bedrock-controlled T2.02B on the Tabor branch in East Corinth village
- Moderate sensitivity was also indicated on only one reach: T1.08 on Meadow Brook in Corinth
- High sensitivity was noted on 18 of 28 segments dispersed throughout the Phase 2 assessment area
- Very High sensitivity was noted in 5 out of the 28 assessed segments: Waits mainstem segments M06B and M07, Tabor Branch segments T2.02A and C, and Meadow Brook T1.09 B.
- Extreme sensitivity was noted on 3 of 28 segments: T1.05A on the South Branch in South Corinth and both segments of Cookville Brook reach T1.06S1.01

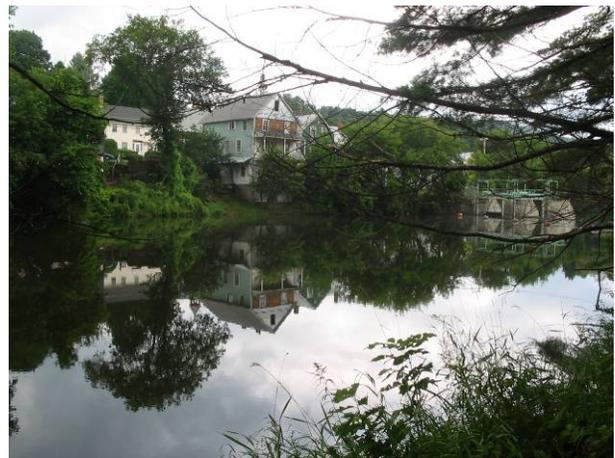
**Figure 31. Reach M03, hydro dam head gate, commercial and residential development along left bank.**

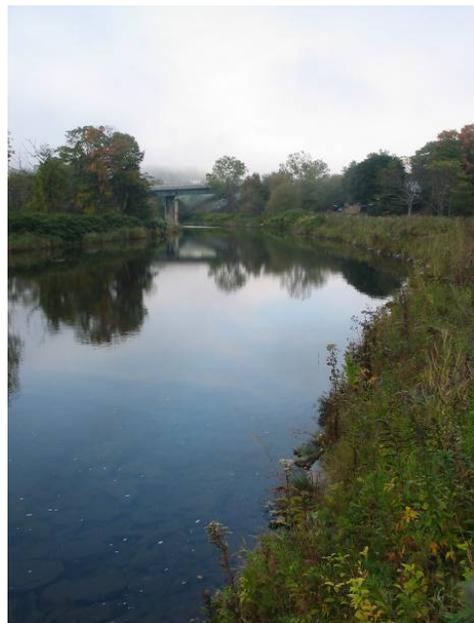
**Figure 33. Bank toe armoring and riprap are common in segment M04A, as are patches of Japanese knotweed as visible left of the Interstate-91 bridge in this photo.**

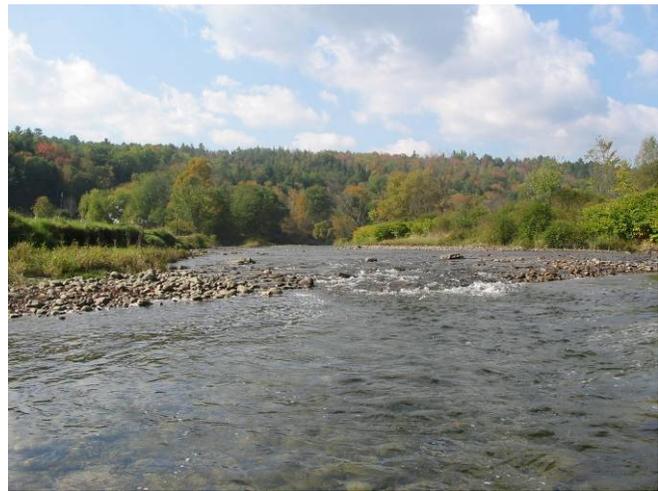
**Figure 34. Segment M04B showing eroded banks and steep riffle at Kenison property near Masonic hall**

- Two bridges at the I-91 overpass and one at South Main St. all present floodplain and channel constrictions primarily due to the presence of piers in all of the structures; deposition was noted above each of these structures, and the left bank abutment of each of these structures also exhibited some scour

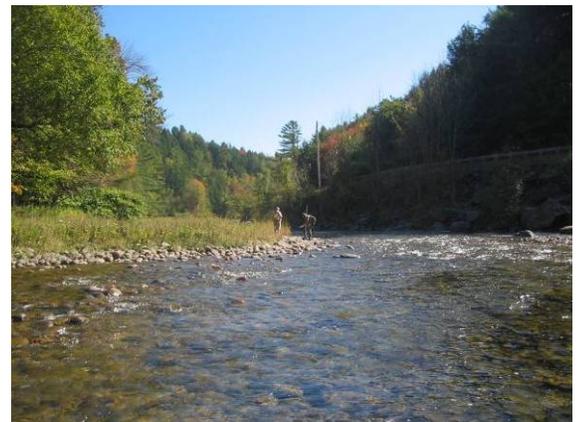
**Figure 36. Segment M05A showing stream entrenchment in areas where the left valley wall and elevation of the road bed off the right bank work in tandem to create a significantly narrower valley.**

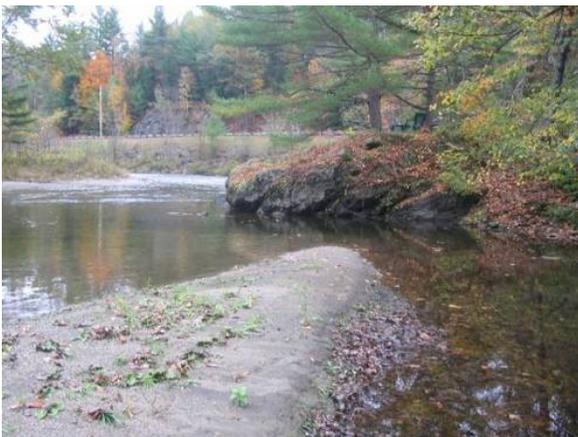
**Figure 37. Segment M05B: Rip rap and Rte 25 road encroachment in background, sidebar downstream of bedrock outcrop in foreground**

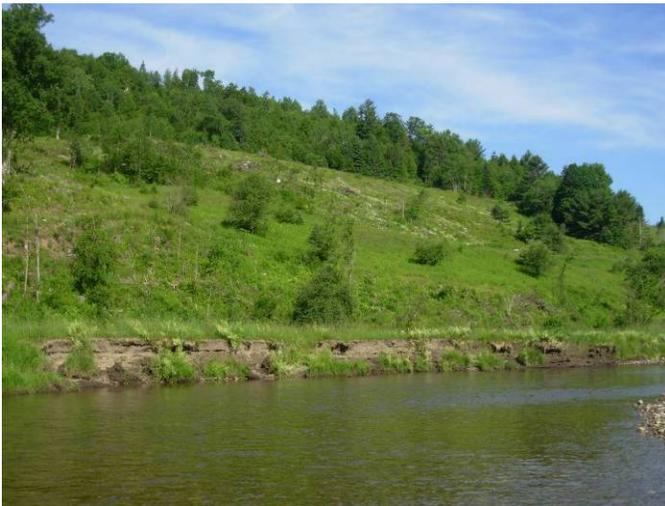
**Figure 40. Waits mainstem reach M07, showing bank erosion in the lower portions of the reach, downstream of the Waits River Rd. bridge**

- M07 is a C-type stream, plane bed with a gravel substrate in a semi-confined valley
- Road encroachment on both banks is significant; Waits River Rd. parallels the reach in it's entirety on the right bank; the left bank is encroached in the downstream portions of the reach
- Though there is narrowing of the valley by encroachment, even with full natural valley width and reference channel width would still be on upper end of semi-confined valley
- Canopy cover and buffers are basically non-existent due to road encroachment and heavy agricultural use; dominant buffers on both banks are < 25 ft
- Bank erosion on right bank was occurring downstream of bridge in lower portions of the reach

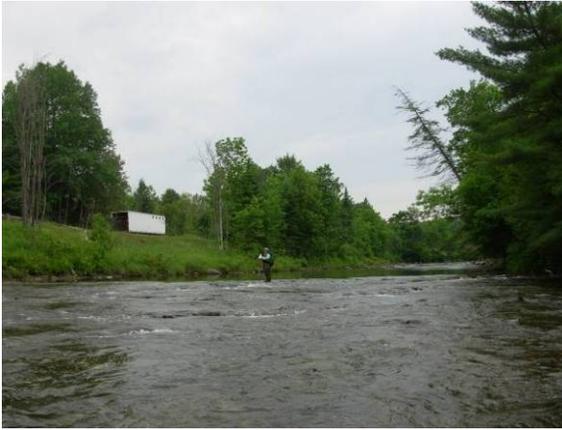
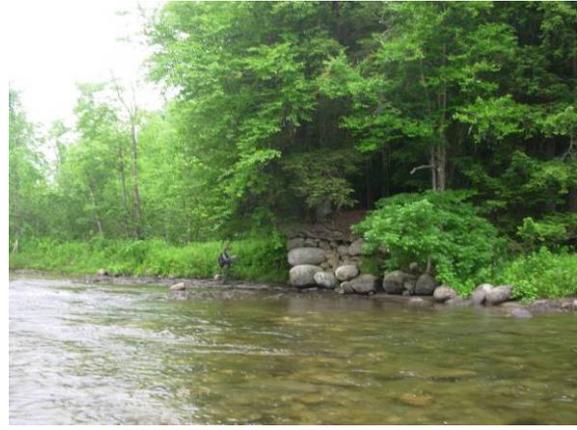
Figure 42. Waits mainstem Reach M08 showing road encroachment (left) and a boulder pile of undetermined purpose on the left bank (right).

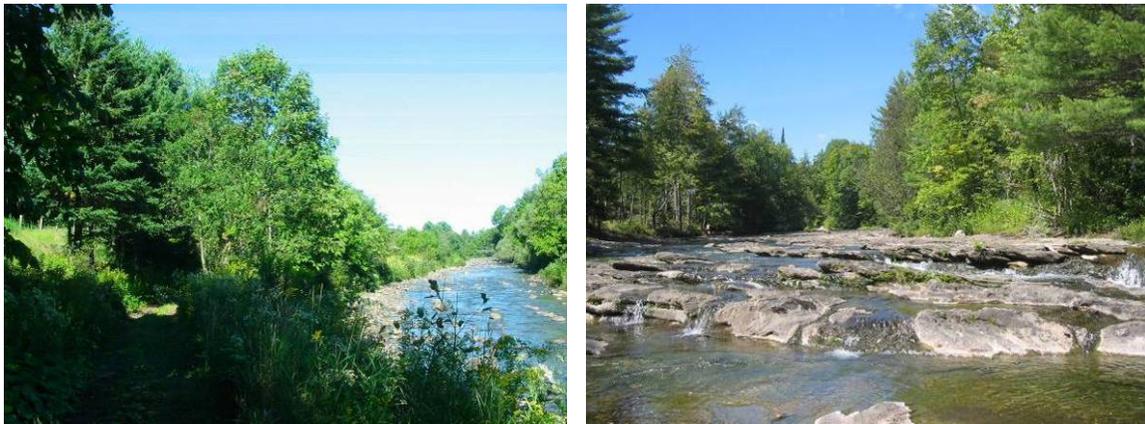
**Figure 44. Reach M09. Picture on the left was taken 300 ft from the East Corinth general store and depicts a snowmobile trail running parallel to the Waits River (M09A). The picture on the right shows bedrock grade controls downstream of the confluence with Pike Hill Brook (M09B).**

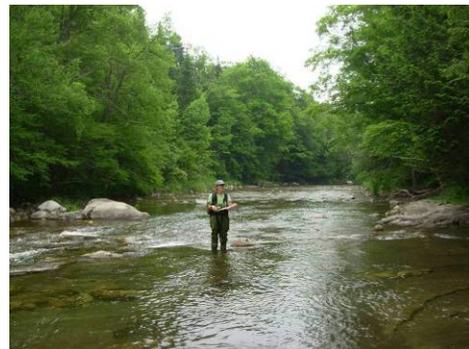
**Figure 47. Reach M10 looking downstream: bedrock in stream is common and serves as a grade control.**

- Reach M10 is a C-type stream, plane bed with a cobble substrate in a narrow valley
- Current encroachments are limited
- Significant forested wetlands mapped in upstream portions of reach
- Large drainage ditches on left bank indicate likely past agricultural activity, historic sawmill located in next reach upstream
- Incision ratio of 2.0 but no stream type departure – floodprone height just barely clears right bank terrace at cross section
- Further downcutting appears limited by bedrock; bedrock in the stream is fairly common
- Buffers on both banks are now forested and are > 100 ft
- Overall adjustment processes are minor and channel evolution stage appears to be arrested stage III; not a lot of active erosion, and widening appears limited by buffers, coarse substrates, bedrock controls, and some floodplain access at flood flows

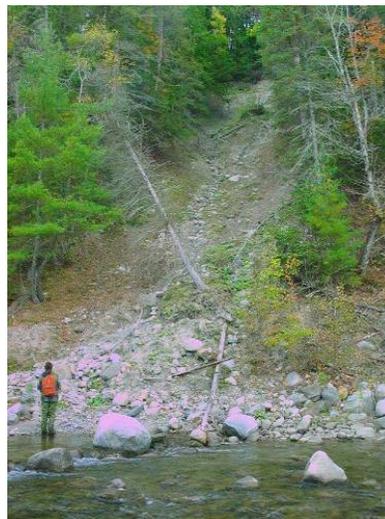
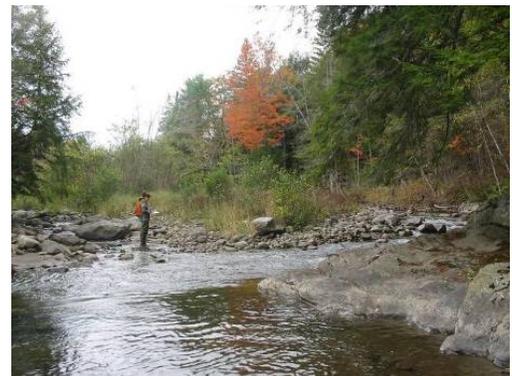
**Figure 49. South Branch reach T1.01: Mass failure on left bank (left) and an island and flood chute indicative of significant aggradation (right).**

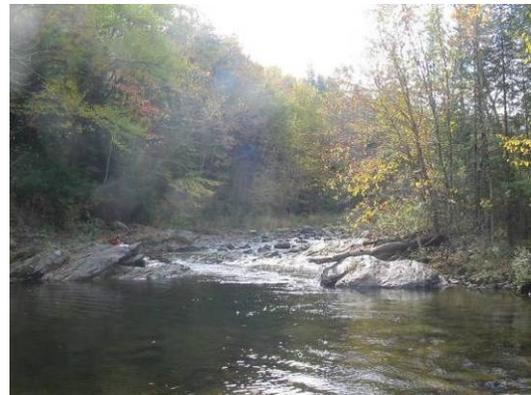
**Figure 51. Reach T1.02 bedrock grade control at downstream end of reach, causing some channel constriction and creating a deep scour pool**

- Left bank buffers were >100 ft; right bank dominant buffers >100 ft, but a subdominant buffer of 26-50 ft was due to road encroachment; there is a snowmobile trail located in what was an old roadbed along the right bank in the upstream portion of the reach
- Bedrock channel (but not floodprone) constriction was noted at the downstream grade control, contributing to formation of a deep scour pool that is popular as a local swimming hole
- Floodprone and further channel constrictions were noted at the Chelsea Rd bridge and an old abutment in the upstream portion of the reach; constriction from existing bridge is due to alignment issues that reduce the effective width of the span
- Fair geomorphic condition, High sensitivity with major widening and planform adjustments, Stage III channel evolution

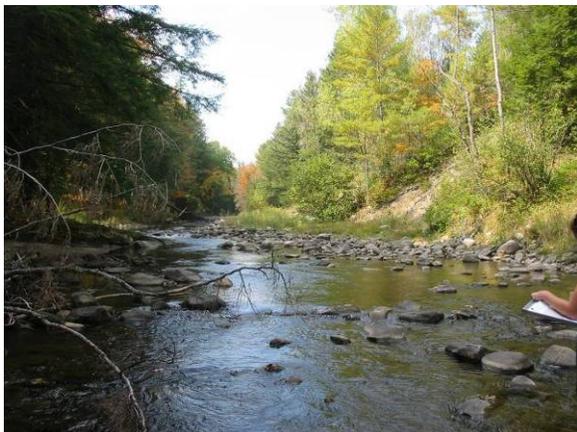
**Figure 53. Reach T1.03 on the South Branch, showing mass failure, steep riffle, and a bedrock outcrop on opposite bank**

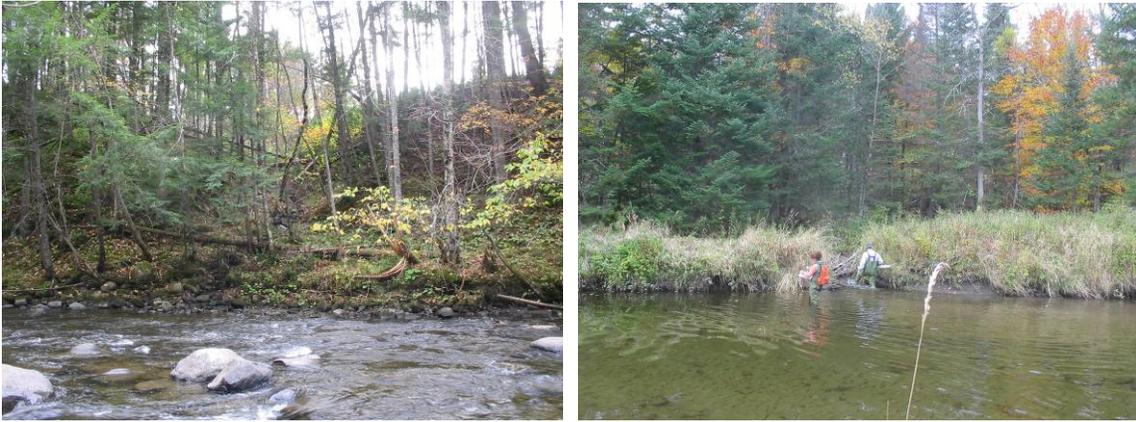
**Figure 55. Stormwater or overland flow inputs appear to have cut through erodible sideslopes in reach T1.04 (left), where suspected former beaver dams were also observed (right).**

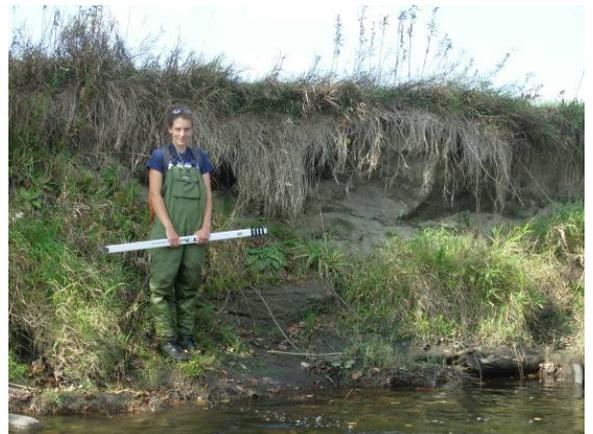
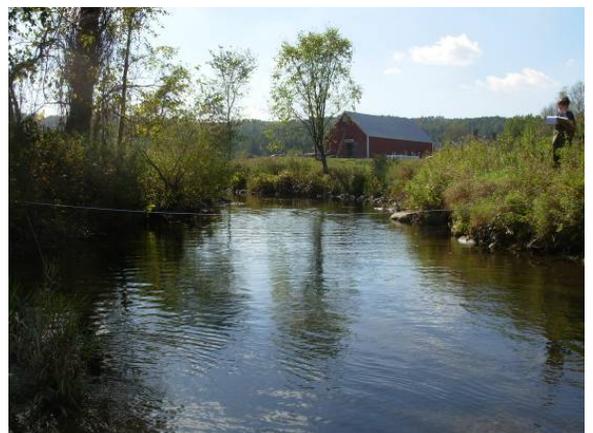
**Figure 57. Segment T1.05A showing eroded banks (top) and development encroachments and agricultural proximity to the stream (bottom).**

- ~500 ft of channel is affected by beaver dam
- Significant aggradation due primarily to deposition of fines
- Road encroachment occurs on both sides of the stream, but only in a short portion of the upstream end (~500 ft) and is present on both banks at the same time; several residential houses are located in close proximity to the stream

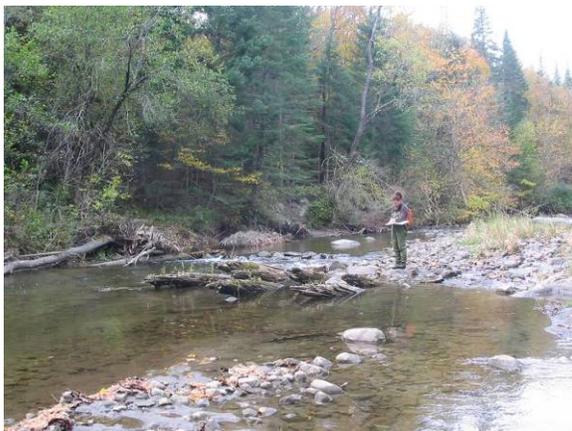
**Figure 60. Reach T1.06 showing old stream ford, bank failure and mid-channel bar**

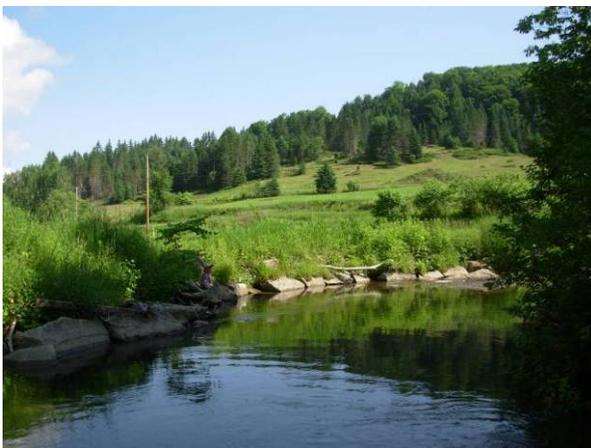
**Figure 63. Reach T1.06S1.01 showing bank toe armoring on the left bank.**

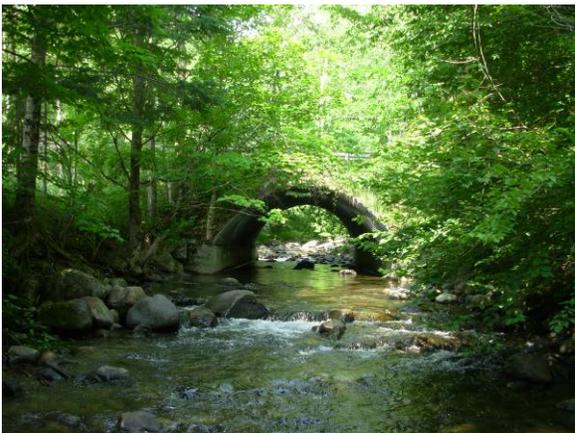
**Figure 64. Turkey Hill Rd. stream crossing in reach T1.07 is undersized but is an excellent design for fish and other aquatic organism passage.**

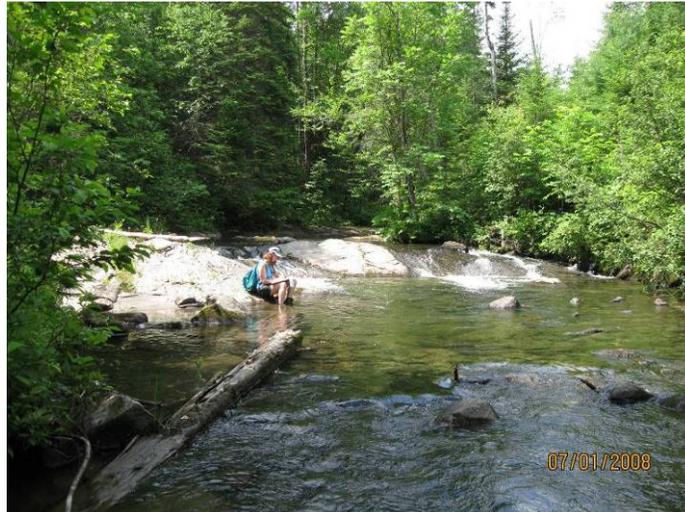
**Figure 65. Two fords were noted in reach T1.08, and timbers in the stream may have been the remains of a temporary skidder bridge or similar structure for a logging operation**

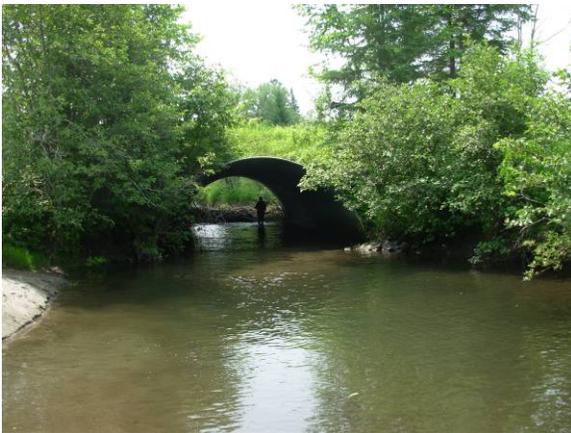
**Figure 66. Arch culvert at Dearborn Hill Rd. in segment T1.09A is partially obstructed by a beaver dam just upstream of the inlet**

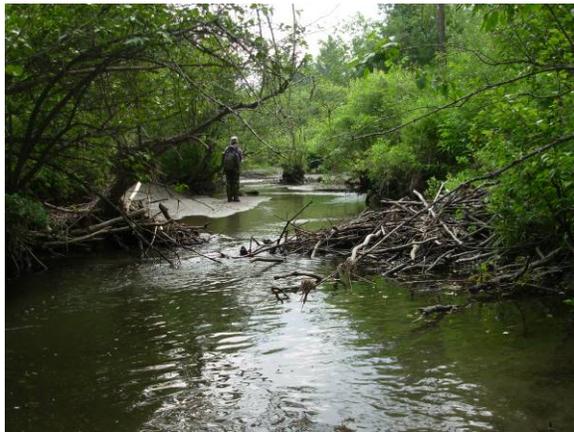
**Figure 68. Beaver dams in segment T1.09B appeared recently blown out.**

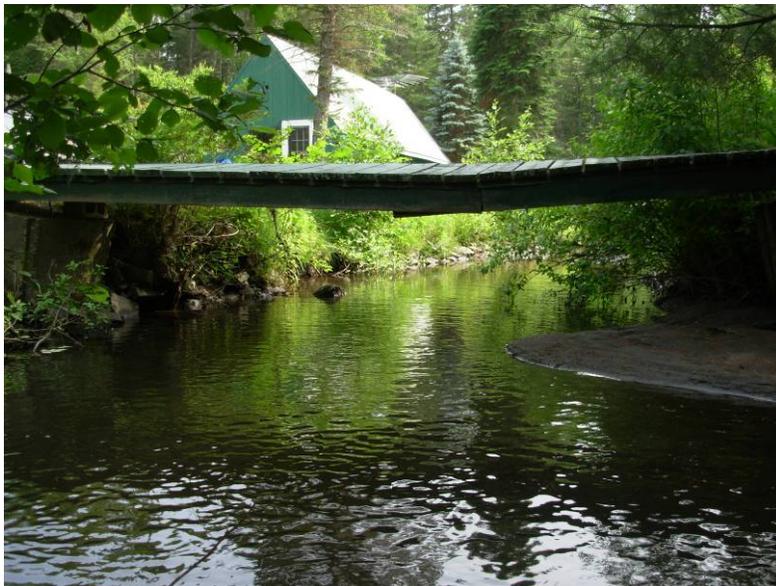
**Figure 69. Development encroachment in segment T1.09C; bank toe stabilization placed on both banks; bridge is a channel constriction with some deposition noted upstream**

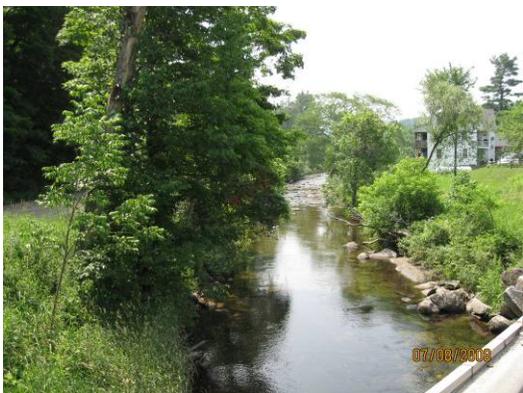
**Figure 71. Encroachments on both sides of T2.02A have obscured terraces that might indicate the extent of access to historic floodplains along the Tabor Branch**

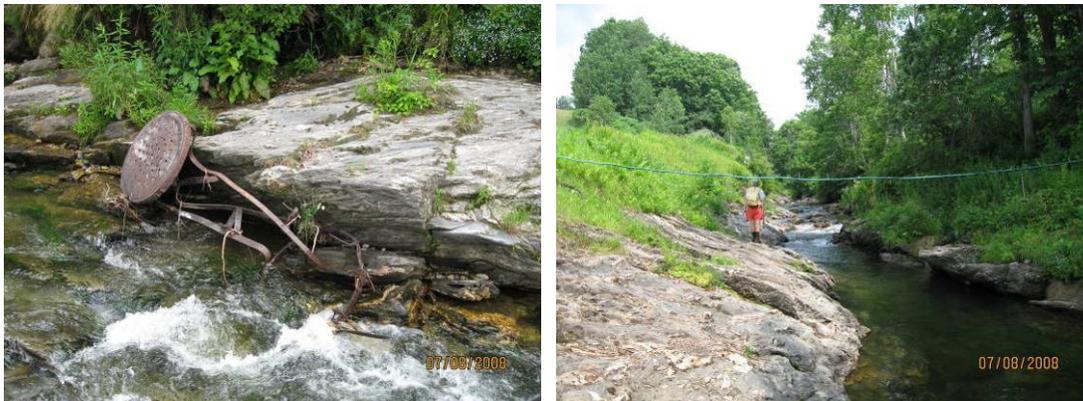
**Figure 73. Tabor Branch segment T2.02B still has old pieces of equipment from mills that operated in this bedrock-controlled section of the stream.**

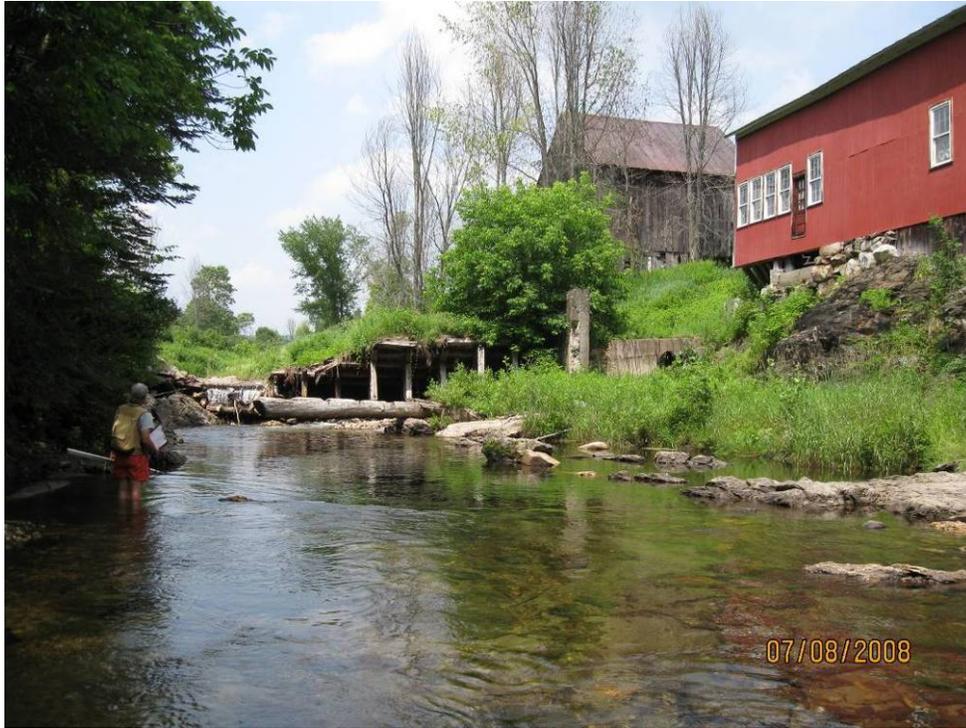
**Figure 74. The old bobbin mill dam at the upstream end of segment T2.02C is still partially intact, and the current owner hopes to restore it to generate power.**

Segment T2.02 C, the furthest upstream segment in the reach, is 2058 ft long and extends from the Chicken Farm Rd. bridge to the confluence of a small tributary and the Tabor Branch, just west of Thompson Rd./Village Rd. intersection, at the old bobbin mill dam that is currently owned by Gordon Kittredge. The dam at the upstream end of the segment is only partially breached (Mr. Kittredge is interested in restoring it for power generation).
