Roaring Brook and East Branch of Roaring Brook
Water Quality Remediation Plan Update 2011
Killington, Vermont

**ROARING BROOK AND EAST BRANCH
OF ROARING BROOK WATER QUALITY
REMEDATION PLAN UPDATE 2011**

***MTB KILLINGTON, LLC, AMSC
KILLINGTON, LLC, SP II RESORT, LLC
& SP LAND COMPANY, LLC***

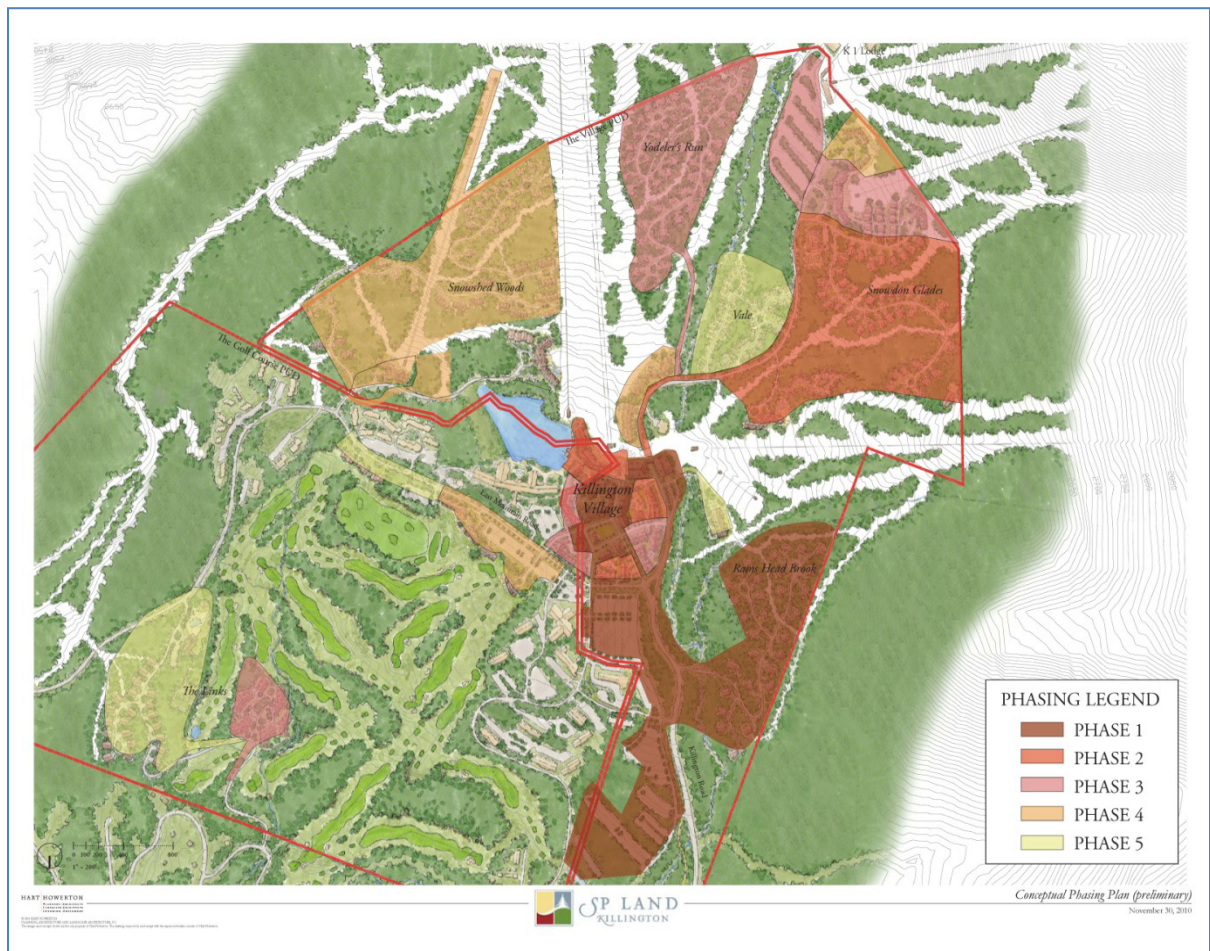
Figure 3: Killington Resort/SP Land Conceptual Development Plan

A conceptual plan showing the phased development is shown below in Figure 3 and potential stormwater detention basin locations associated with the development are shown on the WQRP Map in the map pocket.

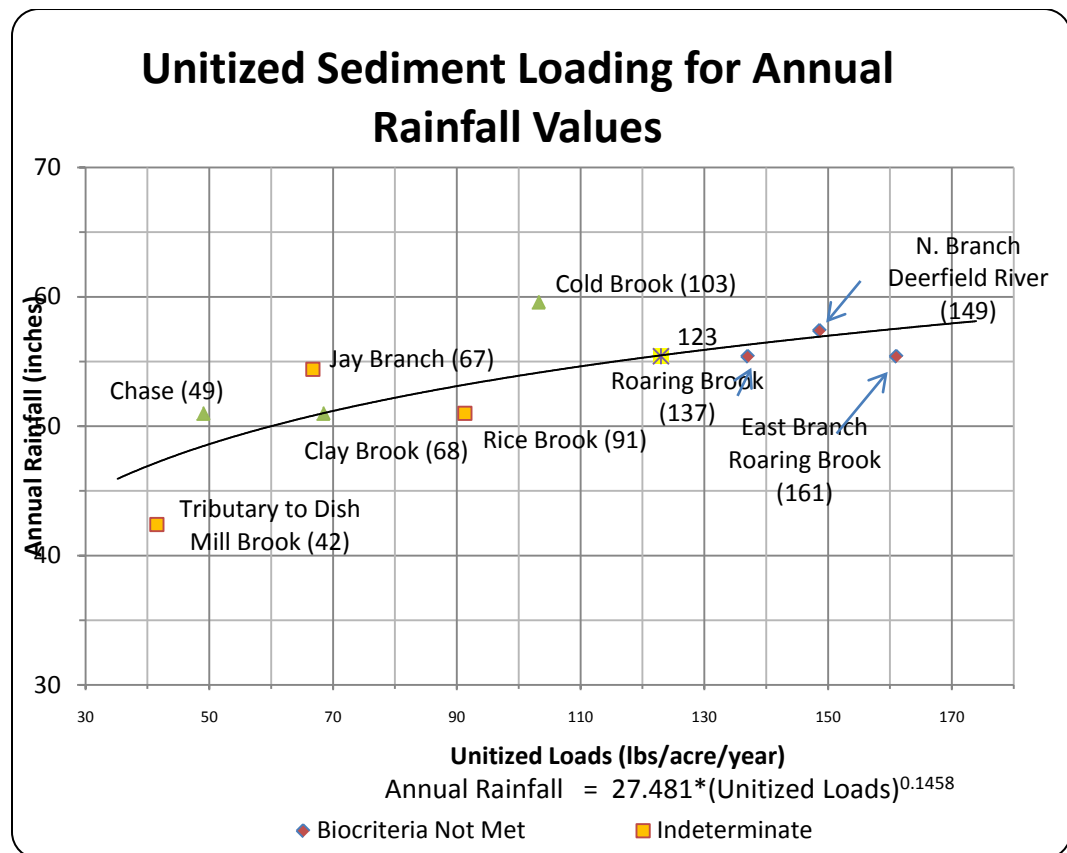
Figure 4 - Sediment Loading Chart Showing Linear Regression and Potential Compliance Point

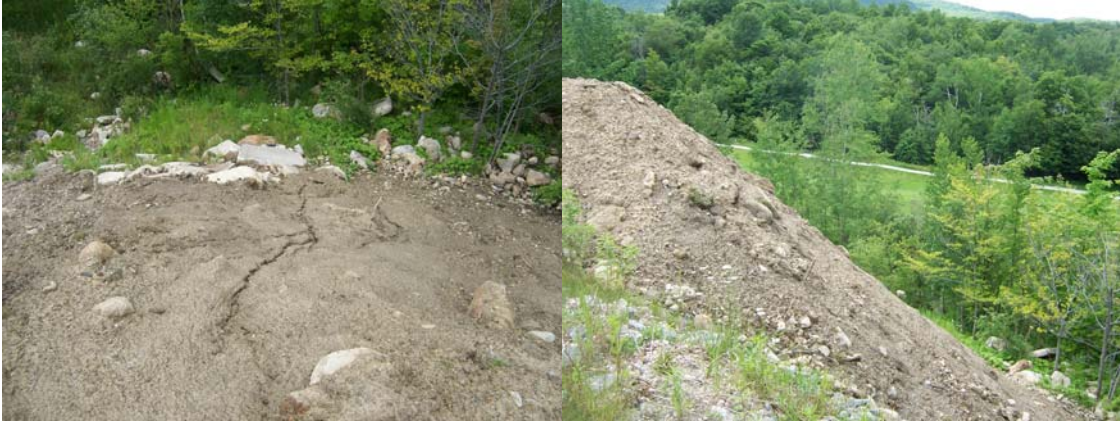
SOURCE #1

Photograph 1 and 2: Large pile (~40 ft high) of exposed and uncontained dirt in close proximity of a tributary of the East Branch of Roaring Brook. The pile of dirt is located at the northern end of the Lower Whiffle Tree lot and is actively eroding.

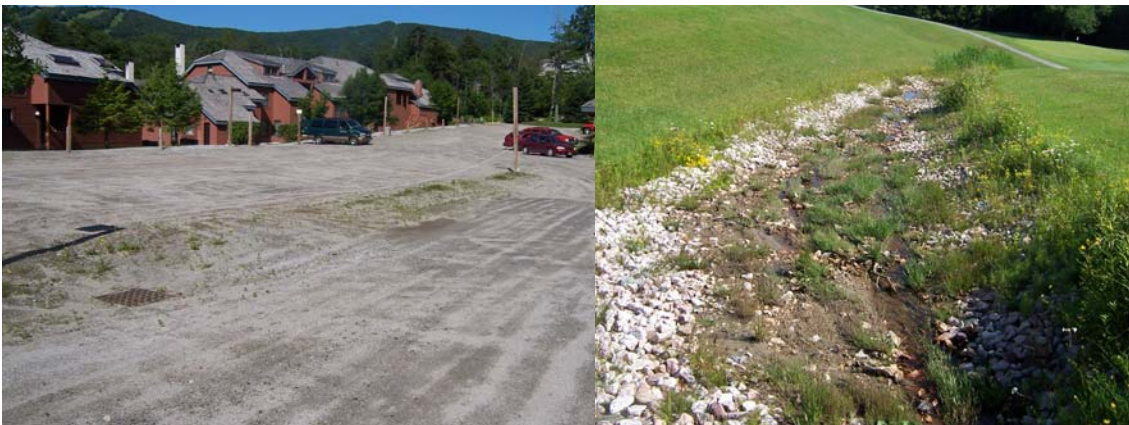
SOURCE #2

Photographs 3 and 4: Through a linked system of storm drains, culverts and swales, the unpaved parking lot at Trail Creek Condo Development is conveying sediment into a tributary of the East Branch of Roaring Brook.

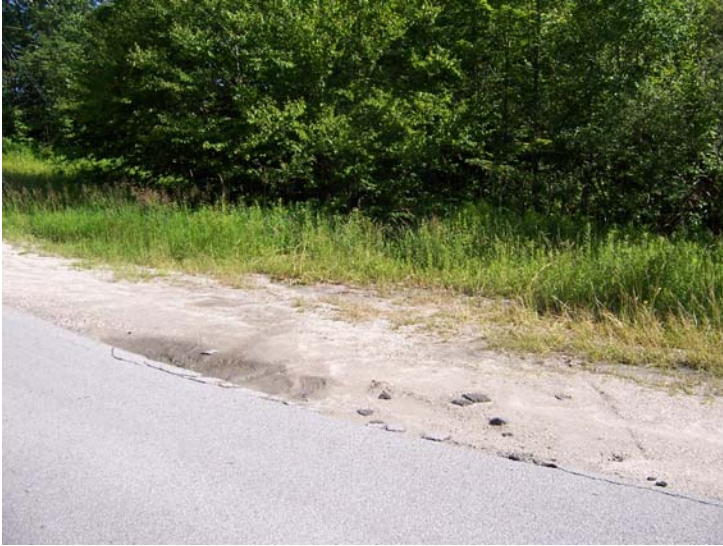
SOURCE #3

Photograph 5: Gravel run off from the edge of E. Mountain Road is contributing sediment to the East Branch of Roaring Brook around the outlet of culvert “C-77”.

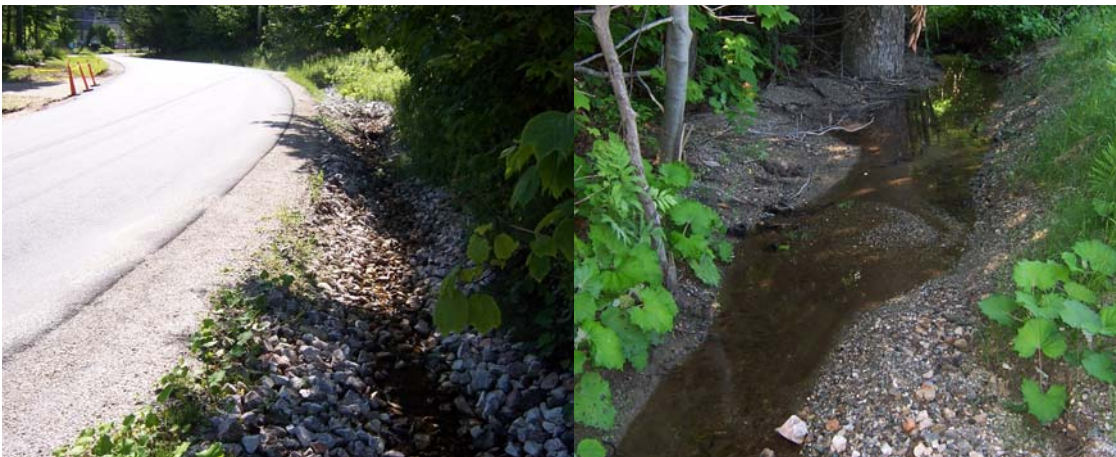
SOURCE #4

Photographs 6 and 7: Across the entrance of “Whiffle Tree” on the south side of E. Mountain Road, a roadside swale is conveying sediment into the East Branch of Roaring Brook.

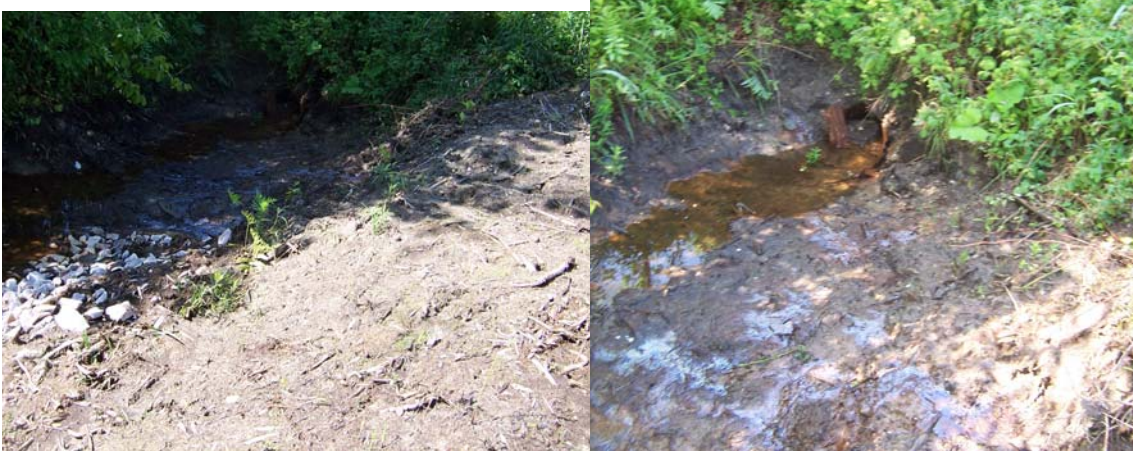
SOURCE #5

Photographs 8 and 9: The banks around the outlet of a culvert are bare of vegetation and eroding. The outlet is located near the KP-25 outfall on the east side of Snowshed Pond.

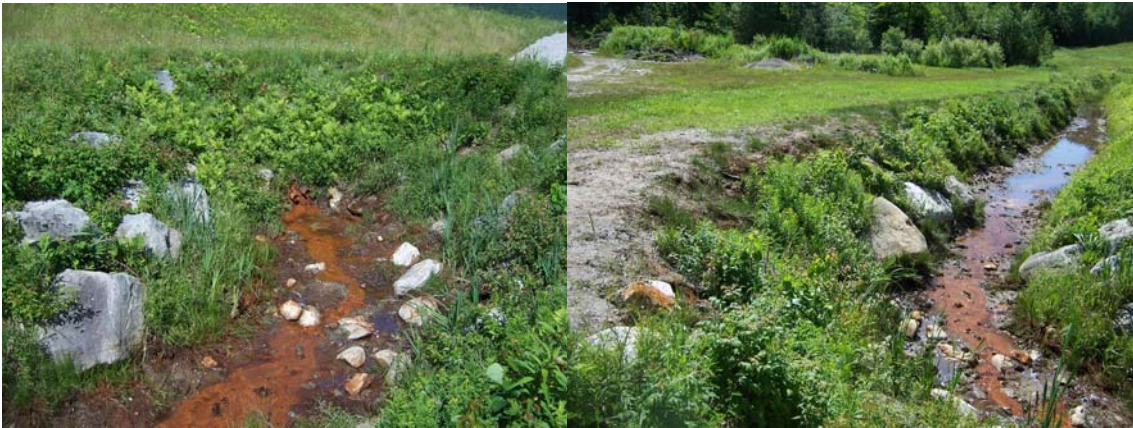
SOURCE #6

Photographs 10 and 11: There is a heavy iron seep and bare banks conveying sediment to the headwaters of the East Branch of Roaring Brook on the east side of Snowshed Pond.

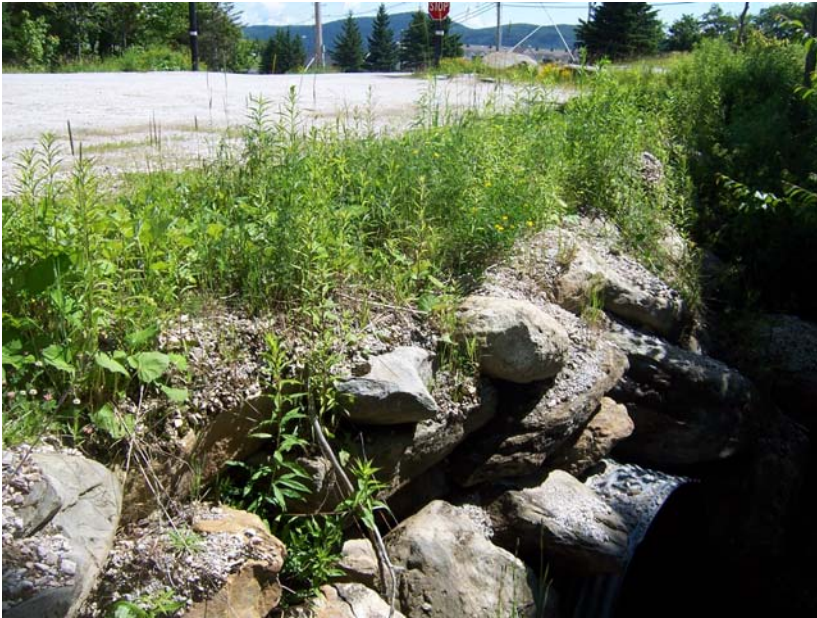
SOURCE #7

Photograph 12: Gravel from the parking lot above the culvert “C-22” inlet is conveying sediment into Roaring Brook over the boulder headwall.

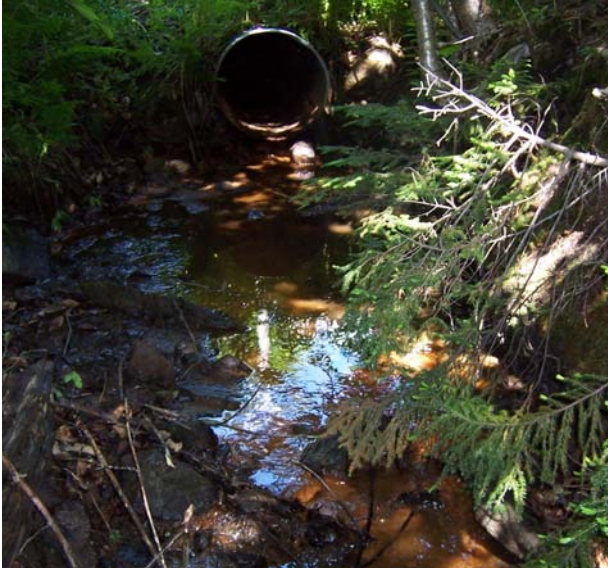
Photograph 13: The outlet from the sediment basin from the “E” and “F” parking lots has a rusted out culvert causing iron seepage and a sediment input into a small tributary of Roaring Brook.

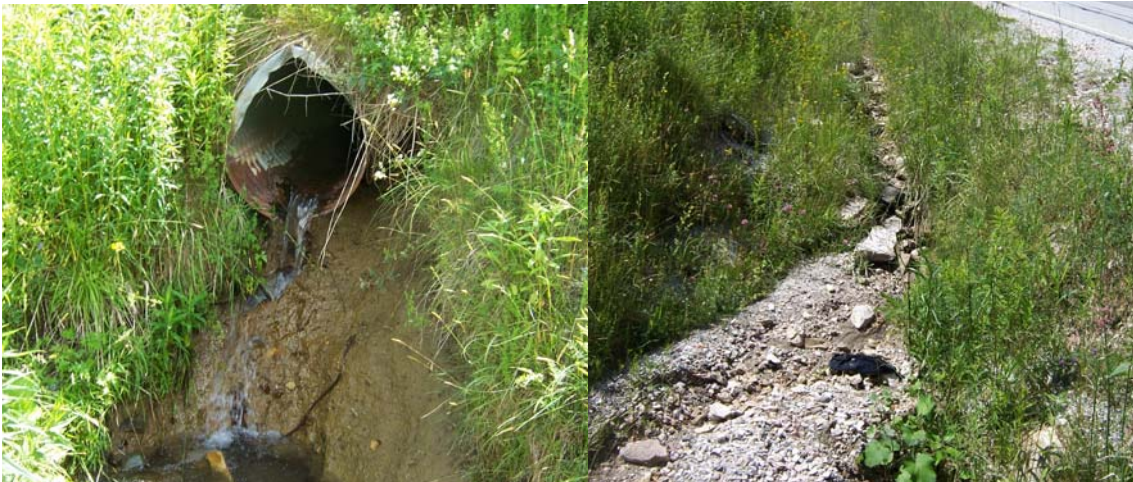
SOURCE #9

Photograph 14 and 15: On the east side of the Access Road, a rusted out perched culvert and gravel filled swale is conveying sediment into a small tributary of Roaring Brook.

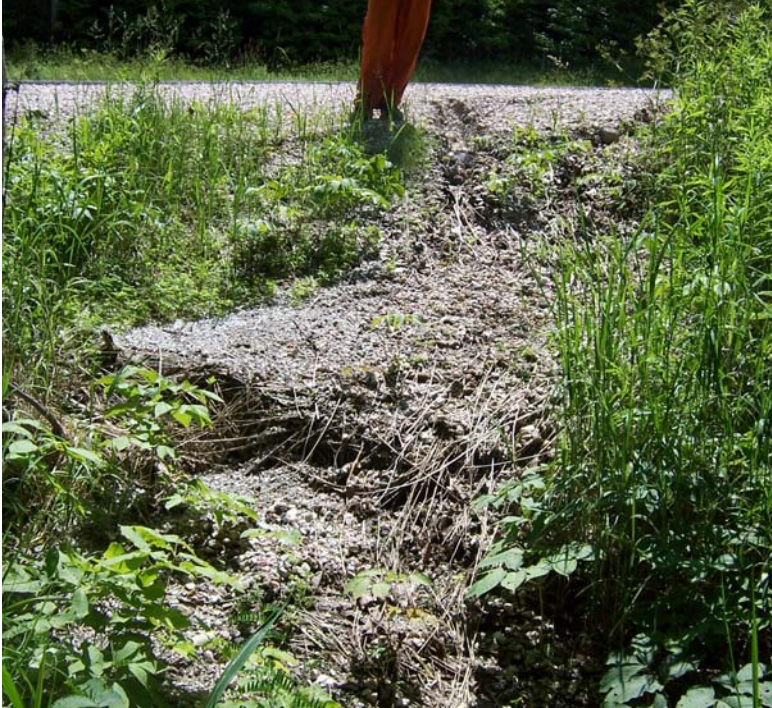
Photograph 16: Roadside gravel on the west side of the access road is washing down towards Roaring Brook.

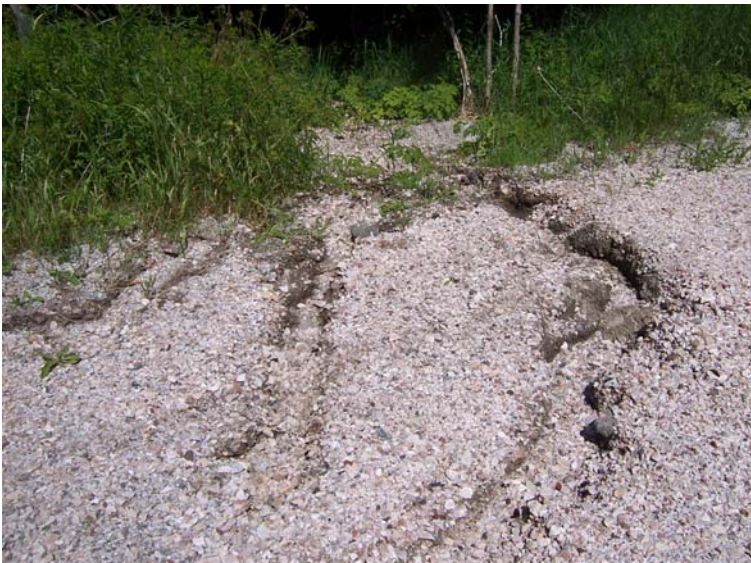
SOURCE #11

Photograph 17: Gravel is eroding off of a roadside bank down towards Roaring Brook on the west side of the access road.

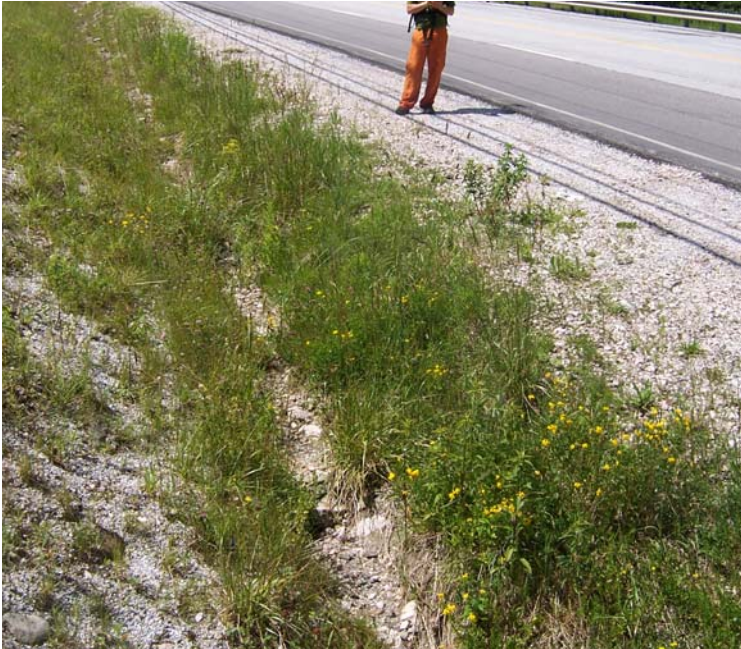
SOURCE #12

Photograph 18: A roadside swale along the east side of the access road is conveying fine sediment and gravel into a tributary of Roaring Brook.

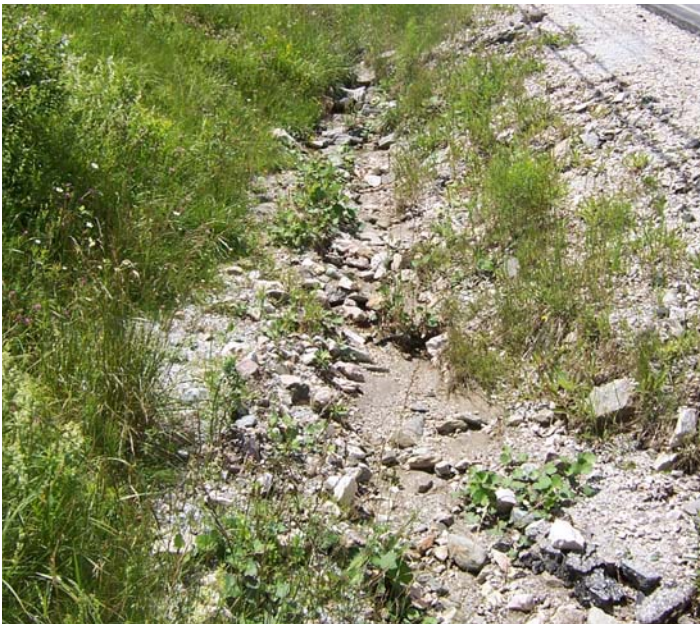
SOURCE #13

Photograph 19: A roadside swale leading to a culvert inlet (on the east side of the access road) is eroding and conveying fine sediment into to a tributary of Roaring Brook.

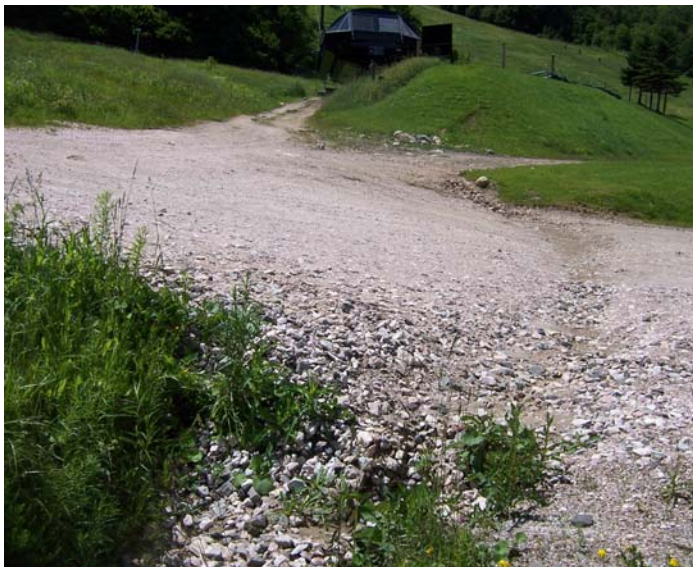
SOURCE # 14

Photograph 20: A culvert is needed at the confluence of several dirt roads and beginning of the roadside swale. Currently, road dirt/gravel washes into the swale and leading to a small tributary of Roaring Brook.

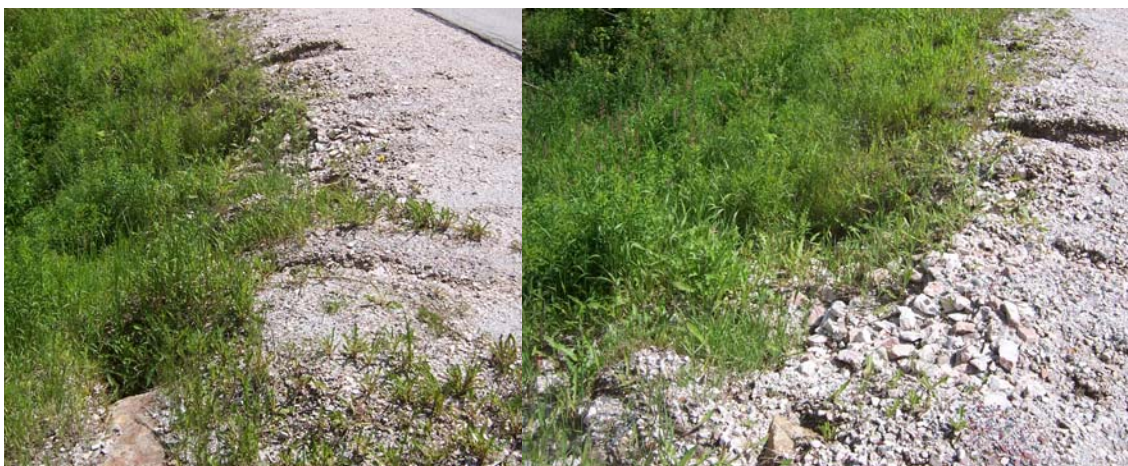
SOURCE #15

Photographs 21 and 22: The outfall on the river right of culvert “C-8’s” headwall is eroding. Rills are contributing road gravel and sediment into Roaring Brook.

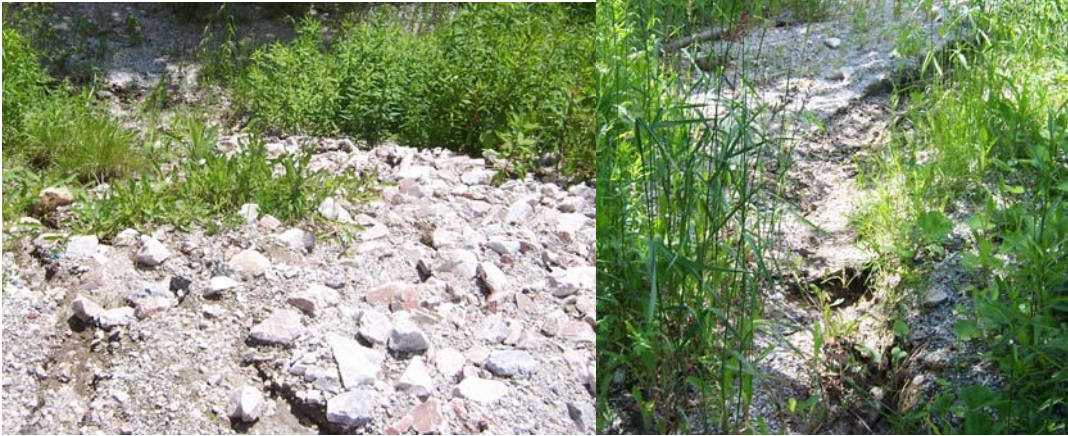
SOURCE #16

Photographs 23 and 24: There is an eroding, gravel and sediment filled tributary on the river left of Roaring Brook just downstream of culver "C-8" off of the Gondola Road. The tributary enters the woods and conveys sediment into the buffer and stream.

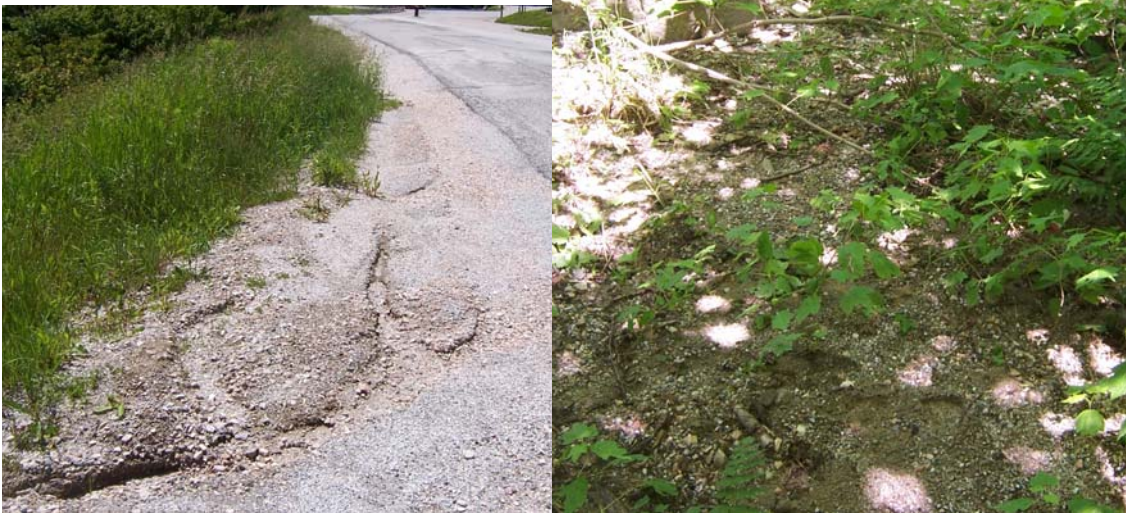
Photographs 25 and 26: There is eroding gravel off of the Gondola Road shoulder and into the riparian buffer of Roaring Brook.

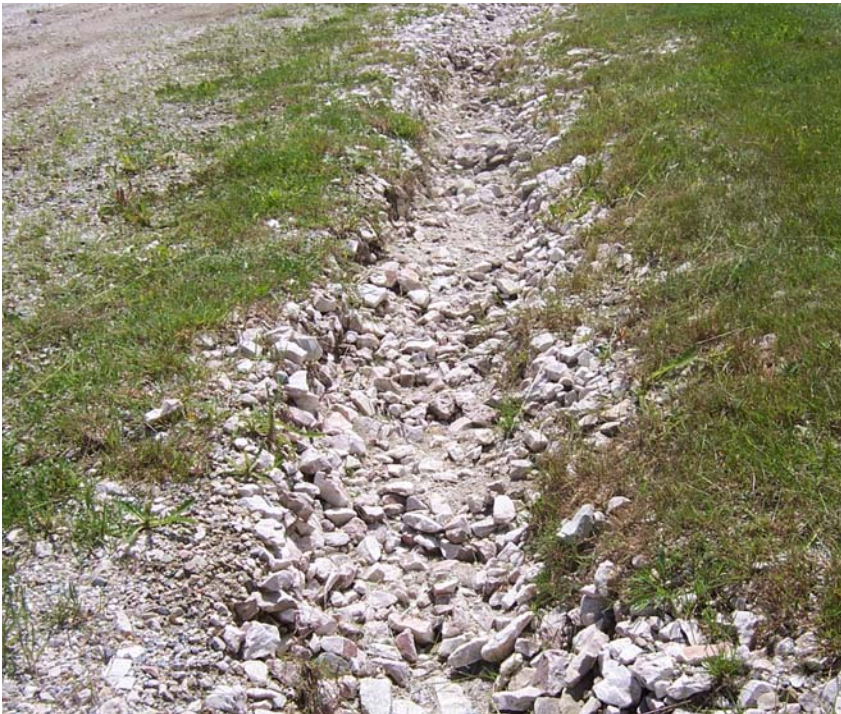
SOURCE #18

Photograph 27: There is an eroding swale located in the Gondola parking lot.

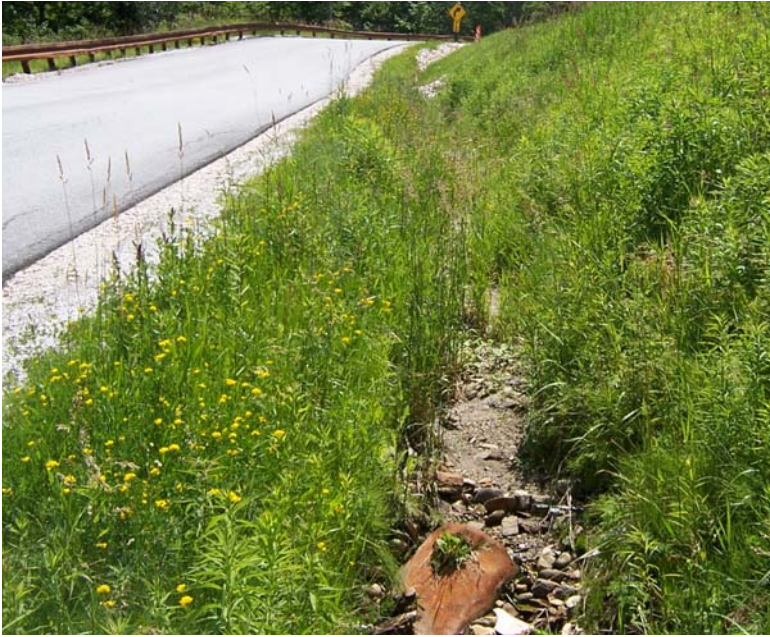
Photograph 28: Swale conveying sediment needs stone and check dams extended down to culvert “C-36”.

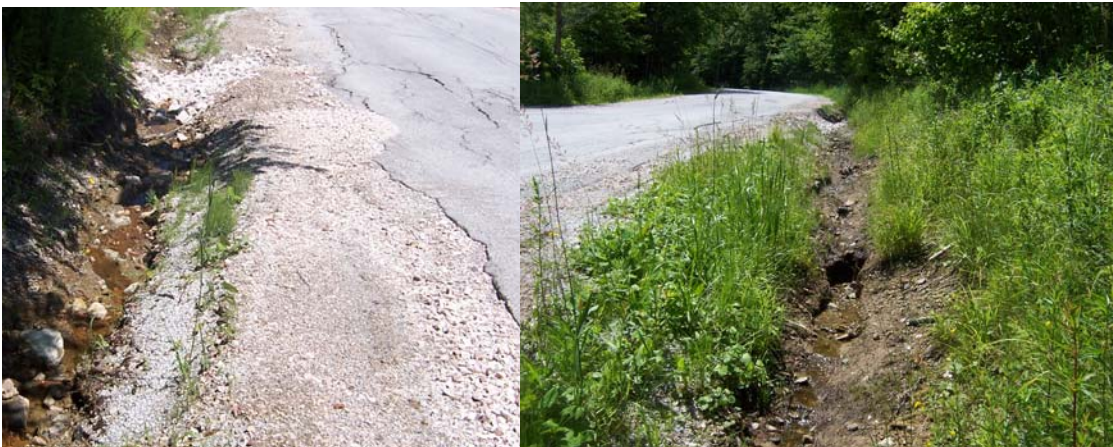
SOURCE #20

Photograph 29 and 30: Instable and eroding swale has clogged a culvert and is contributing sediment to Ram’s Head Brook.

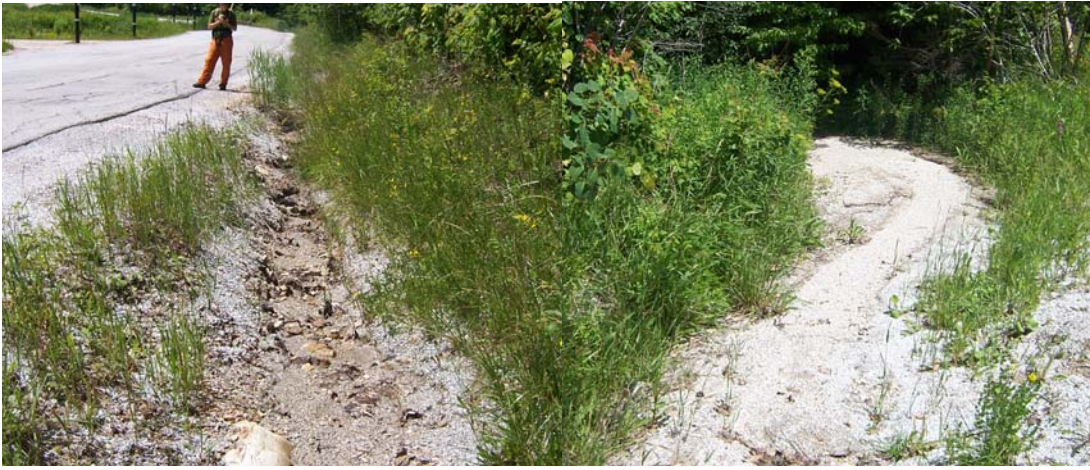
Photograph 31 and 32: Swale by "E" and "F" is instable and contributing gravel to the riparian buffer of Ram's Head Brook on river right.

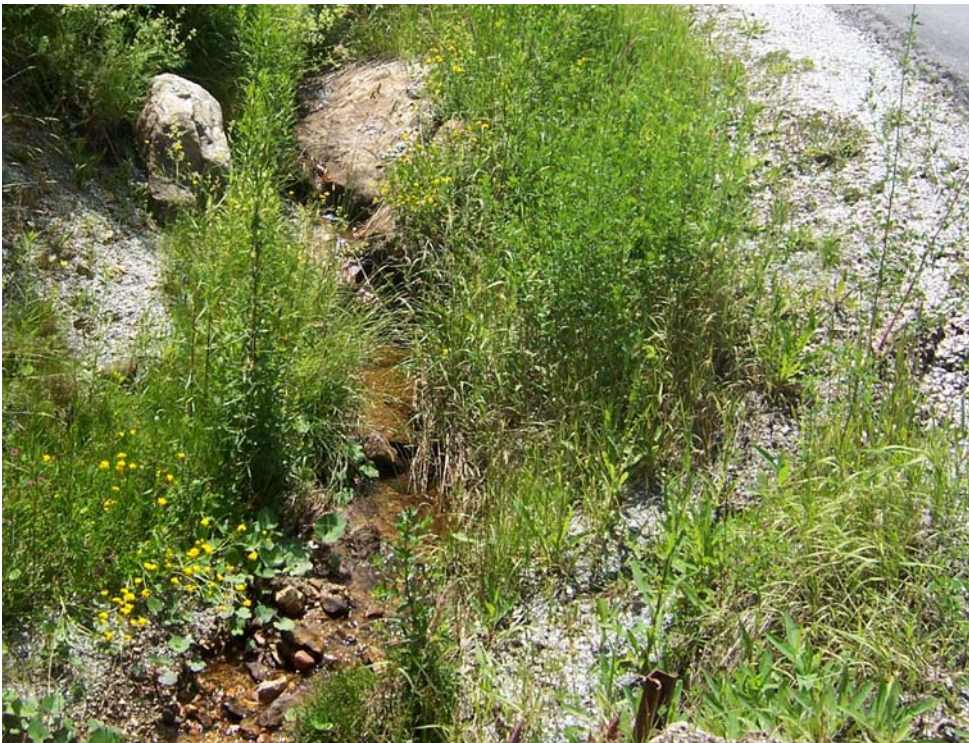
SOURCE #22

Photograph 33: Instable and eroding roadside swale US of culvert "C-40" on the east side of the Access Road.

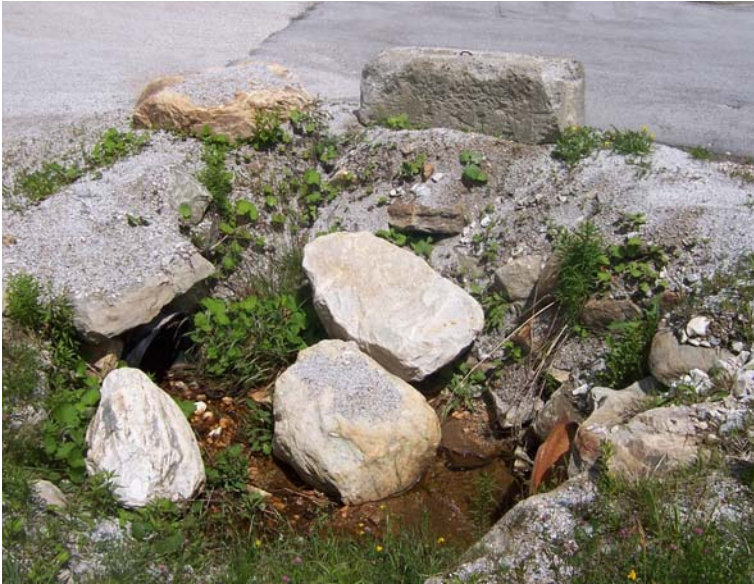
Photograph 34: Gravel is being washed into the day-lighted section of culvert "C-40".

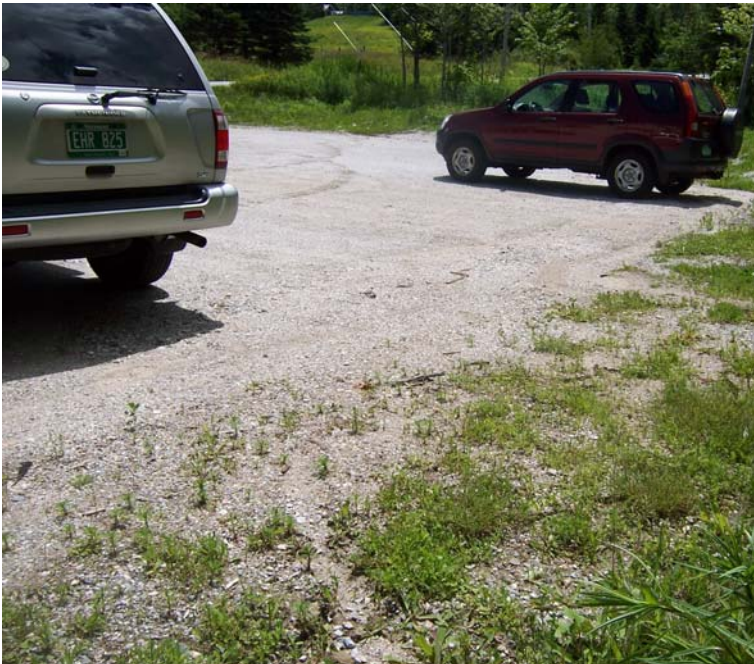
SOURCE #24

Photograph 35: Gravel parking lot has sediment running off into a swale from culvert "C-40" and into Roaring Brook downstream of weir.

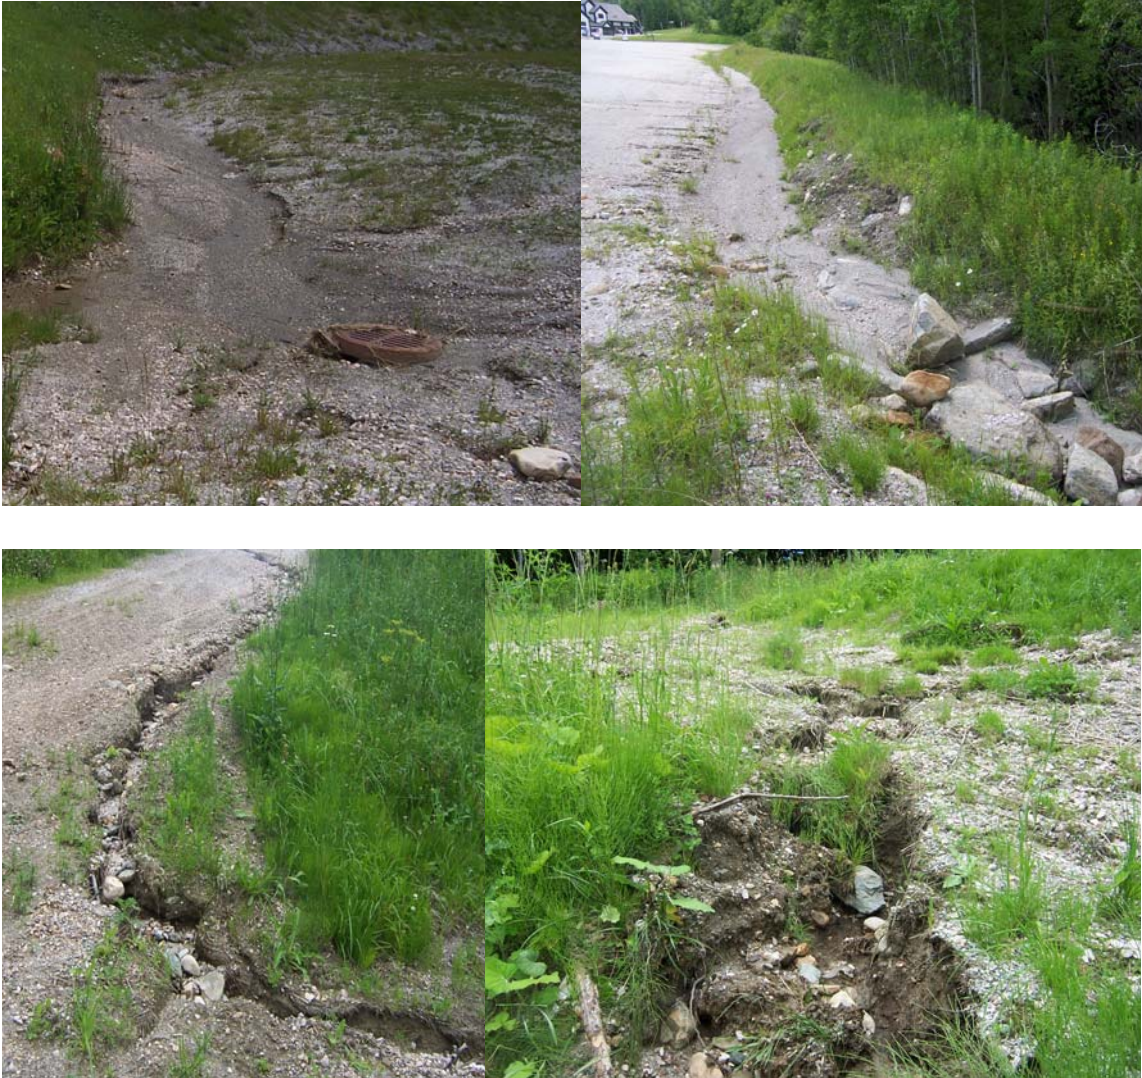
SOURCE #25

Photographs 36, 37, 38 and 39: These are several unstable and eroding swales overloading sediment to the Ram's Head stormwater basin from the Ram's Head parking lot (Photos 36 and 37) and basin access road (Photos 38 and 39).

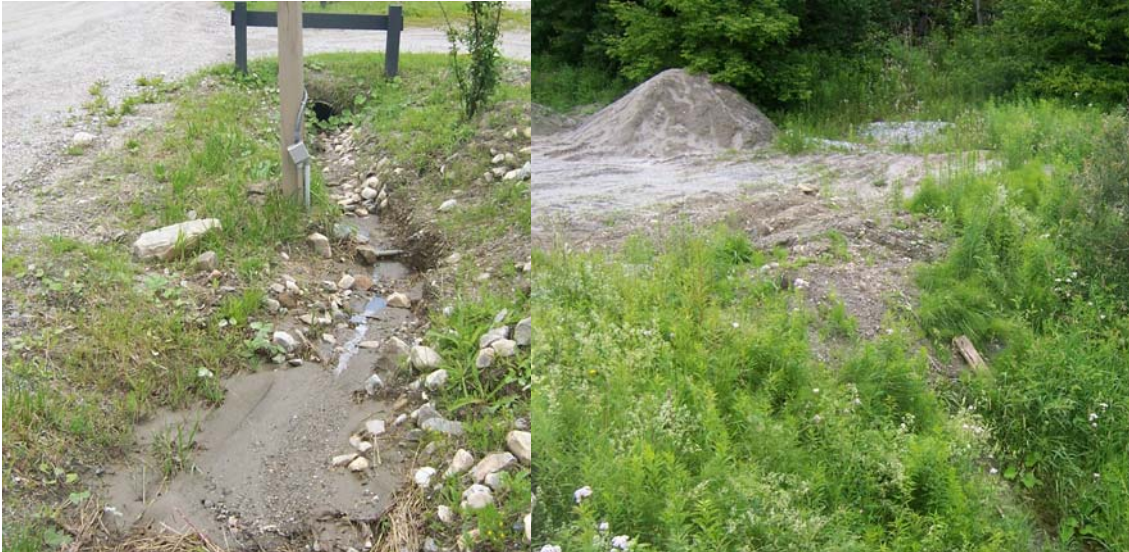
SOURCE #26

Photographs 40 and 41: Instable swale in the Mountain Green gravel parking lot and uncontained gravel/sand mound in north corner of parking lot – both conveying sediment to the Pinnacle Condo roadside swale (Photo 42).

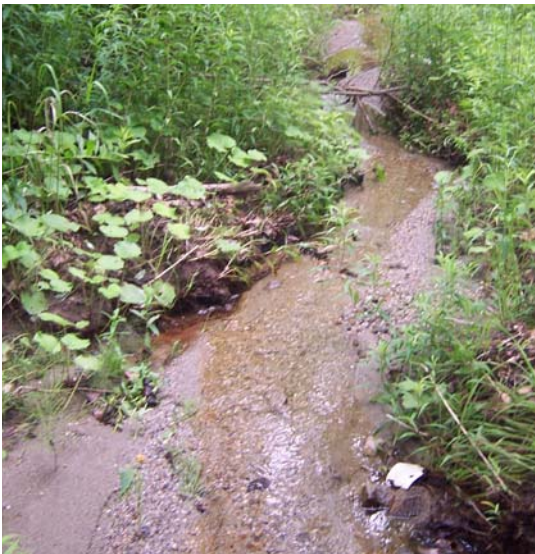
Photograph 42: The eastern branch of the Pinnacle Condo tributary and the roadside swale along the Pinnacle Condo Paved Road are both full of sediment.

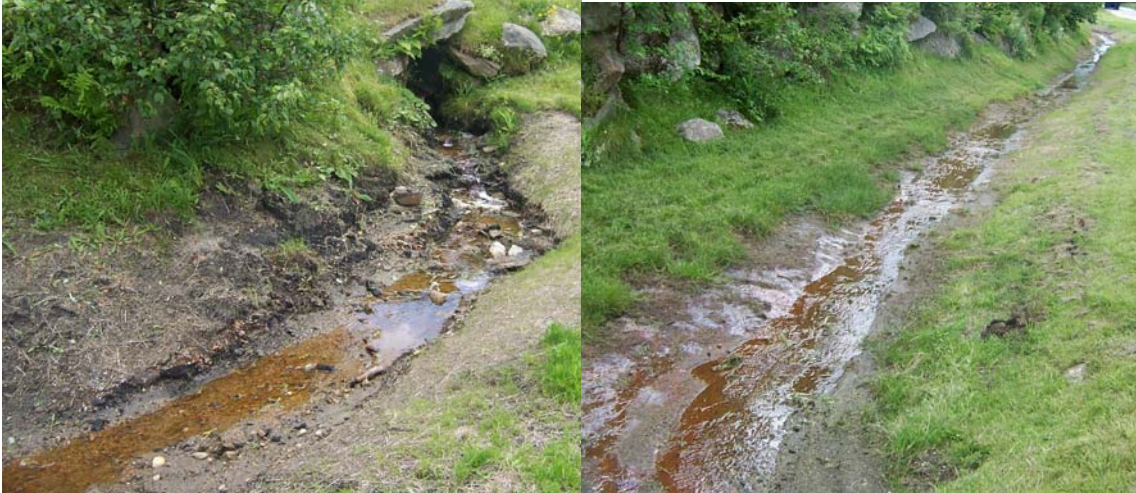
Photographs 43 and 44: The instable and eroding swale along Water Treatment dirt Access Road.

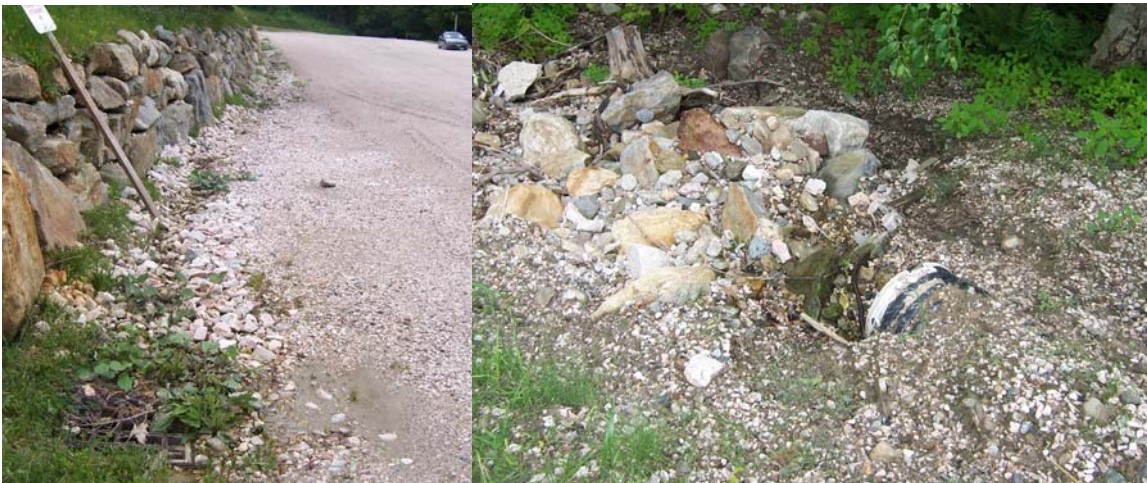
SOURCE 27

Photograph 45 and 46: The upper Whiffle Tree condo gravel parking lot (Photo 45) conveys sediment into a tributary of Roaring Brook via a storm drain. The outlet of the storm drain culvert is instable and eroding (Photo 46).

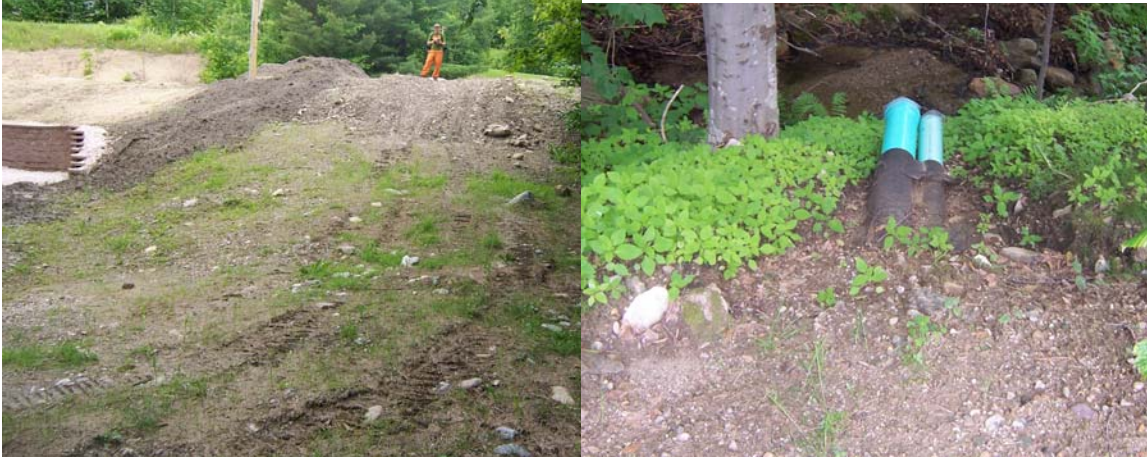
SOURCE 28

Photograph 47 and 48: The uncontained temporary soil disturbances in the lower Whiffle Tree Condo parking lot is conveying sediment to a tributary of Roaring Brook at the culvert outlet (Photograph 48).

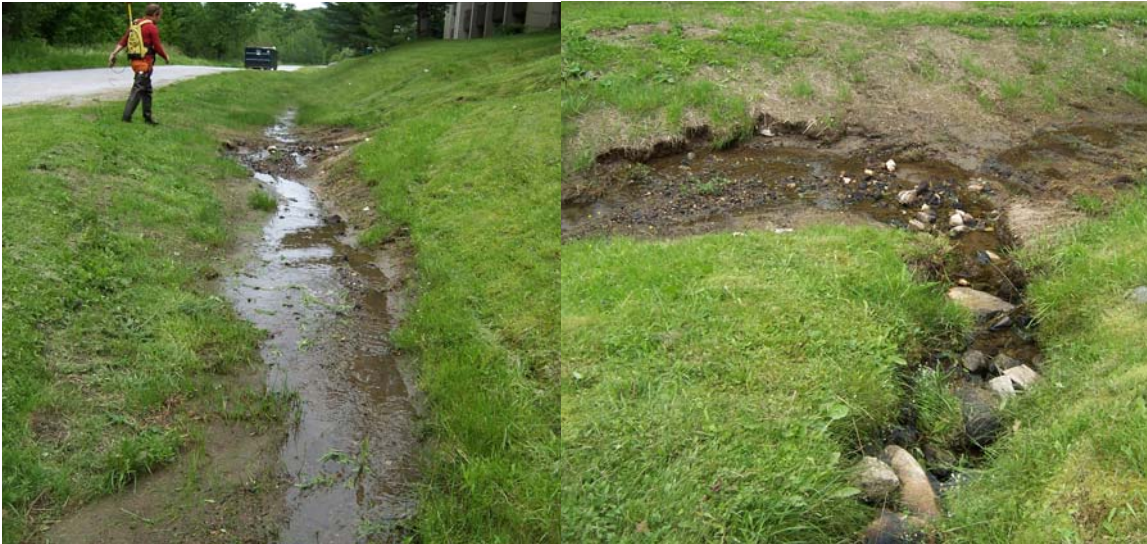
SOURCE 29

Photographs 49 and 50: A sediment filled tributary to Roaring Brook was followed upstream and ended in this eroding swale at the north corner of the Pinnacle Condos.

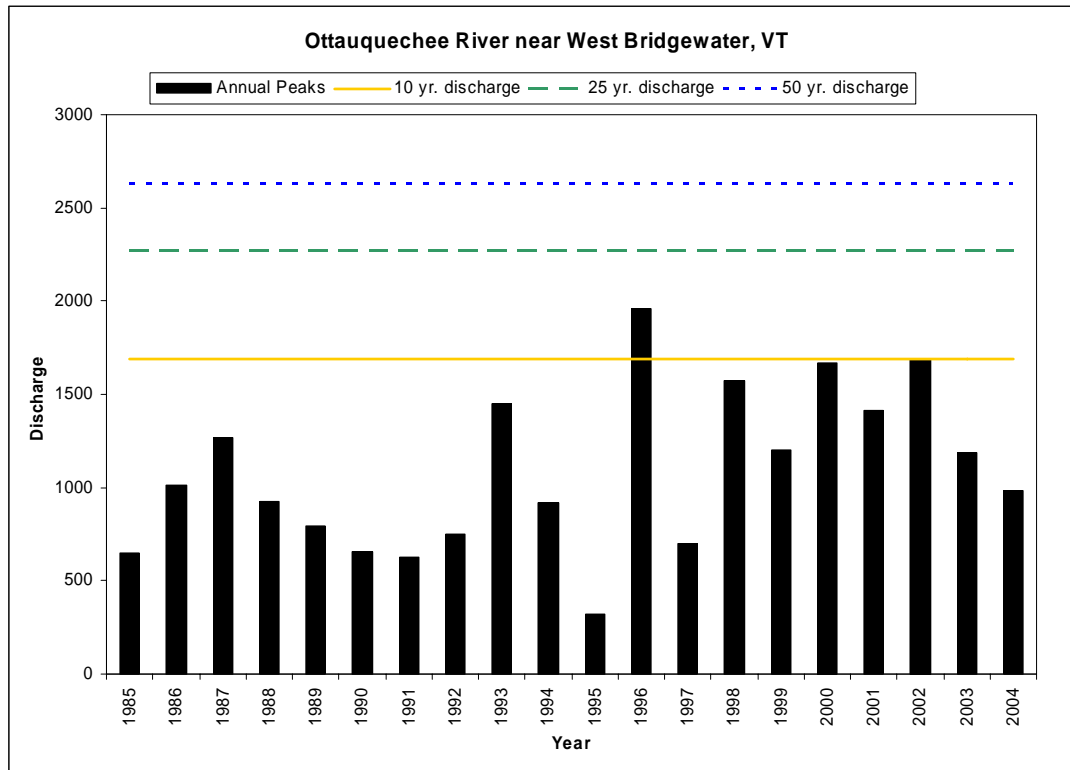
Figure 4. Annual Peak Discharge for Ottawaquechee River near West Bridgewater, VT.

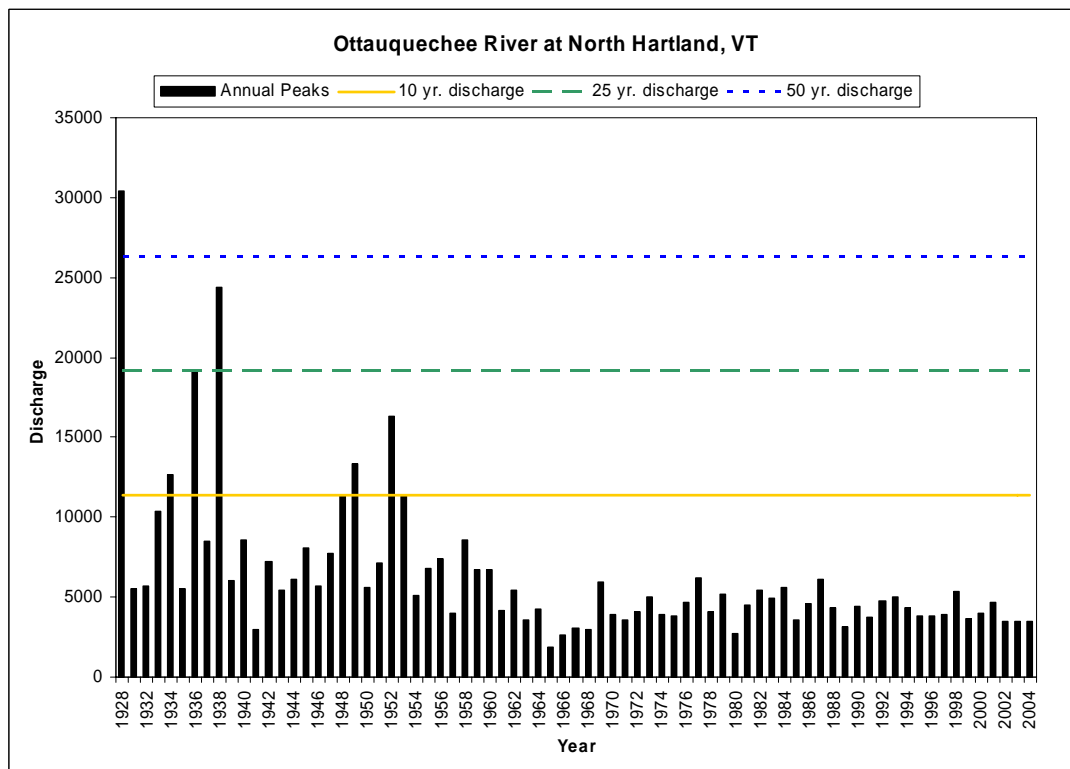
Figure 5. Annual Peak Discharge for Ottawaquechee River at North Hartland, VT.

To get a longer period of record for the area, the USGS gage on the Ottauquechee River in North Hartland, VT (gage #01151500) was also obtained. The drainage area at this gage is 221 square miles. The gage provides a continuous record of flow from 1927 through the present. The USGS indicates that the data from the North Hartland gage is affected by regulation or diversion. The long term record (see Figure 5) shows peak discharges for 1948 and 1953 were at the 10 year recurrence interval. The peak flows for 1934, 1949, and 1952 were between a ten year and 25 year recurrence interval. 1936 was approximately a 50 year recurrence interval, while water year 1928 exceeded the 50 year recurrence interval.

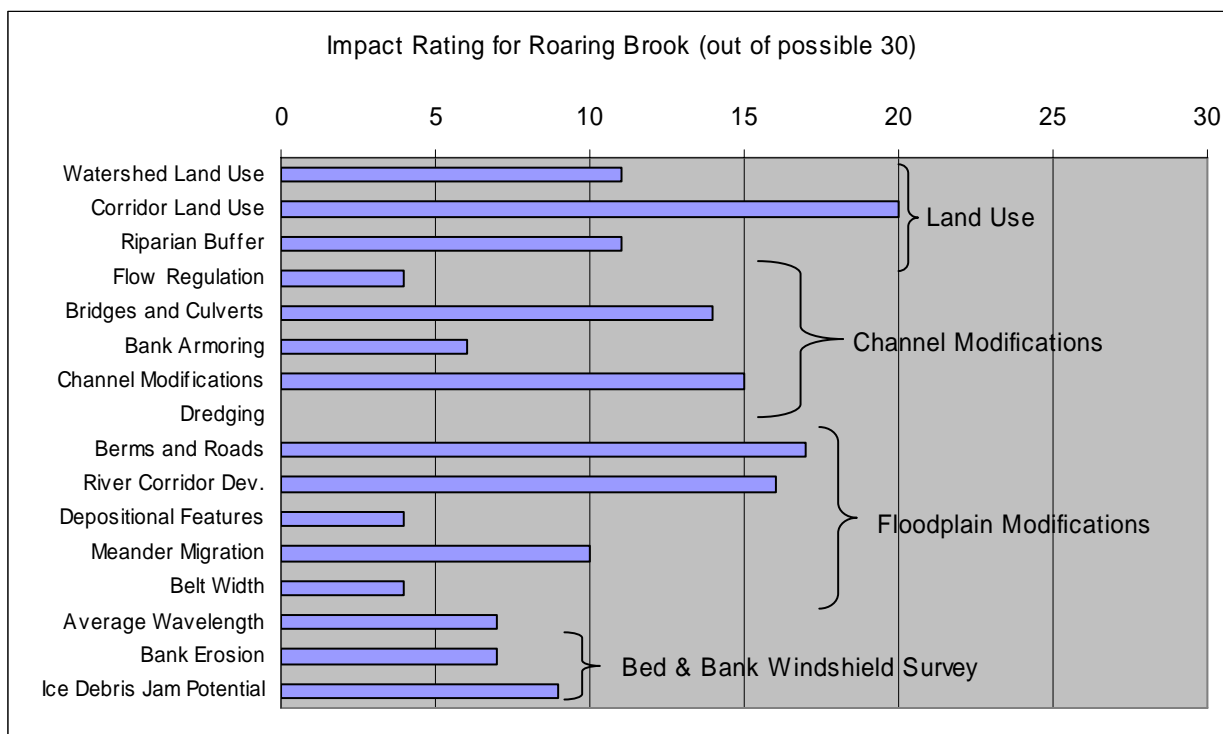
Figure 9: Impact Rating for Roaring Brook Watershed by Parameter and Category

The Phase I evaluates parameters that may cause channel adjustment. These parameters are grouped into four major categories: land use, in-stream modifications, floodplain modifications, and bed and bank windshield survey. For each parameter, the maximum impact score for the entire watershed is 30 (15 reaches times impact score of 2). As shown below in Figure 9, the corridor land use parameters in the land use category received a high impact rating for the watershed. The parameters berms and roads, river corridor development and channel modifications also resulted in high scores.
