Roaring Brook and East Branch of Roaring Brook
Water Quality Remediation Plan Update 2011
Killington, Vermont

**ROARING BROOK AND EAST BRANCH
OF ROARING BROOK WATER QUALITY
REMEDATION PLAN UPDATE 2011**

***MTB KILLINGTON, LLC, AMSC
KILLINGTON, LLC, SP II RESORT, LLC
& SP LAND COMPANY, LLC***

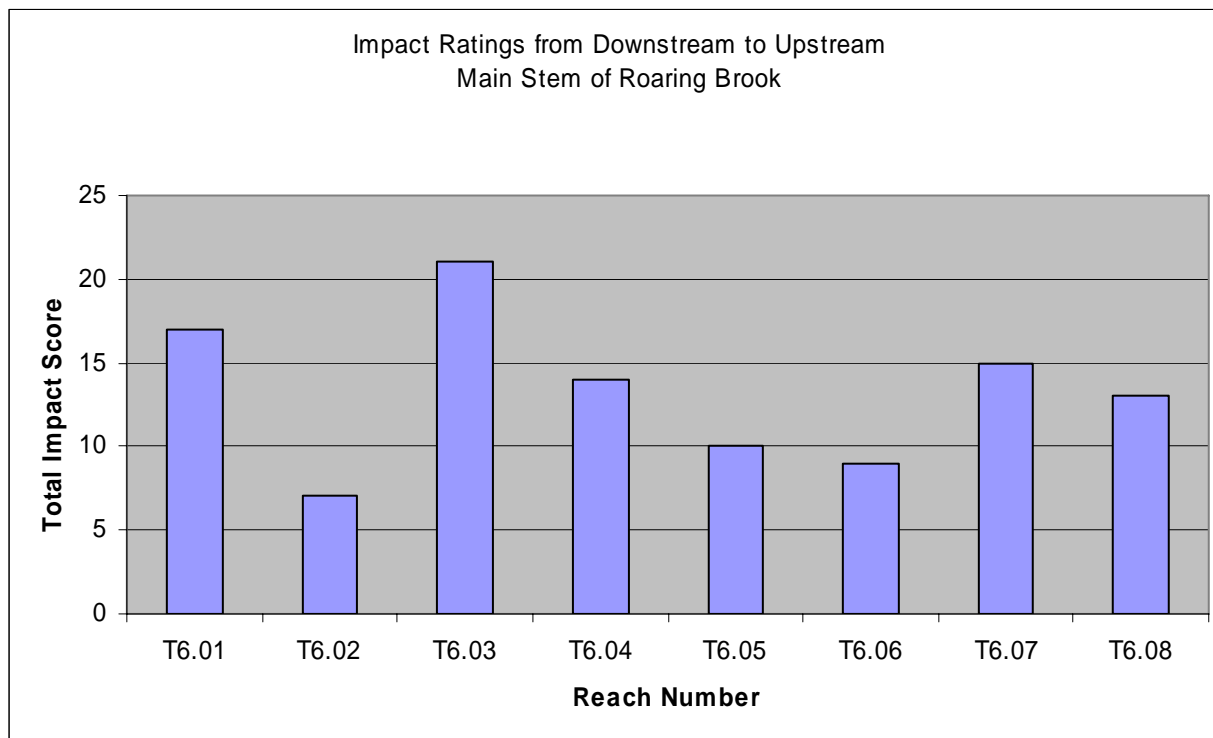
Figure 11: Impact Ratings from downstream to upstream on the main stem of Roaring Brook

Figure 11 shows that the Phase I reach condition is generally related to proximity of roads or development. For the most part, the reaches rated as reference by the DMS were confined streams that require narrower belt widths. The reaches rated as fair or poor were typically unconfined streams located in the more highly developed areas of the watershed.

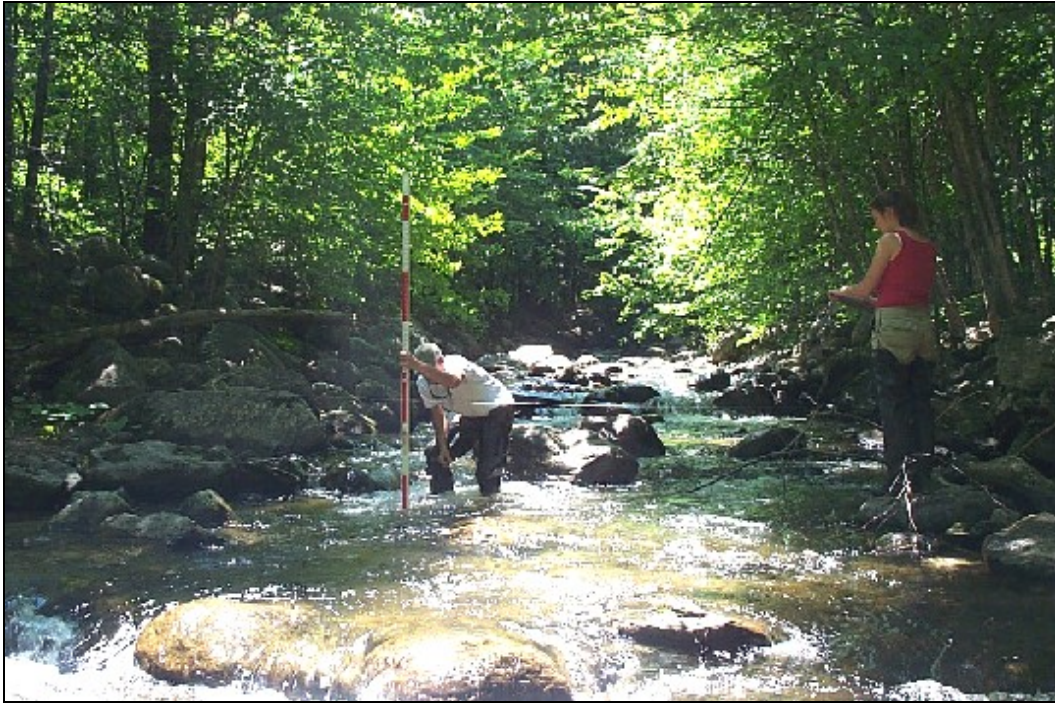
Figure 12: T6.01-A was historically straightened and has become a plane bed stream. Note the high rock berm on the left side of the photograph that was used by a past landowner to prevent the river from accessing its floodplain.

Segment T6.01-A is the first reach in Roaring Brook. It begins at the confluence with the Ottauquechee River and continues upstream to a bridge crossing with VT Route 100. This reach drains the entire Roaring Brook watershed, an area of 5.6 square miles. The historic land use in segment T6.01-A has reverted back to forest and the reach currently has a healthy riparian buffer and a closed channel canopy. This segment is a "C" channel with a plane bed form. It has been significantly influenced by historic channel straightening and dredging and berming (windrowing) which occurred many years ago. The incision ratio of this reach, 1.35, indicated historic channel degradation. As shown below in Figure 12, the incision, along with the large berms and boulders that armor both banks, has eliminated floodplain access for most of this reach. Widening and planform adjustment also appears to have been limited by the bank armor. The straightness of the reach creates effective transport of sediments. Minor aggradation is occurring throughout much of the reach until the confluence of the Ottauquechee River, (Figure 13) where a large depositional feature exists.

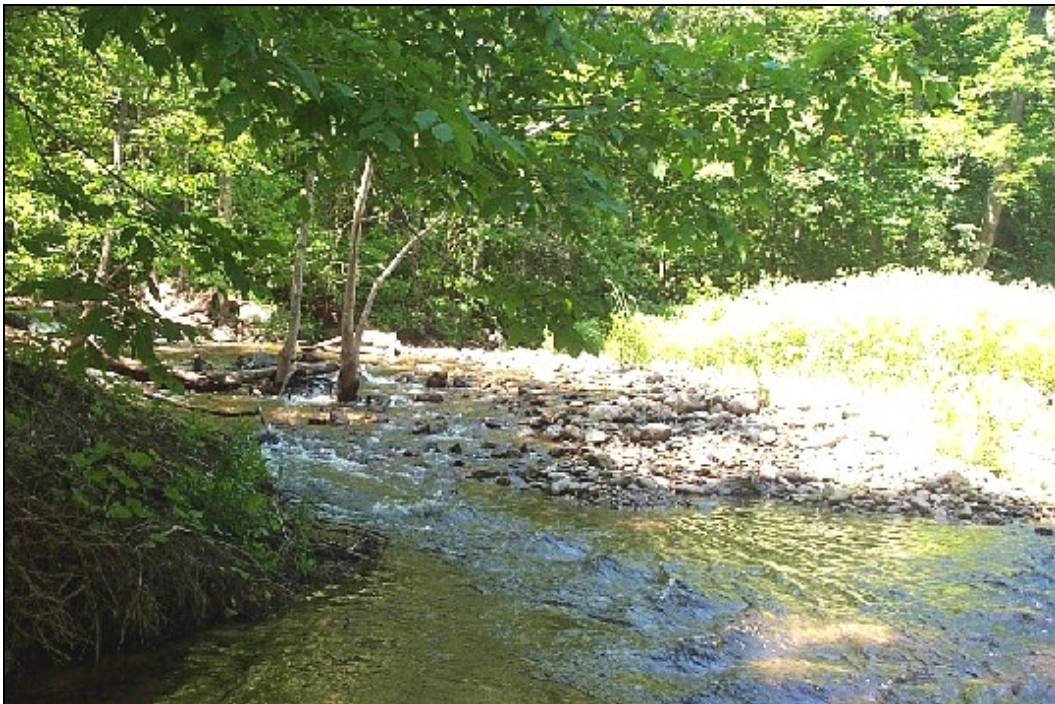
Figure 13: Large depositional feature (delta) at the confluence of Roaring Brook and the Ottauquechee River.

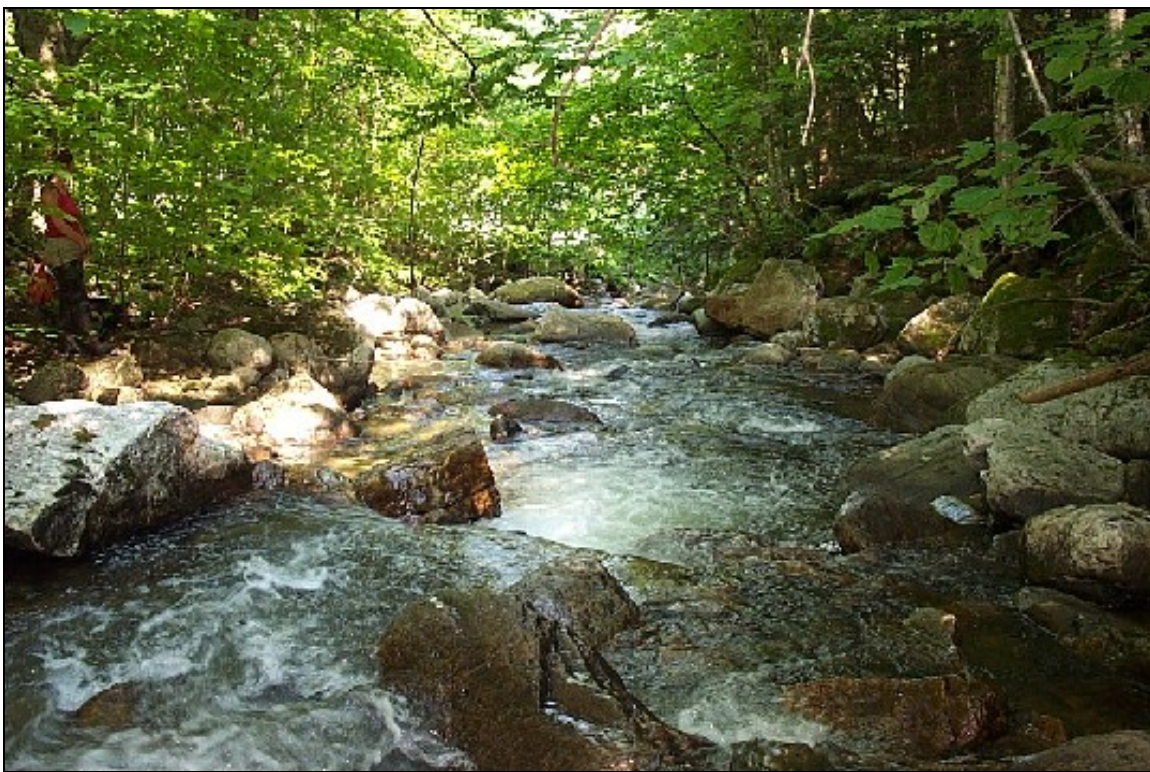
Figure 14: Segment T6.01-B has a step-pool bedform and good riparian conditions.

Segment T6.01-B is also a “C” type channel, however with bedrock grade control at the downstream end and a more natural planform, this segment has retained its bedform as a step-pool system. Despite grade control at the lower end of this reach, there appears to have been some incision that has occurred. The incision ratio measured was 1.61. Minor aggradation and widening was also found to be occurring within this reach. Riparian conditions along the stream were generally excellent, with a closed riparian canopy (see Figure 14) except near the bridge crossing of VT Route 4.

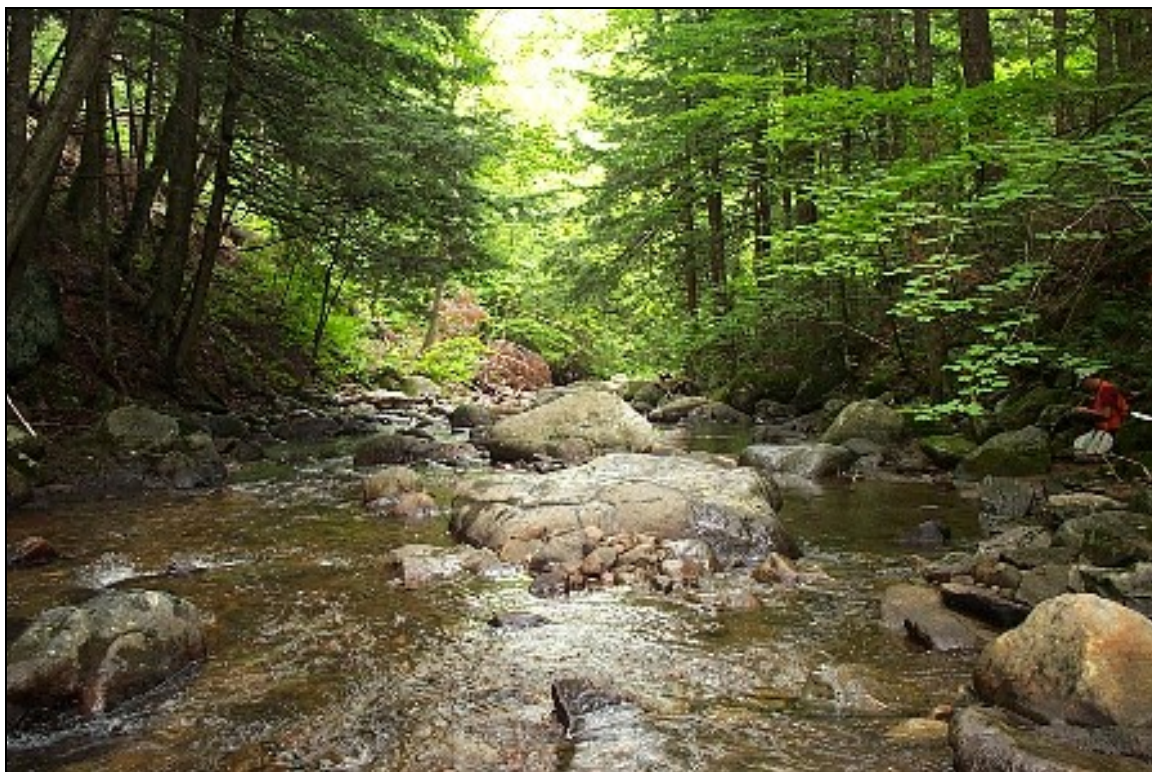
Figure 15: T6.02 is a naturally wide, highly entrenched channel with excellent riparian conditions.

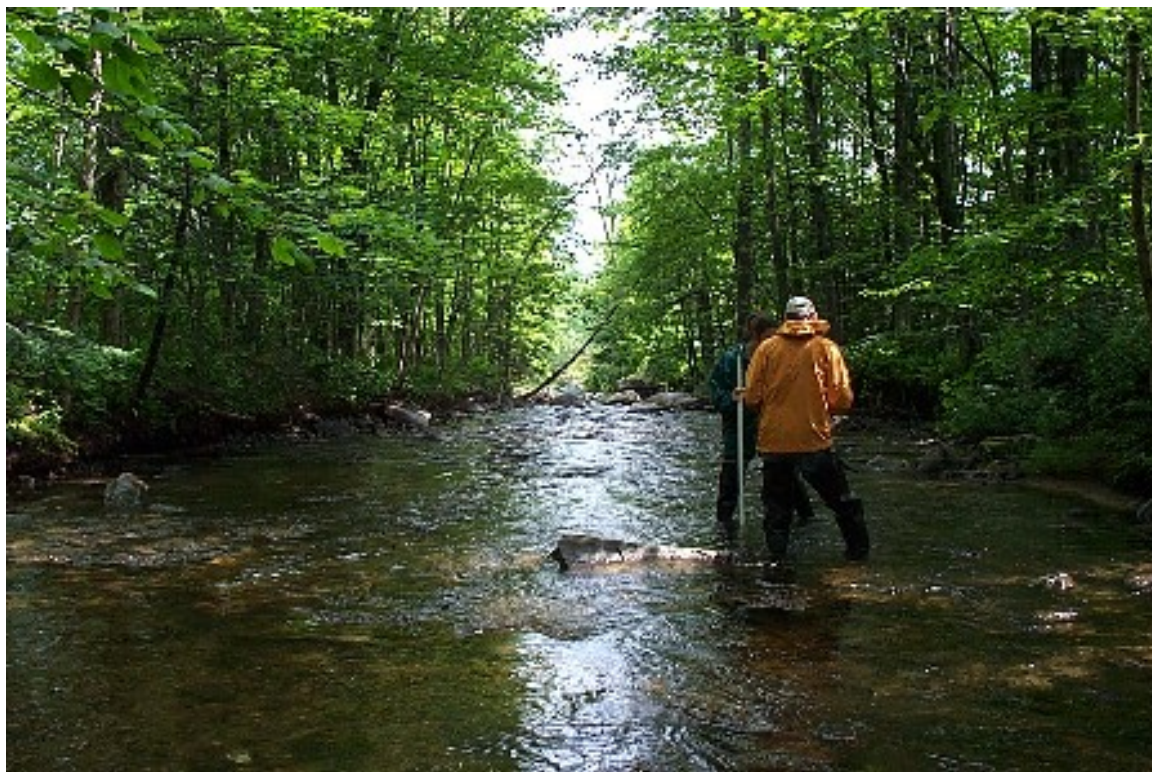
Figure 16: Active aggradation and widening of Reach T6.03.

entrenched. This reach is the first reach that has been greatly affected by commercial development in the stream corridor and appears to have been historically straightened in some areas. Twenty-five to fifty percent of the banks have been armored with rock rip-rap and log revetments. The riparian buffer of both banks, which averages between 25 and 50 feet, has been significantly disturbed by human activities. Three stormwater outfalls empty into this reach. The combination of these human encroachments, historic channel straightening, and other effects have caused some major degradation to occur. An incision ratio of 1.6 was measured in the field. It appears that the stream is currently undergoing minor aggradation (fine particles made up 32% of the pebble count) and widening in response to these impacts (Figure 16).

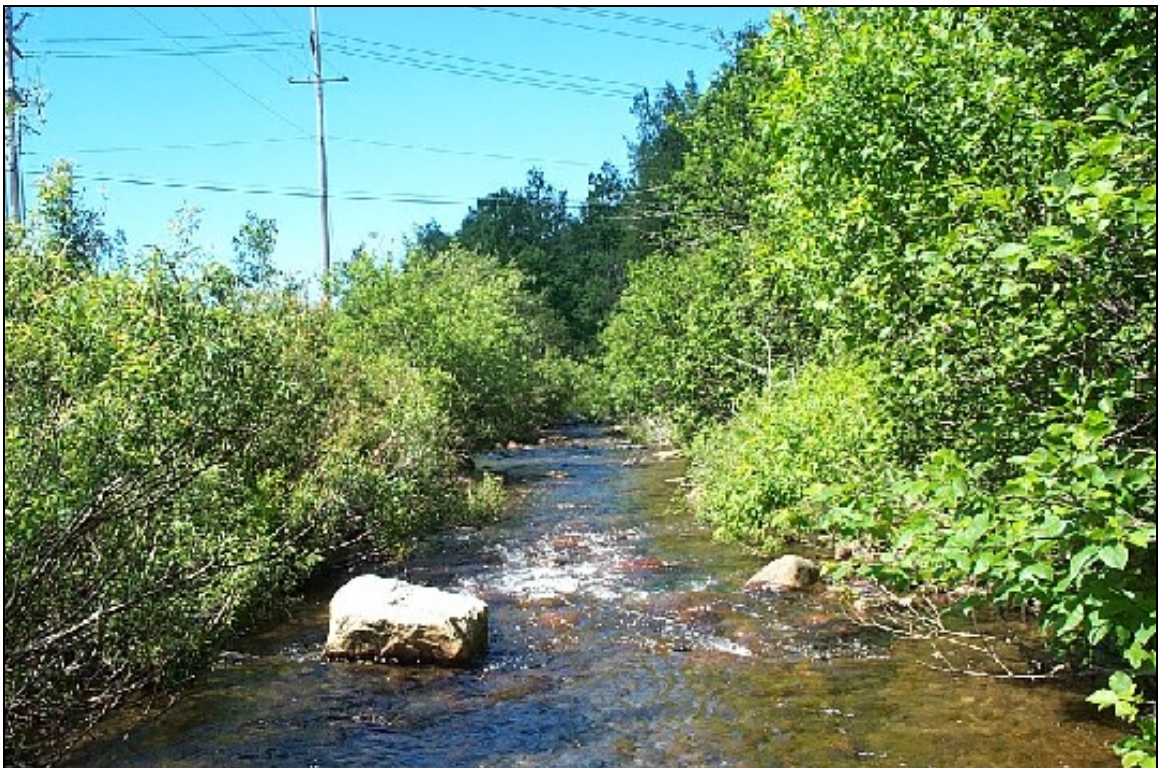
Figure 17: Typical cross-section along reach T6.04 with weak riffle-pool bedform. The brook has historically incised and is showing some evidence of channel widening.

Killington golf course. This reach has also been impacted by historic channel straightening and floodplain encroachment. The current incision ratio was measured to be 1.8, indicating major historic degradation. There was some evidence of current widening as the river attempts to rebuild a new lower floodplain bench. However, it remains wide and shallow, and is a slightly entrenched “C” type channel with a weak riffle pool bedform (Figure 17). T6.04 is actively responding to sediment which is being stored in the form of point and side bars. One active flood chute and an island were noted along the reach indicating that the reach is also undergoing minor planform adjustment. This planform adjustment, however, is limited by the Killington Access Road and the Killington Golf Course which have encroached on the historic floodplain of this reach, effectively changing the valley width by cutting off access to westward channel planform migration. The current riparian corridor is dominated by commercial buildings on the left bank and residential buildings along the right valley wall. The left bank would benefit from riparian buffer restoration as it is dominated by only a 5-25 foot wide buffer. Three stormwater outfalls empty into this reach.

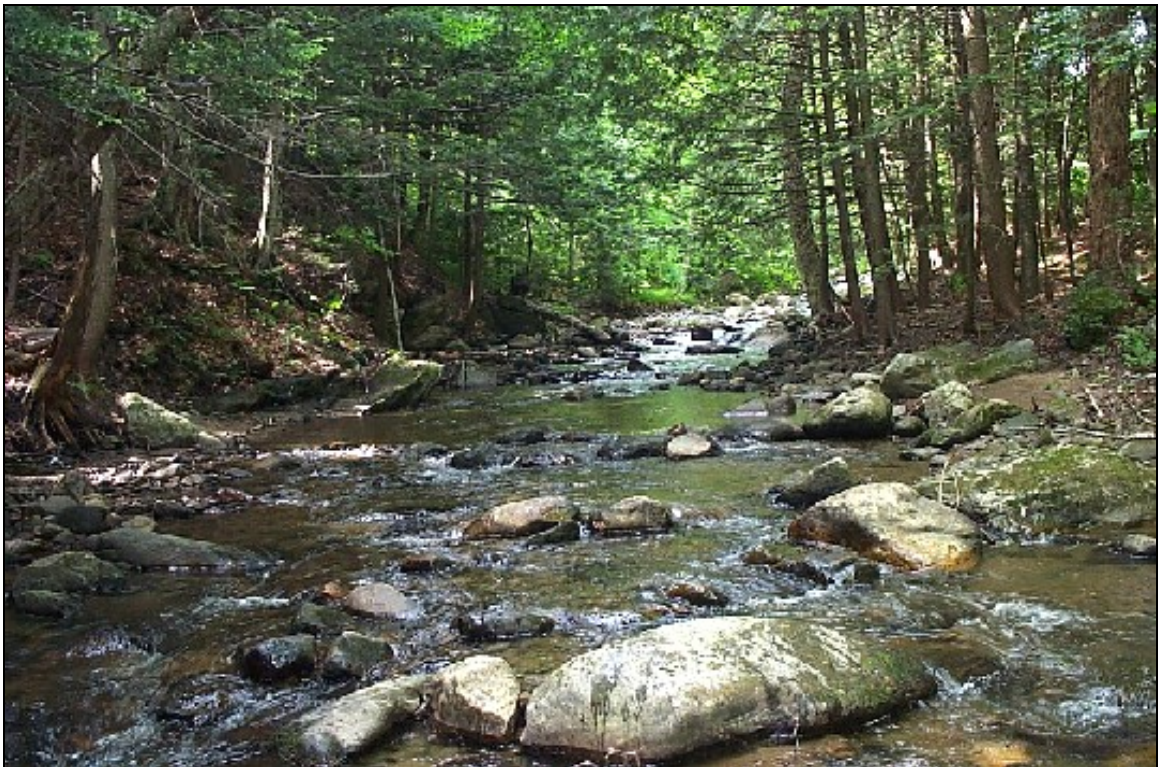
Figure 18: Reach T6.05 has no major adjustment processes occurring. It was likely cobble dominated by reference but is currently dominated by coarse and fine gravels.

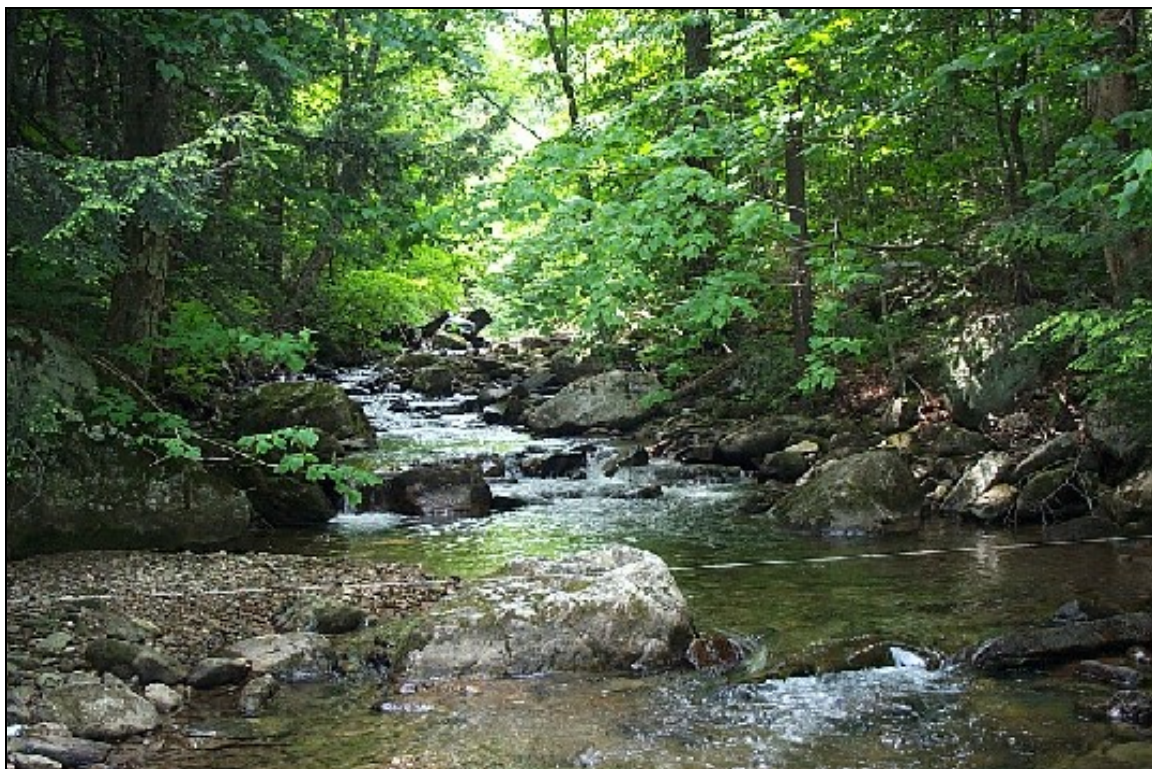
Figure 19: Typical cross-section along reach T6.06. Deposits of gravel (left side of photo), are common throughout this reach.

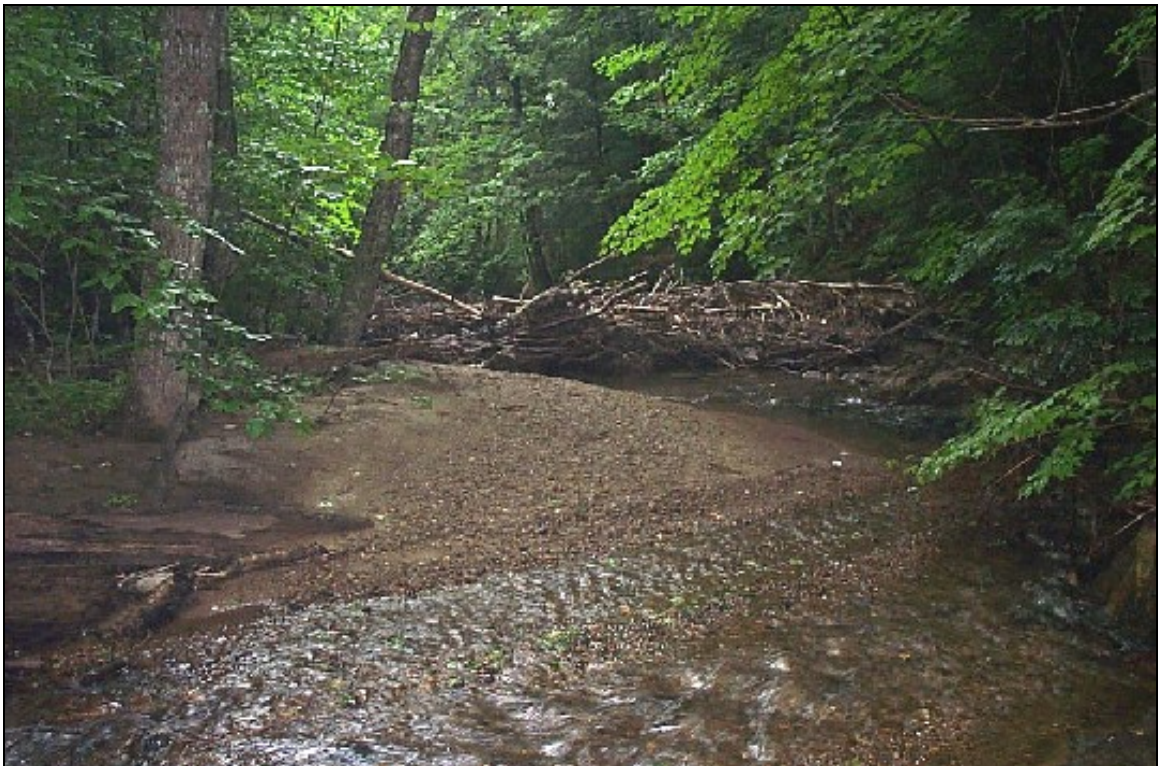
Figure 20: Major sediment buildup at a debris jam along T6.07.

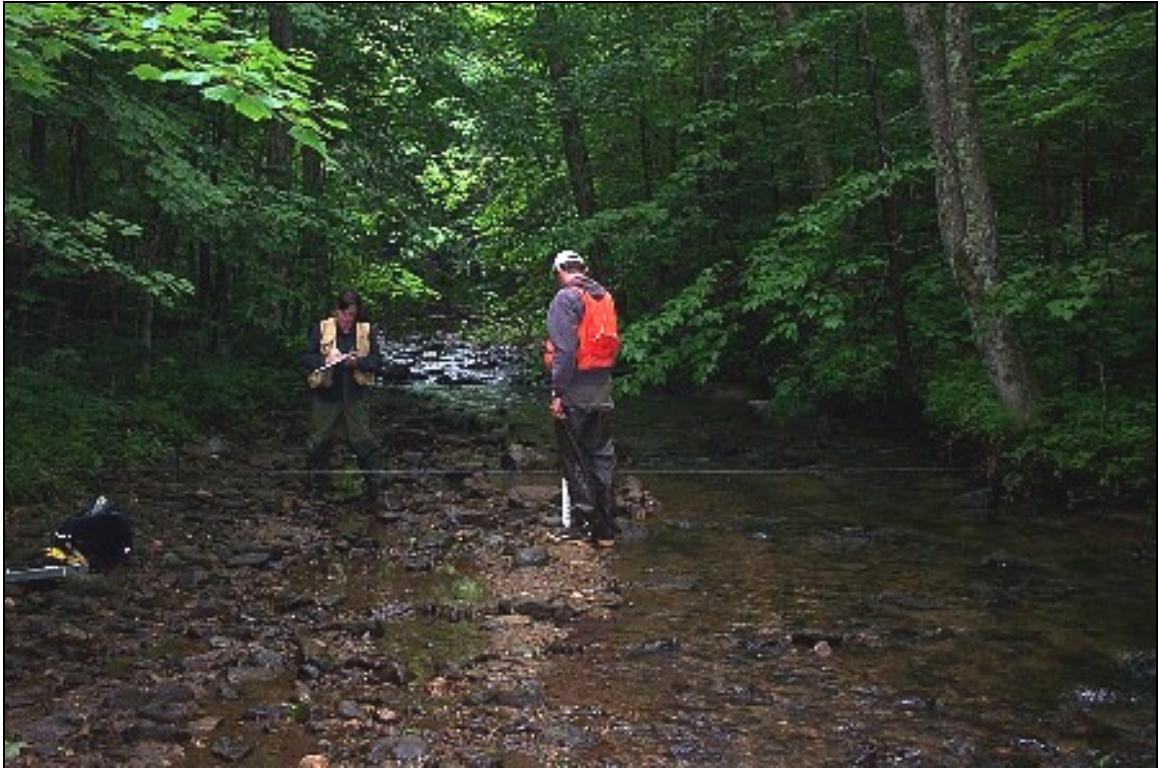
Figure 21: Typical cross-section along reach T6.07. Note the abundant fine sediment that has filled in much of the stream bottom. Habitat in this reach was rated as fair due to excessive sediment and lack of deep pools.

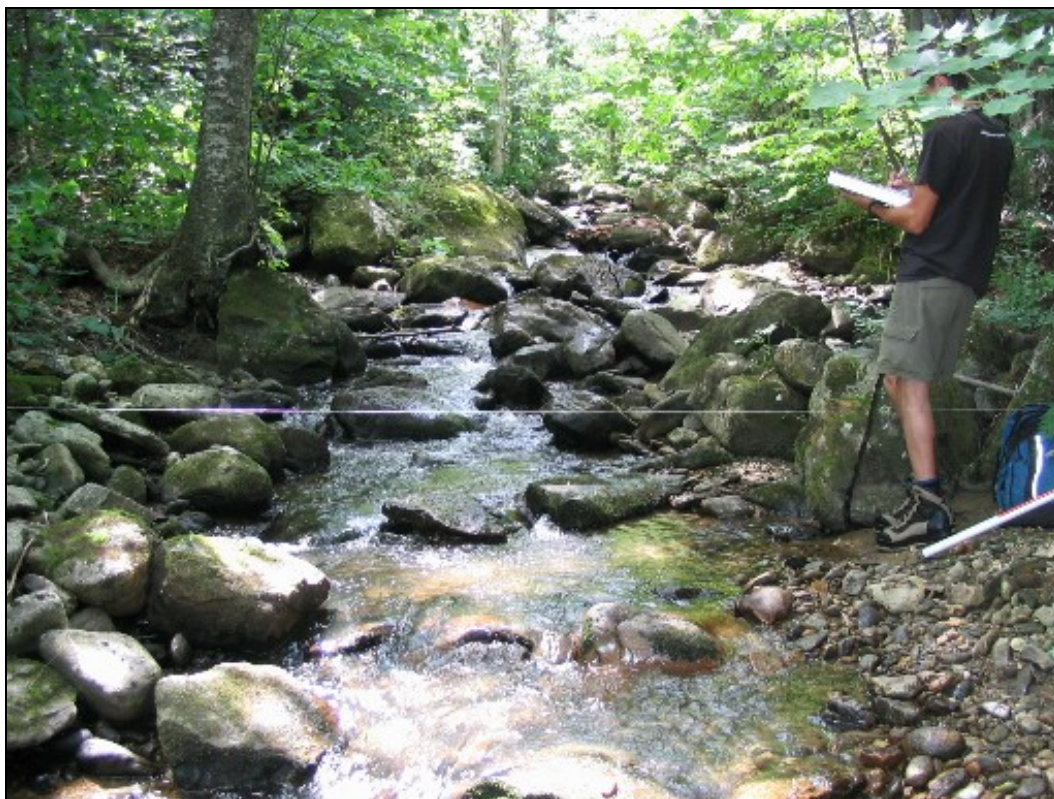
Figure 22: Typical cross-section along reach T6.08.

Reach T6.08 is the highest reach assessed in the Roaring Brook. It begins above the Ram's Head parking lot at elevation 2250 feet and continues under the Killington base lodge upstream to elevation 2640 feet. T6.08 drains a watershed area of only 1.1 square miles. Like most reaches surveyed on the Roaring Brook, T6.08 is slightly incised with an incision ratio of 1.31 (see Figure 22). As shown in Figure 23, the channel is actively adjusting through major aggradation and widening. This step-pool system has one mid channel bar and several side bars indicating abundant sediment in the channel. Habitat within reach T6.08 has been greatly impacted by stormwater runoff. Seven stormwater outfalls drain into this reach bringing allochthonous sediment into the system. Wash off from the Killington Access Road was noted to be a significant contributor of sediment to the upper Roaring Brook watershed. Large gullies, draining road runoff, were noted along Reach T6.08, and pools were filled in with road materials.

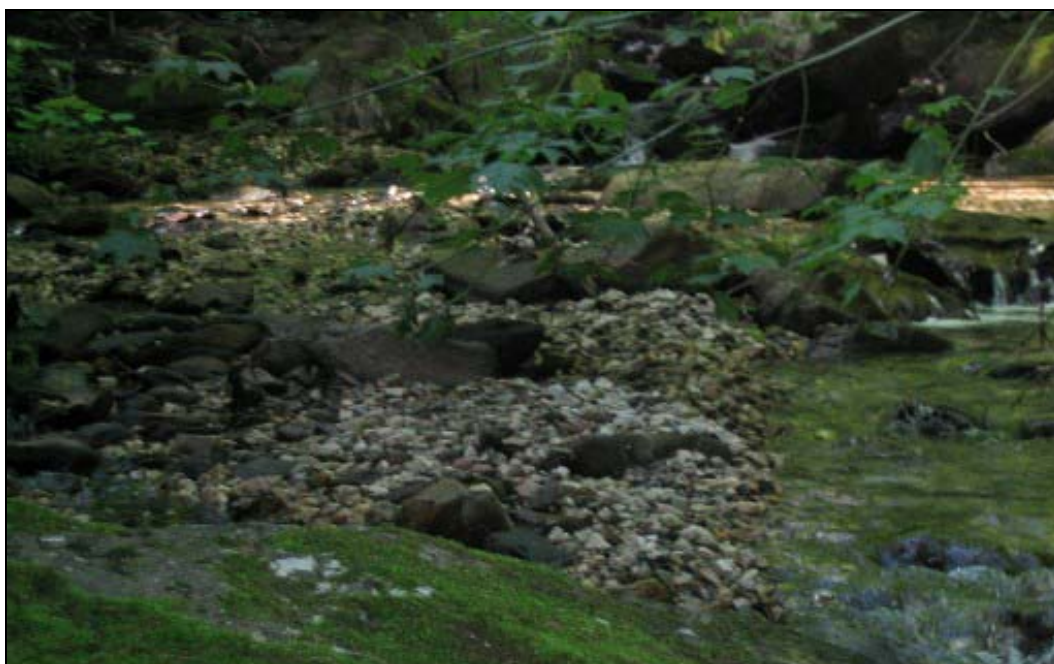
Figure 23: Abundant road gravels and sediment are entering the Roaring Brook system at Reach T6.08.

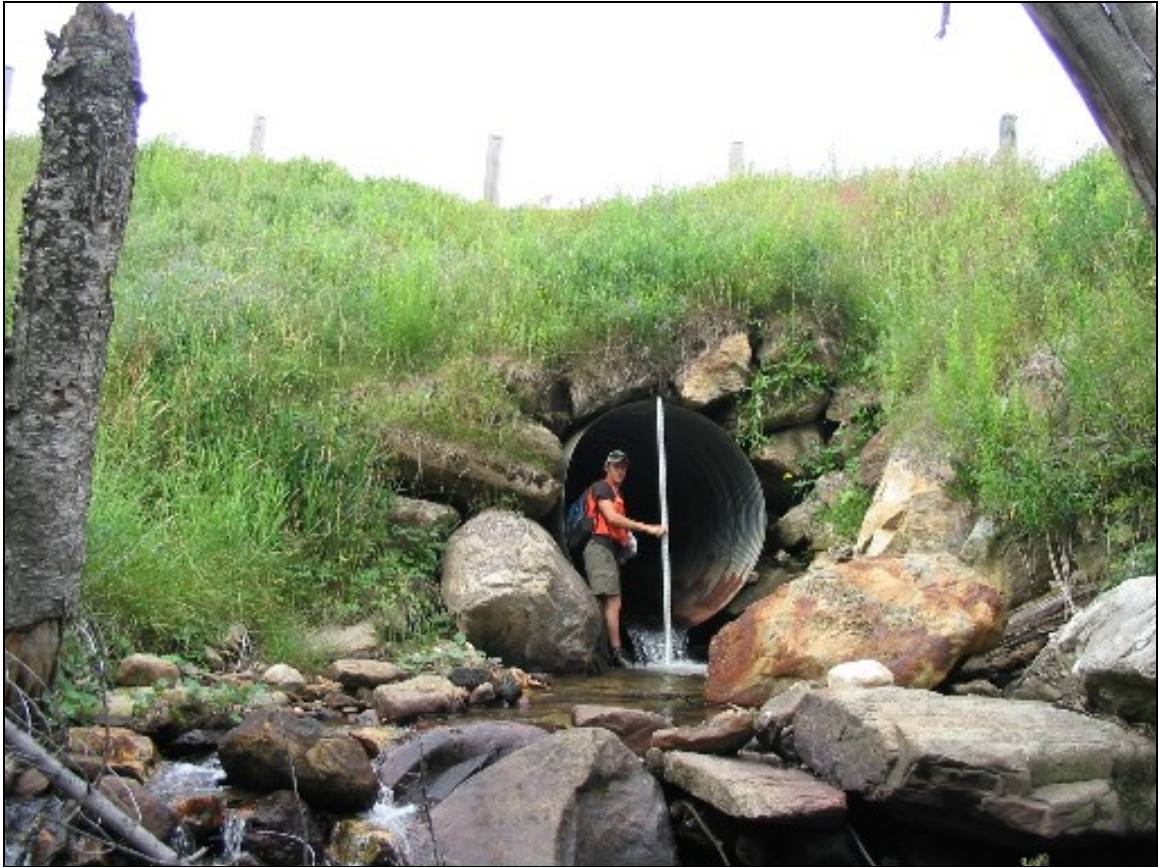
Figure 24: Undersized culverts, like this one on reach T6.08, disrupt the sediment transport capacity of the stream and often lead to both upstream and downstream destabilization.

These morphologic changes tend to migrate both upstream and downstream contributing to system-wide instability. (Ryan 2001)

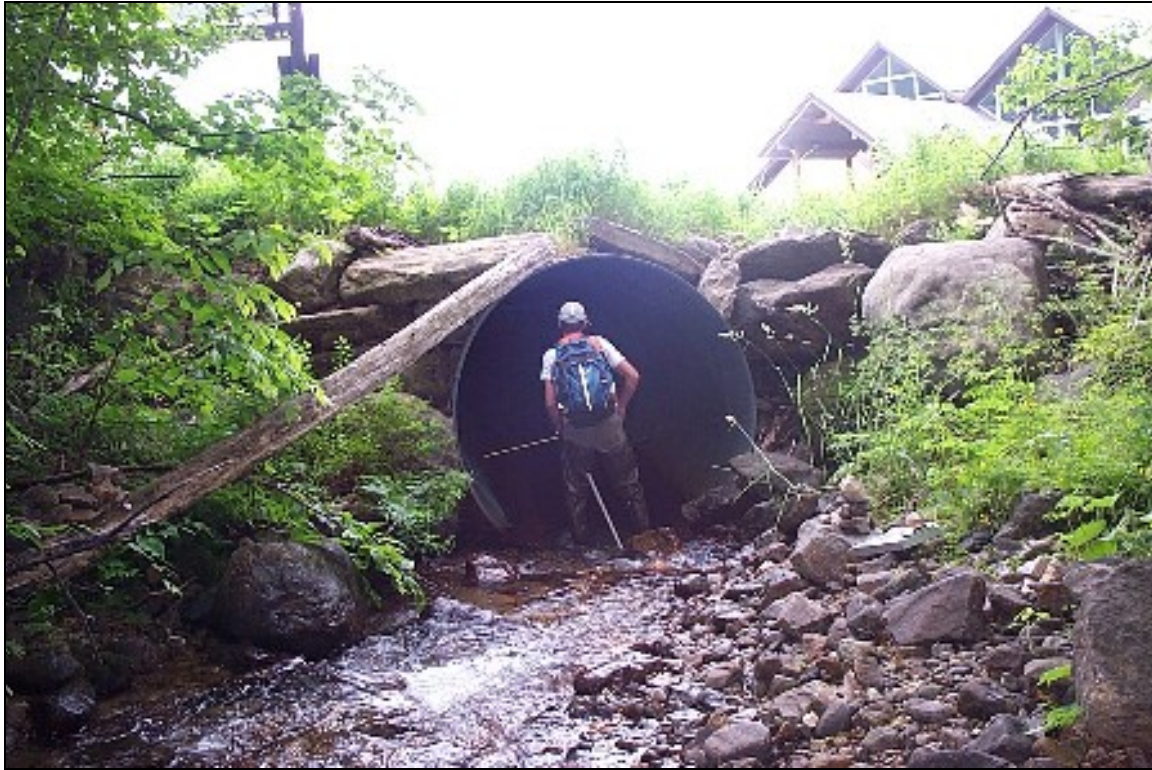
Figure 26: Reach T6.07 rated “fair” for habitat. The reach lacked in-stream woody habitat, riparian vegetation, a riffle-pool system due to historic straightening, and was heavily embedded with fine particles of sand.

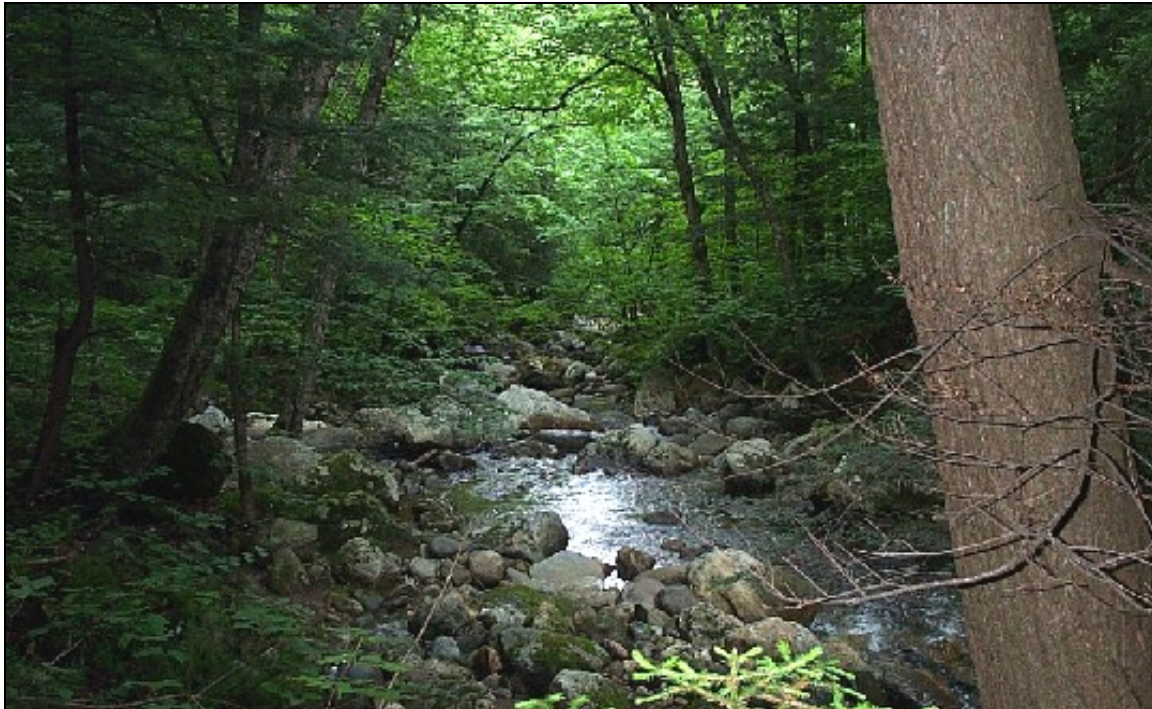
Figure 27: Reach T6.02 rated “good” for habitat. The reach had an abundance of in-stream woody habitat, excellent riparian vegetation and riparian buffer, a diversity of substrates, and a diversity of velocity and depth patterns including many deep pools.
