Re: The Stratton Corporation
Stratton, Vermont
Stratton Water Quality Remediation Plan ("SWQRP")
2015 Annual Performance Report

CERTIFICATE OF SERVICE – STRATTON WATER QUALITY REMEDIATION PLAN 2015 ANNUAL PERFORMANCE REPORT

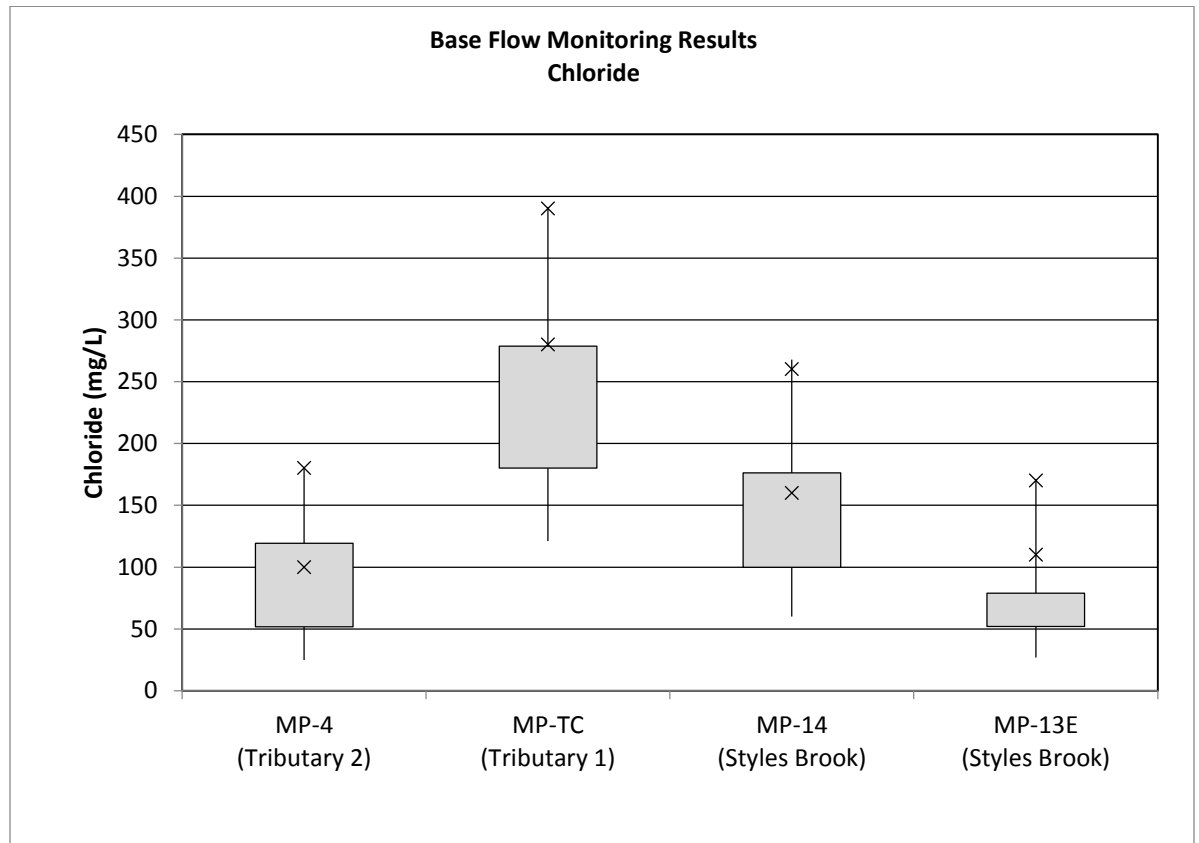
Figure 1: Base Flow Monitoring Results for Chloride

Base Flow chloride values recorded in 2015 were higher than historic average values at all of the stations sampled. Monitoring stations MP-14 and MP-TC both had grab sample results that were above the VWQS chronic criterion of 230 mg/L, with station MP-TC recording values of 280 and 390 mg/L respectively in 2015. Additional monitoring of the streams in Tributary 1 at a regular interval over a period of time would be required to determine if the chloride levels in the stream are in fact at the chronic level.

Base Flow chloride concentrations were above historic averages at all stations in 2015, especially station MP-TC on Tributary 1, which was above the VWQS chronic criterion of 230 mg/L during both rounds of sampling. VHB and Stratton have recognized the elevated chloride values in this stream, and have started to collect additional field measurements for conductivity in an effort to try and pinpoint the source of the chloride inputs into Tributary 1. More information on this can be found in section 3.5 of this report.

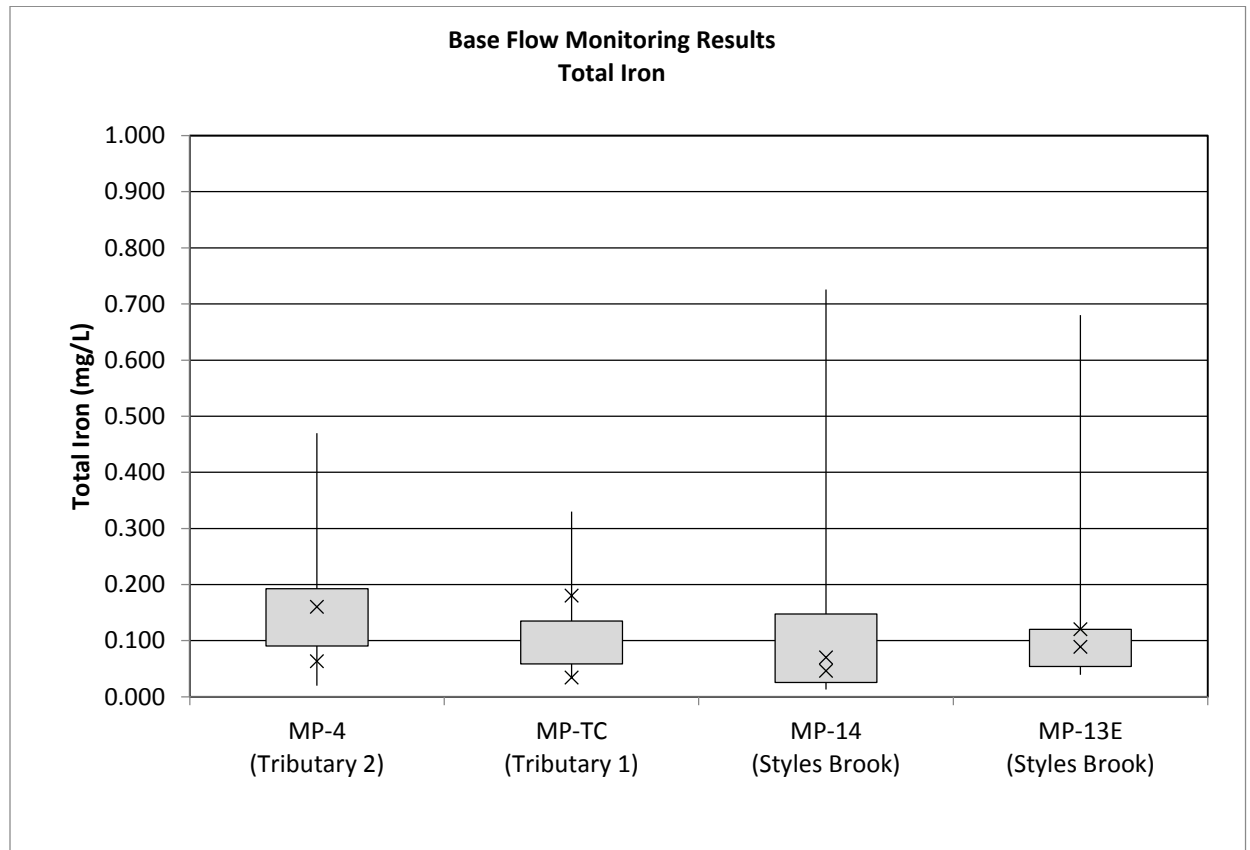
Figure 3: Baseflow Monitoring Results for Total Iron

Base Flow total iron concentrations measured in 2015 were within the historic range from the period of record at each monitoring location with the exception of MP-TC which exhibited a historic low minimum concentration of 0.034 mg/L on September 3, 2015. All total iron concentrations from the four monitored stations remained well below both the VWQS criterion of 1.0 mg/L in 2015.

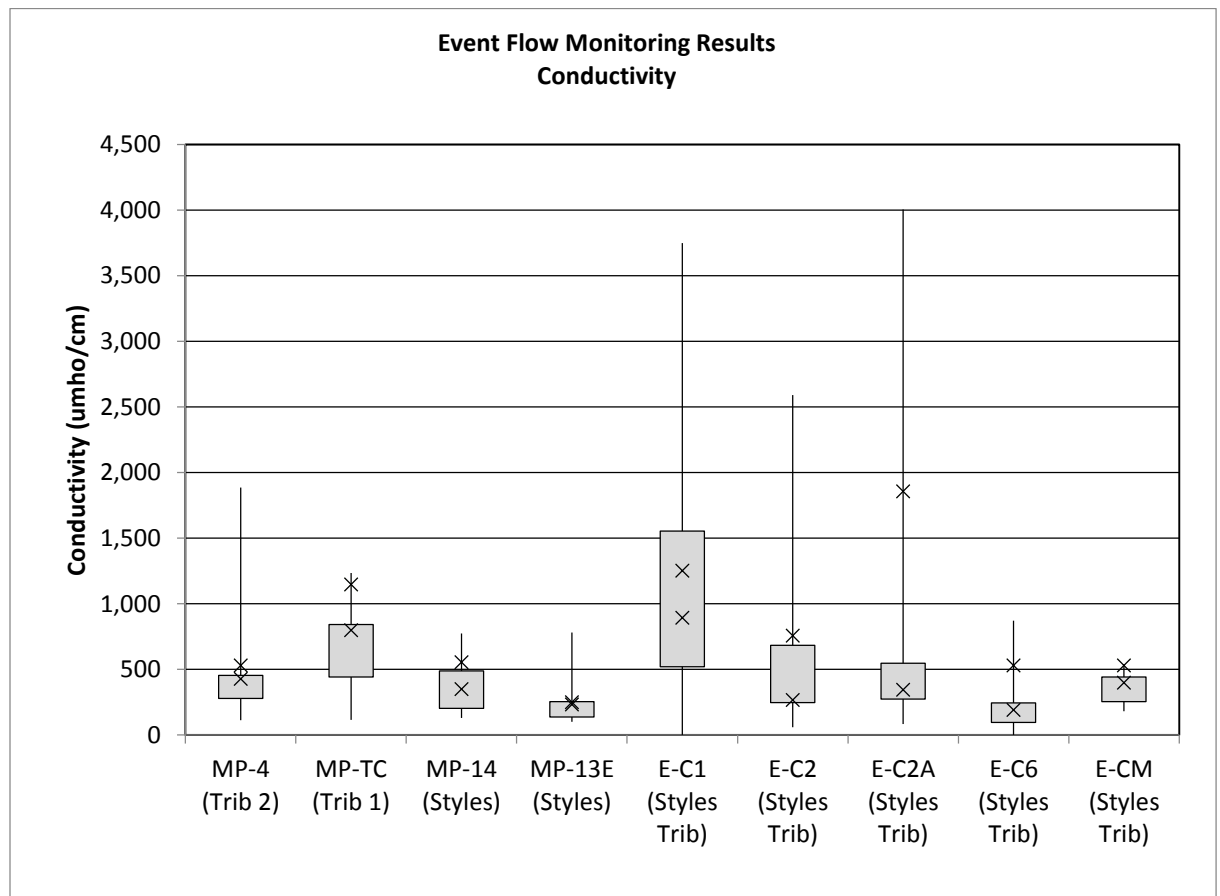
Figure 4: Event Flow Monitoring Results for Conductivity

Event Flow conductivity values measured in 2015 were within the historical ranges from the period of record. Conductivity values remain higher at stations MP-TC, E-C1, E-C2 and E-C2A when compared to the reference station (MP-4) on Tributary 2 and station MP-13E on Styles Brook.

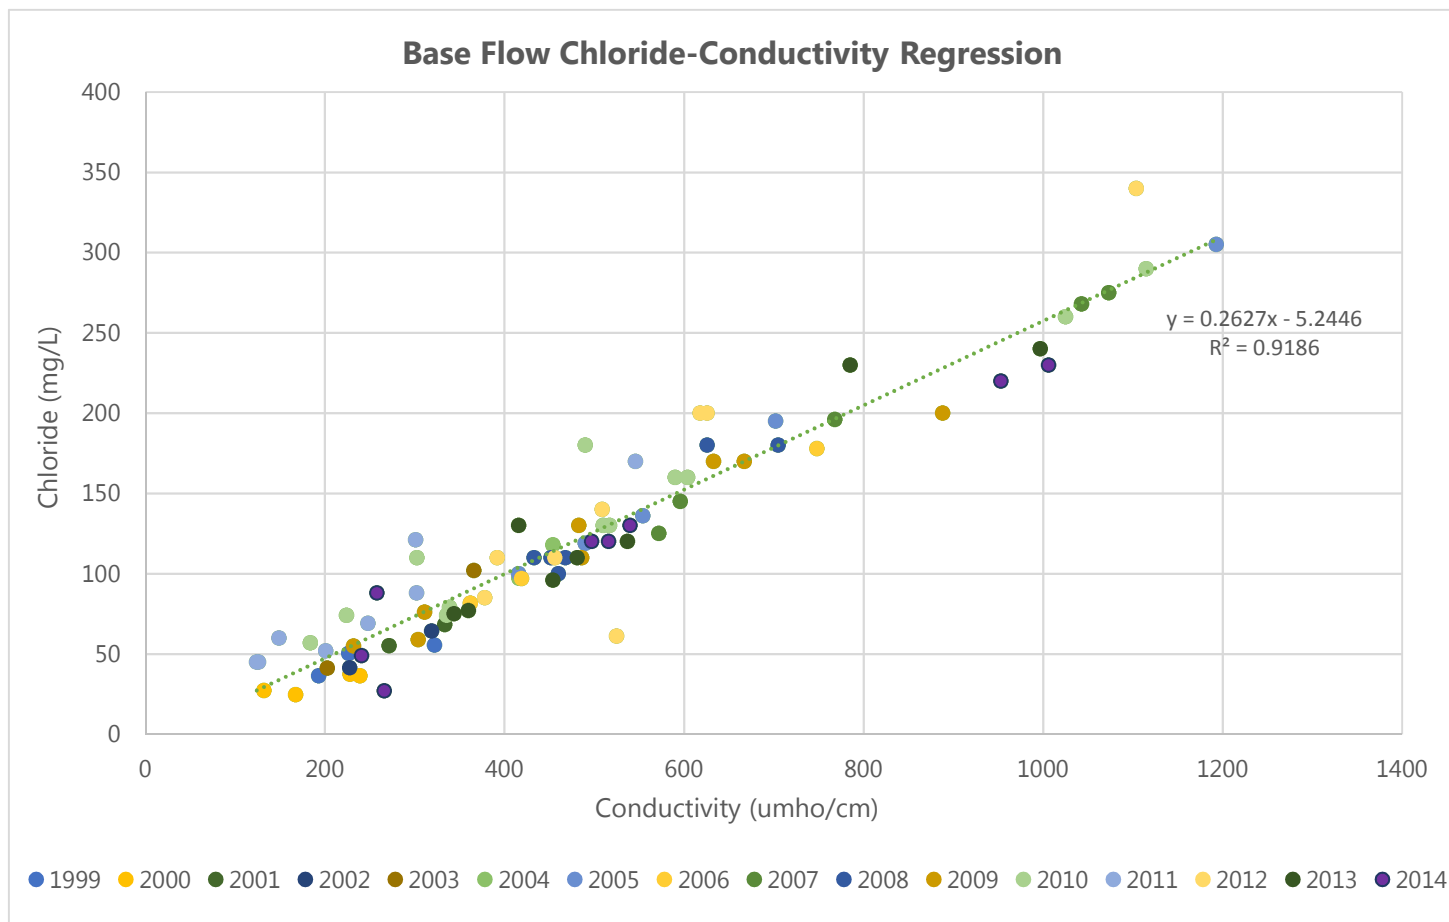
Stratton Mountain Resort
Chloride-Conductivity Regression
May 31, 2016

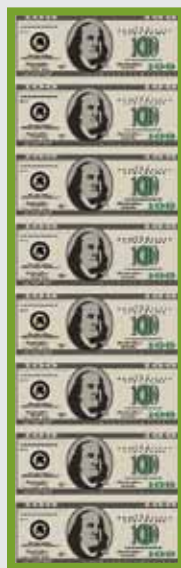
Winter 2008-2009

\$744,590 cost to purchase 10,637 tons of salt.

Total cost savings \$243,810, and a reduction of 3,483 tons of salt

The cost to retrofit the trucks with application regulators was \$140,000. **The total return on their investment was \$103,810 in the first year.**

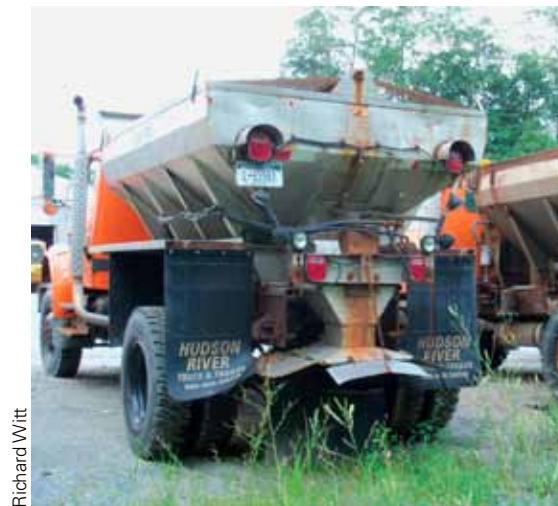
Photo of a truck retrofitted with salt reducing equipment.

There are several manufacturers of road deicing equipment. The control units are installed in the cab of the truck, which regulate the dispersal of the sand or chemical in the spreader.
