Huntington River

Watershed Description

This bacteria TMDL summary applies to a 0.7-mile reach of the Huntington River and includes a watershed reconnaissance survey, a set of site-specific potential bacteria sources, and action items for next steps towards removal of impairment.

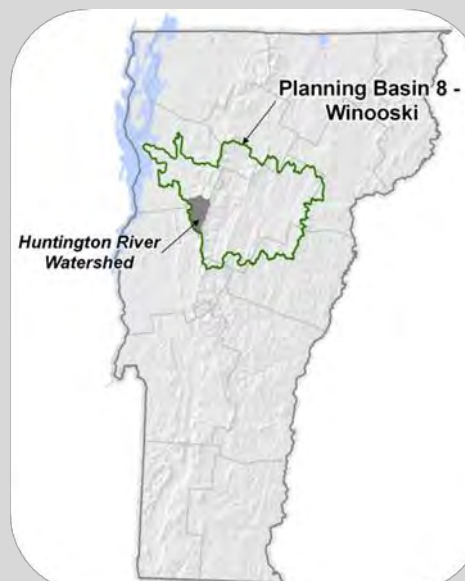
Figure 1: Map of the Huntington River watershed with impaired segment and sampling stations indicated.

The bacteria-impaired reach is 0.7 miles long and drains an area of 45 square miles, primarily within Huntington, Starksboro, and Buels Gore, and including small sections of Duxbury and Fayston (Figure 1). Overall, land use in the watershed is 90% forested, 9% agricultural, <1% developed, and <1% other

Figures 4 and 5 below show *E. coli* levels in recent years (2008 and 2010) at sampling locations within the Town of Huntington (Data obtained from the Huntington River Conservation Partnership, <http://huntingtonriver.org/>.) The graphs present bacteria measurements (on the y-axis) versus sampling locations with increasing distance downstream (on the x-axis). This presentation format is useful because it enables the reader to visualize bacteria concentrations along the river, noting that the sampling locations in Figures 4 and 5 are shown aerially in Figure 1.

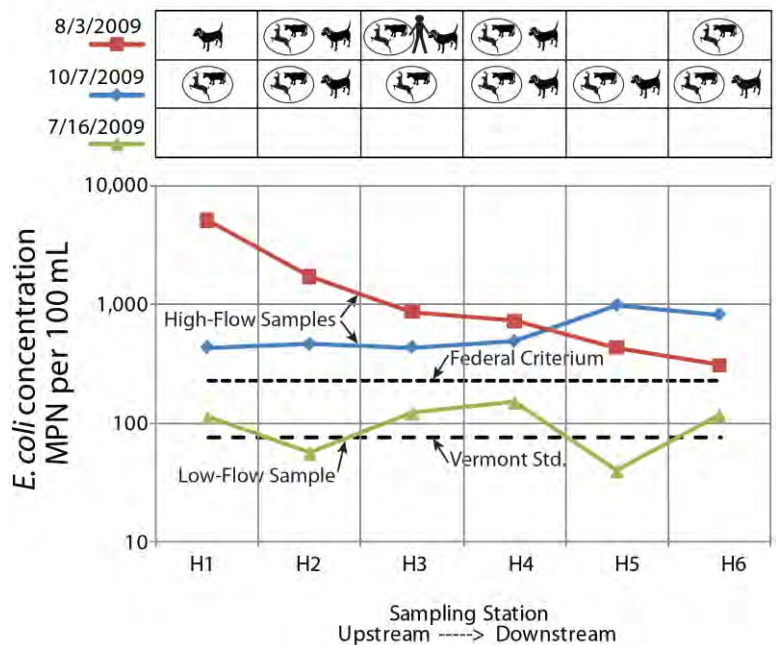
Preliminary results from samples from the Huntington River collected under different flow conditions on three dates indicated that humans were unlikely to be a major source of fecal contamination, except for a single positive result at one station that indicated the potential for human sources. Ruminants were potential sources of fecal contamination at all stations on the Huntington River during one high-flow

Figure 6: Preliminary MST study results on the Huntington River. Sites H1 and H2 correspond East Street and Bridge Street, within the bacteria-impaired segment; the remaining sites are downstream. (Matthews et al., 2011)

event and at all but two stations during the other high-flow event. Canids were potential sources of fecal contamination at some stations during two high-flow events, with genetic-marker concentrations in samples from two of the six stations showing positive results for both storm dates. A base-flow sample showed no evidence of major fecal contamination in the Huntington River from humans, ruminants, or canid (Matthews et al., 2011).

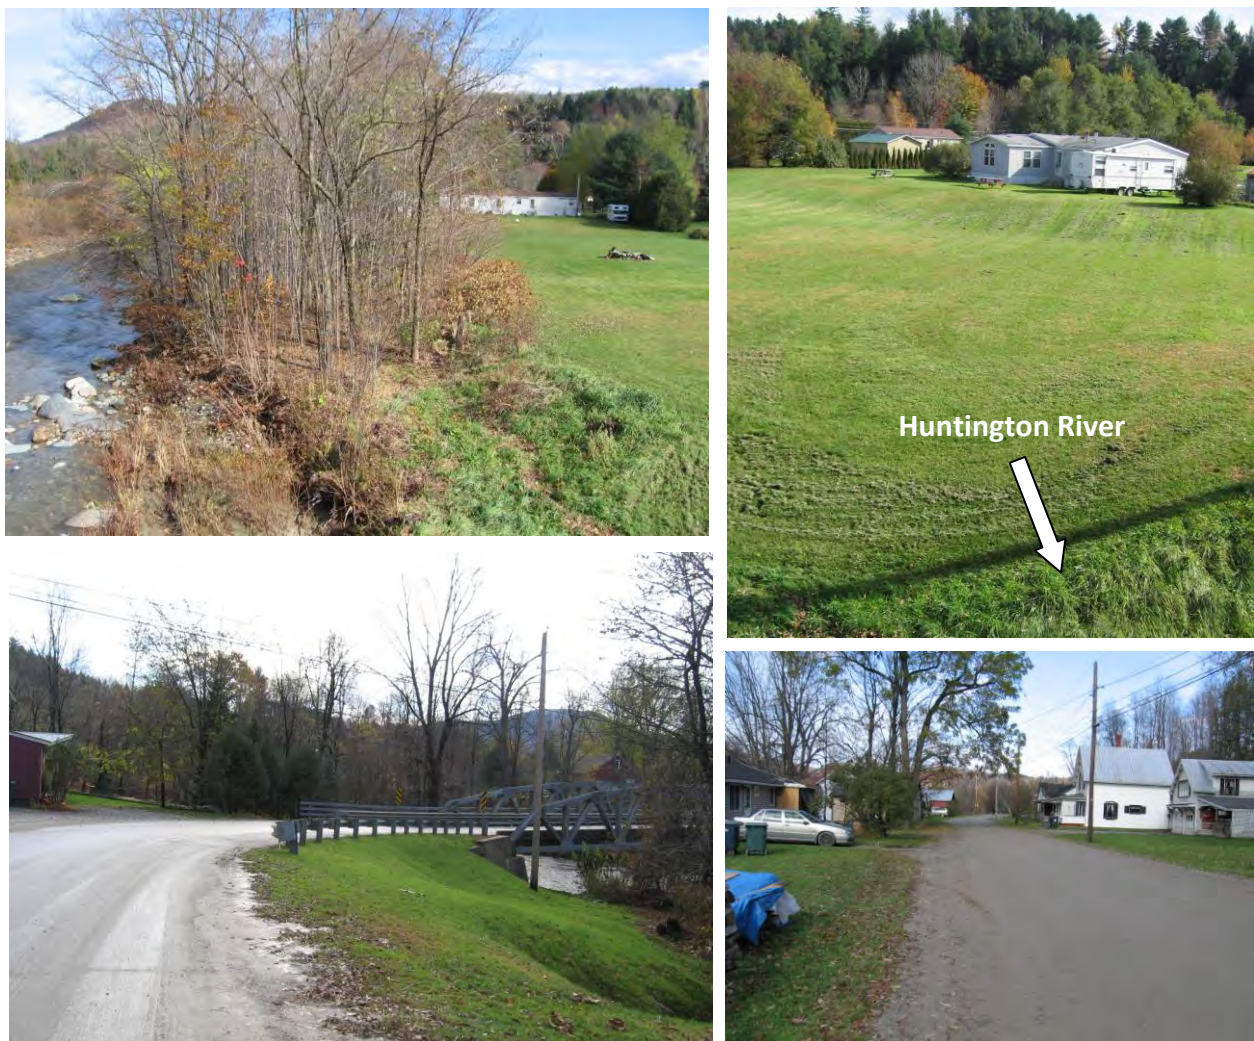
Figure 9: Photos of Site A. Top – houses in Roberts Park, located in Huntington River floodplain; Bottom left – Huntington River Bridge Street crossing; Bottom right – houses on Bridge Street.

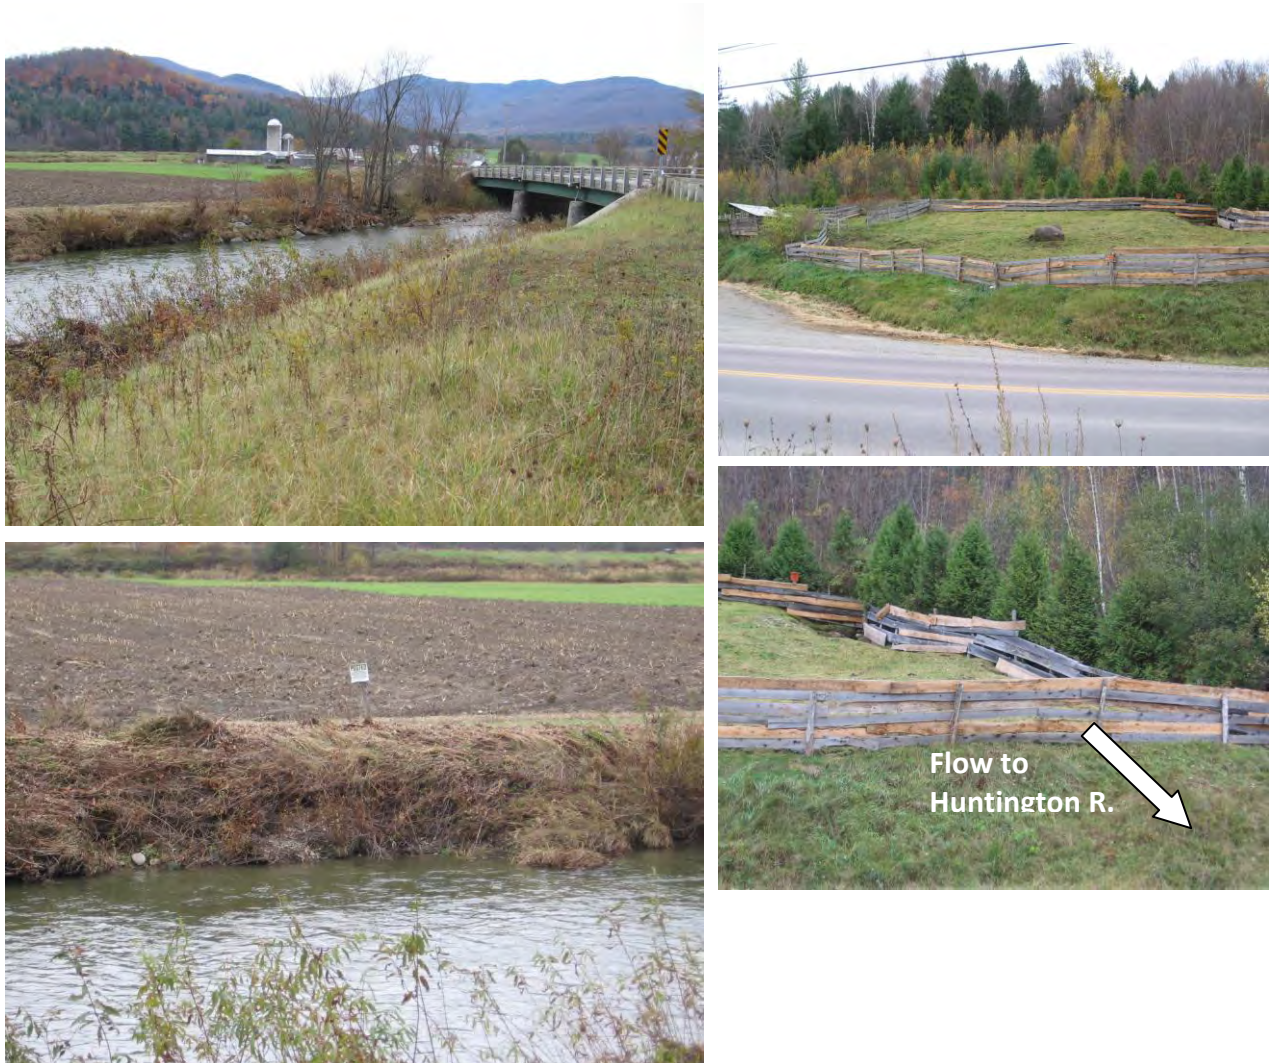
Surface waters must be buffered from annual crop lands by at least 10 feet of perennial vegetation (VAAF, 2006). In some locations along the river, vegetated buffers appear to be less than 10 feet in width. Additionally, mown vegetation, as shown in Figure 11, is less effective at reducing pollutant loads to the river.

Figure 11: Photos of Site B. Left – tilled corn fields; Right – farm animal paddocks on steep slope.

Manure management and stream buffer practices should be reviewed at farms along the Huntington River. Several on-site improvement projects may be appropriate to reduce pollutant runoff from farms to the river. The Natural Resources Conservation Service, the Consolidated Farm Services Agency, USEPA, and other agencies can provide technical assistance and partial funding to support these projects. Potentially appropriate improvement projects may include increasing vegetated buffers, and diverting runoff to vegetated areas (rather than channeling directly to the river).

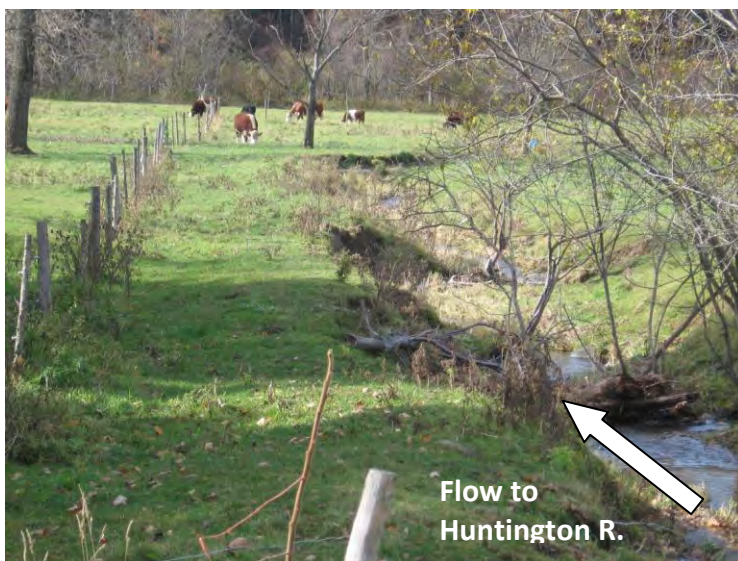
Figure 13: Huntington River tributary at Site C, with cows grazing nearby.

During the 2010 reconnaissance visit, cows on pasture did appear to have direct access to the tributary (Figure 13). Installing fences and drinking water tank to keep cows away from the tributary is recommended.

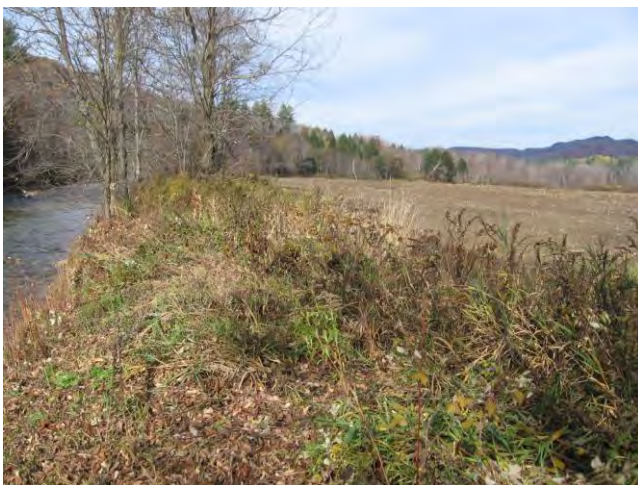
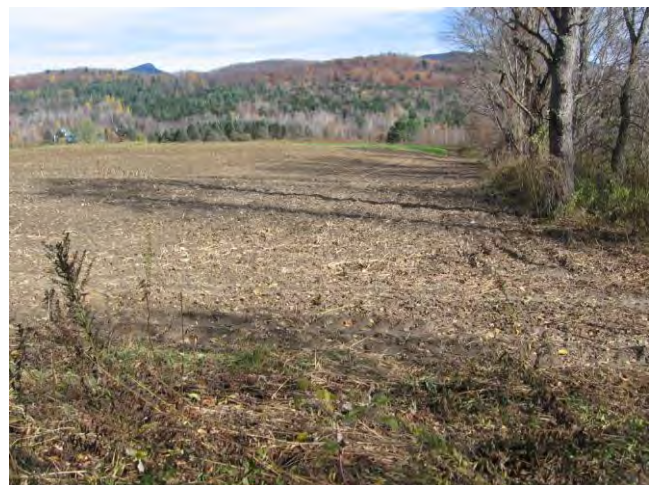
The alluvial soils in the Huntington River floodplains are ideal for agriculture. Many farm fields in the area are adjacent to the river. The Huntington River's vegetated buffer often only includes the bank and a narrow strip at the top of the bank, with a quick transition to agricultural land (HPC, 2007).

Figure 15: Photos of corn fields adjacent to the Huntington River at Site D. Left – example of narrow buffer; Right – view of field from stream bank.

- Agricultural - Farms situated near the Huntington River, such as those described as potential source areas B, C and D should coordinate with the USDA, NRCS and other agencies to assess the extent of agricultural waste application and potentially reduce applications through improved nutrient management planning. These farm operations should also evaluate riparian buffer and identify opportunities to remove areas near the river from production.

- Riparian Corridor –Conduct riparian corridor projects and seek to enhance buffer through a combination of buffer plantings, land conservation, and improved agricultural practices.
