Ompompanoosuc River

Watershed Description

Waterbody Facts (VT14-03)

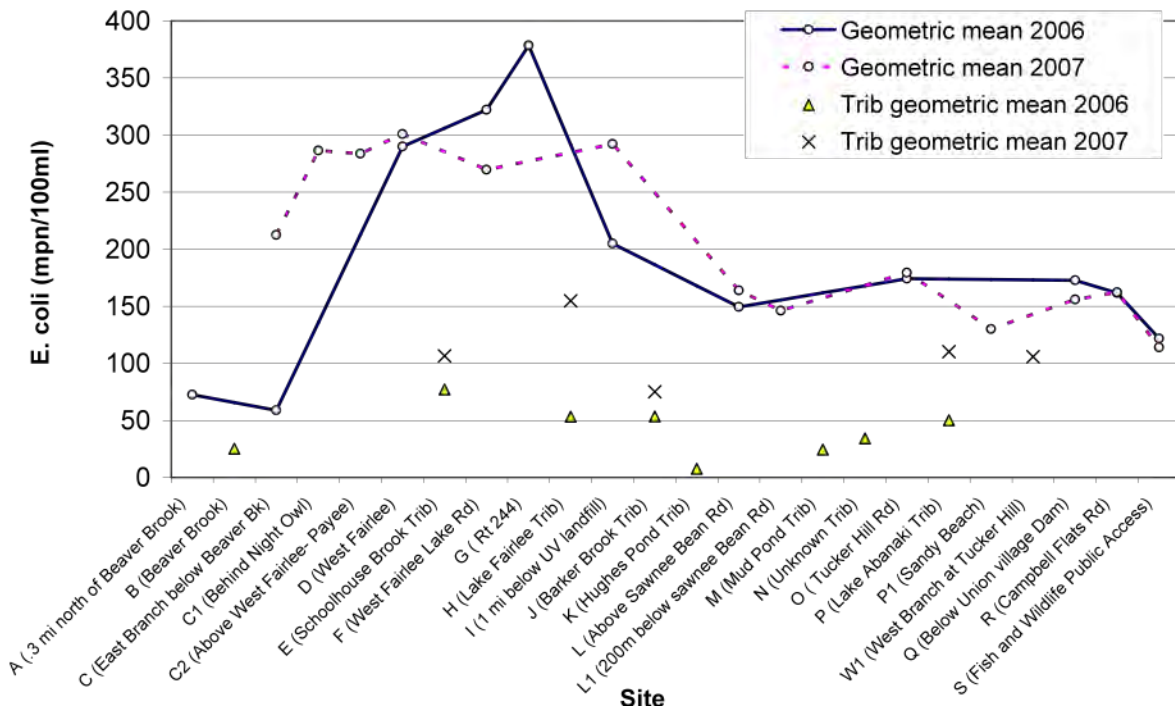
Figure 3: Plots of E.coli bacteria sampling results vs. locations along the Ompomp River for individual 2006 surveys and for geometric means of 2006 and 2007 surveys (Source: OWC 2006 & OWC 2007)

E. coli levels on the East Branch and Main Stem of the Ompompanoosuc River during the summer of 2006

Geometric mean of E. coli levels on the Ompompanoosuc River and tributaries during the summer of 2006 and 2007

In 2006 (top plot of Figure 3), bacteria concentrations were observed to be higher from sampling locations D through G, as shown by the geometric mean concentration line. Wet weather events in 2006 corresponded to the highest bacteria concentration events, as shown by the elevated “red” and “dotted” bars (OWC 2006). These two general observations are useful to identification of bacteria sources because they indicate locations and conditions associated with elevated bacteria measurements.

In 2007, additional sampling (at locations C1 and C2) was conducted in the area between location C and D to support identification of bacteria sources. The lower plot of Figure 3 shows the geometric mean of bacteria measurements at each location and provides a comparison of 2006 and 2007 measurements. Elevated bacteria concentrations were observed further upstream in 2007 (shown as a dotted line) than in 2006 (shown as a solid line). In 2007 the Ompompanoosuc River reach with elevated bacteria concentrations appeared to extend further than in 2006 from upstream of location C to downstream of location I.

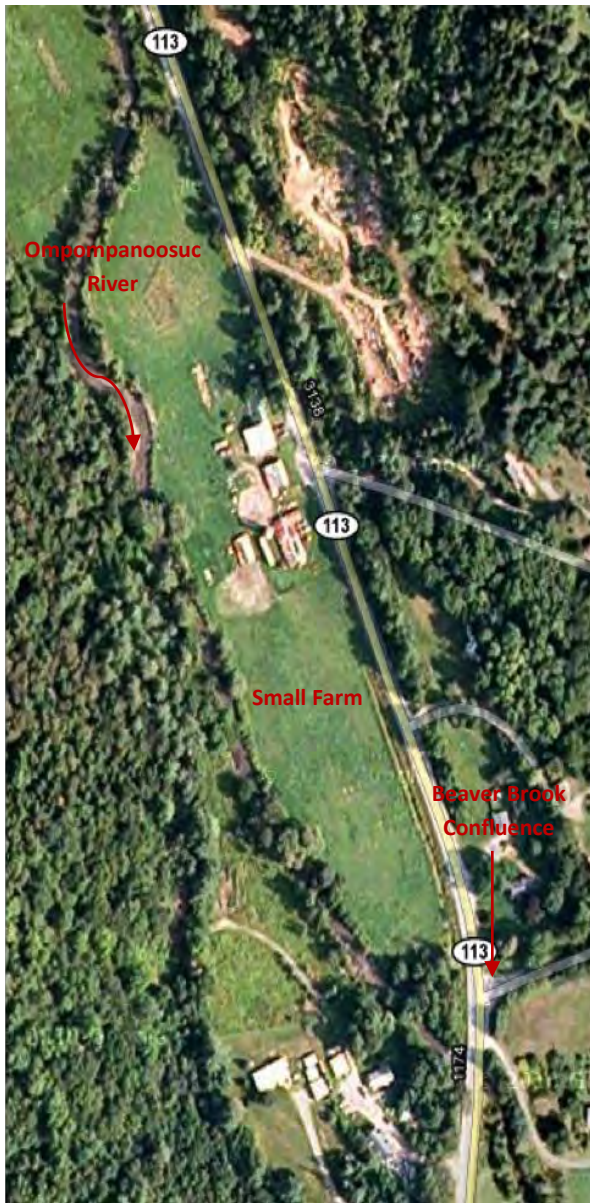
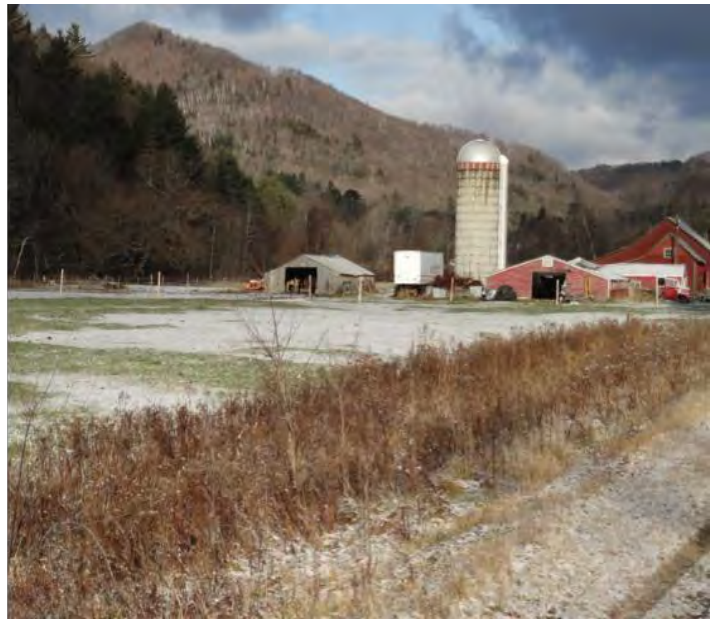
Figure 5: Aerial map and photographs of Site 1 example - Farm immediately upstream of the Beaver Brook confluence

An example of a farm that could potentially contribute bacteria to the Ompompanoosuc is provided in Figure 5. The farm shown in Figure 5 is a livestock operation situated close to the river immediately upstream of the confluence of Beaver Brook. The farm is situated between Route 113 and the Ompompanoosuc River and the river passes under Route 113 at the southern boundary of the farm.

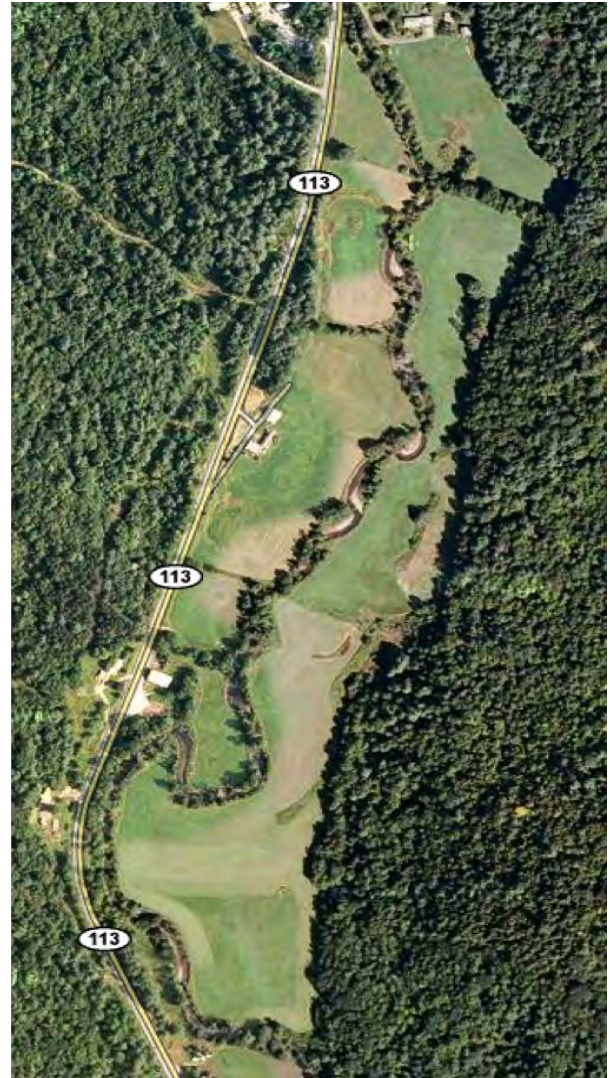
Figure 6: Aerial map of Site 1 - Farmland north of West Fairlee Village

As shown in Figure 6, the riparian buffer is narrow throughout this reach of the Ompompanoosuc with agricultural activities situated close to the river. Manure management and stream buffer practices should be reviewed at farms along the Ompompanoosuc River. Livestock maintenance (including direct access to the river) and manure applications to croplands adjacent to the river likely result in fecal bacteria contributions in this area. Several on-site improvement projects may be appropriate to reduce pollutant runoff from farms to the river. The Natural Resources Conservation Service, the Consolidated Farm Services Agency, USEPA, and other agencies can provide technical assistance and partial funding to support these projects. Potentially appropriate improvement projects may include fencing livestock out of the stream, constructing manure storage facilities, and improving barnyard maintenance.

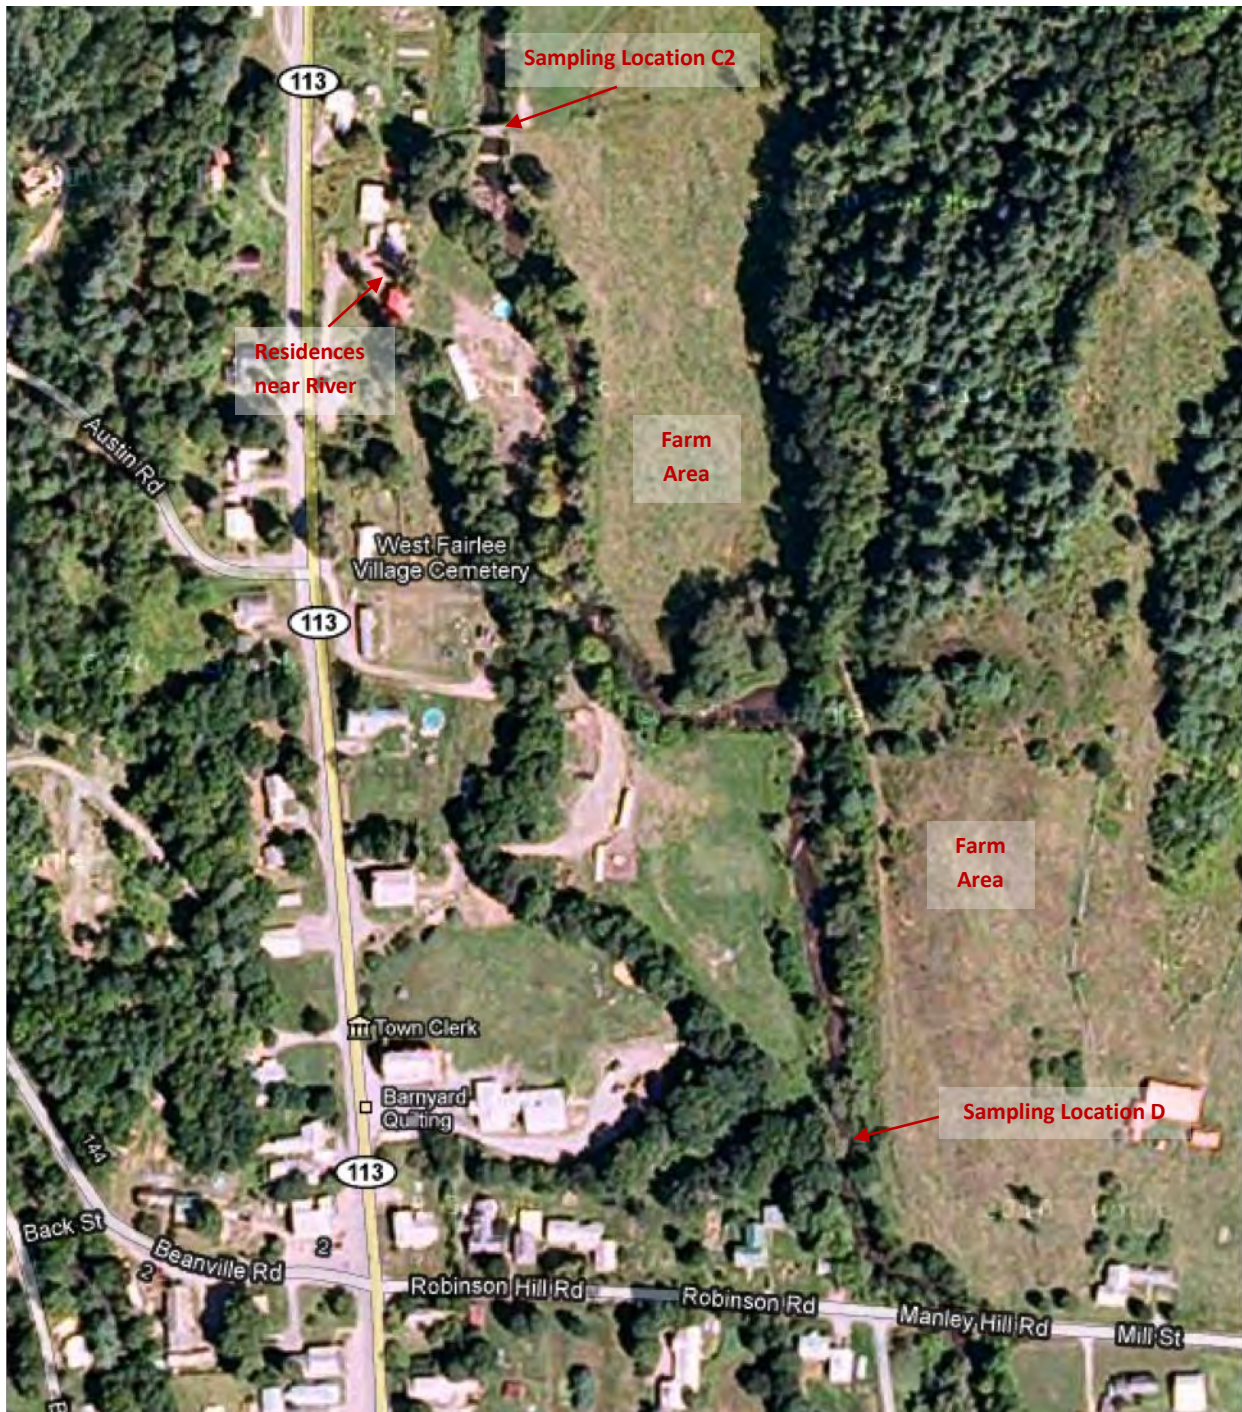
Figure 7: Aerial map of Site 2 – West Fairlee Village with potential source areas indicated

There are numerous residences and several farms situated near the Ompompanoosuc River in West Fairlee Village, as shown in Figure 7. This area includes sampling locations C and D, where elevated bacteria measurements have been observed. Residences are situated along the west bank of the river and several examples are shown in Figure 8. The Ompompanoosuc River flows immediately behind the small residences shown in the top photograph in Figure 8. The white residence is across Route 113 from the river and had a white PVC pipe with water flowing out into a roadway swale (that drains to the river) indicating a potential illicit discharge.

Due to the close proximity of the West Fairlee Village septic systems to the river, they should be investigated to ensure that they are functioning properly. In addition, stormwater runoff and illicit

discharges should be investigated to assess potential adverse impacts of stormwater runoff to this reach of the Ompompanoosuc River.

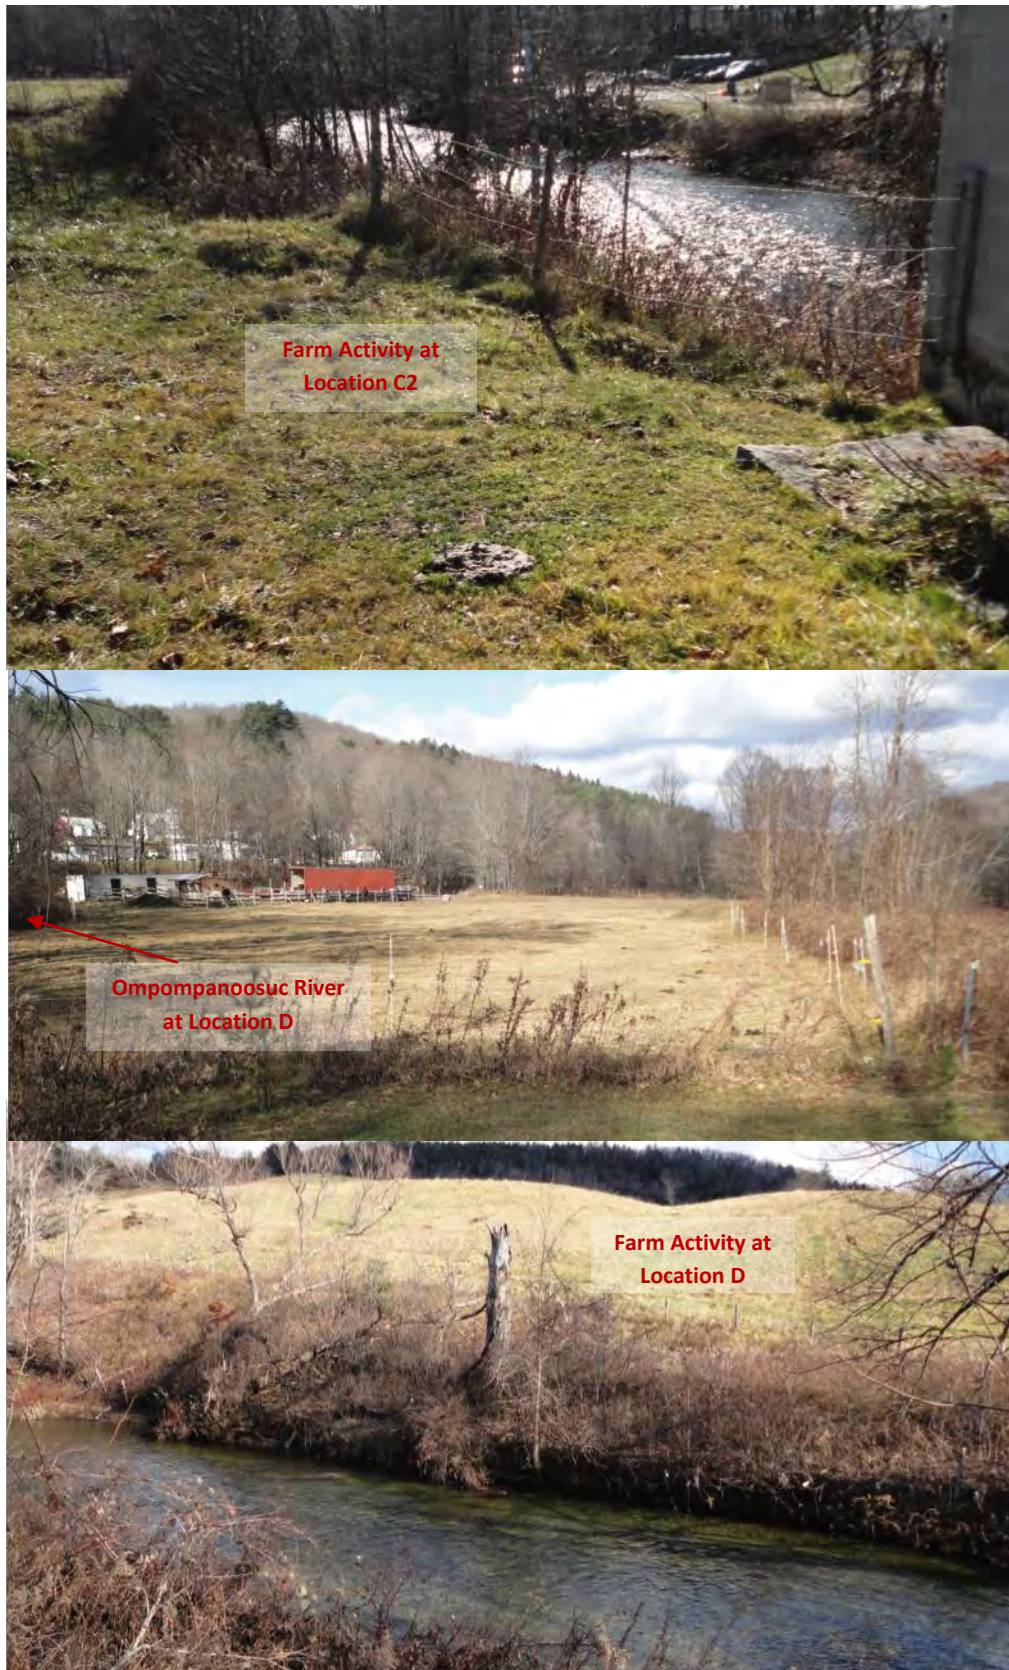
Figure 9: Photographs of Site 2 – Farms near the Ompomp in West Fairlee Village

There are also agricultural activities along the east bank of the Ompompanoosuc in West Fairlee Village, as shown in Figure 9. The top photograph in Figure 9 was taken at sampling location C2 and the lower two photographs were taken at sampling location D. Manure was visible at each location suggesting that transport of animal waste during rainfall events is likely to occur. Agricultural activities including livestock maintenance and manure applications to croplands adjacent to the river likely result in fecal bacteria contributions in this area. Several on-site improvement projects may be appropriate to reduce pollutant runoff from farms to the river. The Natural Resources Conservation Service, the Consolidated Farm Services Agency, USEPA, and other agencies can provide technical assistance and partial funding to support these projects. Potentially appropriate improvement projects may include constructing manure storage facilities and improving barnyard maintenance.

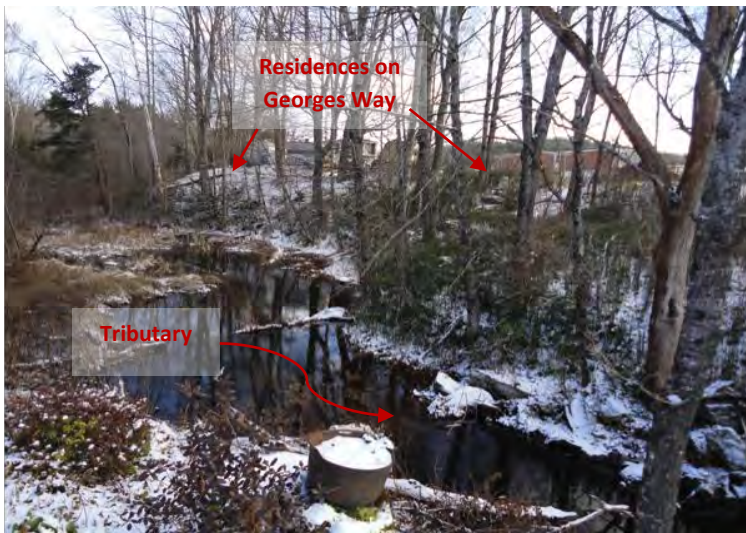
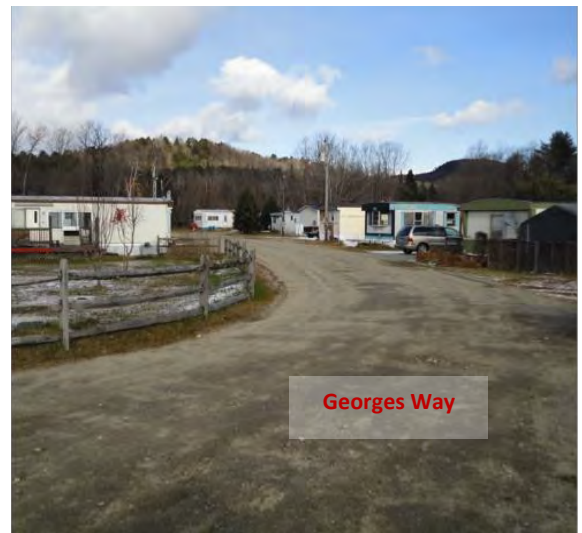
Figure 10: Aerial Map and Photographs of Site 3 – Homes and Farm along West Fairlee Road Tributary

A small tributary flows southward crossing Crossroad/West Fairlee Road and joining the Ompompanoosuc River just north of the Lake Fairlee tributary (Figure 4). As shown in Figure 10, this tributary passes close by a dense residential area (Georges Way) and a farm (Crossroad Farm). Each of these areas may be contributing bacteria to the tributary and, eventually, to the Ompompanoosuc River mainstem. The residences on Georges Way are shown in the two photographs on the bottom of Figure 10. In the photograph on the left, the residences are shown situated close to and above the tributary.

A permit application to replace a failing wastewater disposal system serving 3 three-bedroom residences on Lots 11, 12, 13 of Cold Spring Mobile Home Park on Georges Way in West Fairlee was submitted. The new wastewater system has been approved and the installation certification has been received by DEC Wastewater Division. Due to the close proximity of the Georges Way residences and the Crossroad Farm to this Ompompanoosuc tributary, testing of the remaining systems in the park should be conducted.

- Bacteria Monitoring Program – Conduct a monitoring program featuring locations A, B, C, C1, C2, D, E, F, G, H, I and additional downstream sampling locations, similar to the 2006 and 2007 surveys. Sampling upstream and downstream of potential on-site septic and agricultural sources (a practice known as “bracket sampling”) may also be beneficial for identifying and quantifying sources. Bracket sampling may be particularly useful between sites D and L, where some of the highest bacteria levels have been measured. We also recommend adding a sampling location near the confluence of the Crossroads/West Fairlee Road tributary with the Ompompanoosuc River to support assessment of this potential source area (as shown in Figure 10).
