Otter Creek

Watershed Description

Waterbody Facts (VT03-01)

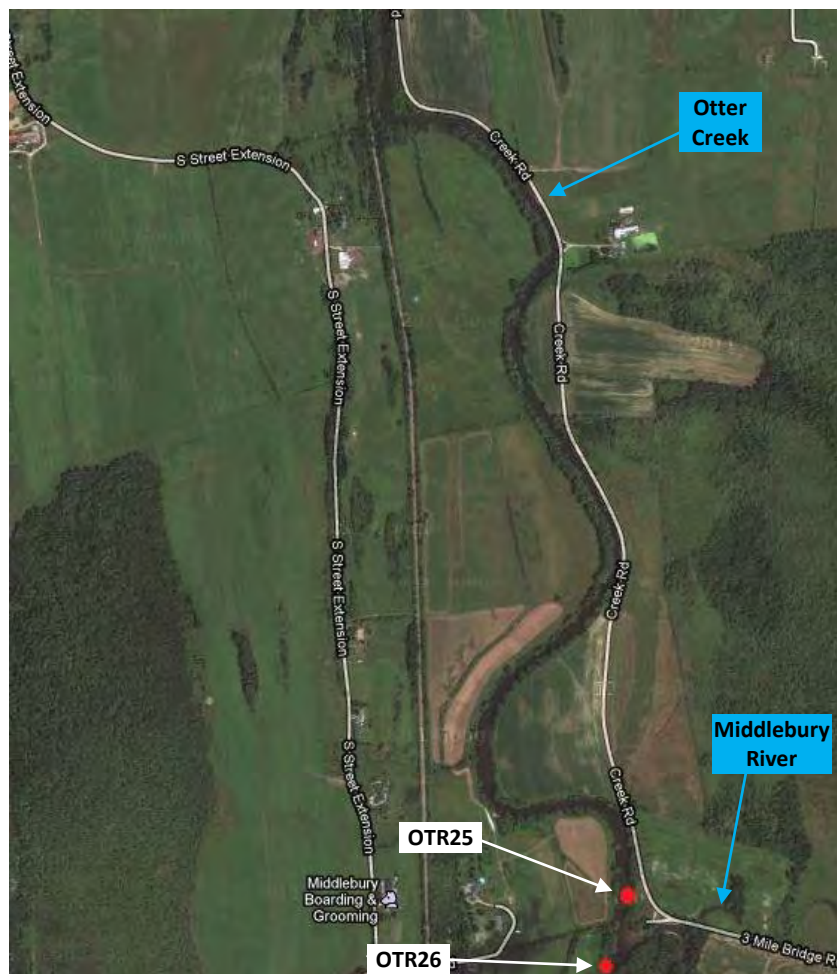
Figure 4: Aerial view of Otter Creek from the upstream end of the impaired segment at the confluence with the Middlebury River (lower right). Stations OTR25 and OTR26 shown in Red

Figure 4 shows the upstream start of the impaired segment at the confluence of Otter Creek and the Middlebury River. As seen in this aerial image, there are large tracts of agricultural land along the creek's banks. In the creek's entire watershed there are a total of 710 farms (NRCS, 2005). Around 200 of these are dairy farms, in addition to numerous beef, sheep, poultry, and vegetable farms. The entire watershed contains 122,000 acres of cropland and 41,000 acres of pasture (NRCS, 2005). Agriculture remains an important cultural and economic resource in Rutland and Addison County (RRPC, 2008). Much of the agricultural land surrounding the impaired segment, and in the creek's course through Addison County in general, was once wetland. Up to one-third of Addison County's farmland may have once been wetland (ACRPC, 1994).
