Little Otter Creek: mouth to river mile 7.8

Watershed Description

Waterbody Facts (VT03-07)

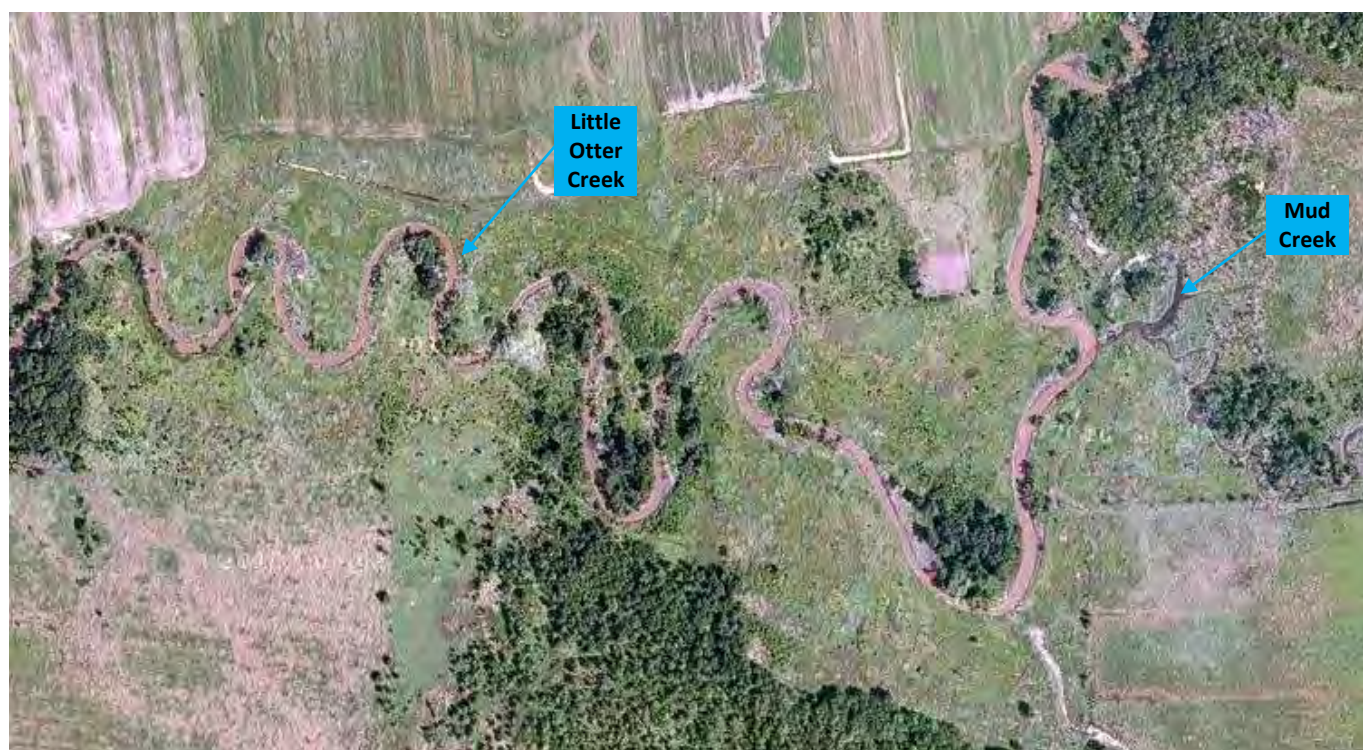
Figure 4: Aerial view of Little Otter Creek from approximately river mile 5.5 to river mile 6.5. Also shown in this view is Mud Creek flowing into Little Otter Creek (center right)(Source: Google Maps).

Figure 4 shows the reach from approximately river mile 5.5 to river mile 6.5 in Ferrisburgh. As seen in this aerial image, there are large tracts of agricultural land along the creek's banks. Agriculture remains an important cultural and economic resource in Addison County (ACRPC, 2008). Furthermore, this impaired segment of Little Otter Creek is completely within the town of Ferrisburgh, where agriculture is critical to the town's economy (Ferrisburgh, 2006). Including the areas outside of Ferrisburgh, Little Otter Creek's watershed is heavily farmed, with many dairy operations and cornfields (LOC, 2009). Given the large percentage of its watershed dedicated to agricultural land uses, Little Otter Creek is considered an agricultural stream (Medalie, 2007). Much of the agricultural land surrounding the impaired segment and in the creek's course through Addison County in general, was once wetland. Up to one-third of Addison County's farmland may have once been wetland (ACRPC, 1994).

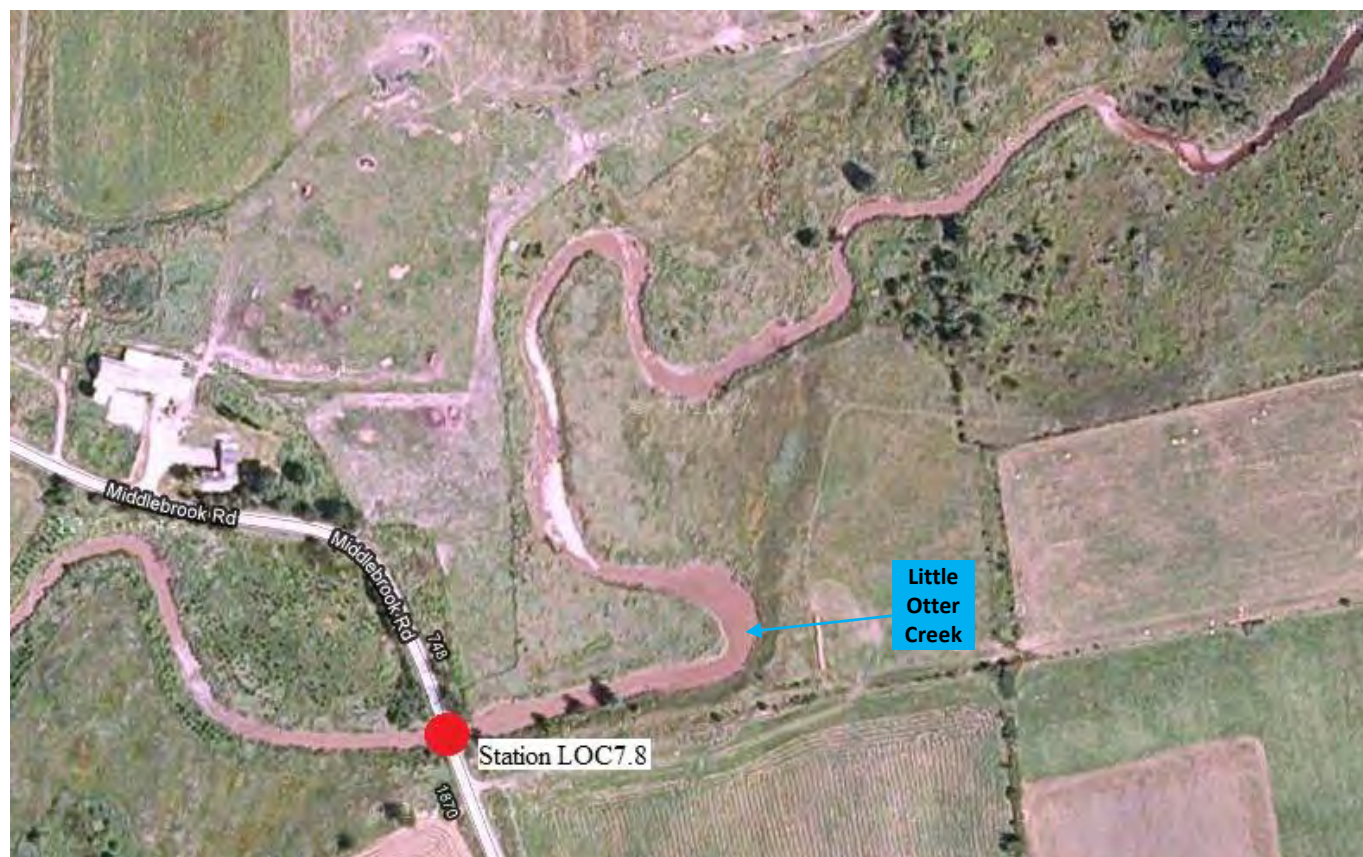
Figure 5: Aerial view of Little Otter Creek upstream and downstream of sampling location LOC7.8 on Middlebrook Road in Ferrisburgh. The location of the sampling station is indicated in red (Source: Google Maps).

the stream via erosion from stormwater runoff can transport bacteria into the water column. Therefore, it is important to carefully consider the numerous pollutants that are adversely impacting Little Otter Creek including not only bacteria, but also nitrogen, phosphorus and sediment. Figure 5 provides an aerial view of Little Otter Creek (upstream and downstream of river mile 7) showing a long stretch of inadequate riparian buffers within agricultural land along a majority of this reach.
