**Stowe Mountain Resort
SMR 2000 Community Plan
Water Quality Management Plan**

2016 Monitoring Report

May 30, 2017

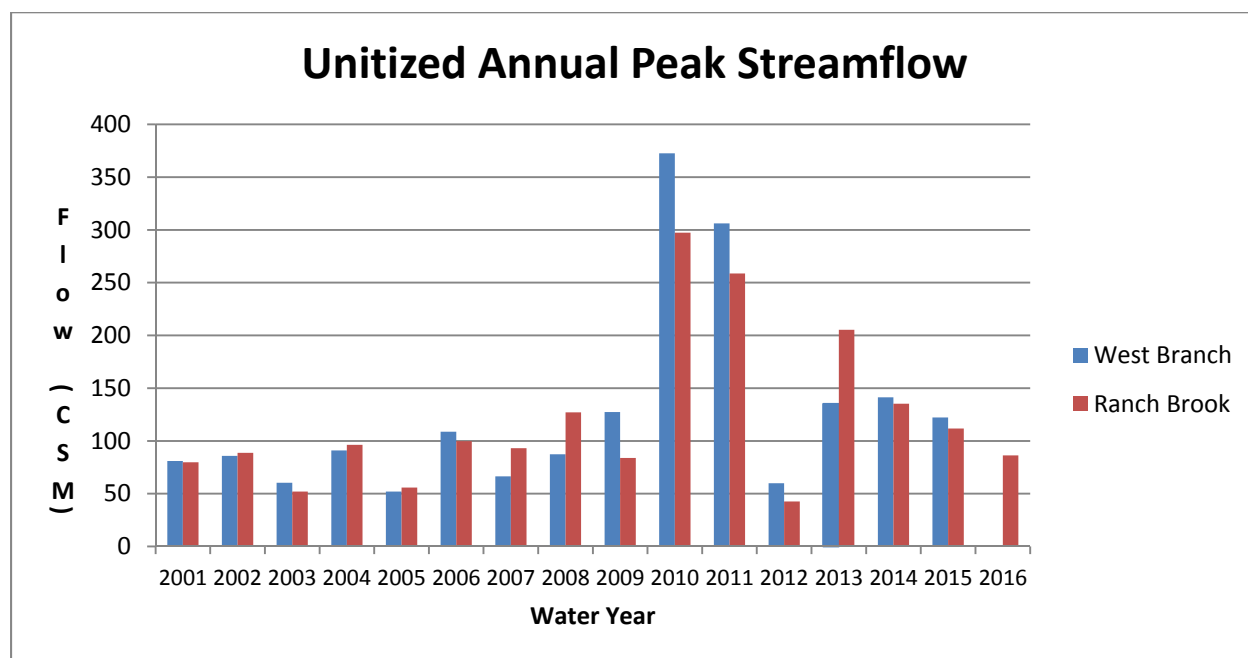
Figure 1. Annual unitized peak stream flow values for the West Branch and Ranch Brook.

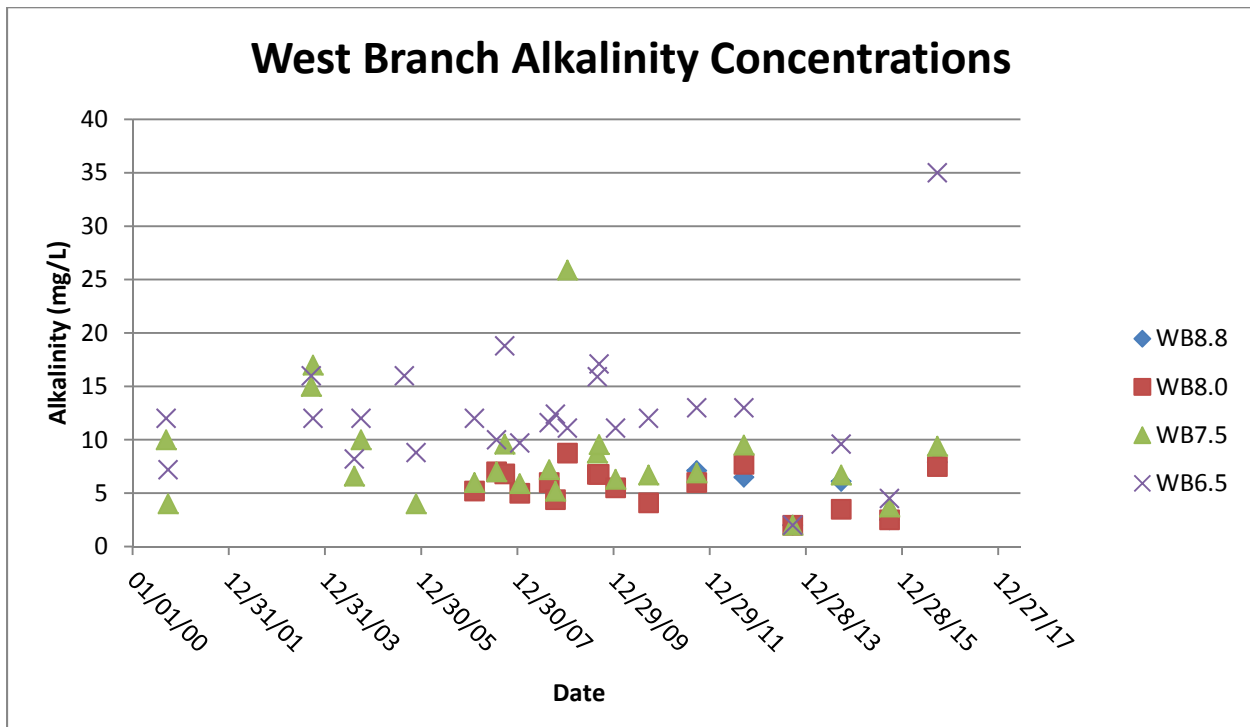
Figure 2. Alkalinity values from 2000 through 2016 for West Branch of Little River.

Figure 2 shows the mean alkalinity values of the West Branch biomonitoring stations for fall 2003 through fall 2016. In 2016, all West Branch stations had mean alkalinity values of less than 10 mg/L as CaCO₃, with the exception of the West Branch at RM 6.5. In previous monitoring years, the alkalinity of West Branch RM 6.5 has always been less than 20 mg/L. It is unclear whether the higher alkalinity recorded at RM 6.5 in 2016 is within the natural variation or is in response to higher alkalinities noted in streams within the past two years on the Spruce side of the Resort.

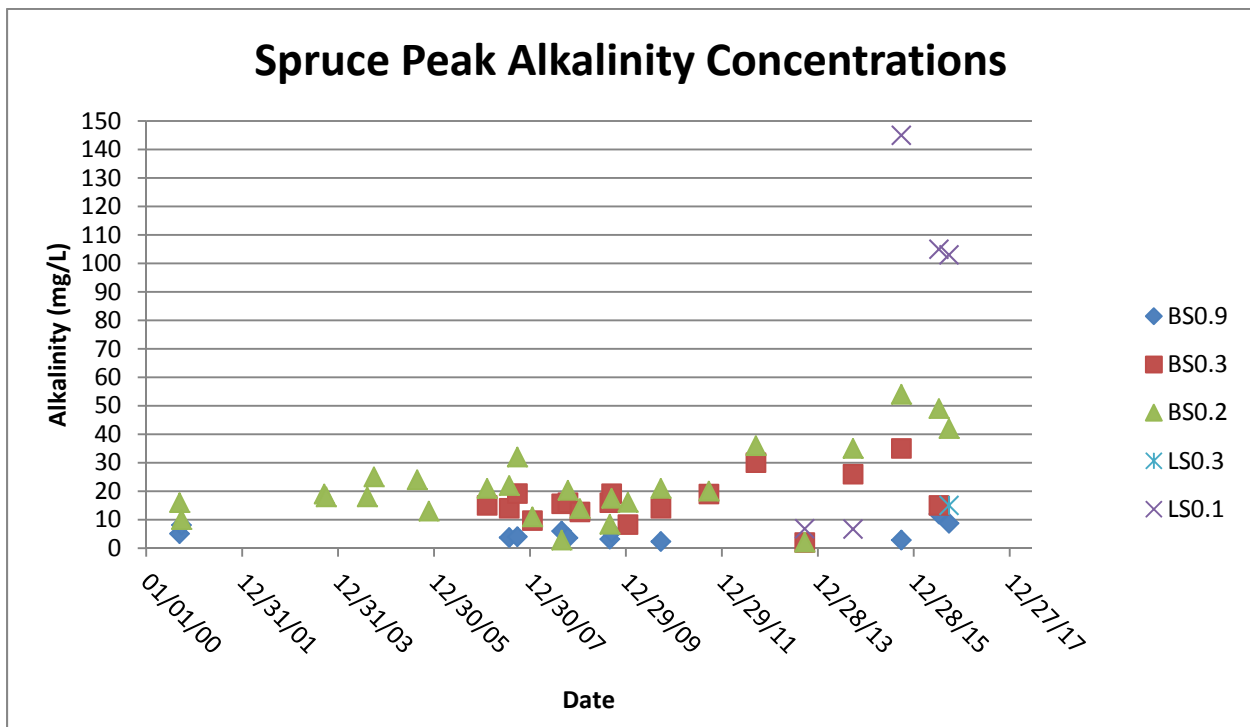
Figure 3. Alkalinity values from 2000 through 2016 for Spruce Peak.

The Big Spruce stations have had the highest alkalinity historically; while Pinnacle Brook and the upper West Branch stations have the lowest. For past years, alkalinity has shown an increasing trend from upstream to downstream on the West Branch. For the 2016 sampling round, Little Spruce Brook at RM 0.1 had the highest alkalinity, as mentioned above. Big Spruce Brook was next highest at RM 0.2 (49 mg/L CaCO_3 and 42 mg/L CaCO_3), followed by the West Branch at RM 6.5 (35 mg/L). The lowest alkalinity values were observed at Pinnacle Brook RM 0.1 (6.3 mg/L CaCO_3) and the West Branch RM 8.8 (7.9 mg/L CaCO_3). These low alkalinity values suggest that some of the streams at and surrounding Stowe Mountain Resort have a low buffering capacity and are susceptible to the impacts from acid precipitation.

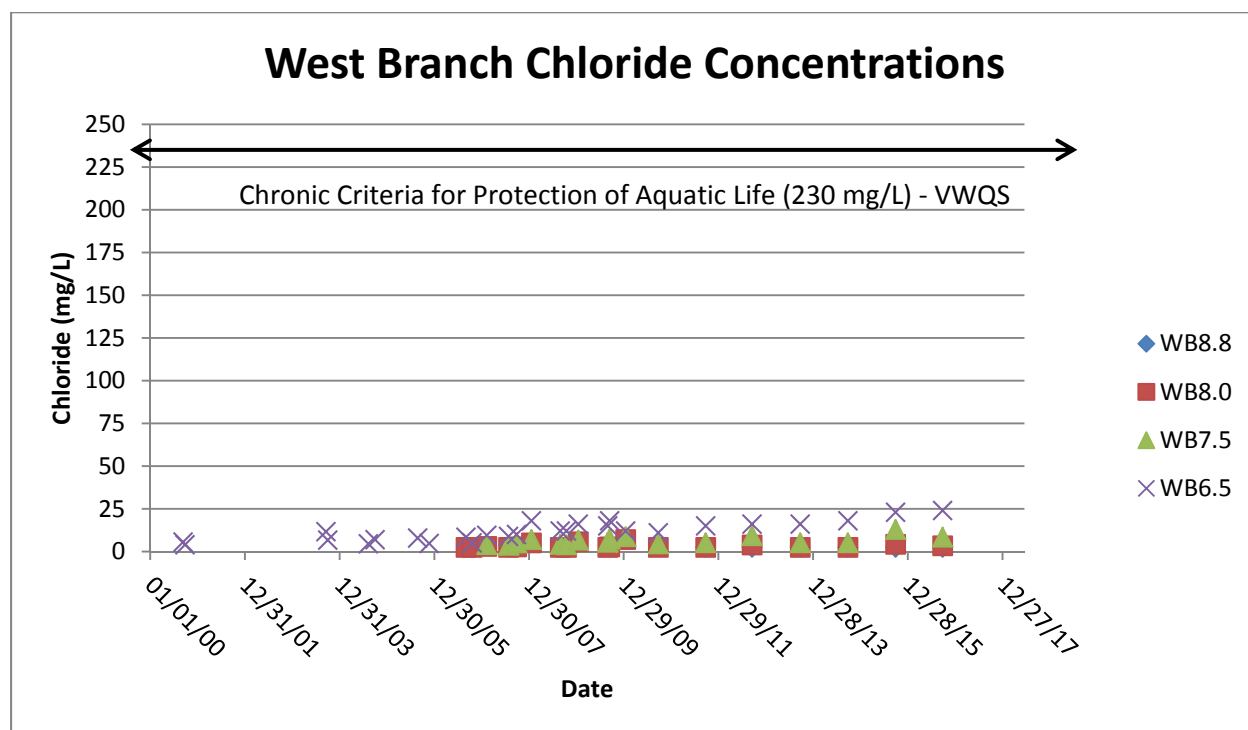
Figure 4. Chloride concentrations from 2000 through 2016 for West Branch of Little River.

Chloride concentrations for the West Branch watershed and the Big Spruce watershed over time are plotted below in Figures 4 and 5. As shown in Figure 4, the chloride concentrations at all the West Branch stations under baseflow conditions have been less than 25 mg/L. These concentrations are well below the chronic criteria for protection of aquatic life, which is listed as an average of 230,000 $\mu\text{g/L}$ (230 mg/L), as well as the acute criteria of 860,000 $\mu\text{g/L}$ (860 mg/L) maximum in the Vermont Water Quality Standards (State of Vermont, 2014 & 2016). As expected, the most downstream West Branch station sampled (WB6.5) had slightly higher chloride concentrations than the upstream stations. The average concentration for the 25 samples at WB6.5 is 12.4 mg/L. Chloride concentrations were lowest at the most upstream station, WB 8.8, and were less than the detection limit of 2.5 mg/L for the annual sampling that was conducted in September 2011 through 2016.

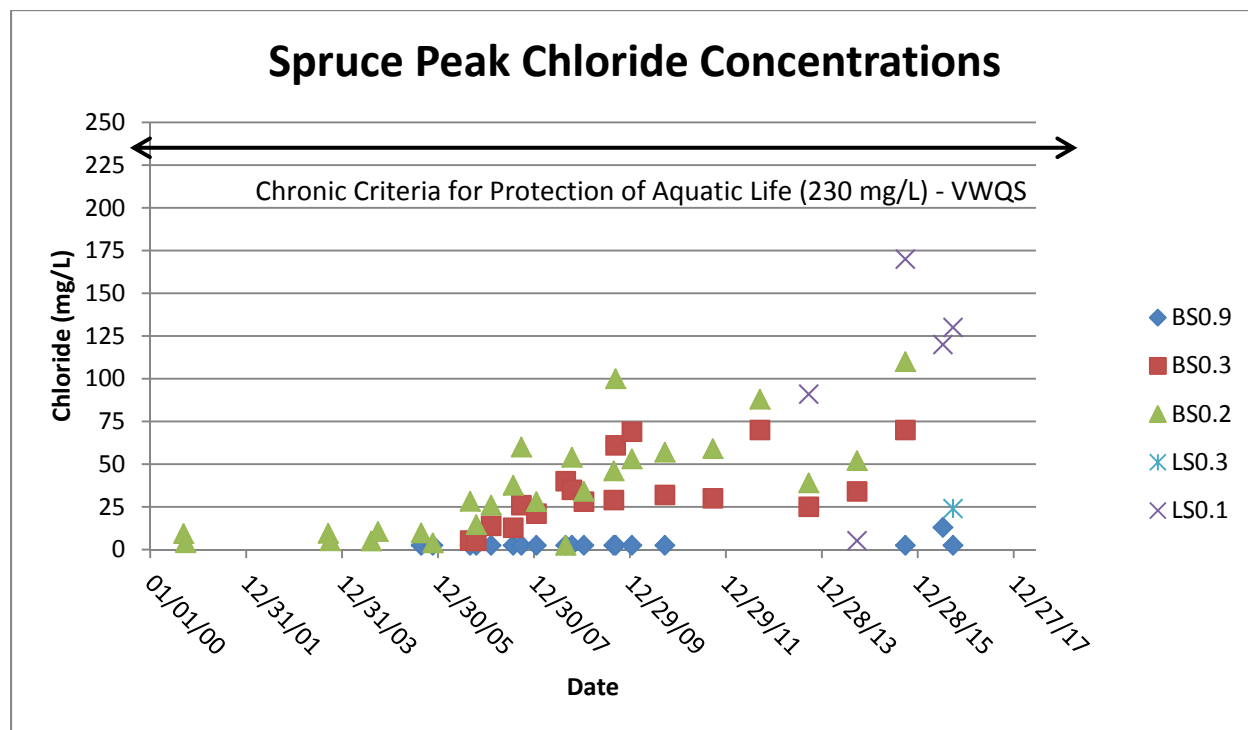
Figure 5. Chloride concentrations from 2000 through 2016 for Spruce Peak.

Baseflow sampling in the Spruce Peak watershed has been conducted for different lengths of time at the monitoring stations. BS0.2, the most downstream station on Big Spruce Brook has the longest period of record (2000, 2003-2016). Chloride concentrations at this most downstream station suggest an upward trend over time. Baseflow sampling has been conducted at BS0.3 since 2006, but was discontinued in 2016. In general, chloride concentrations at BS0.3 have been slightly lower than BS0.2. The most upstream Big Spruce station (BS0.9) has been sampled 17 times over the years with chloride concentrations being recorded less than the detection limit of 2.5 mg/L each time, with the exception of July 2016 when it was reported to be 13 mg/L. The highest chloride concentrations recorded have been at the Little Spruce RM 0.1 station, near the mouth of the brook. Baseflow sampling has been conducted at LS0.1 annually during the past four years. LS at RM 0.3 was added in 2016, and the one chloride sample for the station was 24 mg/L. Chloride concentrations at LS0.1 have ranged from a low of 5.2 mg/L in 2014 to a high of 170 mg/L in 2015. Sampling at this station in 2016 yielded chloride concentrations of 120 mg/L and 130 mg/L on July 7 and September 21, respectively.

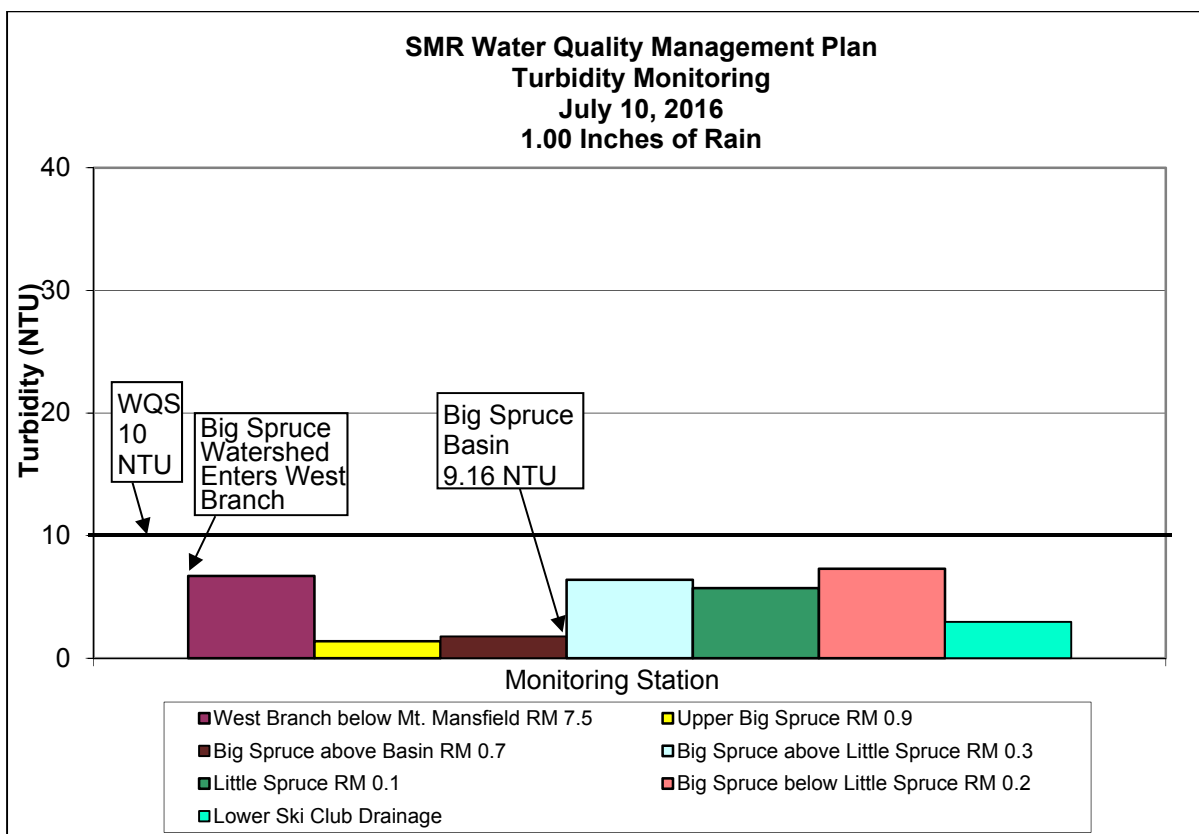
Figure 8. Turbidity results from July 10, 2016.

As shown in Figure 8, turbidity values were below the water quality standard of 10 NTU at all surface water stations on July 10, 2016. The highest turbidity result was on Big Spruce Brook at RM 0.2 (7.29 NTU). The stream station with the lowest turbidity value was upper Big Spruce Brook at RM 0.9 (1.38 NTU). The Big Spruce basin was the only basin outlet sampled, and it measured 9.16 NTU for turbidity. Overall, instream turbidity values were quite low, indicating that erosion and sediment control measures implemented and maintained by the Resort were working effectively. The range of turbidity values by station for this event is shown on the map (Figure 9).

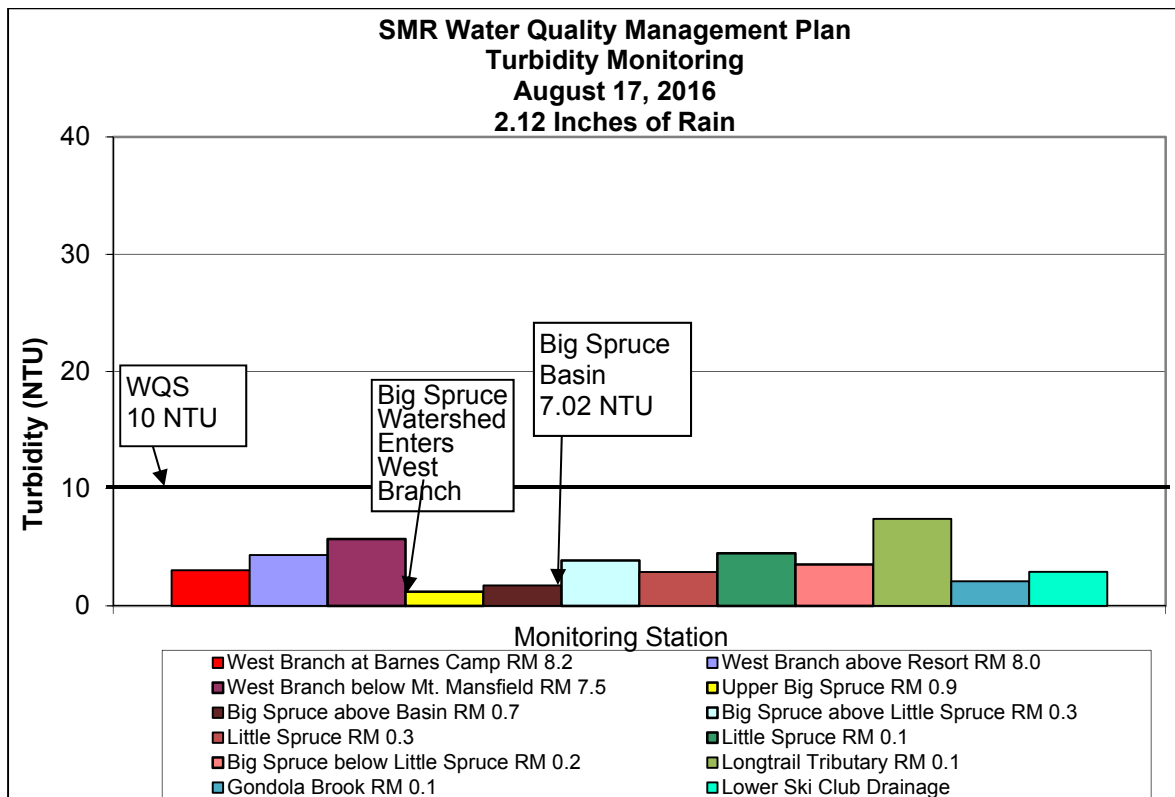
Figure 12. Turbidity results from August 17, 2016.

As shown below in Figure 12, turbidity was below Vermont Water Quality Standards at all stations on August 17, 2016. Turbidities were very low overall, with the highest stream turbidity being 7.42 NTU on Long Trail Brook at RM 0.1. The only basin outlet sampled during this event was the Big Spruce basin, which had a turbidity of 7.02 NTU. Figure 13 displays turbidity values observed at each surface water and basin station on August 17th.

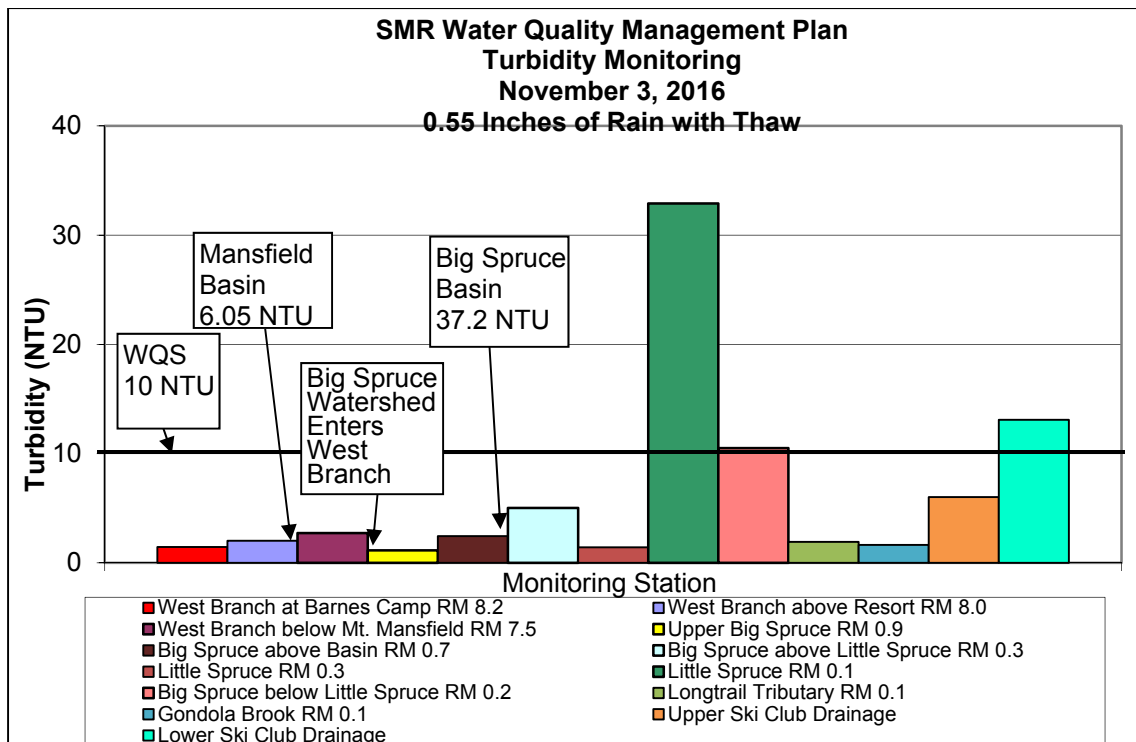
Figure 16. Turbidity results for sampling conducted on November 3, 2016.

The turbidity results for November 3, 2016 were good overall. Two stream stations exceeded the VWQS – Little Spruce at RM 0.1 (32.9 NTU) and Big Spruce at RM 0.2 (10.5 NTU). The remaining stream stations ranged from 1.15 NTU at Big Spruce RM 0.9 to 5.03 NTU at Big Spruce RM 0.3. The Ski Club drainage measured 6.03 NTU at the upper station and 13.1 at the lower station. The Mansfield Basin and Big Spruce Basin measured 6.05 NTU and 37.2 NTU, respectively. Figures 16 and 17 show the turbidity results for this rain event.

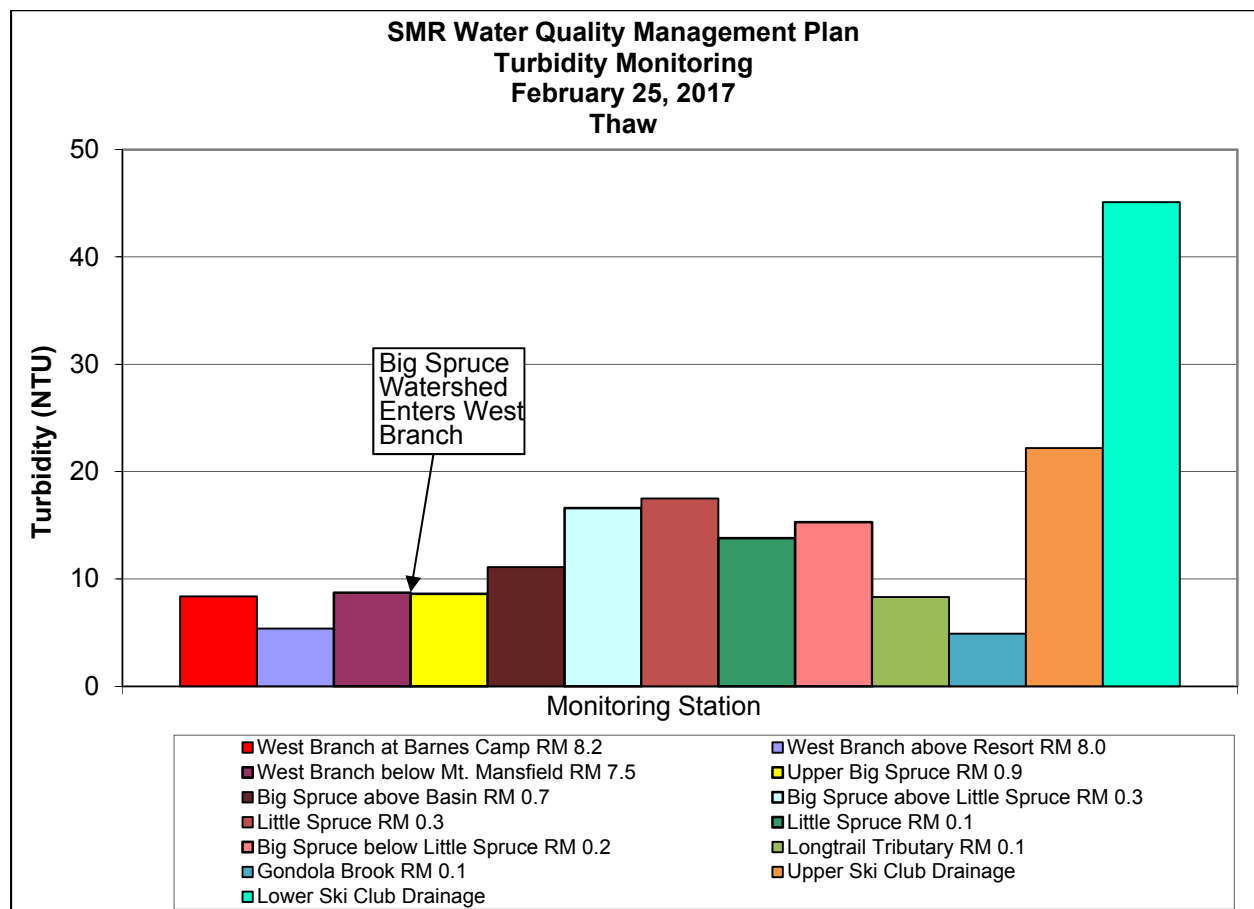
Figure 19. Turbidity results for sampling conducted on February 25, 2017.

Turbidity results were low overall for the stream stations sampled during the February 25, 2017 melt event. The highest turbidities were observed at the lower and upper Ski Club drainage stations, at 45.1 NTU and 22.2 NTU, respectively. Little Spruce Brook at RM 0.3 had a turbidity of 17.5 NTU at the time of sampling, while lower Little Spruce Brook had a turbidity of 13.8 (RM 0.1). The highest turbidity on Big Spruce Brook was recorded at RM 0.3 at 16.6 NTU. Turbidities on the Mansfield side of the Resort were all low, below 9 NTU. Samples were not collected from any sediment basins due to lack of safe access for sampling. Turbidity results for this event are shown below in Figures 19 and 20.

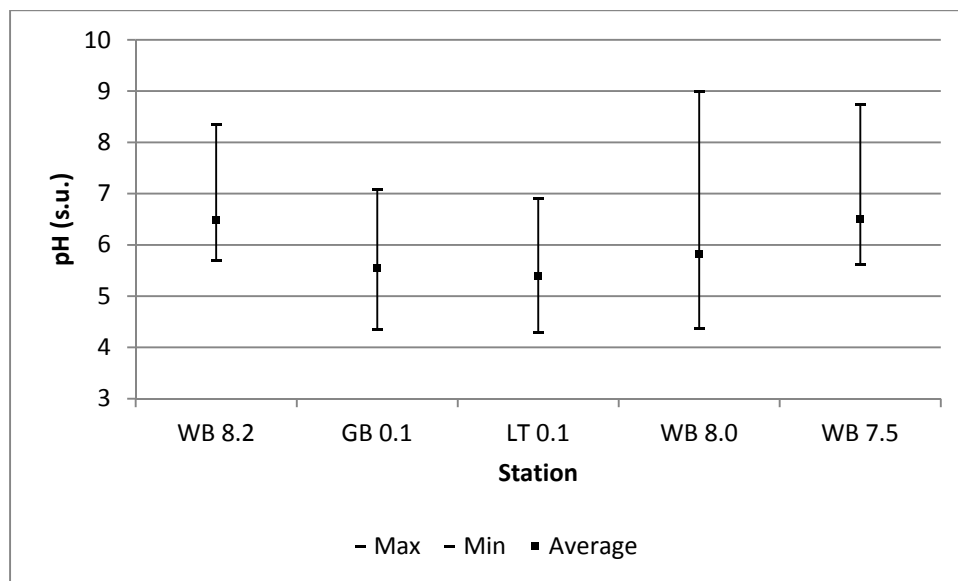
Figure 21. Range and average pH Values for the West Branch.

Event-based sampling reveals that streams in the vicinity of Stowe Mountain Resort are critically acidified. In particular, the high elevation streams and undeveloped watersheds appeared to be severely acid stressed. The West Branch below Barnes Camp, Long Trail Brook and Gondola Brook have mean pH values of less than 6.0 s.u., as shown below in Figure 21. The West Branch above the Resort has a low buffering capacity, as indicated by several years of baseflow chemistry results. Below Barnes Camp, Gondola Brook and Long Trail Brook flow into the West Branch. These small upland streams have low pHs and appear to lower the pH of the West Branch as they flow together. This has implications for the biological community at station WB 8.0 and below.

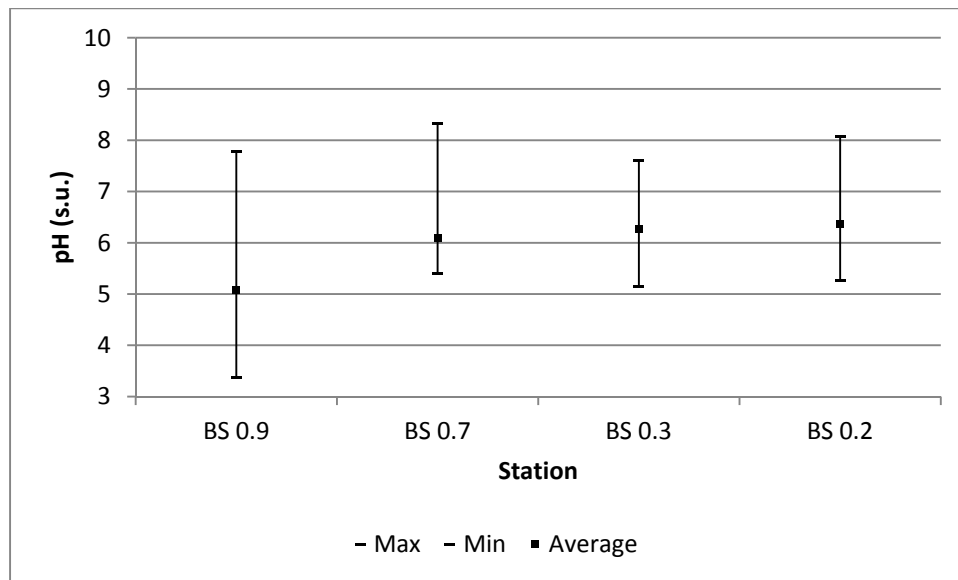
Figure 22. Range and average pH values for Big Spruce Brook.

On the Spruce side of the Resort, stream acidification has also historically been an issue. Upper Big Spruce Brook in the vicinity of RM 0.9 has exhibited low pH values for event-based monitoring over its 14-year monitoring history. The mean pH for BS 0.9 for event-based monitoring is 5.09 s.u. and the minimum is 3.38 s.u., as shown below in Figure 22. Stream pH generally increases downstream of BS 0.9 according to these historic data.

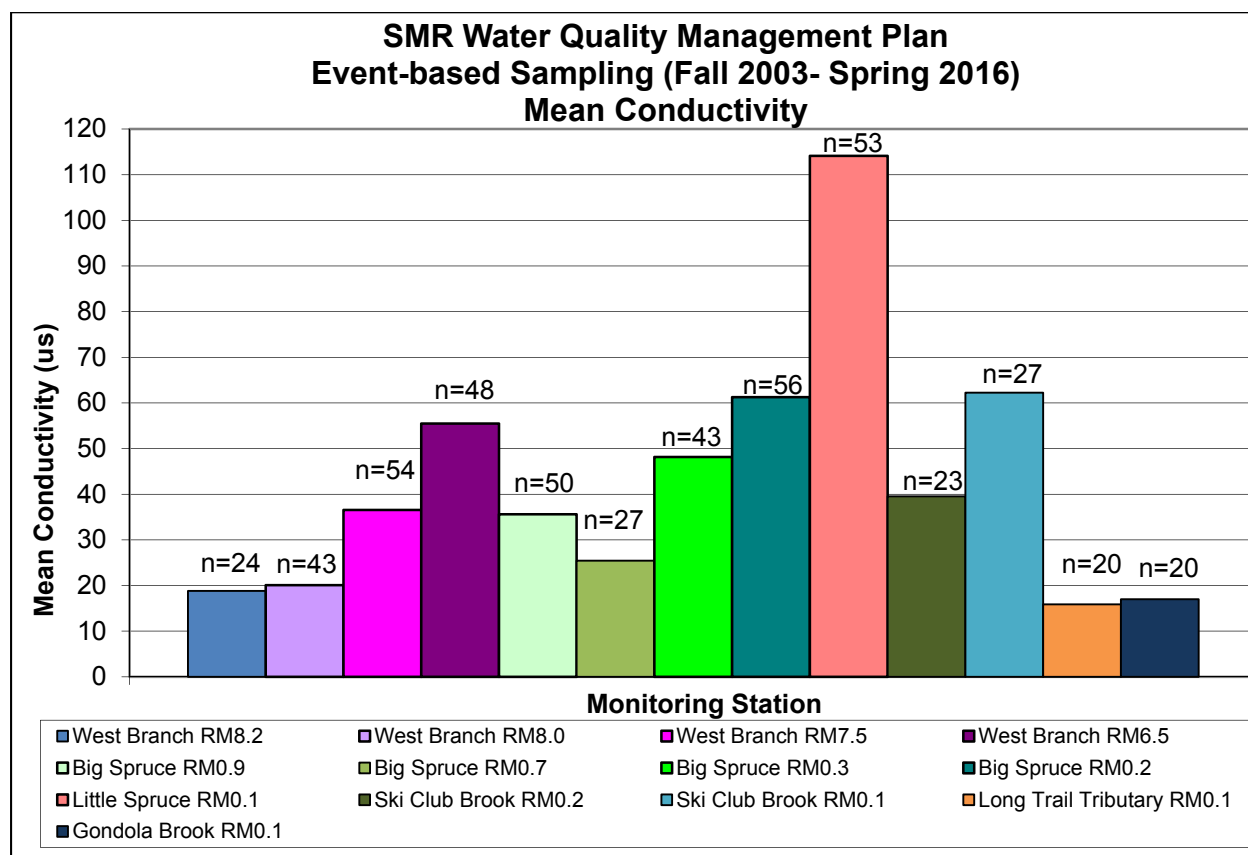
Figure 23. Mean conductivity reported for event-based sampling for fall 2003 through spring 2016.

In general, conductivity levels were highest on Little Spruce Brook and lowest on the upper West Branch, Long Trail Brook, and Gondola Brook. The mean conductivity for the period of fall 2003 through spring 2015 for each of the monitoring stations is provided below in Figure 23.

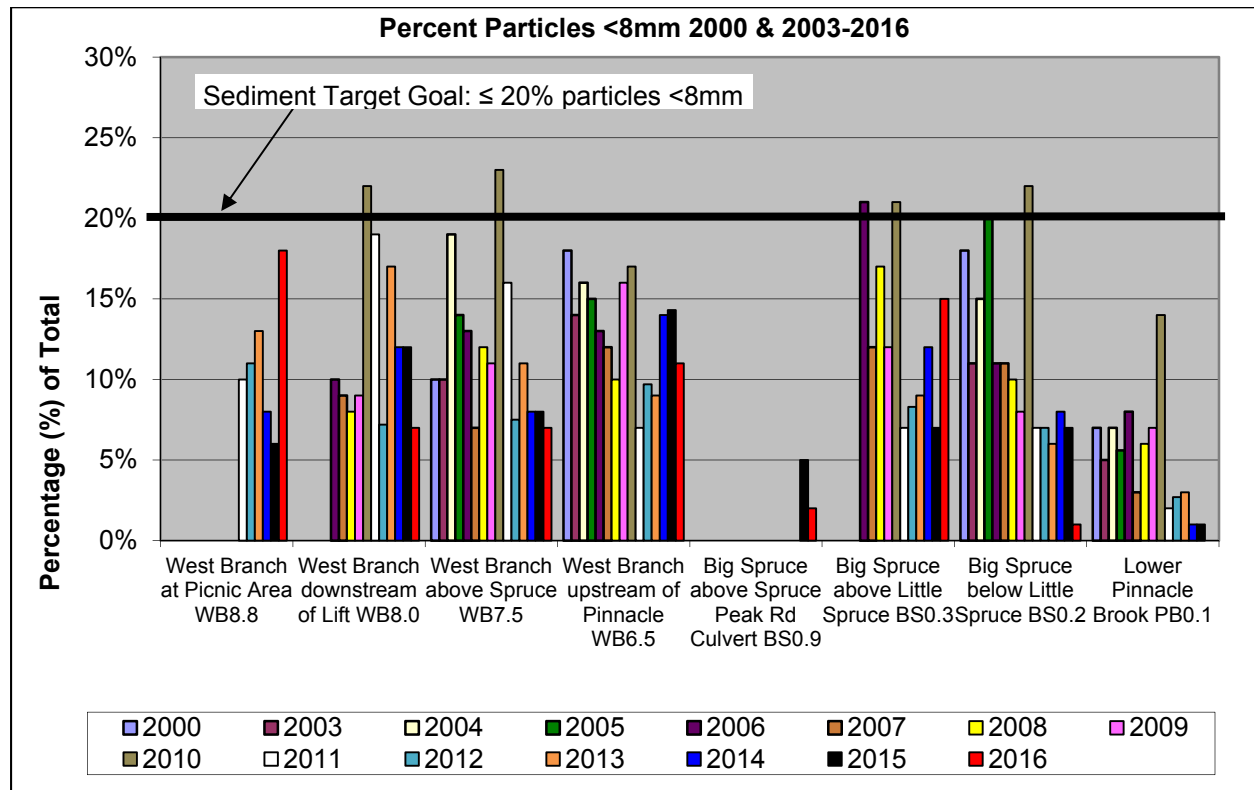
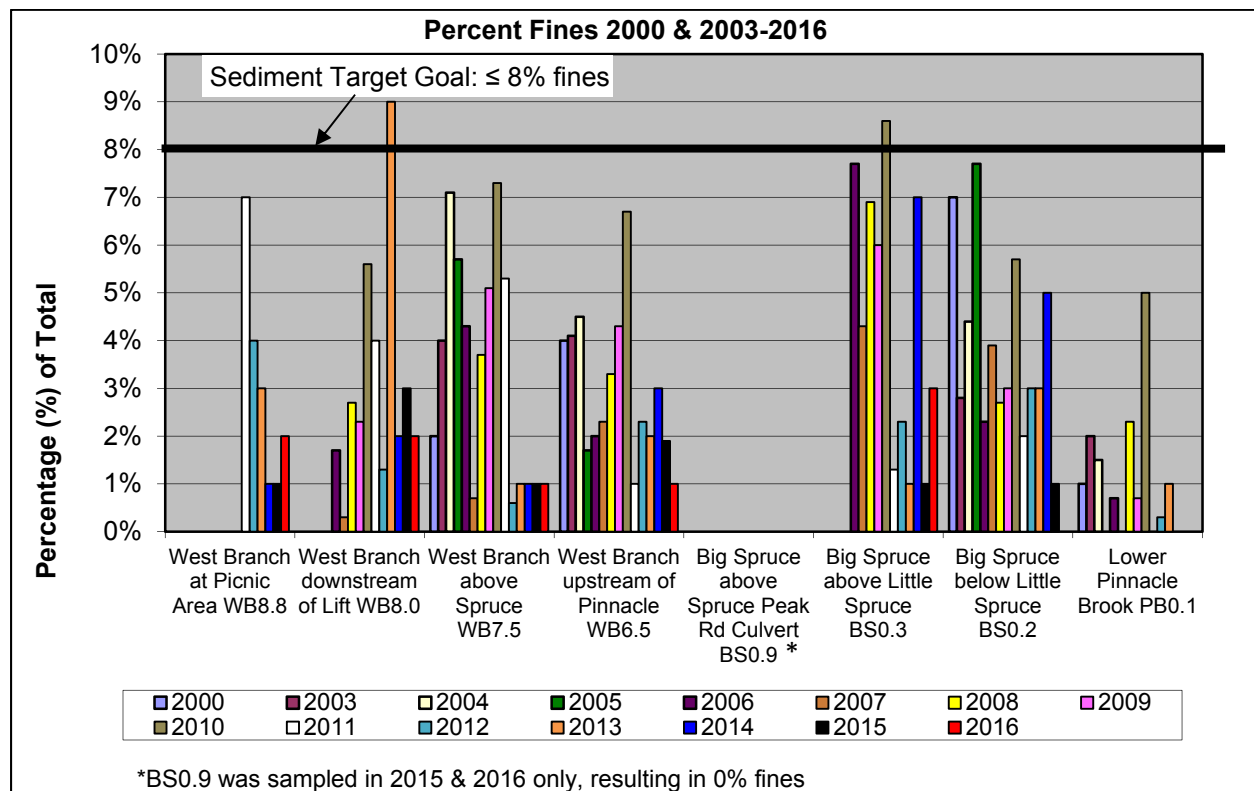
Figures 24 and 25. Substrate Assessment.

The pebble count data serve as an important tool for understanding improvement in habitat from remediation efforts as well as impacts from catastrophic flood events. As shown below in Figure 24, the percentage of particles less than 8 mm met the target threshold of less than or equal to 20 percent of the substrate composition at all monitoring stations in 2016. Both the graph of the percentage of particles less than 8 mm and the percent fines (Figure 25), indicate there was a shift toward smaller particle sizes in 2010. A high flow event in August 2010 was the primary cause and the percentage of fines has generally decreased since 2010 as the sediment works its way through the study area. This shift can be seen for each station on the graphs in Appendix 3.

All the monitoring stations in 2016 also met the target for percent fines. Each station met all three target goals for sediment in 2016. Streams in the vicinity of SMR will continue to be monitored for changes in channel substrate condition as the MDP continues to be implemented.

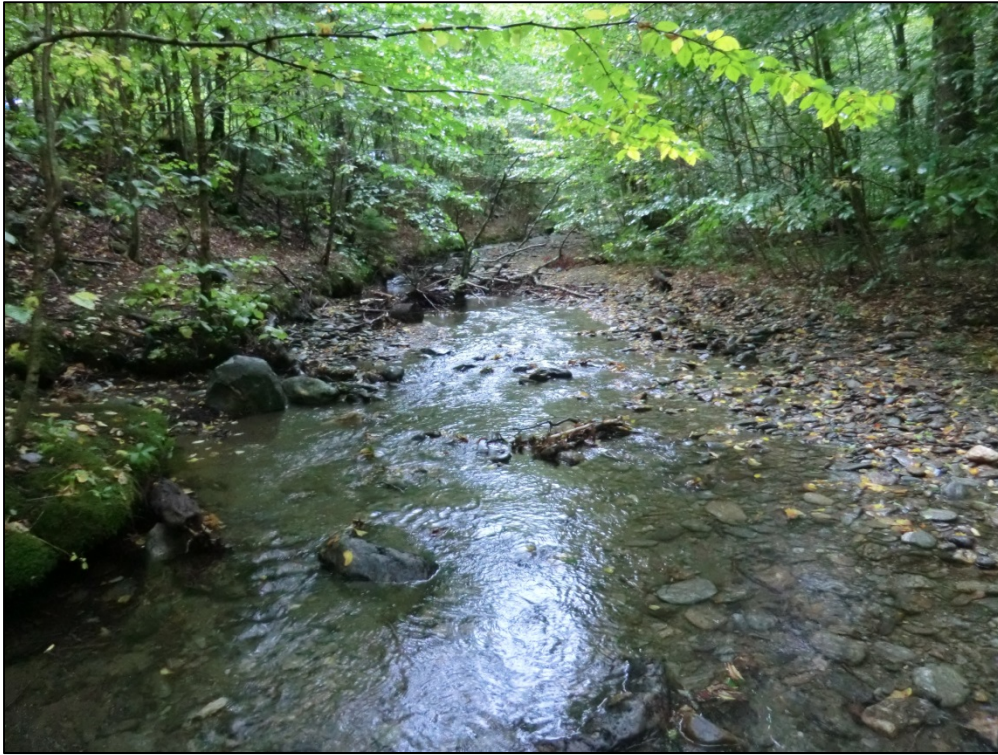
Figure 27. West Branch RM 8.8 (9/23/16).

West Branch RM 8.8 has a surrounding land use of forest and is located off the Notch Road about a half mile upstream of Barnes Camp. Riffle embeddedness was estimated to be within the range of 5-25% and the silt rating was “2-3”. Fine particulate organic material (FPOM) was noted to be present at this station and influenced the silt rating. Diatom coverage on the gravel dominated substrate was estimated to be 50 percent. Stream bank stability was very good (60-80% stable), as shown below in Figure 27.

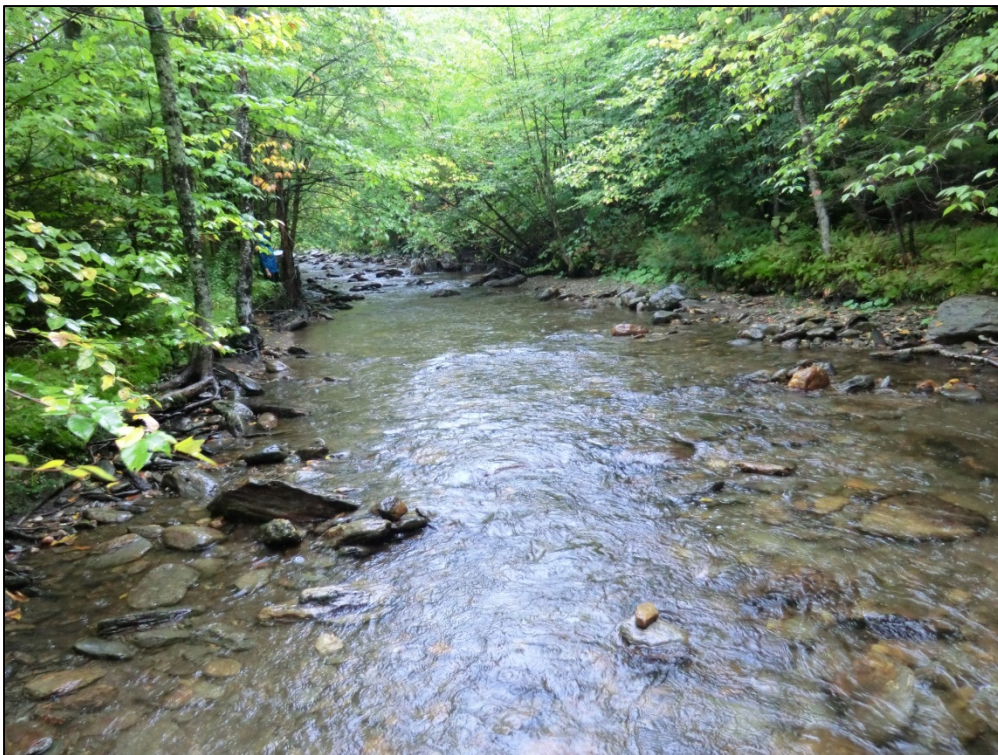
Figure 28. West Branch RM 8.0 (9/23/16).

West Branch RM 8.0 is located downstream of the transfer lift crossing. Small iron seeps were present along the stream margins. Embeddedness was in the range of 5-25% in the riffle habitat. Bank stability was good (40-60% stable). Canopy cover was estimated to be partly open, creating a cover of about 70 percent (Figure 28). The diatom cover was 90 percent.

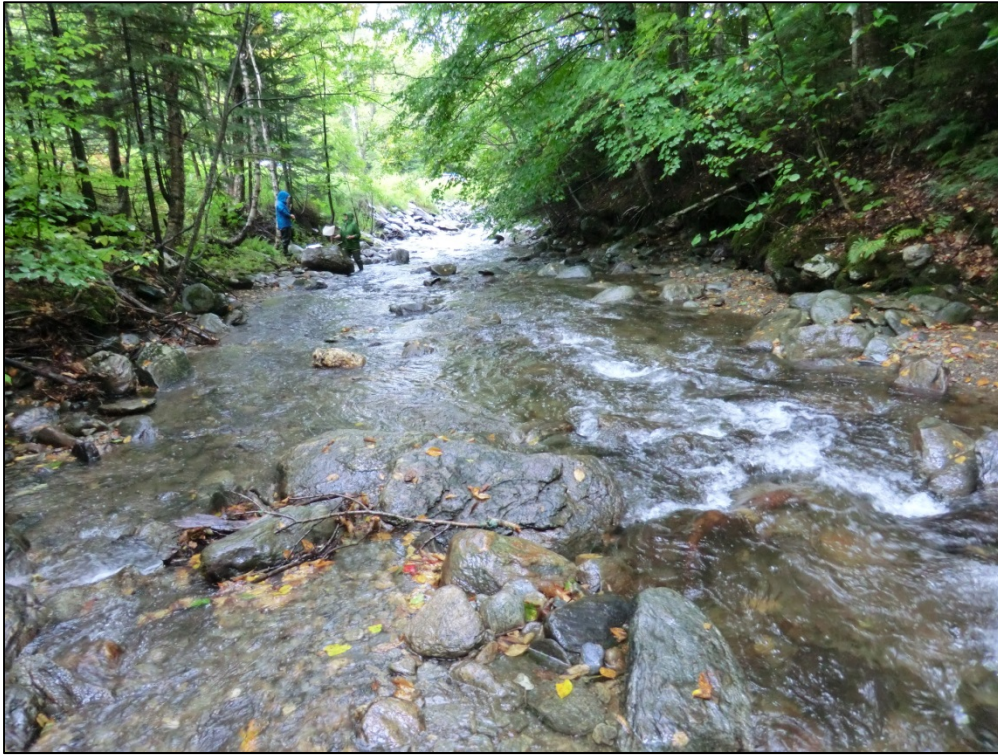
Figure 29. West Branch RM7.5 (9/23/2016).

West Branch RM 7.5 is located downstream of the exit to the Mansfield parking lot, below the outlets of both the Mansfield Basin and the Mansfield Exit Basin. Diatoms were the dominant periphytic cover. Embeddedness was estimated to be 5-25%, and light iron staining was noted. The leaves were mainly on providing a canopy cover of 80 percent, as shown in Figure 29.

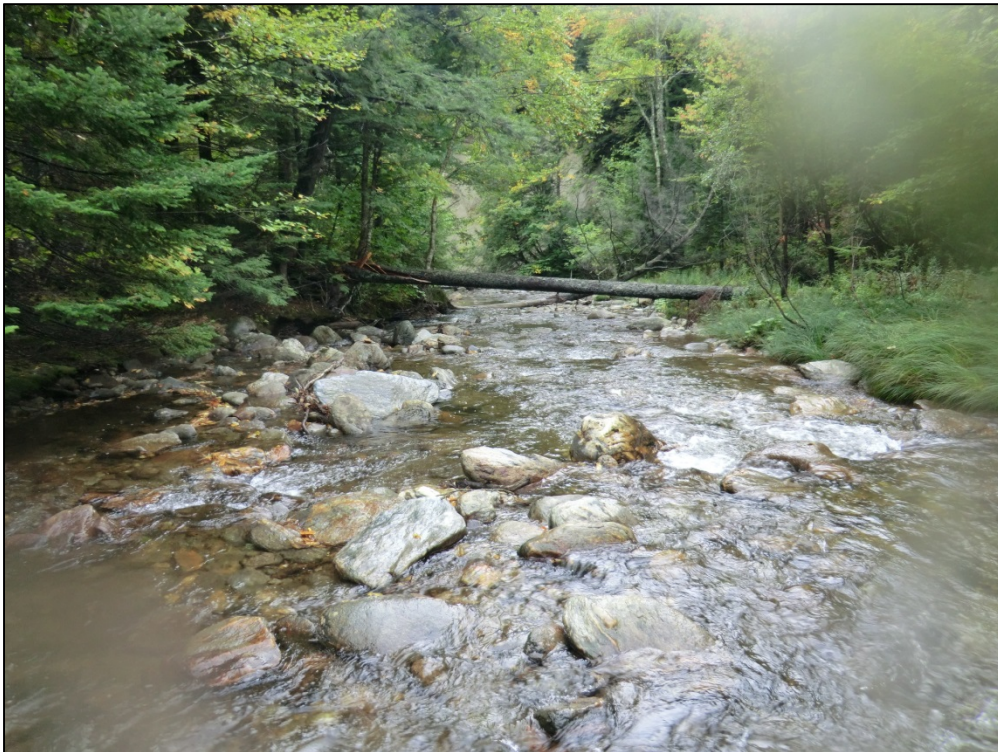
Figure 30. West Branch RM7.4 (9/23/2016).

West Branch 7.4 was added in 2016 to provide a station downstream of the Mansfield parking lot and basin that is less prone to scouring than RM 7.5. The station is located just downstream of station 7.5, immediately below the riprap along Route 108 but above the mass failure on the south bank of the brook. Embeddedness at this station was between 5-25%, canopy cover was 40%, and the station was lower gradient than 7.5 (Figure 30).

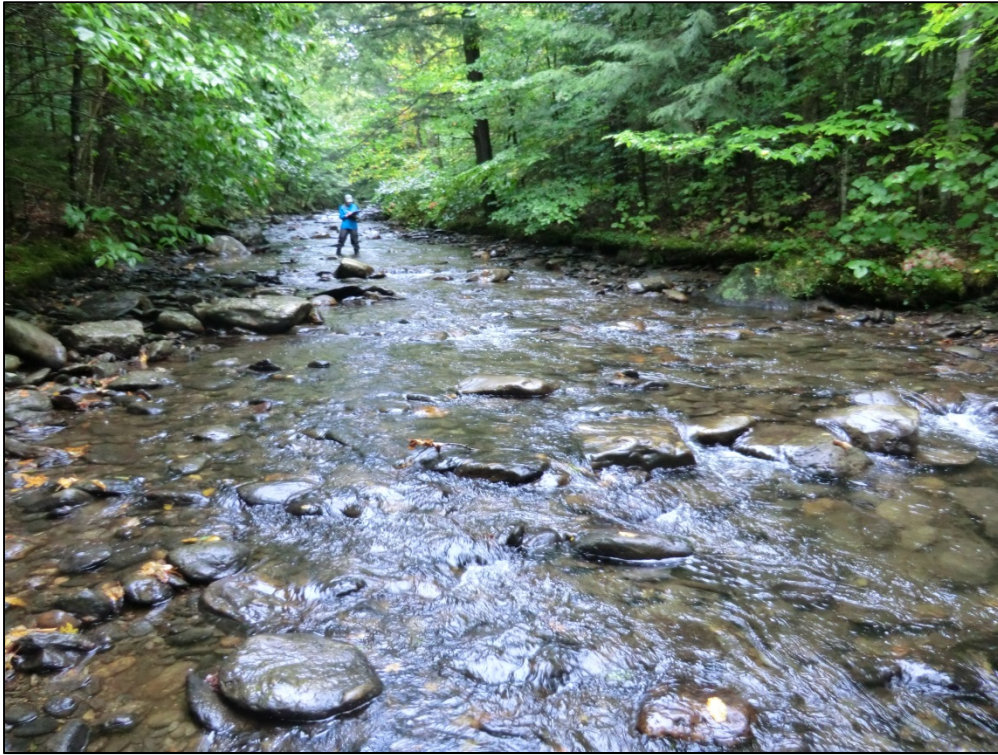
Figure 31. West Branch RM 6.5 above the confluence with Pinnacle Brook (9/23/16).

The lowest station on the West Branch is at RM 6.5, and is located immediately upstream of the confluence with Pinnacle Brook. Bank stability in 2016 was rated as very good at WB 6.5, and substrate embeddedness was rated as 5-25 percent. The diatom coverage was approximately 90 percent. Canopy cover was partly open and was estimated to be 60 percent, as shown in Figure 31.

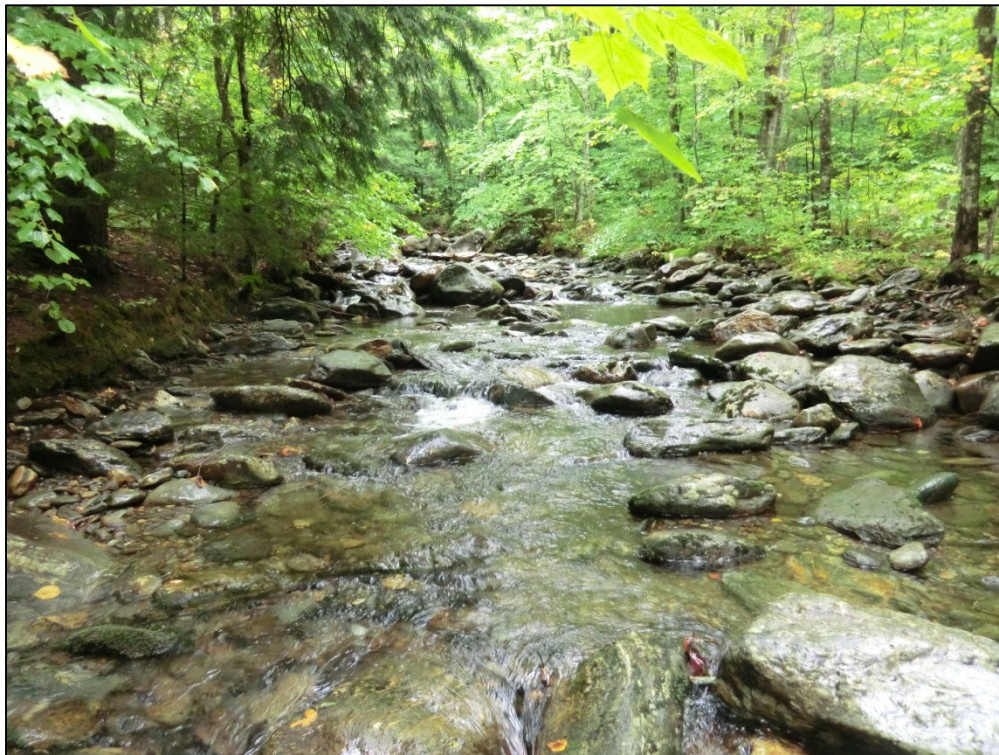
Figure 32. Pinnacle Brook monitoring station (9/23/16).

The reference/control station for biomonitoring is located at the mouth of Pinnacle Brook. In 2016, bank stability was rated as excellent (80-100% stable). Based on habitat observations, the silt rating was 2-3 and embeddedness minimal (0 to 5 percent). Canopy cover was approximately 70 percent and leaves were still on the trees. There was 80% diatom cover and a 10% cover of blue-green algae. Figure 32 shows the Pinnacle Brook monitoring station.

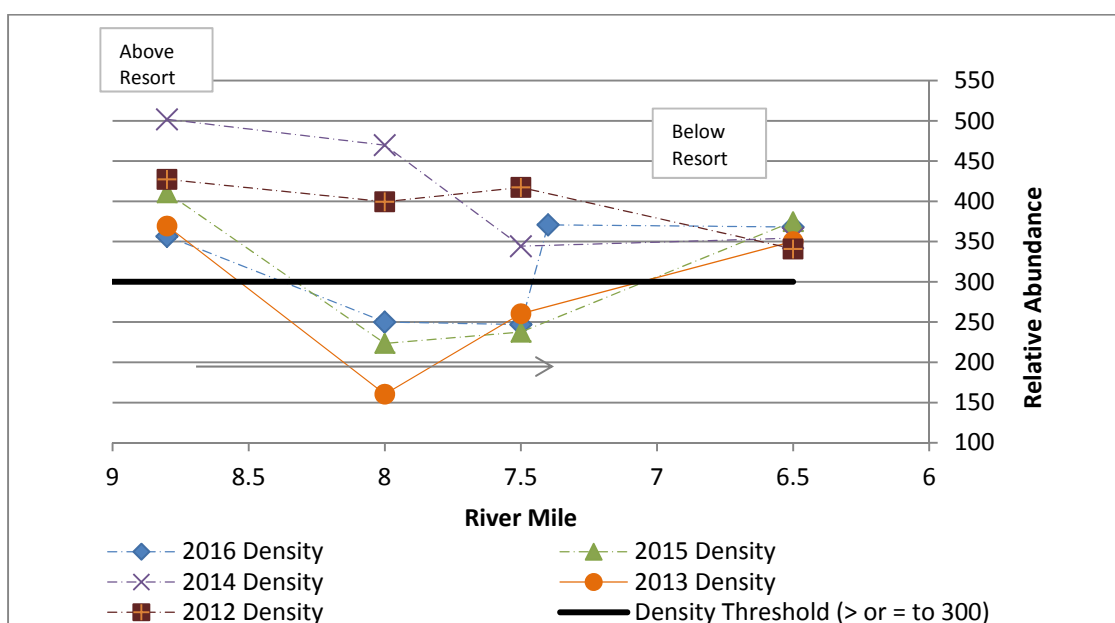
Figure 34. Density in kick net samples for past five years on West Branch.

Graphs of some of the key biometrics were created to better understand trends of the macroinvertebrate community of the West Branch. Biomonitoring data for the past five years collected by Bear Creek Environmental for Stowe Mountain Resort was utilized. The graph of density (Figure 34) shows the number of bugs at RM 8.8 above the Resort is low, but is above the threshold of 300 organisms. The average density in the kick net samples at RM 8.0 and 7.5 (within the Resort) has been less than the threshold of 300 organisms in about half of the years. A recovery in density occurs at RM 6.5 below the Resort.

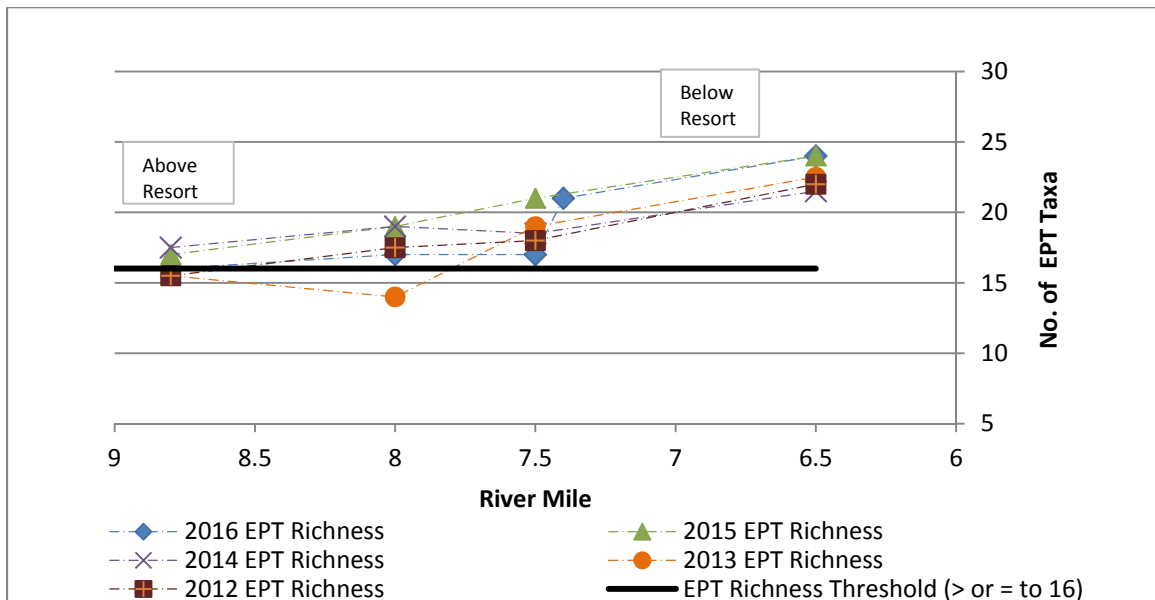
Figure 35. Number of EPT Taxa in kick net samples for past five years on West Branch.

A second graph (Figure 35) shows the number of water quality sensitive organisms from the orders Ephemeroptera (mayflies), Plecoptera (stoneflies) and Trichoptera (caddisflies). Upstream of the Resort at RM 8.8 the number of EPT taxa hover around the threshold value of 16. In other words, in some years the metric is lower than the threshold value and the station does not meet Class B2. In other years, the number of EPT taxa is just above the threshold value. The low EPT Richness and Total Richness are likely attributed to very low alkalinity. Based on water chemistry data collected at RM 8.0, this station also has a low alkalinity and low EPT and Richness, although there was only one sampling event within the past five years that resulted in EPT Richness and Richness values less than the thresholds.
