**Stowe Mountain Resort
SMR 2000 Community Plan
Water Quality Management Plan**

2016 Monitoring Report

May 30, 2017

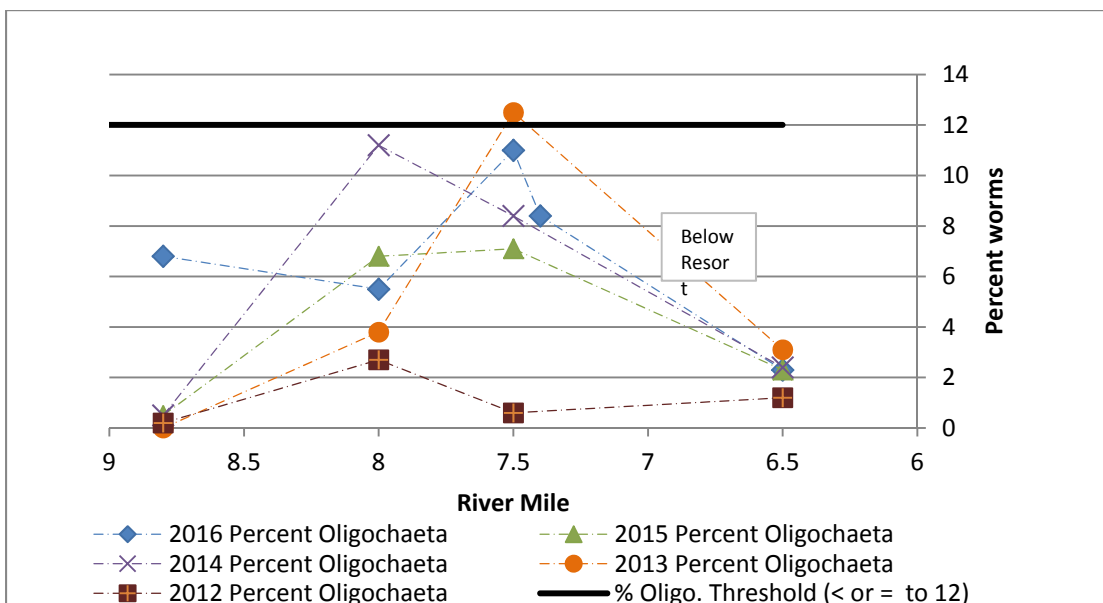
Figure 36. Percentage of Oligochaeta in kick net samples for past five years on West Branch.

Biomonitoring results from WB8.0 and WB 7.5, within the Resort, indicate sedimentation is an issue. The percentage of Oligochaeta at WB 8.0 and WB 7.5 is high compared to stations above and below the Resort, as shown below in Figure 36. Four years ago, Stowe Mountain Resort implemented significant stormwater improvements associated with the parking lots at Mount Mansfield. The Resort continues to look for opportunities to improve stormwater management.
