**DRAFT River Corridor Plan
Castleton River: Town of Castleton**

Rutland County, Vermont

March 2007

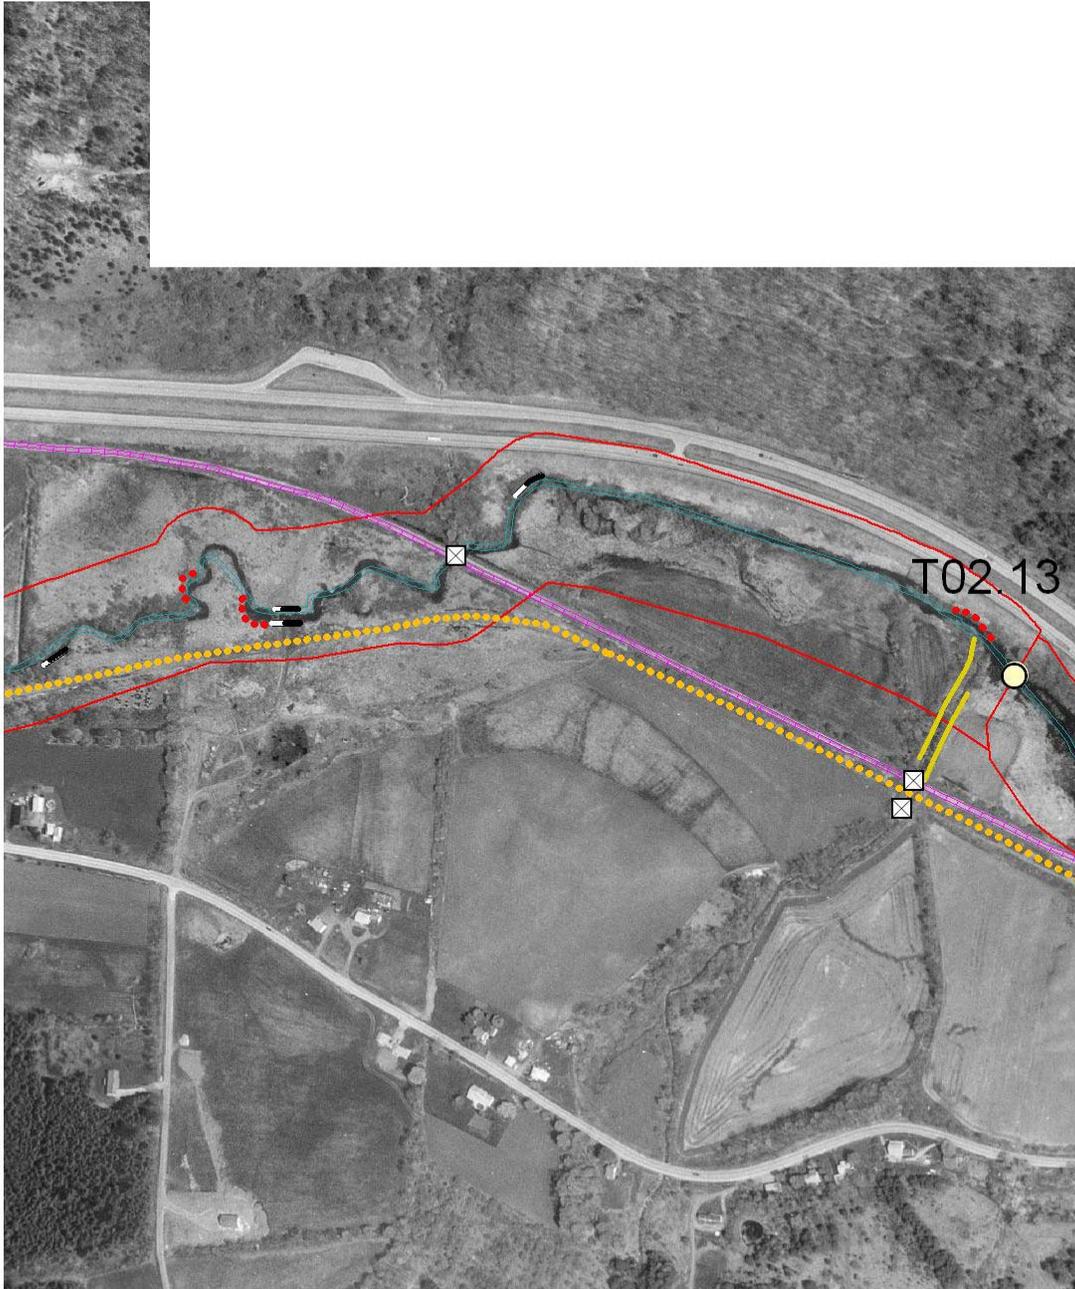
Castleton River watershed
Reach: T2.12 u/s
Date: 6/28/2005

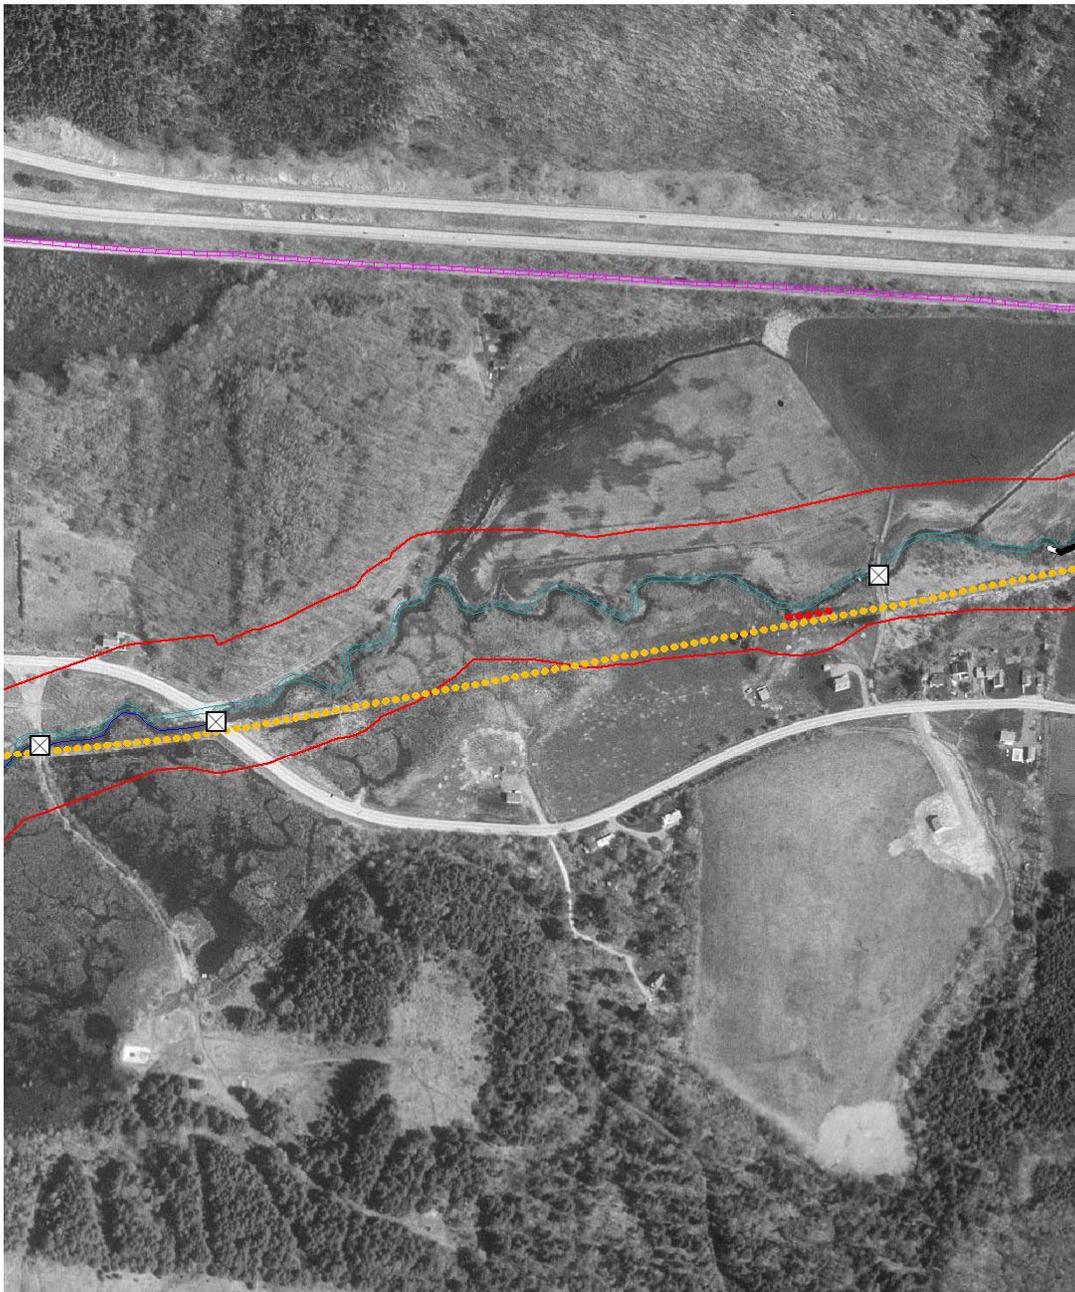
Castleton River watershed
Reach: T2.12 m/s
Date: 6/28/2005

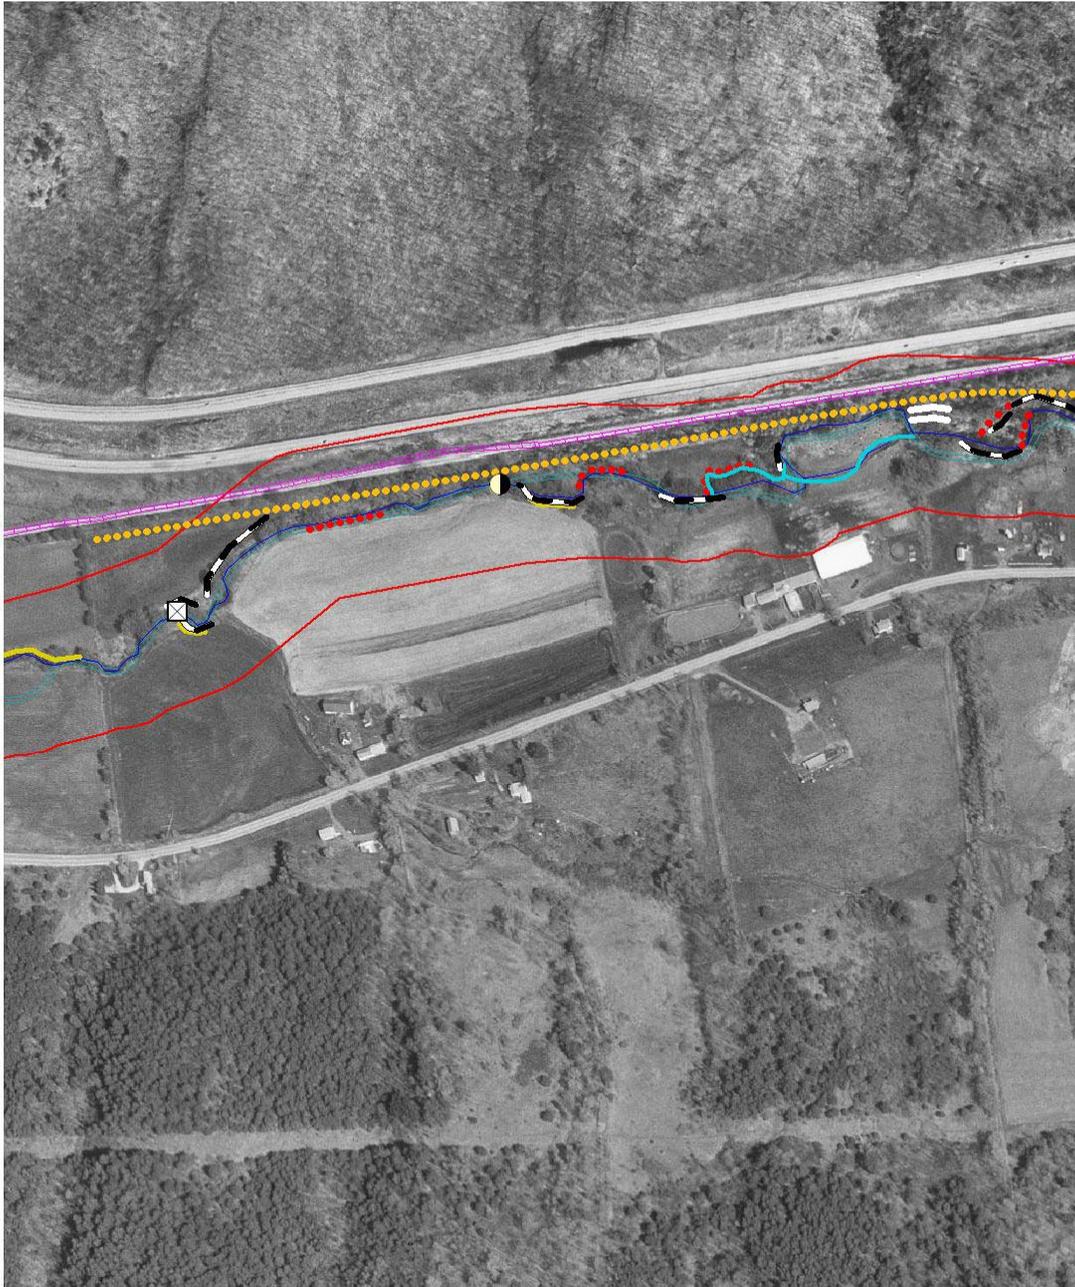
Castleton River watershed
Reach: T2.11 m/s
Date: 6/30/2005

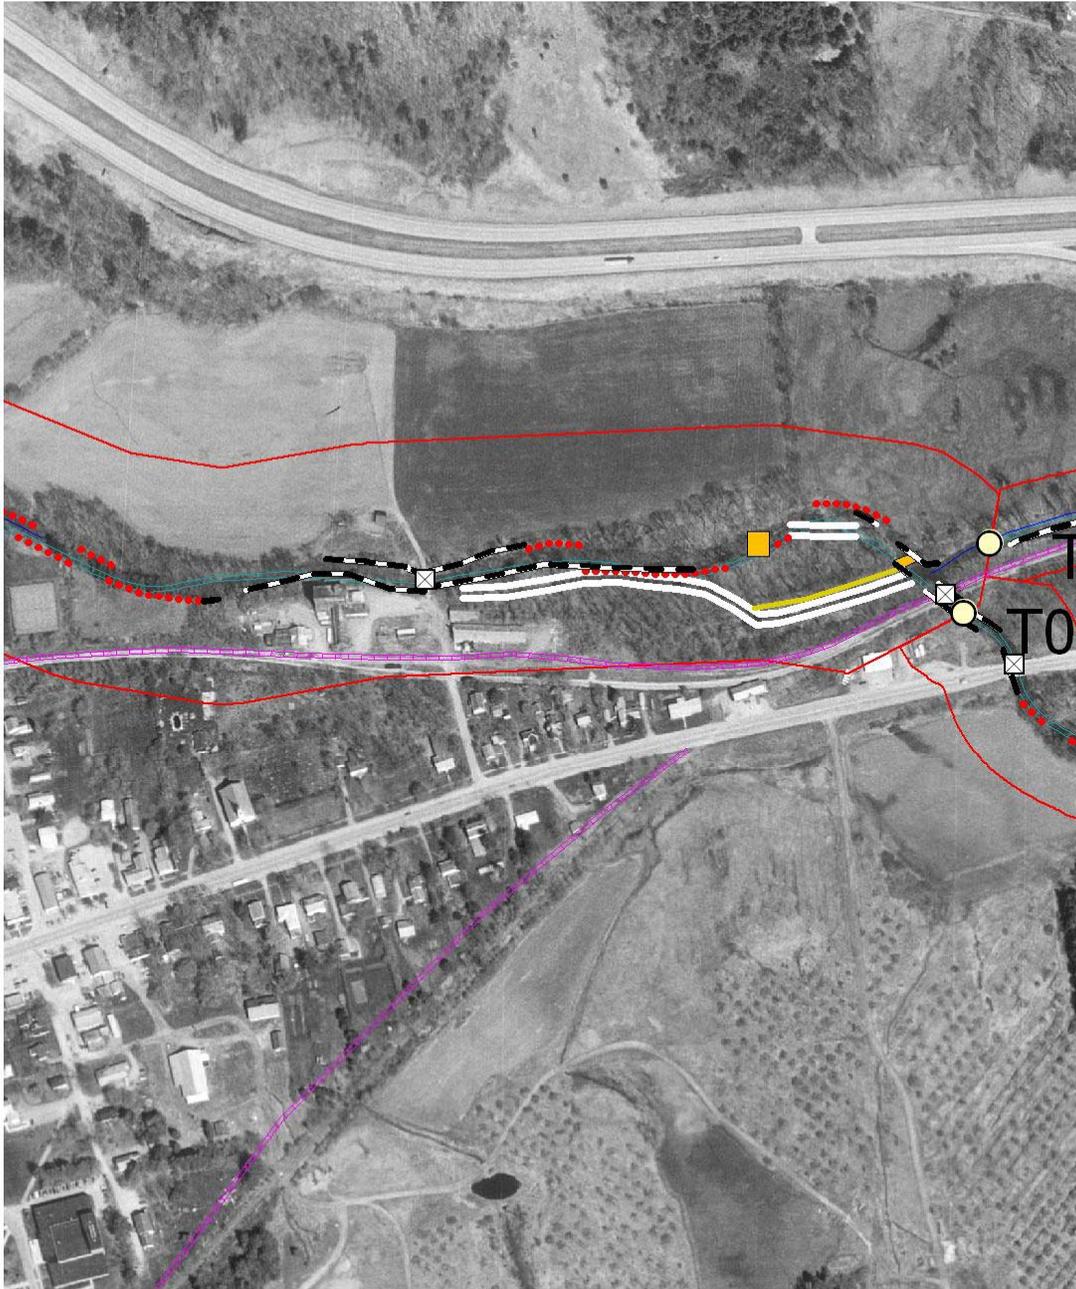
Castleton River watershed
Reach: T2.09 u/s
Date: 8/11/2005
