**Annual Report for General Permit 3-9014 (2012) MS4**

National Pollutant Discharge Elimination System (NPDES) Number: VTR040000 for Stormwater Discharges from Small Municipal Separate Storm Sewer Systems (MS4)

Burlington International Airport  
South Burlington, Vermont

April 1, 2019

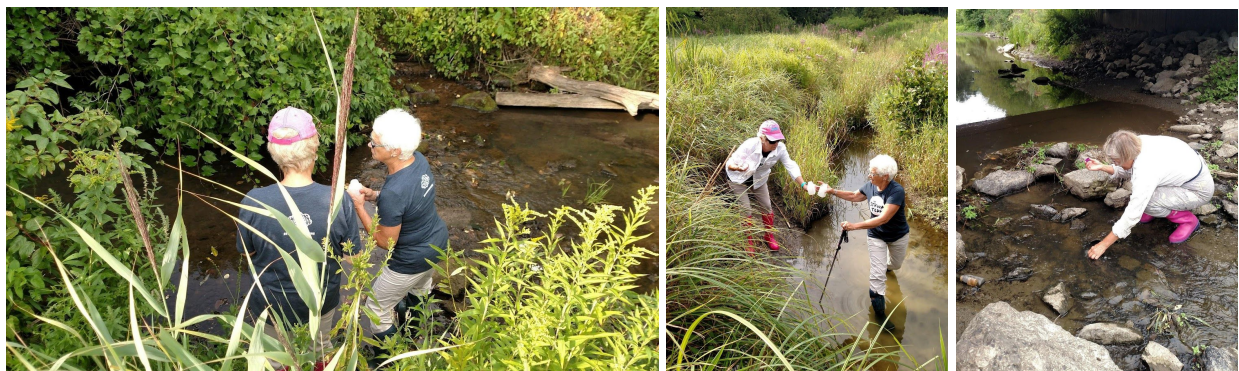
**Figure 6: Volunteers sampling at Indian 10, Indian 20 and Muddy 30 on 8/7/18**

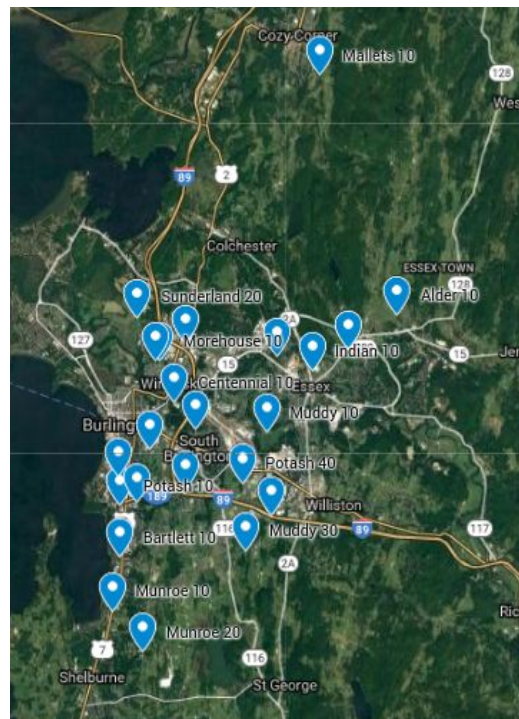
Figure 1: 2018 Rethink Runoff Stream Team Sample Sites. An interactive version of this map is available here:

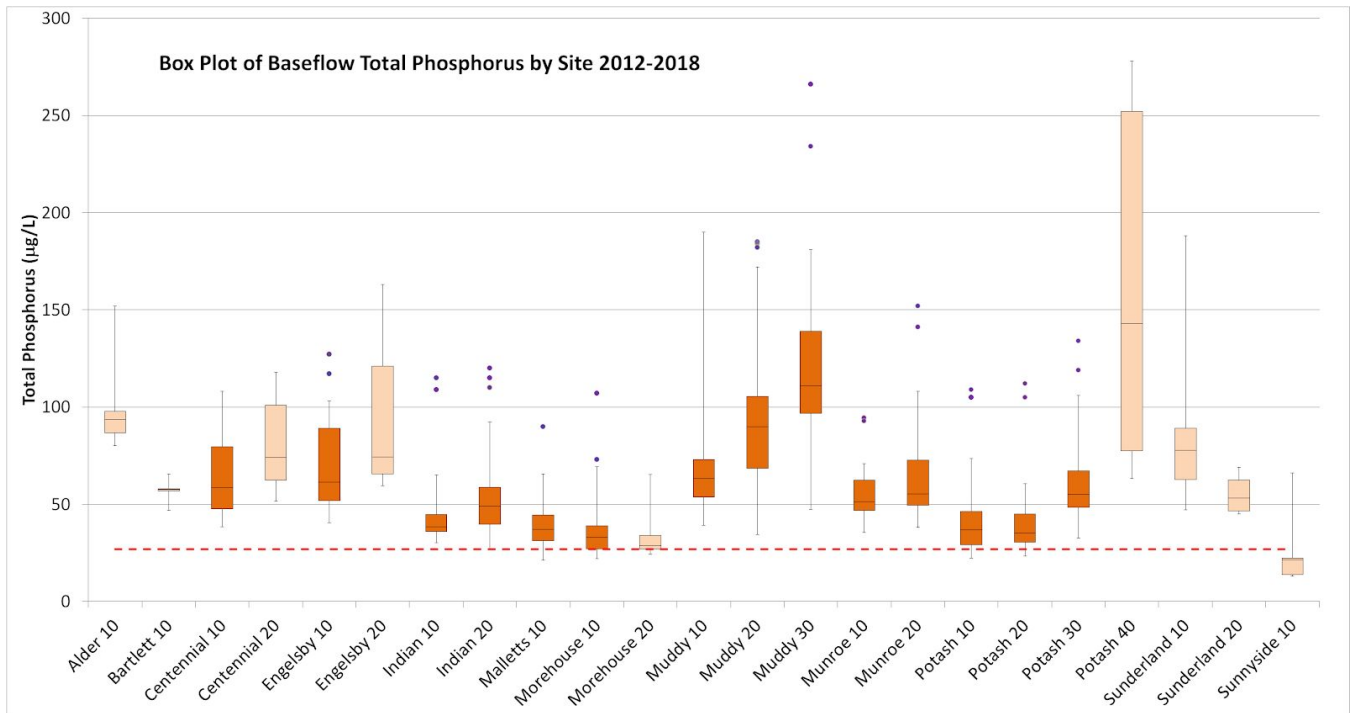
**Figure 2. Comparison of total phosphorus levels across sites 2012-2018.** Box plots indicate first and third quartiles and median values of total phosphorus concentrations for all sites. These values were calculated including sampling dates that may or may not have associated flagged dupe or blank samples. Lighter colored boxes indicate 1-2 years of sampling data, darker boxes indicate 6-7 years of sampling data. Dots indicate outliers which were identified as equal to or greater than 2 times the site’s standard deviation. Red line indicates Vermont’s 2016 Water Quality Standard of 27 micrograms/L.

Figure 2 suggests that phosphorus levels increase as sampling moves upstream. To test this hypothesis, RRST used scatter plots to graph phosphorus data over time by stream and ran statistical analyses on 8 streams that had more than one sampling site. Of the 8 streams that have more than one sampling location, 6 indicated a statistically significantly different value of phosphorus between sites, all of which presented statistically significantly higher concentrations of total phosphorus upstream. Table 4 summarizes the results of these tests. Appendix D summarizes statistics and graph visualizations. This result was somewhat surprising and merits more consideration since we assumed that total phosphorus increased in concentration as water moves downstream and more inputs are introduced.

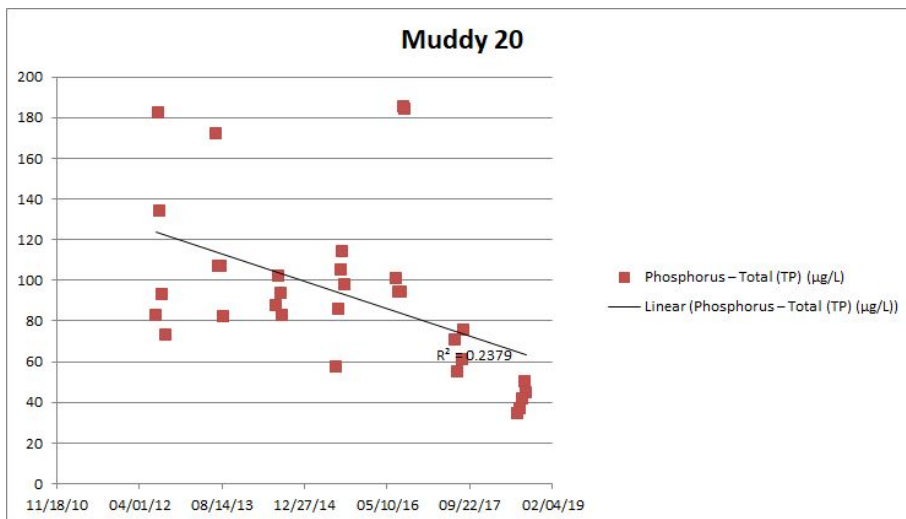
**Figure 3. Total Phosphorus in Muddy 20 since 2012.** Scatter plot visually suggests a downward trend but R2 of the best fit line is still only about 0.24 and not significant.

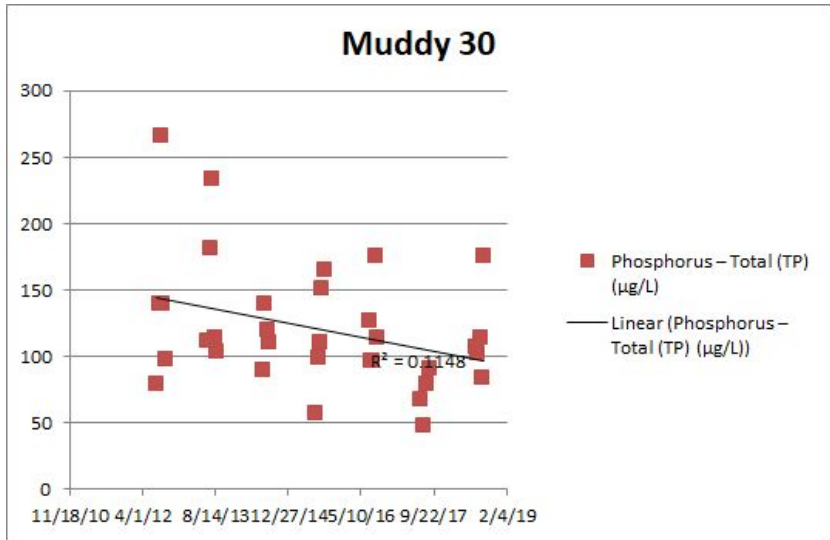
**Figure 4. Total Phosphorus in Muddy 30 since 2012.** Scatter plot visually suggests a downward trend but R2 of the best fit line is still only about 0.12 and not significant.

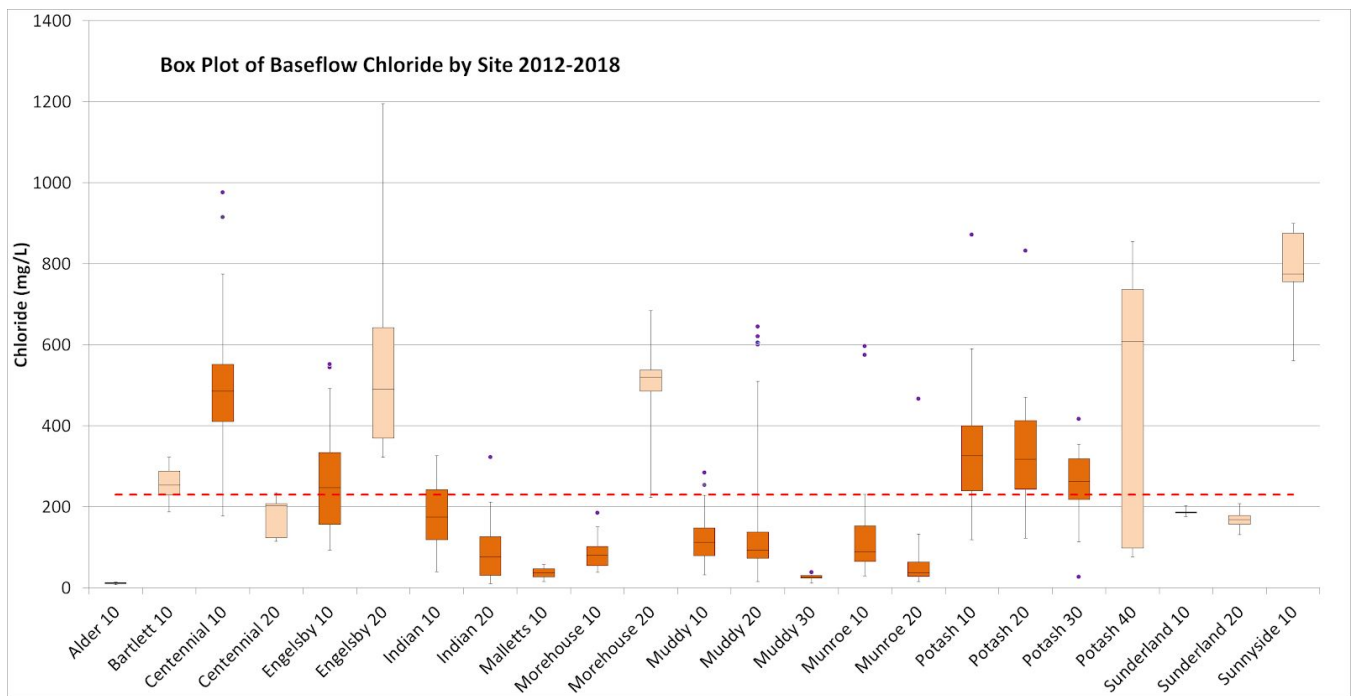
**Figure 5 - Comparison of Chloride levels across sites 2012-2018.** Box plots indicate first and third quartiles and median values of chloride levels (mg/L) for all sites. Lighter colored boxes indicate 1-2 years of sampling data, darker boxes indicate 6-7 years of sampling data. Dots indicate outliers which were identified as equal to or greater than 2 times the site’s standard deviation. EPA’s and Vermont’s standard for 4-day average chloride levels (230 mg/L) is shown by the red line.

Since the onset of this monitoring program, mean chloride levels at Centennial 10 and Potash 10, 20 and 30 have remained notably above 230 mg/L standard. Recently added sampling sites have also presented alarmingly high data including Engelsby 20, Morehouse 20, Potash 40, and Sunnyside 10.

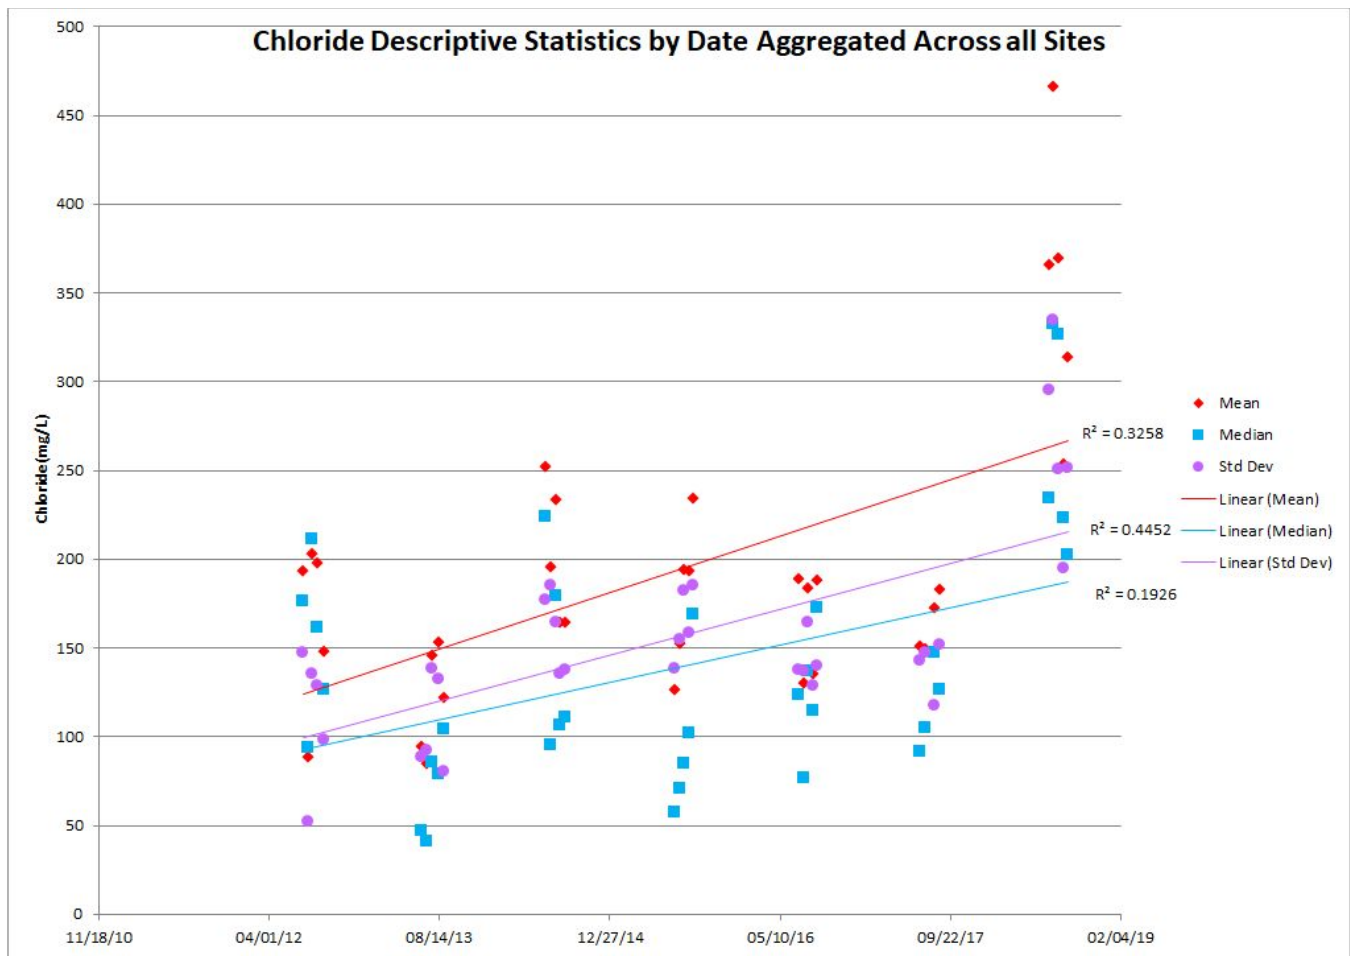
**Figure 6. Descriptive Statistics for chloride data gathered across sites aggregated by date.** Each sampling date since June 2016 had chloride values across sites averaged to determine mean, median, and standard deviation for the entire sampling area.

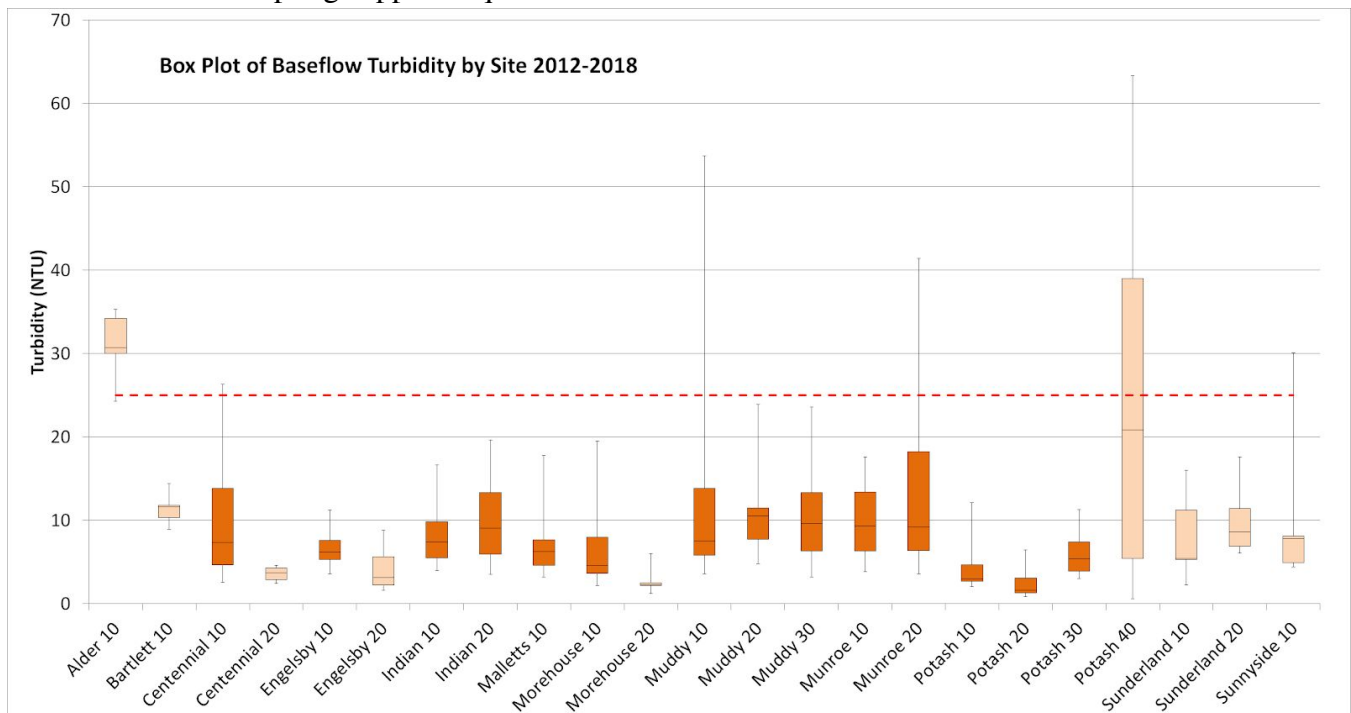
**Figure 7 - Comparison of turbidity levels 2012-2018 during baseflow (dry) conditions.** The standard proposed by the State of Vermont for mean turbidity at baseflow in medium gradient, warm water streams (25 NTU) is indicated by the red line. These values were calculated including sampling dates that may or may not have associated flagged dupe or blank samples.

Mean, baseflow turbidity values have only rarely exceeded the VT standard for warm-water streams of 25 NTU over the seven year sampling period. Of note, however, is the high turbidity recorded for new sampling sites Alder 10 and Potash 40. Higher turbidity in Alder 10 is not surprising because the site is comparatively more agricultural with a couple farms and potential field runoff nearby. Turbidity has not been included in sampling support requests for the 2019 field season but will be revisited in 2020.

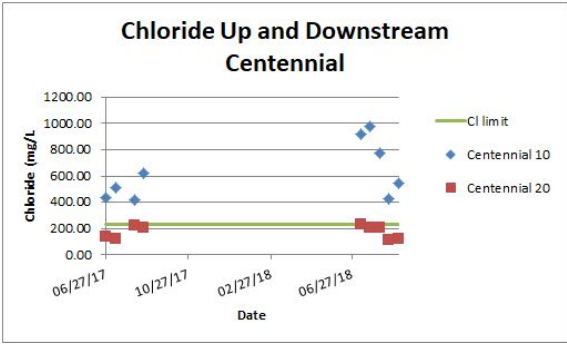
<p><b>Chloride Up and Downstream Centennial</b></p> <p>This scatter plot shows chloride levels (mg/L) from 06/27/17 to 06/27/18. The y-axis ranges from 0.00 to 1200.00. A green horizontal line represents the 'Cl limit' at approximately 200 mg/L. Blue diamonds represent 'Centennial 10' and red squares represent 'Centennial 20'. Most data points are below the limit, with a notable spike for Centennial 10 in early 2018.</p>
Engelsby	0, 6, 0.05

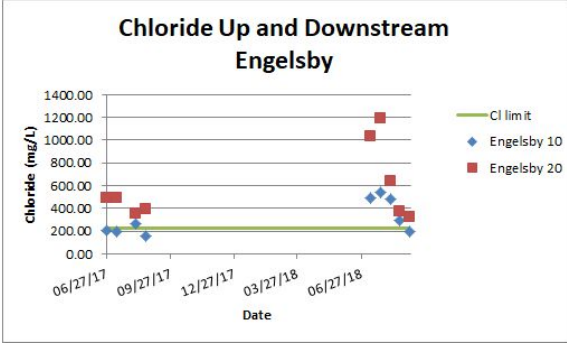
<p><b>Chloride Up and Downstream Engelsby</b></p> <p>This scatter plot shows chloride levels (mg/L) from 06/27/17 to 06/27/18. The y-axis ranges from 0.00 to 1400.00. A green horizontal line represents the 'Cl limit' at approximately 200 mg/L. Blue diamonds represent 'Engelsby 10' and red squares represent 'Engelsby 20'. There is a significant spike for Engelsby 20 in early 2018, reaching over 1000 mg/L.</p>
Indian	1, 187, 0.05

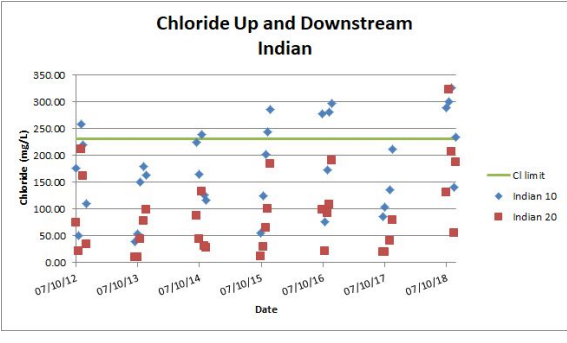
<p><b>Chloride Up and Downstream Indian</b></p> <p>This scatter plot shows chloride levels (mg/L) from 07/10/12 to 07/10/18. The y-axis ranges from 0.00 to 350.00. A green horizontal line represents the 'Cl limit' at approximately 250 mg/L. Blue diamonds represent 'Indian 10' and red squares represent 'Indian 20'. Data points fluctuate around the limit, with several points for Indian 10 exceeding it.</p>

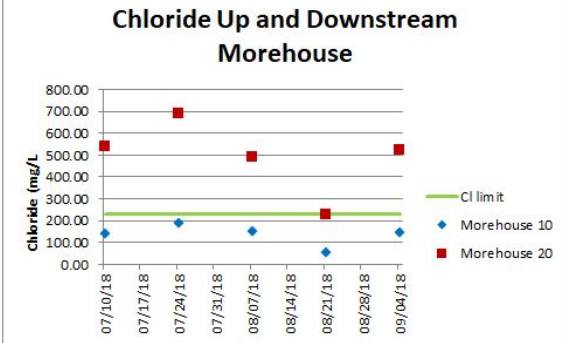
<p><b>Chloride Up and Downstream Morehouse</b></p> <p>This scatter plot shows chloride levels (mg/L) from 07/10/18 to 09/04/18. The y-axis ranges from 0.00 to 800.00. A green horizontal line represents the 'Cl limit' at approximately 200 mg/L. Blue diamonds represent 'Morehouse 10' and red squares represent 'Morehouse 20'. There are several spikes for Morehouse 20, with one reaching nearly 700 mg/L in late July.</p>

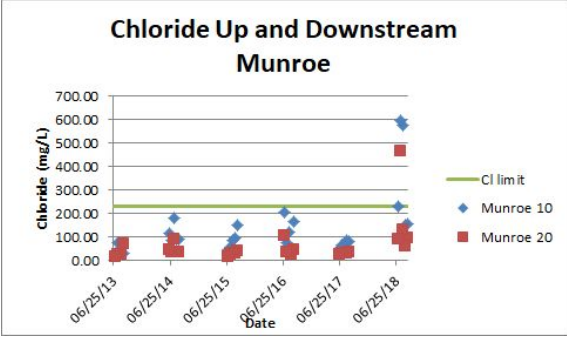
<p><b>Chloride Up and Downstream Munroe</b></p> <p>This scatter plot shows chloride levels (mg/L) for Munroe from 06/25/13 to 06/25/18. The y-axis ranges from 0.00 to 700.00. A green horizontal line indicates the 'Cl limit' at approximately 250 mg/L. Data points are shown for two locations: Munroe 10 (blue diamonds) and Munroe 20 (red squares). Most points are below the limit, but there is a significant spike at 06/25/18 where Munroe 10 reaches approximately 600 mg/L and Munroe 20 reaches approximately 480 mg/L.</p>
<b>Site</b>	<b>K, Critical Value, Two tailed Alpha Value</b>	<b>Visualization</b>
Muddy	57.23, 5.99, 0.05

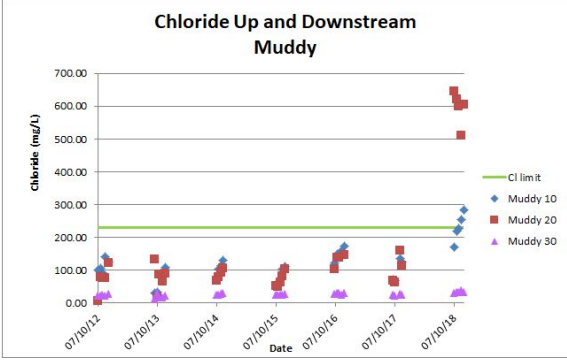
<p><b>Chloride Up and Downstream Muddy</b></p> <p>This scatter plot shows chloride levels (mg/L) for Muddy from 07/10/12 to 07/10/18. The y-axis ranges from 0.00 to 700.00. A green horizontal line indicates the 'Cl limit' at approximately 250 mg/L. Data points are shown for three locations: Muddy 10 (blue diamonds), Muddy 20 (red squares), and Muddy 30 (purple triangles). There is a notable increase in chloride levels at the end of the period, with Muddy 20 reaching approximately 650 mg/L and Muddy 10 reaching approximately 300 mg/L by 07/10/18.</p>

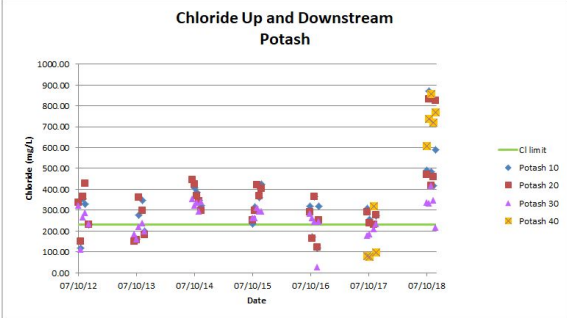
<p><b>Chloride Up and Downstream Potash</b></p> <p>This scatter plot shows chloride levels (mg/L) for Potash from 07/10/12 to 07/10/18. The y-axis ranges from 0.00 to 1000.00. A green horizontal line indicates the 'Cl limit' at approximately 250 mg/L. Data points are shown for four locations: Potash 10 (blue diamonds), Potash 20 (red squares), Potash 30 (purple triangles), and Potash 40 (yellow squares). There is a significant increase in chloride levels at the end of the period, with Potash 40 reaching approximately 900 mg/L and Potash 10 reaching approximately 600 mg/L by 07/10/18.</p>

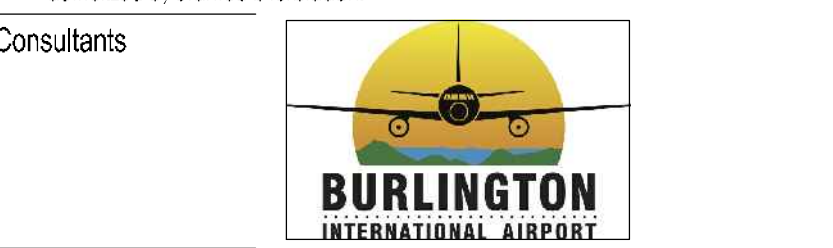
--- (Dashed line)	BTV APPROXIMATE PRINCIPAL BOUNDARY (AIRPORT PROPERTY)
--- (Dashed line)	APPROXIMATE LEASE LINE(S) TO FEDERAL GOVERNMENT
--- (Dashed line)	BTV APPROXIMATE RUNWAY SAFETY AREA
---	DRAINAGE AREA BOUNDARY
█ (Green fill)	ADDITIONAL PROPERTIES OWNED BY THE BURLINGTON INTERNATIONAL AIRPORT OBTAINED THROUGH THE HOME ACQUISITION NOISE COMPATIBILITY PROGRAM

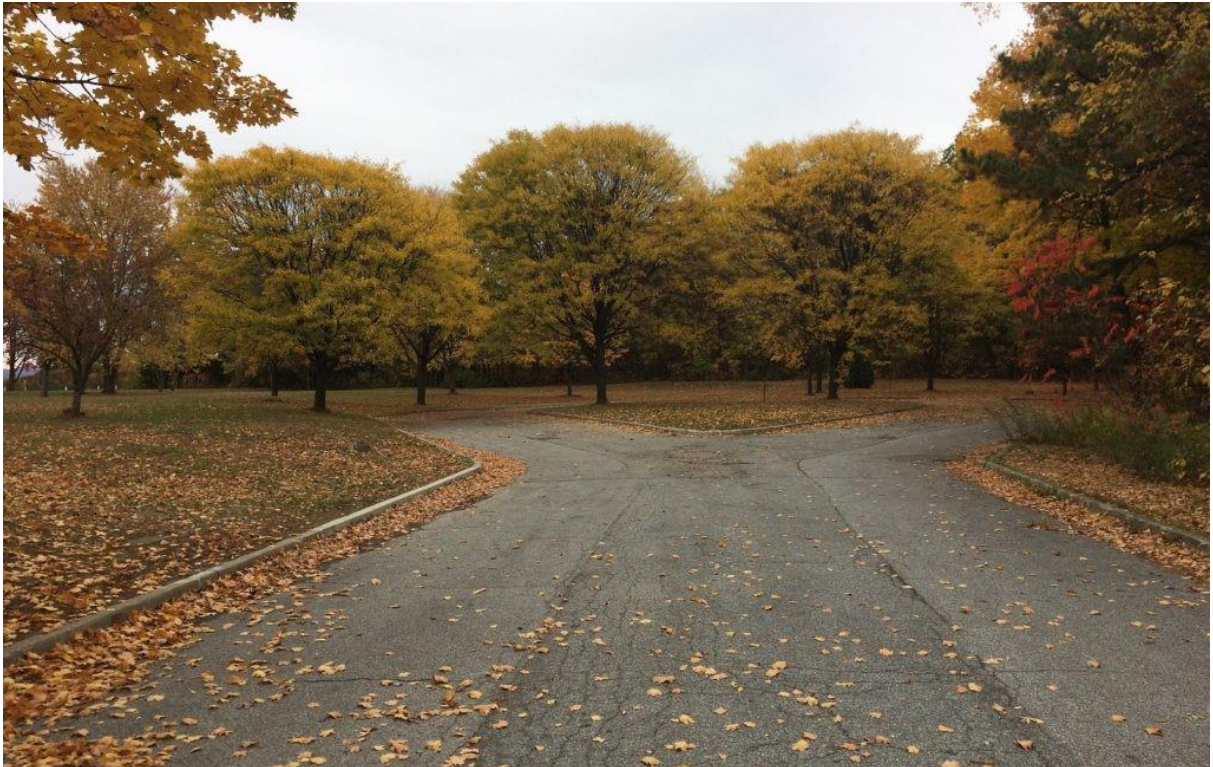
**Picard Circle – Looking East from Airport Parkway**

**A photo of the project site is presented below for reference.**

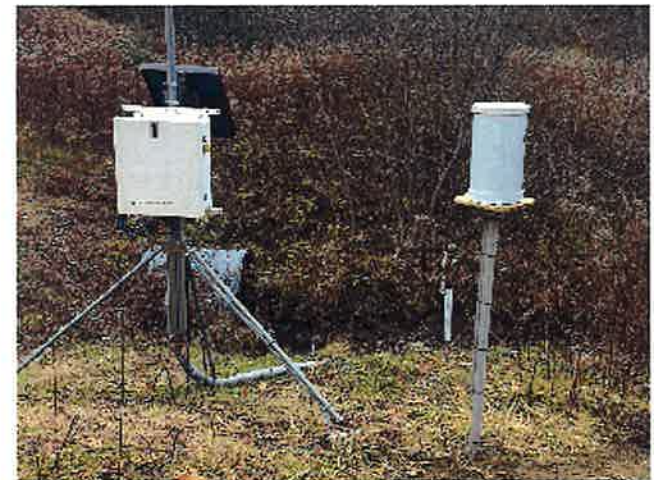
Streamflow and precipitation monitoring station at Sunderland Brook.

Note that five of the precipitation monitoring stations are co-located with streamflow monitoring stations. In these instances, real-time streamflow and precipitation data are displayed on the same web page.

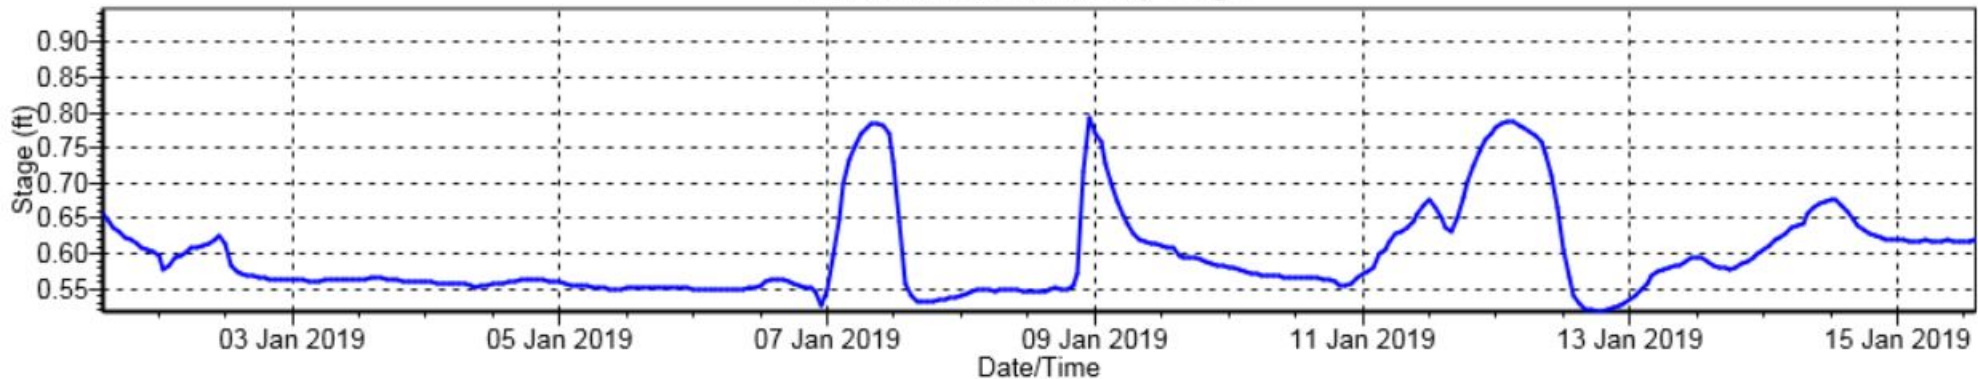
Centennial Brook: Hourly Stage

Centennial Brook: Hourly Temperature and Stage Data

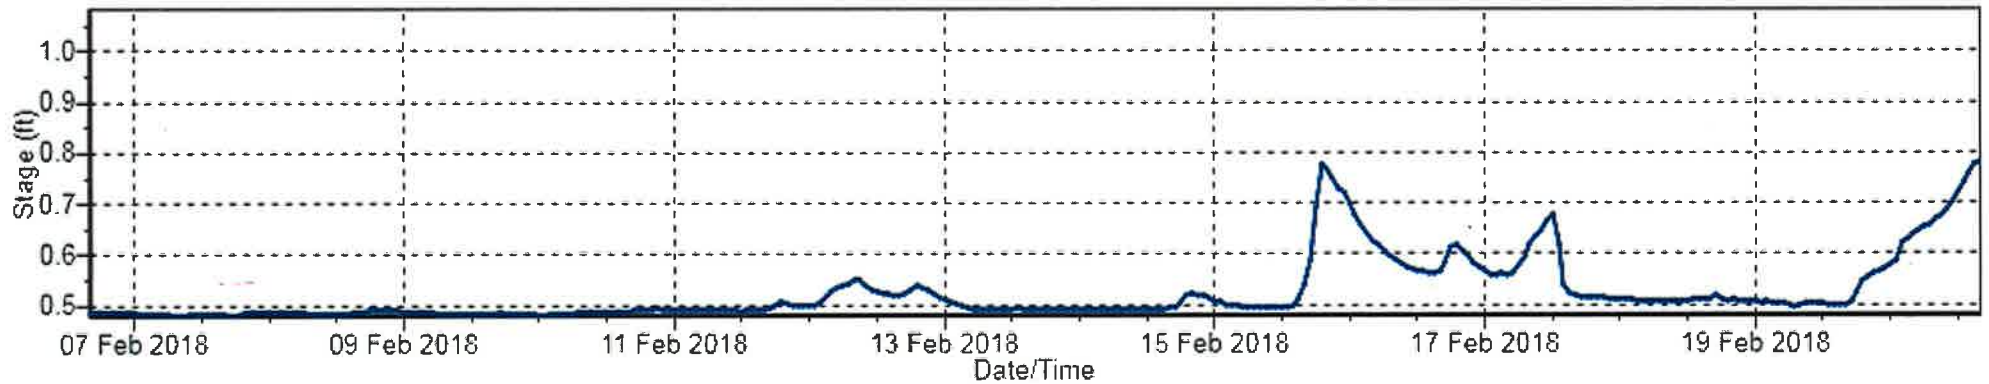
Centennial Brook: Hourly Stage

Centennial Brook: Hourly Temperature and Stage Data

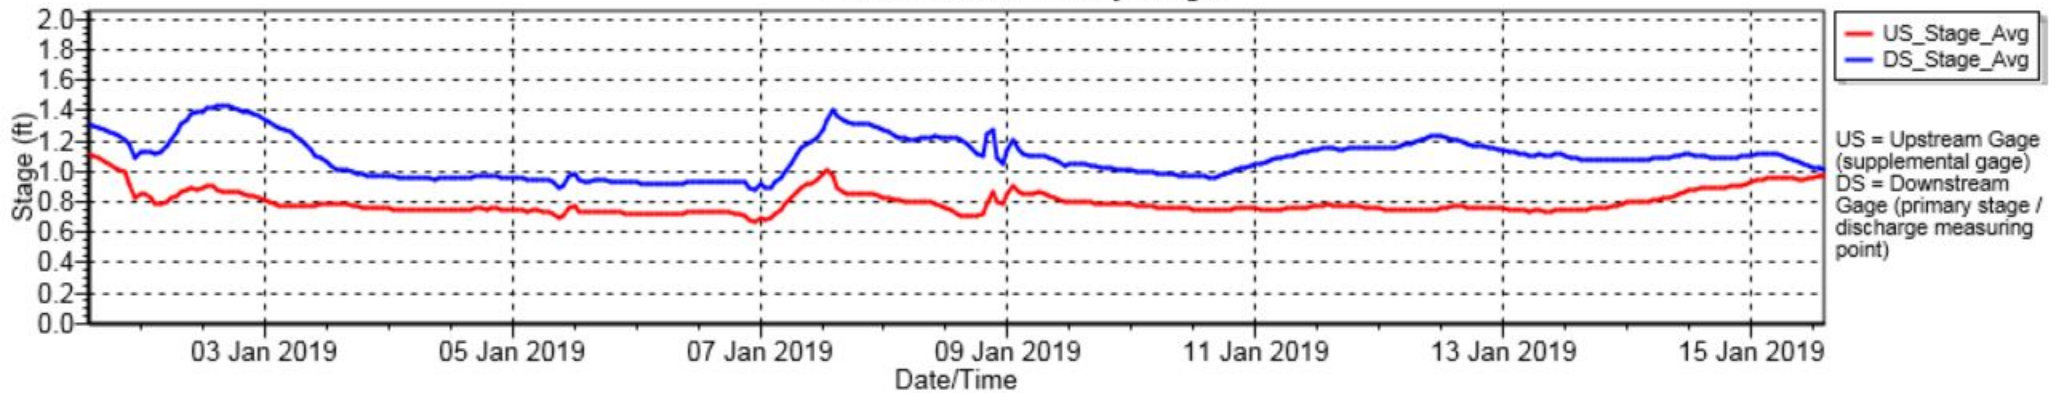
### Potash Brook: Hourly Stage

### Potash Brook: Hourly Temperature and Stage Data - Downstream Gage

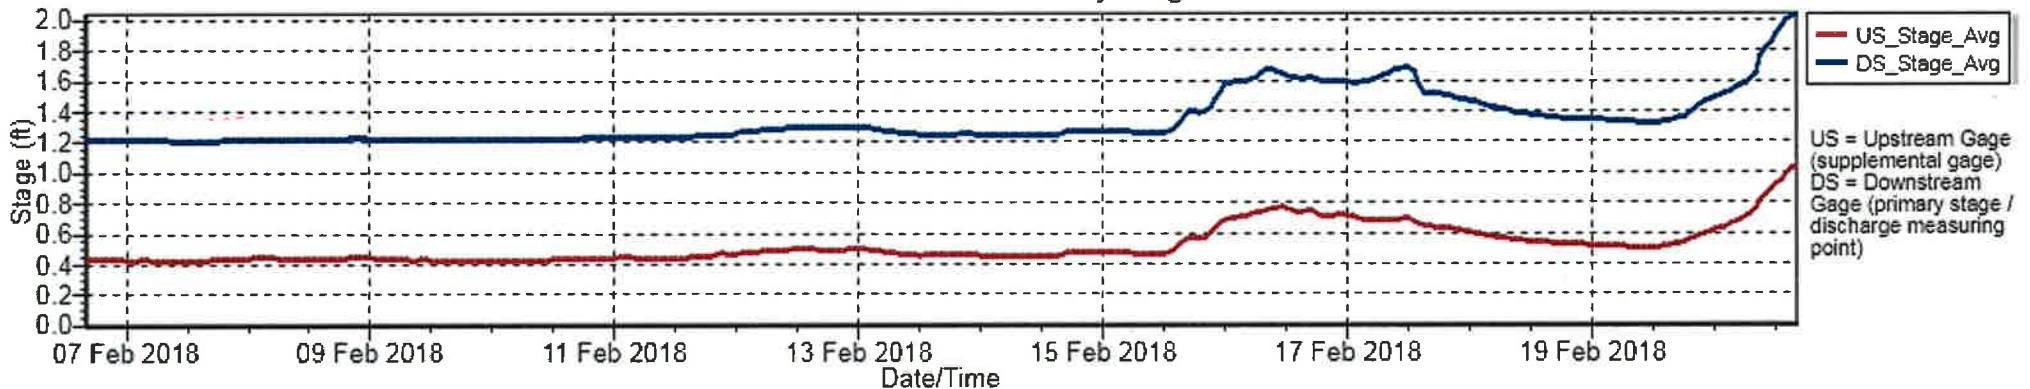
### Potash Brook: Hourly Stage

### Potash Brook: Hourly Temperature and Stage Data - Downstream Gage
