A. Permittee Information
1. Name of MS4: Town of Colchester
2. Permit Number: 7023 - 9014
B. Minimum Control Measures
1. Public Education and Outreach
1.1 Website address: www.colchestervt.gov; www.colchestervt.gov/1837/stormwater-utility

# **Attachment List for 2018 MS4 Annual Report**

# MCM #1 REGIONAL STORMWATER EDUCATION PROGRAM RETHINK RUNOFF

# Water Quality Monitoring Program Summary

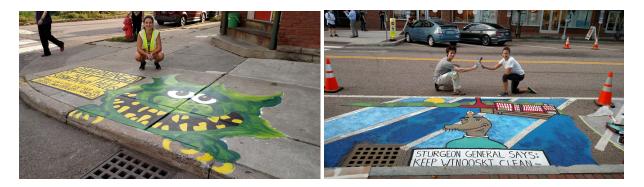
Figure 2: Winooski murals (Chick's Market: artist Holly Greenleaf, left Winooski Falls Way: artists Rachael Forando and Stephen Welter, right)

On the morning of October 10, 2018, the three artists, Holly Greenleaf, Rachael Forando, and Stephen Welter were stationed at their assigned catch basins: Holly at the catch basin outside Chick's Market at the corner of River St and Hickock St. and Rachael and Stephen as an artist team on Winooski Falls way by the bus stop. The artists signed contracts stipulating the requirements and procedures they had to adhere to in order to participate in the project. Instead of traffic paint, self-priming porch and floor enamel was used by all artists. Public Works staff assisted with thoroughly cleaning the areas to be painted and ensuring safety of the artists by providing traffic cones and vests. All murals were completed by the end of the day. Throughout the day, the RRST coordinator checked in with the artists. Each artist was given a pack of Rethink Runoff stickers and a mailing list sign up sheet. Artists reported speaking with about 75 passers-by about the project. They gave away about 30 stickers, and 2 people signed up for the mailing list. WCAX covered the story (see link in Media list above) and Facebook likes and shares were higher for this post than any other post in RRST history. About 2,800 people digitally interacted with the post.

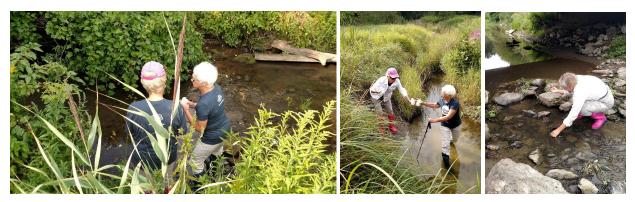
Figure 6: Volunteers sampling at Indian 10, Indian 20 and Muddy 30 on 8/7/18

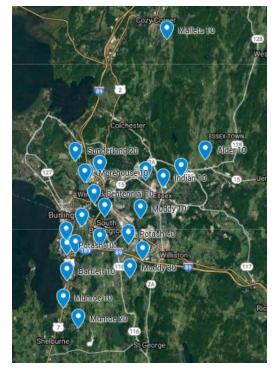
Figure 1: 2018 Rethink Runoff Stream Team Sample Sites. An interactive version of this map is available here:

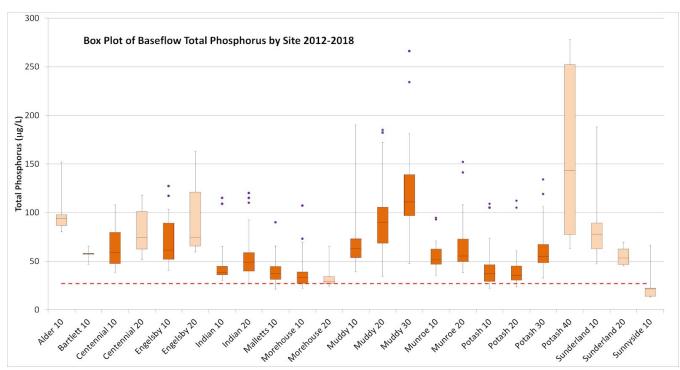
**Figure 2. Comparison of total phosphorus levels across sites 2012-2018.** Box plots indicate first and third quartiles and median values of total phosphorus concentrations for all sites. These values were calculated including sampling dates that may or may not have associated flagged dupe or blank samples. Lighter colored boxes indicate 1-2 years of sampling data, darker boxes indicate 6-7 years of sampling data. Dots indicate outliers which were identified as equal to or greater than 2 times the site's standard deviation. Red line indicates Vermont's 2016 Water Quality Standard of 27 micrograms/L.

Figure 2 suggests that phosphorus levels increase as sampling moves upstream. To test this hypothesis, RRST used scatter plots to graph phosphorus data over time by stream and ran statistical analyses on 8 streams that had more than one sampling site. Of the 8 streams that have more than one sampling location, 6 indicated a statistically significantly different value of phosphorus between sites, all of which presented statistically significantly higher concentrations of total phosphorus upstream . Table 4 summarizes the results of these tests. Appendix D summarizes statistics and graph visualizations. This result was somewhat surprising and merits more consideration since we assumed that total phosphorus increased in concentration as water moves downstream and more inputs are introduced.

Figure 2 also suggests that Muddy Brook has shown consistently high levels of Phosphorus as compared to other sites including some extremely high outliers. Interestingly, temporal data is suggesting a non-significant downward trend of Phosphorus concentrations at sites Muddy 20 and Muddy 30 with Muddy 10 holding relatively constant. This is unique to Muddy Brook and it's not clear what land use changes or restoration efforts could have contributed to this. Figures 3 and 4 show the suggested trends for Muddy 20 and 30 respectively.

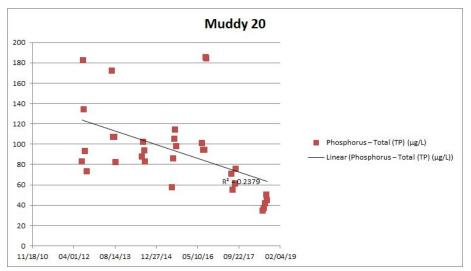
**Figure 3. Total Phosphorus in Muddy 20 since 2012.** Scatter plot visually suggests a downward trend but R2 of the best fit line is still only about 0.24 and not significant.

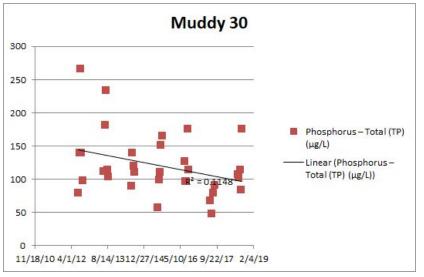
**Figure 4. Total Phosphorus in Muddy 30 since 2012.** Scatter plot visually suggests a downward trend but R2 of the best fit line is still only about 0.12 and not significant.

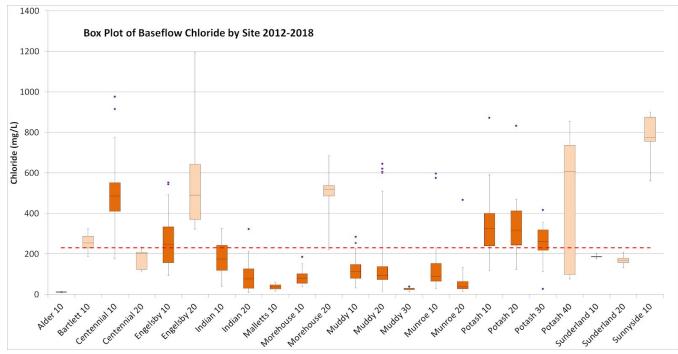
**Figure 5 - Comparison of Chloride levels across sites 2012-2018.** Box plots indicate first and third quartiles and median values of chloride levels (mg/L) for all sites. Lighter colored boxes indicate 1-2 years of sampling data, darker boxes indicate 6-7 years of sampling data. Dots indicate outliers which were identified as equal to or greater than 2 times the site's standard deviation. EPA's and Vermont's standard for 4-day average chloride levels (230 mg/L) is shown by the red line.

Since the onset of this monitoring program, mean chloride levels at Centennial 10 and Potash 10, 20 and 30 have remained notably above 230 mg/L standard. Recently added sampling sites have also presented alarmingly high data including Engelsby 20, Morehouse 20, Potash 40, and Sunnyside 10.

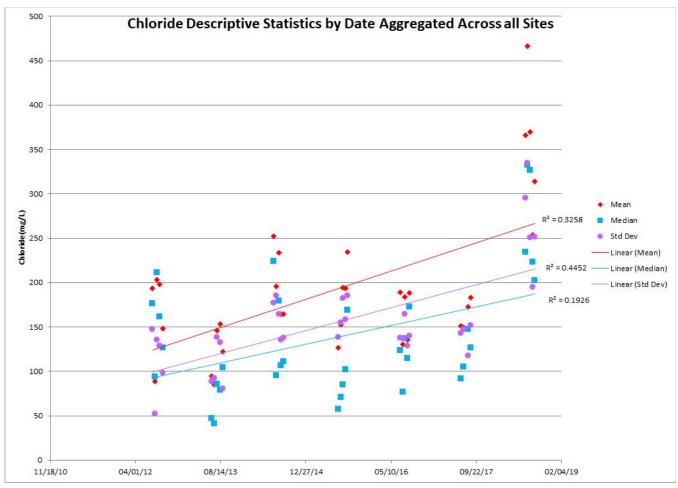
**Figure 6. Descriptive Statistics for chloride data gathered across sites aggregated by date**. Each sampling date since June 2016 had chloride values across sites averaged to determine mean, median, and standard deviation for the entire sampling area.

Aggregated data also suggests a general increasing trend in chloride. Figure 6 below shows that e mean, median, and standard deviation values have all increased slightly over time.

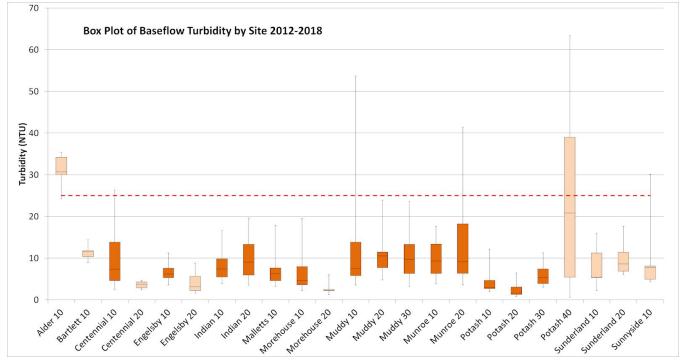
**Figure 7 - Comparison of turbidity levels 2012-2018 during baseflow (dry) conditions.** The standard proposed by the State of Vermont for mean turbidity at baseflow in medium gradient, warm water streams (25 NTU) is indicated by the red line. These values were calculated including sampling dates that may or may not have associated flagged dupe or blank samples.

Mean, baseflow turbidity values have only rarely exceeded the VT standard for warm-water streams of 25 NTU over the seven year sampling period. Of note, however, is the high turbidity recorded for new sampling sites Alder 10 and Potash 40. Higher turbidity in Alder 10 is not surprising because the site is comparatively more agricultural with a couple farms and potential field runoff nearby. Turbidity has not been included in sampling support requests for the 2019 field season but will be revisited in 2020.

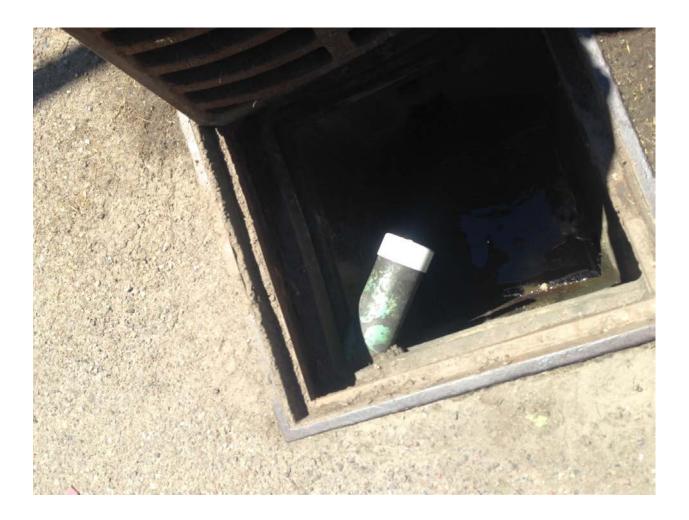
Picture of the capped discharge on Lesage Ln. Had a resident come out that wasn't too happy about it, said it was tied to the four houses' perimeter drains and that he would be back out to hack saw it off later. He also said he had "cleared all this up with Bryan back in the fall".

-----Original Message-----From: Randy Alemy Sent: Friday, June 22, 2018 1:27 PM To: Randy Alemy Subject: Lesage Ln Capped Pipe on Lesage Lane from Randy Alemy's 6/22/2018 email

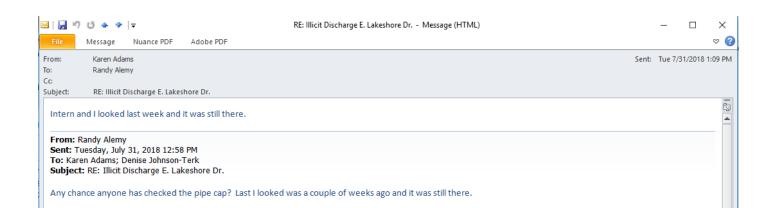
Staff followup to ensure pipe still in place 7/31/2018
