2018 ANNUAL REPORT

EPA MS4 PHASE II – GENERAL PERMIT 3-9014 January 1, 2018 to December 31, 2018

**Prepared by
Krebs & Lansing Consulting Engineers, Inc.
164 Main Street
Colchester, Vermont 05446**

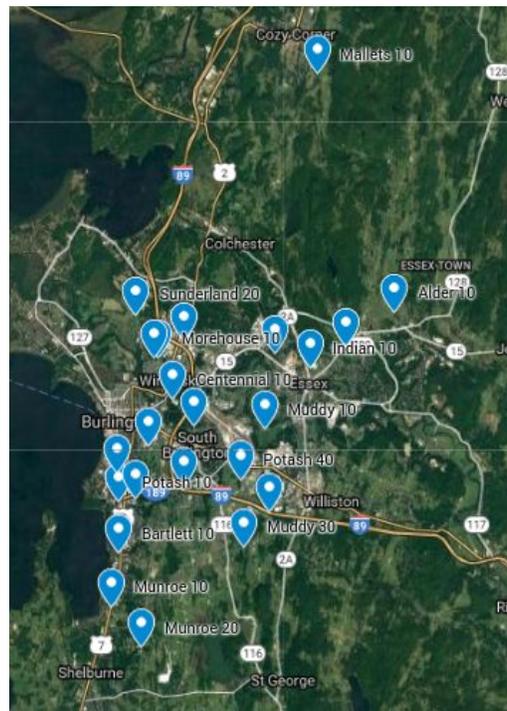
Figure 1: 2018 Rethink Runoff Stream Team Sample Sites. An interactive version of this map is available here:

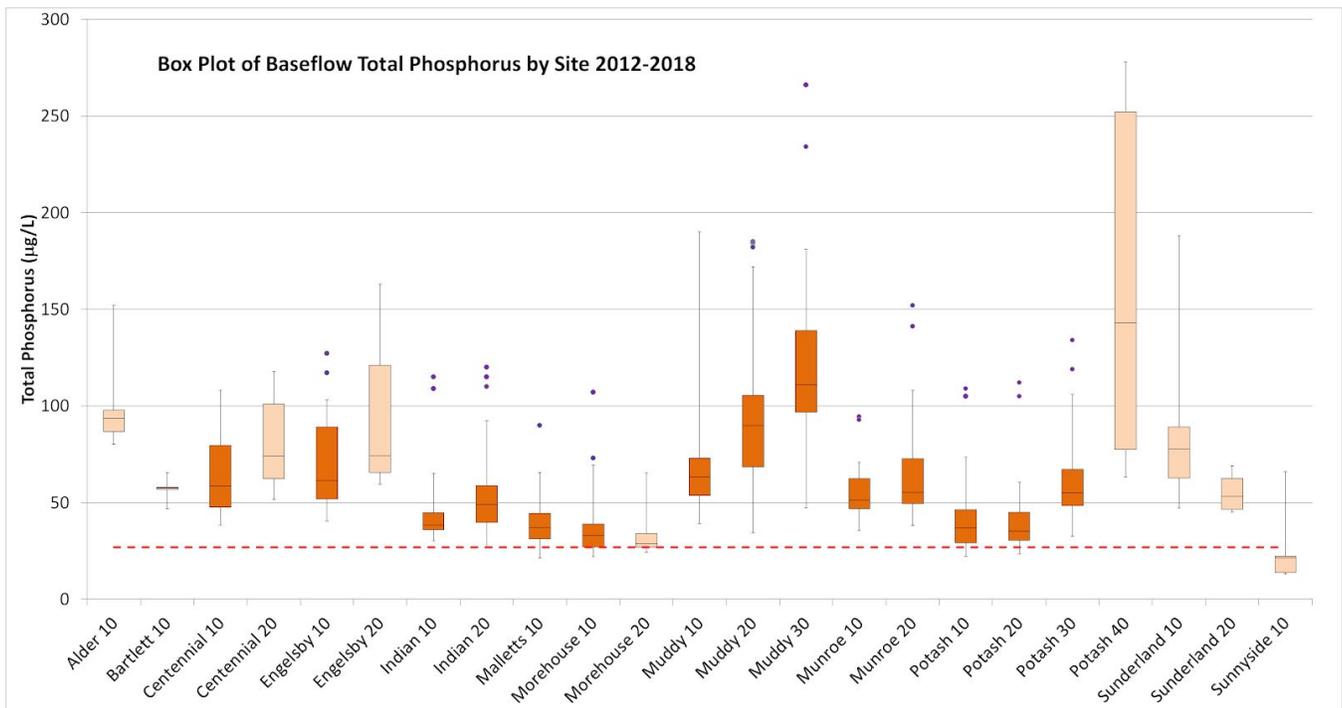
Figure 2. Comparison of total phosphorus levels across sites 2012-2018. Box plots indicate first and third quartiles and median values of total phosphorus concentrations for all sites. These values were calculated including sampling dates that may or may not have associated flagged dupe or blank samples. Lighter colored boxes indicate 1-2 years of sampling data, darker boxes indicate 6-7 years of sampling data. Dots indicate outliers which were identified as equal to or greater than 2 times the site's standard deviation. Red line indicates Vermont's 2016 Water Quality Standard of 27 micrograms/L.

Figure 2 suggests that phosphorus levels increase as sampling moves upstream. To test this hypothesis, RRST used scatter plots to graph phosphorus data over time by stream and ran statistical analyses on 8 streams that had more than one sampling site. Of the 8 streams that have more than one sampling location, 6 indicated a statistically significantly different value of phosphorus between sites, all of which presented statistically significantly higher concentrations of total phosphorus upstream. Table 4 summarizes the results of these tests. Appendix D summarizes statistics and graph visualizations. This result was somewhat surprising and merits more consideration since we assumed that total phosphorus increased in concentration as water moves downstream and more inputs are introduced.

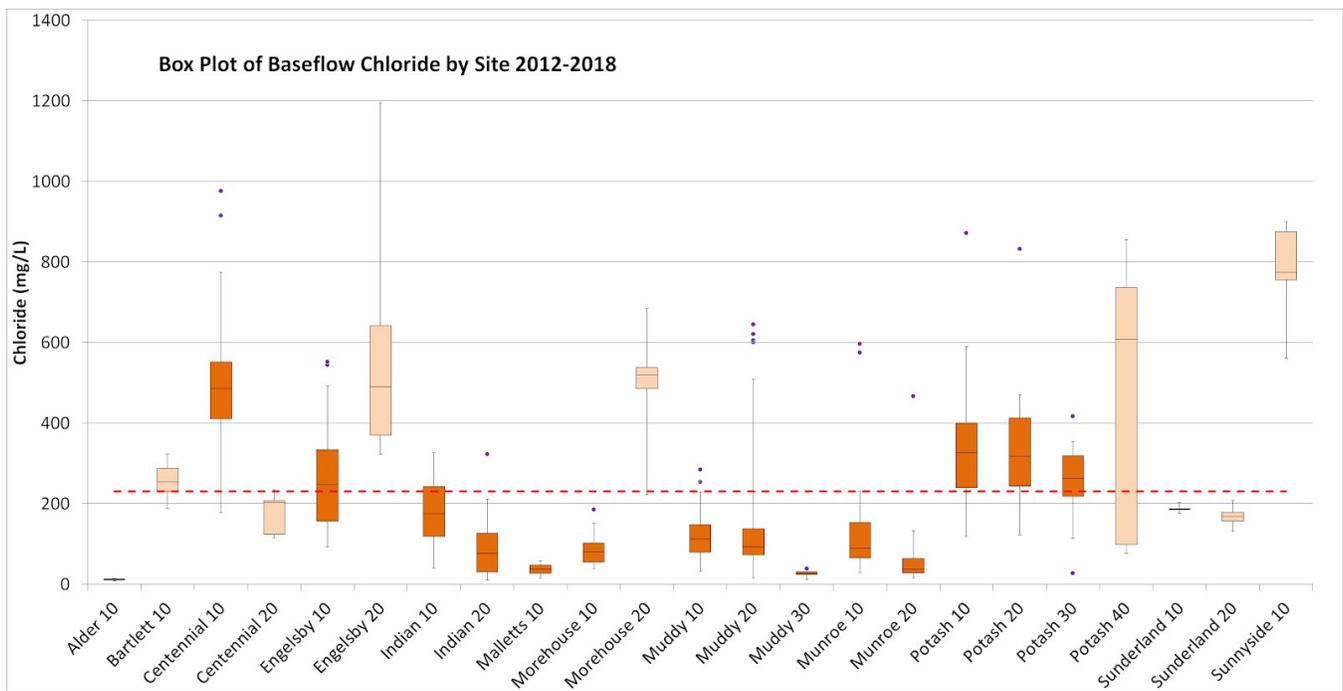
Figure 5 - Comparison of Chloride levels across sites 2012-2018. Box plots indicate first and third quartiles and median values of chloride levels (mg/L) for all sites. Lighter colored boxes indicate 1-2 years of sampling data, darker boxes indicate 6-7 years of sampling data. Dots indicate outliers which were identified as equal to or greater than 2 times the site's standard deviation. EPA's and Vermont's standard for 4-day average chloride levels (230 mg/L) is shown by the red line.

Since the onset of this monitoring program, mean chloride levels at Centennial 10 and Potash 10, 20 and 30 have remained notably above 230 mg/L standard. Recently added sampling sites have also presented alarmingly high data including Engelsby 20, Morehouse 20, Potash 40, and Sunnyside 10.

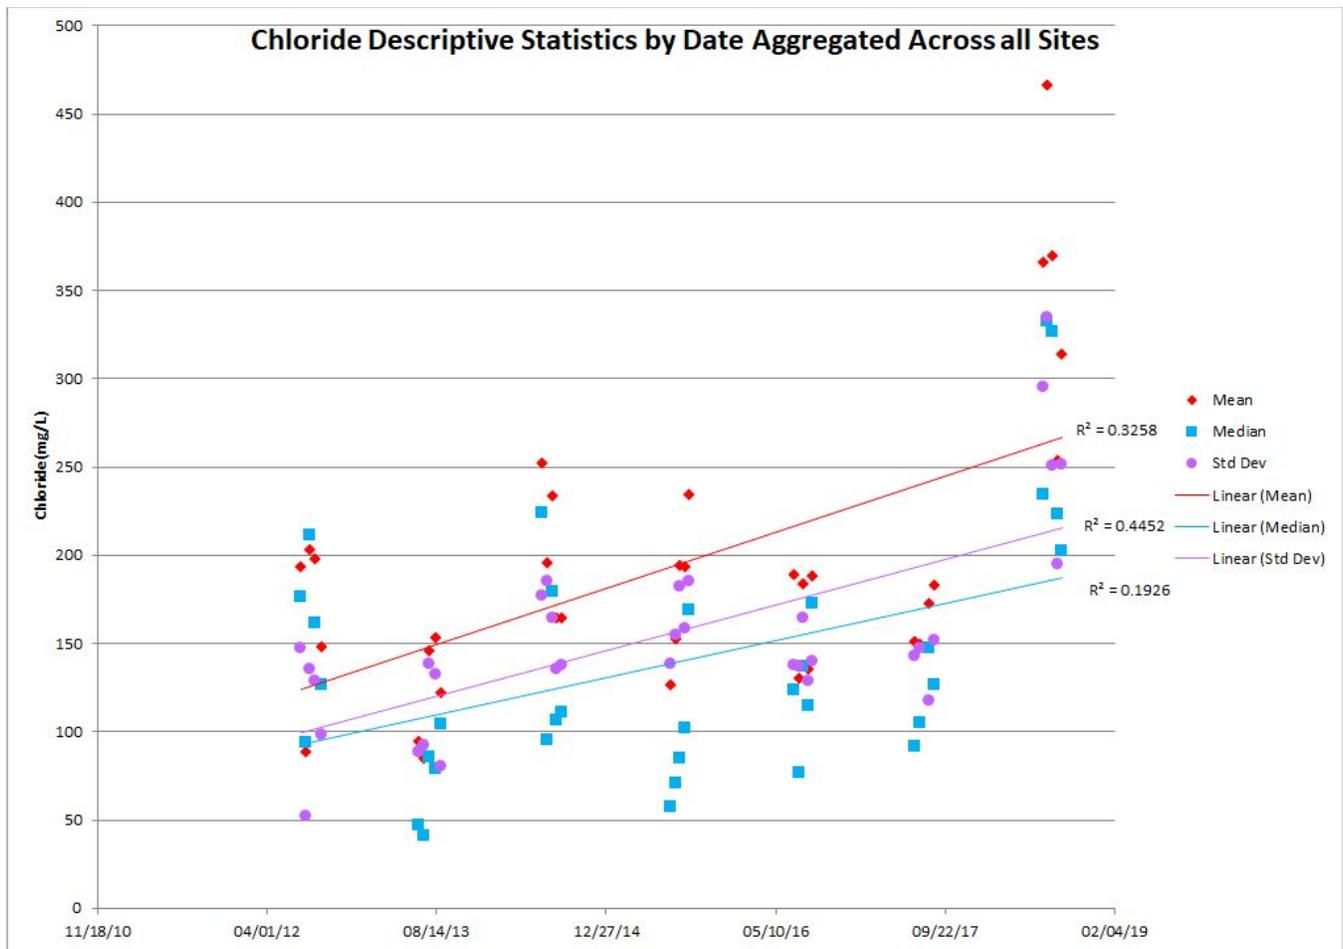
Figure 6. Descriptive Statistics for chloride data gathered across sites aggregated by date. Each sampling date since June 2016 had chloride values across sites averaged to determine mean, median, and standard deviation for the entire sampling area.

Aggregated data also suggests a general increasing trend in chloride. Figure 6 below shows that the mean, median, and standard deviation values have all increased slightly over time.

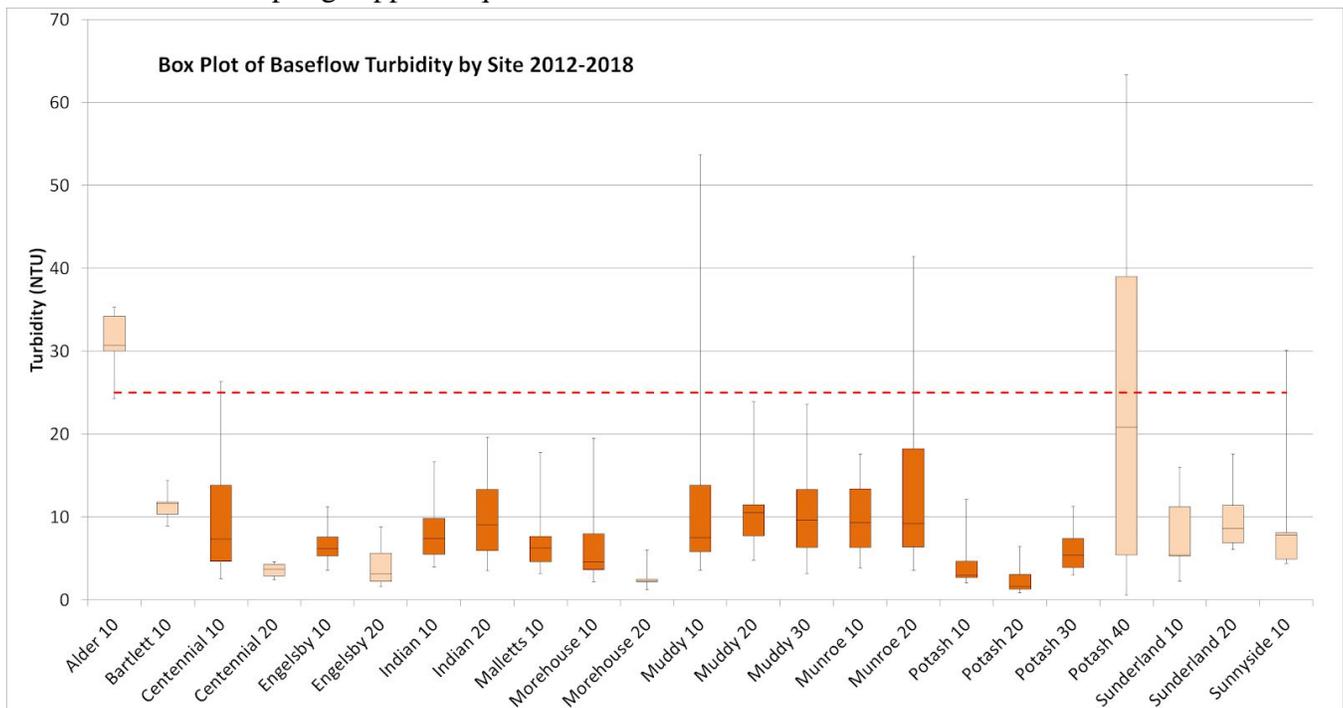
Figure 7 - Comparison of turbidity levels 2012-2018 during baseflow (dry) conditions. The standard proposed by the State of Vermont for mean turbidity at baseflow in medium gradient, warm water streams (25 NTU) is indicated by the red line. These values were calculated including sampling dates that may or may not have associated flagged dupe or blank samples.

Mean, baseflow turbidity values have only rarely exceeded the VT standard for warm-water streams of 25 NTU over the seven year sampling period. Of note, however, is the high turbidity recorded for new sampling sites Alder 10 and Potash 40. Higher turbidity in Alder 10 is not surprising because the site is comparatively more agricultural with a couple farms and potential field runoff nearby. Turbidity has not been included in sampling support requests for the 2019 field season but will be revisited in 2020.

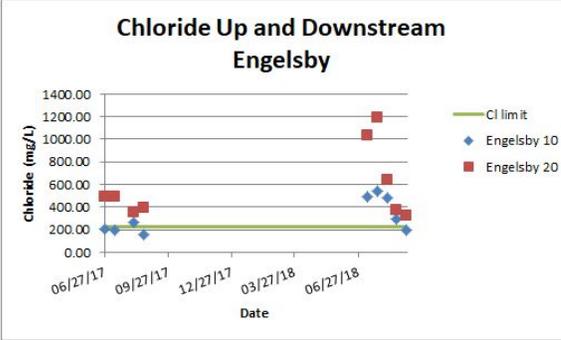
<p>Chloride Up and Downstream Engelsby</p> <p>This scatter plot shows chloride levels (mg/L) from 06/27/17 to 06/27/18. The y-axis ranges from 0.00 to 1400.00. A green horizontal line represents the 'Cl limit' at approximately 200 mg/L. Blue diamonds represent 'Engelsby 10' and red squares represent 'Engelsby 20'. There is a significant spike for Engelsby 20 in early 2018, reaching over 1000 mg/L.</p>
Indian	1, 187, 0.05

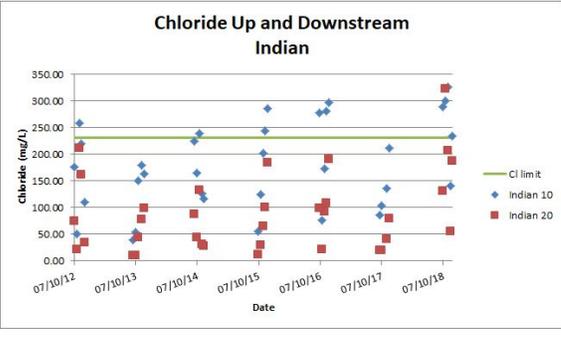
<p>Chloride Up and Downstream Indian</p> <p>This scatter plot shows chloride levels (mg/L) from 07/10/12 to 07/10/18. The y-axis ranges from 0.00 to 350.00. A green horizontal line represents the 'Cl limit' at approximately 250 mg/L. Blue diamonds represent 'Indian 10' and red squares represent 'Indian 20'. Data points fluctuate around the limit, with several points for Indian 10 exceeding it.</p>

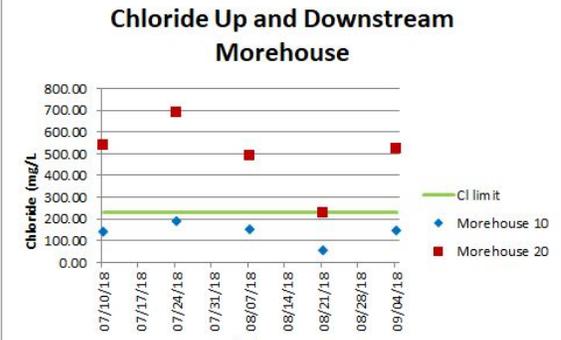
Morehouse	0, 1, 0.1

<p>Chloride Up and Downstream Morehouse</p> <p>This scatter plot shows chloride levels (mg/L) from 07/10/18 to 09/04/18. The y-axis ranges from 0.00 to 800.00. A green horizontal line represents the 'Cl limit' at approximately 200 mg/L. Blue diamonds represent 'Morehouse 10' and red squares represent 'Morehouse 20'. There are several spikes for Morehouse 20, with one reaching nearly 700 mg/L in late July.</p>

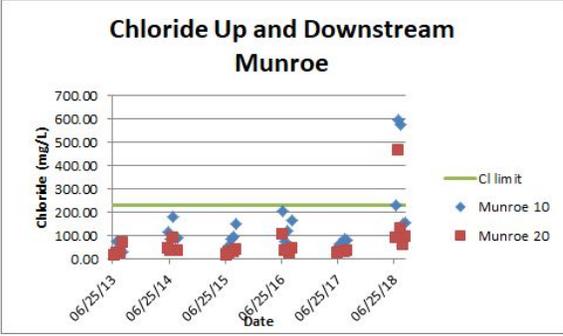
Munroe	9, 117, 0.05

<p>Chloride Up and Downstream Munroe</p> <p>This scatter plot shows chloride levels (mg/L) for Munroe from 06/25/13 to 06/25/18. The y-axis ranges from 0.00 to 700.00 mg/L. A green horizontal line indicates the 'Cl limit' at approximately 250 mg/L. Data points are shown for two locations: Munroe 10 (blue diamonds) and Munroe 20 (red squares). Most readings are below the limit, but there is a significant spike at 06/25/18 where Munroe 10 reaches approximately 600 mg/L and Munroe 20 reaches approximately 480 mg/L.</p>
Site	K, Critical Value, Two tailed Alpha Value	Visualization
Muddy	57.23, 5.99, 0.05

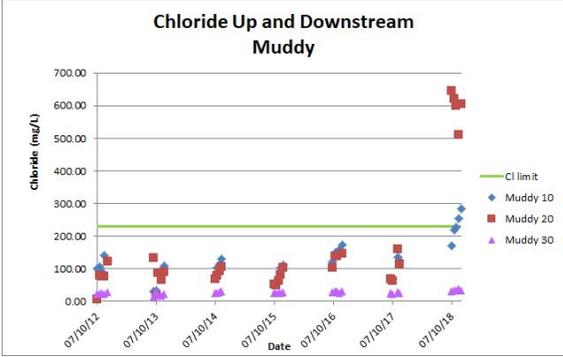
<p>Chloride Up and Downstream Muddy</p> <p>This scatter plot shows chloride levels (mg/L) for Muddy from 07/10/12 to 07/10/18. The y-axis ranges from 0.00 to 700.00 mg/L. A green horizontal line indicates the 'Cl limit' at approximately 250 mg/L. Data points are shown for three locations: Muddy 10 (blue diamonds), Muddy 20 (red squares), and Muddy 30 (purple triangles). There is a notable increase in chloride levels at the end of the period, with Muddy 20 reaching approximately 650 mg/L and Muddy 10 reaching approximately 300 mg/L by 07/10/18.</p>

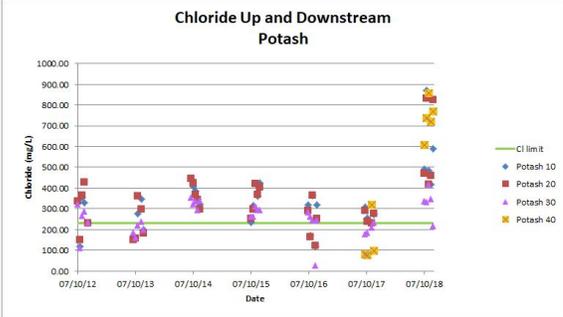
Potash	8.33, 7.81, 0.05

<p>Chloride Up and Downstream Potash</p> <p>This scatter plot shows chloride levels (mg/L) for Potash from 07/10/12 to 07/10/18. The y-axis ranges from 0.00 to 1000.00 mg/L. A green horizontal line indicates the 'Cl limit' at approximately 250 mg/L. Data points are shown for four locations: Potash 10 (blue diamonds), Potash 20 (red squares), Potash 30 (purple triangles), and Potash 40 (yellow squares). There is a general upward trend in chloride levels, with Potash 40 reaching approximately 900 mg/L and Potash 10 reaching approximately 600 mg/L by 07/10/18.</p>

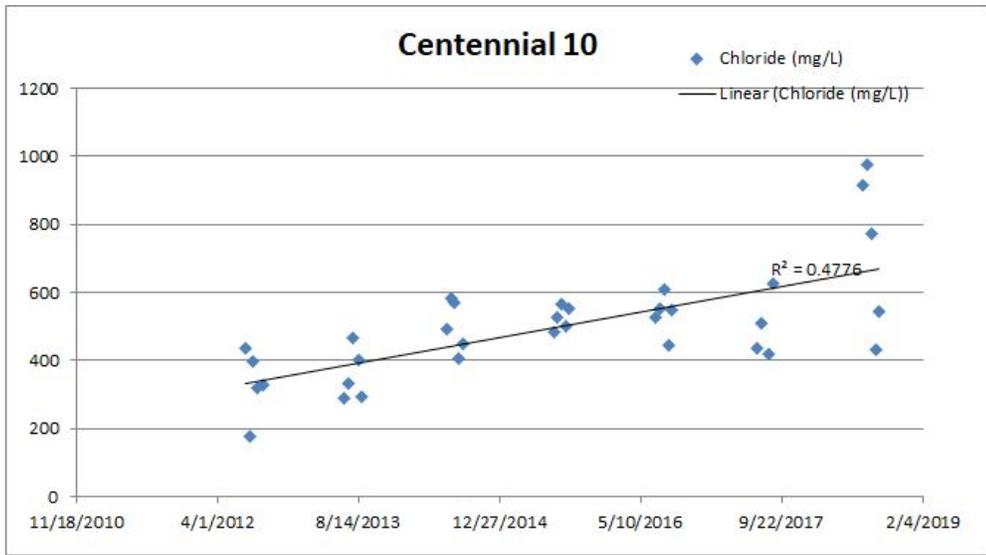
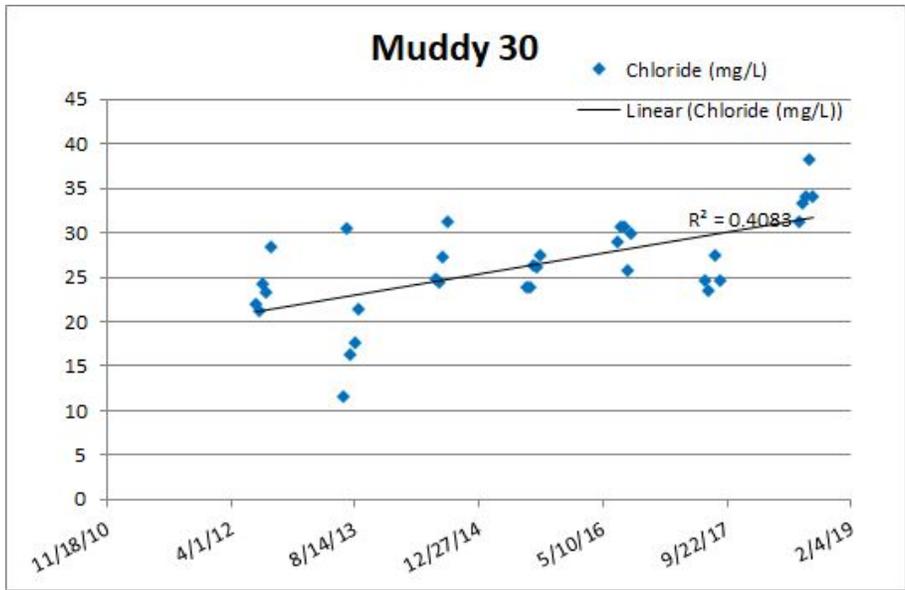
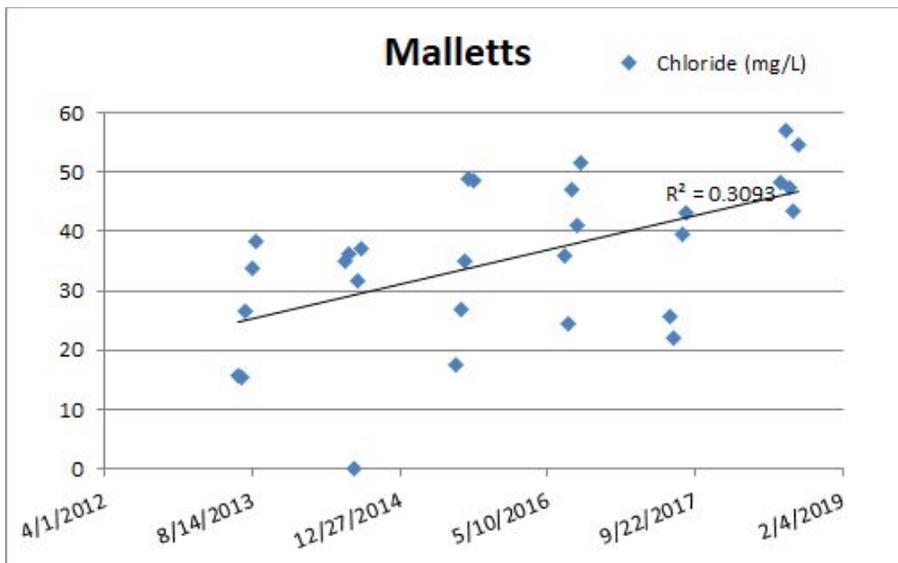
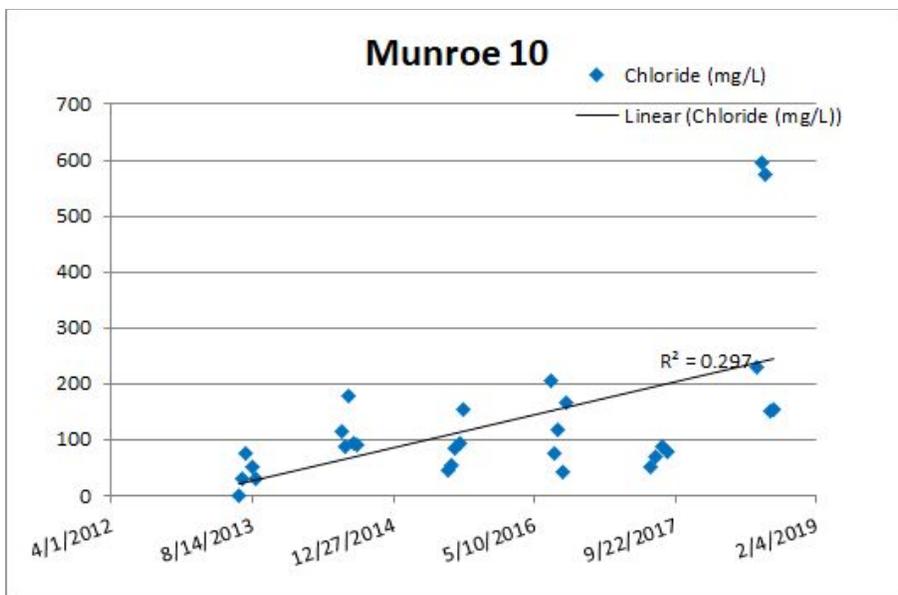
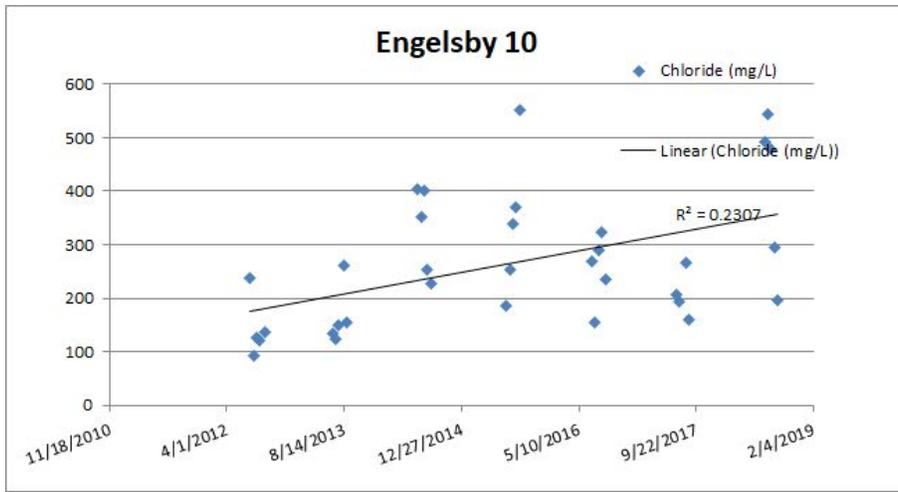
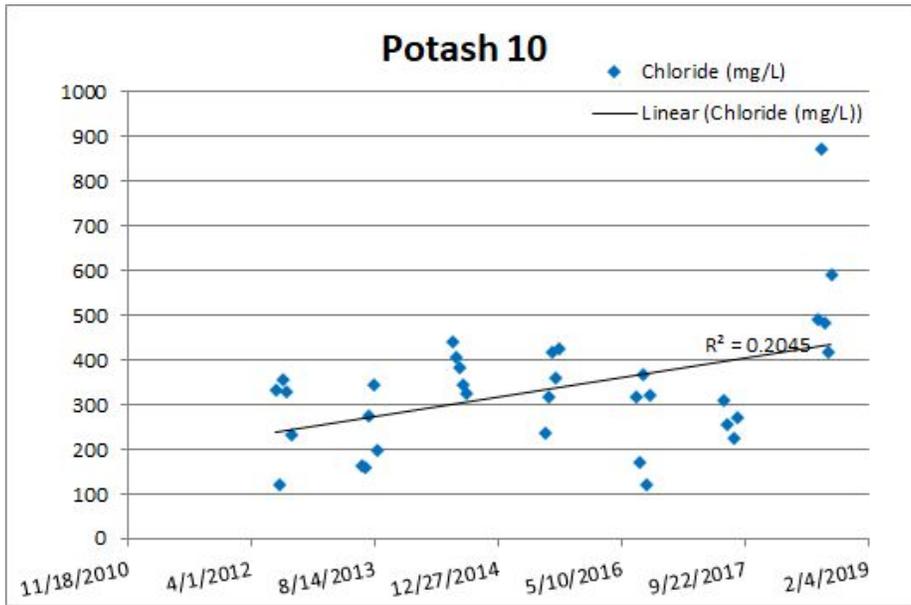
Appendix F. Notable Trends in Chloride Increases Over Time By Site. Sorted in descending order by R2 values.
