STORMWATER MANAGEMENT PLAN FOR SHELDON

FINAL REPORT

Stone Project ID 12-145

January 24, 2014

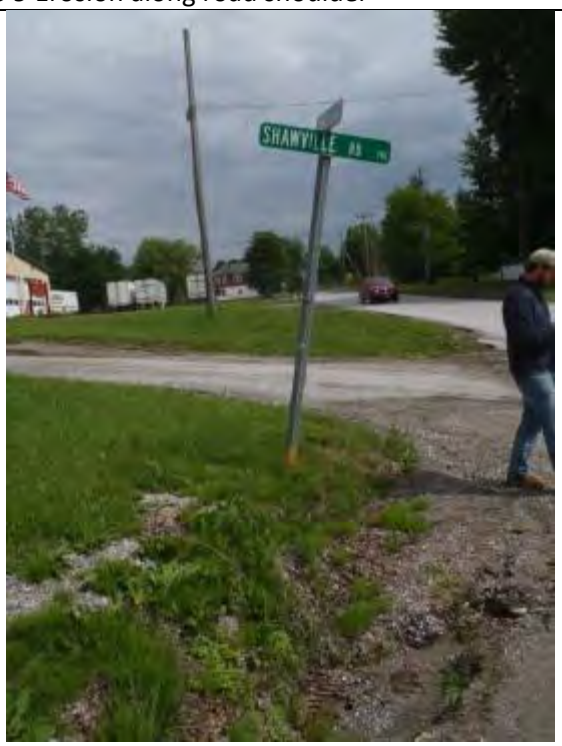
Problem Area ID: MR-7 (cont.)	
Photo 9 Erosion along road shoulder	**Photo 10.** Rock-lined ditch, sediment choked

Photo 11. Shoulder erosion	**Photo 12.** Trenching on gravel driveways subject to heavy truck traffic

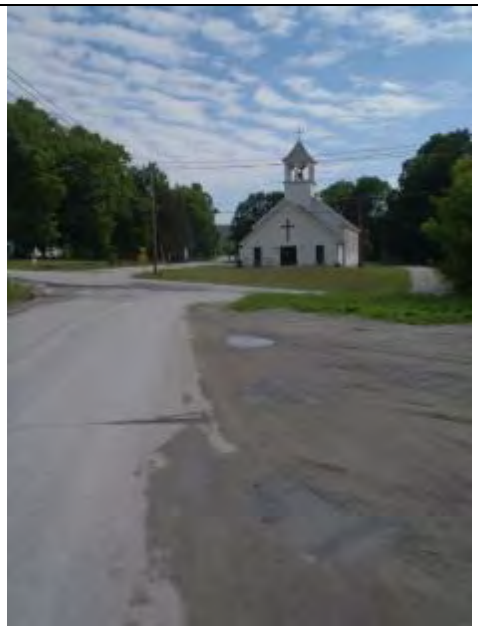
Problem Area ID: MR-7 (cont.)	
Photo 17. Shoulder erosion	**Photo 18.** New drainage structure connected to parking lot behind fire station

Photo 19 Sediment from lot deposited on road surface	**Photo 20.** Sediment deposited at a culvert outfall
