Agency of Agriculture Food & Markets

ARM Division – Water Quality
94 Harvest Lane
Williston, VT 05495

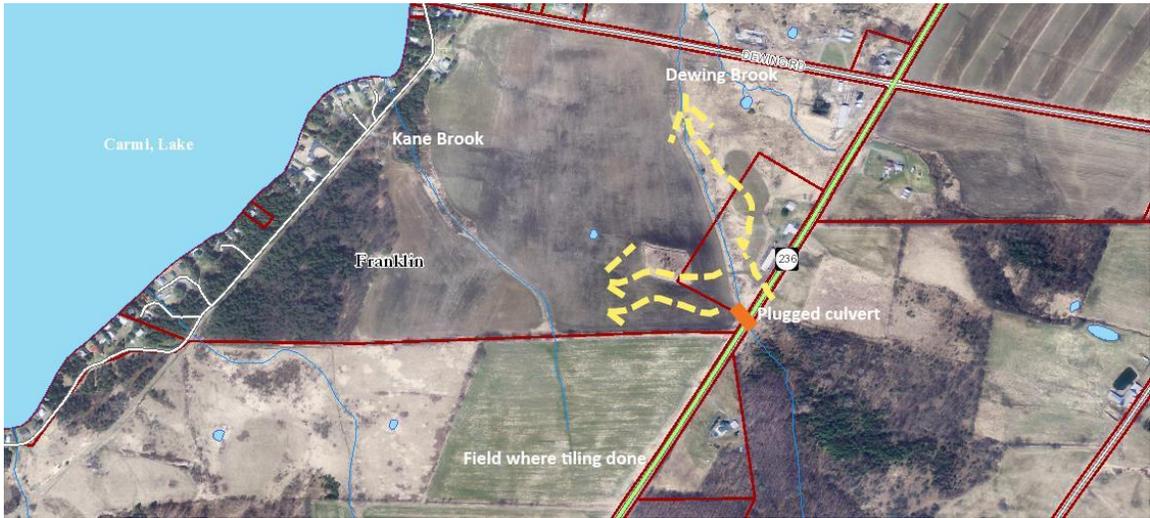
FIELD MAP

I learned that a culvert passing under State Route 236, State Park Road, was plugged with ice during the big melt on January 12. This caused a tremendous amount of water to flow up and over Route 236, then down the

highway for approximately 200 feet before spilling to the west side of the highway near an equipment yard. The flow caused a large amount of erosion and undermined the edge of the highway, stirring up a lot of sediment. I was able to get in touch with Mr. Tim Wilson, Agency of Transportation superintendent of the state highway garage in Enosburg Falls Route 236 resides within Mr. Wilson's jurisdiction. Mr. Wilson confirmed that a 30" culvert was plugged with ice and that the highway crew tried de-icing the culvert with very limited success. Mr. Wilson said the volume of water was tremendous and the velocity of flow was stirring up a lot of silt and sediment from around the road and cutting through the equipment yard on the west side of Route 236.

Based on what I observed on the two different days I went up to this area, coupled with talking to the landowner and most specifically the highway engineer, Mr. Tim Wilson, I believe that the source for most of the silt that washed into Lake Carmi on January 12 was due to the very large volume of water that flowed up and over Route 236 because the culvert under the highway was plugged.
