MEMORANDUM

DATE: February 8, 2024

SUBJECT: Risk Reduction Measures
Prison Pond Dam, Windsor, Vermont
State ID No. 248.07
National ID No. VT00363

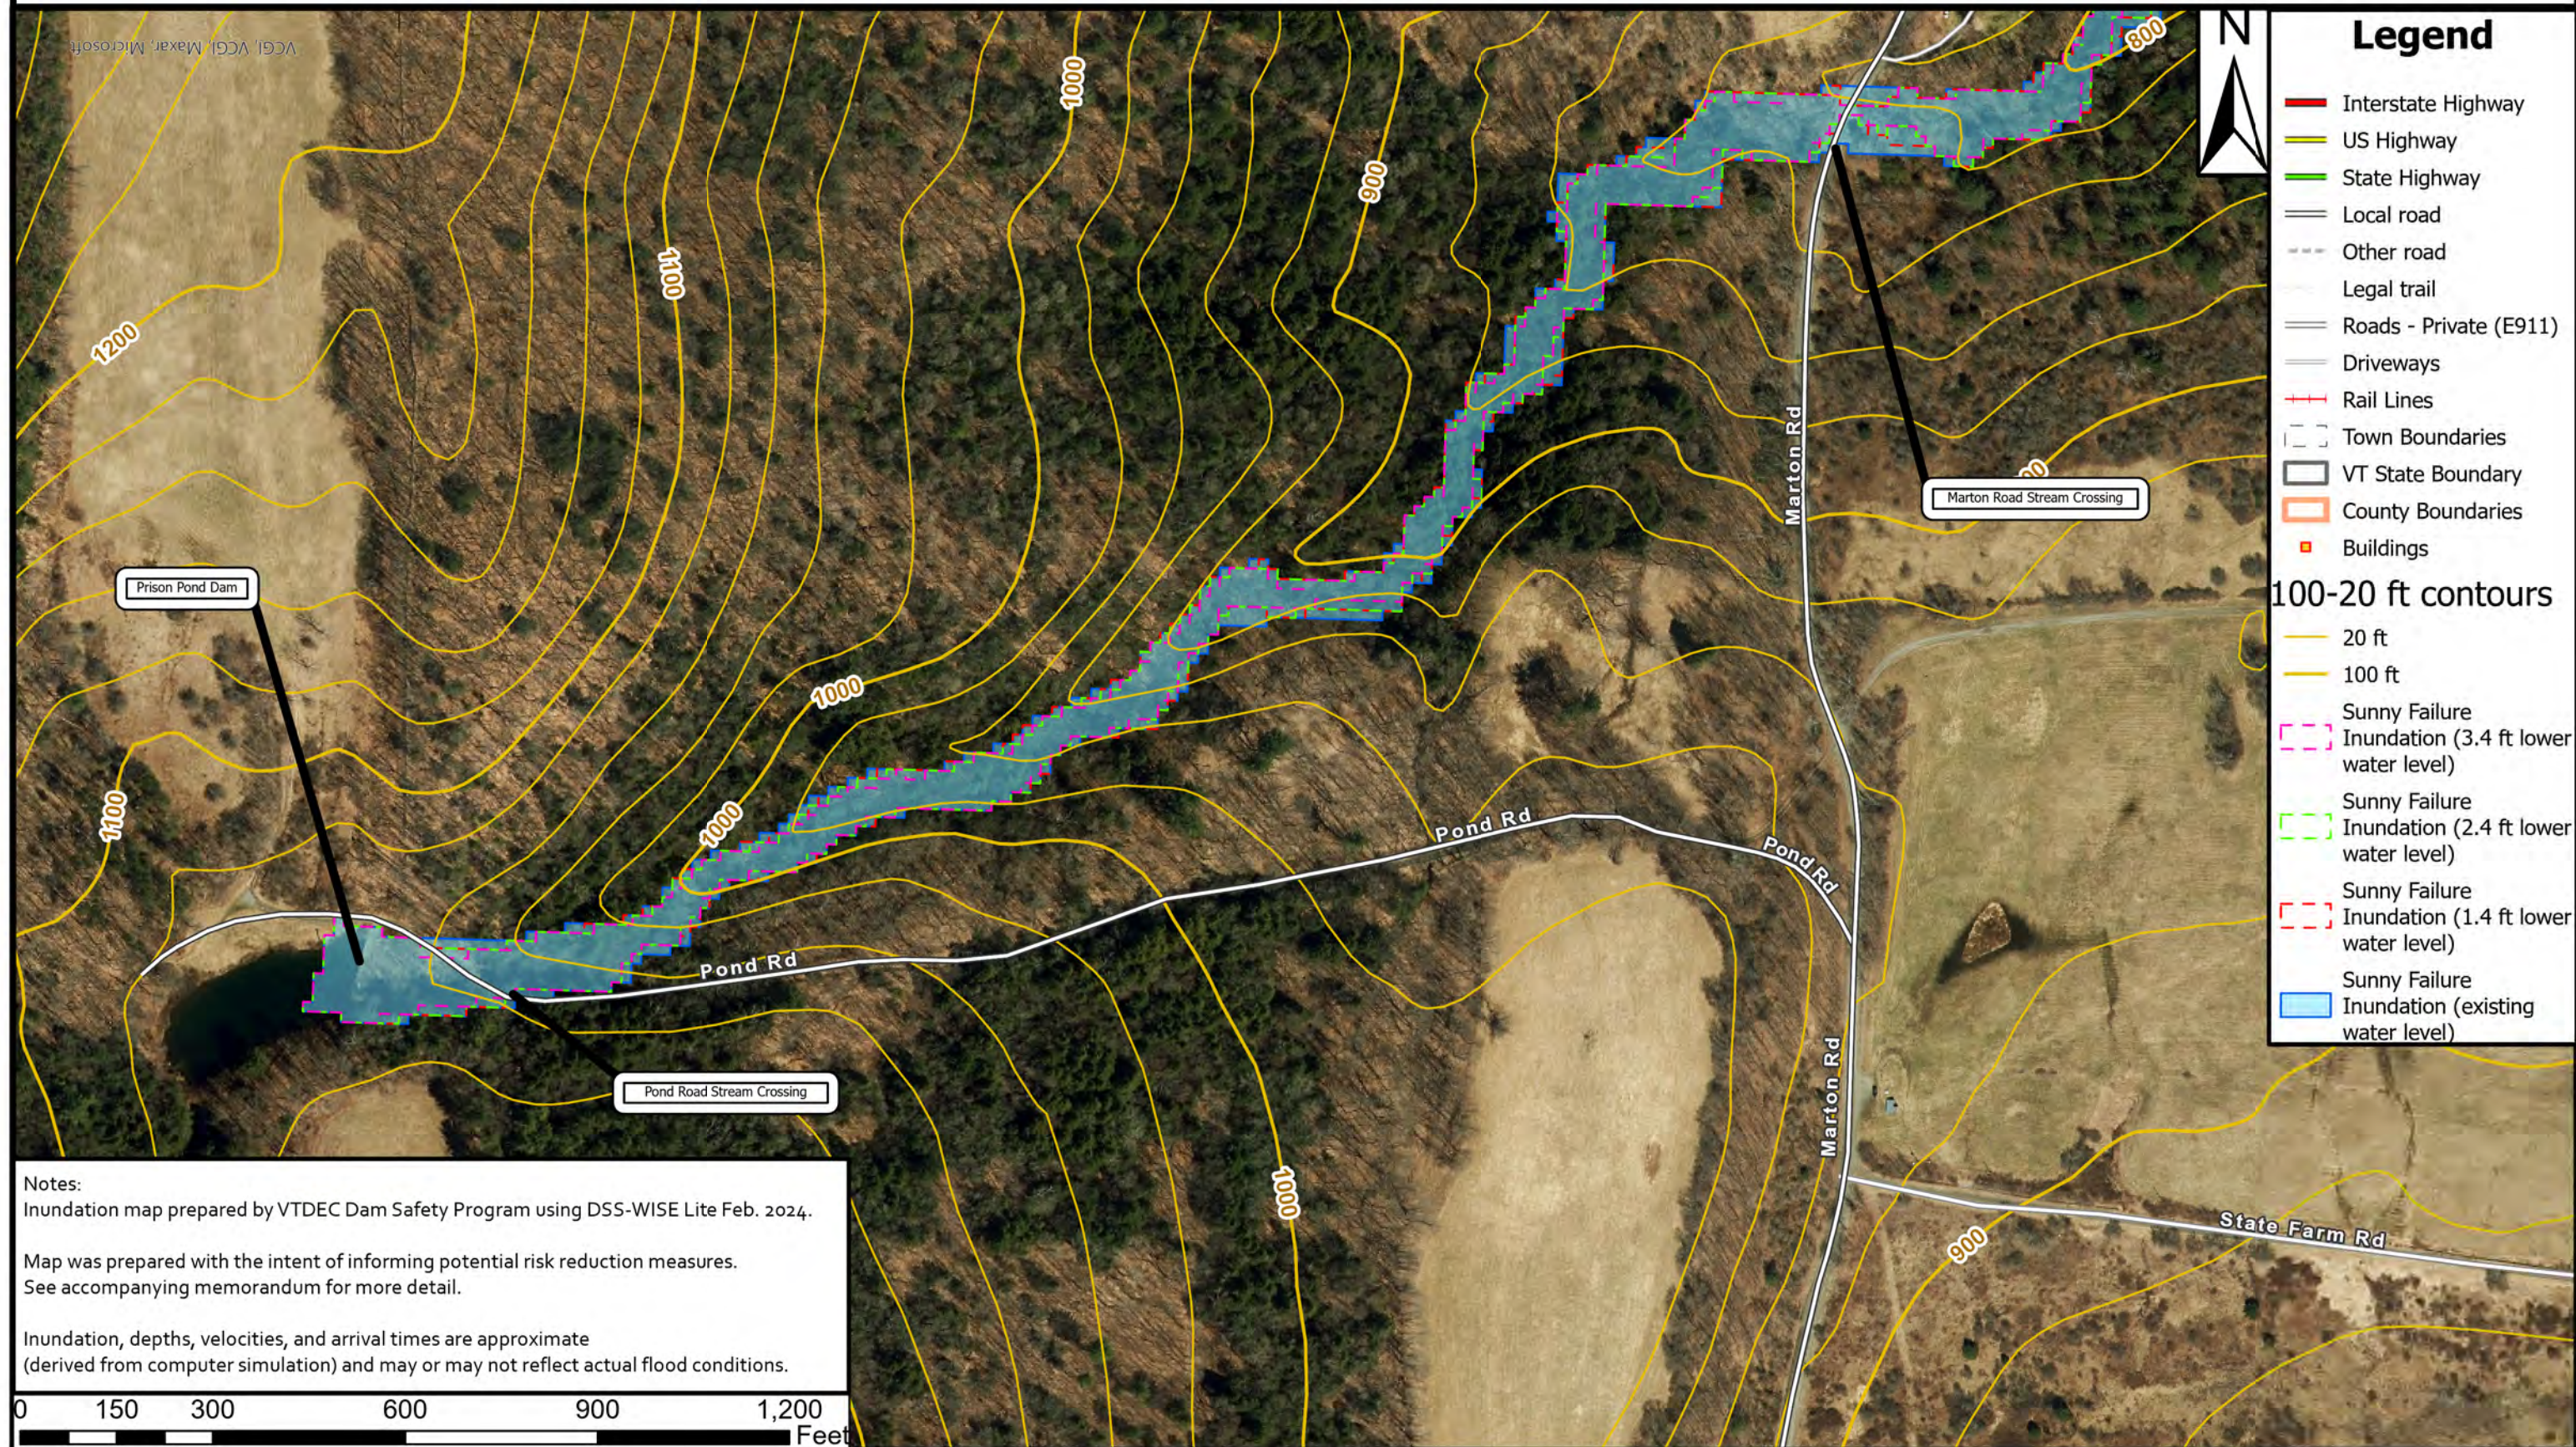
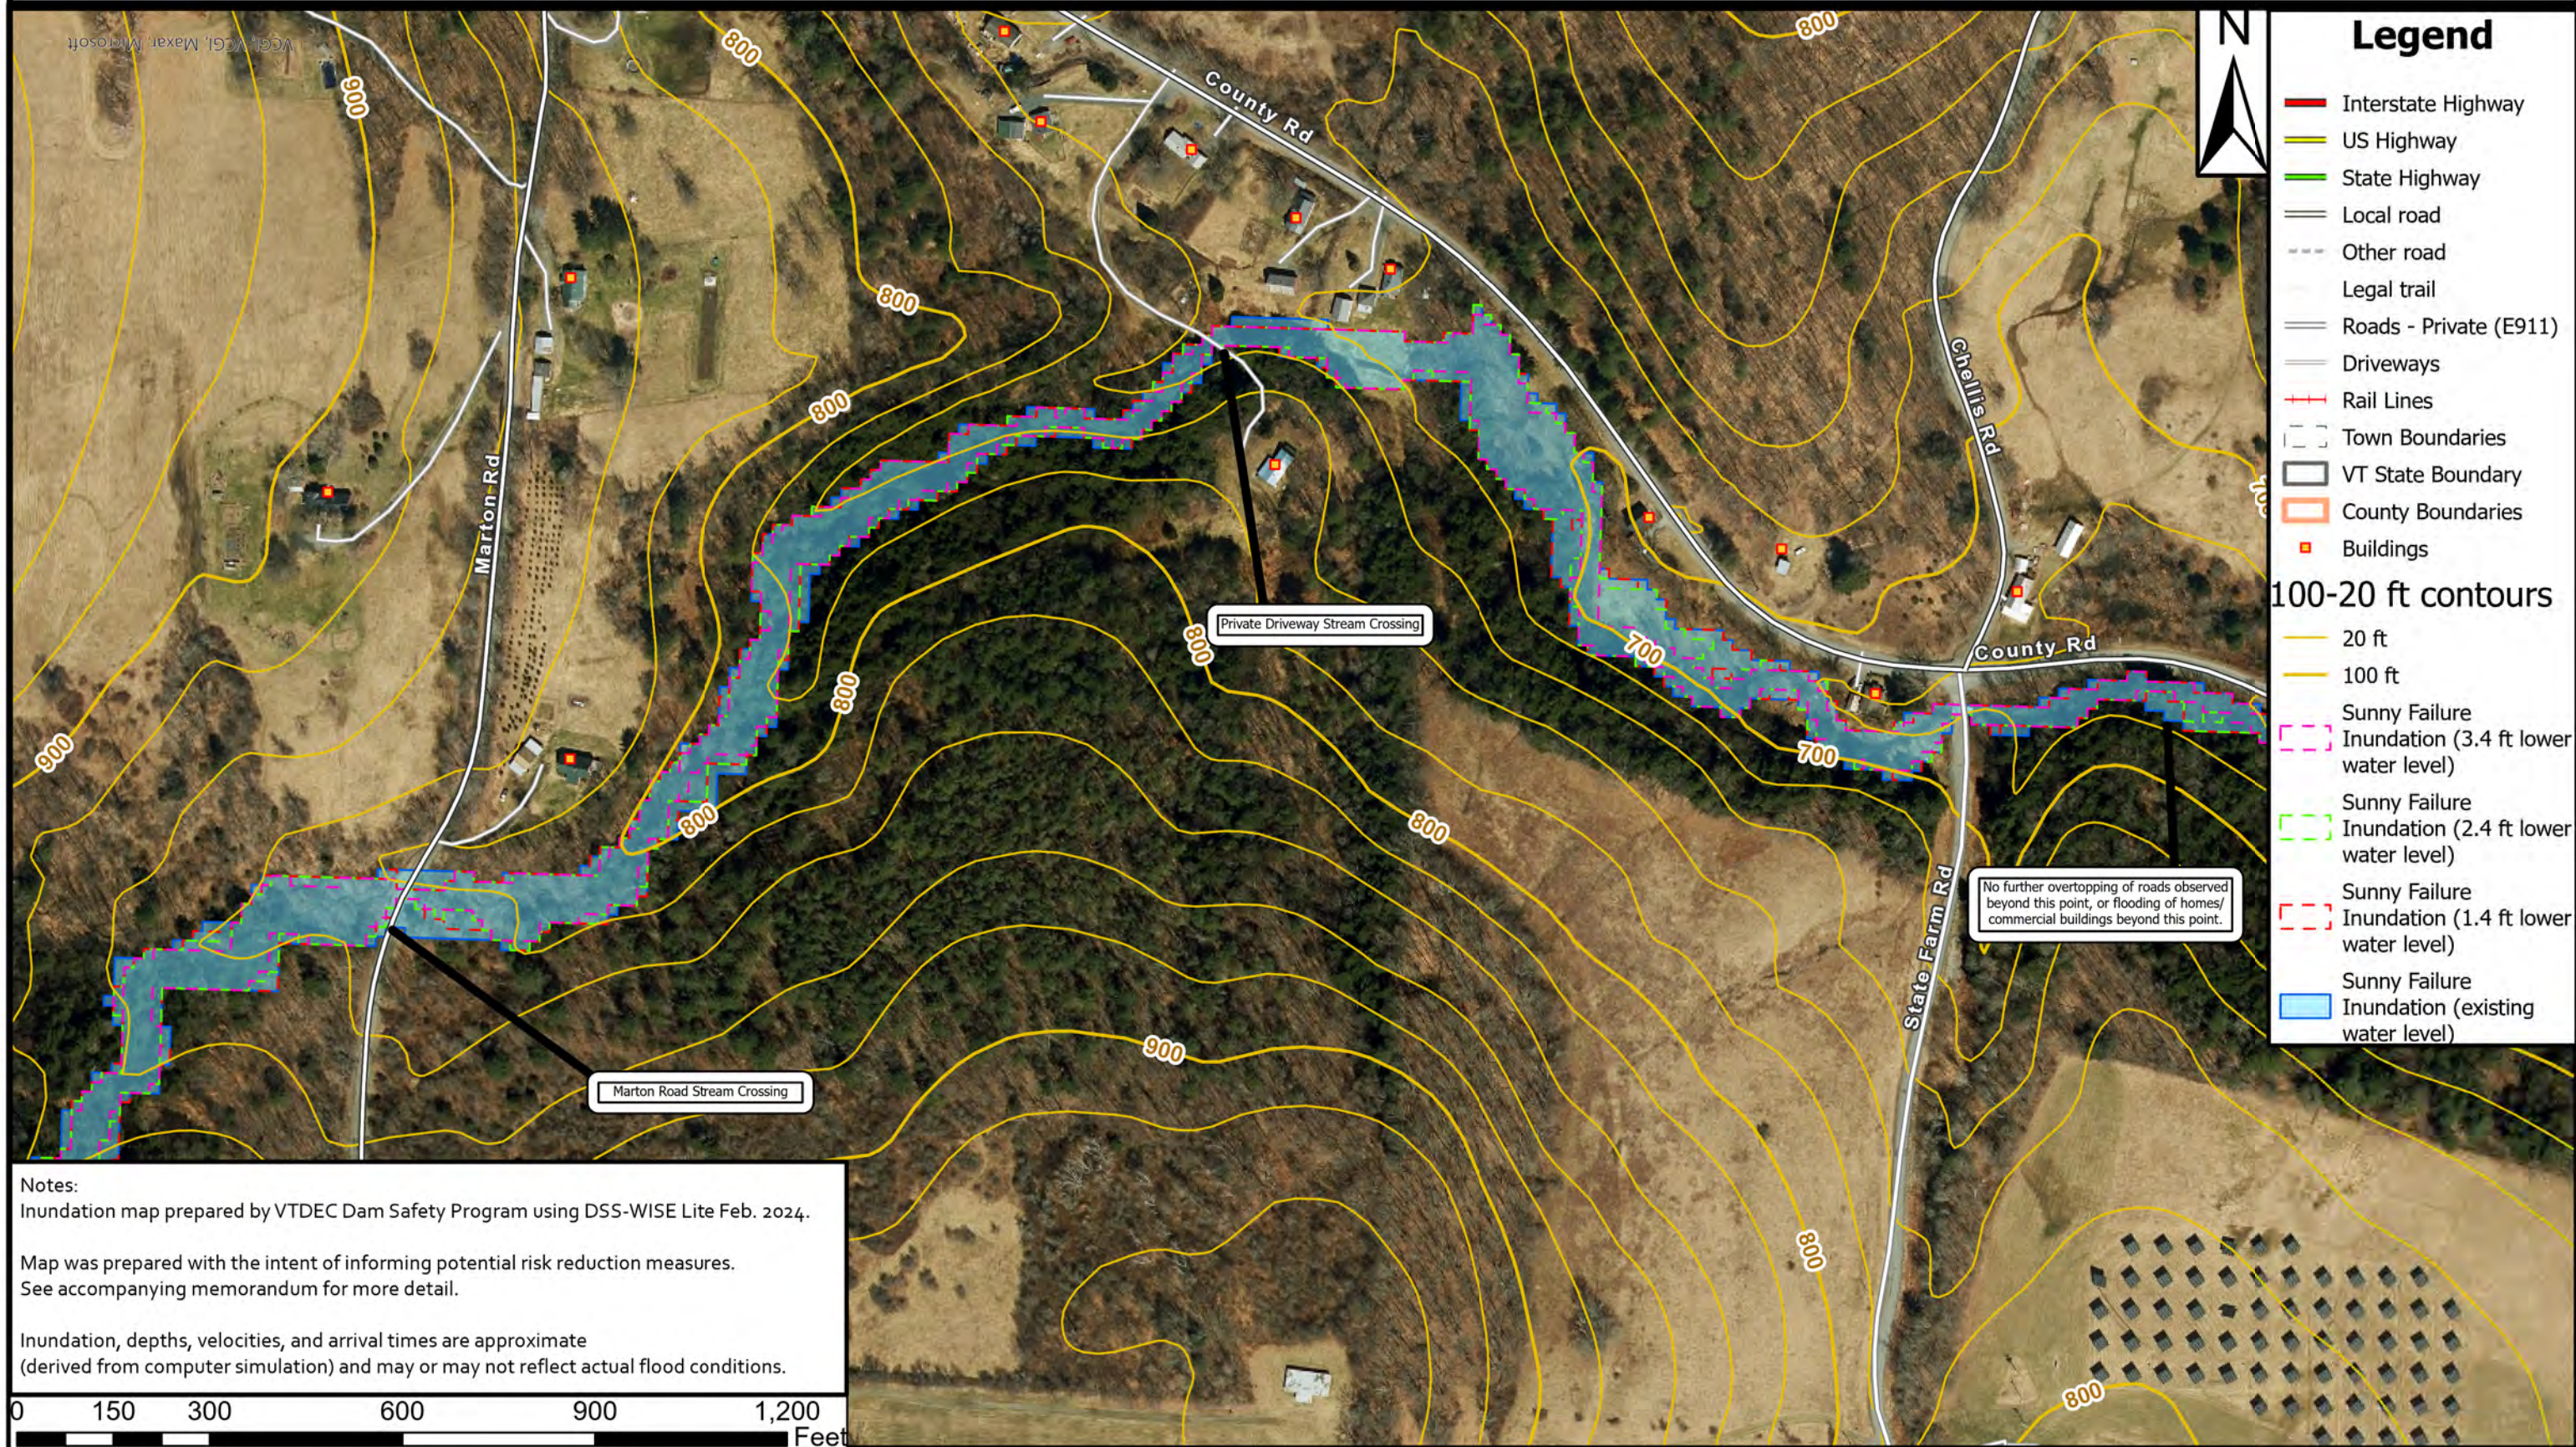
Simplified Dam Failure Inundation Maps

Sunny Failure Inundation (3.4 ft lower water level)

Sunny Failure Inundation (2.4 ft lower water level)

Sunny Failure Inundation (1.4 ft lower water level)

Sunny Failure Inundation (existing water level)

No further overtopping of roads observed beyond this point, or flooding of homes/commercial buildings beyond this point.

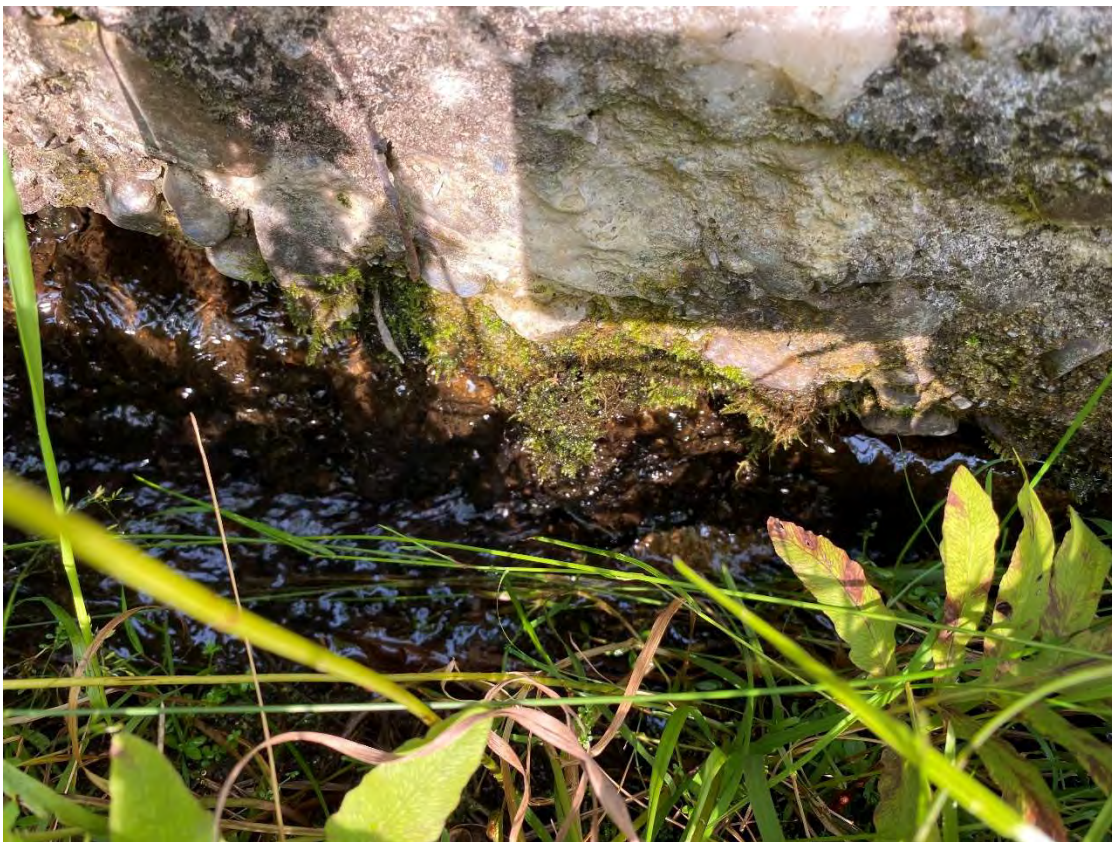
Concrete wall images

- The concrete crest wall to the left and right of the spillway is cracked resulting uncontrolled leakage. This is causing erosion of the downstream embankment and if left unchecked could potentially lead to dam failure. Additionally due to the deteriorated condition of this concrete wall, there is an elevated risk of the wall failing due to inadequate strength to resist loading conditions. A measure to maintain a lower water level which does not result in uncontrolled leakage under normal conditions should be implemented as soon as possible to mitigate the likelihood and potential risks of dam failure. The water level should be maintained at the lower level until remedial repairs are implemented and approved.

Near intersection of left concrete wall with left spillway training wall.
