Vermont Geological Survey Open File Report VG2019-5

# Landslide Inventory of Orange County, Vermont

George Springston Norwich University Department of Earth and Environmental Sciences 108 Harmon Drive, Northfield, VT 05663 802-485-2734; gsprings@norwich.edu December 2019

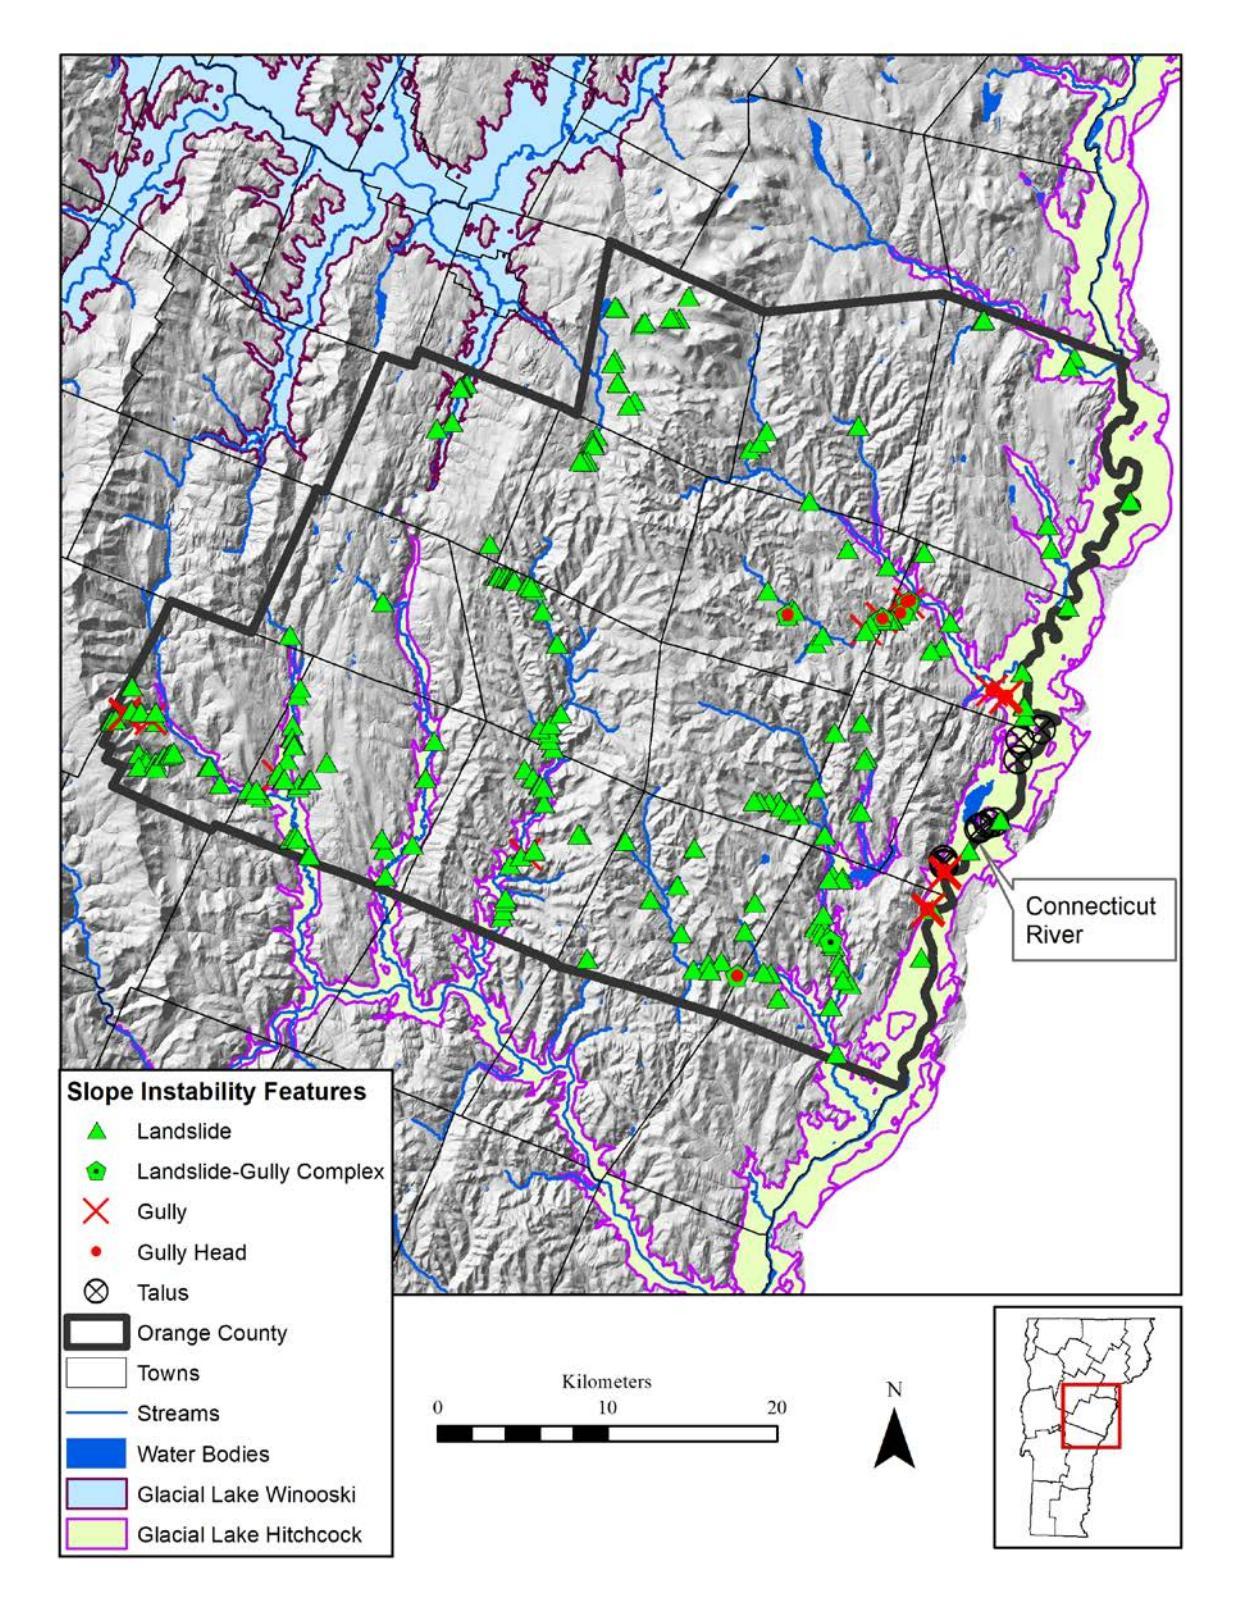
Figure 2. Generalized map of all slope instability hazard sites. These include landslides, landslide-gully complexes, gullies, and talus slopes. These are shown at a larger scale on Plate 1.

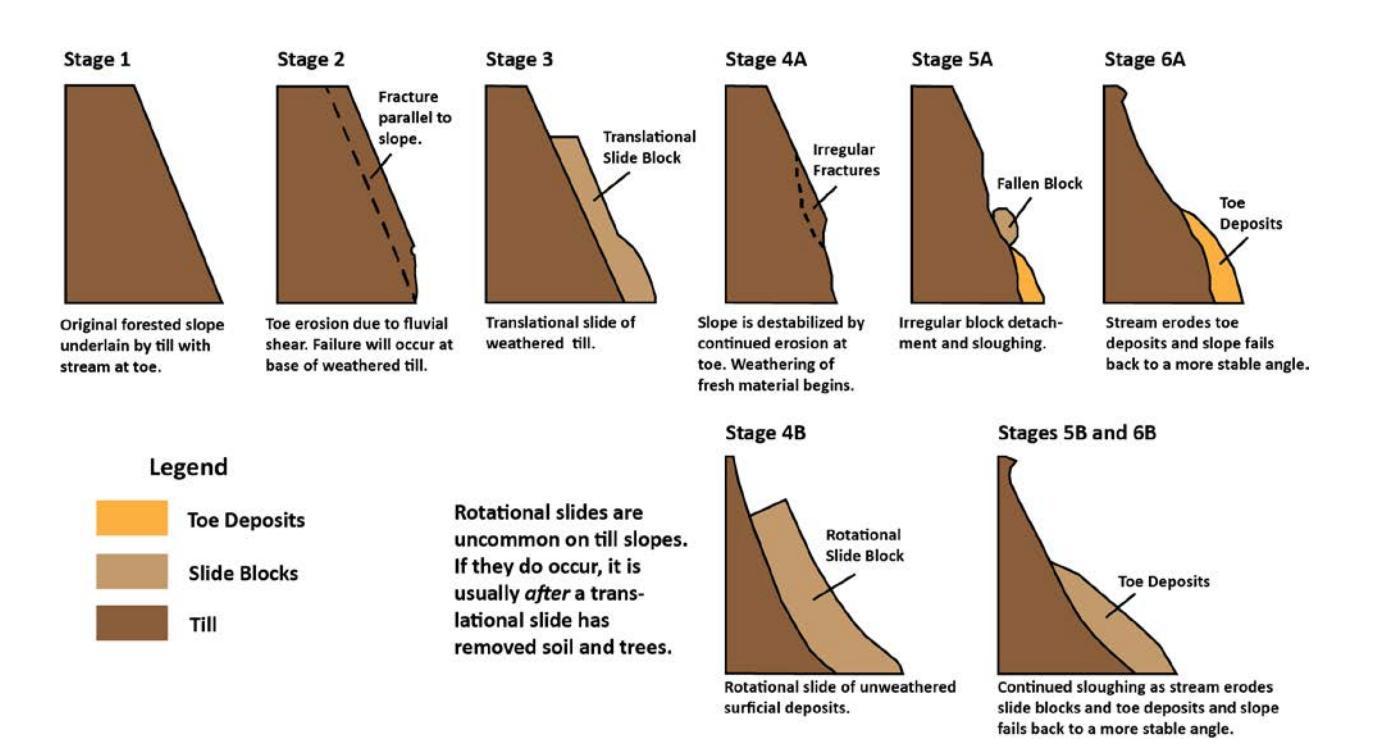
Many of the landslides in Orange County originate in glacial till deposits. A typical landslide in till is shown in Figure 14. Observations of the landslides here and elsewhere in Vermont suggest the following as a common sequence of events on till-dominated slopes in response to catastrophic flood events (Springston and Thomas, 2018). Note that the events described below will not always take place in a sequence of discrete steps. For example, a translational slide on the upper part of a landslide may be occurring at the same time that the base is being undercut by flood waters. The model is illustrated in Figure 15.

- Fluvial shear results in erosion of the bank and/or bed, over-steepening the slope and, if bed erosion occurs, increasing the effective height of the slope. Dense till and lacustrine diamict typically are detached as irregular blocks. Loose materials typically are detached as single grains. At sites where the material is very strong, the stream may undercut the bank, leaving an overhang. Infiltration of rainfall results in an increase in pore-pressure in the surficial material, reducing the effective shear strength of the material.

- Translational slides occur off the upper slope, commonly carrying blocks of soil and trees, with depths of 1.5 to 5 feet (0.5 to 1.5 meters). Parts of the sliding blocks may break up into flows. A rotational slump may occur in place of or following a shallow translational slide. This type of slope failure is more common in lacustrine or ice-contact or stream terrace deposits than in till, but a few examples of rotational slumps have been observed in dense till deposits that were severely undercut by catastrophic flooding.

Figure 15. Model for landslides on till slopes. The initial stages of failure of a wooded streambank by a translational failure are shown in Stages 1 to 3. Stages 4A to 6A show the continued failure of the slope by the detachment of irregular blocks of till. Stages 4B to 6B show an alternate style of rotational failure in till that may occur after heavy stream erosion.
