Detecting and Eliminating Illicit Discharges in the Stevens Branch Watershed and Stowe

Final Report

February 19, 2016

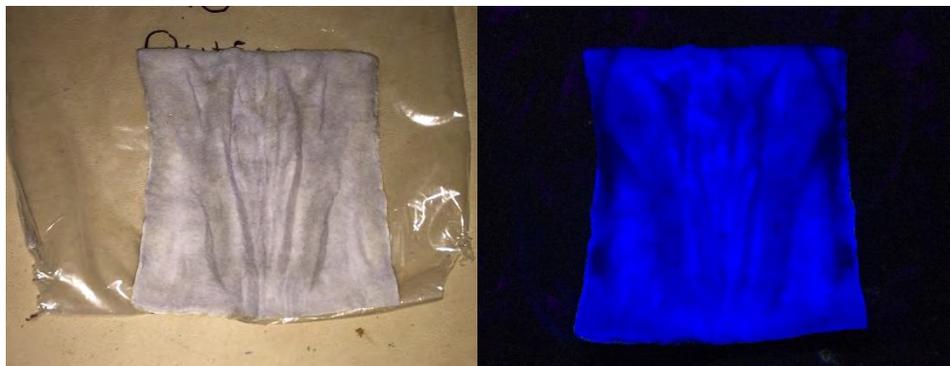
Figure 1. Positive OB monitoring pad under fluorescent lamp (left) and UV lamp (right)

Optical brightener monitoring was performed at outfalls and selected catchbasins and manholes that were flowing at the time of inspection, according to Stone Environmental SOP 6.38.0 (Appendix B). To test for optical brighteners, a cotton pad is placed in the flow stream for a period of 4-10 days, after which the pad is rinsed, dried, and viewed under a long-wave ultraviolet light (“black light”). Florescence of the pad (seen on the right pad in Figure 1) indicates the presence of optical brightener. OB pads are held in a sleeve of

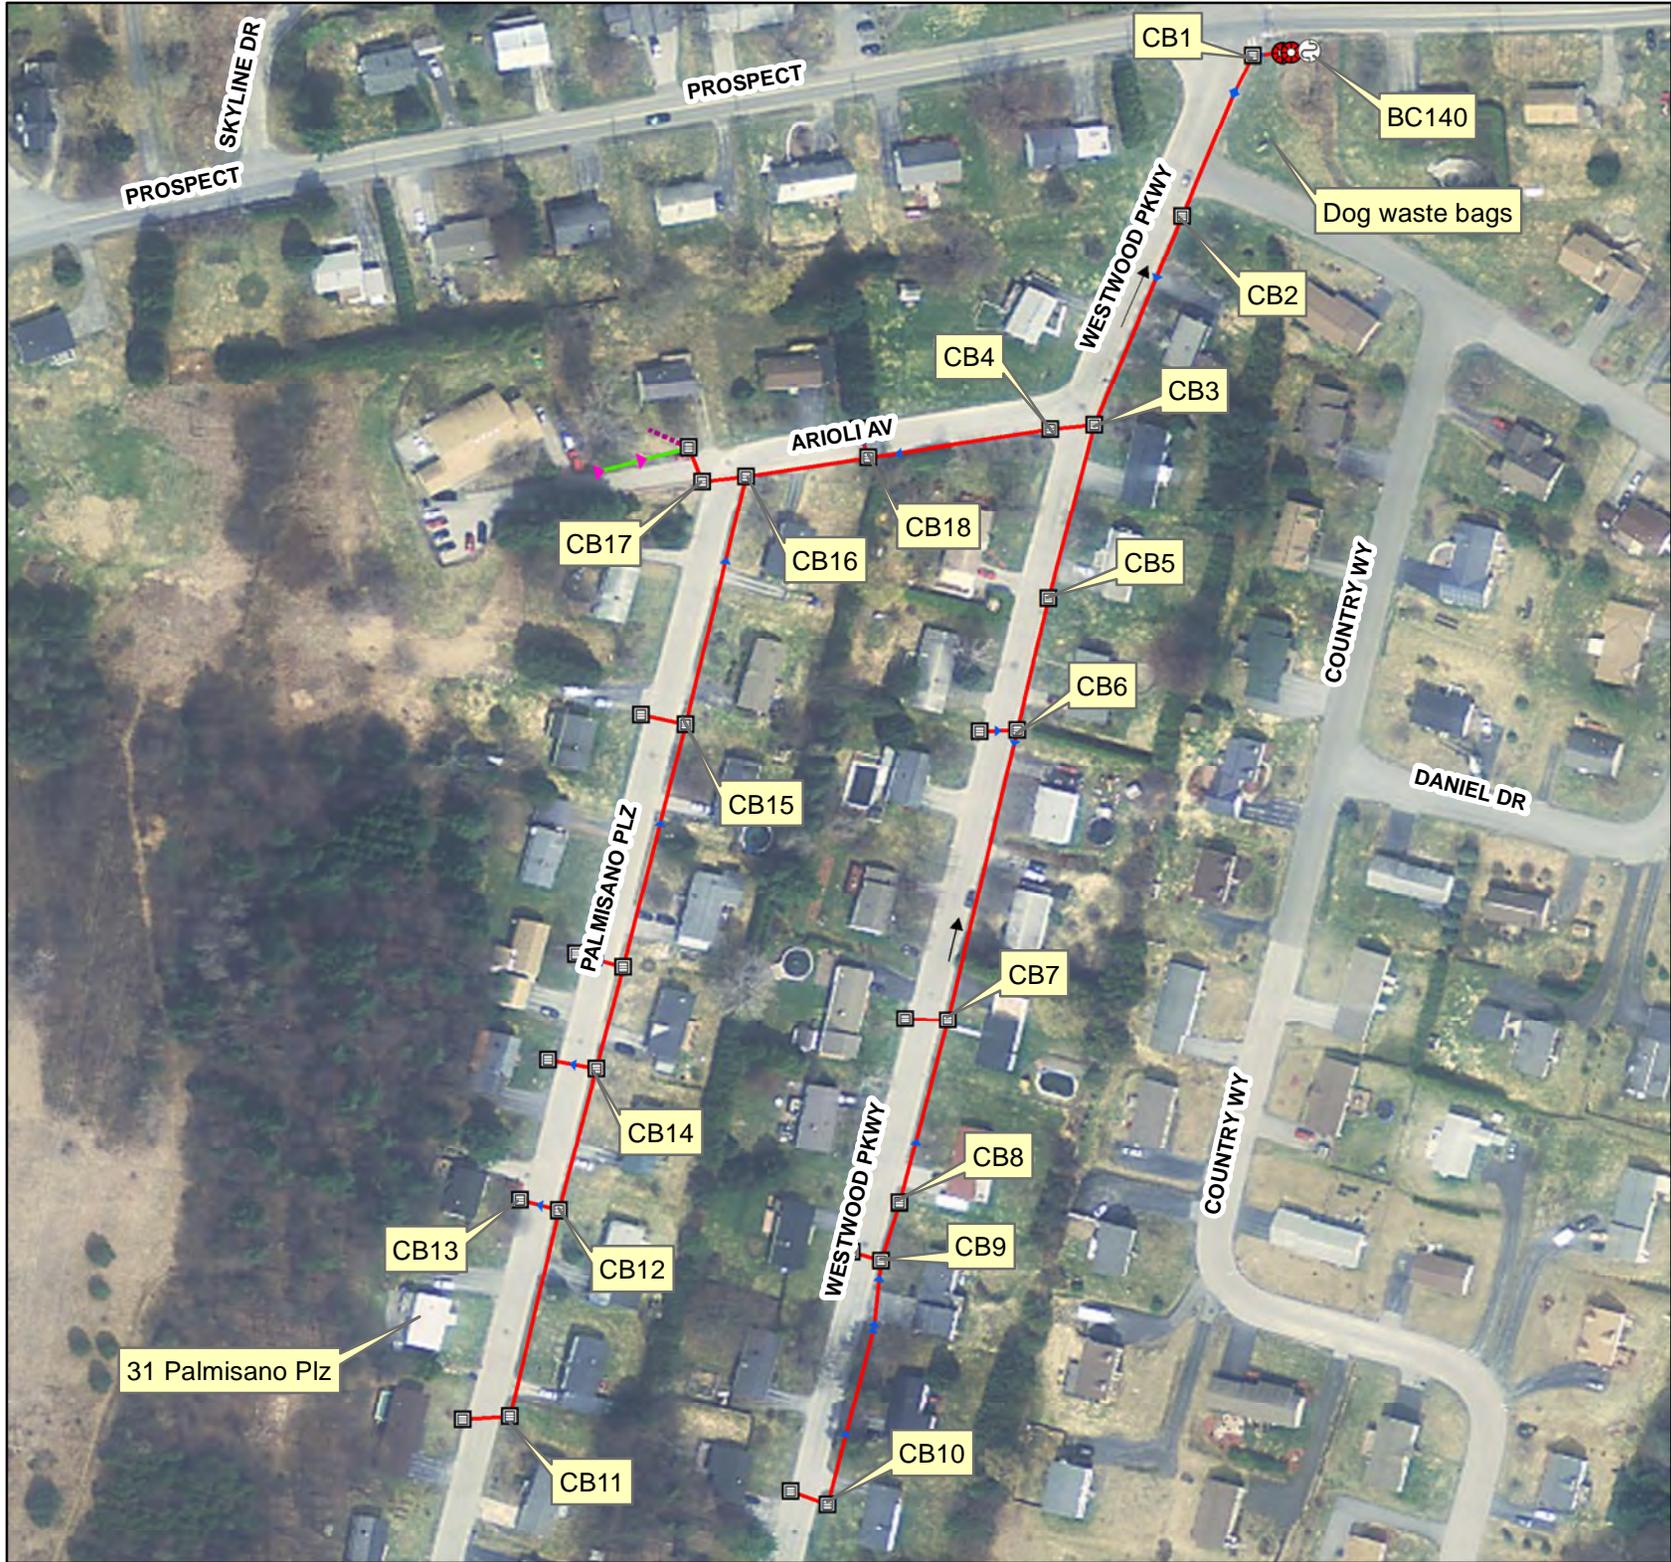
Map BC-1
System BC140
Barre City, VT

- Optical brightener was detected at the outfall on July 31, 2014. A foul odor was observed in the receiving stream channel.
- On September 22, 2015, samples were collected at the outfall for *E. coli* and total phosphorus analysis (Table 20). The phosphorus concentration was very low, 12 µg/L. The *E. coli* concentration (170 MPN/100 mL) was lower than expected given the presence of bags of dog waste in catchbasins in this system. The stream channel upstream and downstream of the outfall was also littered with bags of dog waste.

- Dog waste bags were noted in several catchbasins on Westwood Parkway on September 23, 2015. Disposal of dog waste in catchbasins in this neighborhood is the likely source of the foul odors observed during the 2014 assessment.

- On September 23, 2015, a petroleum odor was observed in catchbasin CB12 and oily residue was observed in catchbasin CB13 on Palmisano Plaza (Map BC-1). Note that CB13 is not mapped accurately; it is located in front of 31 Palmisano Plaza. The catchbasin grate had an oily appearance, indicating waste oil was recently dumped into the drain. A dumpster was located next to this catchbasin in front of 31 Palmisano Plaza (Figure 2).

Conclusion: Three apparently unrelated problems were identified in this system. Disposal of dog waste in catchbasins on Westwood Parkway presents both water quality and human health concerns. Disposal of waste oil in catchbasin CB13 on Palmisano Plaza is illegal. Finally, there appears to be washwater or sanitary wastewater entering the system above catchbasin CB15 on Palmisano Plaza (Map BC-1). The exact source is not known. The most likely explanation is a leaking sewer lateral at a house located between catchbasins CB14 and CB15, possibly discharging to the storm sewer via one of the three pipe connections observed in this section. Another explanation is that the observed petroleum contamination caused false positive optical brightener readings on the Palmisano Plaza line, although the absence of optical brightener in CB12, CB13, and CB14 is counter to this theory.

- Mr. Micheli has spoken to the homeowners of 31 Palmisano Plaza advising them that discharging petroleum products or any other wastes to catchbasins is illegal. In our January 19, 2016 meeting, Mr. Micheli stated he would check on the issue periodically. If any further petroleum spill or dumping to the municipal drainage system occurs, Mr. Micheli will refer the matter to DEC enforcement.
- Stone recommends the City of Barre install placards on catchbasins on Westwood Parkway or a sign near the intersection of Westwood Parkway and Prospect Street advising residents not to dump wastes in catchbasins.
- Stone recommends dye testing of houses between catchbasins CB14 and CB15 to identify any possible graywater connections or leaking sewer laterals. Specifically, we recommend dye testing houses 8, 12, 16, and 20 Palmisano Plaza.

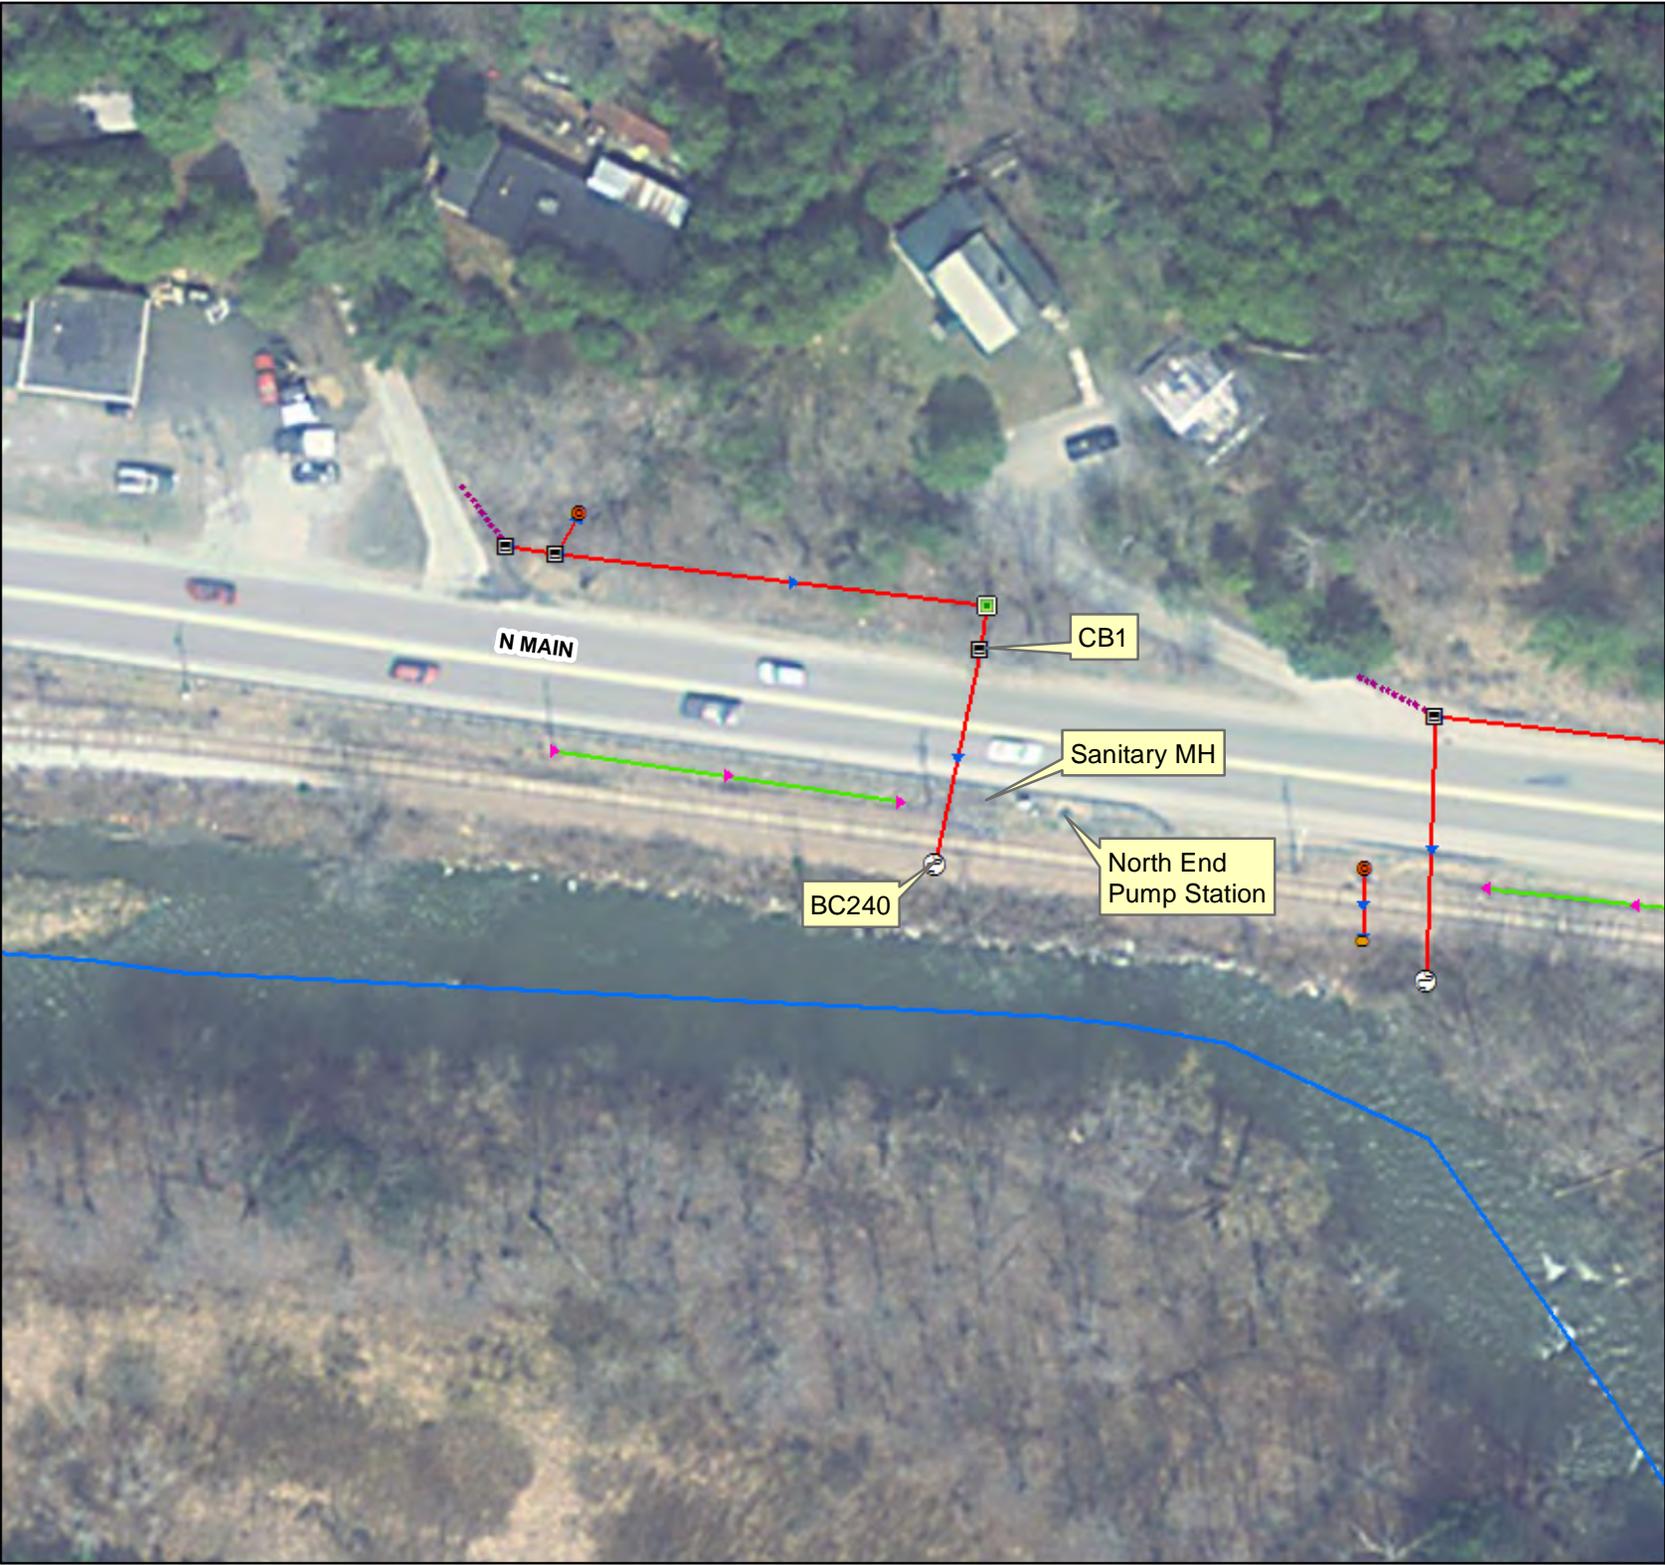
Map BC-2
System BC240
Barre City, VT

- Wastewater odor and pump sounds were consistently observed at the outfall. Optical brightener was detected at the outfall on both occasions it was monitored.
- There was no flow on September 22, 2015, the day *E. coli* samples were collected in Barre.
- On December 11, 2015, a sanitary manhole located directly west of the North End pump station was accessed. A pipe was found apparently connecting the sanitary manhole to the stormline, with an invert a few inches above the floor of the manhole (Figure 5). Dye poured into the pipe opening quickly flowed to the outfall (Figure 6).
- The Barre Department of Public Works determined that a valve intended to restrict sewer overflow from the pipe to the storm sewer was not working properly.

Conclusion: Based on wastewater odors and pump sounds repeatedly observed at the outfall, the gray appearance of water in the splash pool below the outfall, and the presence of optical brightener, a direct connection between the sanitary sewer and the stormwater system was suspected. A direct connection via a sewer overflow pipe was confirmed on December 11, 2015.

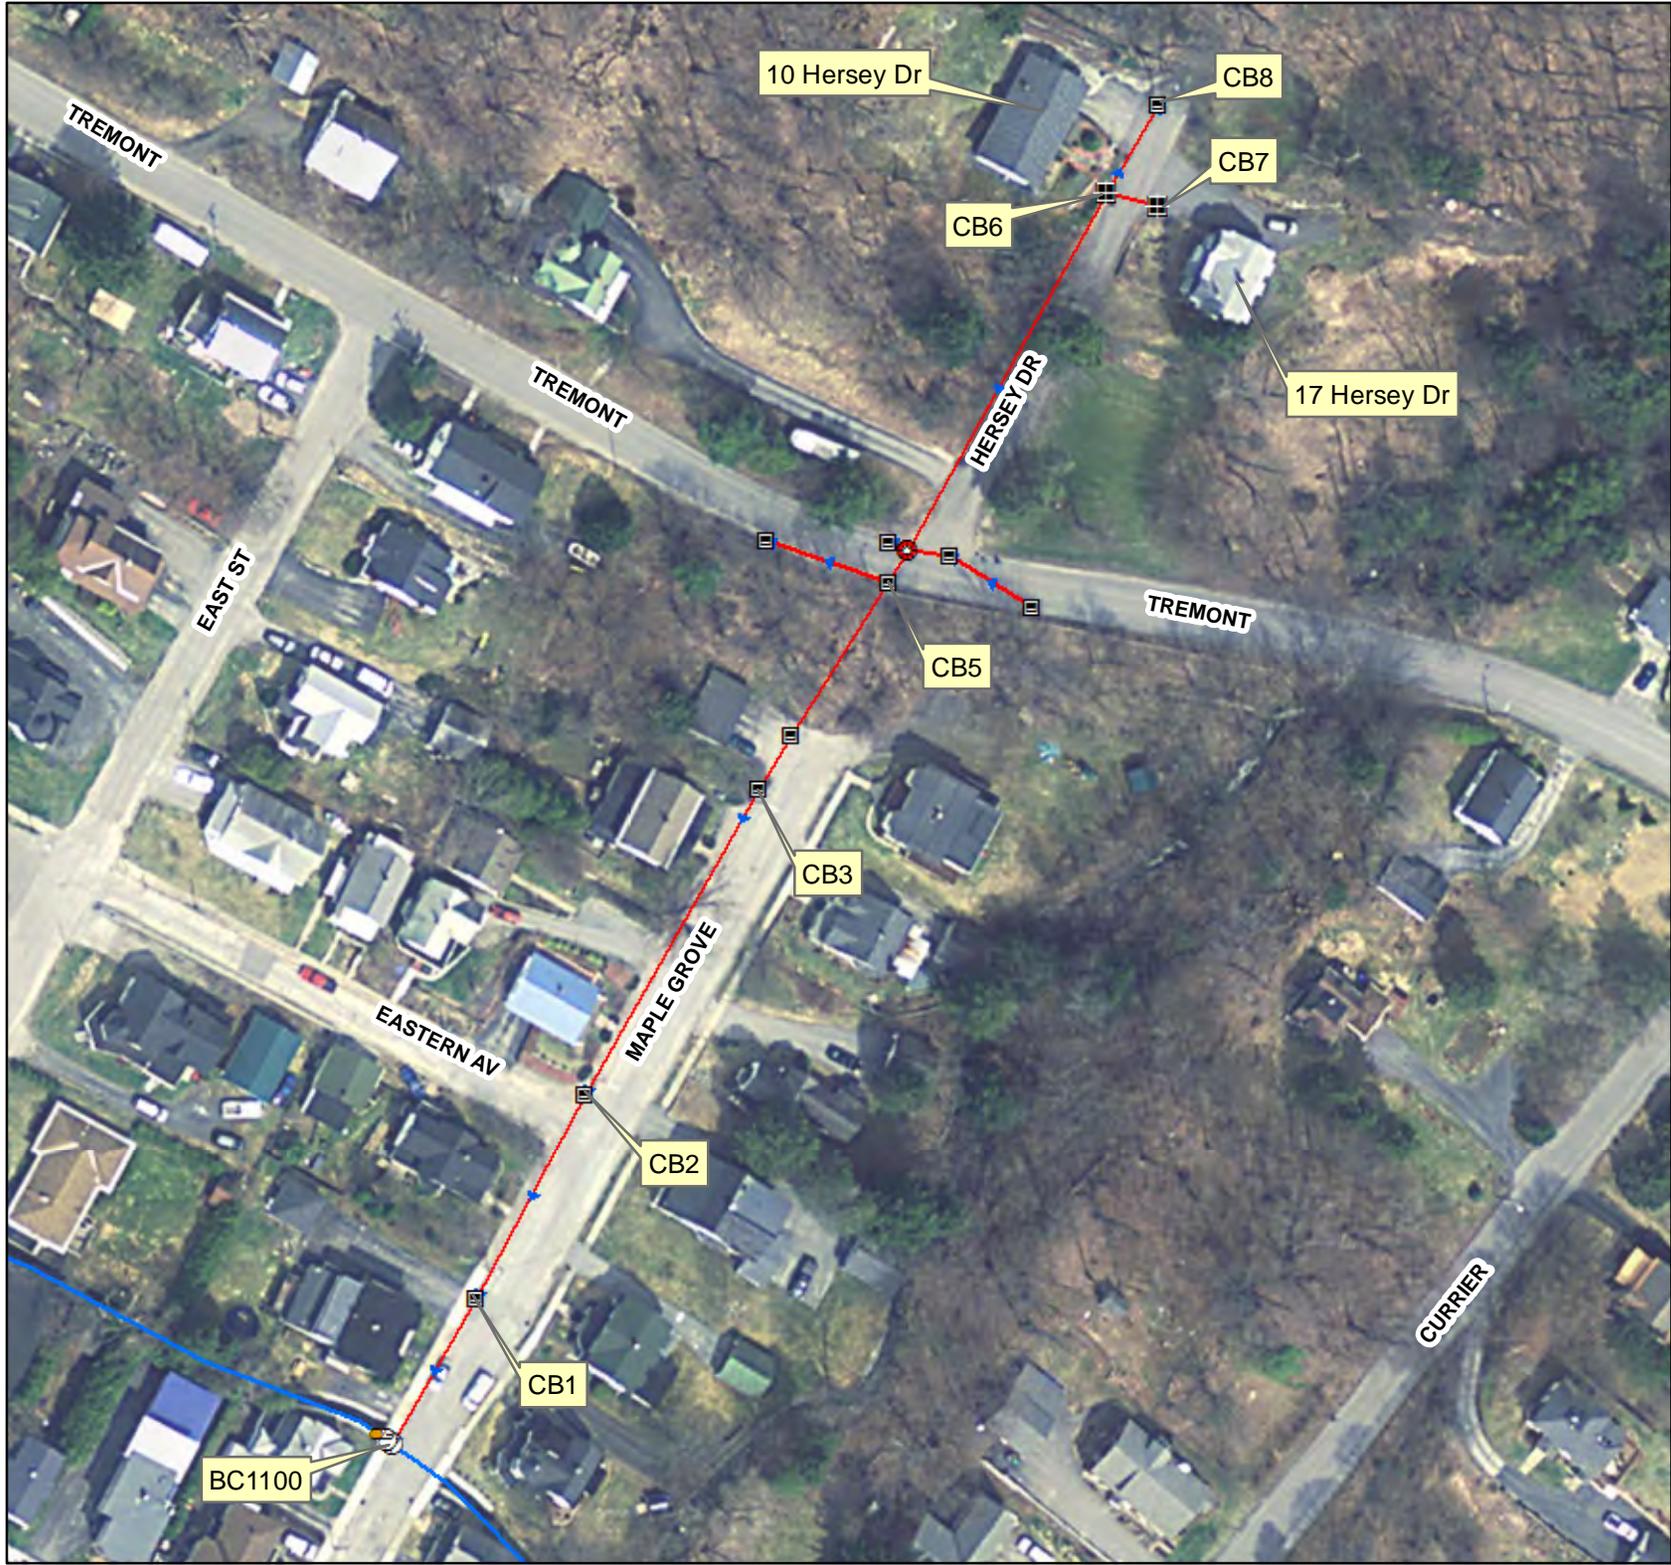
Map BC-3
System BC1100
Barre City, VT

Conclusion: We suspect diluted sanitary wastewater is discharging to the Hersey Drive storm sewer in the vicinity of catchbasin CB6. The most likely explanation is that a leaking sewer lateral serving 10 Hersey Drive is infiltrating the storm sewer at or immediately up-pipe of catchbasin CB6 (between CB6 and CB8 or between CB6 and CB7).

Resolution: In our January 19, 2016 meeting, the City of Barre Department of Public Works confirmed they plan to dye test the house at 10 Hersey Drive. Given some uncertainty regarding optical brightener testing at catchbasin CB7 and dye testing of 17 Hersey Drive, we also recommend the City retest 17 Hersey Drive, watching for dye at catchbasin CB6.

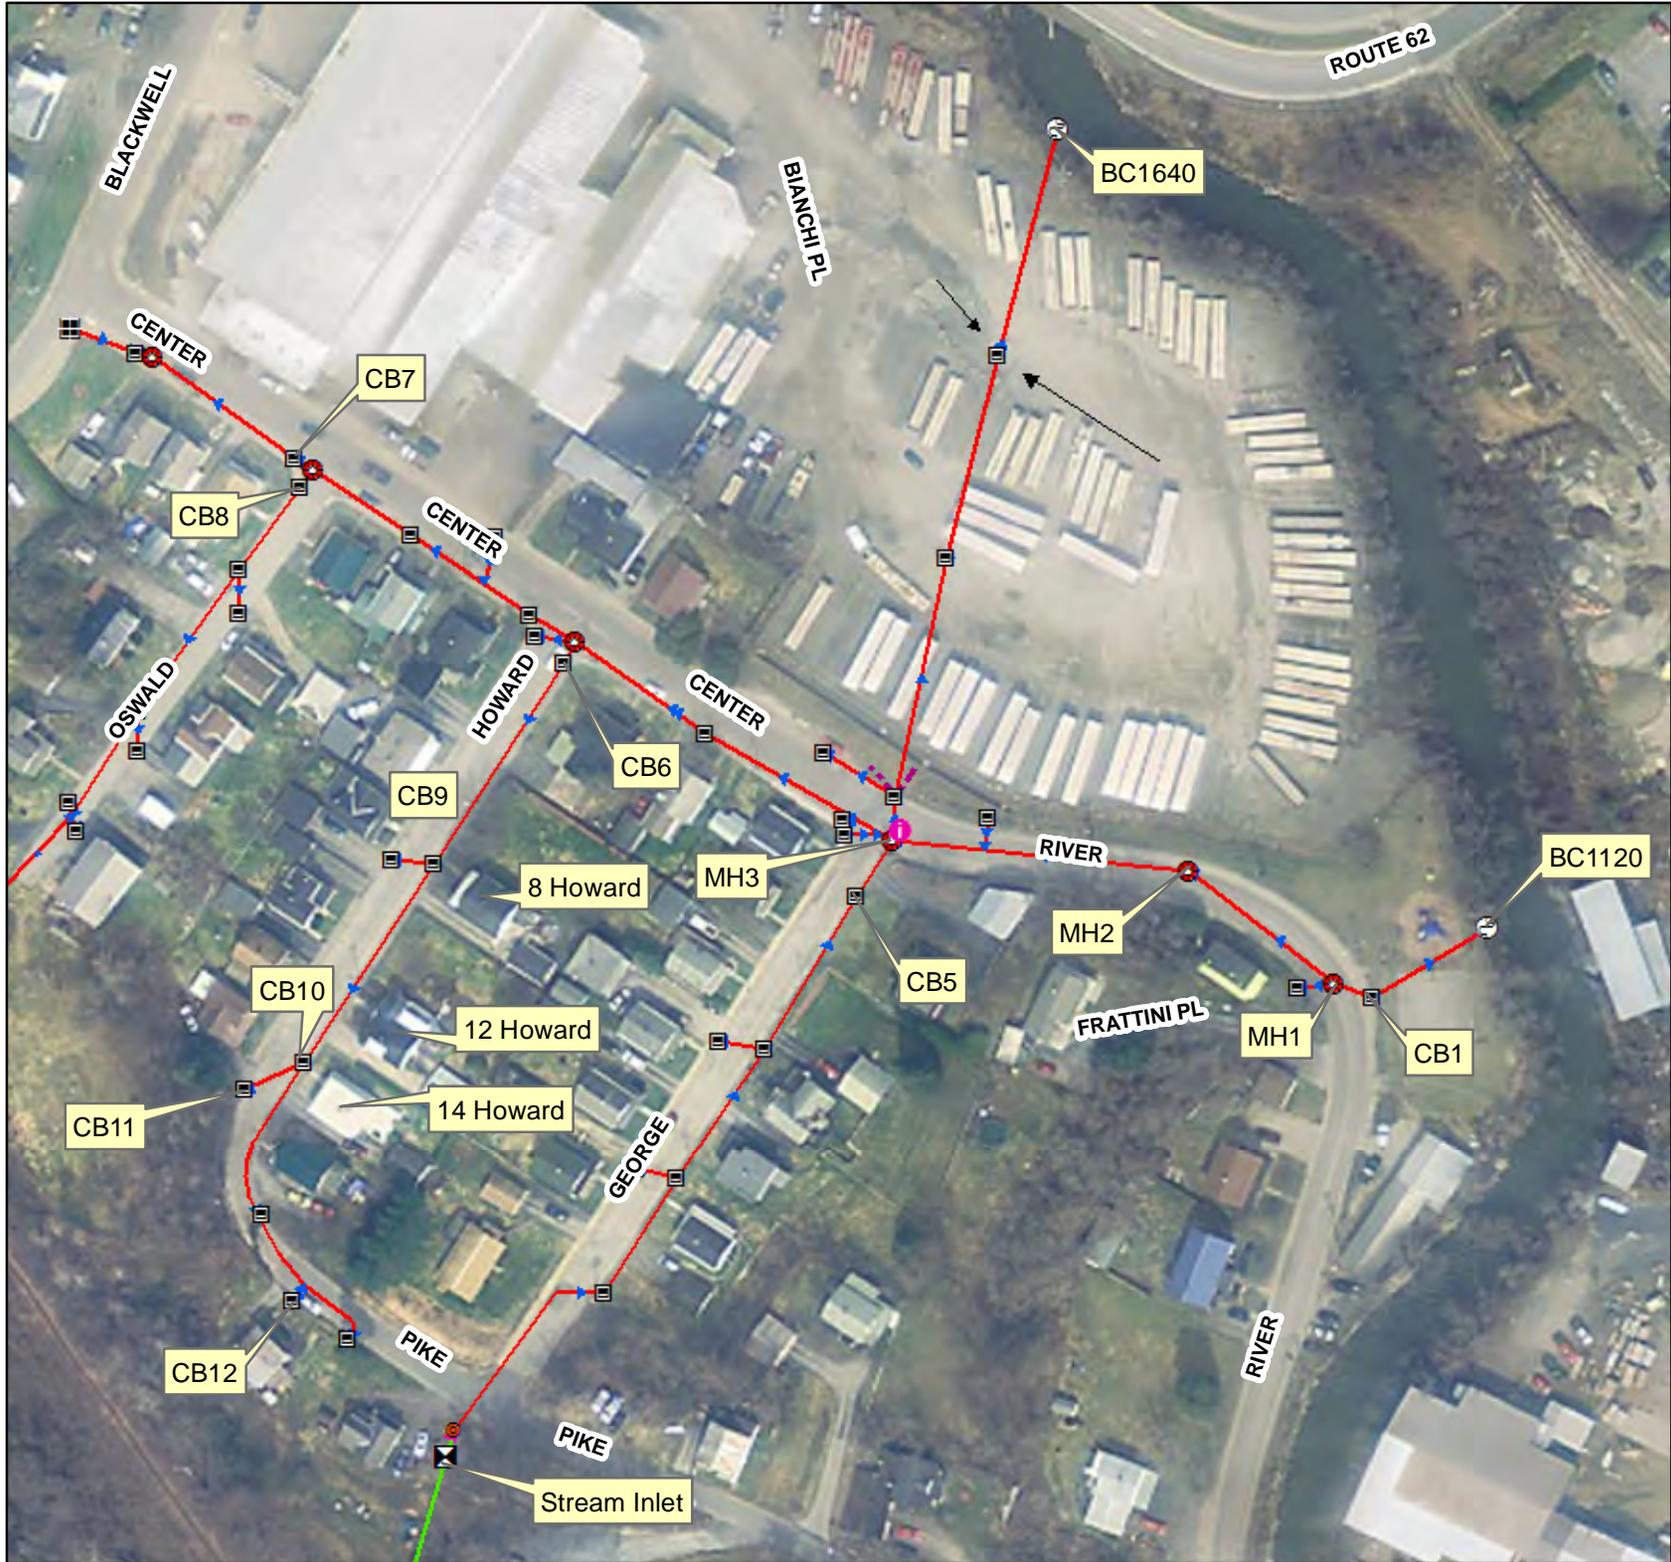
**Map BC-4
System BC1120
Barre City, VT**

- Optical brightener was detected at the outfall in a monitoring pad deployed on September 25, 2014. Optical brightener was also detected at catchbasin CB1 and manhole MH3 (Map BC-4). A strong wastewater odor was observed at CB1.

- The concrete sewer main flowing through stormwater manhole MH1 (Figure 7) has reportedly been repaired multiple times in the last decade. This pipe was found to be leaking badly when FWR and Stone performed the first Barre City IDDE project in 2006. According to the Department of Public Works, it was repaired in 2006 and again more recently. In a November 24, 2015 meeting, Everett Hoyt indicated he had recently inspected the pipe section and it was not leaking. Mr. Hoyt also explained that he had

found and cleared a major obstruction in the sewer main in the sanitary manhole immediately below this section of pipe. The obstruction has caused wastewater to surcharge but not overflow the sanitary manhole.

-
- In November, 2015, the Department of Public Works reportedly cleaned the storm line on Howard Street in preparation for inspecting it with a closed circuit TV camera. A camera malfunction delayed the work. Oil stains were observed on the catchbasin CB9 grate.

Conclusions: We suspect there are (or were) two sources of optical brightener—and wastewater—entering this system. One source is (or was) in the area where the sanitary sewer crosses the storm sewer (in or near catchbasin CB1, manhole MH1, or the storm line connecting the two structures). Water pressure in the sewer main resulting from obstruction in the sanitary manhole likely caused wastewater and sewer odors to infiltrate the underlying storm drain, either via an unknown direct connection or through gaps and cracks in the walls of the structures. Cleaning the sewer main appears to have eliminated or reduced this source. Because optical brightener was detected on the main line up to catchbasin CB9 on Howard Street, potentially masking sources lower in the system, we cannot say conclusively that the source near CB1 and MH1 was eliminated by cleaning the sanitary sewer.

We suspect a second source of optical brightener on Howard Street, but have been unable to confirm this to date through camera inspection or dye testing. The Department of Public Works plans to conduct camera inspection on Howard Street when conditions allow. However, another explanation is that oil dumping or leaking from a vehicle into catchbasin CB9 (oil was observed on the grate) could have caused false positive OB detections.
